Date: 20th March 2025  
Reference: 15-974 V33

## GAS MEMBRANE VALIDATION – BENNETT STREET

| <b>Project Name:</b> | Bennett Street |
| <b>Plot:</b> | 26-28 |

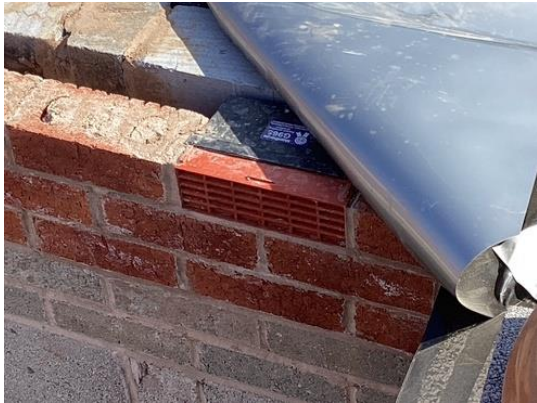
Photo 1

| <b>Are telescopic vents present?</b> | Yes |

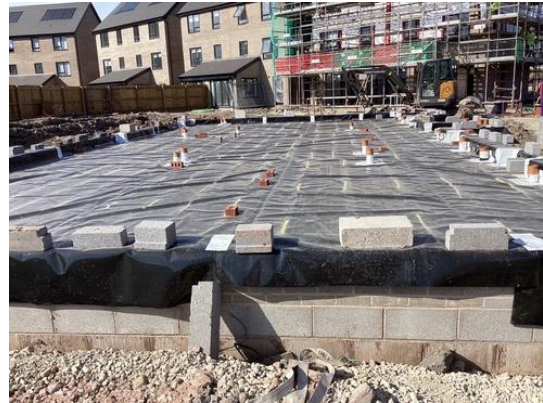
Photo 2

| <b>Gas Membrane Type: Manufacturer, gauge, and colour. (Take photos where possible showing Label)</b> | Black GP Titanflex |
| <b>Gas Membrane Condition: Open punctures, tears, rips, stretching, Presence of debris, Repairs, Signs of weakness such as raised or sunken indentations, Protection plan in place to restrict access to laid gas membrane? IF FAIL DESCRIPTION IN ACTIONS AND PHOTOS REQUIRED</b> | <div>Pass</div> |

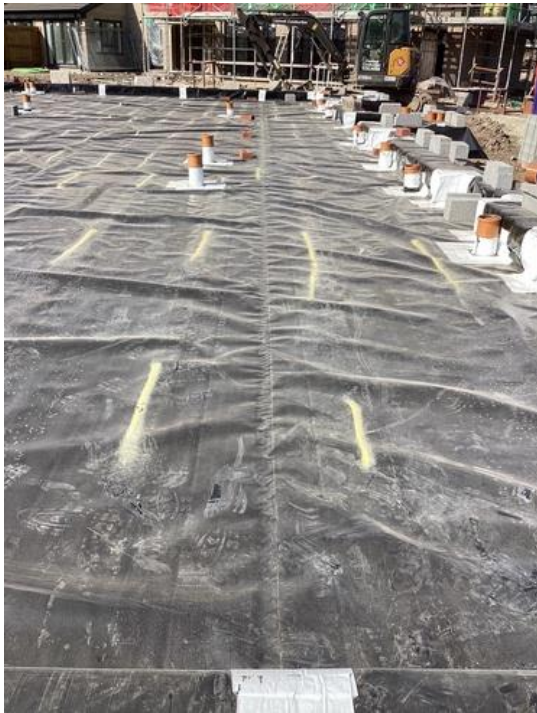
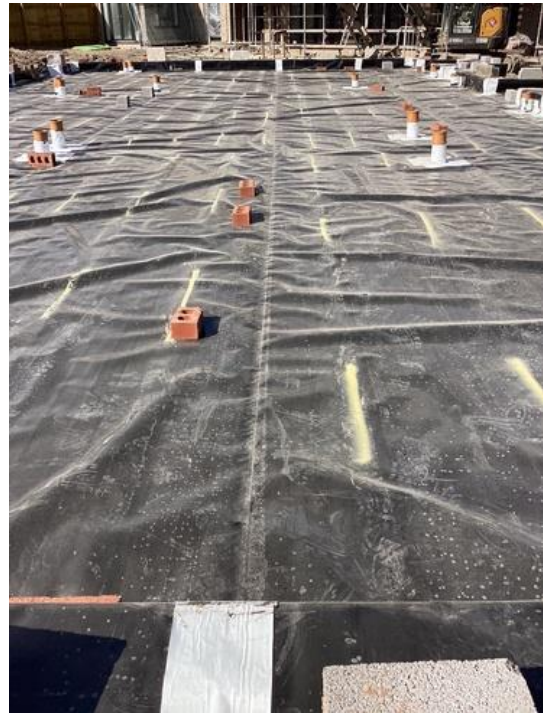
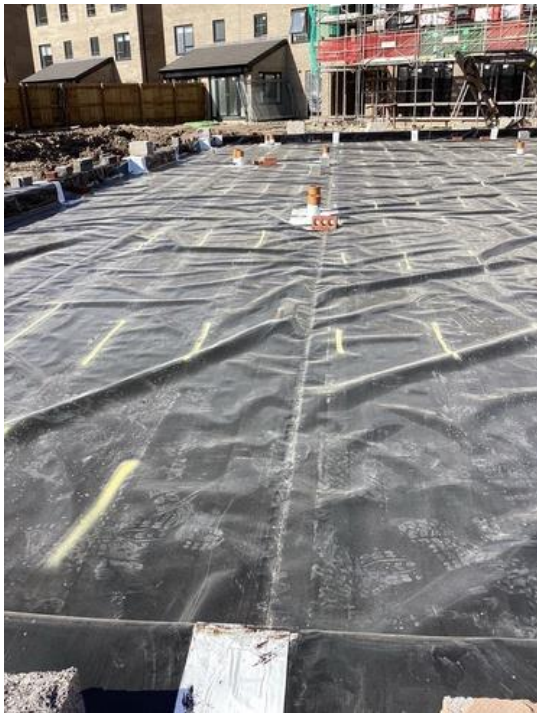
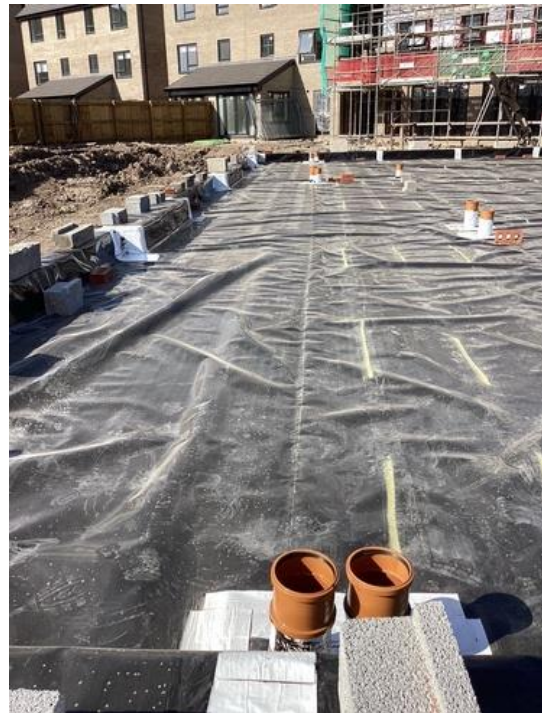
| <b>Are welds complete?</b> | Yes |

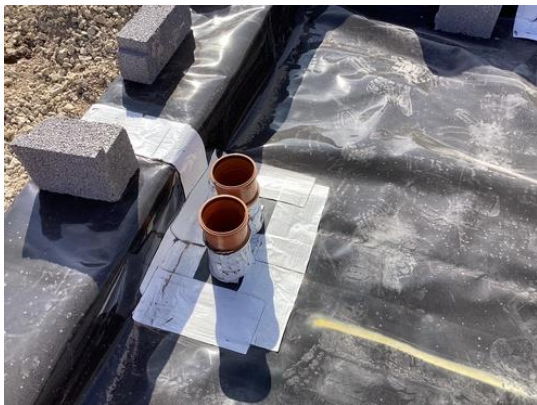
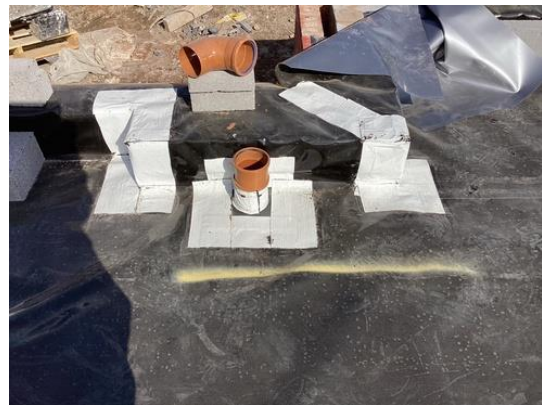
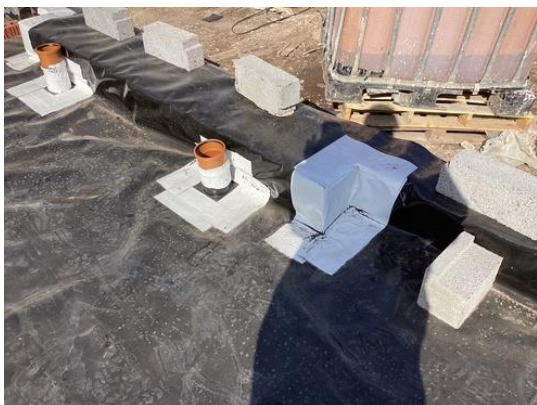
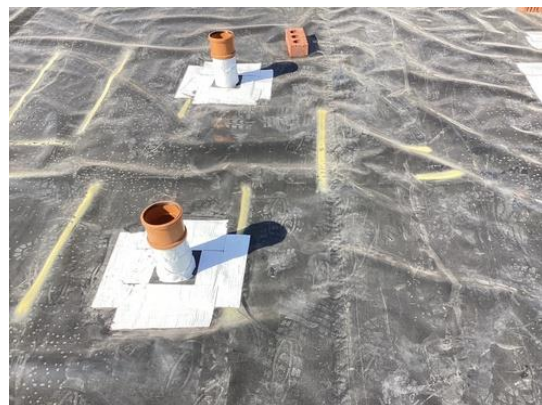
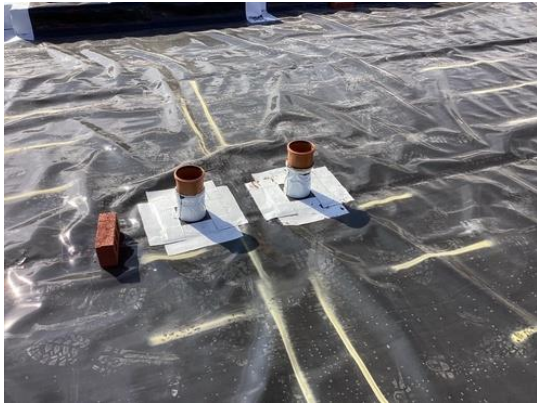
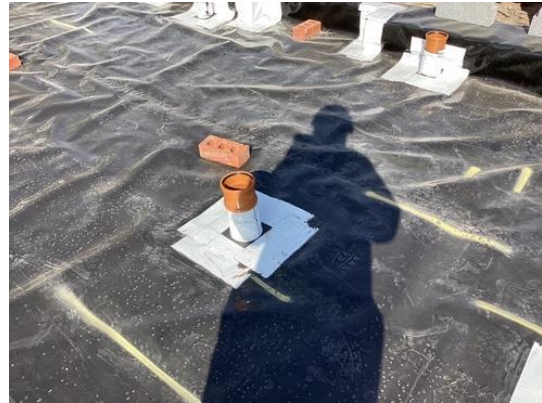
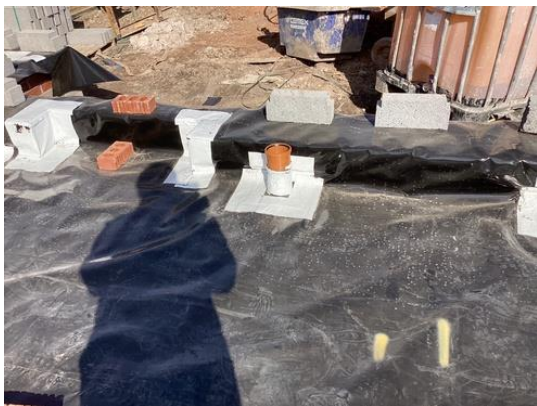
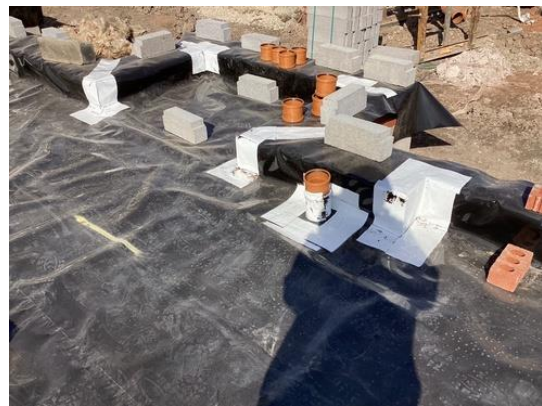
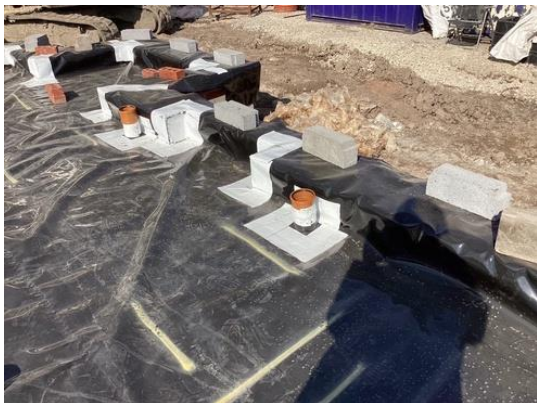
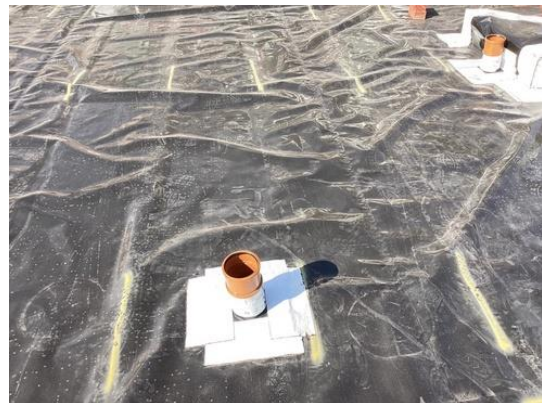
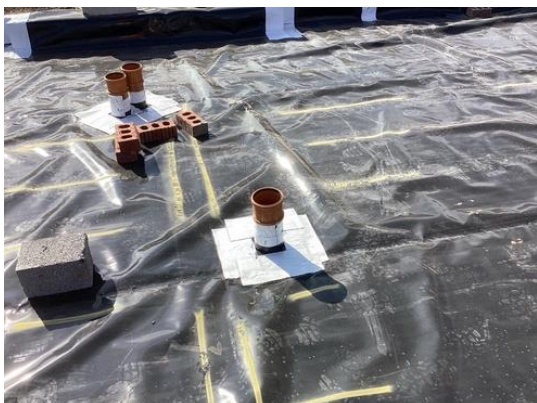
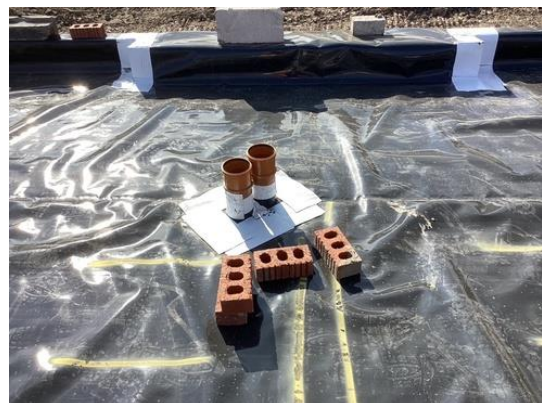
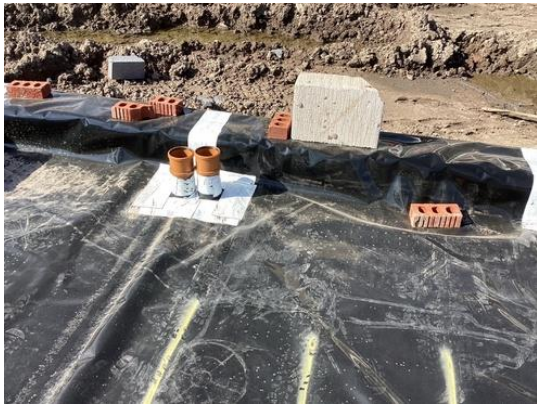
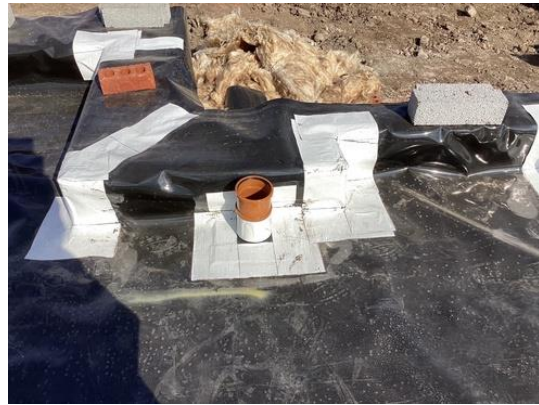
**Service entries seals: Top hats seal arrangements fixed around service entries? Use of Jubilee clips or Bitumastic Sealant**

Pass

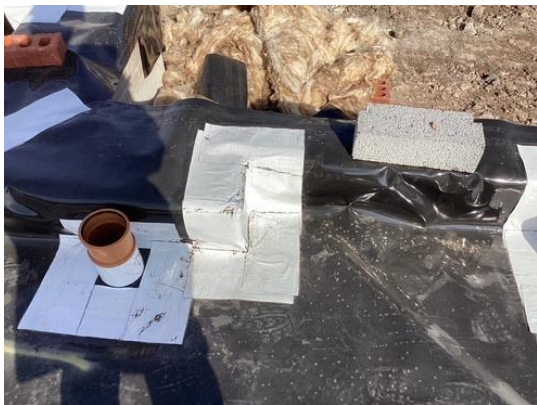
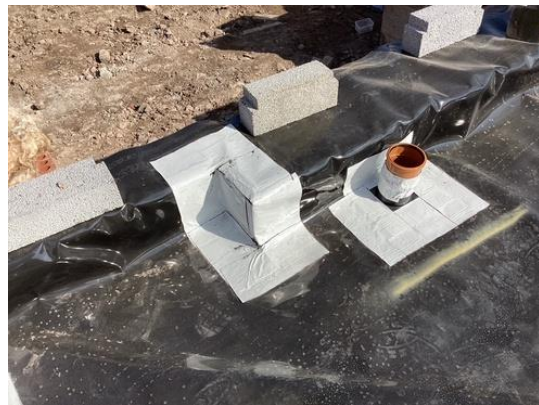
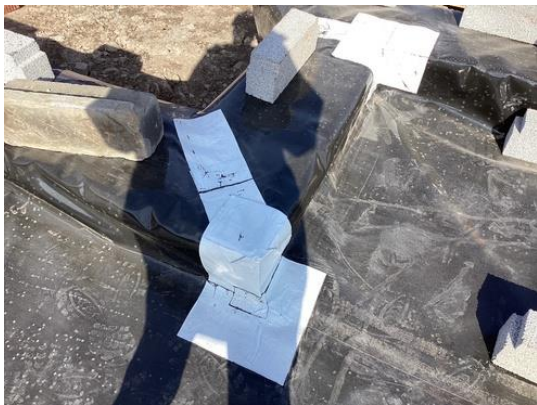
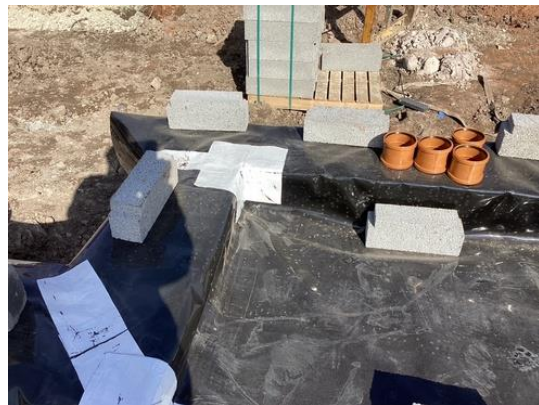
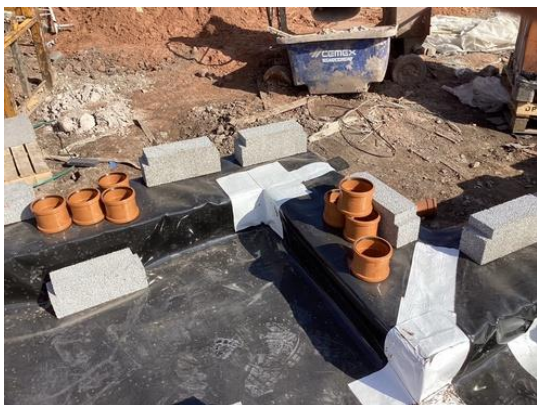
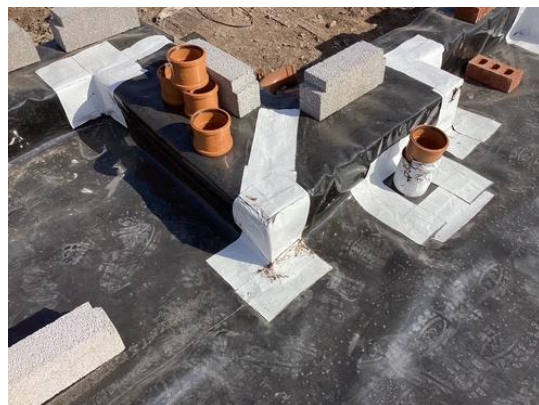
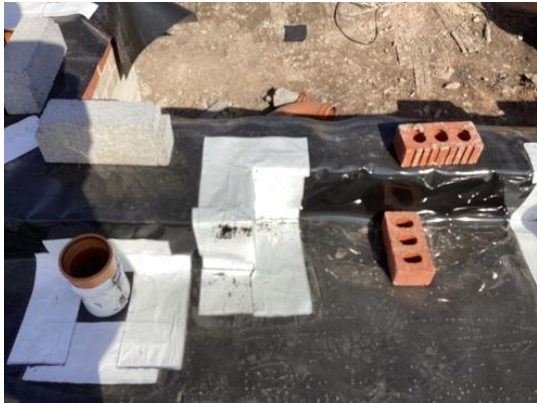
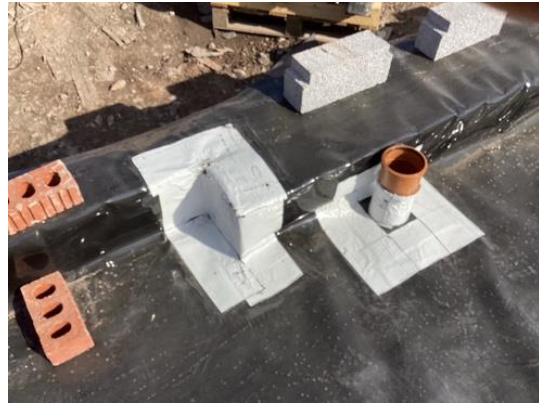
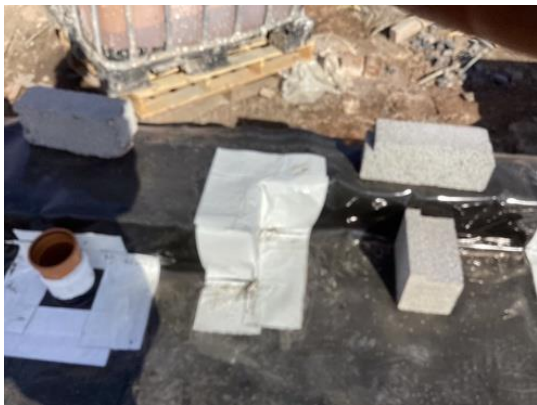
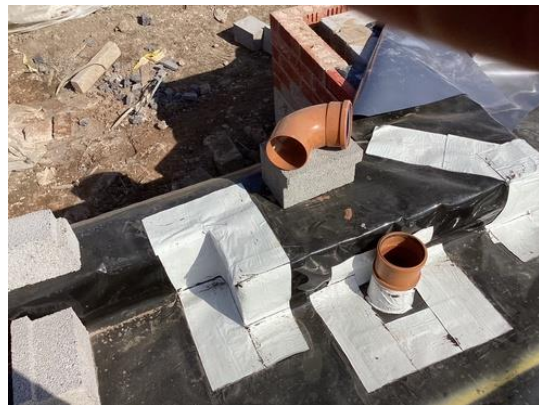
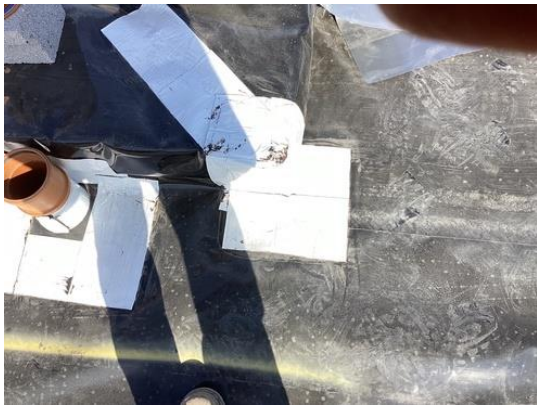
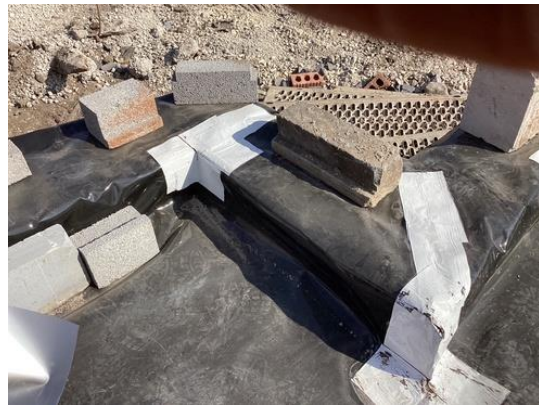
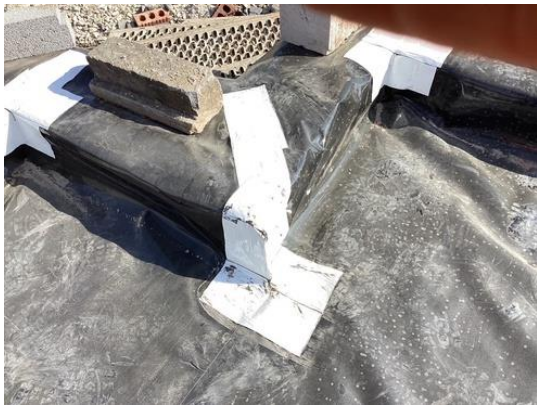
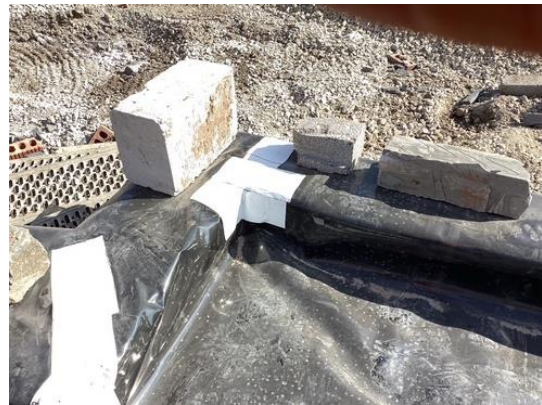
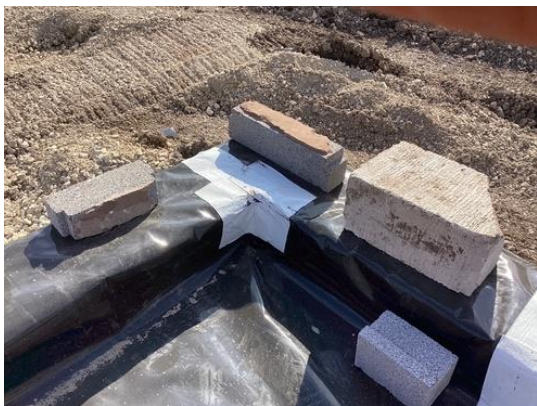
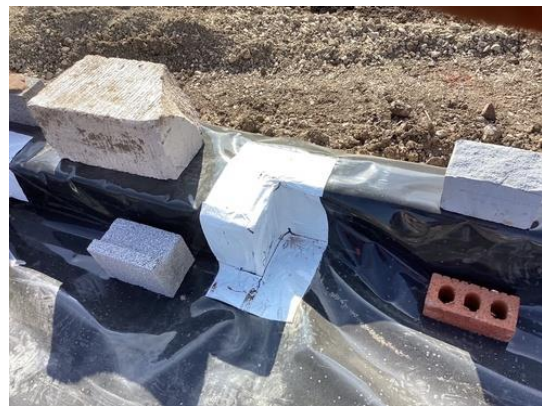
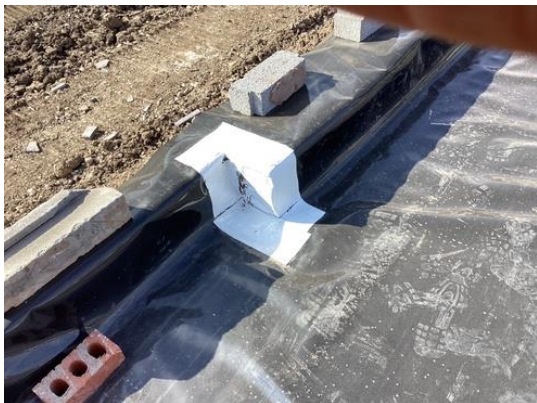
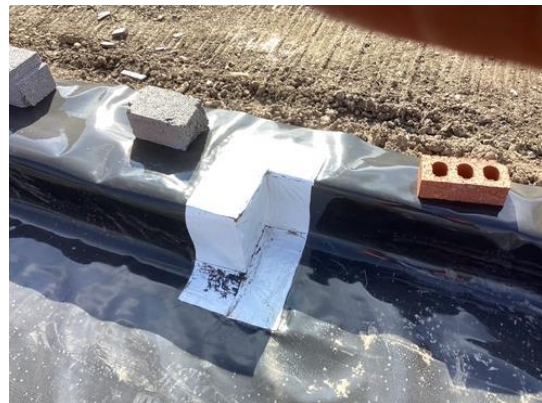
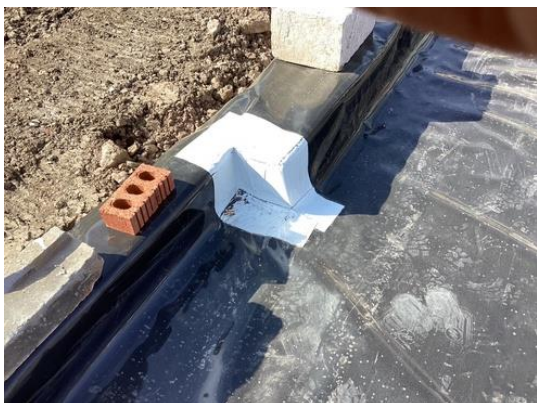
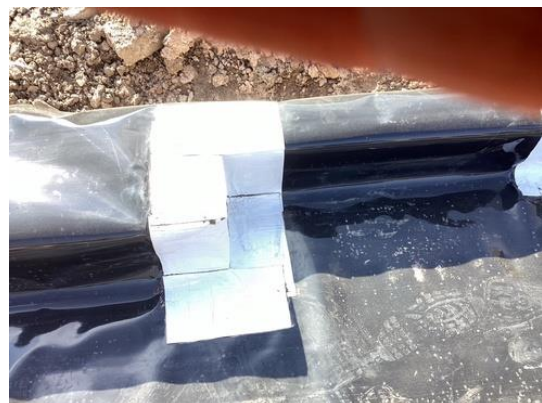
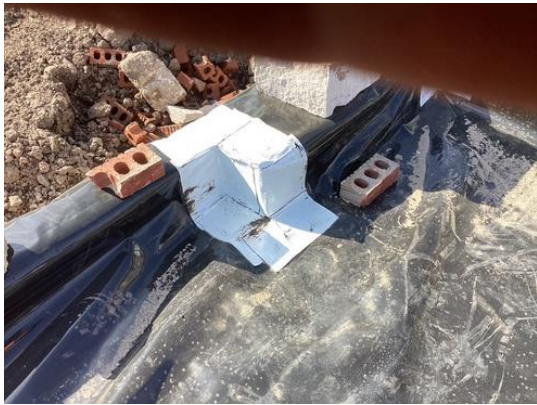
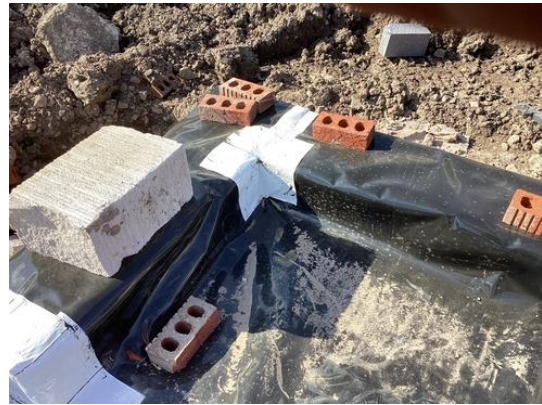
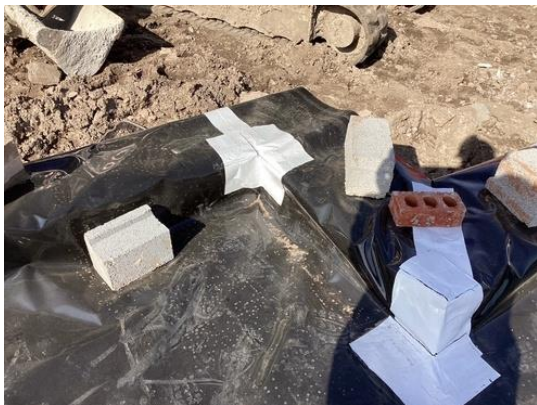
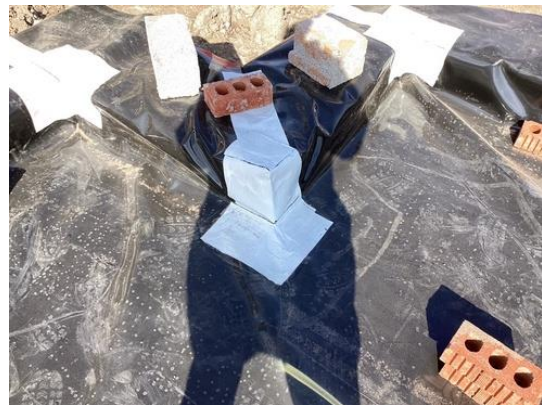
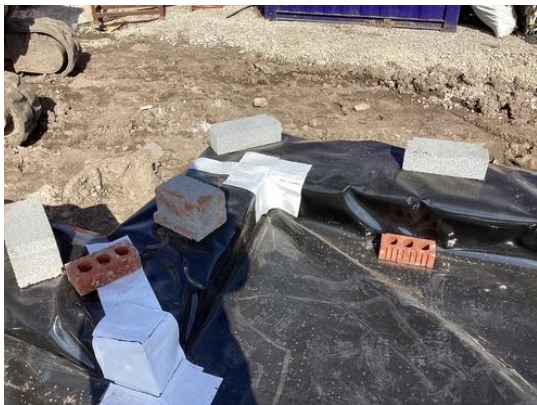
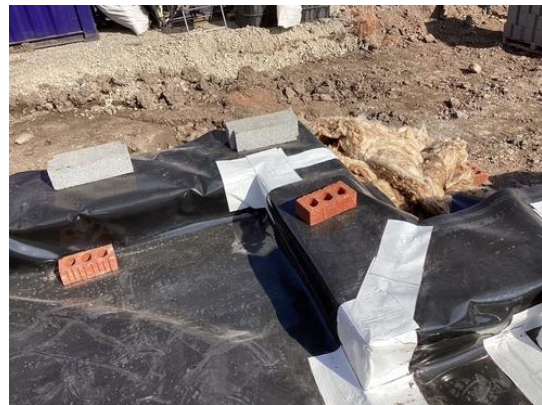
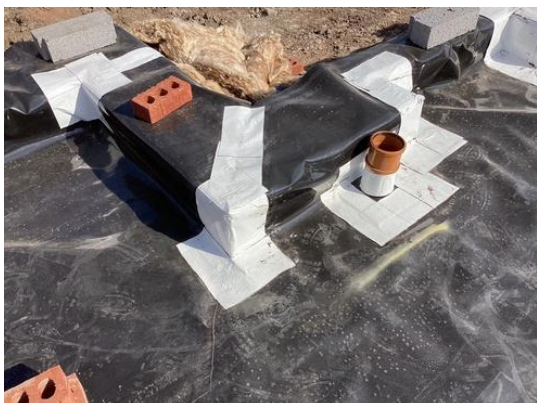
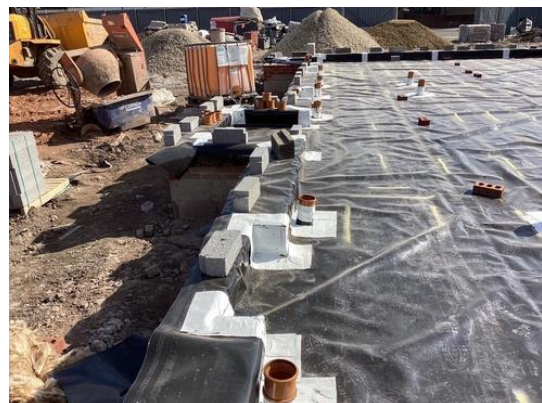
**Corners / Internal joints: Check all corners are correctly formed or contractor has used preformed corners.**

Pass

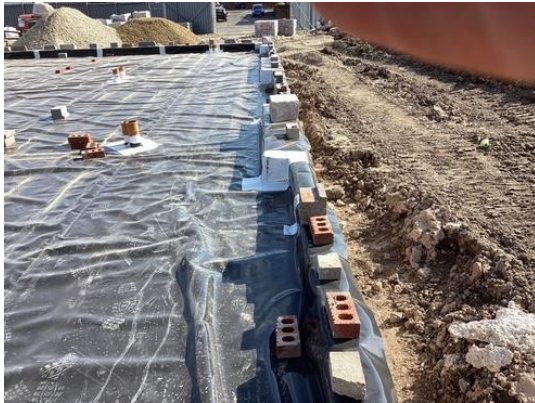
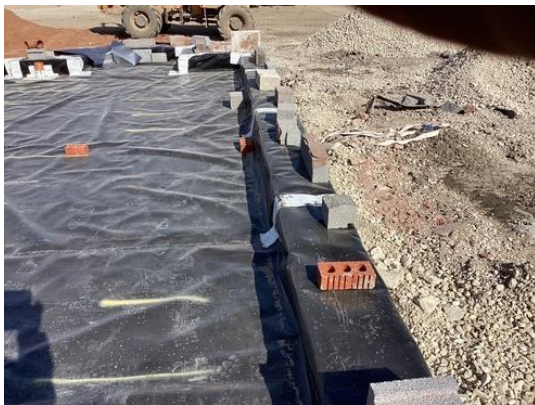
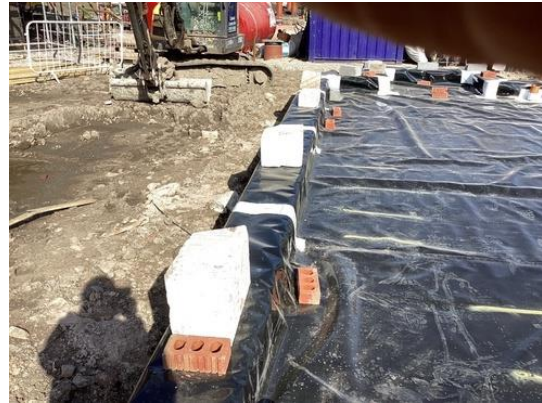
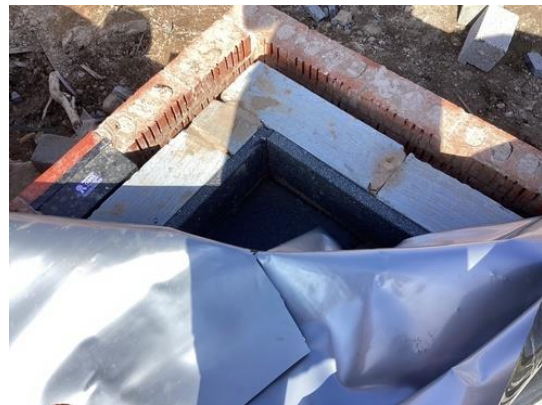
**Extent of Coverage: Is the membrane covering the entire plot? Does membrane span over outside walls?**

Yes

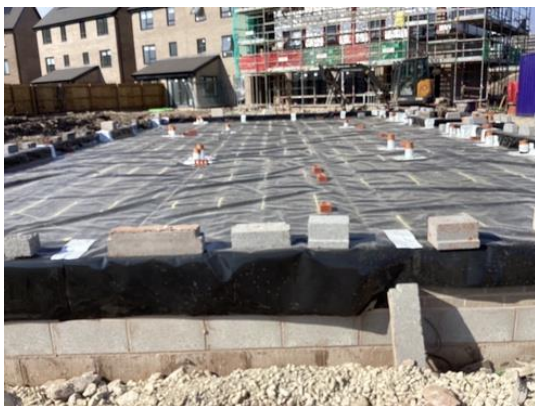
Photo 53

**Slab / membrane condition (is membrane clear of snow, standing water, debris or insulation): Can membrane be fully seen and photographed – ask contractor to remove any debris so membrane can be fully seen and inspected – this is a requirement of NHBC and local authorities.**

Pass

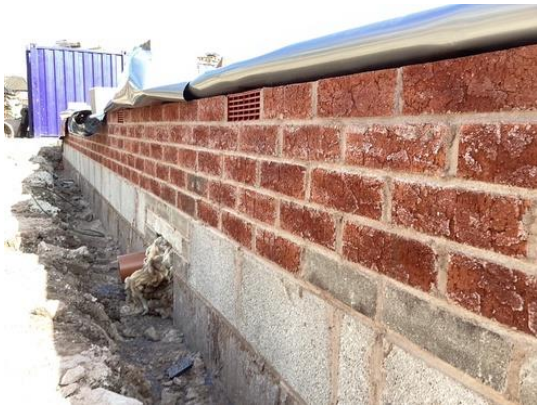
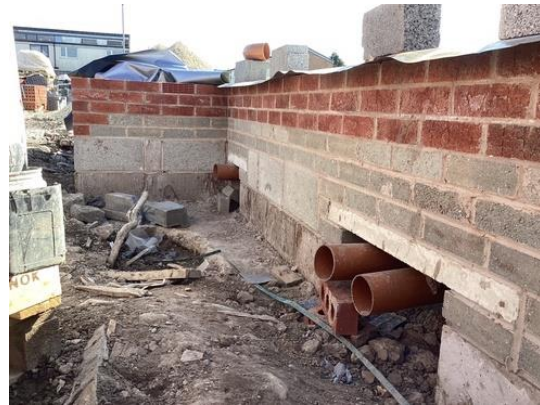
**External Wall Air bricks: Numbers, size. positions as design drawing? (Minimum of 3 walls)**

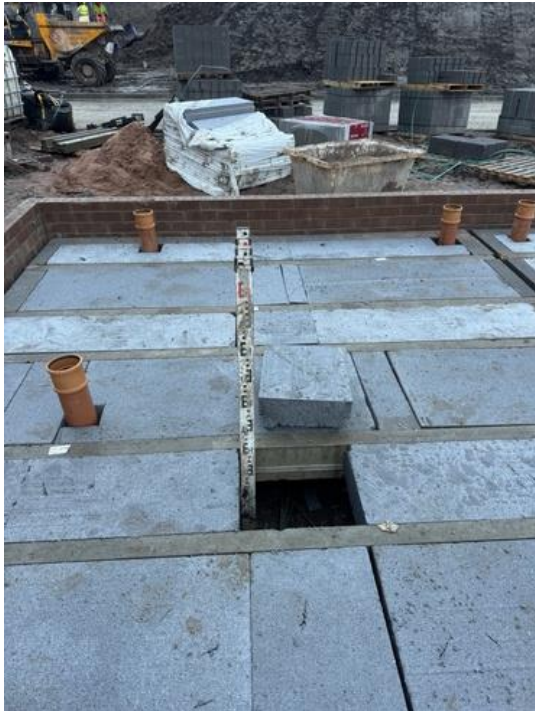
Photo 1

| Is the void clear? | Yes |
| Depth of Void | 250 |

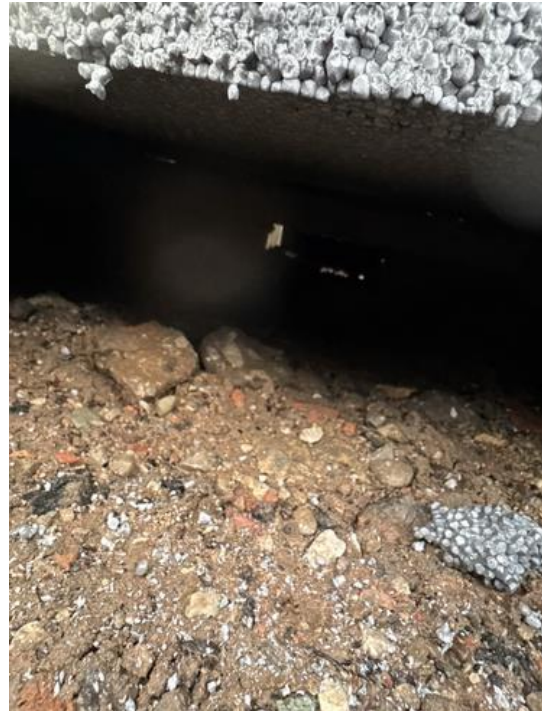
Photo 2

### Are Sleeper Walls Vented?

Yes

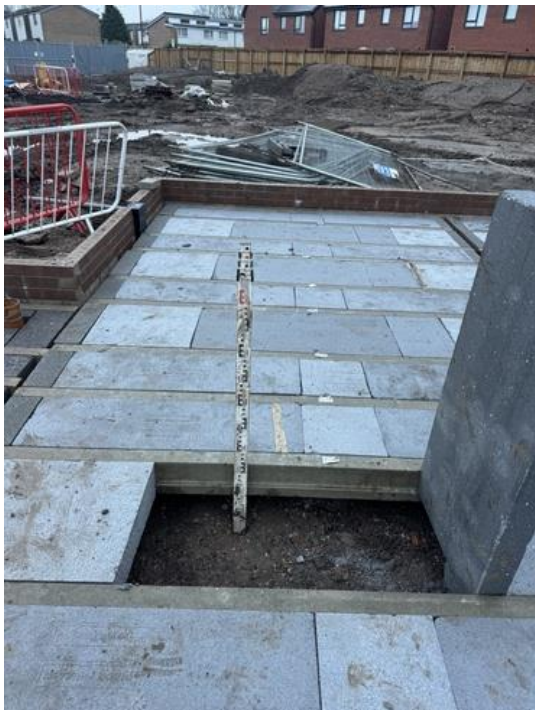
Photo 3

| Is the void clear? | Yes |
| Depth of Void | 200 |

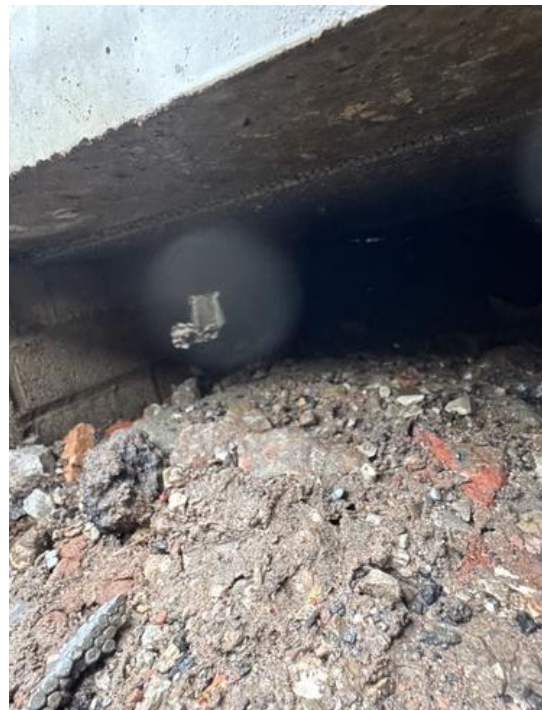
Photo 4

**Are Sleeper Walls Vented?**

Yes
