## Hammerstone Road Depot, Manchester

# Discharge of Planning Condition 11

**Curtins Ref: HRD-CUR-00-XX-T-RE-006**

Revision: P02

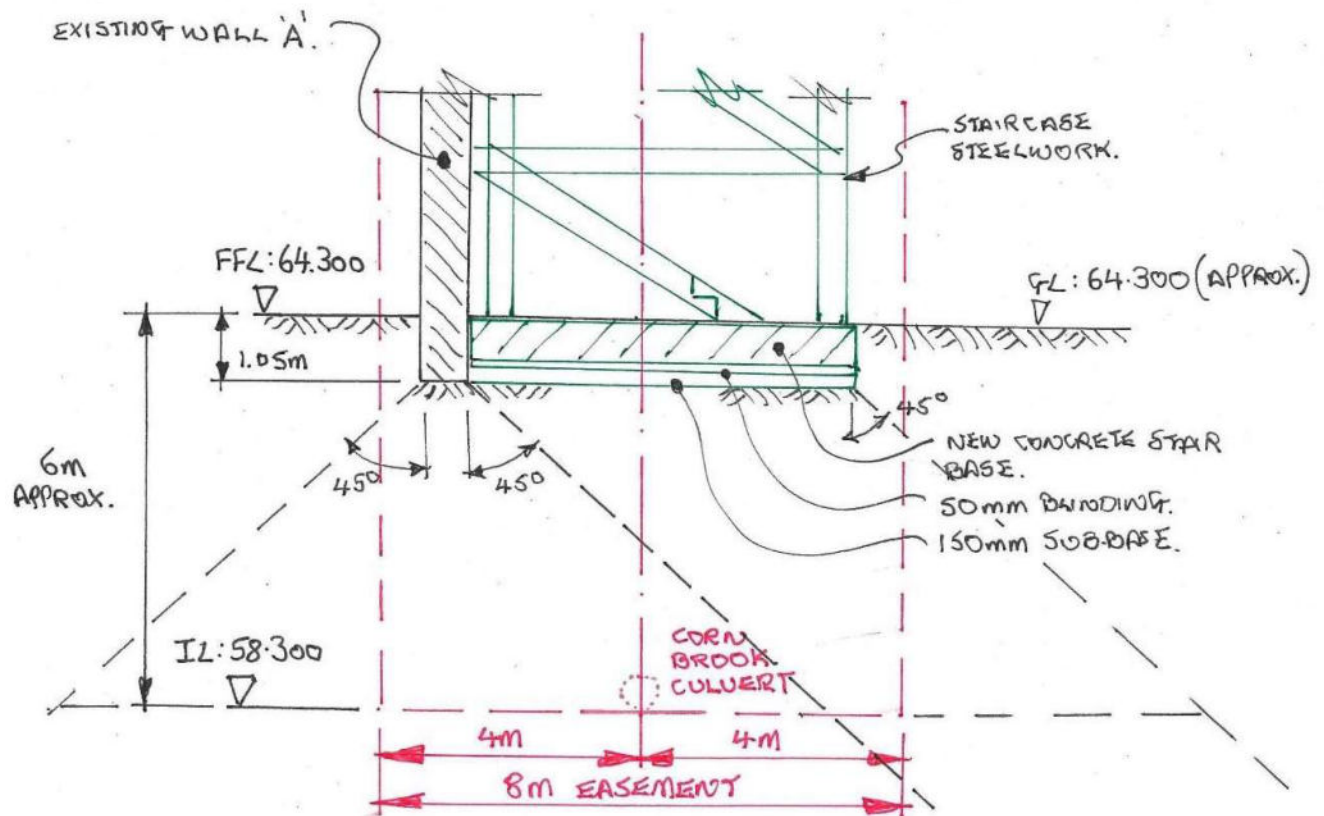
Figure 2.1 – Sectional View

The Sectional View above shown in Figure 2.1 indicates the arrangements of the existing building and proposed staircase and associated concrete slab in relation to the existing Corn Brook Culvert.

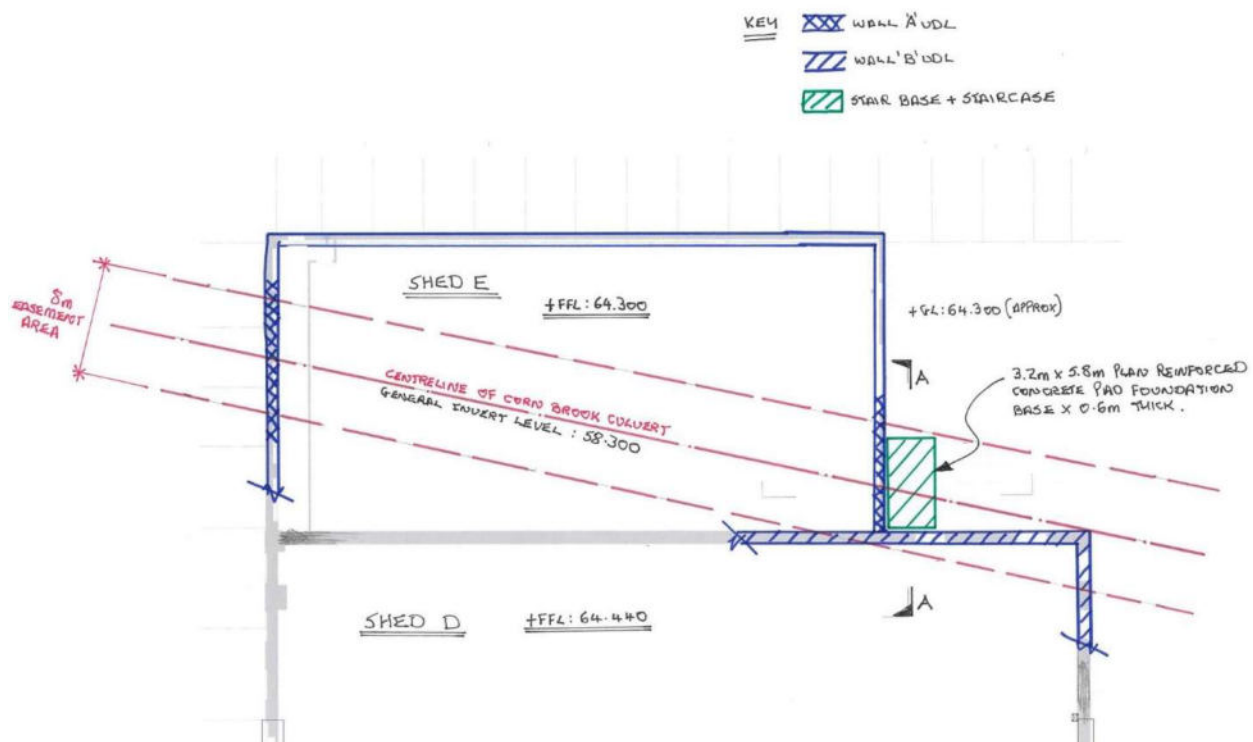
Figure 3.1 – Foundation Plan

With reference to Figure 3.1 above and Figure 2.1 and associated notes, loadings and descriptions within Section 2.0, the relationship between the existing building, existing Corn Brook Culvert and the proposed new staircase and pad foundation are indicated and explained.

As discussed previously, Existing Walls 'A' and 'B' are built directly over the existing Corn Brook Culvert, imposing considerable loads. The new staircase and pad foundation are small in comparison not only in scale but also in actual applied load.

As determined within Section 2.0, the existing building load applied at the Corn Brook Culvert level is 23 kN/m run, the new staircase and pad foundation create an additional 4.5 kN/m run, and approximate 20% increase. The reduction of the building use-imposed load from 20 kN/m<sup>2</sup> to 5 kN/m<sup>2</sup> is a reduction in load of 75%.

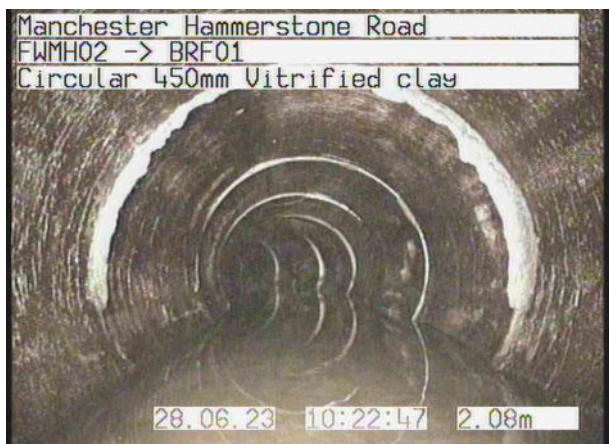
FWMH02X\_a7ce946b-a5c9-424a-86eb-51f0a8fcff04\_20230628\_102921\_045.jpg, 00:00:59, 2.08 m  
Attached deposits, encrustation at joint from 8 o'clock to 4 o'clock, 10% cross-sectional area loss

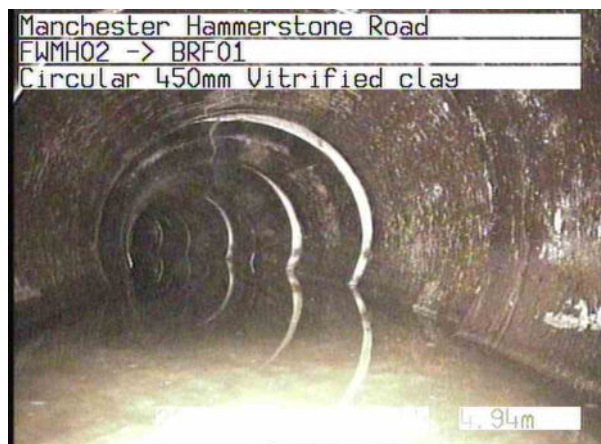
| Scale: 1:135 | Position [m] | Code | Observation | MPEG | Photo | Grade |
|---|---|---|---|---|---|---|
| | 3.51 | CCJ | Crack, circumferential at joint from 11 o'clock to 2 o'clock | 00:02:00 | FWMH02X_e7d97b54-054d-48 | 2 / 2 |

FWMH02X\_e7d97b54-054d-4842-80fd-ac972e072d39\_20230704\_091850\_824.jpg, 00:02:00, 3.51 m  
Crack, circumferential at joint from 11 o'clock to 2 o'clock

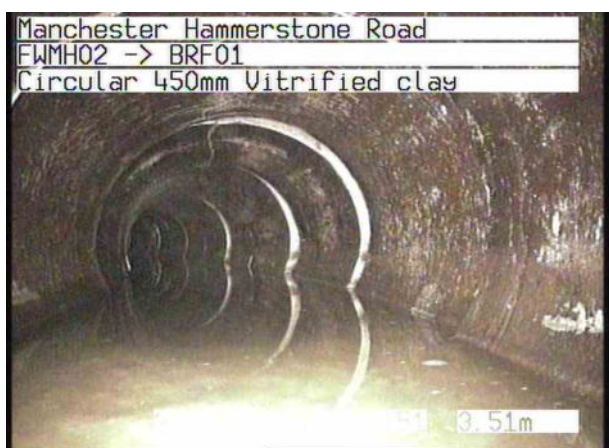
| Scale: 1:135 | Position [m] | Code | Observation | MPEG | Photo | Grade |
|---|---|---|---|---|---|---|
| | 3.51 S02 | CLJ | Crack, longitudinal at joint at 12 o'clock, start | 00:02:06 | FWMH02X_2a4034d0-619c-41 | |

FWMH02X\_2a4034d0-619c-4168-ab0f-bc0f286ce88d\_20230704\_091855\_605.jpg, 00:02:06, 3.51 m  
Crack, longitudinal at joint at 12 o'clock, start

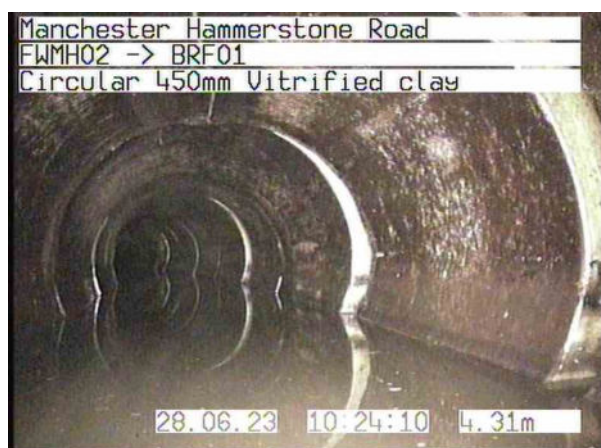
FWMH02X\_a9c62bf7-3e55-45f3-a47c-e56f0c333b3e\_20230704\_091900\_013.jpg, 00:02:25, 4.31 m  
Line deviates left, start

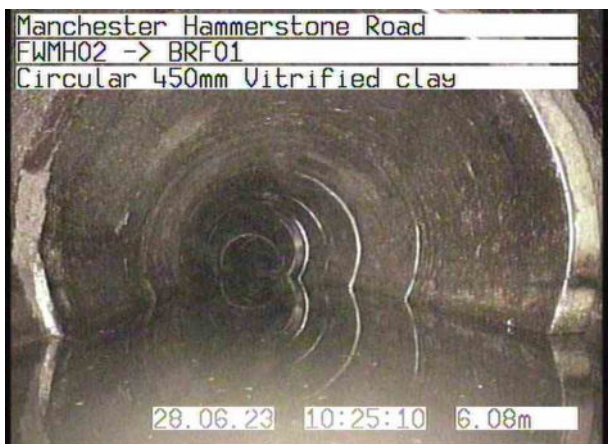
| Scale: 1:135 | Position [m] | Code | Observation | MPEG | Photo | Grade |
|---|---|---|---|---|---|---|
| | 6.09 | B | Broken pipe at 9 o'clock | 00:03:27 | FWMH02X_843432e1-3587-4e | 4 |

FWMH02X\_843432e1-3587-4ec5-aad0-246872d8816d\_20230704\_092046\_828.jpg, 00:03:27, 6.09 m  
Broken pipe at 9 o'clock

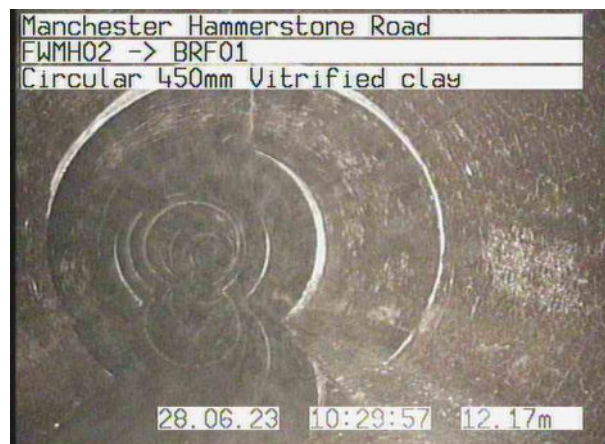
| Scale: 1:135 | Position [m] | Code | Observation | MPEG | Photo | Grade |
|---|---|---|---|---|---|---|
| | 12.17 | FLJ | Fracture, longitudinal at joint at 12 o'clock | 00:08:01 | FWMH02X_a5d1eb1f-37c1-4bc | 3 / 2 |

FWMH02X\_a5d1eb1f-37c1-4bc2-8a2e-f654ab212450\_20230628\_103631\_547.jpg, 00:08:01, 12.17 m  
Fracture, longitudinal at joint at 12 o'clock

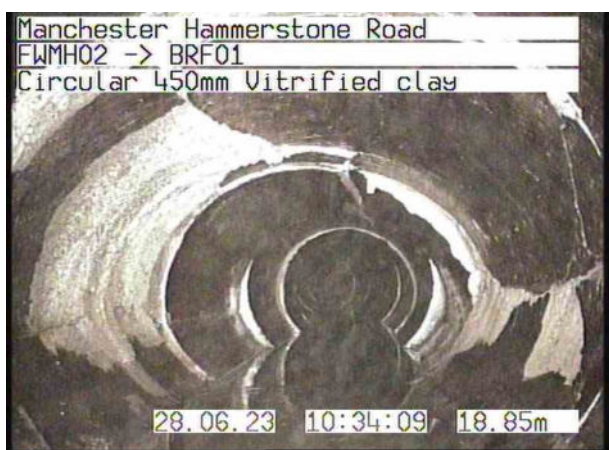
| Scale: | 1:135 | Position [m] | Code | Observation | MPEG | Photo | Grade |
|---|---|---|---|---|---|---|---|
| | | 18.85 | B | Broken pipe from 8 o'clock to 4 o'clock | 00:12:19 | FWMH02X_7d793936-b1e4-4fb | 4 |

FWMH02X\_7d793936-b1e4-4fb6-b0b0-916719dee72a\_20230704\_092158\_557.jpg, 00:12:19, 18.85 m  
Broken pipe from 8 o'clock to 4 o'clock

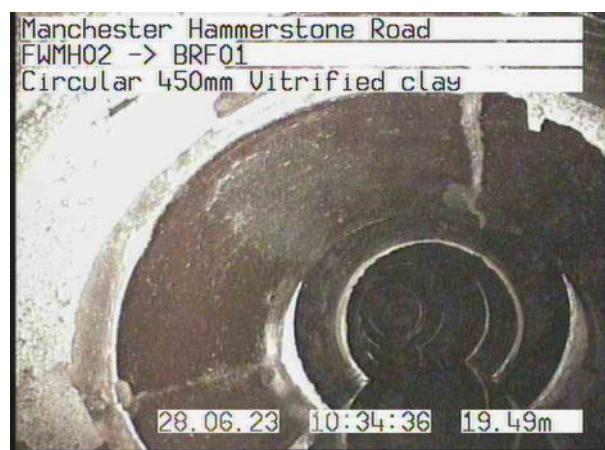
| Scale: | 1:135 | Position [m] | Code | Observation | MPEG | Photo | Grade |
|---|---|---|---|---|---|---|---|
| | | 19.49 | ID | Infiltration, dripping at 12 o'clock | 00:12:41 | FWMH02X_7c48f7e4-fcd9-4bc9 | |

FWMH02X\_7c48f7e4-fcd9-4bc9-810b-eea80249d89c\_20230628\_104110\_684.jpg, 00:12:41, 19.49 m  
Infiltration, dripping at 12 o'clock

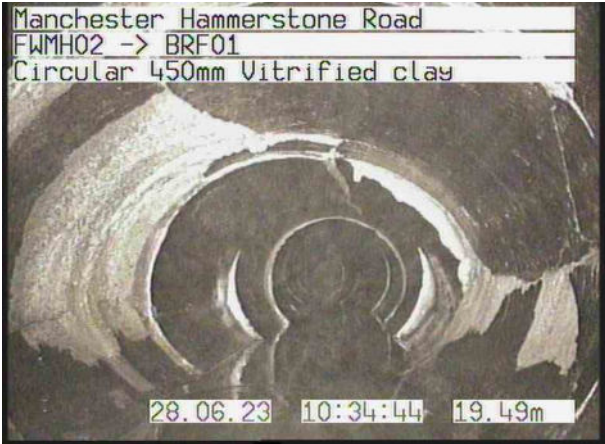
FWMH02X\_efbfd325-baf5-469d-b1a8-2b283e3c7379\_202306  
28\_104118\_343.jpg, 00:12:41, 19.49 m  
Infiltration, dripping at 12 o'clock

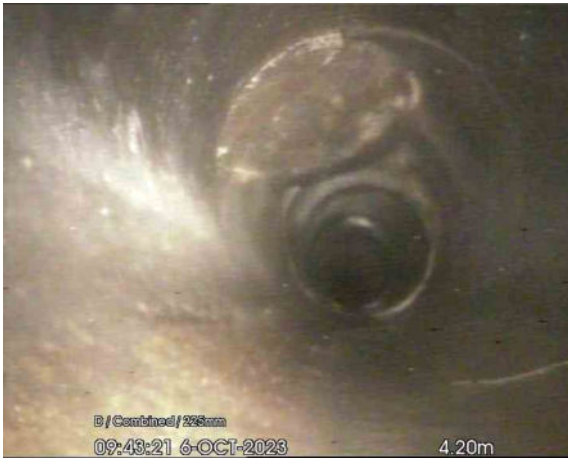
MH C1 DS\_4-20m\_094321.jpg, 00:00:22, 4.20 m  
Hole in drain or sewer from 9 o'clock to 2 o'clock, POOR  
REPAIR

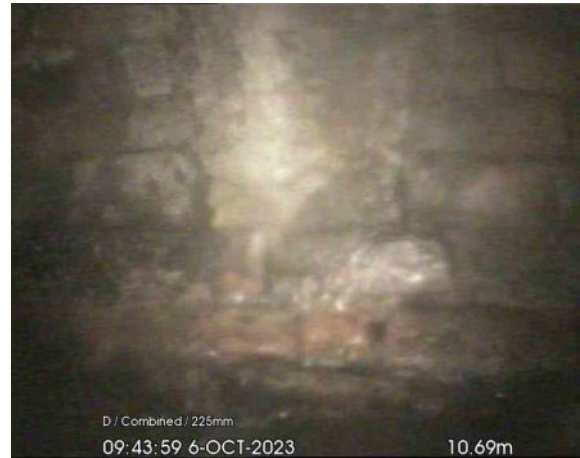
MH C1 DS\_10-69m\_094359.jpg, 00:00:47, 10.69 m  
Finish node, major connection without manhole, reference: DS,  
CULVERT

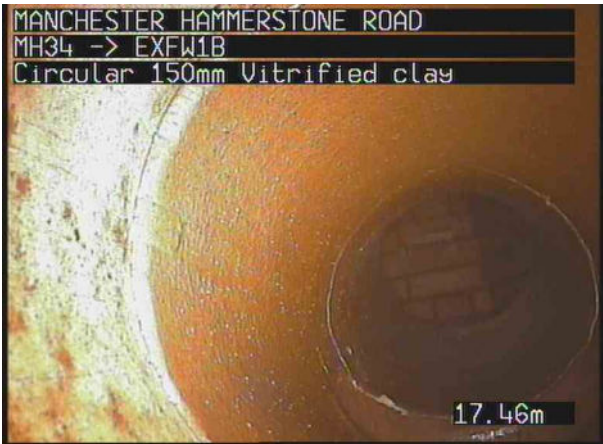
MH34X\_0941c1a5-6953-41b3-8a84-c1a6191d4dc4\_2023082  
2\_125832\_514.jpg, 00:01:20, 17.46 m

Fracture, circumferential from 12 o'clock to 12 o'clock, ON  
BACKDROP

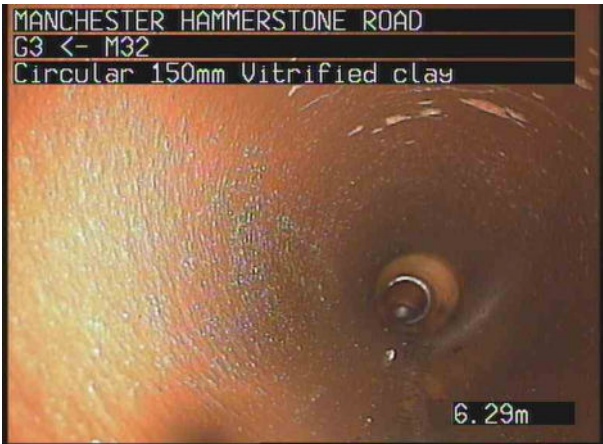
G3X\_0aa1f7fa-6cd4-4596-b480-e012c28a25d0\_20230822\_14  
5216\_936.jpg, 00:00:42, 6.29 m  
Surface damage, spalling from 10 o'clock to 2 o'clock

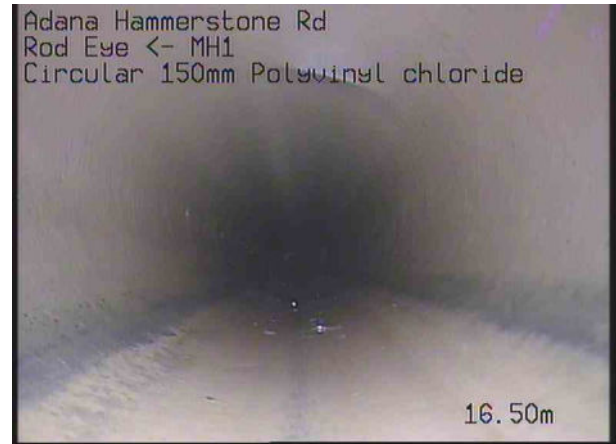
Rod  
EyeX\_ccd54a6e-8f3a-4a5b-afef-6d8136f2e6f5\_20231002\_110  
406\_458.jpg, 00:01:41, 16.50 m  
Deformed sewer or drain, 5%

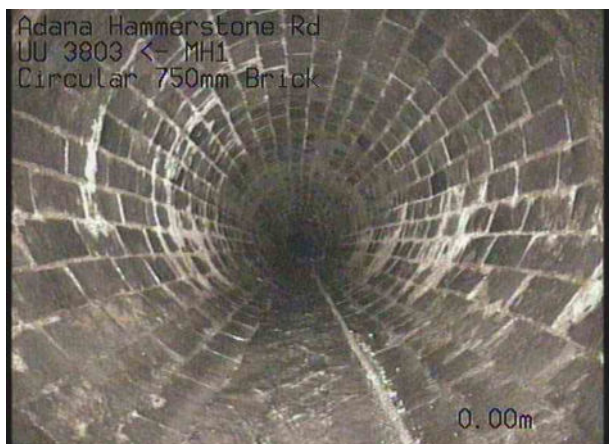
3803X\_eca04b50-e131-4dfe-8786-ba9a1bf9edd0\_20230929\_110618\_260.jpg, 00:00:38, 0.60 m  
Attached deposits, encrustation from 7 o'clock to 5 o'clock, 5% cross-sectional area loss, start, Patchy

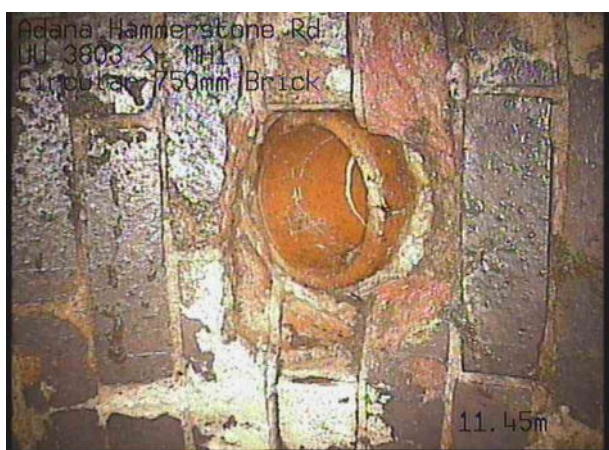
3803X\_2d64c7c1-4914-4176-8e85-39894b60b95c\_20230929\_110716\_314.jpg, 00:01:37, 11.45 m  
Connection other than junction at 1 o'clock, 150mm dia

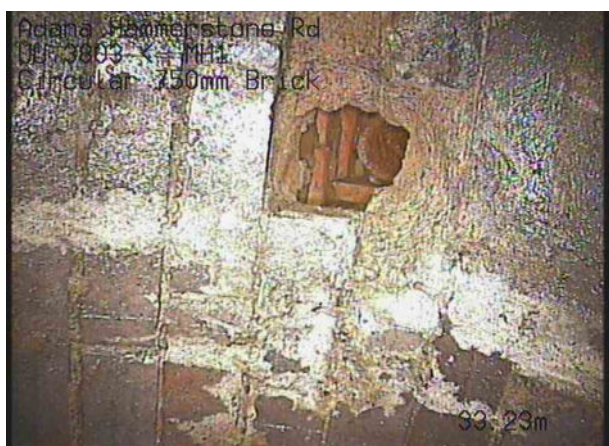
Connection defective, connecting pipe is damaged at 12 o'clock, 150mm dia, saddle to main missing

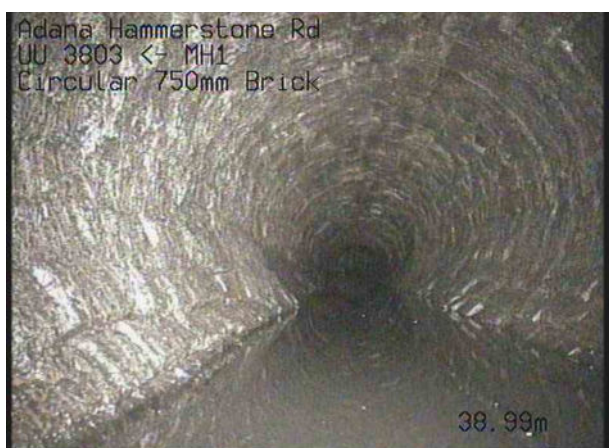
Attached deposits, encrustation from 7 o'clock to 5 o'clock, 10% cross-sectional area loss, change, Patchy

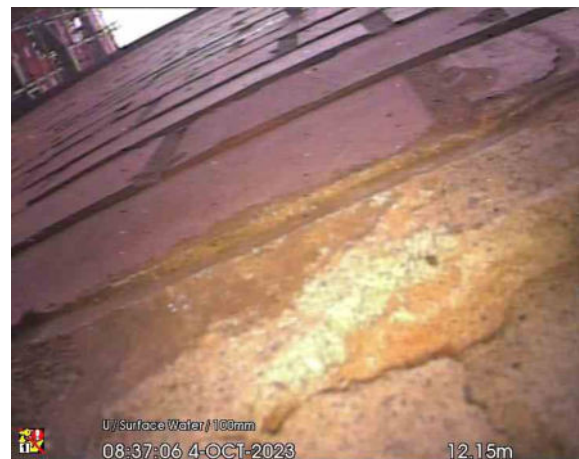
MH3 US RWP\_12-15m\_083706.jpg, 00:01:02, 12.15 m  
Survey abandoned, RWP MISSING OFF WALL

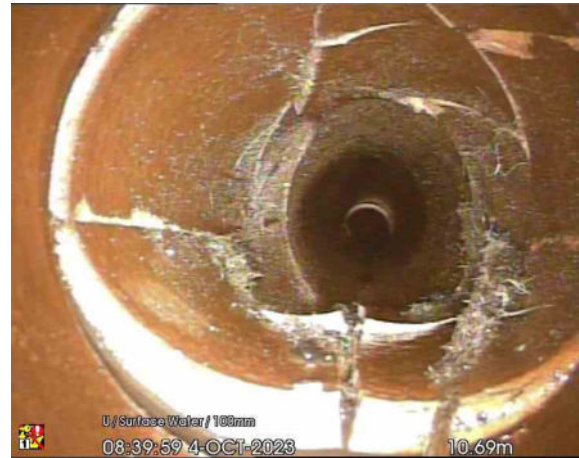
MH3 US ACO\_10-69m\_083959.jpg, 00:00:48, 10.69 m  
Fractures, multiple at 12 o'clock

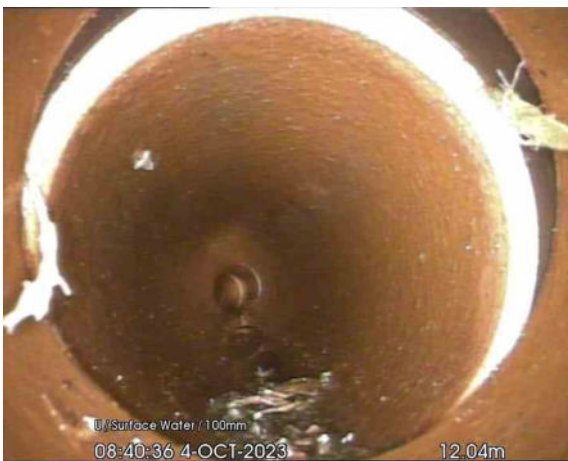
MH3 US ACO\_12-04m\_084036.jpg, 00:01:08, 12.04 m  
Joint displaced, large

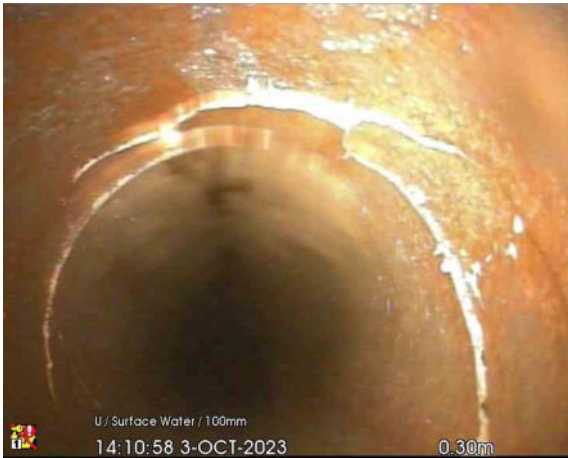
MH4 US GULLY\_0-30m\_141058.jpg, 00:00:04, 0.30 m  
Fractures, multiple at joint from 8 o'clock to 5 o'clock

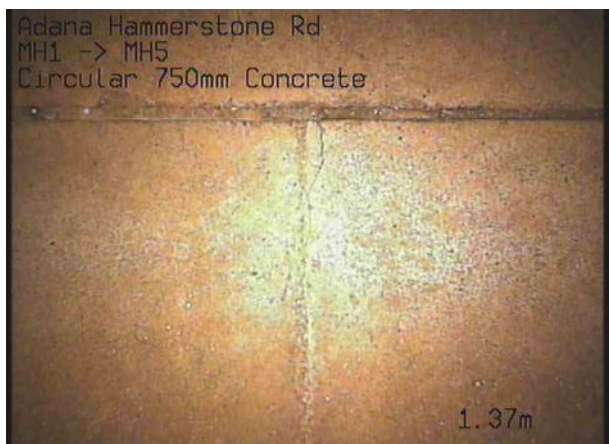
MH1X\_e8ddb24d-3b20-4023-afa7-0dde4b1c943f\_20230929\_082331\_720.jpg, 00:00:36, 1.37 m  
Fracture, longitudinal at 12 o'clock, start

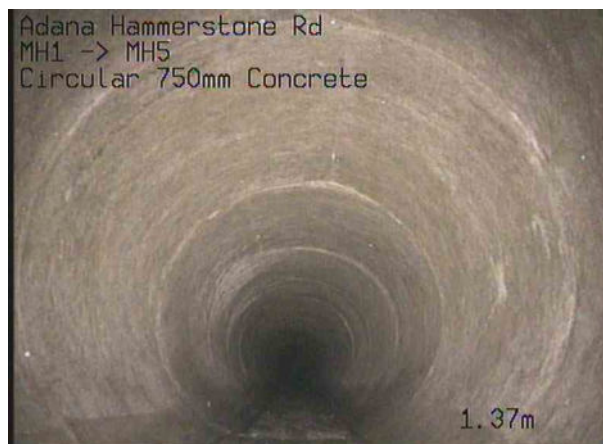
MH1X\_3c9c27db-fb99-4094-9bf2-97fcb271940e\_20230929\_082340\_048.jpg, 00:00:36, 1.37 m  
Fracture, longitudinal at 12 o'clock, start

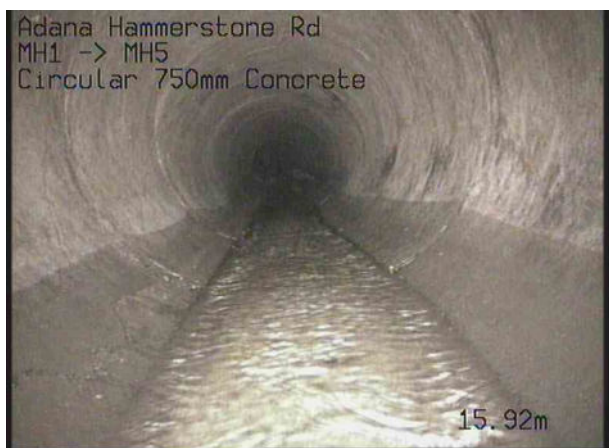
MH1X\_57c3ec85-d13d-4d4f-ba57-254ecc38816c\_20230929\_082539\_013.jpg, 00:02:43, 15.92 m  
Fracture, longitudinal at 7 o'clock

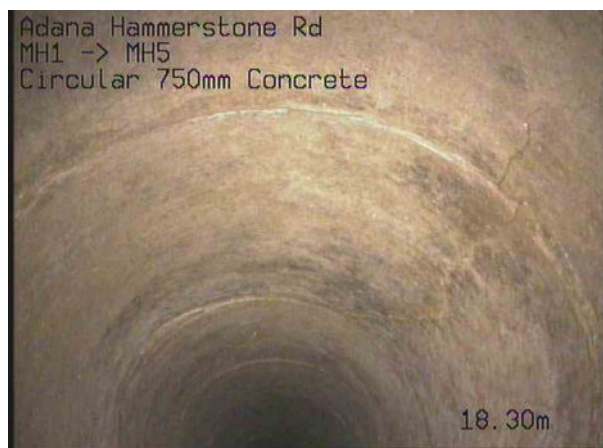
MH1X\_c2594daa-fcaf-402d-bd67-0043181de174\_20230929\_082633\_141.jpg, 00:03:37, 18.30 m  
Fracture, longitudinal at 2 o'clock, start

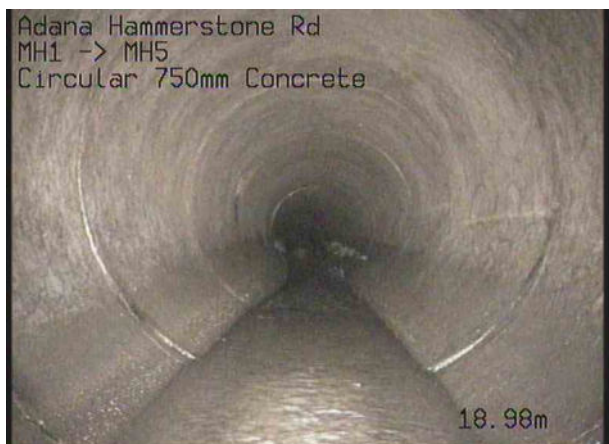
MH1X\_b6fec33a-22d3-4af2-9836-bf00c744b5a6\_20230929\_082711\_786.jpg, 00:04:16, 18.98 m  
Fracture, circumferential from 3 o'clock to 9 o'clock

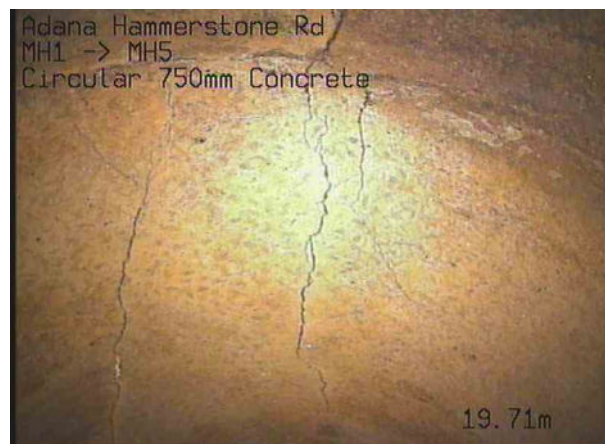
MH1X\_56c66650-3221-4101-b6ba-7d3f042609b4\_20230929\_082729\_854.jpg, 00:04:34, 19.71 m  
Fractures, multiple from 11 o'clock to 2 o'clock

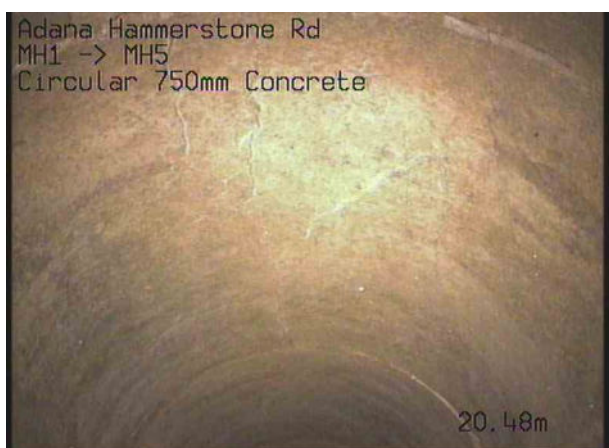
MH1X\_e097ea5e-e366-4a2c-9436-68de88a165e2\_20230929\_082822\_672.jpg, 00:05:06, 20.48 m  
Fractures, multiple from 12 o'clock to 12 o'clock, start

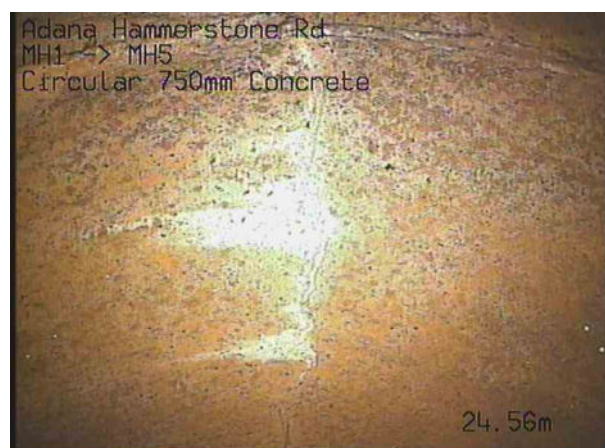
MH1X\_3d9dbc05-6e24-48b4-bd28-cb39d0947a73\_20230929\_082952\_988.jpg, 00:06:57, 24.56 m  
Fracture, longitudinal at 12 o'clock, start

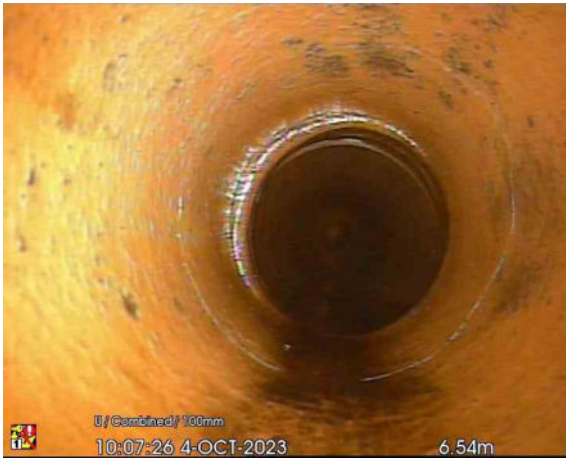
MH24 US\_6-54m\_100726.jpg, 00:00:35, 6.54 m  
Fracture, circumferential at joint at 12 o'clock

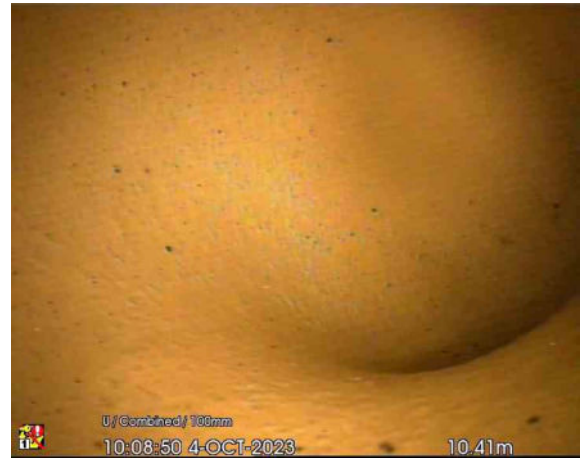
MH24 US\_10-41m\_100850.jpg, 00:01:26, 10.41 m  
Survey abandoned, UNABLE TO PASS BENDS

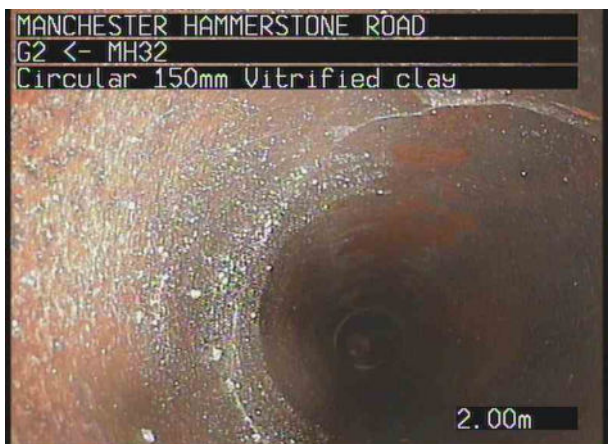
G2X\_d3ff5865-e93a-4ec7-a84c-383277f4871d\_20230822\_14  
4547\_320.jpg, 00:00:26, 2.00 m  
Fracture, circumferential at joint from 12 o'clock to 12 o'clock,  
FROM HOLE

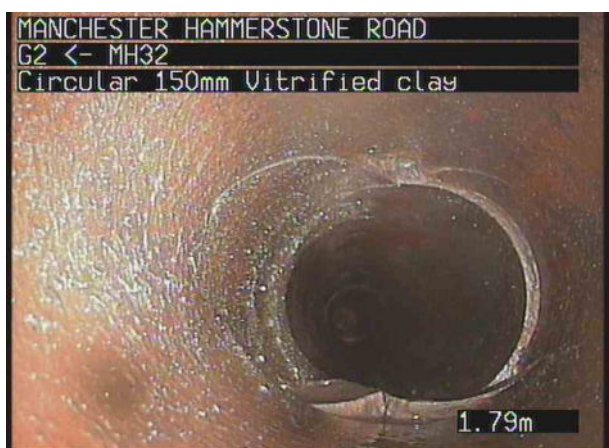
G2X\_747da227-0512-4bbe-84f2-efa2331e3276\_20230822\_14  
4655\_798.jpg, 00:01:08, 2.30 m  
Deformed sewer or drain, 10%

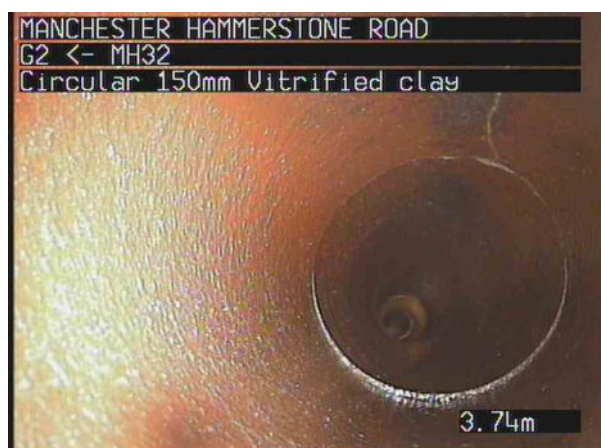
G2X\_ab06da00-461d-487a-9062-864238af2135\_20230822\_1  
44730\_122.jpg, 00:01:49, 3.74 m  
Fracture, longitudinal at joint at 1 o'clock

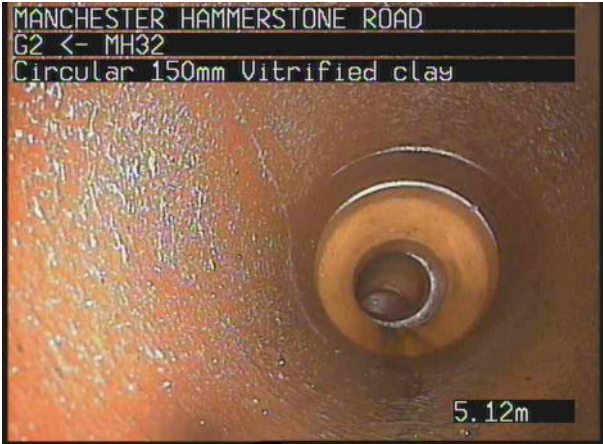
G2X\_7d0afabf-d9d6-4a7d-873b-f683bedce10f\_20230822\_144  
819\_634.jpg, 00:02:07, 5.12 m  
Fracture, circumferential from 12 o'clock to 12 o'clock

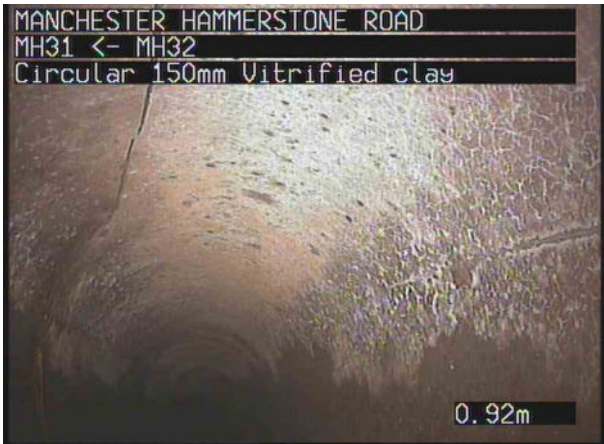
MH31X\_56cae0d2-2bc6-4c28-862c-216765a5cfea\_20230822\_142250\_192.jpg, 00:00:24, 0.90 m  
Fracture, longitudinal at joint at 11 o'clock

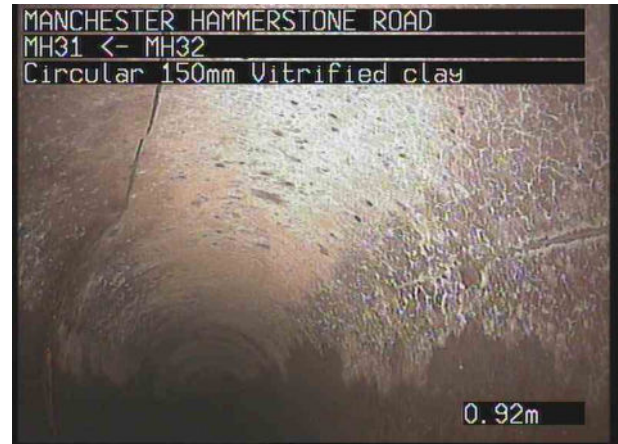
MH31X\_a7e1bd3b-4274-4a7a-8eac-753dbce24893\_20230822\_142250\_429.jpg, 00:00:24, 0.90 m  
Fracture, longitudinal at joint at 11 o'clock

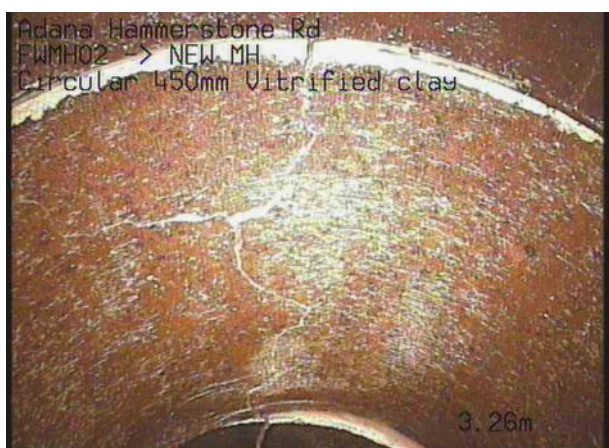
FWMH02X\_d67fa18a-261f-42cc-b472-823572ada9df\_20230929\_124648\_735.jpg, 00:02:12, 3.26 m  
Fracture, longitudinal at 12 o'clock, start

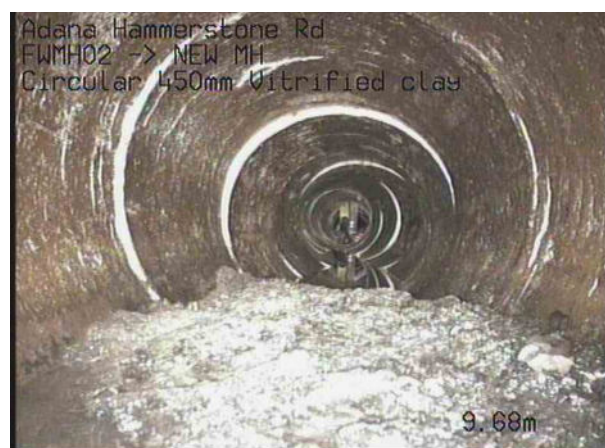
FWMH02X\_22d30264-c456-4ae7-aeda-8c7f10495bb9\_20230929\_124915\_902.jpg, 00:04:32, 9.68 m  
Settled deposits, hard or compacted, 30% cross-sectional area loss, Concrete

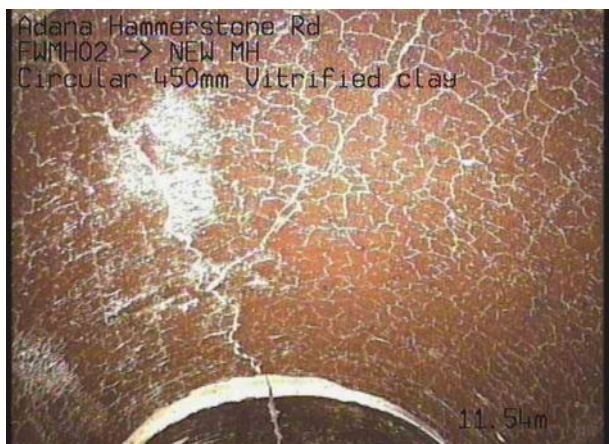
FWMH02X\_633f7784-7216-4371-80bf-317db178d39e\_20230929\_125002\_555.jpg, 00:05:27, 11.54 m  
Fracture, longitudinal at 12 o'clock, start

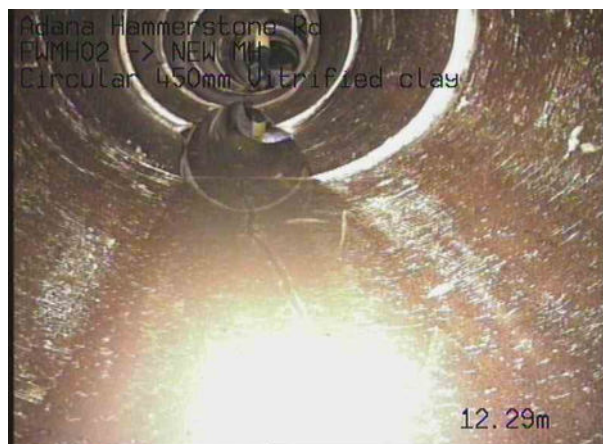
FWMH02X\_f3b58675-fd07-4717-8b15-d7f2aa510cb6\_20230929\_125036\_729.jpg, 00:06:02, 12.29 m  
Fracture, longitudinal at 6 o'clock

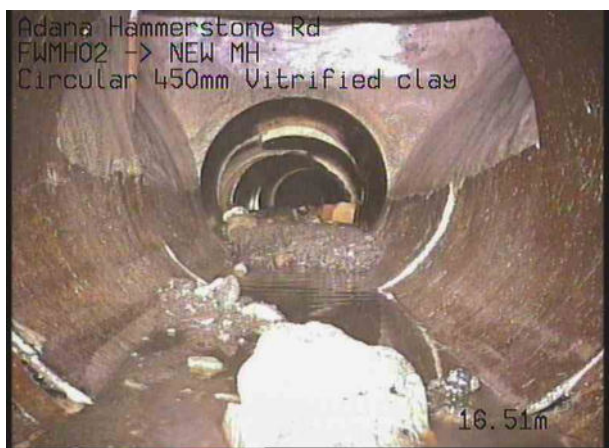
FWMH02X\_88bea82c-ac8f-4bd6-ad0a-3f201e129369\_20230929\_125210\_984.jpg, 00:07:37, 16.51 m  
Other obstacles, brick or masonry in invert at joint from 5 o'clock to 6 o'clock, 10% cross-sectional area loss

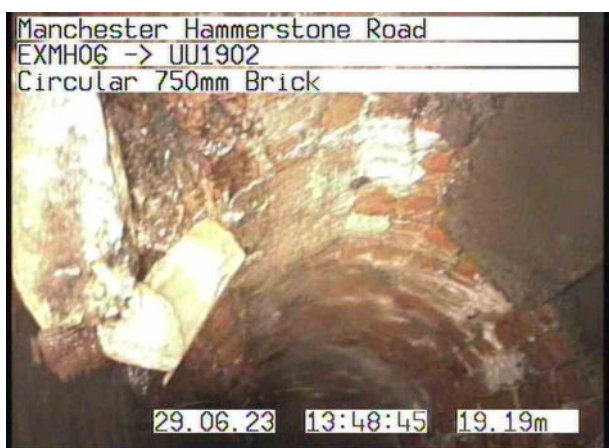
EXMH06X\_1122bd28-ce2d-4a72-aa66-86907662bf99\_20230704\_092352\_690.jpg, 00:01:51, 19.18 m  
Other obstacles, brick or masonry in invert from 7 o'clock to 8 o'clock, 15% cross-sectional area loss, Unable to jet due to bricks catching encrustation

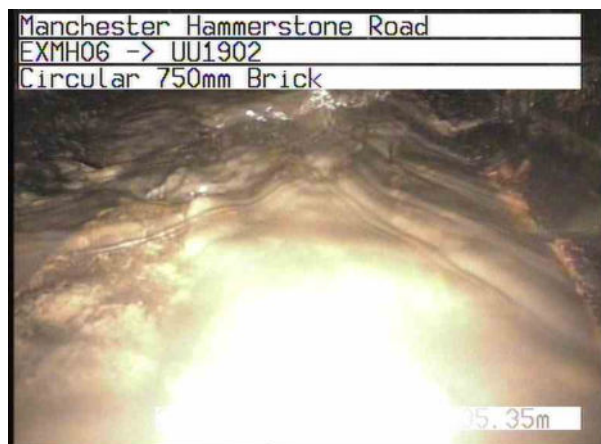
EXMH06X\_db1f7b05-343a-4923-9bc0-7baf1208481a\_20230704\_092412\_620.jpg, 00:04:43, 35.12 m  
Deformed horizontally, 5%, Bricks moved causing an improper flow

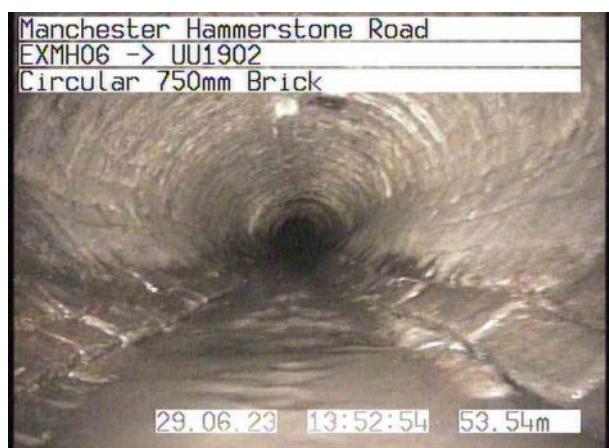
EXMH06X\_b2d37cc8-baa6-4236-ae01-568821f6fe03\_20230704\_092421\_558.jpg, 00:06:00, 53.59 m  
Attached deposits, encrustation from 8 o'clock to 4 o'clock, 5% cross-sectional area loss, start

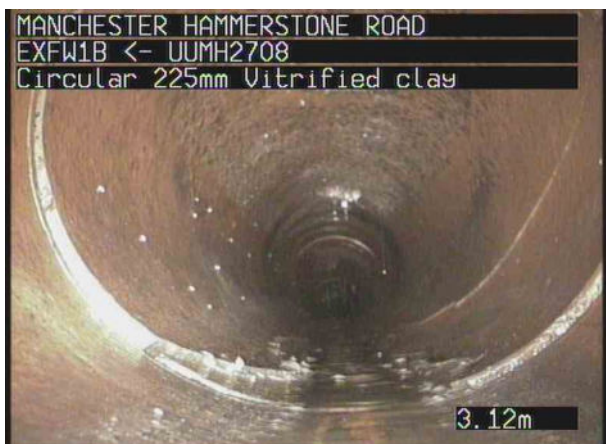
EXFW1BX\_4dbb72b1-1295-4541-a76e-22125fdc992b\_20230822\_110208\_059.jpg, 00:00:46, 3.09 m  
Fracture, circumferential at joint from 1 o'clock to 10 o'clock

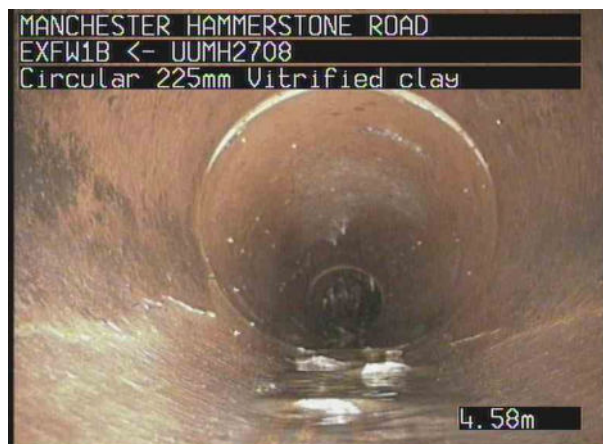
EXFW1BX\_db974e72-2cce-4a01-80a6-9243de8bc956\_20230822\_110300\_543.jpg, 00:01:32, 4.58 m  
Fracture, longitudinal at 4 o'clock

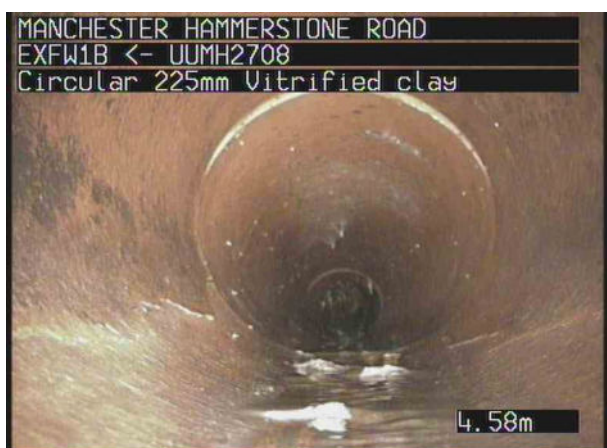
EXFW1BX\_5939447d-403e-4a0f-ae56-577e9bebf2b4\_20230822\_110312\_377.jpg, 00:01:38, 4.58 m  
Fracture, longitudinal at 8 o'clock

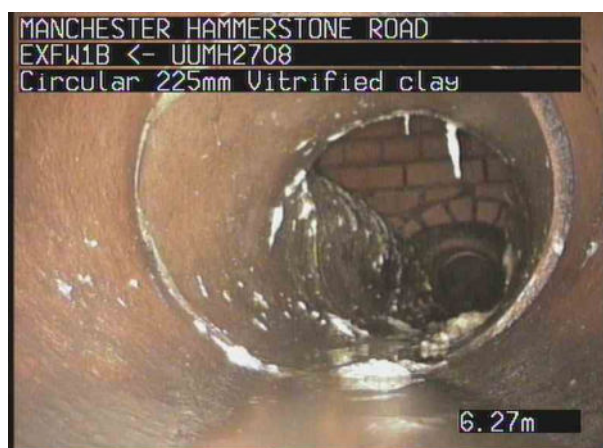
EXFW1BX\_1f52a089-6d68-439b-b6e4-a2acf425ded2\_20230822\_110353\_274.jpg, 00:02:03, 6.29 m  
Fracture, circumferential at joint from 10 o'clock to 1 o'clock

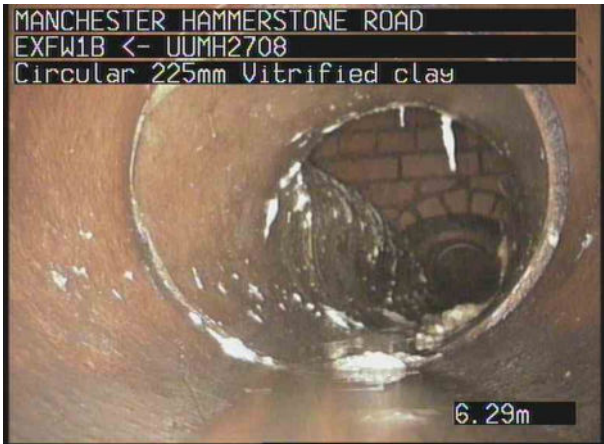
EXFW1BX\_9b32c581-e6a0-4426-97a8-5dfa9d785a36\_20230  
822\_110456\_184.jpg, 00:02:03, 6.29 m  
Fracture, circumferential at joint from 10 o'clock to 1 o'clock
