## Asbestos Refurbishment and Demolition Survey

Job Ref No: **22004**

17th September 2025

### APH Ltd, Bradnor Road, Manchester, M22 4TE

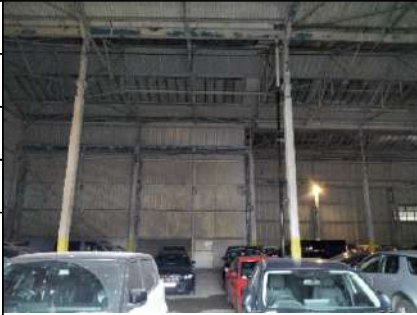
| Asbestos Detected | | | | | |
|---|---|---|---|---|---|
| Location ID | B0 74 15 09 | | | | |

| Building | Floor | Area | Description | Location ID | Asbestos Type | Qty | Material | Condition | Notifi able | Action | MRA Score | Urgency | Sample No. | Cert. No. |
|---|---|---|---|---|---|---|---|---|---|---|---|---|---|---|
| Main Building | Ground Floor | Room 1 | Asbestos Cement Roof Sheets | B0 74 15 09 | Chrysotile (white) | 150 Sq m | Asbestos Cement | Low damage: e.g. A few scratches or surface marks | No | Remove | 3 | Low | GP-01 | SCO/25/265 65 |

| Asbestos Detected | | | | | |
| Extent of Damage / Deterioration | Low damage: e.g. A few scratches or surface marks | I | Asbestos Type | Chrysotile (white) | I |
| Quantity | 150 Sq m | | | | |

| Asbestos Detected | | | | | |
|---|---|---|---|---|---|
| Recommendations: | Remove by a competent asbestos removal contractor. All work carried out should be in accordance with the Control of Asbestos Regulations 2012. | | | | |

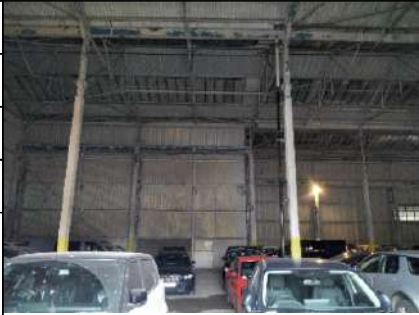
| No Asbestos Detected | | | | | |
|---|---|---|---|---|---|
| Location ID | 23 74 BA 8C | | | | |

| Building | Floor | Area | Description | Location ID | Sample No. | Cert. No. |
|---|---|---|---|---|---|---|
| Main Building | Ground Floor | Room 1 | Bitumen lining to Walls | 23 74 BA 8C | GP-02 | SCO/25/26565 |

| No Asbestos Detected | | | | | |
| Extent of Damage / Deterioration | N/A | 0 | Asbestos Type | NADIS | 0 |

| No Asbestos Detected | | | | | |
|---|---|---|---|---|---|
| Recommendations: | No asbestos detected in the sample. No further work required. | | | | |

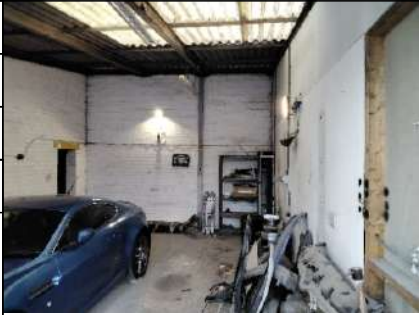
| Asbestos Strongly Presumed | | | | | |
|---|---|---|---|---|---|
| Location ID | 11 12 CA 5Z | | | | |

| Building | Floor | Area | Description | Location ID | Asbestos Type | Qty | Material | Condition | Notifiable | Action | MRA Score | Urgency | Sample No. | Cert. No. |
|---|---|---|---|---|---|---|---|---|---|---|---|---|---|---|
| Main Building | Ground Floor | Room 2 | Asbestos Cement Roof Sheets | 11 12 CA 5Z | Chrysotile (white) | 30 Sq m | Asbestos Cement | Low damage: e.g. A few scratches or surface marks | No | Remove | 3 | Low | SA/GP-01 | SCO/25/265 65 |

| Asbestos Strongly Presumed | | | | | |
| Extent of Damage / Deterioration | Low damage: e.g. A few scratches or surface marks | I | Asbestos Type | Chrysotile (white) | I |
| Quantity | 30 Sq m | | | | |

| Asbestos Strongly Presumed | | | | | |
|---|---|---|---|---|---|
| Recommendations: | Remove by a competent asbestos removal contractor. All work carried out should be in accordance with the Control of Asbestos Regulations 2012. | | | | |

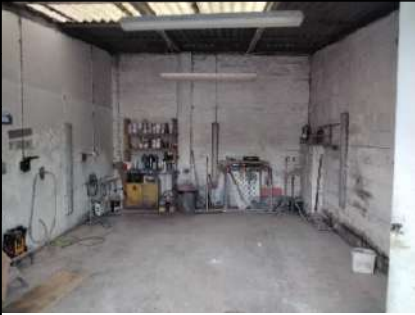
| Asbestos Strongly Presumed | | | | | |
|---|---|---|---|---|---|
| Location ID | 46 Z3 63 Z2 | | | | |

| Building | Floor | Area | Description | Location ID | Asbestos Type | Qty | Material | Condition | Notifiable | Action | MRA Score | Urgency | Sample No. | Cert. No. |
|---|---|---|---|---|---|---|---|---|---|---|---|---|---|---|
| Main Building | Ground Floor | Room 3 | Asbestos Cement Roof Sheets | 46 Z3 63 Z2 | Chrysotile (white) | 30 Sq m | Asbestos Cement | Low damage: e.g. A few scratches or surface marks | No | Remove | 3 | Low | SA/GP-01 | SCO/25/265 65 |

| Asbestos Strongly Presumed | | | | | |
| Extent of Damage / Deterioration | Low damage: e.g. A few scratches or surface marks | I | Asbestos Type | Chrysotile (white) | I |
| Quantity | 30 Sq m | | | | |

| Asbestos Strongly Presumed | | | | | |
|---|---|---|---|---|---|
| Recommendations: | Remove by a competent asbestos removal contractor. All work carried out should be in accordance with the Control of Asbestos Regulations 2012. | | | | |

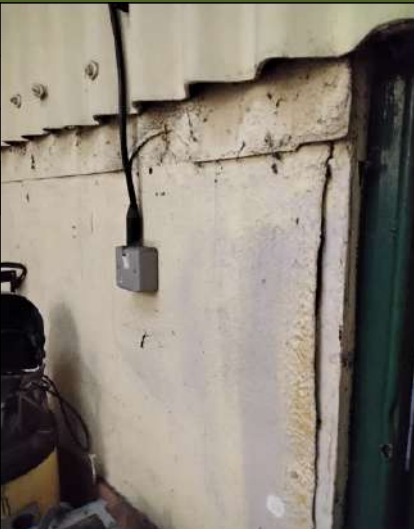
| No Asbestos Detected | | | | | |
|---|---|---|---|---|---|
| Location ID | 76 DB DB 0C | | | | |

| Building | Floor | Area | Description | Location ID | Sample No. | Cert. No. |
|---|---|---|---|---|---|---|
| Main Building | Ground Floor | Room 4 | Bitumen Lining to Wall | 76 DB DB 0C | SA/GP-02 | SCO/25/26565 |

| No Asbestos Detected | | | | | |
| Extent of Damage / Deterioration | N/A | 0 | Asbestos Type | NADIS | 0 |

| No Asbestos Detected | | | | | |
|---|---|---|---|---|---|
| Recommendations: | No asbestos detected in the sample. No further work required. | | | | |

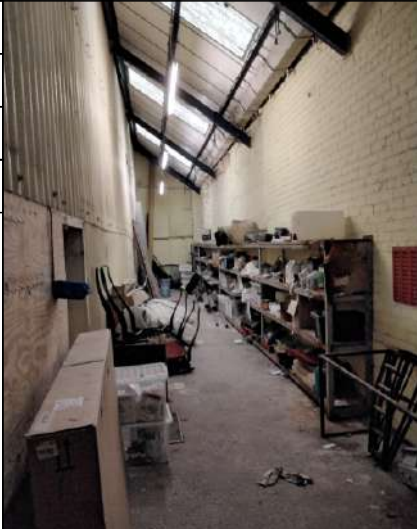
| Asbestos Detected | | | | | |
|---|---|---|---|---|---|
| Location ID | 2C 6A 96 4A | | | | |

| Building | Floor | Area | Description | Location ID | Asbestos Type | Qty | Material | Condition | Notifi able | Action | MRA Score | Urgency | Sample No. | Cert. No. |
|---|---|---|---|---|---|---|---|---|---|---|---|---|---|---|
| Main Building | Ground Floor | Room 4 | Asbestos Cement Walls Sheets | 2C 6A 96 4A | Chrysotile (white) | 40 Sq m | Asbestos Cement | Low damage: e.g. A few scratches or surface marks | No | Remove | 3 | Low | SA/GP-03 | SCO/25/265 65 |

| Asbestos Detected | | | | | |
| Extent of Damage / Deterioration | Low damage: e.g. A few scratches or surface marks | I | Asbestos Type | Chrysotile (white) | I |
| Quantity | 40 Sq m | | | | |

| Asbestos Detected | | | | | |
|---|---|---|---|---|---|
| Recommendations: | Remove by a competent asbestos removal contractor. All work carried out should be in accordance with the Control of Asbestos Regulations 2012. | | | | |

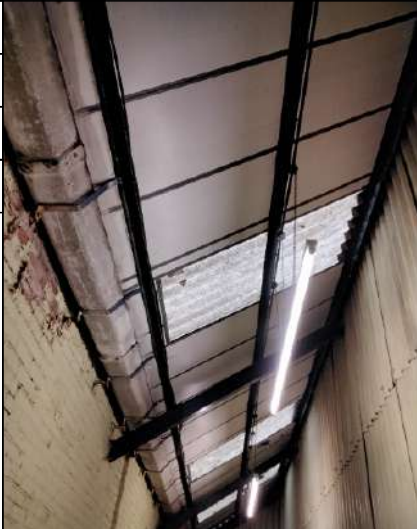
| Asbestos Strongly Presumed | | | | | |
|---|---|---|---|---|---|
| Location ID | A6 80 B3 0A | | | | |

| Building | Floor | Area | Description | Location ID | Asbestos Type | Qty | Material | Condition | Notifiable | Action | MRA Score | Urgency | Sample No. | Cert. No. |
|---|---|---|---|---|---|---|---|---|---|---|---|---|---|---|
| Main Building | Ground Floor | Room 4 | Asbestos Cement Guttering | A6 80 B3 0A | Chrysotile (white) | 5 Lin m | Asbestos Cement | Low damage: e.g. A few scratches or surface marks | No | Remove | 3 | Low | Strongly Presumed | |

| Asbestos Strongly Presumed | | | | | |
| Extent of Damage / Deterioration | Low damage: e.g. A few scratches or surface marks | I | Asbestos Type | Chrysotile (white) | I |
| Quantity | 5 Lin m | | | | |

| Asbestos Strongly Presumed | | | | | |
|---|---|---|---|---|---|
| Recommendations: | Remove by a competent asbestos removal contractor. All work carried out should be in accordance with the Control of Asbestos Regulations 2012. | | | | |

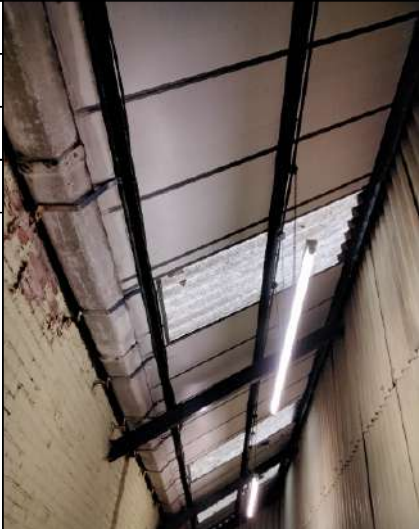
| No Asbestos Detected | | | | | |
|---|---|---|---|---|---|
| Location ID | 6A A6 DB 97 | | | | |

| Building | Floor | Area | Description | Location ID | Sample No. | Cert. No. |
|---|---|---|---|---|---|---|
| Main Building | Ground Floor | Room 4 | Plasterboard/metal framework to Ceiling | 6A A6 DB 97 | GP-04 | SCO/25/26565 |

| No Asbestos Detected | | | | | |
| Extent of Damage / Deterioration | N/A | 0 | Asbestos Type | NADIS | 0 |

| No Asbestos Detected | | | | | |
|---|---|---|---|---|---|
| Recommendations: | No asbestos detected in the sample. No further work required. | | | | |

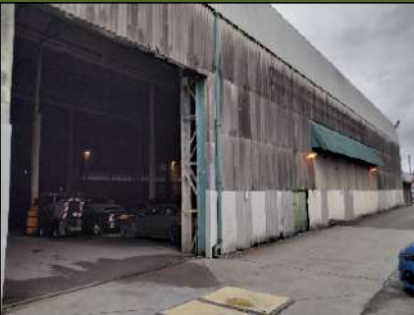
| Asbestos Strongly Presumed | | | | | |
|---|---|---|---|---|---|
| Location ID | 27 A5 C0 0D | | | | |

| Building | Floor | Area | Description | Location ID | Asbestos Type | Qty | Material | Condition | Notifiable | Action | MRA Score | Urgency | Sample No. | Cert. No. |
|---|---|---|---|---|---|---|---|---|---|---|---|---|---|---|
| Main Building | External | Walls | Asbestos Cement Wall Sheets | 27 A5 C0 0D | Chrysotile (white) | > 500 Sq m | Asbestos Cement | Low damage: e.g. A few scratches or surface marks | No | Remove | 3 | Low | SA/GP-03 | SCO/25/265 65 |

| Asbestos Strongly Presumed | | | | | |
| Extent of Damage / Deterioration | Low damage: e.g. A few scratches or surface marks | I | Asbestos Type | Chrysotile (white) | I |
| Quantity | > 500 Sq m | | | | |

| Asbestos Strongly Presumed | | | | | |
|---|---|---|---|---|---|
| Recommendations: | Remove by a competent asbestos removal contractor. All work carried out should be in accordance with the Control of Asbestos Regulations 2012. | | | | |

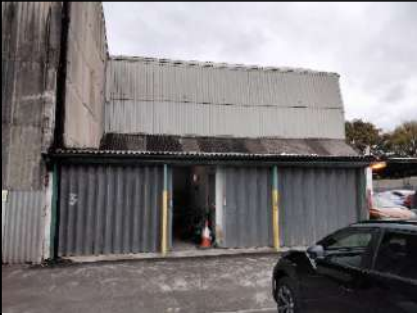
| Asbestos Strongly Presumed | | | | | |
|---|---|---|---|---|---|
| Location ID | C8 73 2C C5 | | | | |

| Building | Floor | Area | Description | Location ID | Asbestos Type | Qty | Material | Condition | Notifiable | Action | MRA Score | Urgency | Sample No. | Cert. No. |
|---|---|---|---|---|---|---|---|---|---|---|---|---|---|---|
| Main Building | External | Roof | Asbestos Cement Roof Sheets | C8 73 2C C5 | Chrysotile (white) | 150 Sq m | Asbestos Cement | Low damage: e.g. A few scratches or surface marks | No | Remove | 3 | Low | SA/GP-01 | SCO/25/265 65 |

| Asbestos Strongly Presumed | | | | | |
| Extent of Damage / Deterioration | Low damage: e.g. A few scratches or surface marks | I | Asbestos Type | Chrysotile (white) | I |

| Asbestos Strongly Presumed | | | | | |
|---|---|---|---|---|---|
| Recommendations: | Remove by a competent asbestos removal contractor. All work carried out should be in accordance with the Control of Asbestos Regulations 2012. | | | | |
