## **Schedule Of Works.**

### **Portland House**

The works relate to elevation repairs, redecoration and roofing repairs to 103a Portland Street, Manchester M1 6DF. Portland House is a Grade 2 Listed Building ( listing number 1247058) situated within The Whitworth Street Conservation Area.

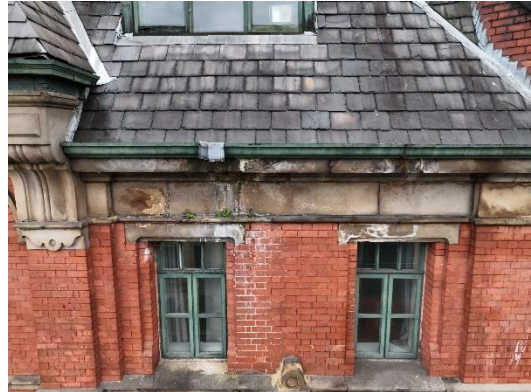
### **R1 North 0101**

1. Lead has been used in an attempt to repair a section of cast iron gutter, however the area below still appears damp.
2. The paintwork to the gutters has deteriorated and all the cast iron gutters should be decorated.
3. Directly below the lead repair there is staining, moss and vegetation growth and spalled stonework

From the drone footage R1 North 0101 and R2 East 0561 lead has been used to repair the cast iron joints.This often indicates corrosion of the cast iron gutter.

If the corrosion is so severe, that the joints cannot be repaired then replace of the section should be considered.

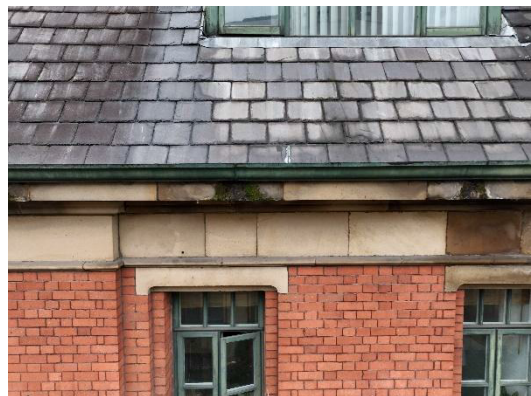
### **R2 East 0550**

1. The paintwork to the gutters has deteriorated, all of the cast iron gutters should be redecorated.
2. Directly below the gutter joints there is staining and moss growth to the stone.

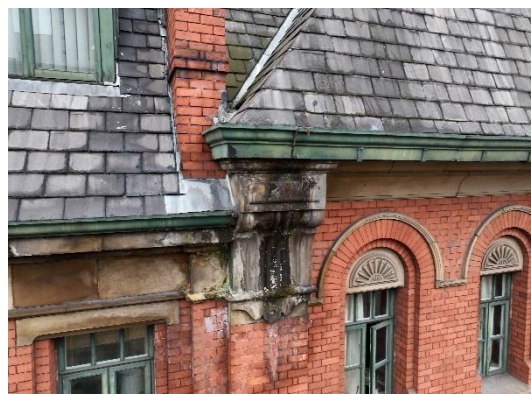
### **R2 East 0555**

1. The paintwork to the gutters has deteriorated, all cast iron gutters should be decorated.
2. Directly below the gutter joints there is staining and moss growth to brick and stone.
3. The mortar joints to the brick chimney stack

are cracked and missing.

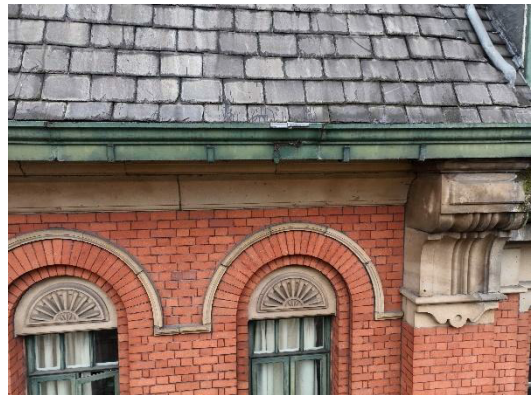
### **R2 East 0561**

1. Lead has been used in attempt to repair a section of the cast iron gutter.
2. The paintwork to the gutters has deteriorated and all of the cast iron gutters should be redecorated.
3. This section of guttering has been fitted with metal supports beneath it.

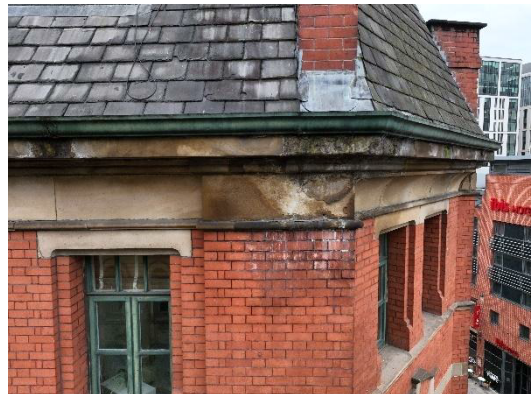
### **R2 East 0573**

1. There is water staining, moss growth and spalled stonework below the gutter joint.

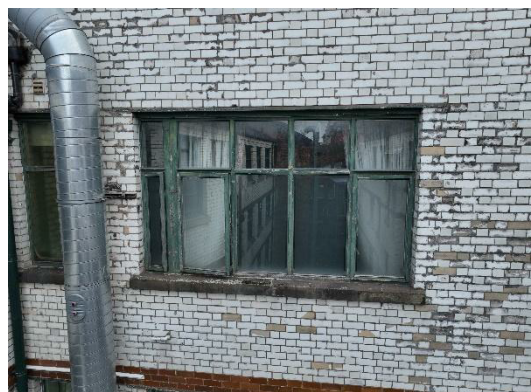
### **WE 1201**

1. The paint to the timber framed window has Deteriorated and there are signs of rot present.
2. There is moss growth and staining to the stone Aill.
3. A number of ceramic bricks have spalled and some have been infilled with mortar.

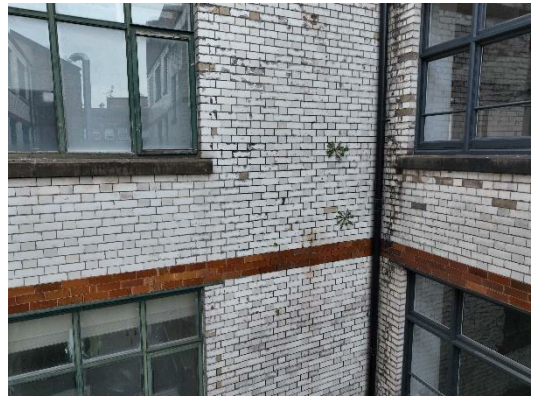
## **WE 1214**

1. There is dark staining around the down pipe suggesting a gutter leak.
2. There is vegetation growth in between the ceramic tiles.
3. The mortar joints in between the ceramic bricks is missing and cracked.
4. A number of ceramic tiles are spalled and some have been infilled with mortar.

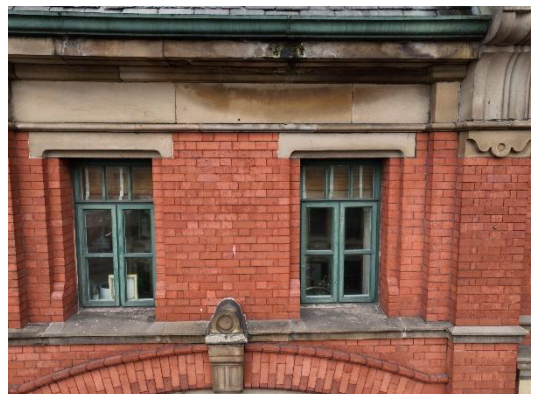
## **NE 4<sup>th</sup> 0136**

1. There is water staining and moss growth to the stonework below a leaking gutter joint.
2. The mortar joint to the brick and stone are cracked and missing in areas.
3. The paint to the timber framed windows and cast gutters has deteriorated and requires redecoration.

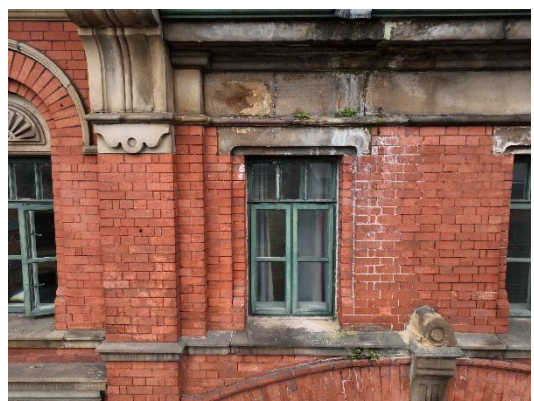
## **NE 4<sup>th</sup> 0156**

1. There is spalling, water staining and vegetation growth to the brick and stonework below a leaking gutter joint. An attempt to repair the gutter joint with

lead has been made.

2. The paint to the timber framed windows has deteriorated and the seal around the window frame has perished.

3. The mortar joints to the brick are cracked and missing in areas .

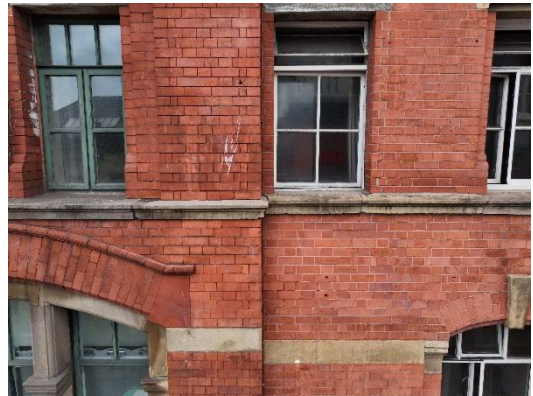
### **NE 3rd 0216**

1. The brickwork around the left-hand window and the brick pier are marked with white paint.

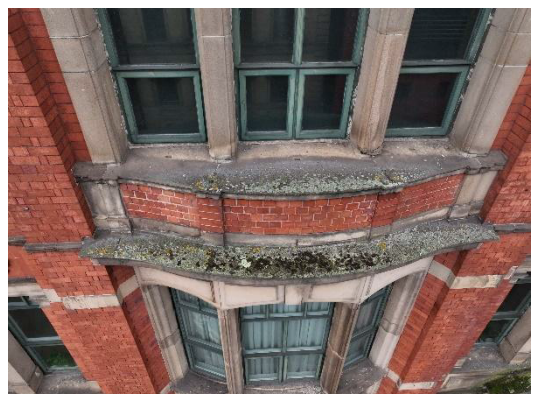
### **NE 3rd 0233**

1. There is lichen and moss growth to the stone sills.

2. The paint to the timber framed windows has deteriorated and the seal around the window frame has perished.

3. There is a crack in the keystone above the window.

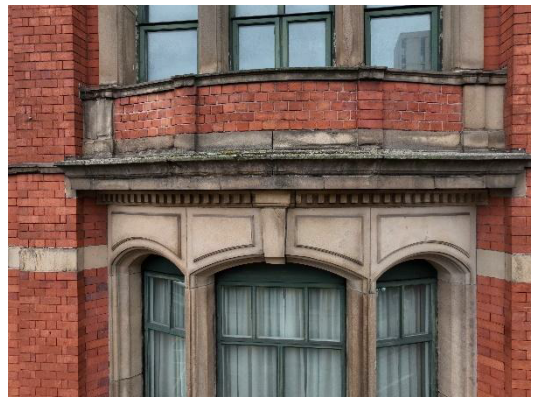
### **NE 2<sup>nd</sup> 0299**

1. There are areas of spalled stonework above the bay window.
2. The mortar joints to the brick and stone are cracked and missing in areas.
3. There is a crack in the keystone above the window.

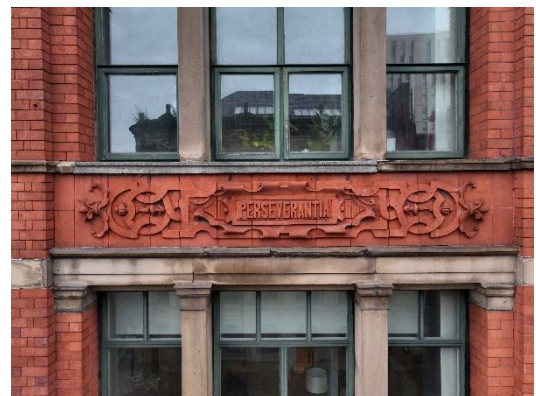
### **NE 2<sup>nd</sup> 0310**

1. There are a small number of hairline cracks to the terracotta tiles and the mortar joints are missing.
2. To the left of the window there is a damaged brick which should be replaced.
3. There are some areas of spalled stonework surrounding the terracotta tiling.

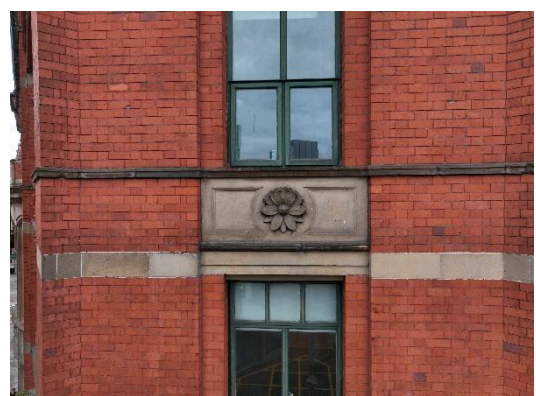
### **NE 2<sup>nd</sup> 0321**

1. A white mastic appears to have been used to repoint the stonework instead of mortar. The mastic should be removed.

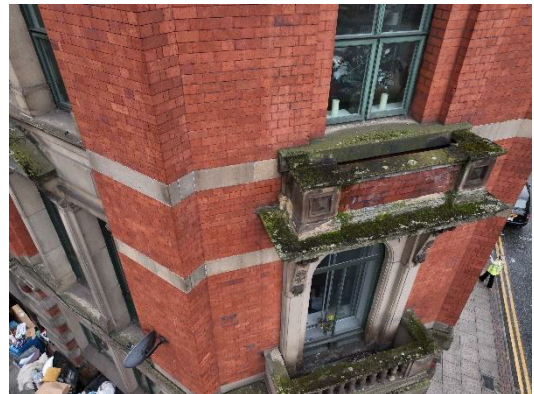
### **NE 2<sup>nd</sup> 0327**

1. There is moss and algae growth to stone sills and a build-up of debris on the balcony area.

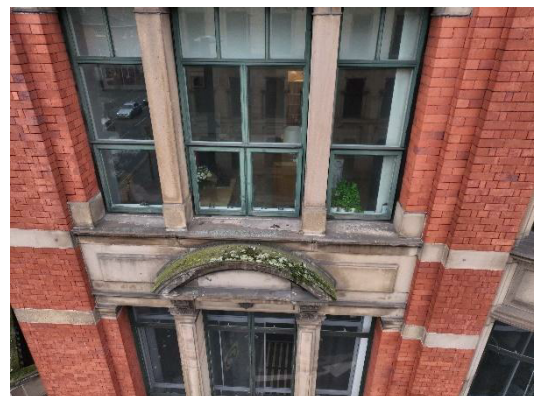
### **NE 2<sup>nd</sup> 0340**

1. The paint to the timber frame d windows has deteriorated.
2. The mortar joints to the bricked stone are cracked and missing in areas.
3. There is evidence of historic sill repairs.
4. There is moss and algae growth to stone window arch.

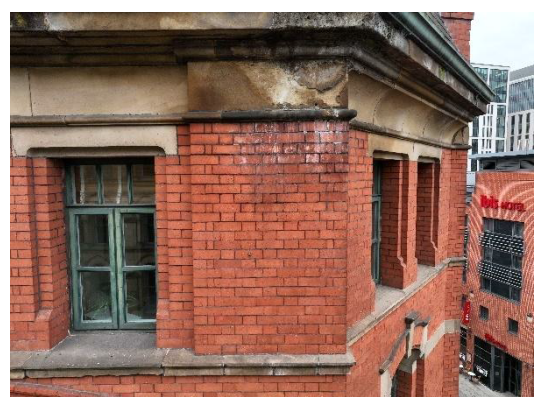
### **EE 4<sup>th</sup> 0575**

1. There is spalling and water staining to the brick and stonework below a leaking gutter joint.
2. The paint to the timber window frame has deteriorated and the seal around the window frame

has perished.

3. The mortar joints to the brick and stoneware cracked and missing in areas.
4. There is a small crack to the left-hand side of the stone lintel and damage at the base of the stone sill.

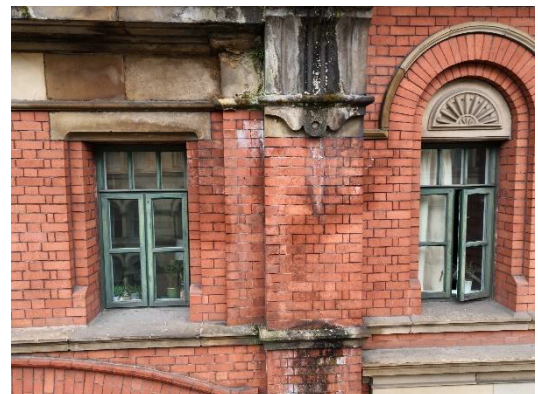
#### **EE 4<sup>th</sup> 0594**

1. There is spalling, water staining and moss growth to the brick and stonework below a leaking gutter.
2. The paint to the timber framed windows has deteriorated and the seal around the window Frame has perished.
3. The mortar joints to the brick and stone are cracked and missing in areas.

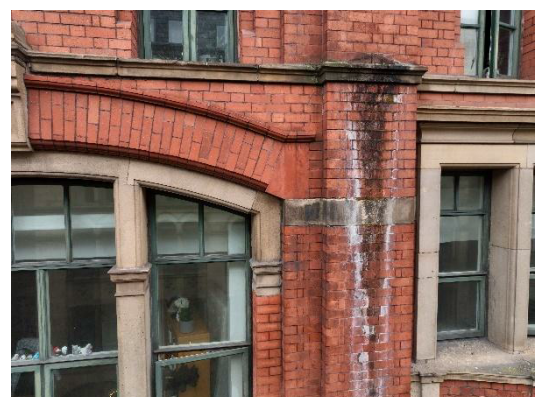
#### **EE 3<sup>rd</sup> 0674**

1. The paint to the timber frame has deteriorated.
2. There is efflorescence, water staining and algae growth to brick and stonework below a leaking gutter joint.

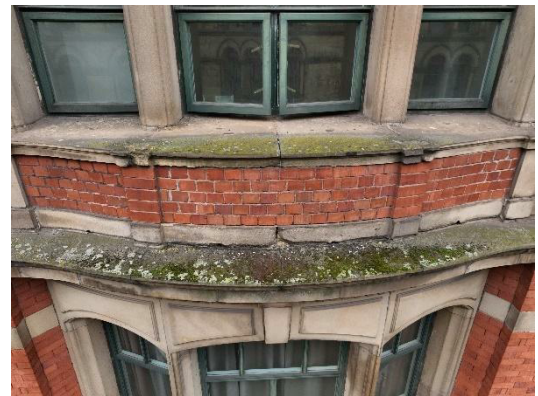
### **EE 3<sup>rd</sup> 0752**

1. There is moss and lichen growth to stone sills.
2. The mortar joints to brick and stone are cracked and missing areas.
3. The stonework is spalled and damaged in areas.

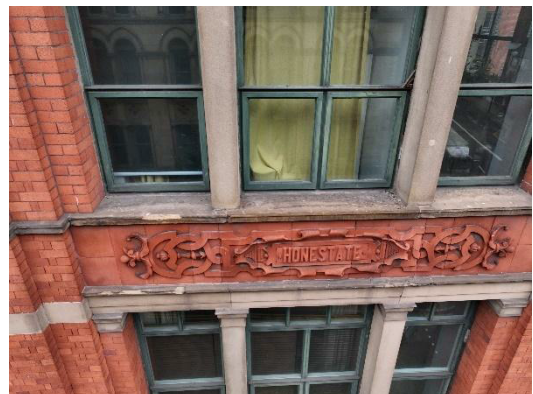
### **EE 3<sup>rd</sup> 0760**

1. There are a small number of hairline cracks to the terracotta tiles and the mortar joints are missing.
2. There are areas of spalled stonework surrounding the terracotta tiling.
3. The paint to the timber framed windows has deteriorated, there are signs of rot and the seal around the window frame has perished.

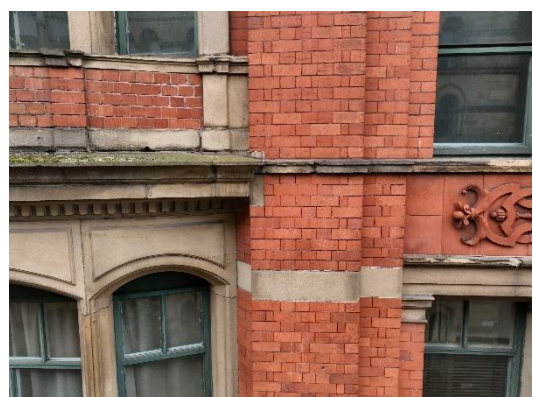
### **EE 2<sup>nd</sup> 0774**

1. The mortar joints to the brick and stone are cracked and missing in areas.

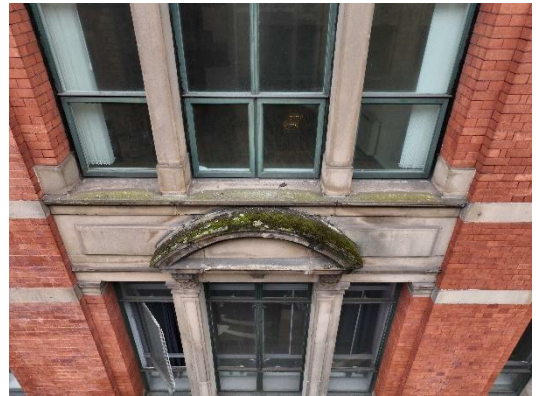
### **EE 2<sup>nd</sup> 0806**

1. There is moss and algae growth to the stone window arch and sill.
2. The paint to the timber framed windows has deteriorated.

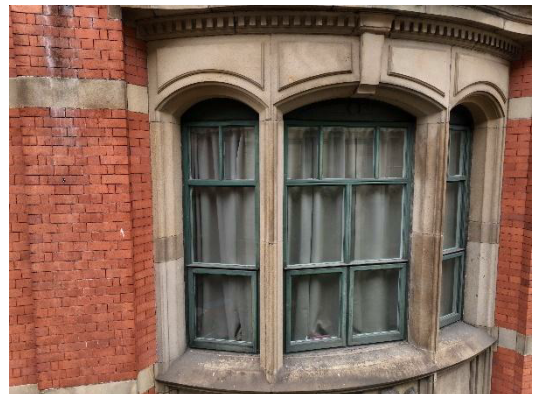
### **EE 2<sup>nd</sup> 0817**

1. The paint to the timber framed windows has deteriorated.
2. The mortar joints to the brick and stone are cracked and missing in areas.
3. There is staining to the wall below a leaking gutter.

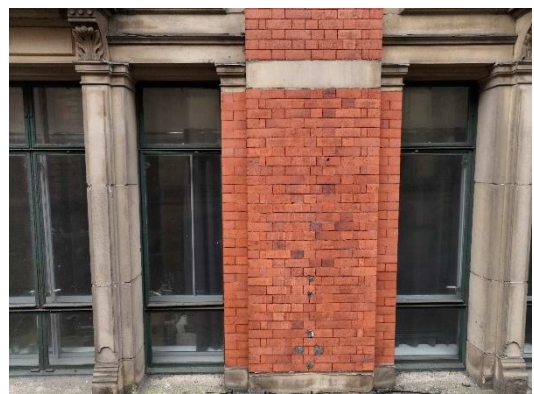
### **EE 1<sup>st</sup> 0878**

1. There are glue marks on brickwork where a fixture has been removed.
2. The mortar joints to the brick and stone are cracked and missing in areas.

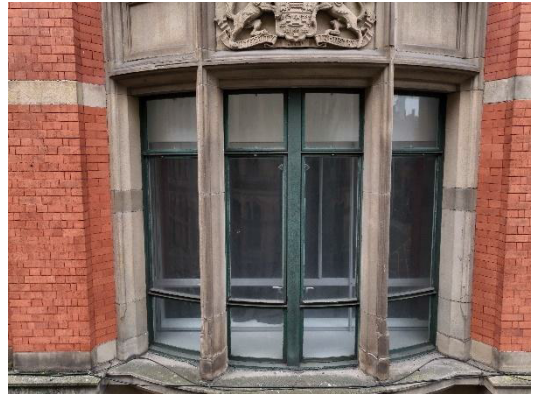
## **EE 1<sup>st</sup> 0889**

1. The paint to the timber framed windows has deteriorated.
2. The mortar joints to the brick and stone are cracked and missing in areas.
