**STRUCTURAL SURVEY REPORT:  
621 BURNAGE LANE, MANCHESTER, M19 1WB**

RP-H1137-01-R0

**STRUCTURAL SURVEY OF:  
621 BURNAGE LANE, MANCHESTER, M19 1WB**

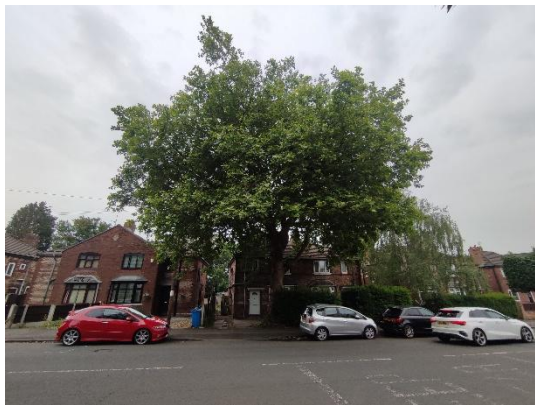
*Photo 1 – View of property frontage and mature London Plane*

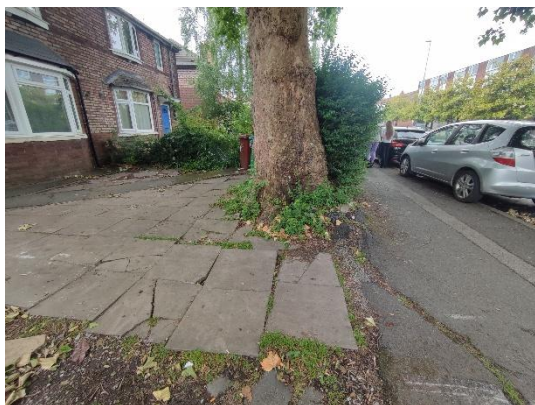
- (iv.) Significant undulations and displacements of the concrete flags linked to the trunk and lateral root growth of the subject tree were observed within the Client's property. Similar undulations and cracks to the surfacing were also observed on the pedestrian footpath adjacent to the tree. This also poses a trip hazard to the members of the public using this area.

*Photo 3 – View of base of tree and damage to concrete flagstones and surfacing of public footway*

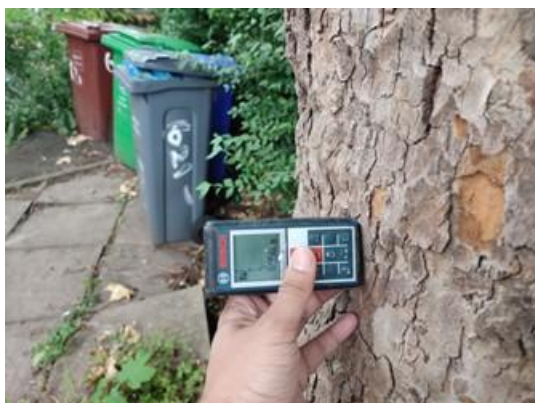
- (i.) The subject tree was found to be growing in close proximity to the front elevation of the Client's property (i.e. 6.05m away). The influence distance (radius) of the tree is 19.5m as described in the NHBC chapter 4.2.

*Photo 4 – The distance between the tree and Client's property was measured as 6.05m. The zone of influence of this tree is 19.5m.*

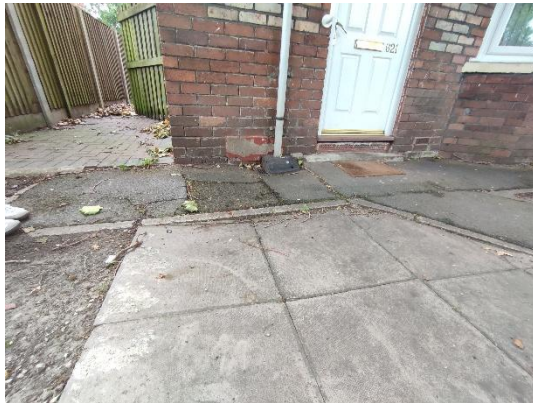
*Photo 6 – Undulations observed in the surfacing adjacent to the front and side elevations. The client highlighted that the drains were previously inspected and significant root ingress was observed.*

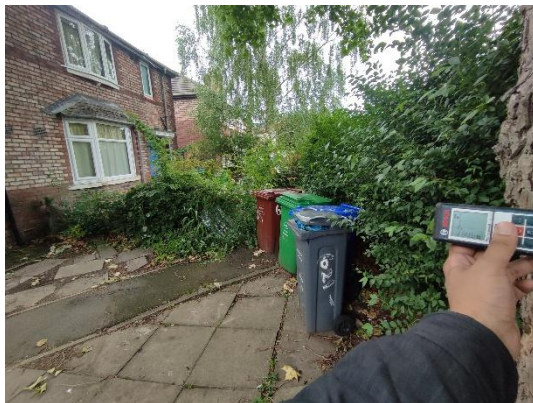
*Photo 7 – The distance between the tree and neighbouring property which had previously been damaged and subsequently repaired was measured as 7.85m. The zone of influence of this tree is 19.5m.*

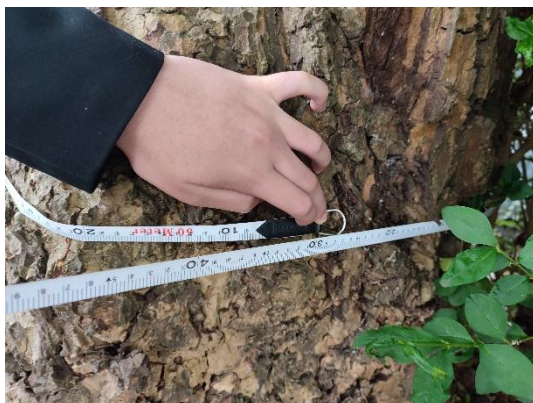
*Photo 8 – The tree trunk girth was measured as approx. 3.3m i.e. 1.05m diameter.*

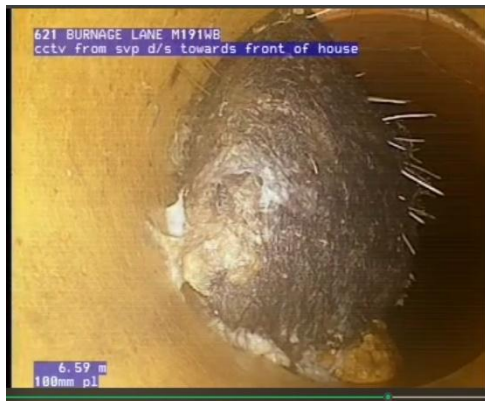
Photo 10 – 50% blockage observed in the drain pipe at the front of the property (Ch. 6.59m)

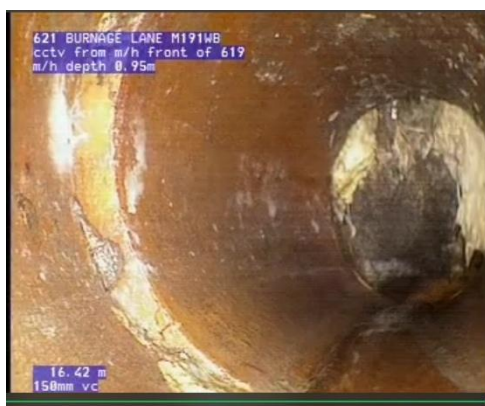
Photo 11 – 95% blockage at the front of the property (Ch. 16.54m, see drainage report)

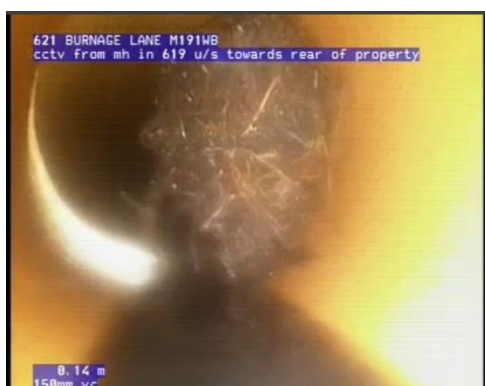
Photo 12 – 50% blockage to the side elevation (Ch. 0.14m)

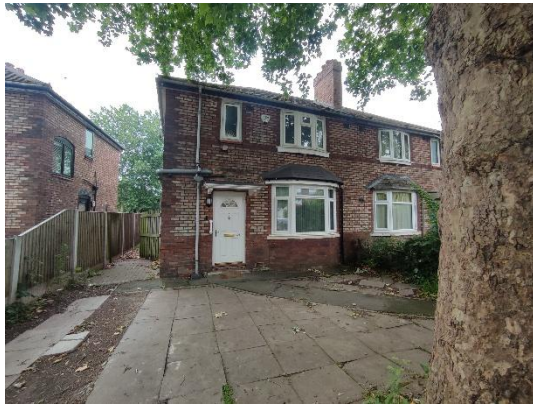
*Photo 13 – View of the front elevation of the property*

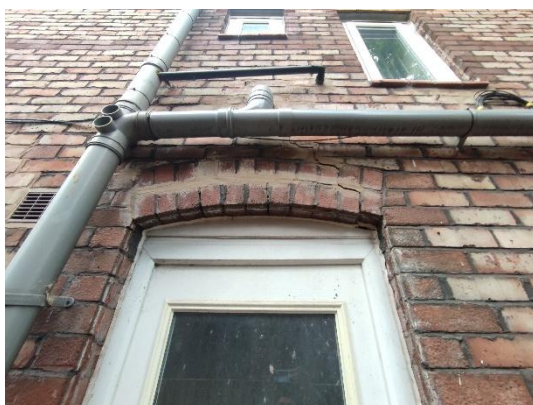
*Photo 16 – Diagonal stepped cracking noted above the ground-floor segmental arch lintel (cracking to right).*

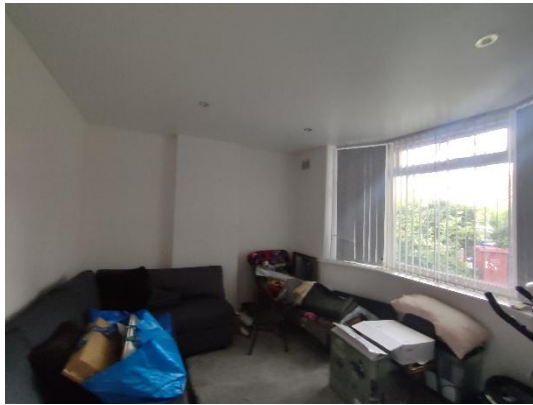
*Photo 17 – View of the room overlooking the front garden, cracks observed on walls perpendicular to front elevation wall and bay window construction measured/observed to incline slightly*

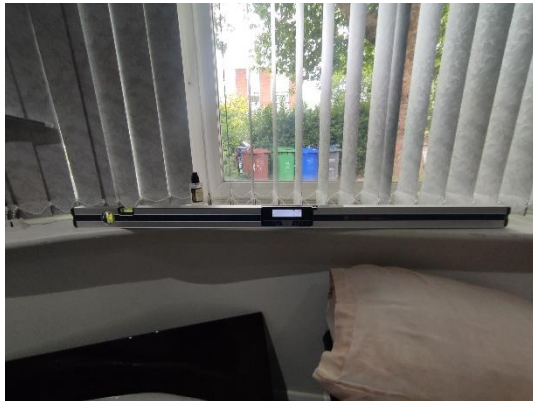
*Photo 18 – Horizontal checks of the bay window area indicate inclinations of 7mm per meter, cracks also noted on the walls perpendicular to this wall*

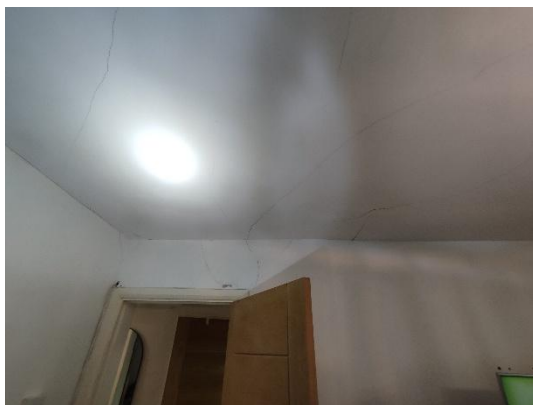
*Photo 19 – Widespread diagonal cracks (<1mm wide), indicative of ongoing movements*

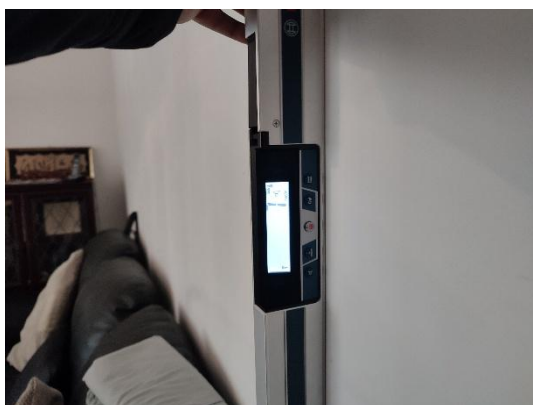
*Photo 20 – Slight vertical inclinations of 7mm per meter to main load bearing walls.*

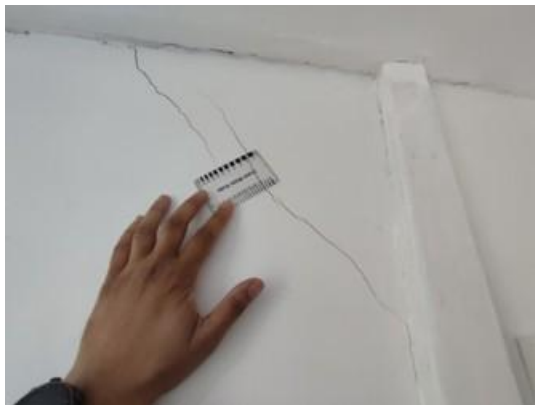
*Photo 21 – Diagonal cracks measured as 1mm wide*

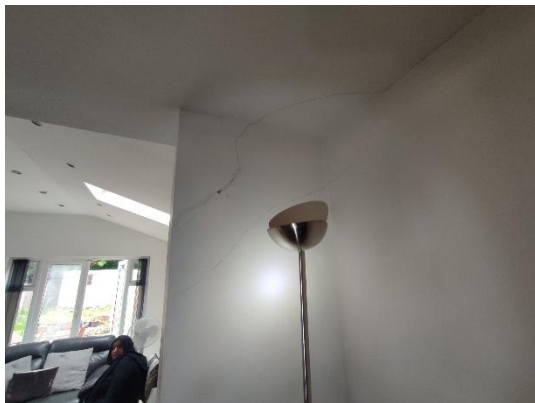
*Photo 22 – Diagonal cracks extending to party wall with neighbouring property*

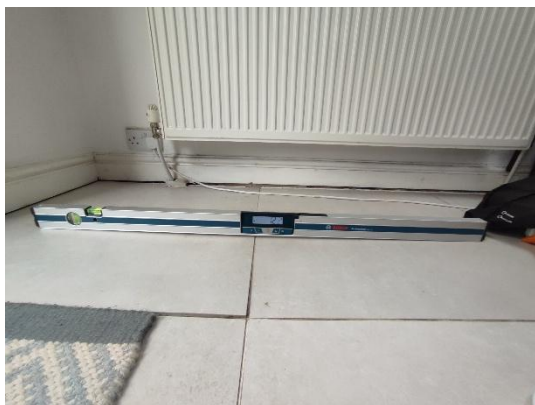
*Photo 23 – Floor dropping in areas, 20mm gap noted between flooring and skirting boards, horizontal inclinations of up to 12mm per meter recorded.*

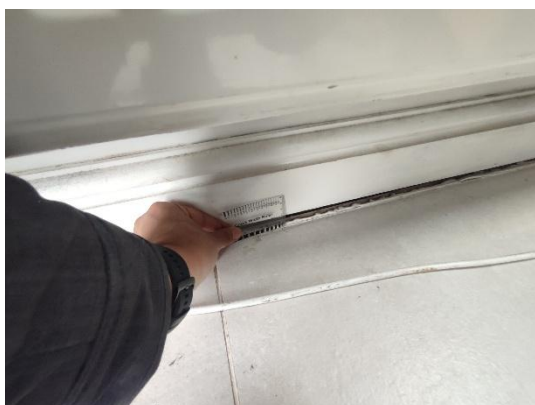
*Photo 24 – 20mm gap between flooring and skirting boards, the presence of sealant on the tiles is indicative that this has occurred in the recent past.*

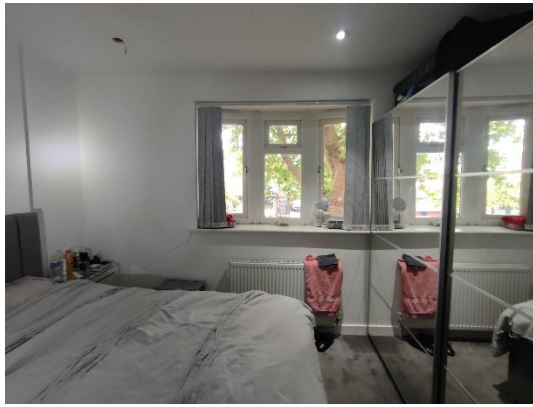
*Photo 25 – View of bedroom overlooking mature tree at the front of the property*

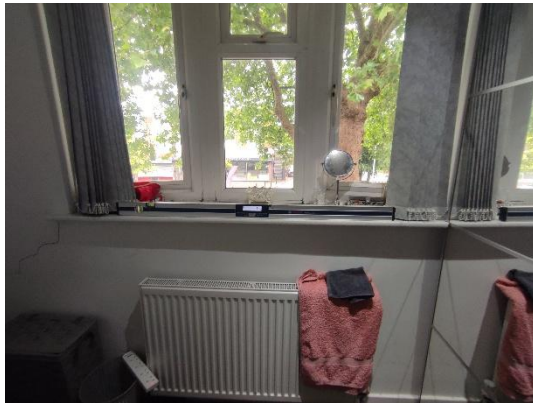
*Photo 26 – Close up of bay window. Slight inclination of 4mm per metre observed. 2mm wide diagonal stepped crack located at the bottom corner of the window. Further diagonal crack observed behind the wardrobe at the top right of this window.*

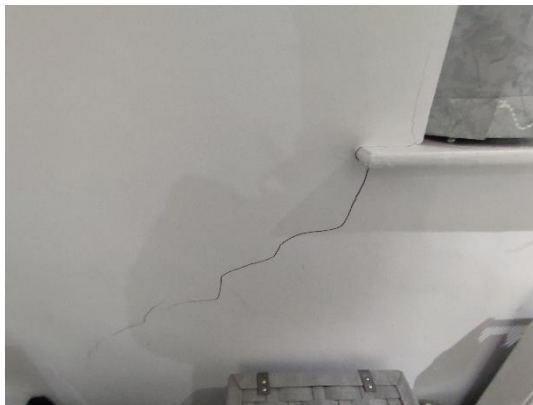
*Photo 27 – View of the 2mm wide diagonal stepped crack to the bottom left corner of the window*

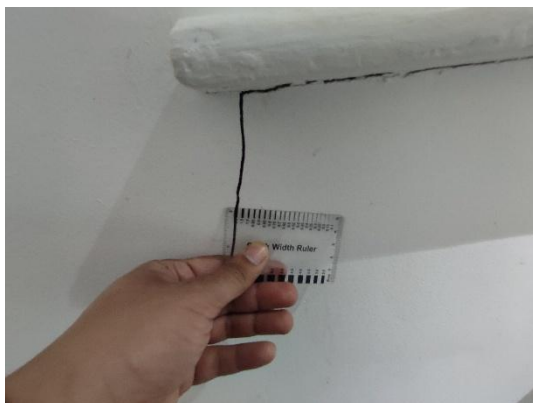
*Photo 28 – Crack measured as 2mm wide*

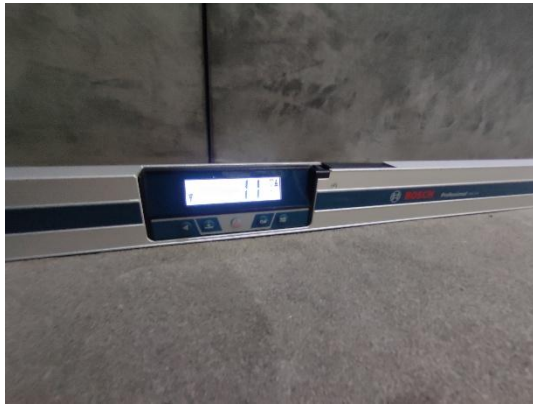
*Photo 29 – Inclination of floor recorded as 11mm per meter in areas.*

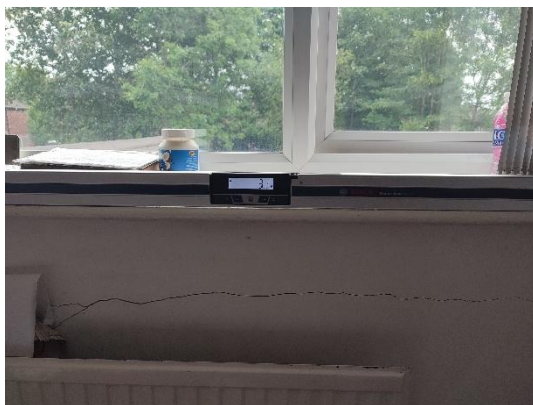
*Photo 31 – Horizontal cracks beneath the window and inclinations of 3mm per metre observed on the window sill*

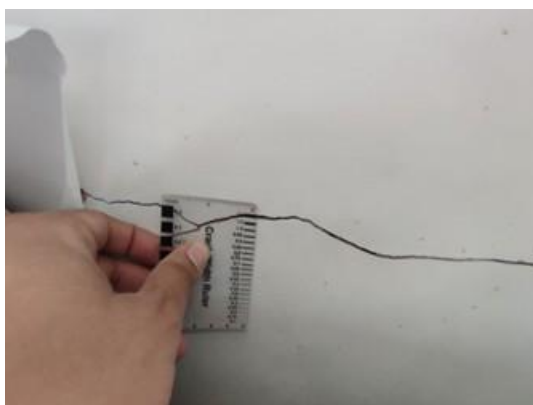
*Photo 32 – The cracks beneath the window sill were observed to be relatively deep and 2mm wide*

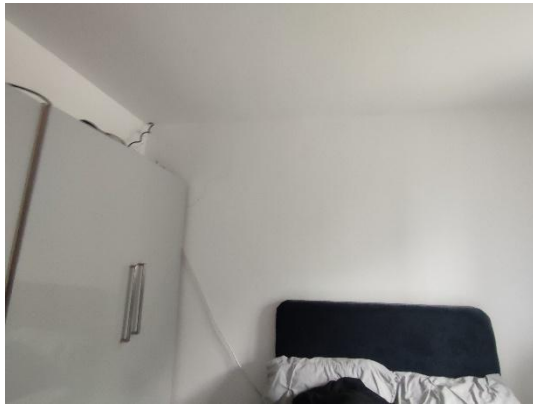
*Photo 33 – Partially obscured diagonal crack extending across the side elevation wall, the crack was noted to be 1.5mm wide*

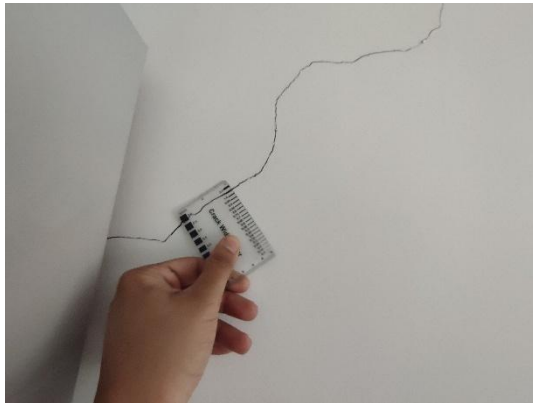
*Photo 34 – Closeup of crack.*

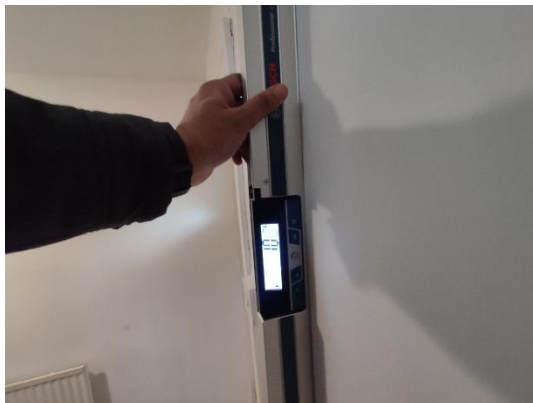
*Photo 35 – Verticality checks indicate inclinations of 10mm per metre*

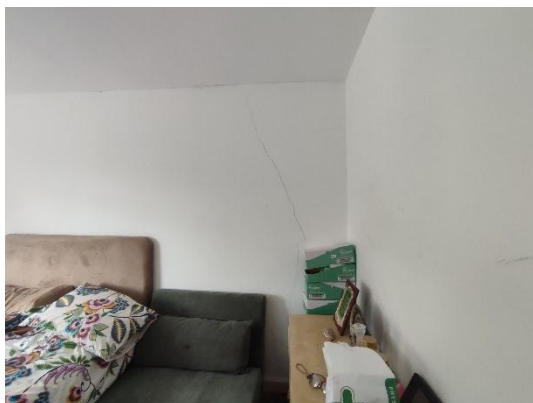
*Photo 36 – Diagonal cracks observed on the party wall indicative of slight movements of the foundations potentially affecting both properties*

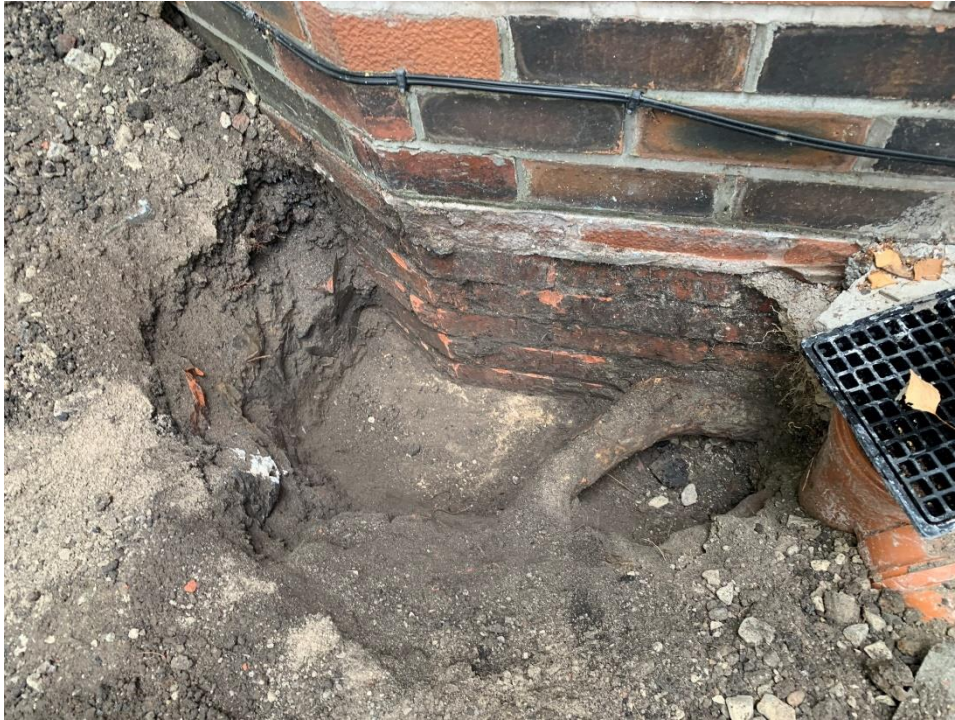
**Photograph 4**

Trial Pit Showing Root

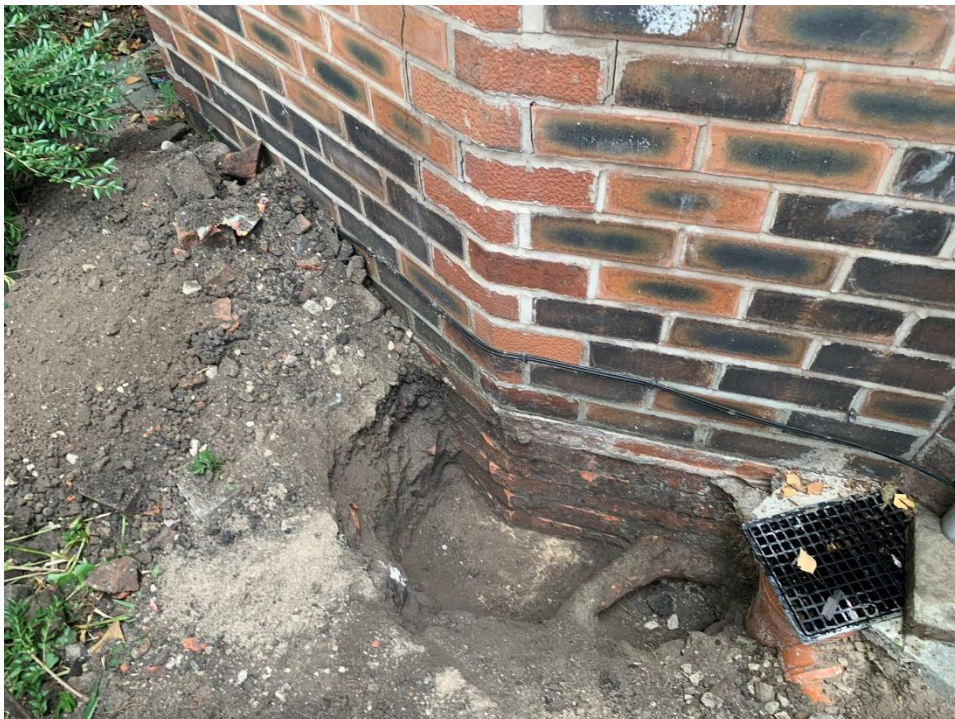
**Photograph 4**

Trial Pit with Root and Crack Shown

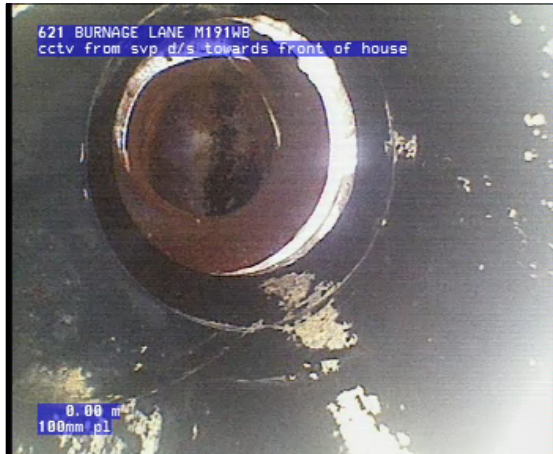
Photo: 1\_1\_4\_A.jpg, 00:00:01  
 0m, Fracture, circumferential at joint, from 7 to 5 o'clock

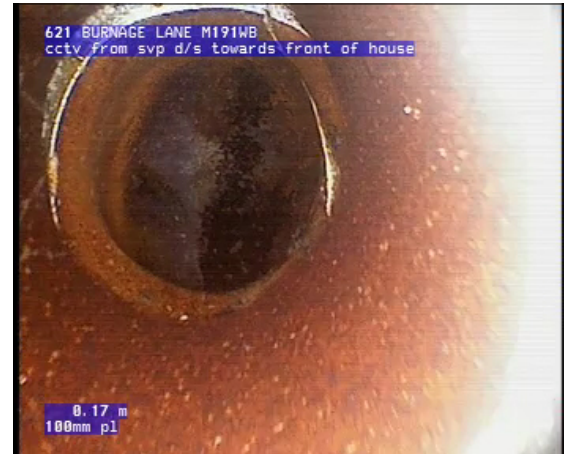
Photo: 1\_1\_5\_A.jpg, 00:00:13  
 0.08m, Fracture, circumferential at joint, from 1 to 4 o'clock

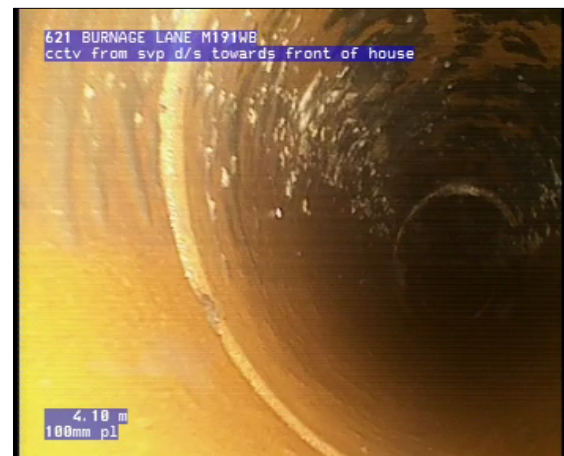
Photo: 1\_1\_10\_A.jpg, 00:00:46  
 4.1m, Attached deposits, grease, from 9 to 3 o'clock, 5% cross-sectional area loss, Start

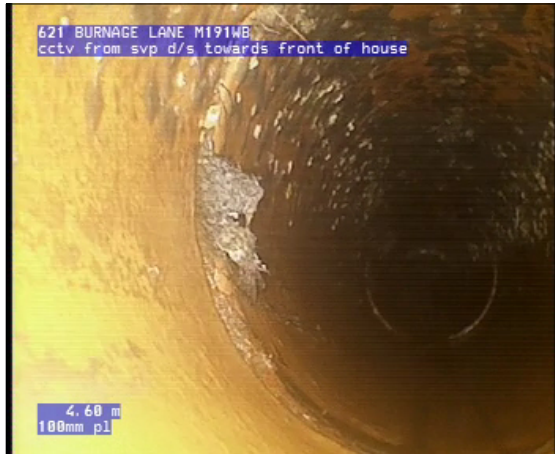
Photo: 1\_1\_11\_A.jpg, 00:00:49  
4.6m, Roots, fine at joint

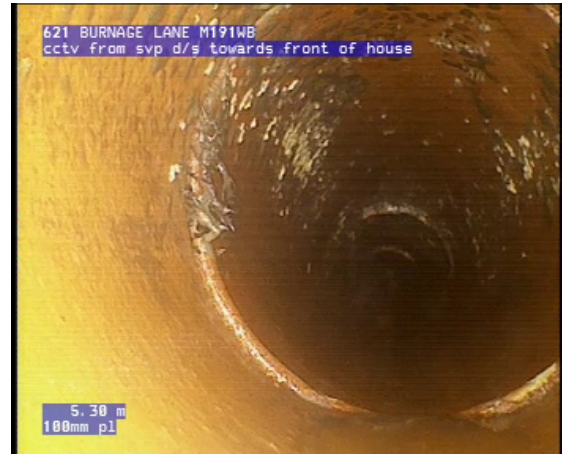
Photo: 1\_1\_12\_A.jpg, 00:00:53  
5.3m, Roots, fine at joint

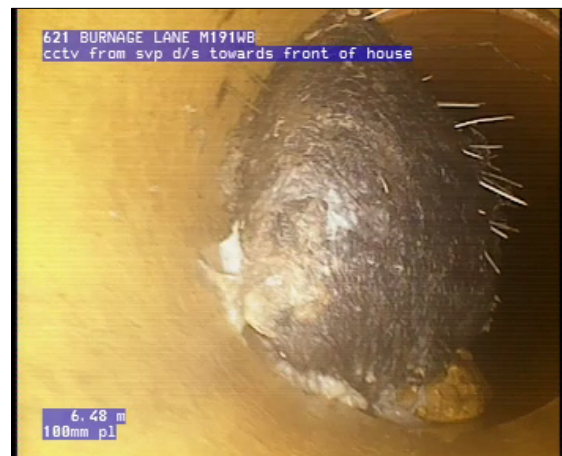
Photo: 1\_1\_14\_A.jpg, 00:01:07  
6.48m, Roots, mass at joint, 50% cross-sectional area loss

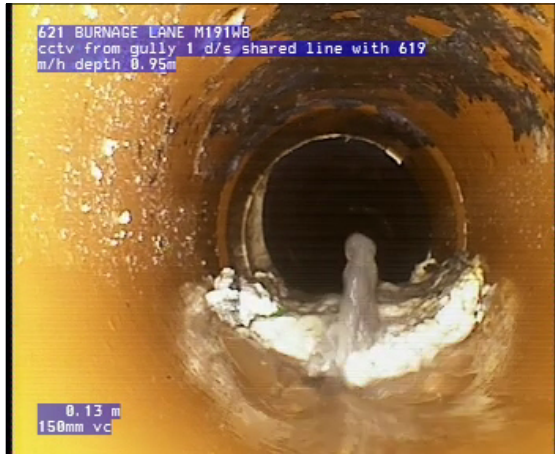
Photo: 3\_3\_22\_A.jpg, 00:00:16  
 0.13m, Settled deposits, hard or compacted, 20% cross-sectional area loss  
 Remarks: Grout

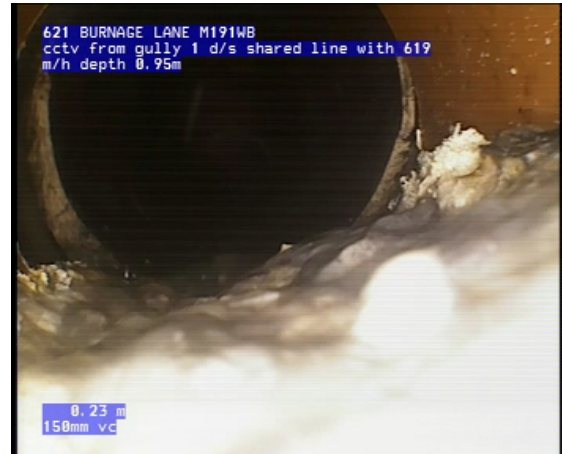
Photo: 3\_3\_23\_A.jpg, 00:00:19  
 0.14m, Joint displaced, large

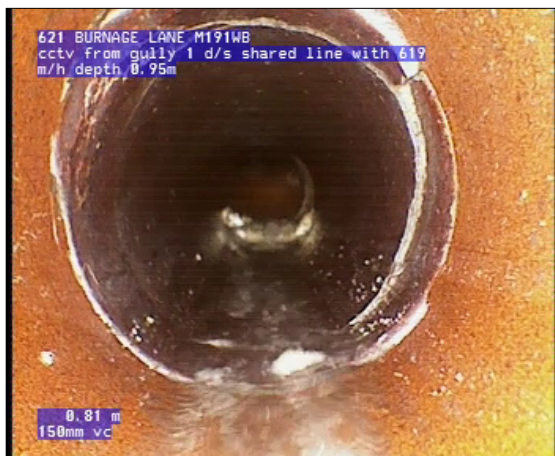
Photo: 3\_3\_24\_A.jpg, 00:00:26  
 0.81m, Fracture, circumferential at joint, from 7 to 5 o'clock

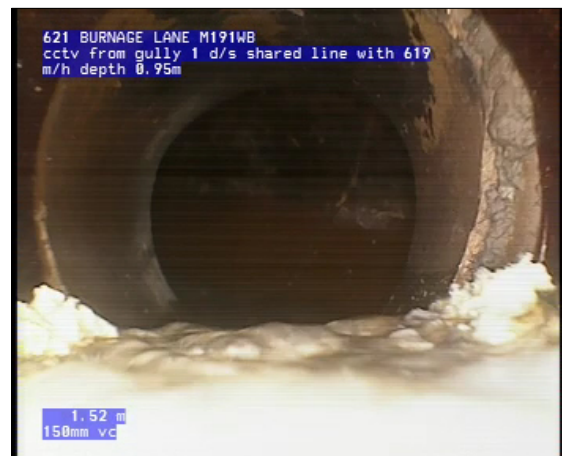
Photo: 3\_3\_25\_A.jpg, 00:00:32  
 1.52m, Joint displaced, large

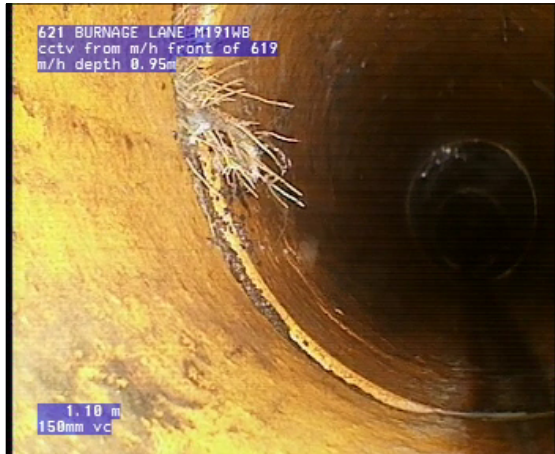
Photo: 5\_5\_34\_A.jpg, 00:00:09  
0.99m, Roots, fine at joint

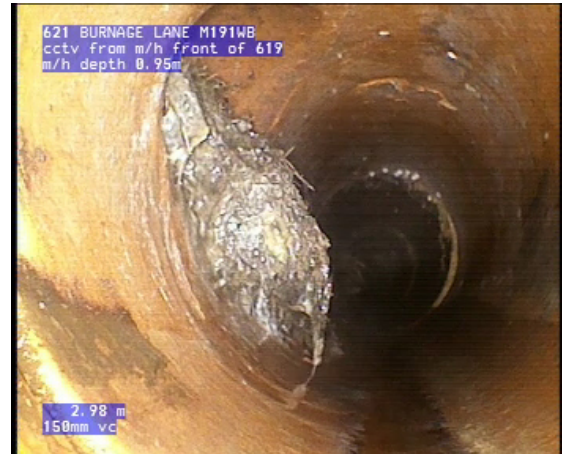
Photo: 5\_5\_35\_A.jpg, 00:00:21  
2.98m, Junction, at 11 o'clock, diameter 100mm Remarks:  
Roots coming out from junction

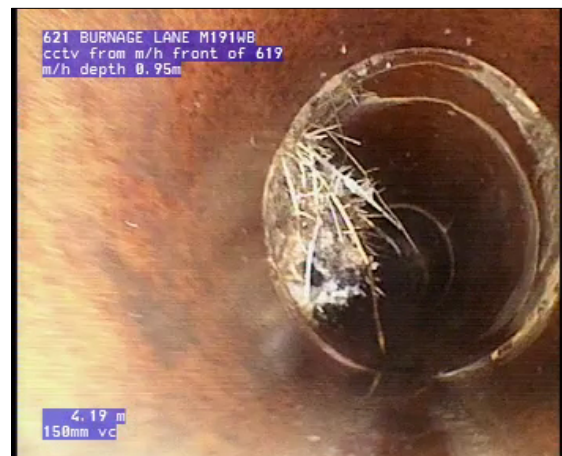
Photo: 5\_5\_37\_A.jpg, 00:00:32  
4.19m, Fracture, circumferential at joint, from 11 to 5 o'clock

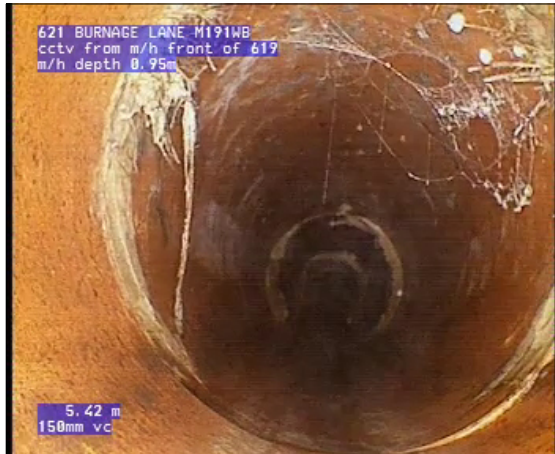
Photo: 5\_5\_38\_A.jpg, 00:00:45  
 5.42m, Roots, fine at joint

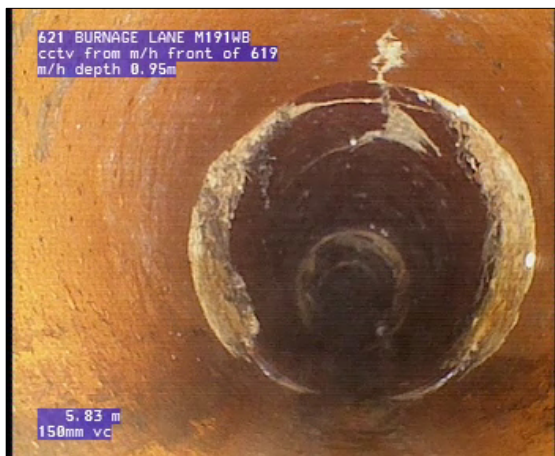
Photo: 5\_5\_40\_A.jpg, 00:00:49  
 5.83m, Fracture, circumferential at joint, from 11 to 1 o'clock

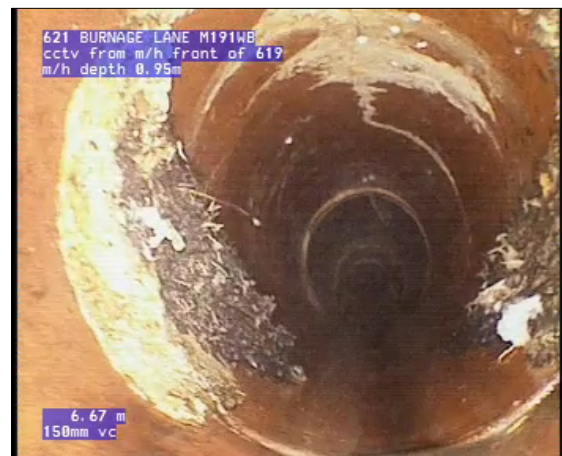
Photo: 5\_5\_41\_A.jpg, 00:00:53  
 6.67m, Attached deposits, encrustation at joint, from 7 to 5 o'clock, 10% cross-sectional area loss

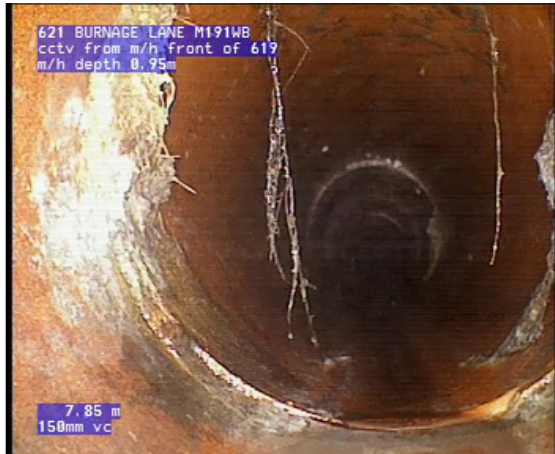
Photo: 5\_5\_42\_A.jpg, 00:01:02  
 7.85m, Roots, fine at joint

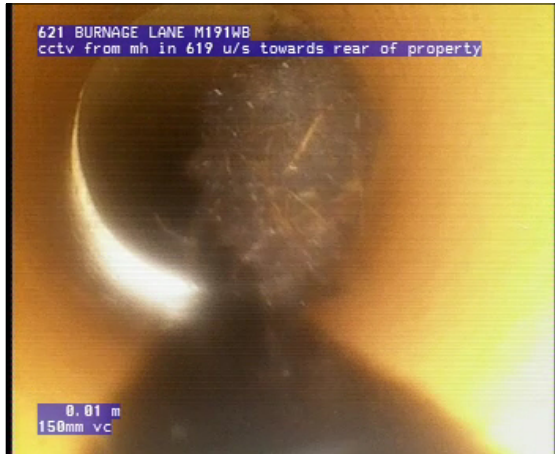
Photo: 6\_6\_52\_A.jpg, 00:00:05  
0.01m, Roots, mass at joint, 50% cross-sectional area loss
