Gas Membrane Installation  
Validation Report  
Triton Construction  
Trade City  
Elizabeth Street  
Cheetham Hill  
Manchester  
M8 8JJ

## Appendix 1 – Site Survey Sheets

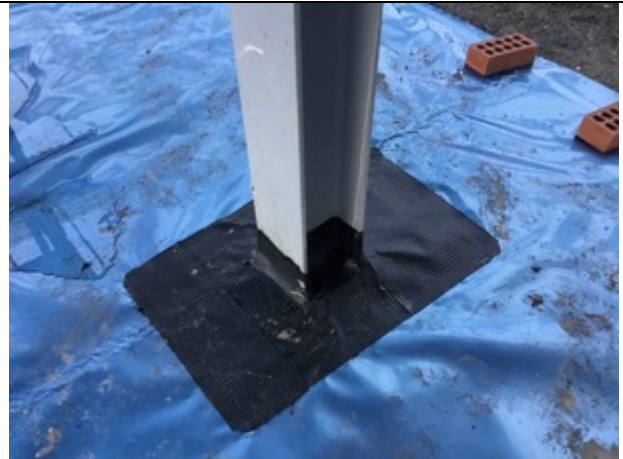
Unit 3 sealed stanchion detailing

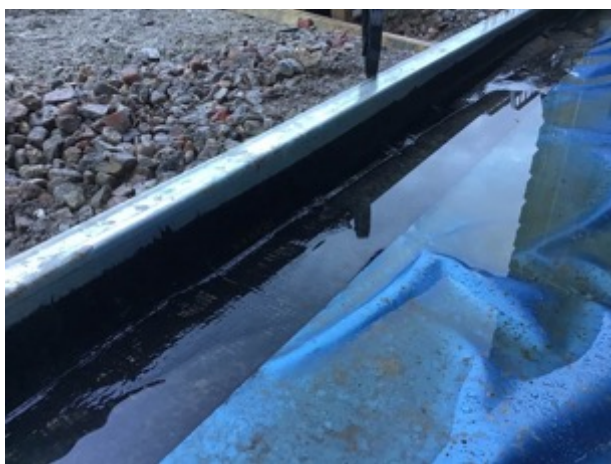
Sealed perimeter retro fit detailing

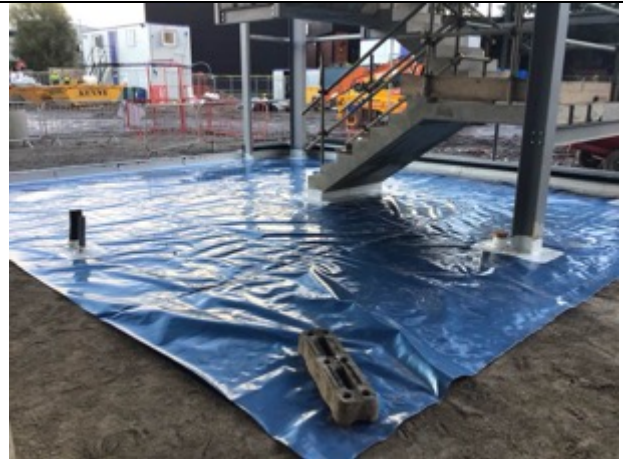
Core area 4 overview

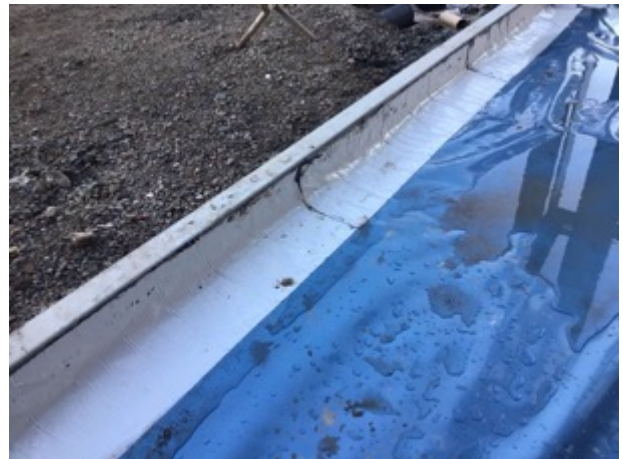
Core 4 sealed perimeter retro fit detailing

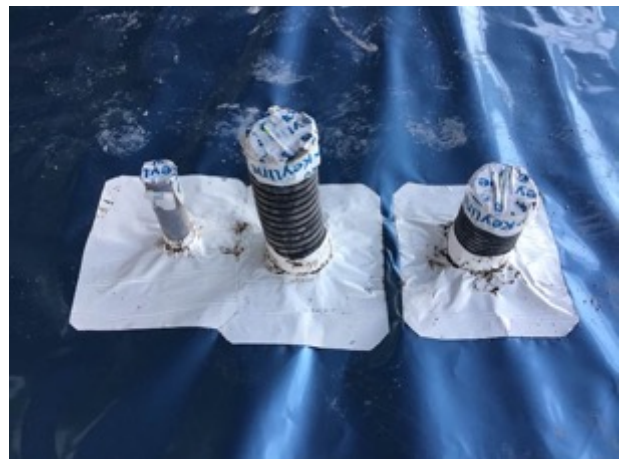
Core 5 sealed pipe penetrations

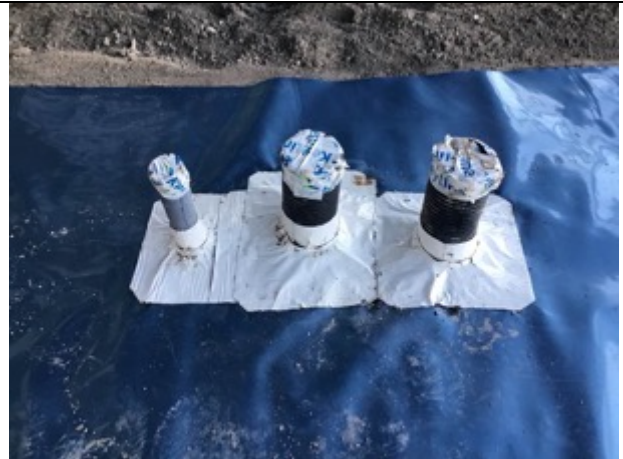
Core 6 sealed pipe penetrations

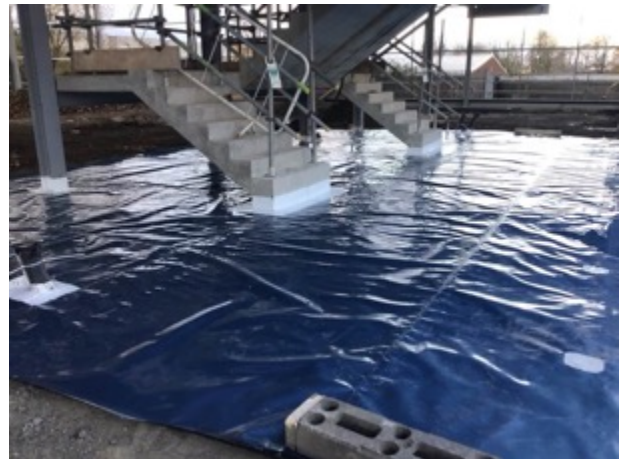
Core area 7 & 8 overview

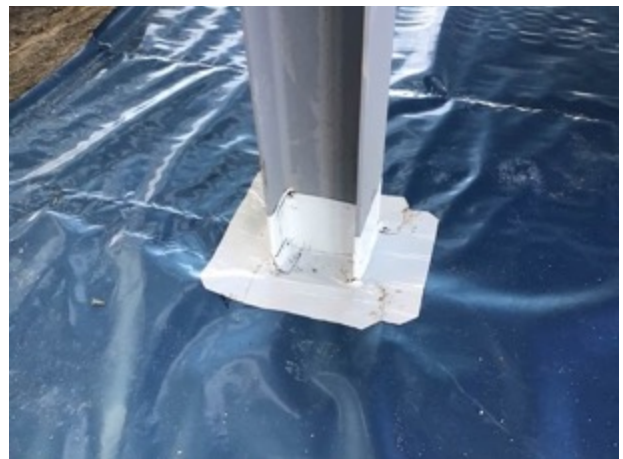
Core 7 sealed stanchion detailing

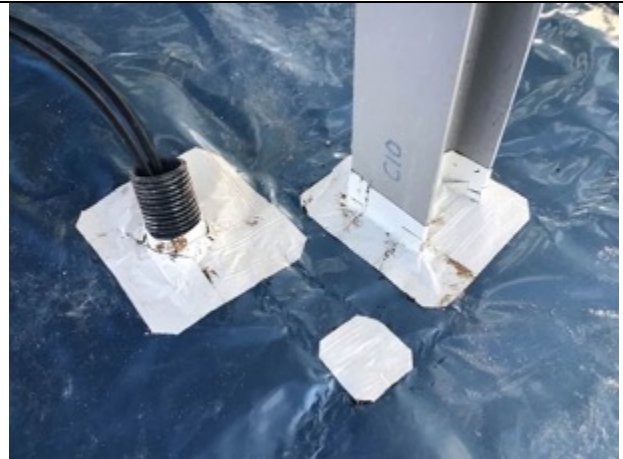
Core 8 sealed stanchion detailing, pipe penetration and patch repair

During our inspection the following defects and repairs were carried out: 4no patch repairs made by the installers in core area 8 using SAGM and heat applied.

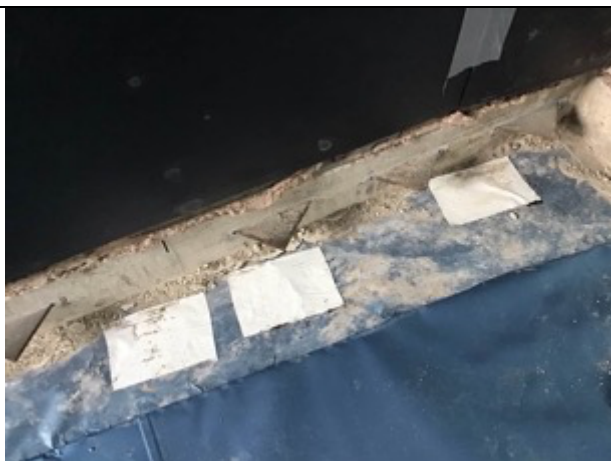
Unit 2 patch repairs

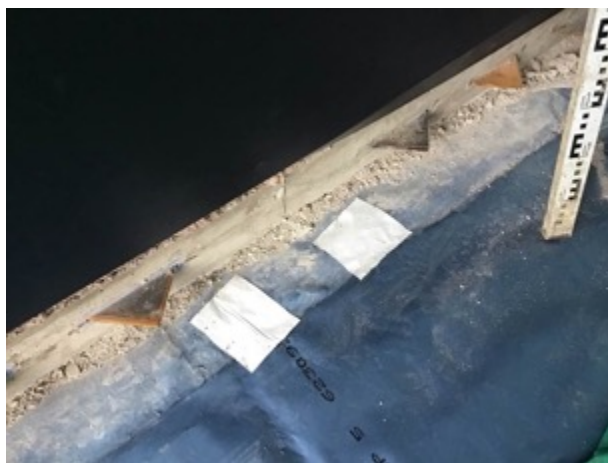
Unit 3 patch repairs

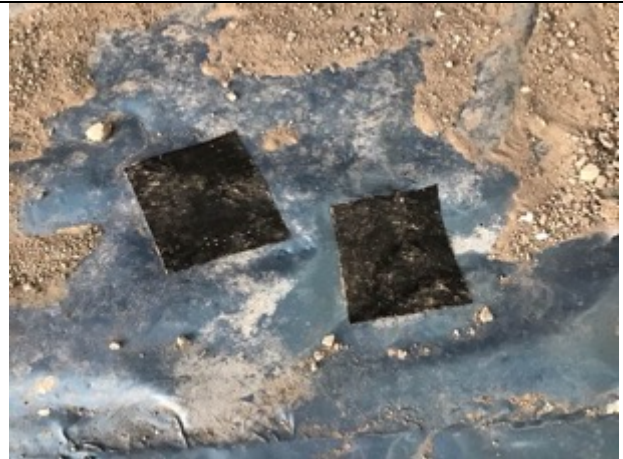
Sealed SAGM patch repairs

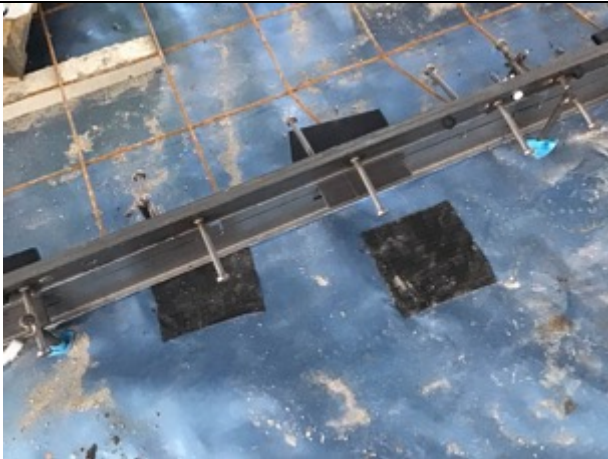
Sealed patch repairs

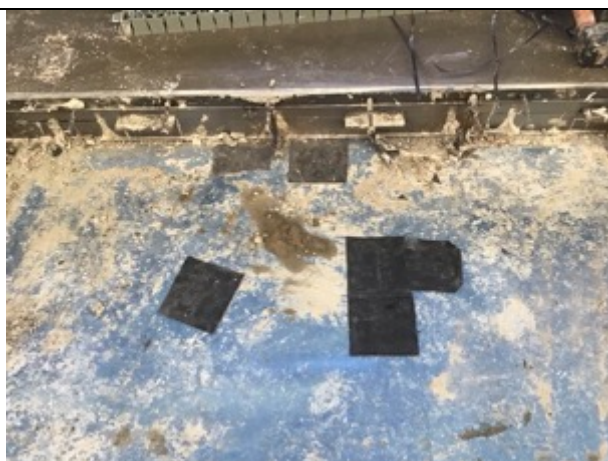
Sealed patch repairs

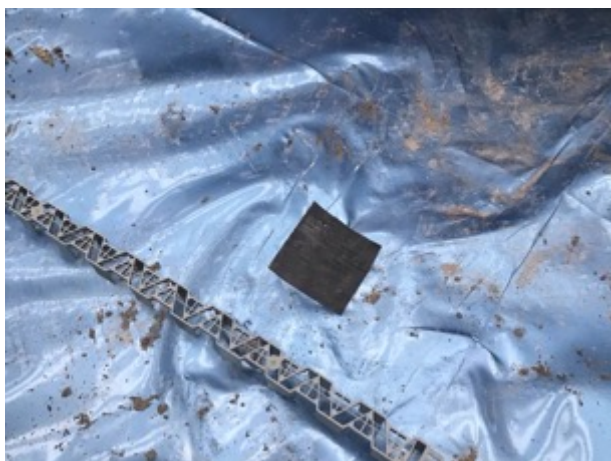
Sealed patch repair
