**87-97 Northmoor Road, Levenshulme Manchester, M13 5RT**

## **Compartmentation Survey Report**

| <b>Document Reference</b> | HFS.GP.NorthMoorRoad.CompartmentationSurvey.1.0 |

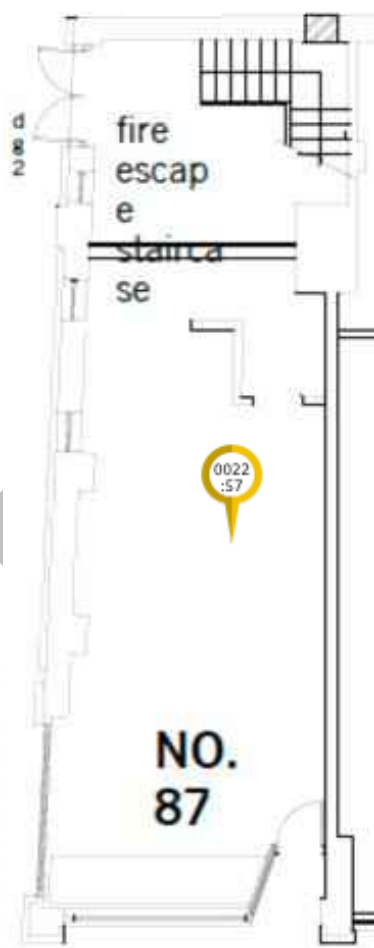
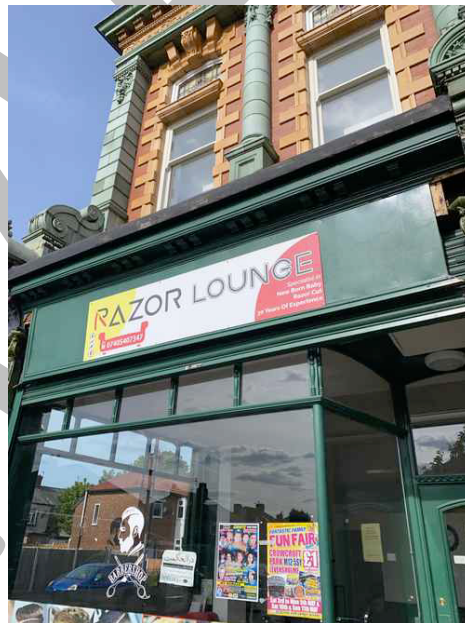
Importantly, no defects requiring remediation were identified during the survey. This is visually represented within the digital record (see yellow pin indicating 'No Action' required). As such, all compartmentation lines at 87 Northmoor Road are deemed compliant, supporting the site's evacuation strategy and ensuring no undue risk is posed to adjacent occupancies.

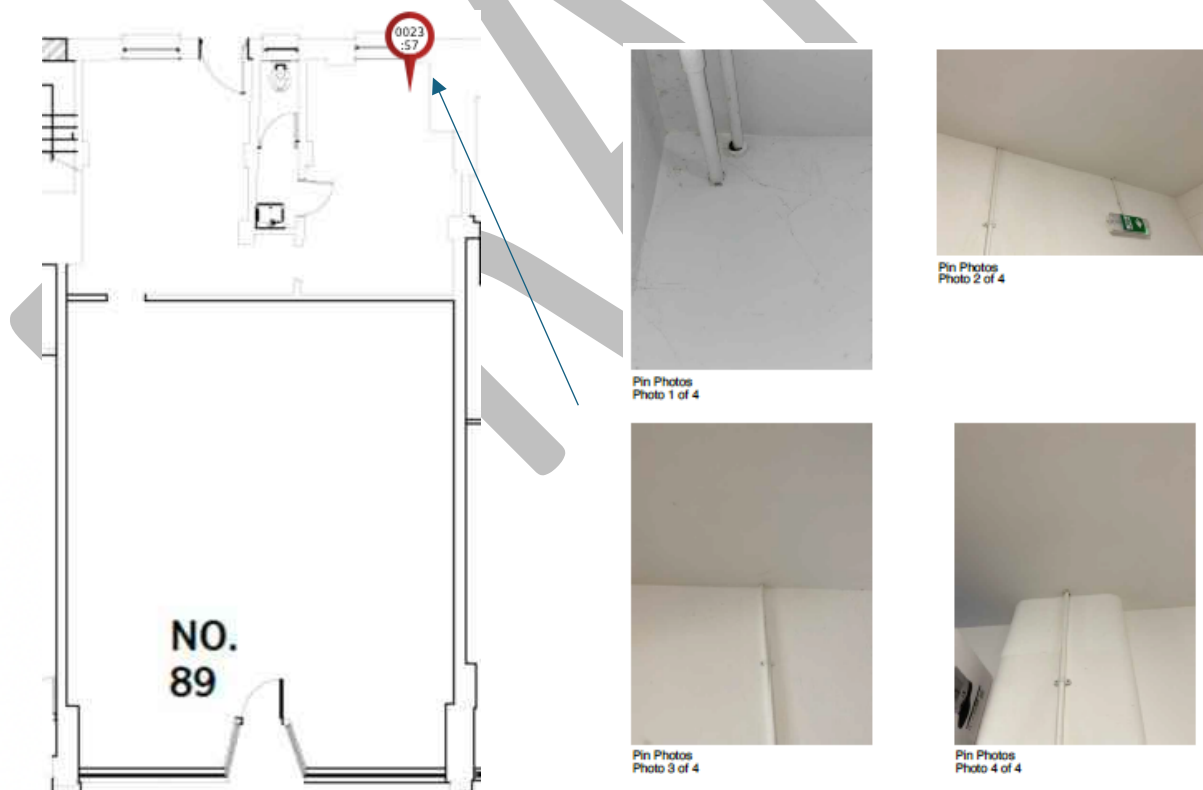
While the overall level of compartmentation is deemed effective, a small number of minor breaches were identified during the inspection—specifically, instances where plastic conduit (x4) & copper pipes (x2) pass through compartment lines without appropriate sealing. Fewer than 6 breaches were noted in total, and although it cannot be definitively confirmed whether these breaches compromise the true compartment line or only interim partitions, the effort, cost, and simplicity of remediation justify their resolution as a precautionary measure.

The recommended remedial action involves mastic sealing only, and these works are categorised as low risk / low priority. Their resolution will confirm the integrity of the compartmentation without requiring significant disruption.

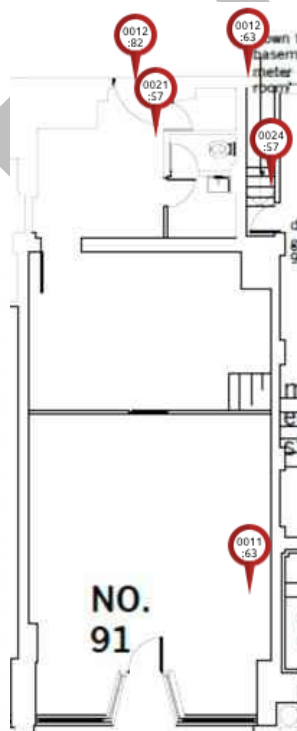
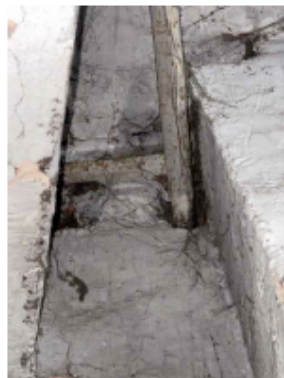
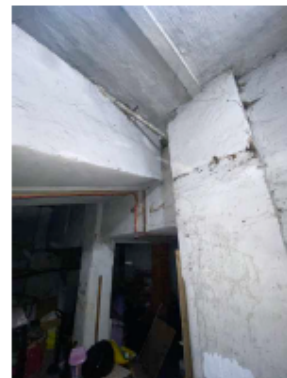
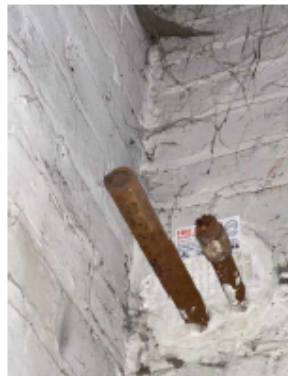
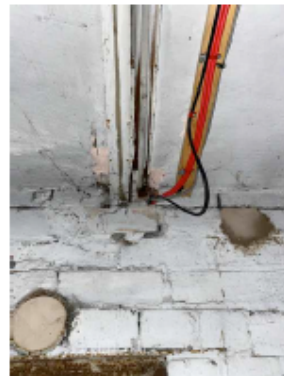
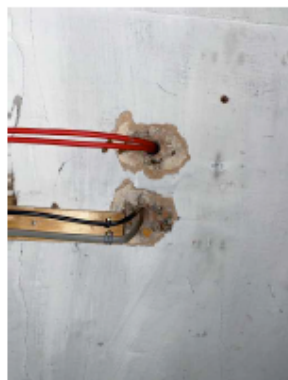
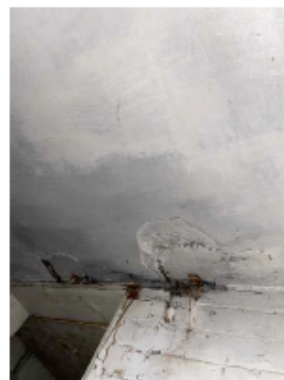
During the inspection, several minor defects in compartmentation were identified, predominantly within the basement area. These issues relate to unsealed service penetrations, where plastic conduit and other small services pass through compartment lines. Defects identified are considered low-risk, low-priority, however should be completed to ensure appropriate compartmentation of areas..

Recommended remedial works involve the application of basic mastic seals around penetrations. The number of breaches is limited (fewer than 15), and the required works are minor in nature—easily addressed without significant cost or operational disruption.

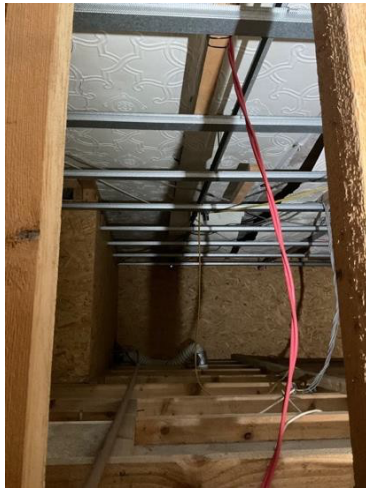
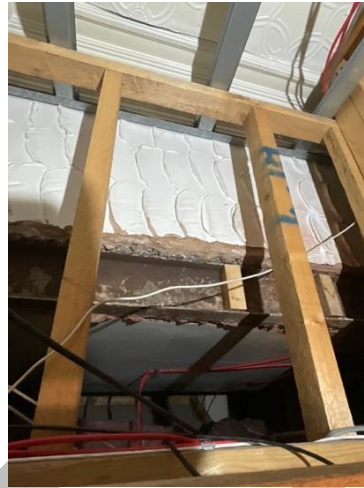
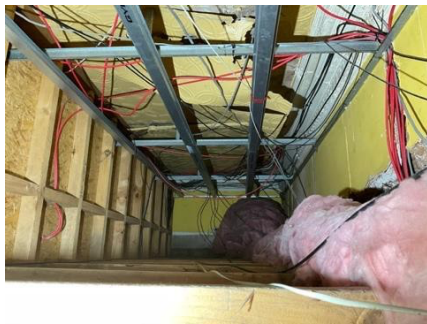
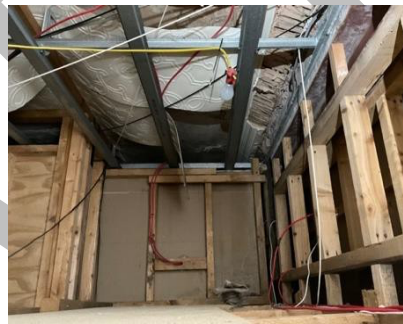
One of the most significant findings—and a key point of clarification—was the confirmation of a concrete slab separating the community centre from the residential accommodation above. Previous concerns raised by other surveyors stemmed from the presence of lath and plaster visible in the ceiling void above a flexible plasterboard ceiling. This led to the assumption that the entire ceiling was of lath and plaster construction. However, intrusive inspection through ceiling hatches confirmed that a concrete slab is present across multiple sampled areas, thereby substantiating the existing compartmentation—with the exception of the office/former toilet area (detailed below).

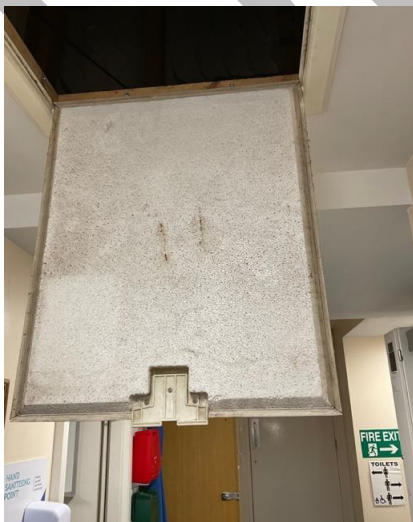
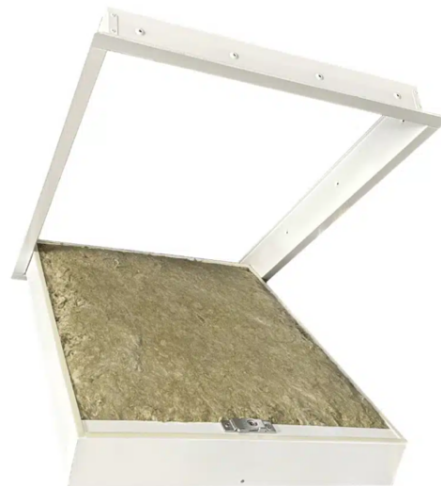
The ceiling void, which is approximately 600mm deep, cannot reasonably accommodate fire detection due to restricted access. As a mitigation measure, we advise the removal of existing plastic ceiling hatches and replacement with certified fire-rated equivalents. This will allow the compartment below to contain any fire products, supported by the presence of effective fire detection and warning systems in each room of origin.

Isolated service penetrations and linear breaches were noted in various areas, all assessed as moderate-risk and requiring standard remedial attention.

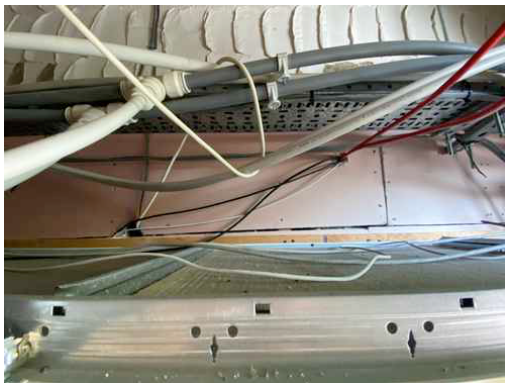
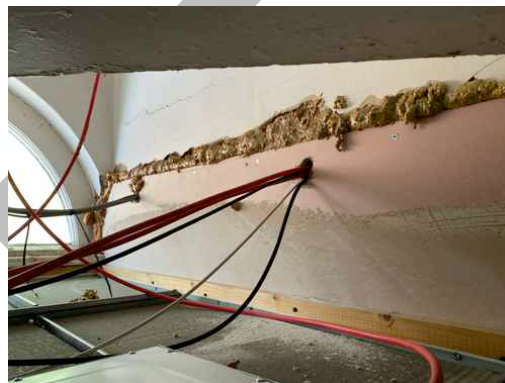
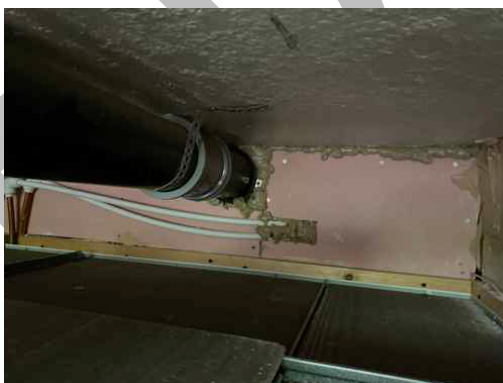
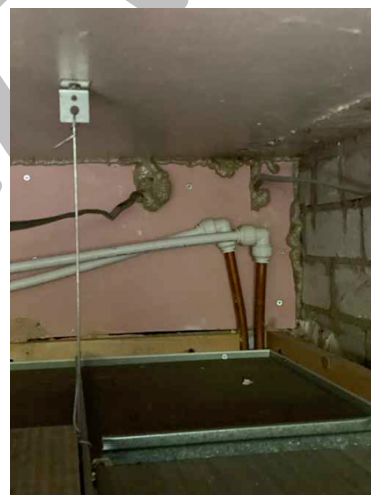
One of the primary areas of concern is the office/former toilet, located at the head of the basement stairwell, which acts as a single means of escape. Despite appearing compliant at surface level, inspection above the suspended ceiling revealed significant failings: use of polyurethane expanding foam, unsealed service penetrations, and linear gaps that could allow the passage of smoke and flame into protected escape routes. This area has been identified as a high priority for remediation and must be addressed accordingly.

All doors within the community centre require some level of remedial action, with most needing a full overhaul or replacement to meet contemporary fire safety standards. Positively, it should be noted that extensive door replacement works have already been completed within the basement, including the installation of certified fire door leaves without air transfer grilles, which support the protection of escape corridors.

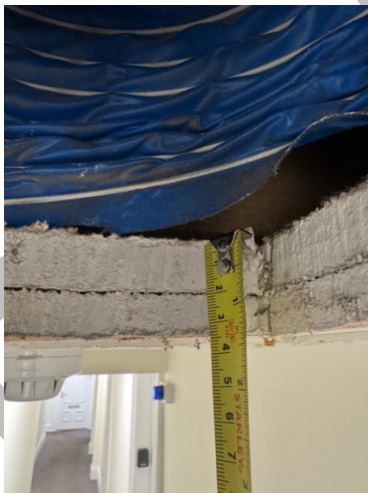
Both walls and ceiling linings within communal areas and within flats are made up on x2 15mm gypsum based plasterboard which provide a minimum of 60 minutes fire resistance; however as displayed below, there are various openings within these linings which compromise the integrity of linings.

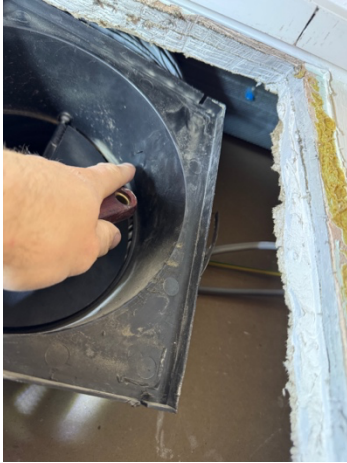
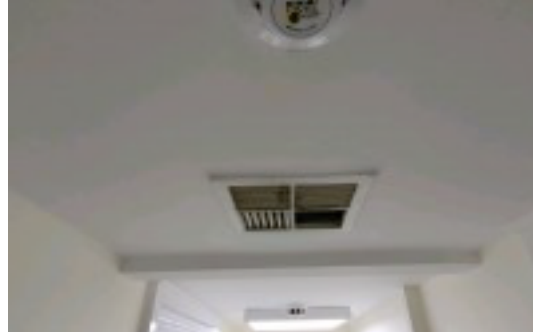
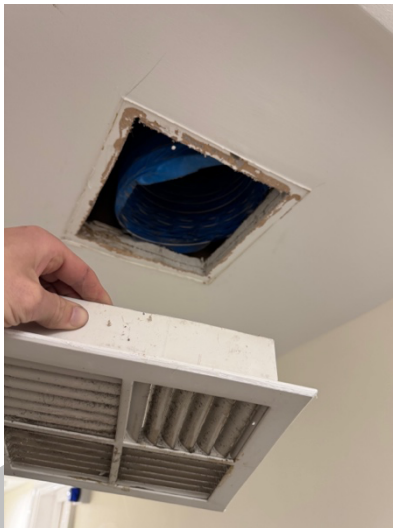
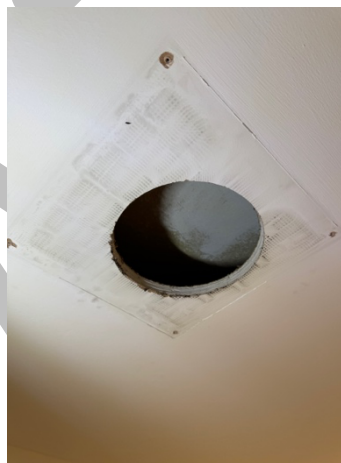
An example of openings within linings are ventilation grills within the walls and ceilings of first and second floor communal areas. The exact purpose of these vents is unclear but appears to relate to airflow and ventilation for communal corridors as there is no natural ventilation present. Following destructive and intrusive inspections of areas, there is no indication that the flexible ducting penetrates directly into the residential flats. It instead appears to travel through a concealed void sat between communal linings and linings within the flats e.g. between compartment lines. However, it is our professional judgement that the original conversion works did not adequately address fire and smoke control for these areas of ventilation.

As a result, we recommend that all existing vents be replaced and fitted with intumescent -lined air valves (This will require a degree of making good for aesthetic purposes) .

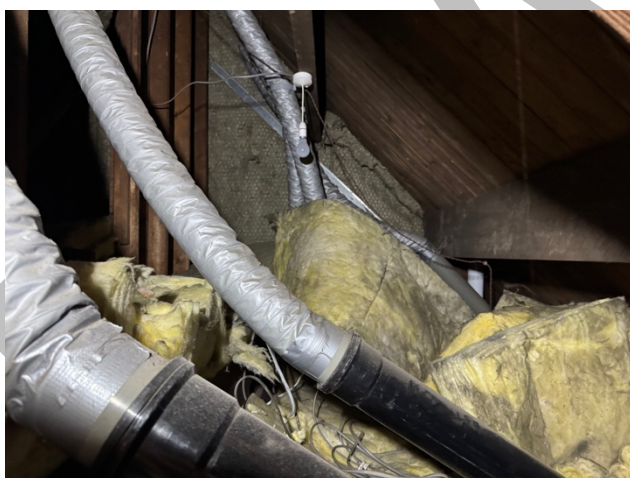
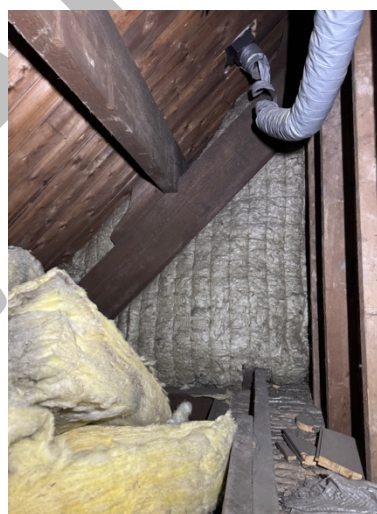
These issues result in compromised fire separation between flats, allowing potential pathways for the spread of fire and smoke between units through the roof space. Due to limited access, unsafe working conditions, and the occupied status of the building, retrospective remediation is not considered feasible. Any corrective works would likely require roof removal and reinstatement, which could be aligned with planned roofing works to reduce disruption and improve viability. See below image displaying a proposed solution:

Further complicating the issue is the decorative, curved ceiling design within the dwellings. This feature restricts any reliable assessment of the ceiling's fire resistance. It is therefore assumed that the ceiling offers only nominal resistance, likely sufficient to delay fire spread long enough to allow for safe evacuation. However, this limitation also effectively renders fire-rated ceiling hatches ineffective, as the room below cannot be guaranteed to contain the fire.

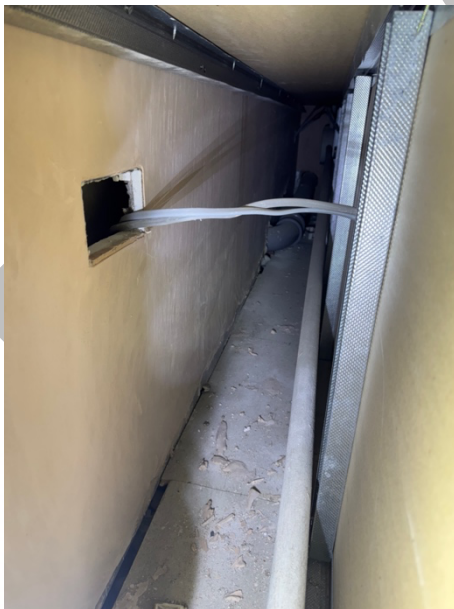
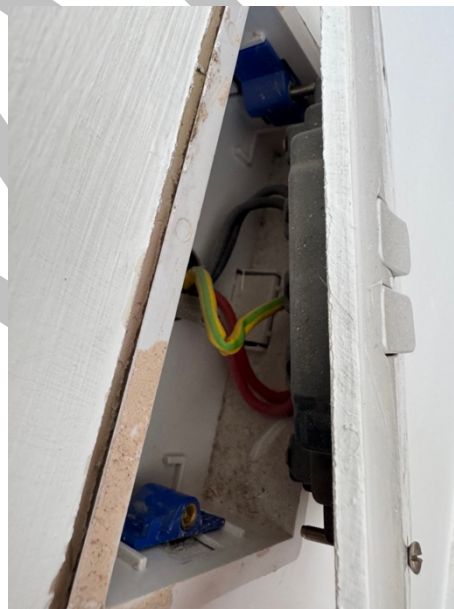
Elsewhere within the sampled flats, additional intrusive inspections revealed further compartmentation failings: Electrical sockets lacked intumescent putty pads, and plasterboard linings showed visible breaches. These conditions create potential for lateral fire spread between rooms or into void areas, however remediation is not feasible without major disruption, further reinforcing the need for enhanced detection systems.

Further works involved lifting floorboards in internal cupboards and bathrooms to assess floor separation between the first and second floors. The construction revealed chipboard flooring underdrawn with two 15mm gypsum plasterboards, which appears to provide some fire resistance. However, this construction detail is not recognised as a tested system in British Gypsum literature and falls outside the knowledge base of typical passive fire systems. Regardless of its tested status, it must be noted that remedial action is not viable, and thus this element must also be mitigated through the recommended fire detection strategy.

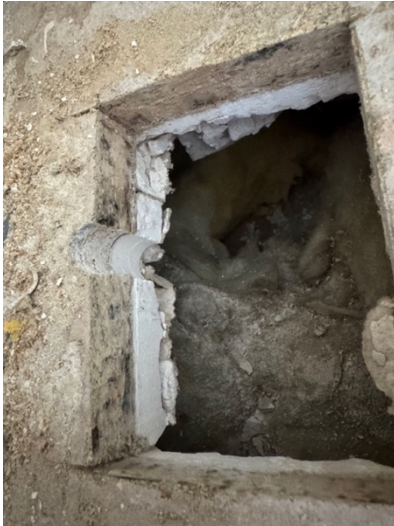
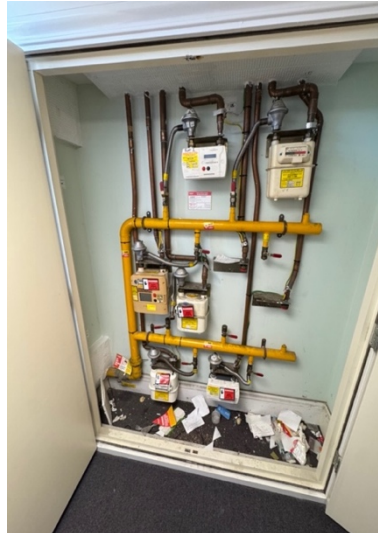
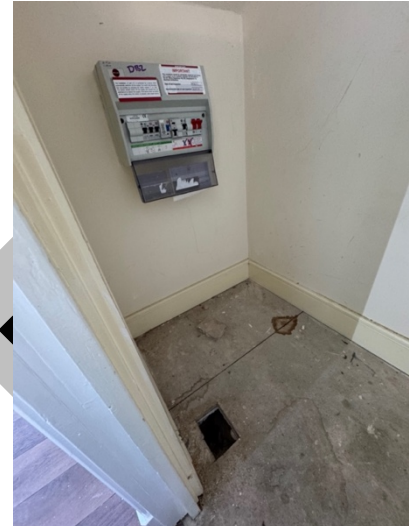
Service Cupboards Within Communal Means of Escape are located within the first and second floor communal escape routes and contain gas meters which serve dwellings. These enclosures were inspected as part of the compartmentation survey, with specific attention paid to their potential impact on fire safety and protected means of escape given their high risk status. Each cupboard was found to be adequately compartmented, with no visible defects, breaches, or compromise to the fire-resisting construction. The surrounding structure, door sets, and internal linings appear to provide a sufficient level of fire resistance, consistent with the function of containing utility services within protected routes.
