## CDM 2.0 Pre-Construction, Works Information Package & Design (WIP)

| Document Control | | | |
|---|---|---|---|
| Document Name: | | 25aNWCU-CRT-AN-011-014-WP-C-0001 | |
| Document Title: | | Store Street Aqueduct Leak Repairs | |

| General Information | |
|---|---|
| Waterway | Ashton Canal |

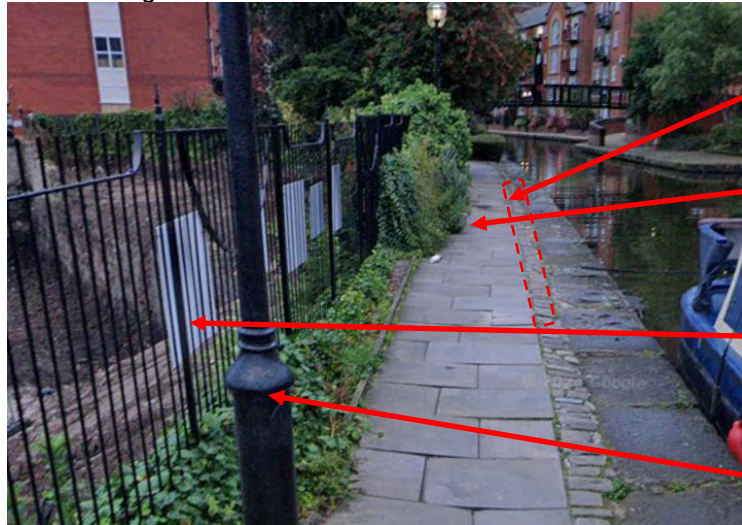
View looking US

Approximate location  
of the leak – near  
vegetation

Construction Site

Street Furniture – potential LV  
cables

5m grout curtain

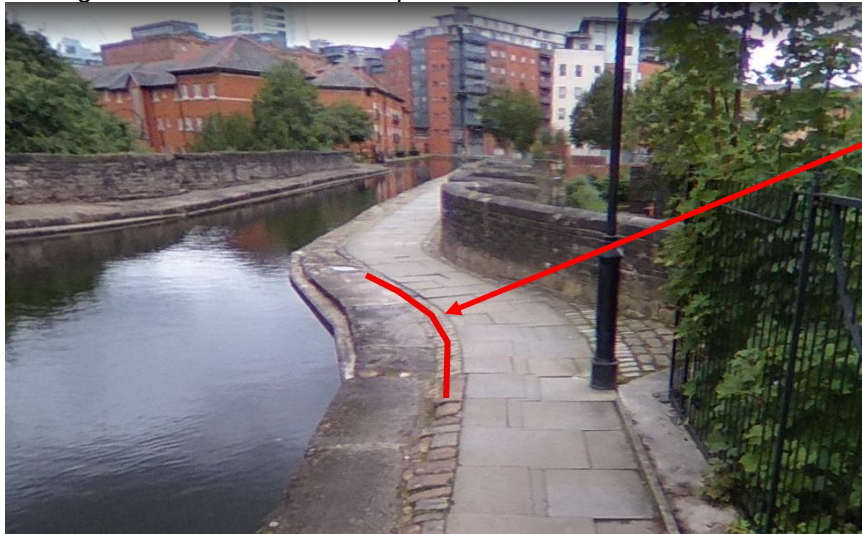
Leakage onto Store Street – Towpath Level **ON HOLD PENDING LBC**

8m grout curtain

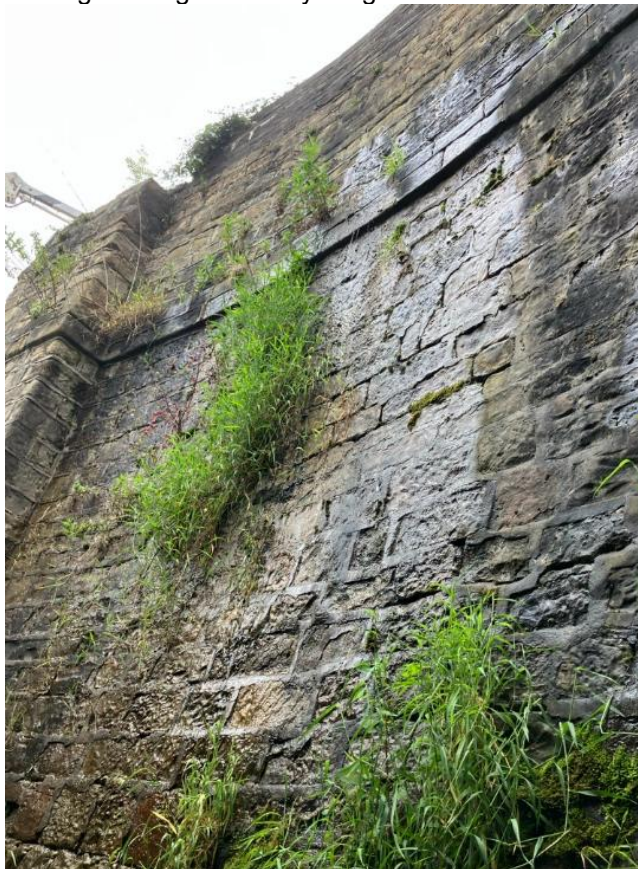
Leakage through masonry wing wall from street level
