## Citylabs 4.0

## Condition 10 Drainage Scheme

# Citylabs4.0 - Drainage Maintenance Plan

Reference: L025-ARU-90-01.00-D-C-000004 – Drainage Maintenance Plan

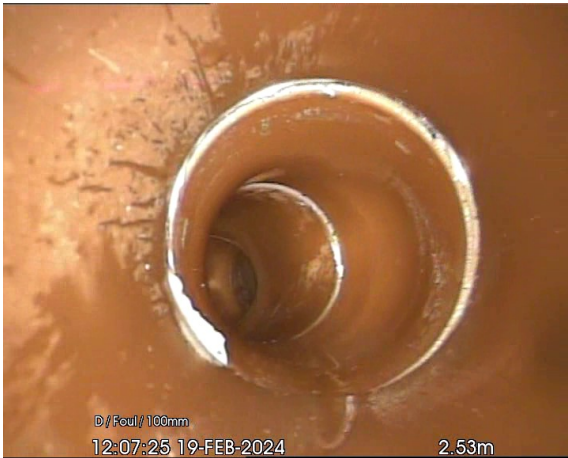
18X\_4407e400-db61-41bf-a106-9af9e3682a95\_20240220\_13  
0452\_072.jpg, 00:00:12, 2.53 m  
Attached deposits, encrustation at 7 o'clock, 5%  
cross-sectional area loss

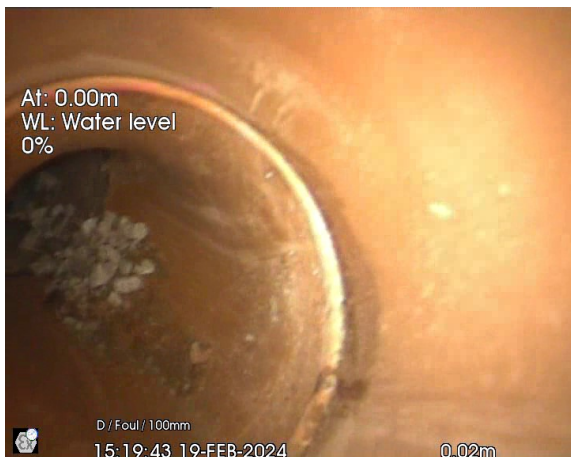
23X\_c9193ec7-2856-419d-b543-537437b5a12a\_20240220\_130726\_204.jpg, 00:00:16, 0.53 m  
Settled deposits, hard or compacted, 5% cross-sectional area loss, STONES UNABLE TO JET

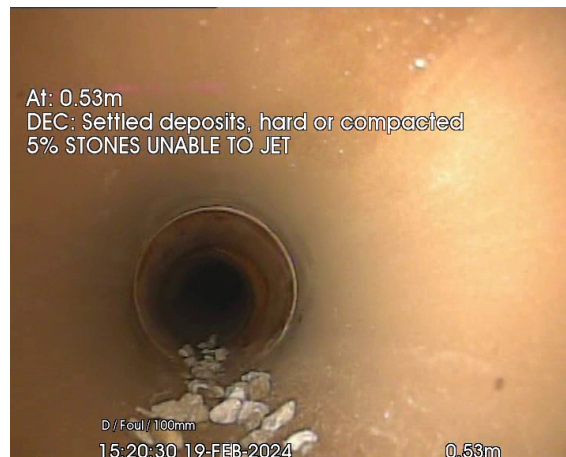
23X\_a6fa35dc-f304-4b1b-a927-afd43327ad87\_20240220\_130737\_782.jpg, 00:00:16, 0.53 m  
Settled deposits, hard or compacted, 5% cross-sectional area loss, STONES UNABLE TO JET

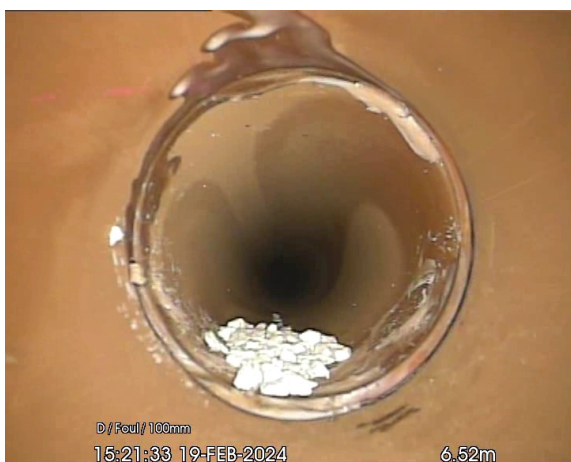
23X\_02178932-7984-4a5b-b4ee-d4d9c6864987\_20240220\_130752\_169.jpg, 00:00:40, 6.64 m  
Settled deposits, hard or compacted, 5% cross-sectional area loss, STONES

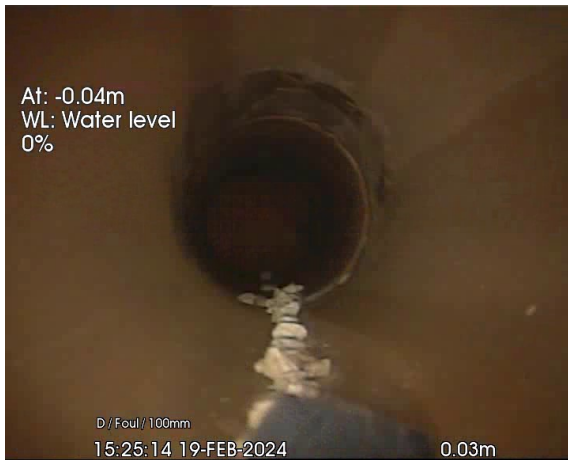
25X\_771747d0-0e43-4179-86a4-d82d3fb5ba30\_20240220\_1  
30837\_022.jpg, 00:00:02, 0.30 m

Settled deposits, coarse, 5% cross-sectional area loss

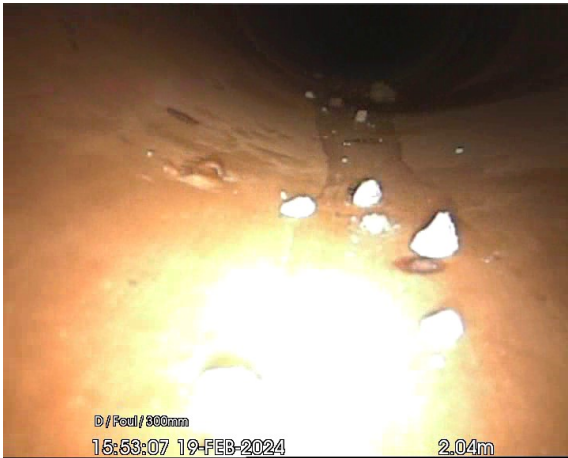
38X\_a4c8fb9b-916e-4ed0-ba2d-8d6210d3afb6\_20240220\_1312\_229.jpg, 00:00:07, 2.04 m  
Settled deposits, coarse, 5% cross-sectional area loss

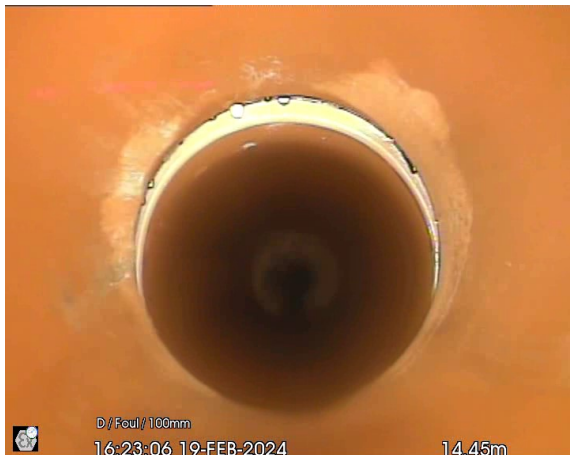
FWMH2X\_8c1af0ea-f610-4d69-abc1-e5237699f7e9\_20240220\_131509\_849.jpg, 00:00:44, 14.55 m  
Joint displaced, medium
