# Hutton + Rostron Environmental Investigations Limited

## 466-468 Moss Lane East: Window Condition Survey

Site note 3 for 27-28 February 2024, job no. 214-22

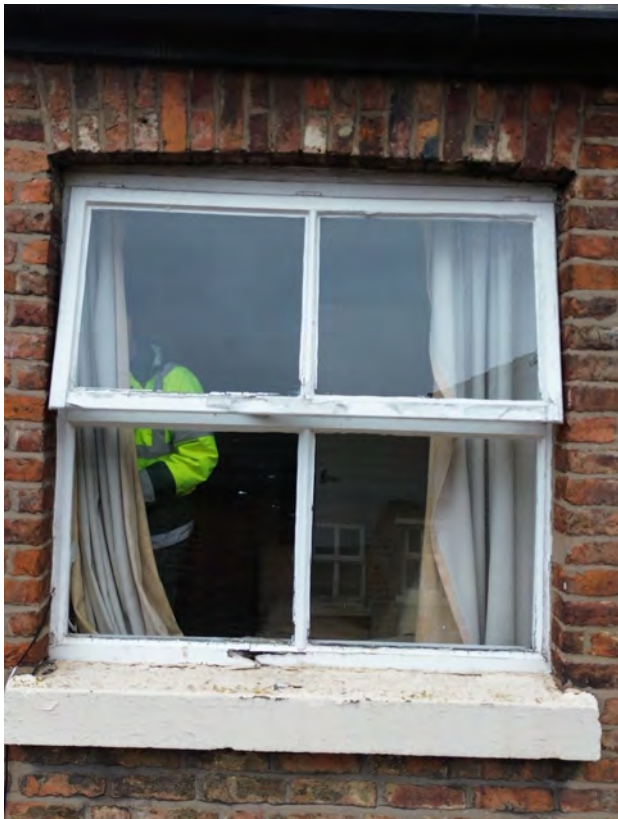
**Fig 2:**

| REF | ELEV | FLOOR | UNIT | WINDOW TYPE | MAT | DIMENSIONS (MM) | OPERABILITY | RELEASE | EASE | REHANG | BALANCE | RENEW | RE-ALIGN | ELEMENTS TO REPAIR | ELEMENTS TO REPLACE | PREVIOUS REPAIRS | GLAZING & PUTTY | FURNITURE | DECORATION | ADDITIONAL COMMENTS | PHOTO REFERENCE |
|---|---|---|---|---|---|---|---|---|---|---|---|---|---|---|---|---|---|---|---|---|---|
| E.2.2 | E | 2 | 2 | 2x2 pane timber casement with 1no. opening awning | Timber | ~1325x1410mm | Operable | - | - | - | - | - | - | The base of both jambs and the central mullion are decayed and <b>should be repaired with timber splice repairs</b> | Timber sill is decayed for full length and <b>should be replaced</b> | | Single-glazed. Window putty is beyond the end of its service life and <b>should be renewed</b> | 1no. modern casement stay to awning. Casement stay is misaligned making window difficult to lock shut and <b>should be realigned</b> . 1no. modern restrictor has been fitted to prevent full opening of window | Window has been painted with a modern, film-forming paint which is inappropriate for a timber window and is flaking. <b>Decoration should be stripped back and window redecorated with an appropriate moisture vapour permeable paint</b> | | Fig. 2 |

Window E.2.2; showing general view

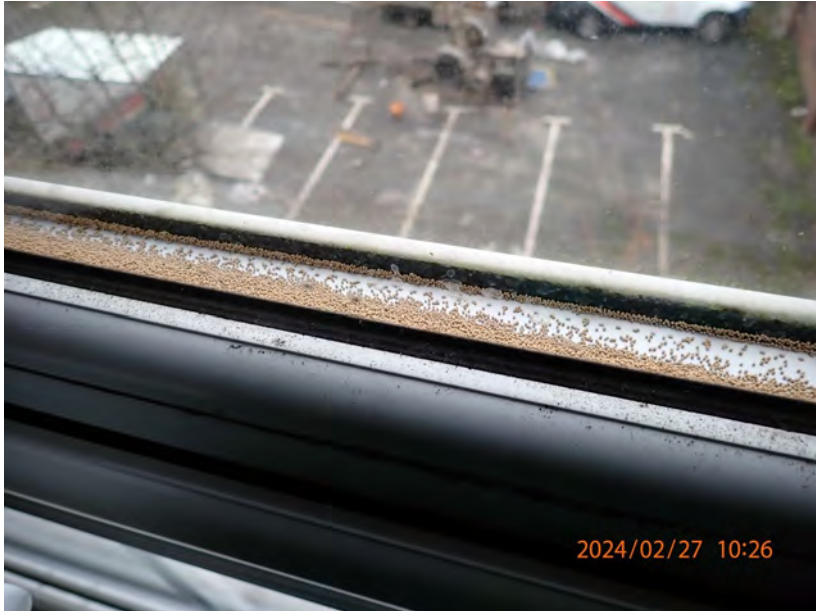
**Fig 7:**

Window S.2.6; showing close up view of desiccant beads within glazing unit

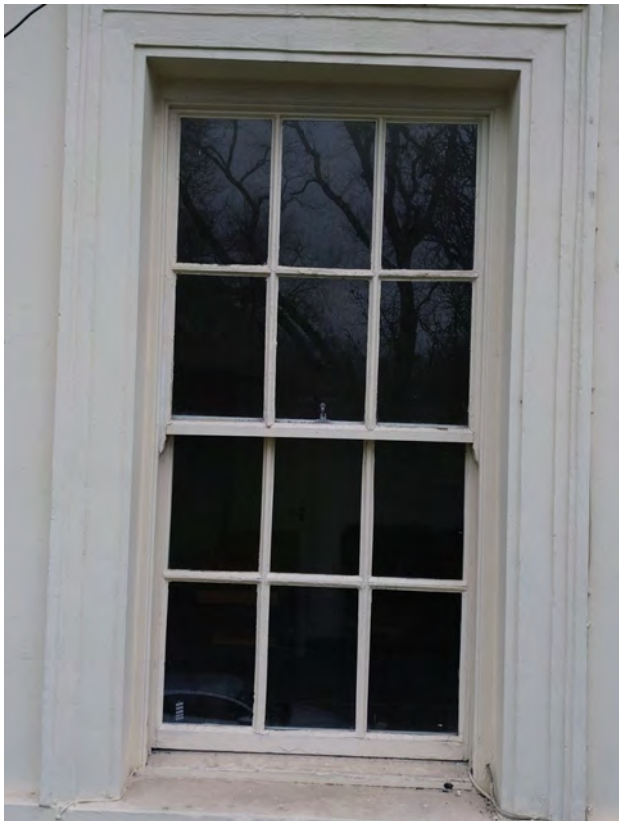
**Fig 10:**

| REF | ELEV | FLOOR | UNIT | WINDOW TYPE | MAT | DIMENSIONS (MM) | OPERABILITY | RELEASE | EASE | REHANG | BALANCE | RENEW | RE-ALIGN | ELEMENTS TO REPAIR | ELEMENTS TO REPLACE | PREVIOUS REPAIRS | GLAZING & PUTTY | FURNITURE | DECORATION | ADDITIONAL COMMENTS | PHOTO REFERENCE |
|---|---|---|---|---|---|---|---|---|---|---|---|---|---|---|---|---|---|---|---|---|---|
| N.1.1 | N | 1 | 1 | Single-hung 6 over 6 timber sash with fixed upper sash and sliding lower sash | Timber | ~2240x1215mm | Partially operable - lower sash does not run parallel to frame | | | | Lower sash | | | Outer lining is decayed at base and <b>should be repaired with a timber splice repair</b> . Corresponding parting bead is decayed at base and <b>should be repaired with a timber splice repair</b> | | | Single-glazed. Window putty is beyond the end of its service life and <b>should be renewed</b> | 2no. metal handles to lower sash which have been painted with a modern film-forming paint. 1no. modern sash lock | Window has been painted with a modern, film-forming paint which is inappropriate for a timber window and is flaking. <b>Decoration should be stripped back and window redecorated with an appropriate moisture vapour permeable paint</b> | Holes have been drilled in frame for electrical cables to pass through | Fig. 10 |

Window N.1.1; showing general view

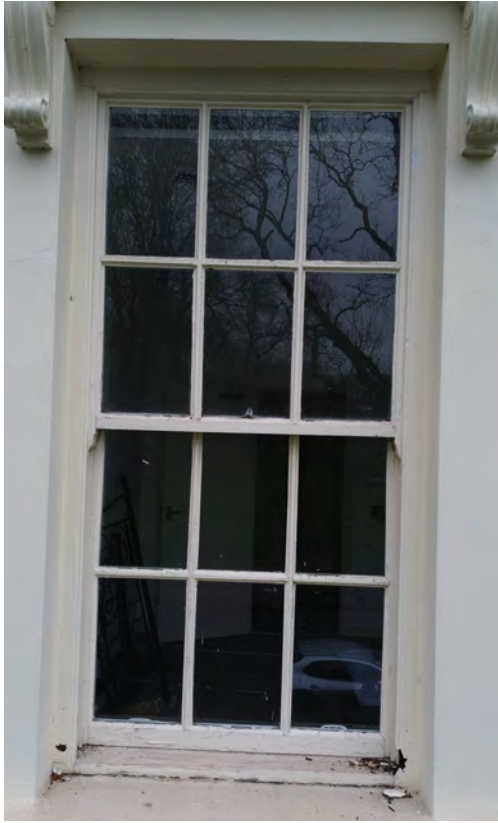
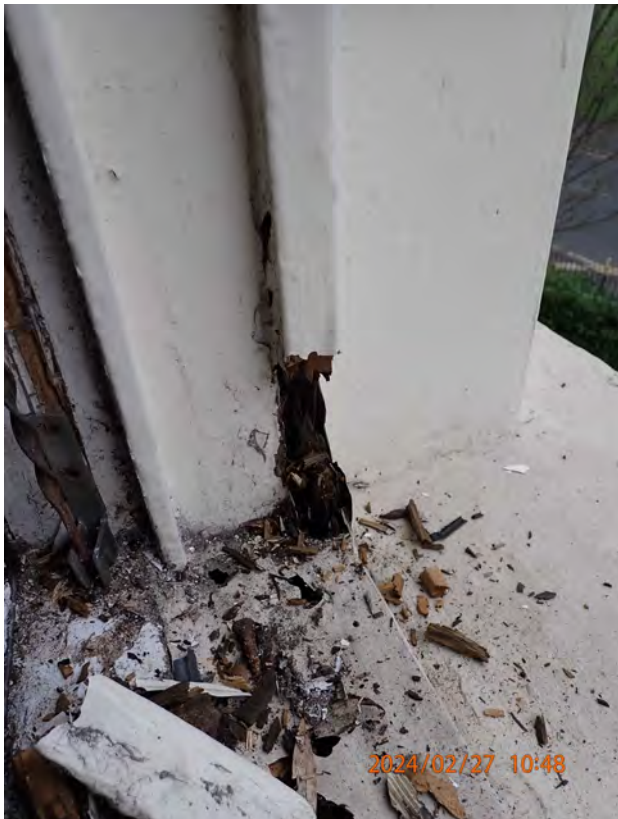
| REF | ELEV | FLOOR | UNIT | WINDOW TYPE | MAT | DIMENSIONS (MM) | OPERABILITY | RELEASE | EASE | REHANG | BALANCE | RENEW | RE-ALIGN | ELEMENTS TO REPAIR | ELEMENTS TO REPLACE | PREVIOUS REPAIRS | GLAZING & PUTTY | FURNITURE | DECORATION | ADDITIONAL COMMENTS | PHOTO REFERENCE |
|---|---|---|---|---|---|---|---|---|---|---|---|---|---|---|---|---|---|---|---|---|---|
| N.1.2 | N | 1 | 2 | Single-hung 6 over 6 timber sash with fixed upper sash and sliding lower sash | Timber | ~2240x1175mm | Partially operable - lower sash is binding in frame | | Lower sash | | Lower sash | | Lower sash | Both outer linings are decayed at base and <b>should be repaired using timber splice repairs</b> | Timber sill is decayed for full length and <b>should be replaced</b> | | Single-glazed. 2no. panes to lower sash are cracked and <b>should be replaced</b> . Window is beyond the end of its service life and <b>should be renewed</b> | 2no. metal handles to lower sash which have been painted with a modern film-forming paint. 1no. modern sash lock | Window has been painted with a modern, film forming paint which is trapping moisture resulting in decay to timber elements. <b>Decoration should be stripped back and window redecorated with an appropriate moisture vapour permeable paint</b> | | Fig. 11-12 |

Window N.1.2; showing general view

Window N.1.2; showing timber decay to outer lining and sill

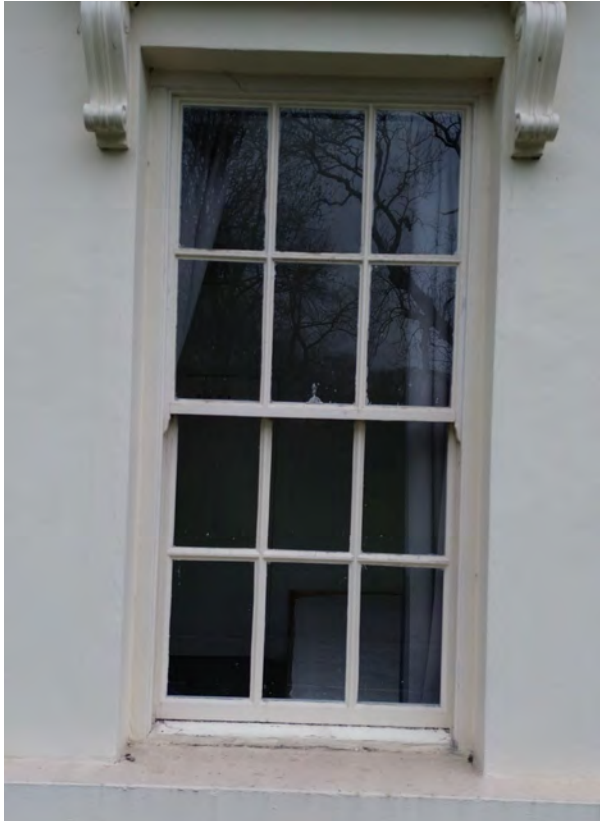
**Fig 13:**

| REF | ELEV | FLOOR | UNIT | WINDOW TYPE | MAT | DIMENSIONS (MM) | OPERABILITY | RELEASE | EASE | REHANG | BALANCE | RENEW | RE-ALIGN | ELEMENTS TO REPAIR | ELEMENTS TO REPLACE | PREVIOUS REPAIRS | GLAZING & PUTTY | FURNITURE | DECORATION | ADDITIONAL COMMENTS | PHOTO REFERENCE |
|---|---|---|---|---|---|---|---|---|---|---|---|---|---|---|---|---|---|---|---|---|---|
| N.1.3 | N | 1 | 3 | Single-hung 6 over 6 timber sash with fixed upper sash and sliding lower sash | Timber | ~2170x1165mm | Partially operable - lower sash does not stay open | | | | | Lower sash | Lower sash | | Timber sill is decayed for full length and <b>should be replaced</b> | | Single-glazed. Window putty is at the end of its service life and <b>should be renewed</b> | 2no. metal handles to lower sash which have been painted with a modern film-forming paint. 1no. modern sash lock | Window has been painted with a modern, film-forming paint which is inappropriate for a timber window and is flaking. <b>Decoration should be stripped back and window redecorated with an appropriate moisture vapour permeable paint</b> | | Fig. 13 |

Window N.1.3; showing general view

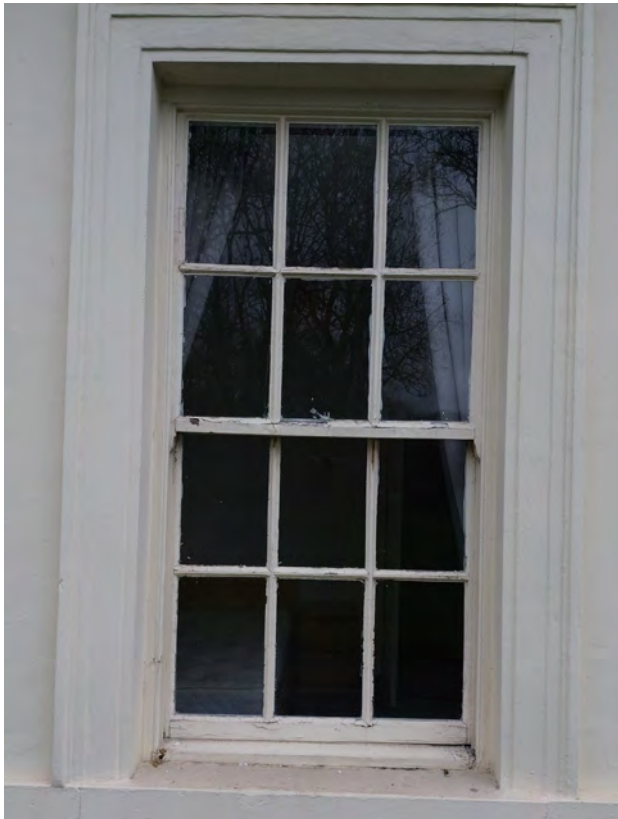
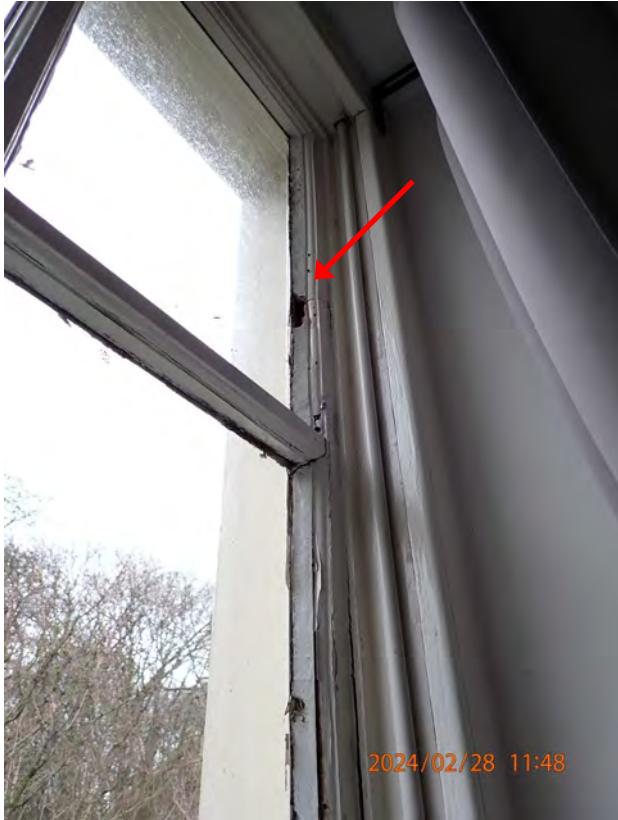
| REF | ELEV | FLOOR | UNIT | WINDOW TYPE | MAT | DIMENSIONS (MM) | OPERABILITY | RELEASE | EASE | REHANG | BALANCE | RENEW | RE-ALIGN | ELEMENTS TO REPAIR | ELEMENTS TO REPLACE | PREVIOUS REPAIRS | GLAZING & PUTTY | FURNITURE | DECORATION | ADDITIONAL COMMENTS | PHOTO REFERENCE |
|---|---|---|---|---|---|---|---|---|---|---|---|---|---|---|---|---|---|---|---|---|---|
| N.1.4 | N | 1 | 4 | Single-hung 6 over 6 timber sash with fixed upper sash and sliding lower sash | Timber | ~2215x1195mm | Operable | | | | | | Lower sash | There is decay to the base of both inner and outer linings which <b>should be repaired with timber splice repairs</b> | Timber sill is decayed for the full length and <b>should be replaced</b> . Both stiles to the upper sash are decayed and <b>should be replaced</b> . Allowance should also be made for replacement of the upper meeting rail | | Single-glazed. 1no. pane to the lower sash is cracked and <b>should be replaced</b> . Window putty is beyond the end of its service life and <b>should be renewed</b> | 2no. metal handles to lower sash which have been painted with a modern film-forming paint. 1no. modern sash lock | Window has been painted with a modern, film-forming paint which is inappropriate for a timber window and is flaking. <b>Decoration should be stripped back and window redecorated with an appropriate moisture vapour permeable paint</b> | | Fig. 14-15 |

Window N.1.4; showing general view

Window N.1.4; showing timber decay to upper sash

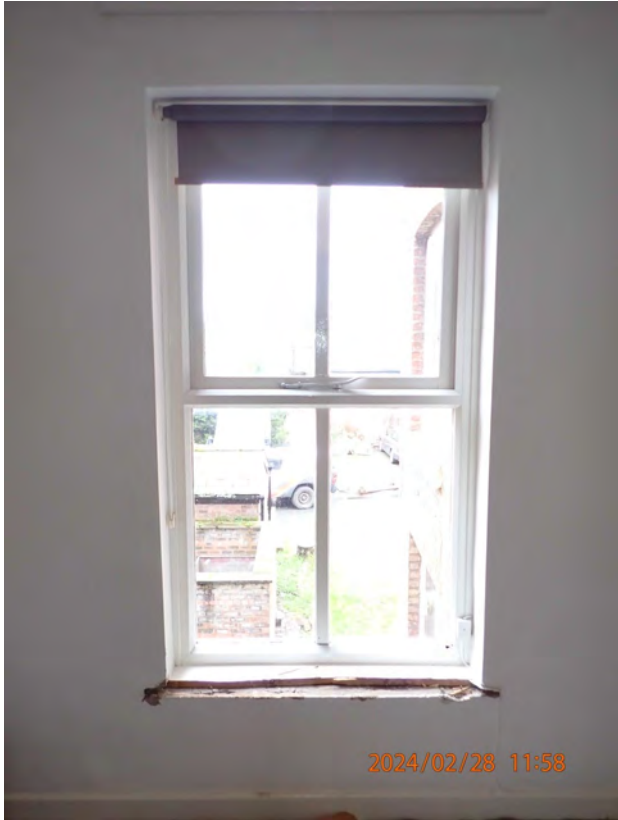
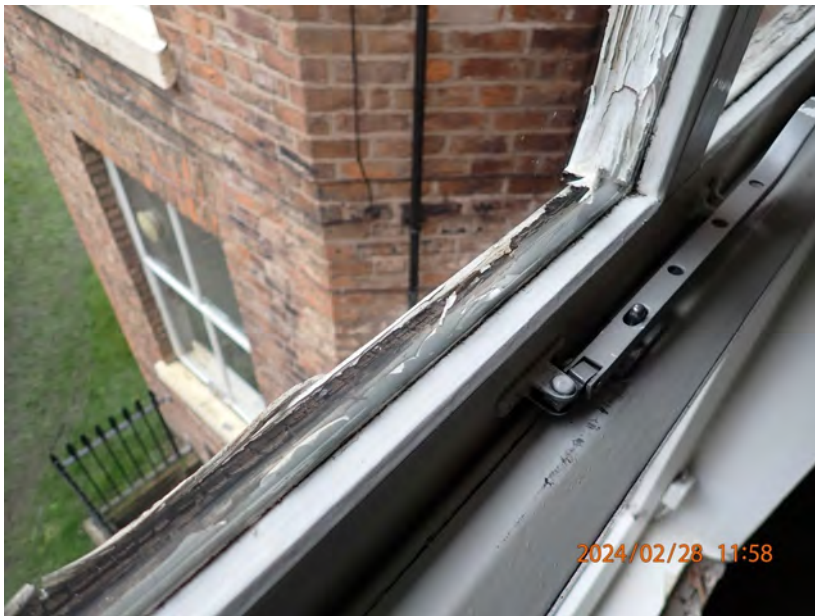
| REF | ELEV | FLOOR | UNIT | WINDOW TYPE | MAT | DIMENSIONS (MM) | OPERABILITY | RELEASE | EASE | REHANG | BALANCE | RENEW | RE-ALIGN | ELEMENTS TO REPAIR | ELEMENTS TO REPLACE | PREVIOUS REPAIRS | GLAZING & PUTTY | FURNITURE | DECORATION | ADDITIONAL COMMENTS | PHOTO REFERENCE | |
|---|---|---|---|---|---|---|---|---|---|---|---|---|---|---|---|---|---|---|---|---|---|---|
| S.1.6 | S | 1 | 6 | 2x2 pane timber casement with 1no. opening awning | Timber | ~1685x940mm | Partially operable - awning is binding on window frame | | Awning | | | | | There is decay to the base of both jambs and to the base of the central mullion which <b>should be repaired using timber splice repairs</b> . There is suspected decay to the base of both stiles and the central mullion to the awning. <b>Allowance should be made for repair of both stiles and the central mullion with timber splice repairs</b> | Timber sill is decayed for full length and <b>should be replaced</b> . Bottom rail to awning is decayed for full length and <b>should be replaced</b> | | Single-glazed | 1no. modern metal casement stay to awning. The casement stay does not match one of the pins meaning the window cannot be properly locked shut. <b>Casement stay should be replaced with a working stay which can be locked shut</b> | Window has been painted with a modern, film-forming paint which is inappropriate for a timber window and is flaking. <b>Decoration should be stripped back and window redecorated with an appropriate moisture vapour permeable paint</b> | | Fig. 17-19 | |

Window S.1.6; showing general view

Window S.1.6; showing timber decay to bottom rail of awning

Window S.1.6; showing non-matching pins to casement stay, preventing casement stay from being locked shut

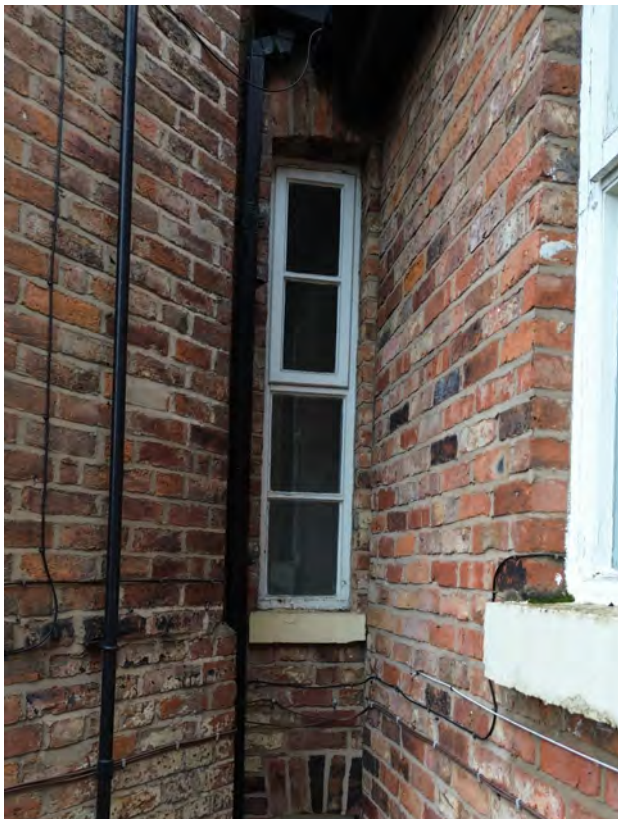
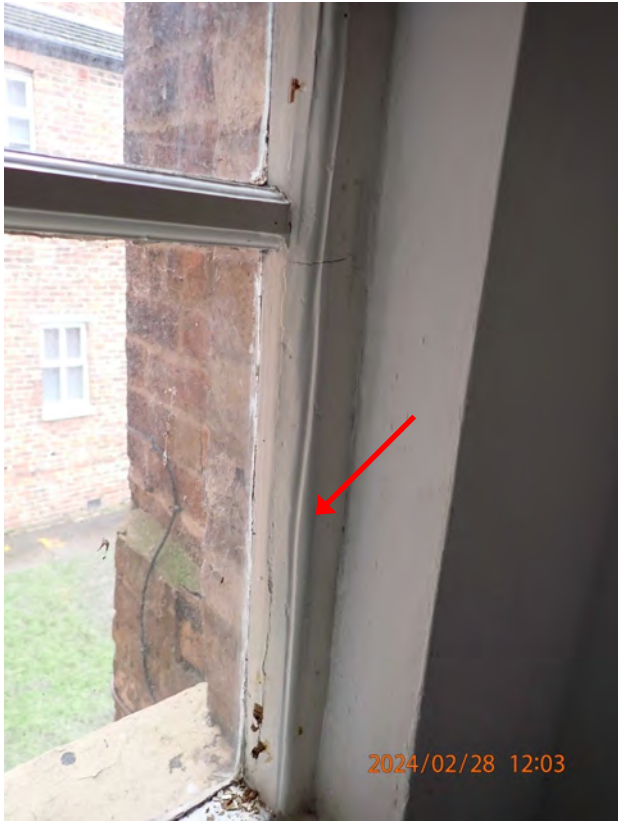
| REF | ELEV | FLOOR | UNIT | WINDOW TYPE | MAT | DIMENSIONS (MM) | OPERABILITY | RELEASE | EASE | REHANG | BALANCE | RENEW | RE-ALIGN | ELEMENTS TO REPAIR | ELEMENTS TO REPLACE | PREVIOUS REPAIRS | GLAZING & PUTTY | FURNITURE | DECORATION | ADDITIONAL COMMENTS | PHOTO REFERENCE | |
|---|---|---|---|---|---|---|---|---|---|---|---|---|---|---|---|---|---|---|---|---|---|---|
| E.1.7 | E | 1 | 7 | 1x4 pane timber casement with 1no. opening awning | Timber | ~1785x385mm | Partially operable - awning is binding on window frame | | Awning | | | | | There is a previous putty repair to the base of the south jamb which has been crudely formed and <b>should be replaced with a proper timber splice repair</b> | Timber sill is decayed for full length and <b>should be replaced</b> . <b>Allowance should also be made for full replacement of the lower transom</b> | | Single-glazed. Window putty is at the end of its service life and <b>should be renewed</b> | 1no. modern metal casement stay | Window has been painted with a modern, film-forming paint which is inappropriate for a timber window and is flaking. <b>Decoration should be stripped back and window redecorated with an appropriate moisture vapour permeable paint</b> | | Fig. 20-21 | |

Window E.1.7; showing general view

Window E.1.7; showing previous putty repair to south jamb timber decay

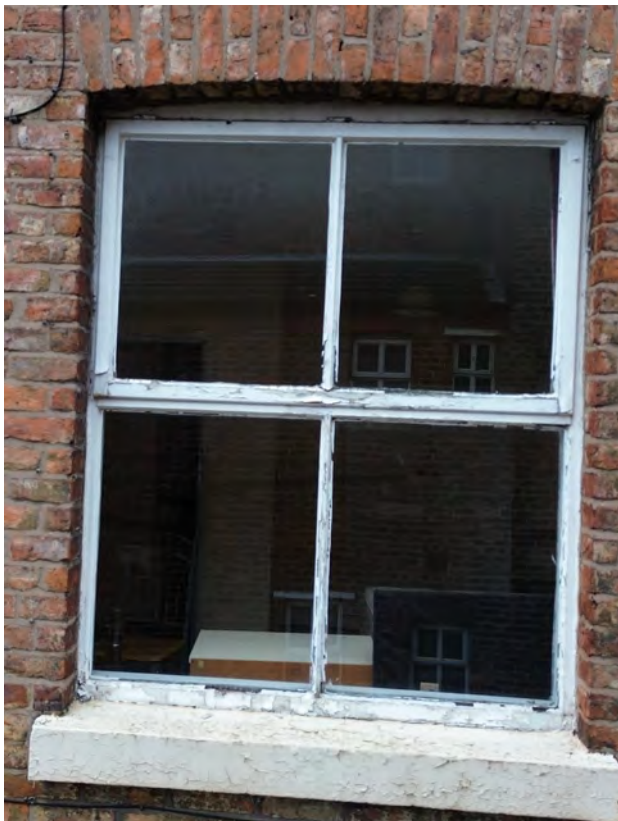
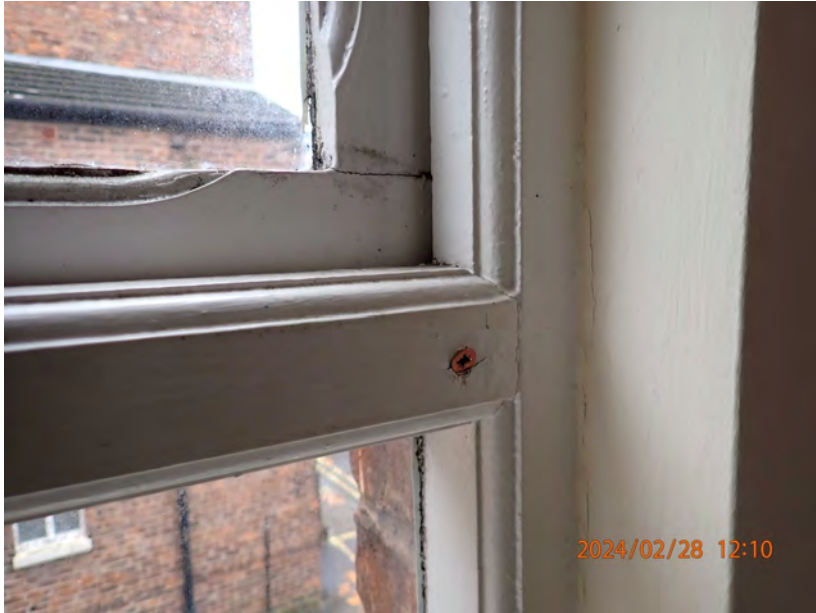
| REF | ELEV | FLOOR | UNIT | WINDOW TYPE | MAT | DIMENSIONS (MM) | OPERABILITY | RELEASE | EASE | REHANG | BALANCE | RENEW | RE-ALIGN | ELEMENTS TO REPAIR | ELEMENTS TO REPLACE | PREVIOUS REPAIRS | GLAZING & PUTTY | FURNITURE | DECORATION | ADDITIONAL COMMENTS | PHOTO REFERENCE | |
|---|---|---|---|---|---|---|---|---|---|---|---|---|---|---|---|---|---|---|---|---|---|---|
| E.1.8 | E | 1 | 8 | 2x2 pane timber casement with 1no. opening awning | Timber | ~1725x1410mm | Inoperable - awning has been fixed shut with screw | Awning | | | | | | There is localised decay to the timber sill and base of the north jamb at the joint between the sill and jamb. <b>Both elements should be repaired with a timber splice repair</b> . The joint between the bottom rail of the awning and the central mullion has opened | | | Single-glazed. Window putty is beyond the end of its service life and is missing in several locations. <b>Window putty should be renewed</b> | 1no. modern metal casement stay. Casement stay is misaligned with its locking pins so window cannot be locked. <b>Locking pins should be realigned to allow casement stay to be locked</b> | Window has been painted with a modern, film-forming paint which is inappropriate for a timber window and is flaking. <b>Decoration should be stripped back and window redecorated with an appropriate moisture vapour permeable paint</b> | | Fig. 22-24 | |

Window E.1.8; showing general view

Window E.1.8; showing screw used to fix awning shut

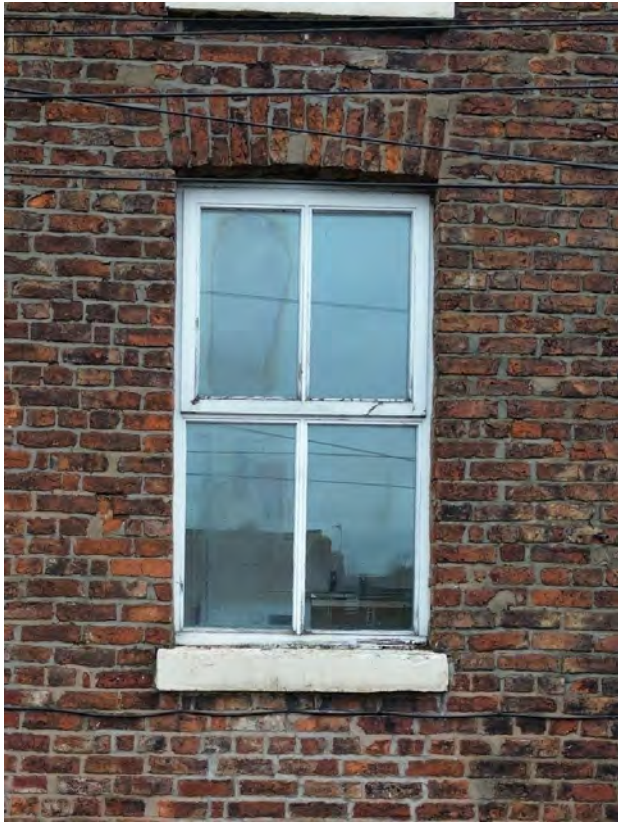
Fig 25:

| REF | ELEV | FLOOR | UNIT | WINDOW TYPE | MAT | DIMENSIONS (MM) | OPERABILITY | RELEASE | EASE | REHANG | BALANCE | RENEW | RE-ALIGN | ELEMENTS TO REPAIR | ELEMENTS TO REPLACE | PREVIOUS REPAIRS | GLAZING & PUTTY | FURNITURE | DECORATION | ADDITIONAL COMMENTS | PHOTO REFERENCE | |
|---|---|---|---|---|---|---|---|---|---|---|---|---|---|---|---|---|---|---|---|---|---|---|
| S.1.9 | S | 1 | 9 | 2x2 pane timber casement with 1no. opening awning | Timber | ~1805x1005mm | Operable | - | - | - | - | - | - | The timber sill is decayed at the east end and <b>should be repaired using a timber splice repair</b> . <b>Allowance should also be made for repair to the base of the east jamb using a timber splice repair</b> | | - | Double-glazed. There was condensate in all double-glazing units, suggesting glazing seals have failed. <b>Double-glazing units should be replaced</b> | 1no. modern metal casement stay | Window has been painted with a modern, film-forming paint which is inappropriate for a timber window and is flaking. <b>Decoration should be stripped back and window redecorated with an appropriate moisture vapour permeable paint</b> | | Fig. 25-26 | |

Window S.1.9; showing general view

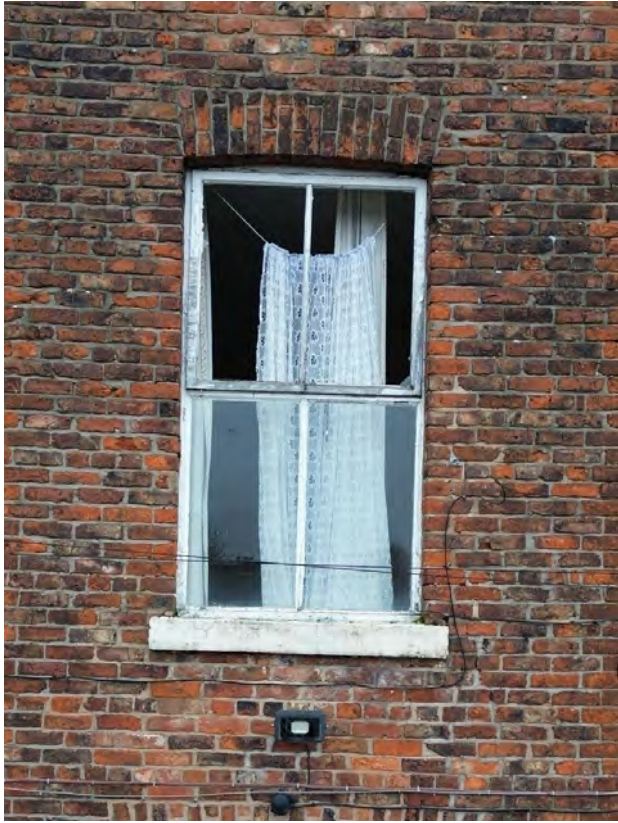
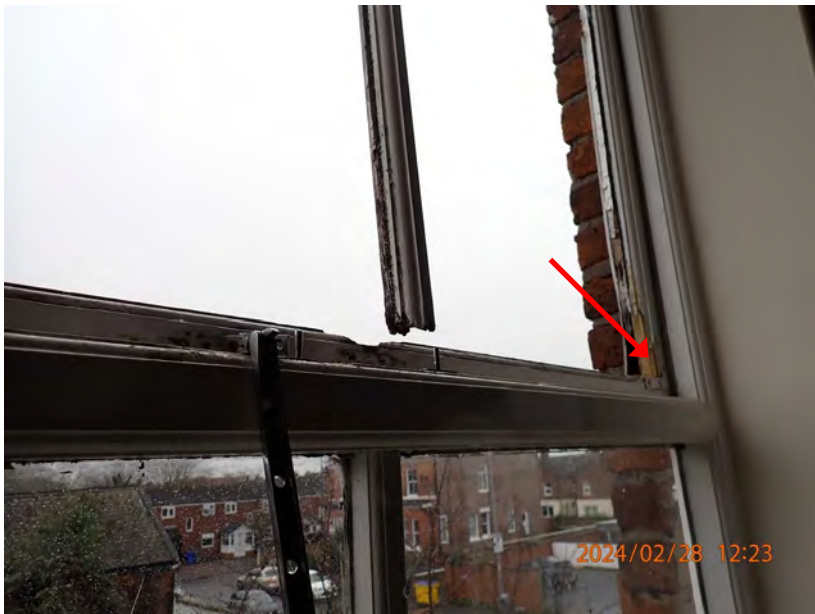
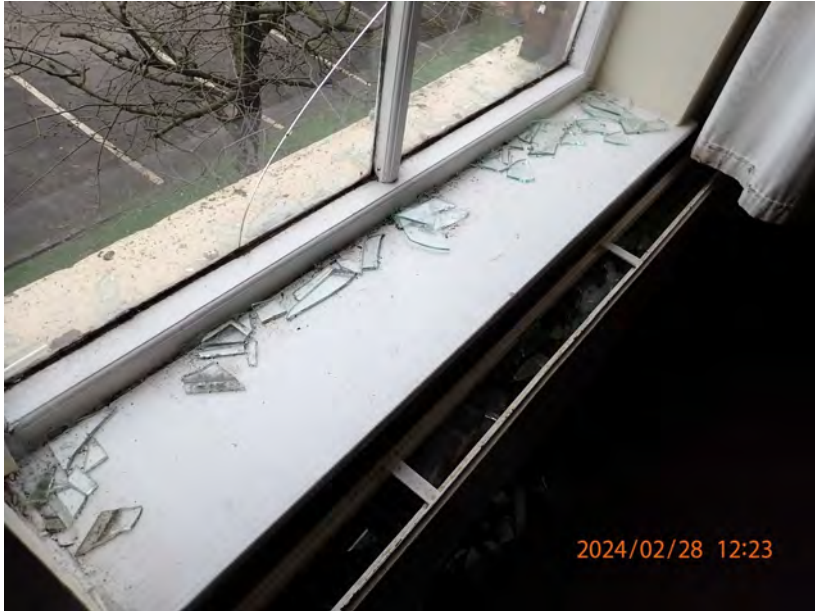
| REF | ELEV | FLOOR | UNIT | WINDOW TYPE | MAT | DIMENSIONS (MM) | OPERABILITY | RELEASE | EASE | REHANG | BALANCE | RENEW | RE-ALIGN | ELEMENTS TO REPAIR | ELEMENTS TO REPLACE | PREVIOUS REPAIRS | GLAZING & PUTTY | FURNITURE | DECORATION | ADDITIONAL COMMENTS | PHOTO REFERENCE | |
|---|---|---|---|---|---|---|---|---|---|---|---|---|---|---|---|---|---|---|---|---|---|---|
| S.1.10 | S | 1 | 10 | 2x2 pane timber casement with 1no. opening awning | Timber | ~2225x1190mm | Inoperable due to poor condition of window | | | | | | | There is decay to the base of the mullion to the awning. There is decay to the base of both stiles to the awning. The west stile has been previously repaired with putty. 2no. L-shaped metal surface plates have been fixed to the awning at the joint between the stiles and bottom rail to reinforce the joint. <b>The awning should be replaced in a like-for-like manner</b> | There are timber splice repairs to the base of both jambs, suggesting previous timber decay in this location. Splice repairs are poorly executed - <b>consideration should be given to replacing them with more appropriate repairs</b> | | Single-glazed. Both panes to awning have been completely smashed. 1no. pane is cracked. <b>3no. panes should be replaced</b> . Window putty is beyond the end of its service life and <b>should be renewed</b> | 1no. modern metal casement stay has been partially pulled off. <b>Casement stay should be replaced</b> | Window has been painted with a modern, film-forming paint which is inappropriate for a timber window and is flaking. <b>Decoration should be stripped back and window redecorated with an appropriate moisture vapour permeable paint</b> | <b>This window should be secured and boarded as a matter of urgency to prevent unauthorised entry to the building and ingress by pests such as pigeons</b> | Fig. 27-29 | |

Window S.1.10; showing general view

Window S.1.10; showing timber decay to mullion awning and missing glazing. Note; L-shaped metal surface plate to awning joints

Window S.1.10; showing broken glass from awning glazing

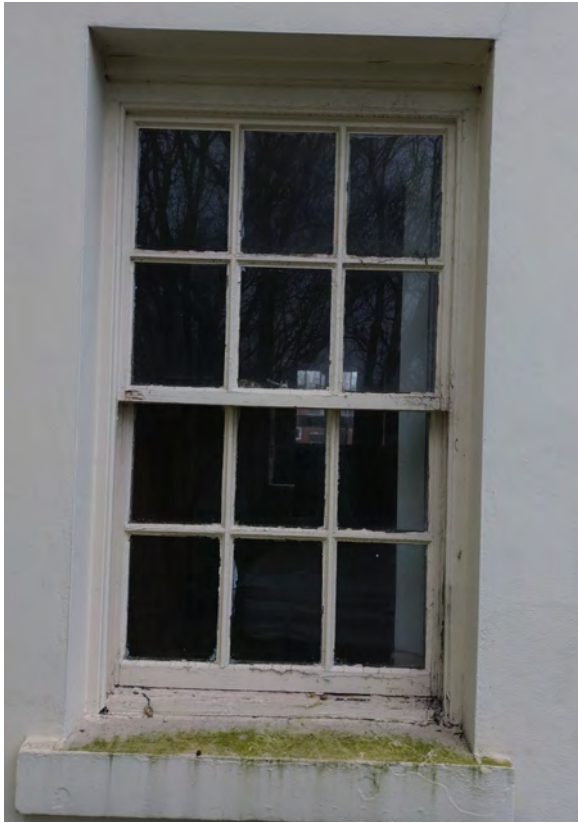
**Fig 35:**

| REF | ELEV | FLOOR | UNIT | WINDOW TYPE | MAT | DIMENSIONS (MM) | OPERABILITY | RELEASE | EASE | REHANG | BALANCE | RENEW | RE-ALIGN | ELEMENTS TO REPAIR | ELEMENTS TO REPLACE | PREVIOUS REPAIRS | GLAZING & PUTTY | FURNITURE | DECORATION | ADDITIONAL COMMENTS | PHOTO REFERENCE |
|---|---|---|---|---|---|---|---|---|---|---|---|---|---|---|---|---|---|---|---|---|---|
| N.G.1 | N | G | 1 | Single-hung 6 over 6 timber sash with fixed upper sash and sliding lower sash | Timber | ~1600x1015mm | Partially operable - lower sash is binding in frame, preventing full opening | | | | | | | Both outer linings are decayed at the base and <b>should be repaired using timber splice repairs</b> . There is decay to the base of the lower stile on the west side which <b>should be repaired using a timber splice repair. Allowance should be made for repair of the bottom rail of the awning with a timber splice repair</b> | Timber sill is decayed for full length and <b>should be replaced</b> | | Single-glazed. 1no. pane to the lower sash is cracked and <b>should be replaced</b> . Window putty is at the end of its service life and <b>should be renewed</b> | 2no. modern handles to the lower sash and 3no. sash locks (only one of which is operable). <b>Redundant sash locks should be removed</b> | Window has been painted with a modern, film-forming paint which is inappropriate for a timber window and is flaking. <b>Decoration should be stripped back and window redecorated with an appropriate moisture vapour permeable paint</b> | | Fig. 35 |

Window N.G.1; showing general view

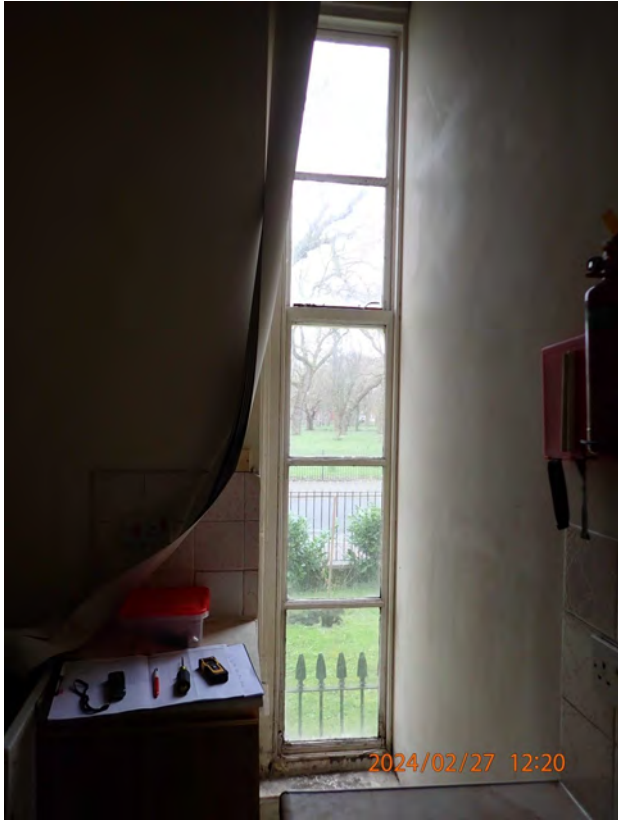
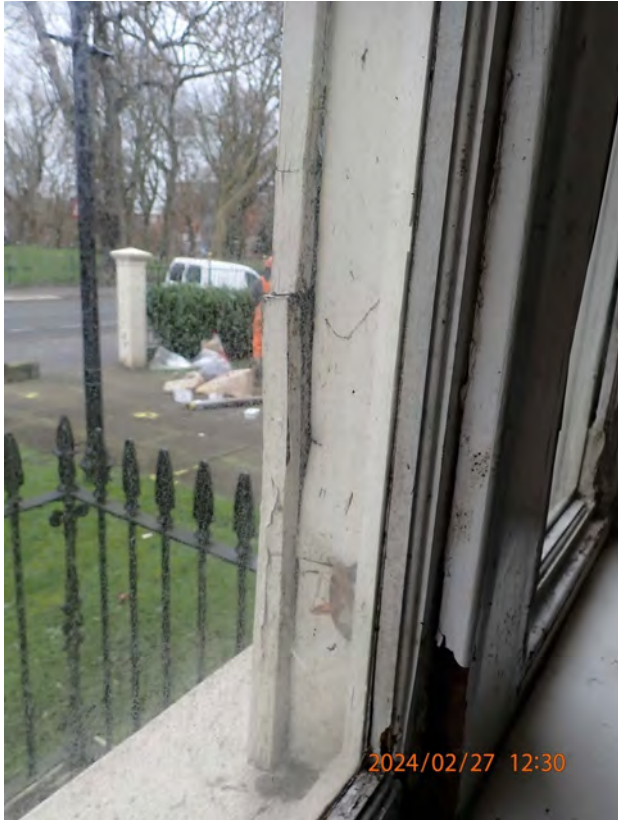
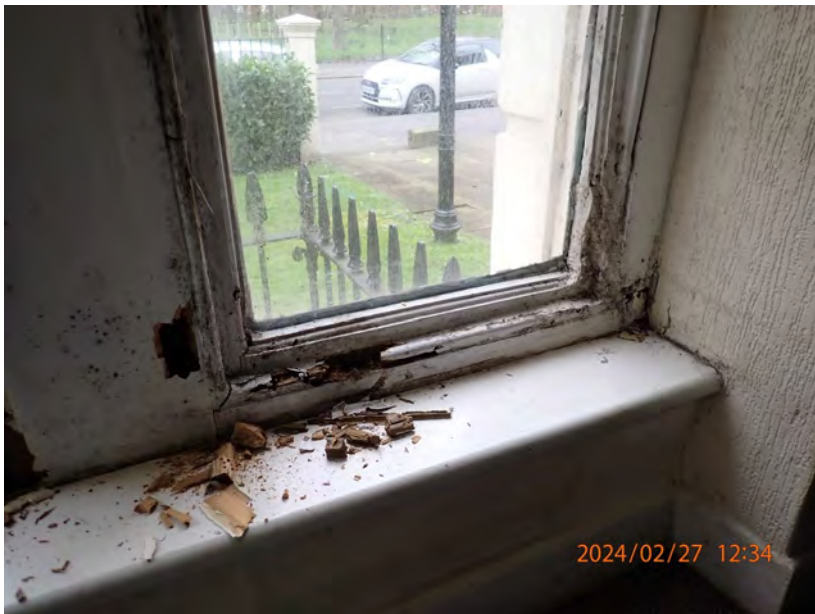
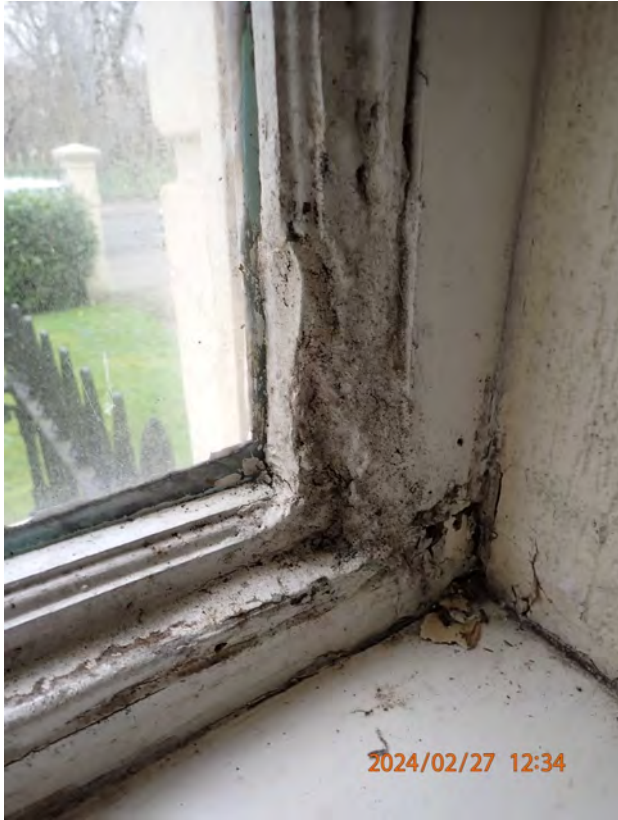
| REF | ELEV | FLOOR | UNIT | WINDOW TYPE | MAT | DIMENSIONS (MM) | OPERABILITY | RELEASE | EASE | REHANG | BALANCE | RENEW | RE-ALIGN | ELEMENTS TO REPAIR | ELEMENTS TO REPLACE | PREVIOUS REPAIRS | GLAZING & PUTTY | FURNITURE | DECORATION | ADDITIONAL COMMENTS | PHOTO REFERENCE |
|---|---|---|---|---|---|---|---|---|---|---|---|---|---|---|---|---|---|---|---|---|---|
| N.G.2a | N | G | 2a | Former single-hung 2 over 3 sash converted into timber casement with 1no. opening awning | Timber | ~2815x500mm | Operable | - | - | - | - | - | - | Both lower stiles to former sliding sash are decayed at the base and <b>should be repaired with timber splice repairs</b> . The sill and base of the outer lining at the west end are decayed and <b>should be repaired using timber splice repairs</b> | Bottom rail of the former sliding sash is decayed for full length and <b>should be replaced. Allowance should be made for replacement of timber sill</b> | | Single-glazed. Window putty is beyond the end of its service life and should be renewed | 1no. modern casement stay to awning. Casement stay has been fixed to 2no. timber batons which, in turn, are fixed to the meeting rail of the former sliding sash | Window has been painted with a modern, film-forming paint which is inappropriate for a timber window and is flaking. <b>Decoration should be stripped back and window redecorated with an appropriate moisture vapour permeable paint</b> | Window forms tripartite window with N.G.2b and N.G.2c. There is an internal partition wall between N.G.2a and N.G.2b. | Fig. 36-44 |
| N.G.2b | N | G | 2b | Single-hung 6 over 9 timber sash with fixed upper sash and sliding lower sash | Timber | Opening for N.G.2b and N.G.2c = ~2805x1780mm / Window N.G.2b = ~2805x1205mm | Inoperable - both sash cords have snapped | | | | | | | There is localised decay at the joints between the sill and both inner linings which <b>should be repaired with timber splice repairs</b> | Staff bead is decayed for full length and <b>should be replaced. Allowance should be made for replacement of the timber sill, and timber splice repair to both outer linings</b> | | Single-glazed. Window putty is beyond the end of its service life and is missing in several locations. <b>Window putty should be renewed</b> | 2no. metal handles to lower sash and 1no. modern sash lock | Window has been painted with a modern, film-forming paint which is inappropriate for a timber window and is flaking. <b>Decoration should be stripped back and window redecorated with an appropriate moisture vapour permeable paint</b> | Window forms tripartite window with N.G.2a and N.G.2c. There is an internal partition wall between N.G.2a and N.G.2b | Fig. 36-44 |
| N.G.2c | N | G | 2c | Former single-hung 2 over 3 sash converted into timber casement with 1no. opening awning | Timber | Opening for N.G.2b and N.G.2c = ~2805x1780mm / Window N.G.2b = ~2805x500mm | Operable | - | - | - | - | - | - | The base of the east lower stile is missing and has been crudely repaired with putty. <b>This should be replaced with a proper timber splice repair</b> . The base of both inner linings and both staff beads are decayed and <b>should be repaired with timber splice repairs</b> . The west outer lining is decayed and <b>should be repaired using a timber splice repair</b> | The timber sill is decayed for the full length and <b>should be replaced</b> . The bottom rail of the former sliding sash is decayed for the full length and <b>should be replaced</b> | | Single-glazed. Window putty is beyond the end of its service life and <b>should be renewed</b> | 1no. modern casement stay to awning. Casement stay has been fixed to 2no. timber batons which, in turn, are fixed to the meeting rail of the former sliding sash | Window has been painted with a modern, film-forming paint which is inappropriate for a timber window and is flaking. <b>Decoration should be stripped back and window redecorated with an appropriate moisture vapour permeable paint</b> | Window forms tripartite window with N.G.2a and N.G.2b | Fig. 36-44 |

Window N.G.2a; showing general view from interior. Note partition wall between windows N.G.2a and N.G.2b

Window N.G.2b; showing decay to outer lining

Window N.G.2c; showing decay to sill

Window N.G.2c; showing previous putty repair

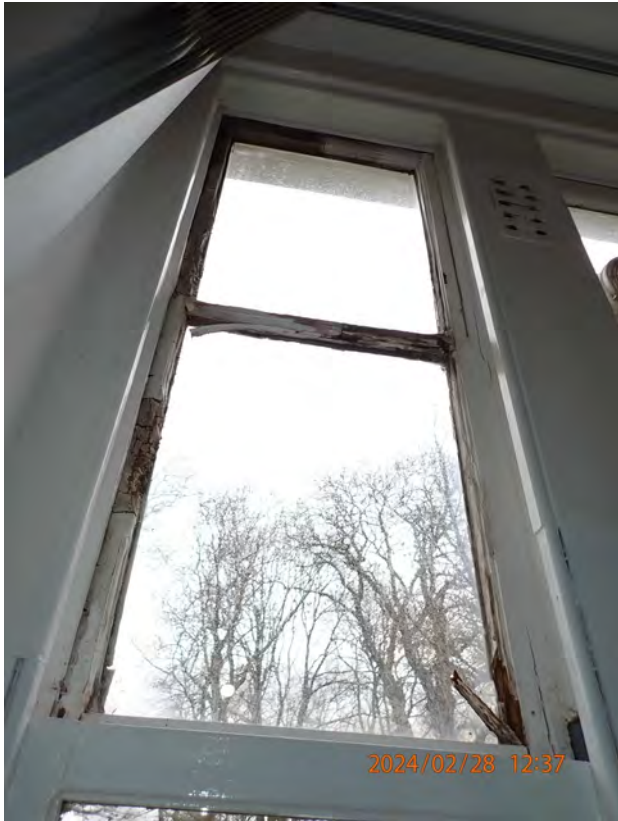
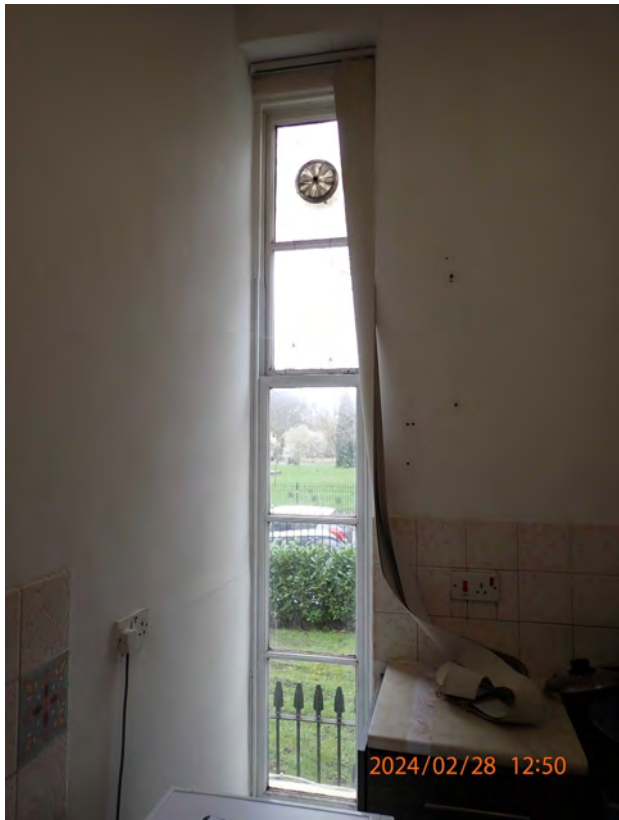
| REF | ELEV | FLOOR | UNIT | WINDOW TYPE | MAT | DIMENSIONS (MM) | OPERABILITY | RELEASE | EASE | REHANG | BALANCE | RENEW | RE-ALIGN | ELEMENTS TO REPAIR | ELEMENTS TO REPLACE | PREVIOUS REPAIRS | GLAZING & PUTTY | FURNITURE | DECORATION | ADDITIONAL COMMENTS | PHOTO REFERENCE |
|---|---|---|---|---|---|---|---|---|---|---|---|---|---|---|---|---|---|---|---|---|---|
| N.G.5b | N | G | 5b | Former single-hung 6 over 9 timber sash converted into timber casement with 1no. opening awning | Timber | Opening for N.G.5a and N.G.5b = ~2800x1775mm / Window N.G.5b ONLY = ~2800x1190mm | Partially operable - awning cannot be fully closed due to position of previous sash lock. This presents a security risk to the building | | | | | | | The west outer lining is decayed at the base and <b>should be repaired using a timber splice repair</b> | The east outer lining between windows 5b and 5c is decayed at the window head and <b>should be replaced</b> | There was 1no. previous timber splice repair to the west stile of the lower sash | Single-glazed. 1no. pane to lower sash is cracked and <b>should be replaced</b> . Plastic vents have been fitted to 2no. panes in the awning. Window putty is beyond the end of its service life and <b>should be renewed</b> | 2no. modern metal casement stays to awning which have been painted with a modern film forming paint. Casement stays are misaligned and <b>should be realigned to allow window to be locked shut</b> | Window has been painted with a modern, film-forming paint which is inappropriate for a timber window and is flaking. <b>Decoration should be stripped back and window redecorated with an appropriate moisture vapour permeable paint</b> | Window forms tripartite window with N.G.5a and N.G.5c. There is a internal partition wall between N.G.5b and N.G.5c | Fig. 47-51 |
| N.G.5c | N | G | 5c | Former single-hung 2 over 3 sash converted into timber casement with 1no. opening awning | Timber | ~2800x595mm | Not tested - retrofitted window lock is locked and key is not present therefore operability could not be tested | - | - | - | - | - | - | There is localised decay to the base of the inner lining to the east which <b>should be repaired using a timber splice repair</b> . There is decay to the window head at the east end which <b>should be repaired using a timber splice repair</b> . Allowance should be made for repair of adjoining timber elements | Allowance should be made for replacement of the timber sill | | Single-glazed. A vent has been fitted to 1no. pane to the awning. Window putty is beyond the end of its service life and <b>should be renewed</b> | 1no. modern metal casement stay which has been painted with a modern, film-forming paint. 1no. retrofitted window lock. | Window has been painted with a modern, film-forming paint which is inappropriate for a timber window and is flaking. <b>Decoration should be stripped back and window redecorated with an appropriate moisture vapour permeable paint</b> | Window forms tripartite window with N.G.5a and N.G.5b. There is a internal partition wall between N.G.5b and N.G.5c | Fig. 47-51 |

Window N.G.5a; showing severe decay to awning (former fixed sash)

Window N.G.5c; showing general view from interior. Note partition wall between windows N.G.5b and N.G.5c

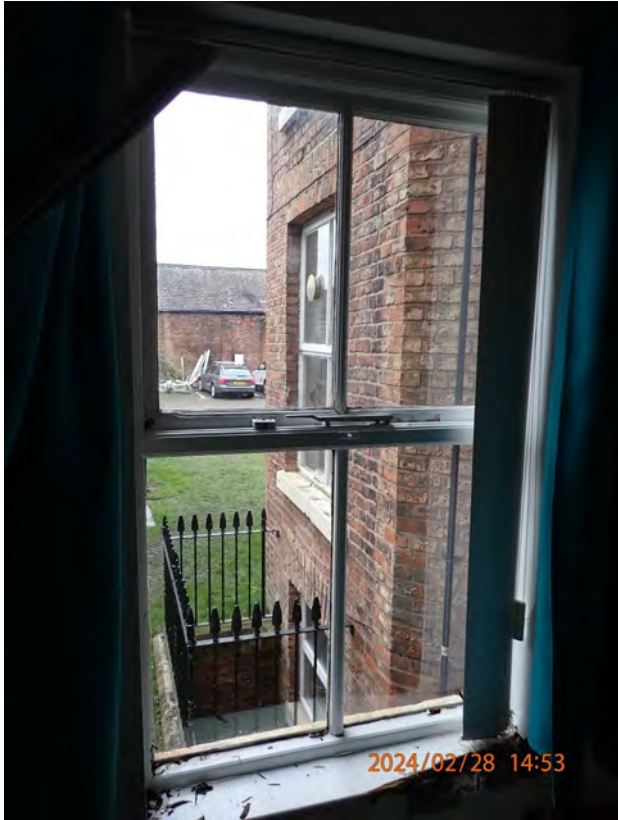
**Fig 53:**

| REF | ELEV | FLOOR | UNIT | WINDOW TYPE | MAT | DIMENSIONS (MM) | OPERABILITY | RELEASE | EASE | REHANG | BALANCE | RENEW | RE-ALIGN | ELEMENTS TO REPAIR | ELEMENTS TO REPLACE | PREVIOUS REPAIRS | GLAZING & PUTTY | FURNITURE | DECORATION | ADDITIONAL COMMENTS | PHOTO REFERENCE |
|---|---|---|---|---|---|---|---|---|---|---|---|---|---|---|---|---|---|---|---|---|---|
| S.G.7 | S | G | 7 | 2x2 pane timber casement with 1no. opening awning | Timber | ~1690x1000mm | Inoperable - retrofitted window lock is locked and key is not present | - | - | - | - | - | - | There is localised decay to the base of both jambs which <b>should be repaired with timber splice repairs</b> | Timber sill is decayed for full length and <b>should be replaced</b> . Transom is decayed for full length and should be replaced | | Single-glazed. Window putty is beyond the end of its service life and <b>should be renewed</b> | 1no. modern metal casement stay which has been painted with a modern, film-forming paint. 1no. retrofitted window lock. | Window has been painted with a modern, film-forming paint which is inappropriate for a timber window and is flaking. <b>Decoration should be stripped back and window redecorated with an appropriate moisture vapour permeable paint</b> | | Fig. 53-54 |

Window S.G.7; showing general view

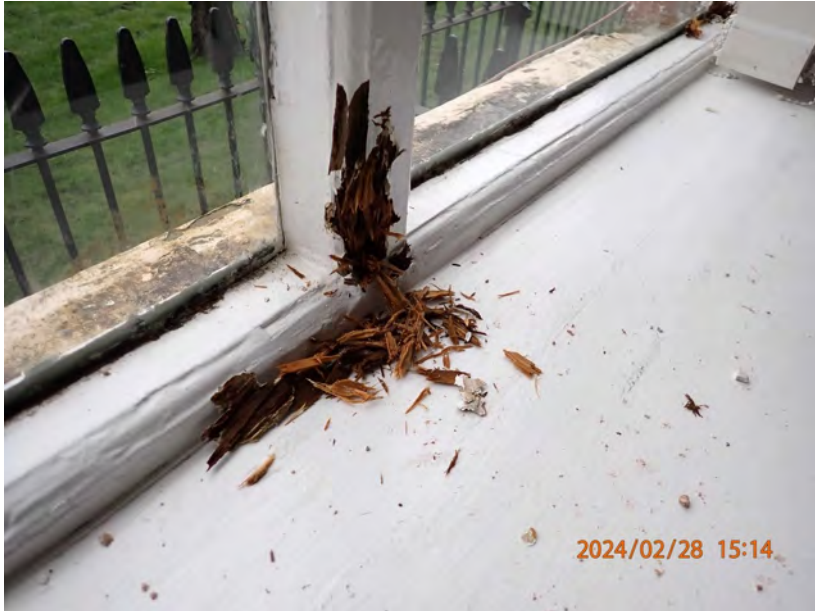
**Fig 61:**

Window S.G.11; showing timber decay to mullion and sill

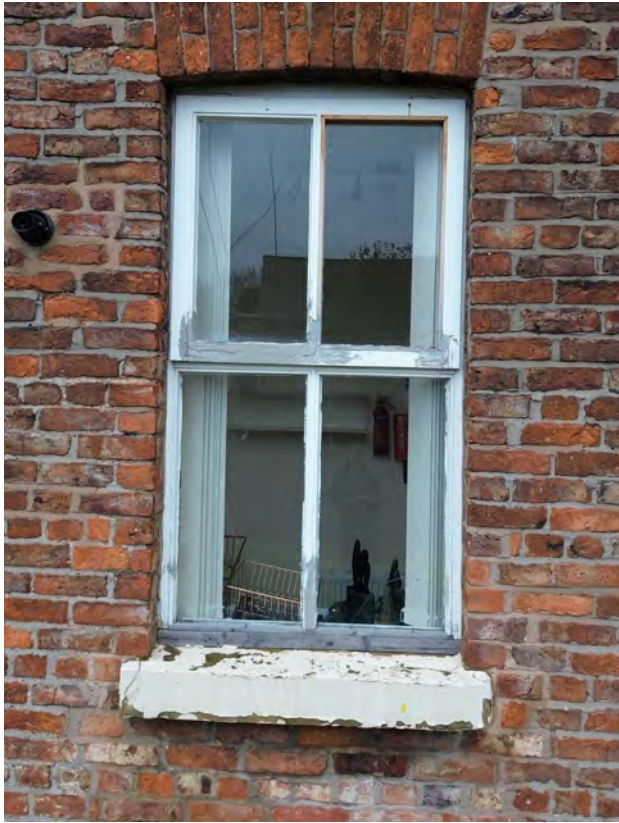
**Fig 63:**

Window S.G.13; showing general view. Note timber batons fixed to decayed sill. Note extensive putty repairs to window frame

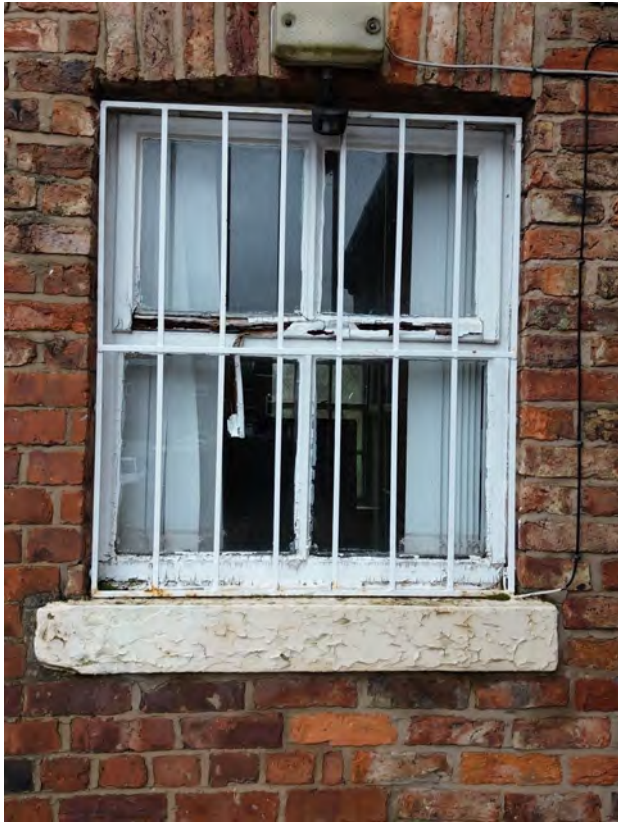
**Fig 67:**

Window W.G.17; showing general view. Note decay to bottom rail
