Osbornes Yard, Manchester

# **Contamination Delineation Investigation and Removal Validation Report**

Job Number  
**LKC231691**

Report Date  
**July 2025**

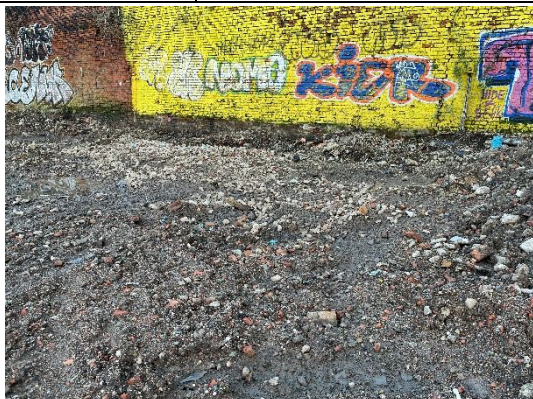
| LKC SITE DIARY | | | |
|---|---|---|---|
| Photograph 1: View of former underground fuel tank area which demolition contractors have already removed the tanks and backfilled excavation with rubble. | | Photograph 2: Site had reduced in levels by 0.5m. | |

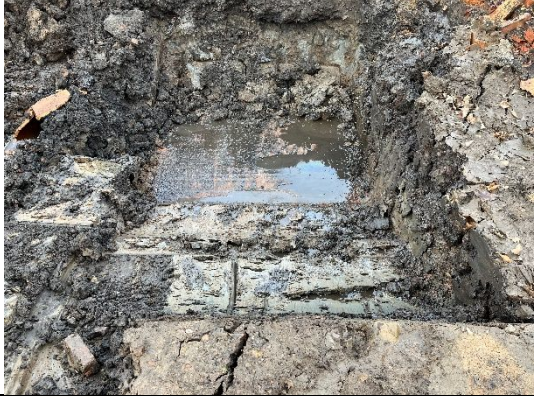
| <p><b>Photograph 5:</b> Setting up bunded area in preparation to stockpile contaminated material.</p> | <p><b>Photograph 6:</b> View of start of excavation in Area 1, site of former small fuel tank. Some dark grey HC contaminated layer and sheen of perched water noted.</p> |

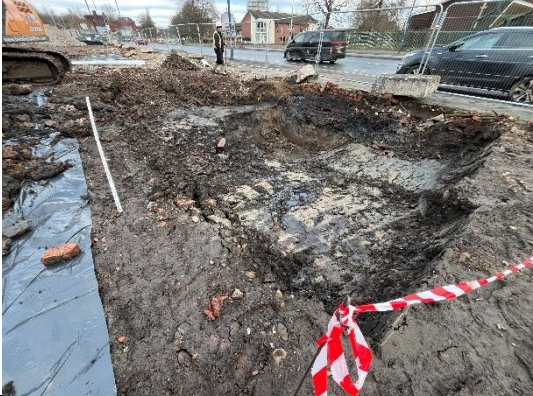
| <p><b>Photograph 7:</b> Contamination hotspot delineated. Excavated stopped at eastern site boundary.</p> | <p><b>Photograph 8:</b> View of contamination at eastern site boundary.</p> |

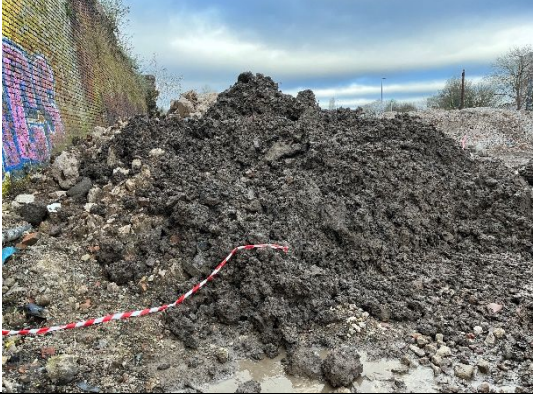
| <p><b>Photograph 9:</b> View of SP1 – material left by demolition contractor from tank removal.</p> | <p><b>Photograph 10:</b> View of SP2 – material excavated from Area 1.</p> |

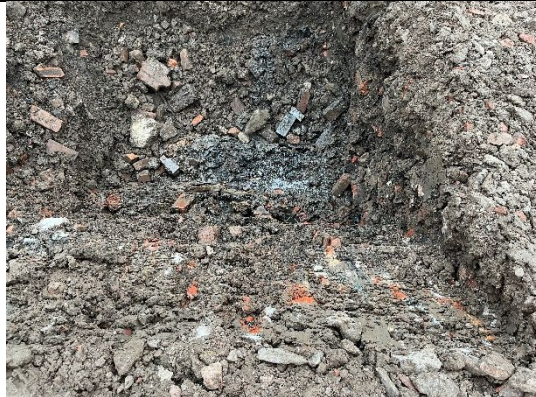
| LKC SITE DIARY | | | |
|---|---|---|---|
| Photograph 1: Setting up of second Visqueen bunded area. | | Photograph 2: Visual start of HC contaminated ground at 0.7mbgl. | |

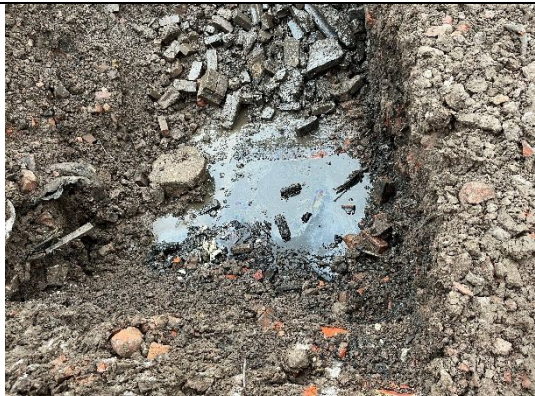
| LKC SITE DIARY | | | |
|---|---|---|---|
| Photograph 3: Visually HC contaminated rubble and perched water. | | Photograph 4: HC contaminated material stockpile on visqueen. | |

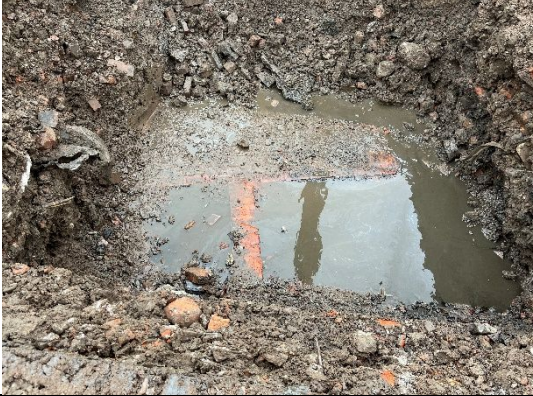
| <p><b>Photograph 5:</b> Concrete base at 1.9mbgl with brick partitions. .</p> | <p><b>Photograph 6:</b> Black HC contaminated present directly below concrete slab.</p> |

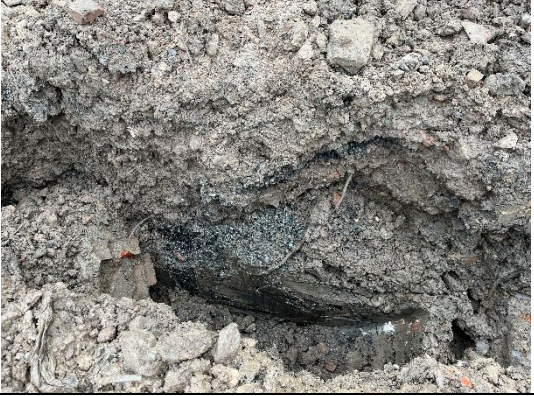
| <p><b>Photograph 7:</b> Trial trench started at the west of the site, to the rear of the former underground fuel tanks.</p> | <p><b>Photograph 8:</b> HC contamination can be seen seeping along granular layer.</p> |

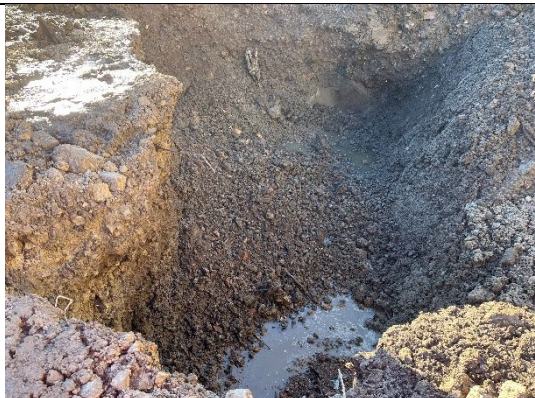
| LKC SITE DIARY | | | |
|---|---|---|---|
| Photograph 3: Excavation is filled with demolition rubble from the removal of the tanks by the demolition contractor previously. | | Photograph 4: HC contaminated staining in the clay at 2mbgl along the west of the site. | |

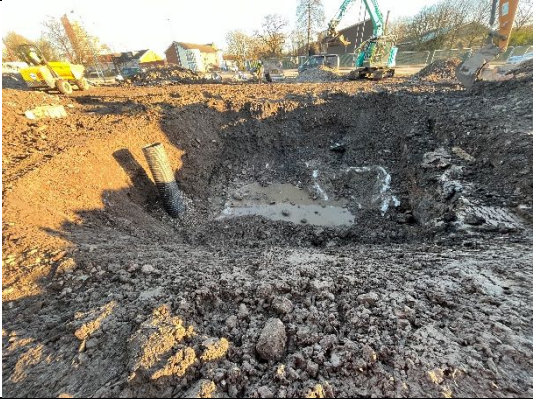
| <p><b>Photograph 5:</b> Concrete base at 3.9mbgl which tanks used to be sat on.</p> | <p><b>Photograph 6:</b> Clay present beneath the concrete slab, appeared clean.</p> |

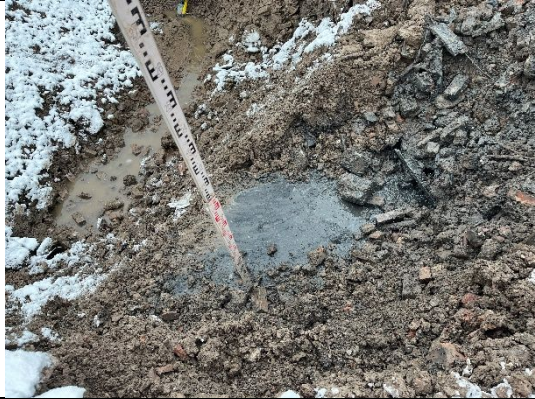
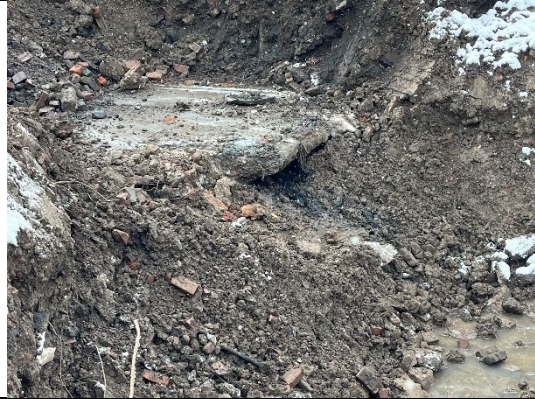
| LKC SITE DIARY | | | |
|---|---|---|---|
| Photograph 1: Shallower concrete slab encountered to the front of the former tanks, towards the former forecourt, at approximately 2.5mbgl. HC staining noted on concrete slab. | | Photograph 2: Some black staining noted in a localised area beneath the concrete slab. | |

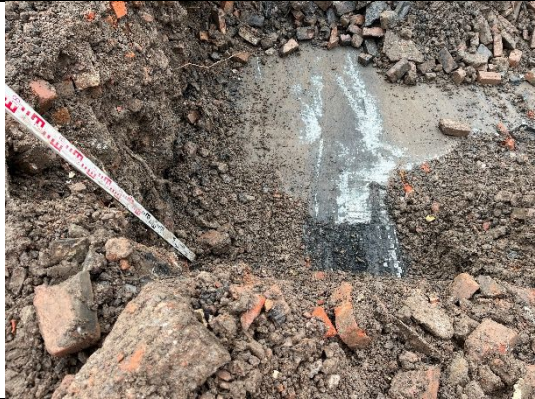
| LKC SITE DIARY | | | |
|---|---|---|---|
| Photograph 3: Buried manhole cover noted at approximately 1.8mbgl. | | Photograph 4: Concrete slab continued towards the road in the east of the site. | |
