# CONSTRUCTION MANAGEMENT PLAN

**TGB Builders** - 1390-92 ASHTON OLD ROAD

Sept 2025 REV B

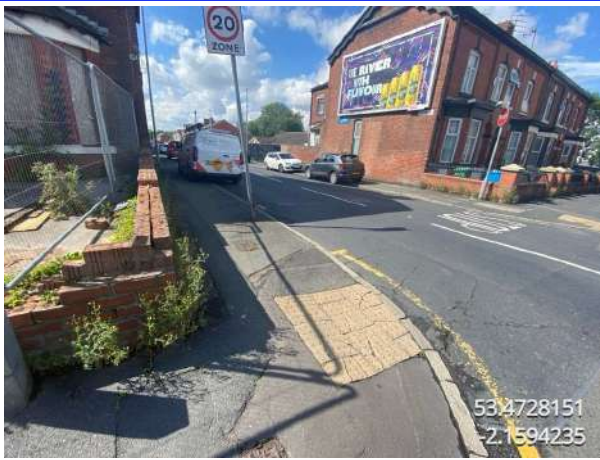
### **PICTURE 1**

Severely damaged tactiles giving rise to possible trip hazards due to overrunning of the corner. Carriageway surfacing showing evidence of failure. Damaged road sign post (corrosion and leaning). Kerbs in need of remediation and new signpost recommended.

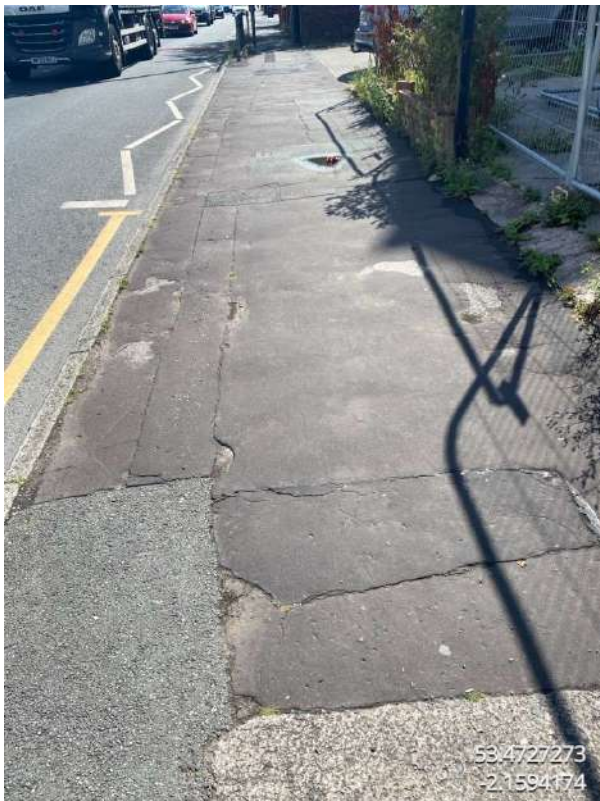
### **PICTURE 2**

Multiple instances of footway scarring throughout with frequent patches. Longitudinal fractures are also frequent. Potentially sign of subsurface defects due to water penetration.

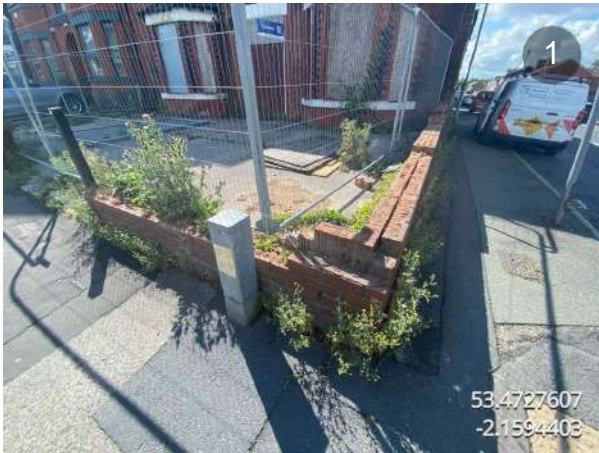
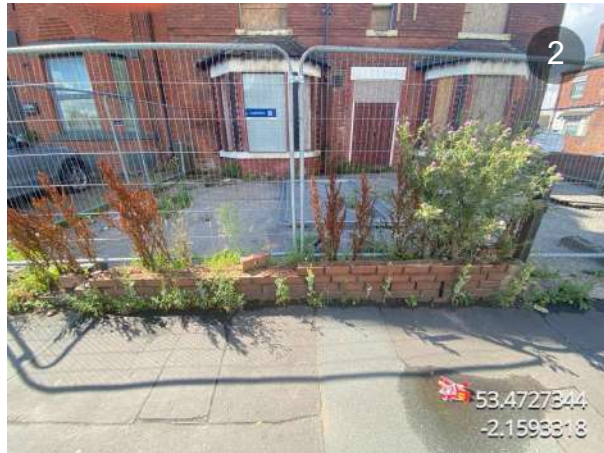
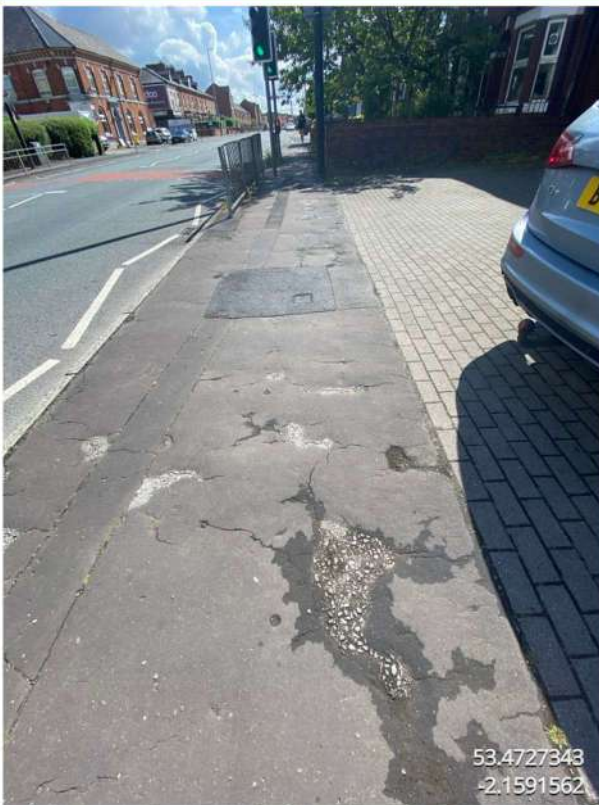
### PICTURE 3

External wall of site completely damaged with vegetation growing throughout. Potential to undermine existing structure.

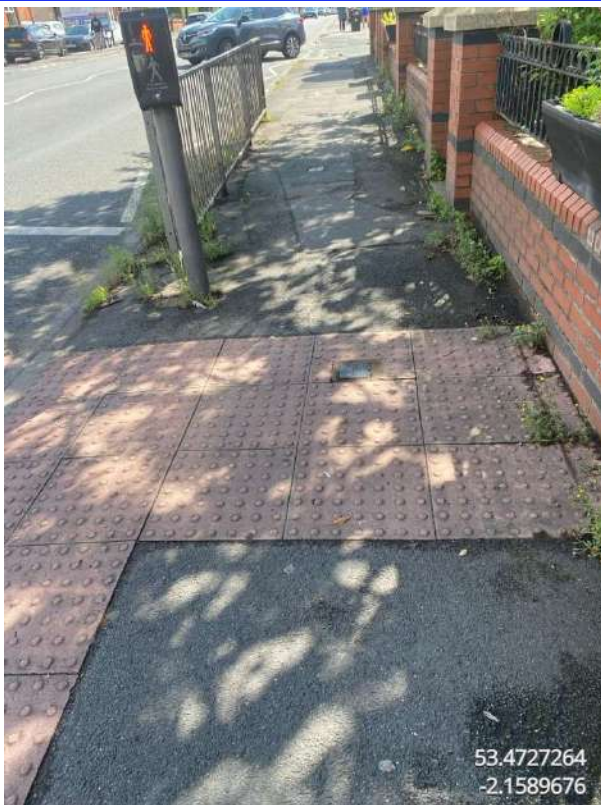
### PICTURE 4

Multiple instances of delamination. Base course exposed in many areas. Further evidence of potential frost erosion.

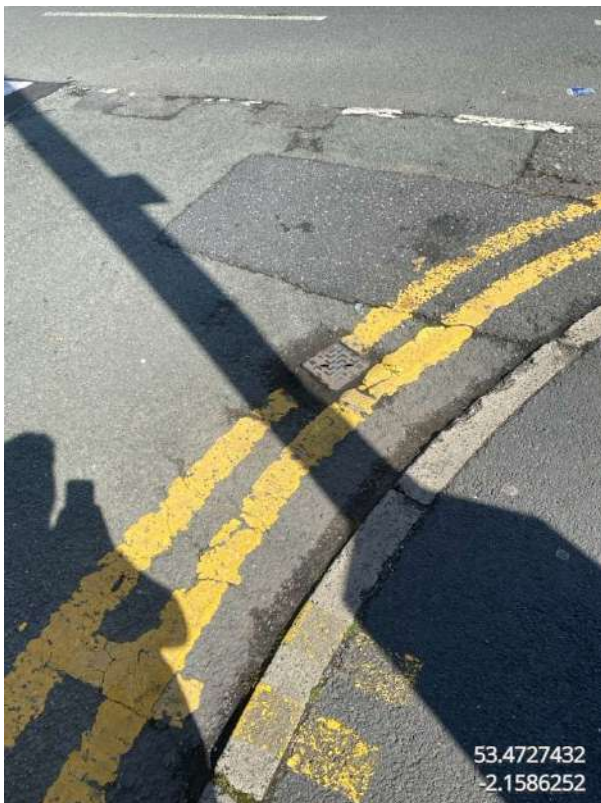
**PICTURE 5**

Multiple areas of vegetation growth through surface course with surface cracking evident in multiple locations. Possible subsurface defects. Recommend repairs as necessary. May require further intervention of subsurface defects identified.

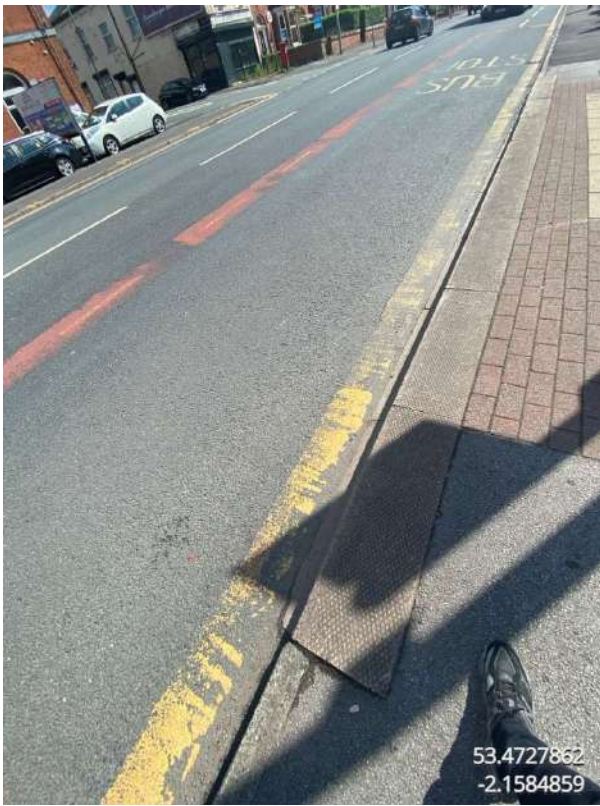
**PICTURE 6**

Sunken valve on junction with Delamere St, potential that infrastructure below ground level could be affected.

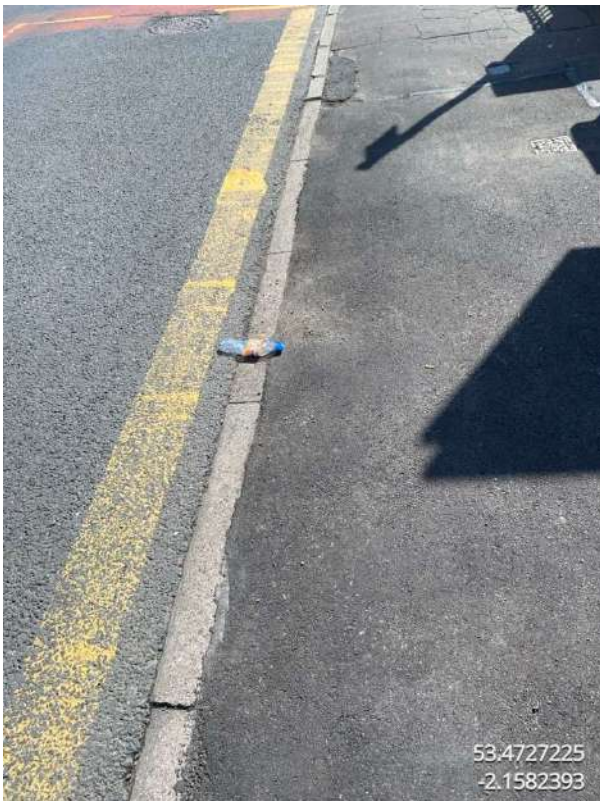
### **PICTURE 7**

Carriageway in general good condition throughout. Bus stop shown adjacent to Delamere St. Road markings showing wear.

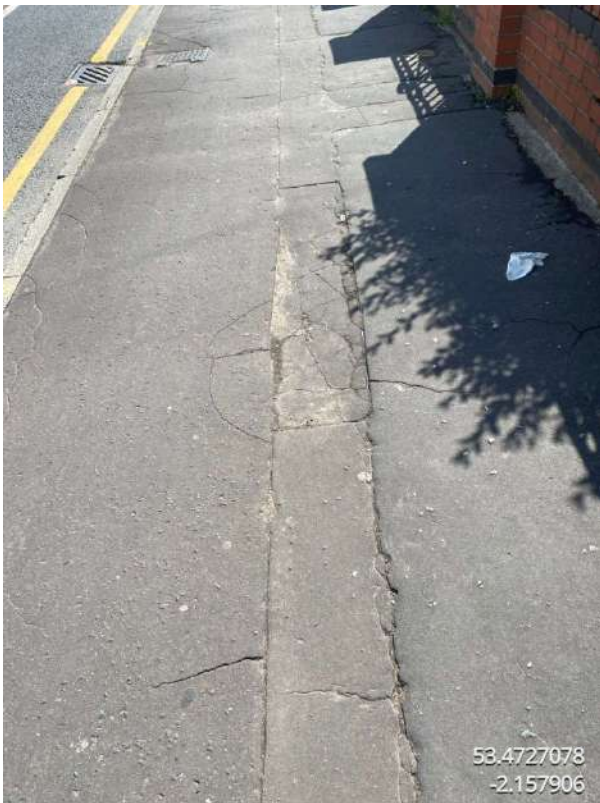
### **PICTURE 8**

Sunken bullnose kerb showing low spots potentially causing damage to foundation.

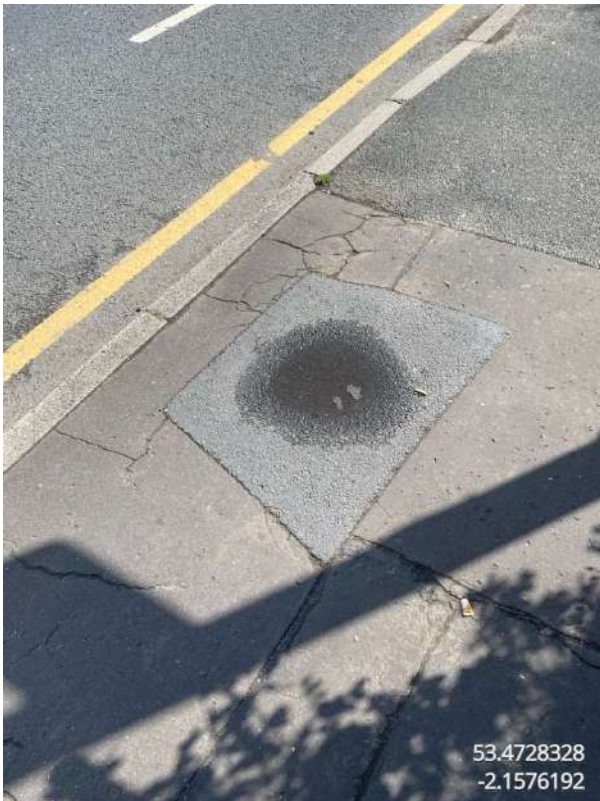
**PICTURE 9**

Failure of previous works resulting in fractures and cracking as shown. Further fractures and cracking occur throughout extents of survey. Further deterioration likely to result in potential trip hazards.

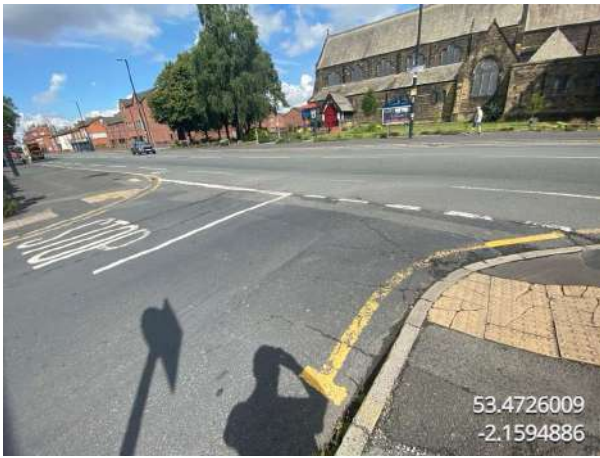
### PICTURE 15

Record of condition of existing site for the attention of all relevant parties.

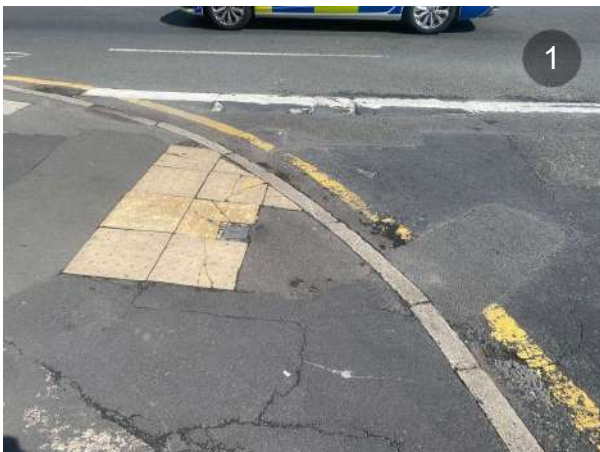
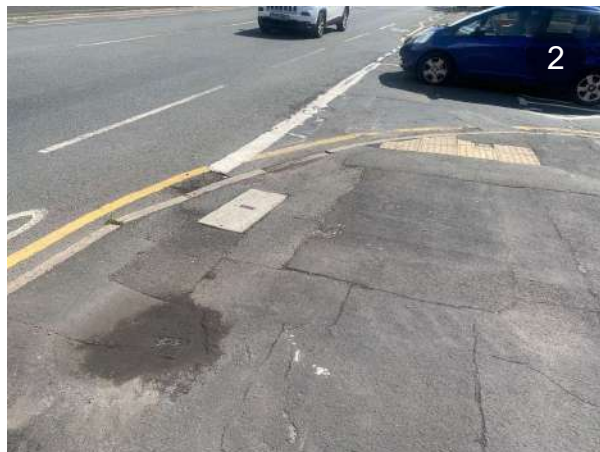
### PICTURE 18

Tactile flagging on west side of Capital Road damaged and incomplete. Does not adhere to standards and should be repaired/replaced. Footway around tactiles showing signs of numerous previous repairs and cracking.

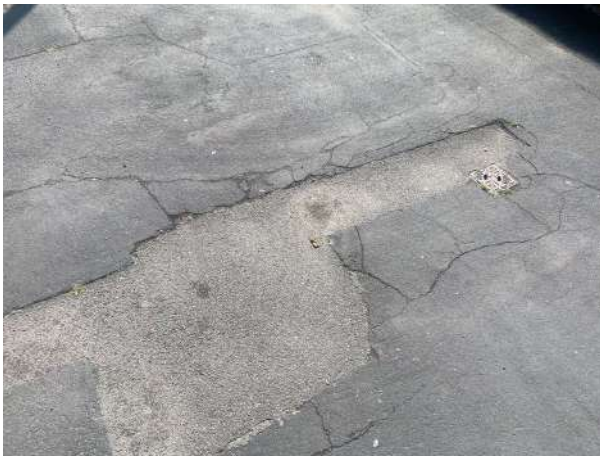
**PICTURE 19**

Footway between Capital Road & Abbey Hey Lane shows signs of previous works that have been poorly carried out, resulting in subsidence and cracking of adjacent paved area.

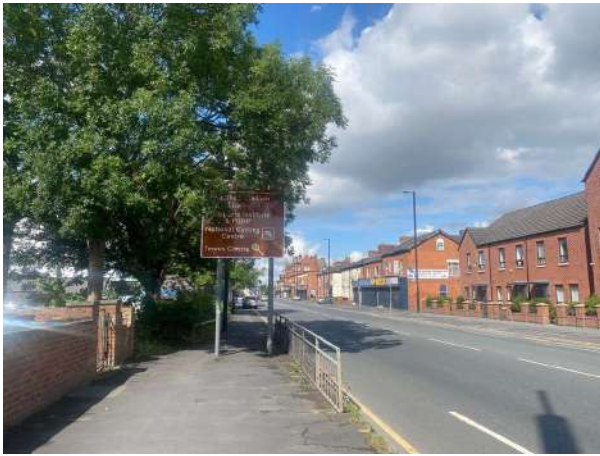
**PICTURE 20**

Vegetation overgrowth obstructing vision of ADS. Recommend clearance.

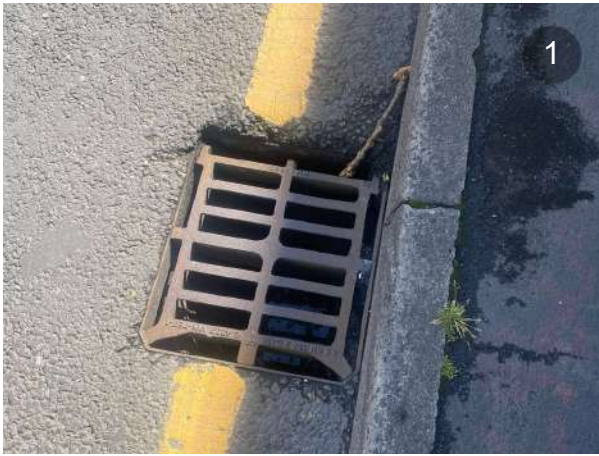
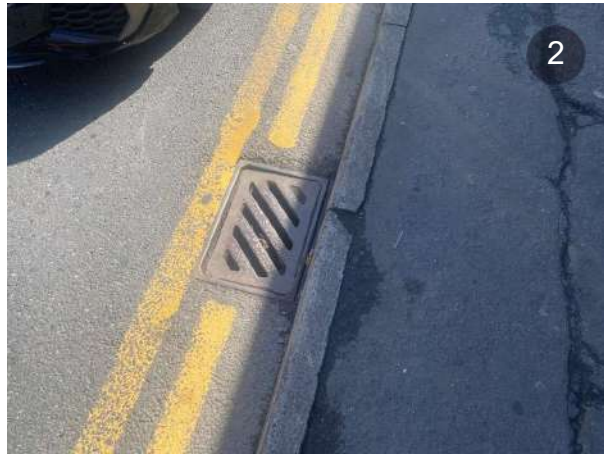
## PICTURE 22

Most gulleys along the surveyed path appeared to be in reasonable condition, some appear to be in need of cleansing/jetting to clear any blockages. Would recommend CCTV survey to be carried out along survey extents.

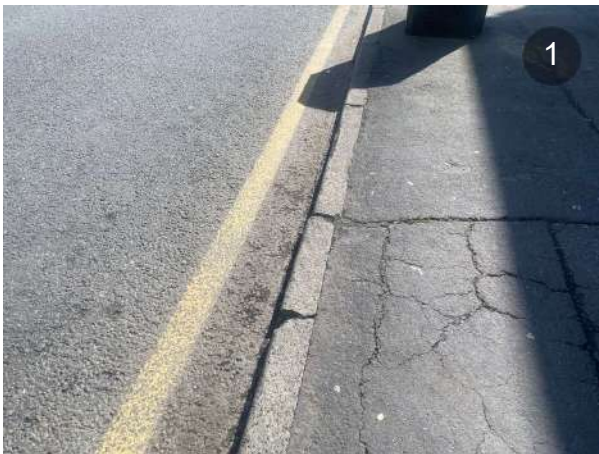
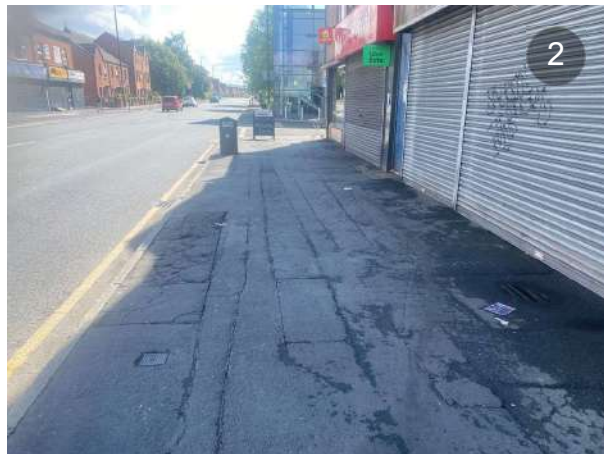
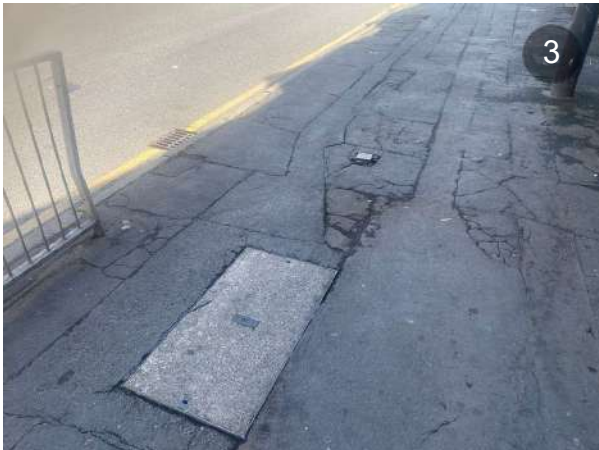
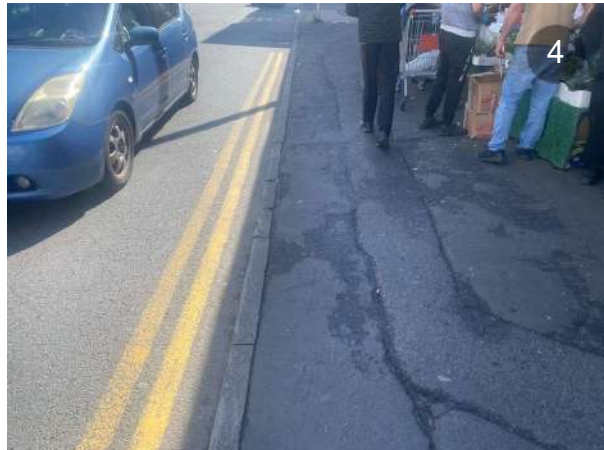
## PICTURE 23

Footpath between Abbey Hey Lane and Vine Street is in poor condition, with multiple intrusions and repairs throughout. High level of surface cracking also present. This footpath is likely to deteriorate further and inspection is recommended, with possible further intervention to binder course materials being suspected.

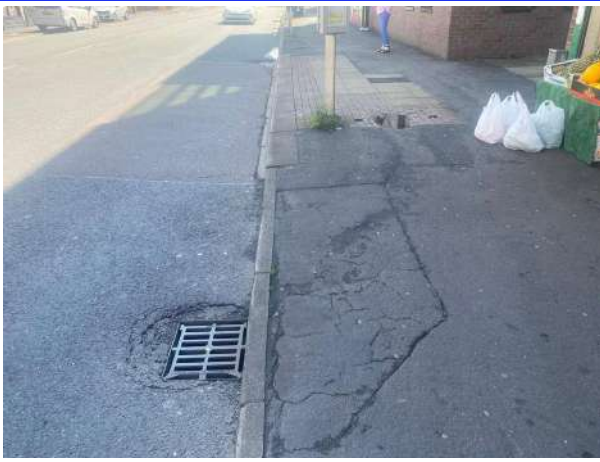
#### **PICTURE 24**

Sunken gulley located near bus stop adjacent to Barber Street. This appears to also extend to subsidence behind the kerblines. Possible washout of material. Recommend further investigation, with resetting ironworks and localised resurfacing as a minimum. Bus stop showing signs of ponding and requires remediation works.

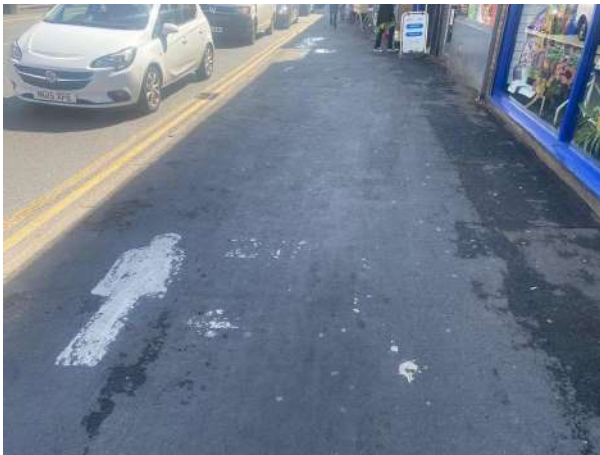
#### **PICTURE 25**

Redundant Footway marking shown here, recommend clearance

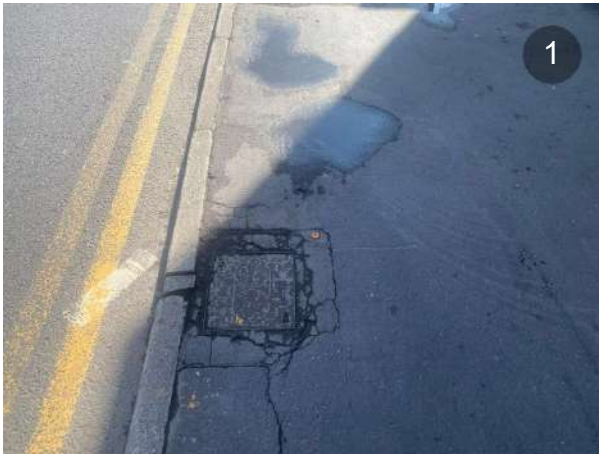
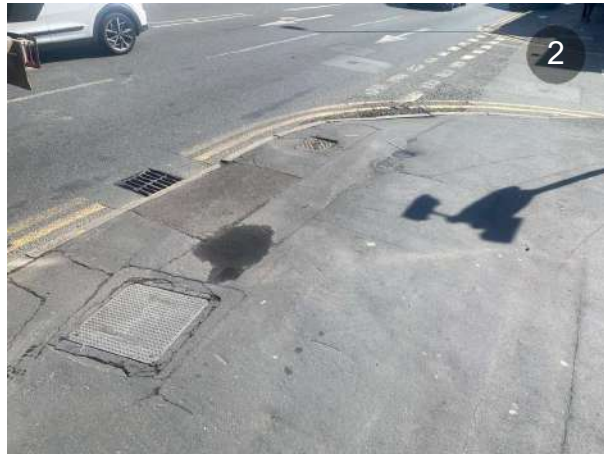
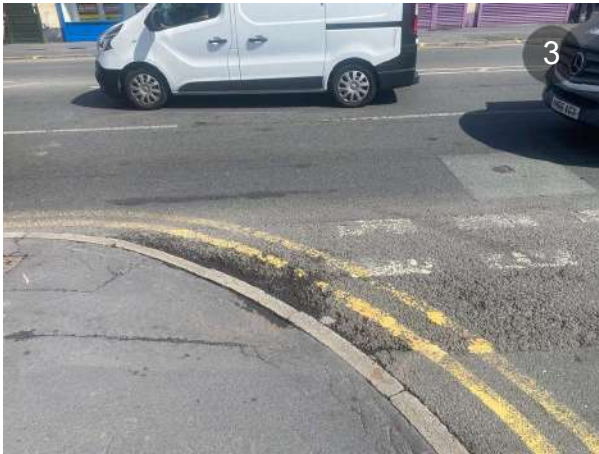
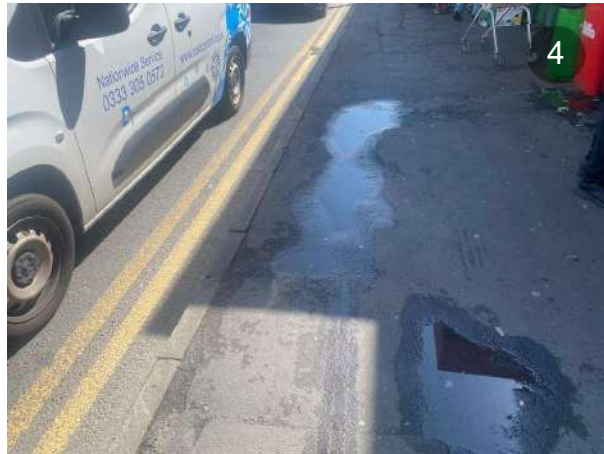
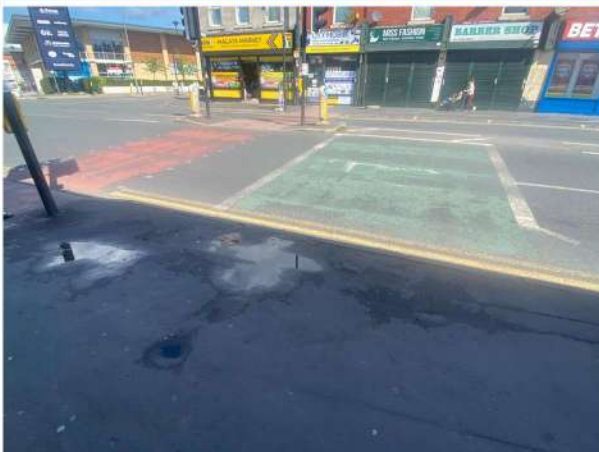
Multiple low spots and sunken ironworks shown between Vine Street and Barber Street, with damage to existing kerblines. Suspect kerb overrunning.

Recommend resetting kerbs and all ironworks, with repairs to surfacing as necessary.
