# CCTV Report

91 Buckingham Road  
Manchester, M210QT

20/12/2024

72389CCTV-01

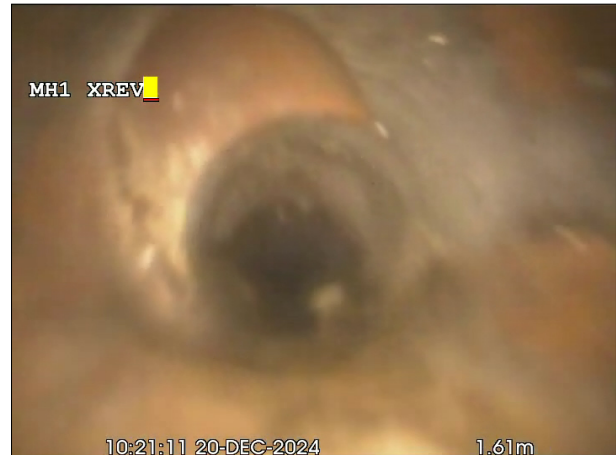
| 1:75 | position | code | observation | counter | photo | grade |
|---|---|---|---|---|---|---|
| | | JN | Junction at 11 o'clock, dia 100 mm | 00:00:00 | 2_4a | (Constr) 0 |

Photo: 2\_4a, 00:00:00  
1.6m, Junction at 11 o'clock, dia 100 mm

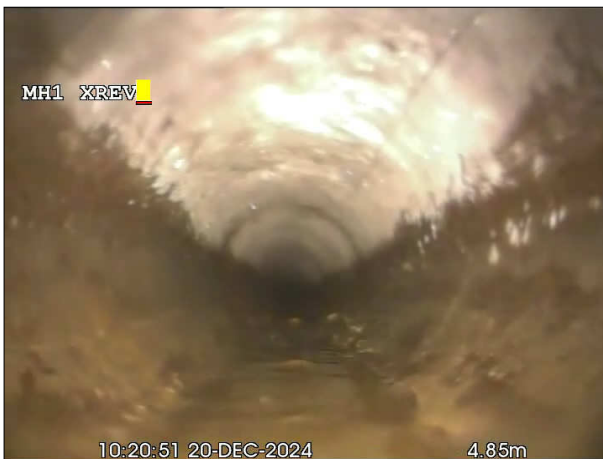
| 1:75 | position | code | observation | counter | photo | grade |
|---|---|---|---|---|---|---|
| | | GP | General Condition photograph | 00:00:00 | 2_5a | (Misc) 0 |

Photo: 2\_5a, 00:00:00  
5m, General Condition photograph

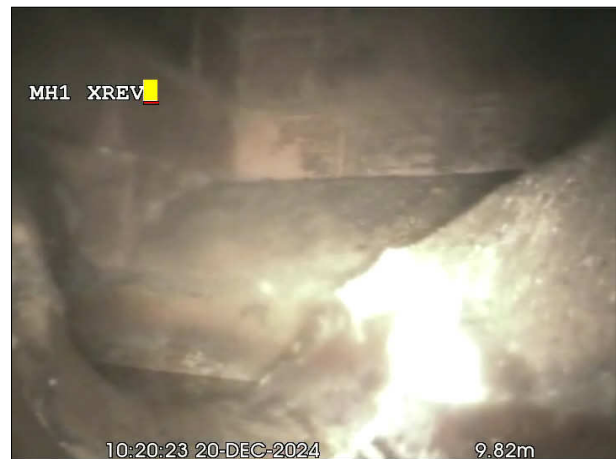
| 1:75 | position | code | observation | counter | photo | grade |
|---|---|---|---|---|---|---|
| | | FH | Finish Survey, Remark: Survey Finished, Man Hole reached | 00:00:00 | 13_6a | (Misc) 0 |

Photo: 13\_6a, 00:00:00  
9.8m, Finish Survey, Remark: Survey Finished, Man Hole reached

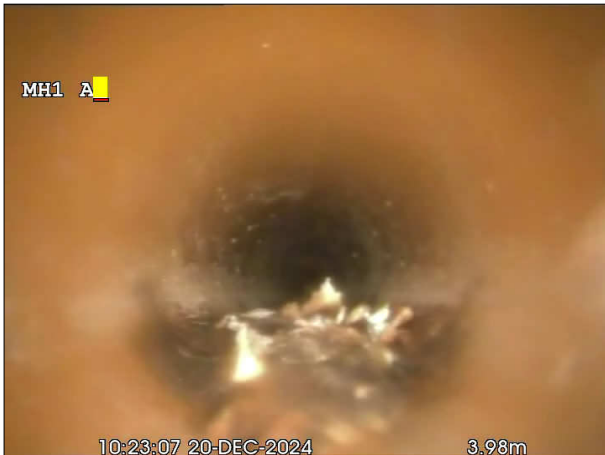
| 1:75 | position | code | observation | counter | photo | grade |
|---|---|---|---|---|---|---|
| | 4.00 | S1 DES | Debris silt, 15 % cross-sectional area loss, Start | 00:00:00 | 17_4a | (Serv) 1 |

Photo: 17\_4a, 00:00:00  
4m, Debris silt, 15 % cross-sectional area loss, Start

MH1A

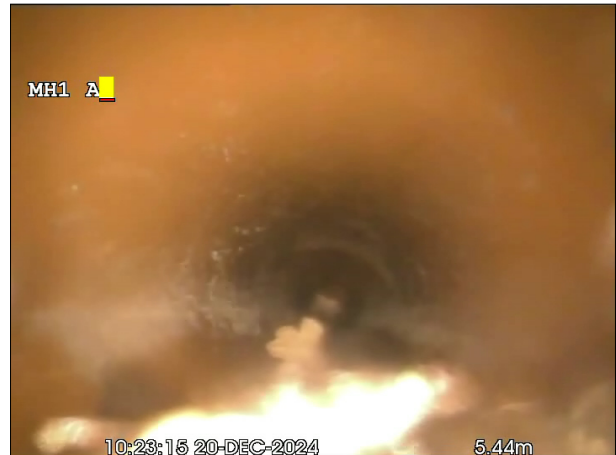
| 1:75 | position | code | observation | counter | photo | grade |
|---|---|---|---|---|---|---|
| | 5.00 | GP | General Condition photograph | 00:00:00 | 18_5a | (Misc) 0 |

Photo: 18\_5a, 00:00:00  
5m, General Condition photograph

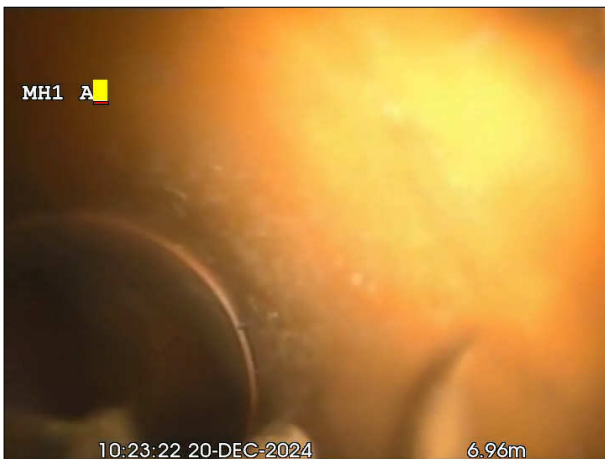
| 1:75 | position | code | observation | counter | photo | grade |
|---|---|---|---|---|---|---|
| | 7.00 | LL | Line of Sewer deviates left | 00:00:00 | 19_6a | (Serv) 0 |

Photo: 19\_6a, 00:00:00  
7m, Line of Sewer deviates left

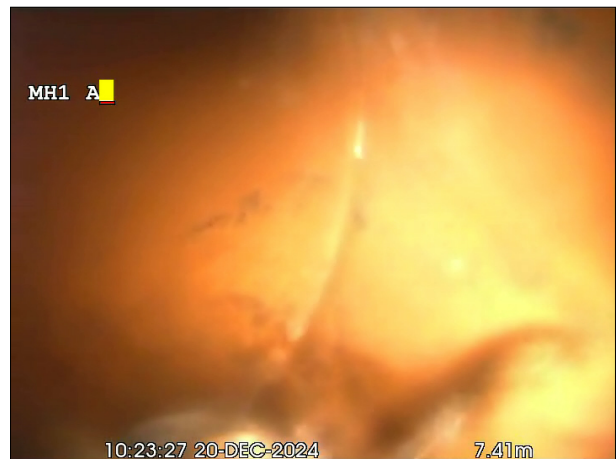
| 1:75 | position | code | observation | counter | photo | grade |
|---|---|---|---|---|---|---|
| | 7.40 | LU | Line of Sewer deviates up | 00:00:00 | 20_7a | (Serv) 0 |

Photo: 20\_7a, 00:00:00  
7.4m, Line of Sewer deviates up

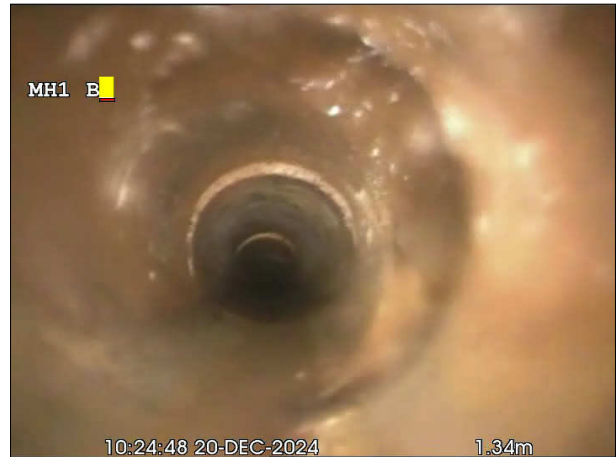
| 1:75 | position | code | observation | counter | photo | grade |
|---|---|---|---|---|---|---|
| | 1.35 | JN | Junction at 03 o'clock, dia 100 mm | 00:00:00 | 4_5a | (Constr) 0 |

Photo: 4\_5a, 00:00:00  
1.35m, Junction at 03 o'clock, dia 100 mm

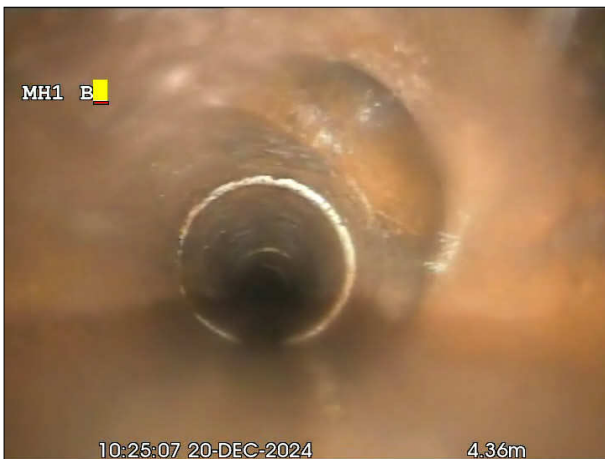
| 1:75 | position | code | observation | counter | photo | grade |
|---|---|---|---|---|---|---|
| | 4.35 | JN | Junction at 03 o'clock, dia 100 mm | 00:00:00 | 4_6a | (Constr) 0 |

Photo: 4\_6a, 00:00:00  
4.35m, Junction at 03 o'clock, dia 100 mm

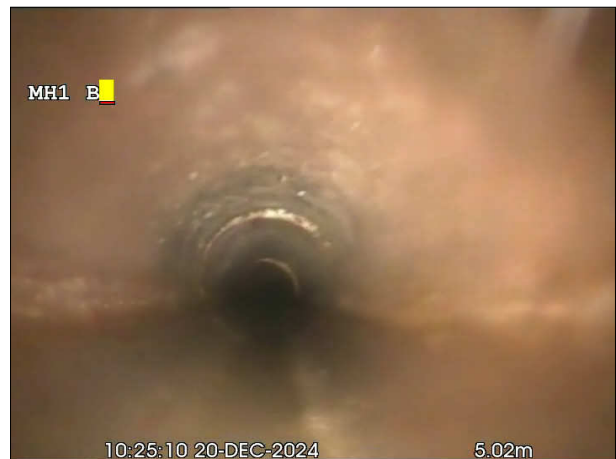
| 1:75 | position | code | observation | counter | photo | grade |
|---|---|---|---|---|---|---|
| | 5.00 | GP | General Condition photograph | 00:00:00 | 4_7a | (Misc) 0 |

Photo: 4\_7a, 00:00:00  
5m, General Condition photograph

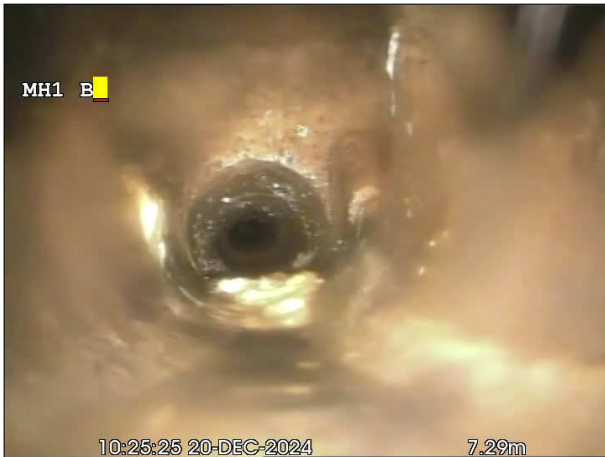
| 1:75 | position | code | observation | counter | photo | grade |
|---|---|---|---|---|---|---|
| | 7.30 | FH | Finish Survey, Remark: Man Hole Reached | 00:00:00 | 4_8a | (Misc) 0 |

Photo: 4\_8a, 00:00:00  
7.3m, Finish Survey, Remark: Man Hole Reached

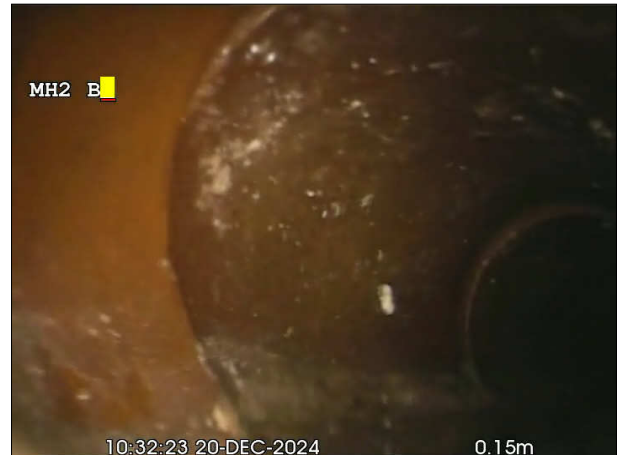
| 1:93 | position | code | observation | counter | photo | grade |
|---|---|---|---|---|---|---|
| | 0.15 | F1 | CU Camera Underwater, Finish, Remark: Loss of Vision | 00:00:00 | 5_5a | (Misc) 0 |

Photo: 5\_5a, 00:00:00  
0.15m, Camera Underwater, Finish, Remark: Loss of Vision

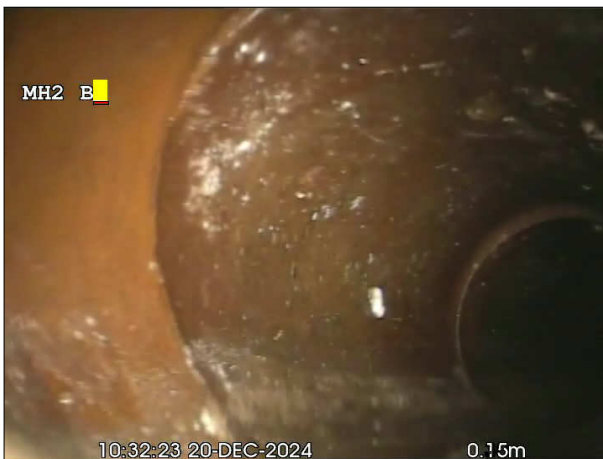
| 1:93 | position | code | observation | counter | photo | grade |
|---|---|---|---|---|---|---|
| | 0.15 | LR | Line of Sewer deviates right | 00:00:00 | 5_6a | (Serv) 0 |

Photo: 5\_6a, 00:00:00  
0.15m, Line of Sewer deviates right

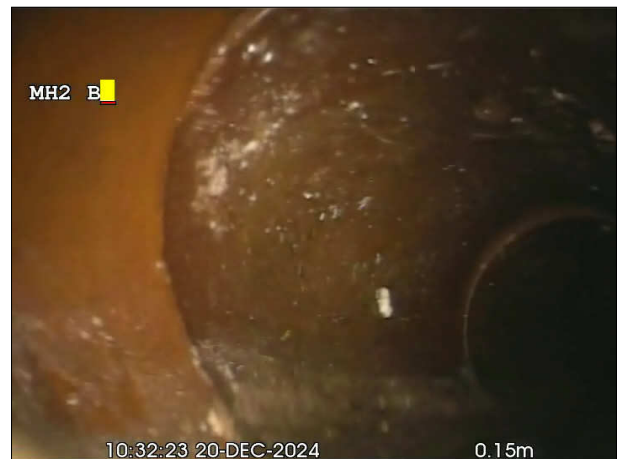
| 1:93 | position | code | observation | counter | photo | grade |
|---|---|---|---|---|---|---|
| | 0.20 | GP | General Condition photograph | 00:00:00 | 5_7a | (Misc) 0 |

Photo: 5\_7a, 00:00:00  
0.2m, General Condition photograph

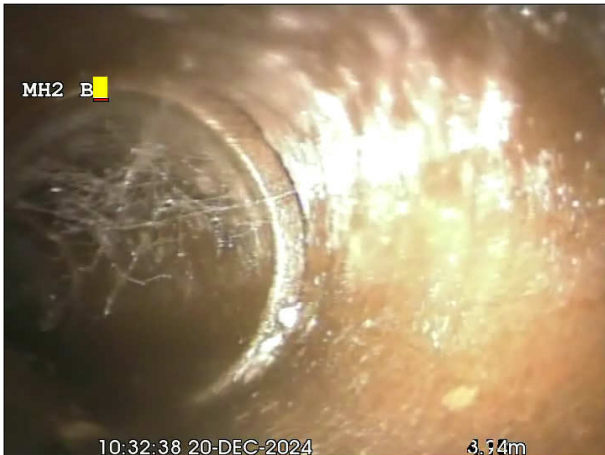
| 1:93 | position | code | observation | counter | photo | grade |
|---|---|---|---|---|---|---|
| | 4.40 | LL | Line of Sewer deviates left | 00:00:00 | 5_9a | (Serv) 0 |

Photo: 5\_9a, 00:00:00  
4.4m, Line of Sewer deviates left

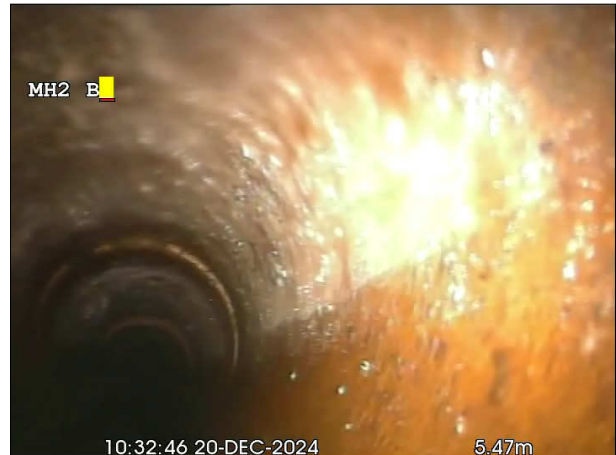
| 1:93 | position | code | observation | counter | photo | grade |
|---|---|---|---|---|---|---|
| | 5.00 | GP | General Condition photograph | 00:00:00 | 5_10a | (Misc) 0 |

Photo: 5\_10a, 00:00:00  
5m, General Condition photograph

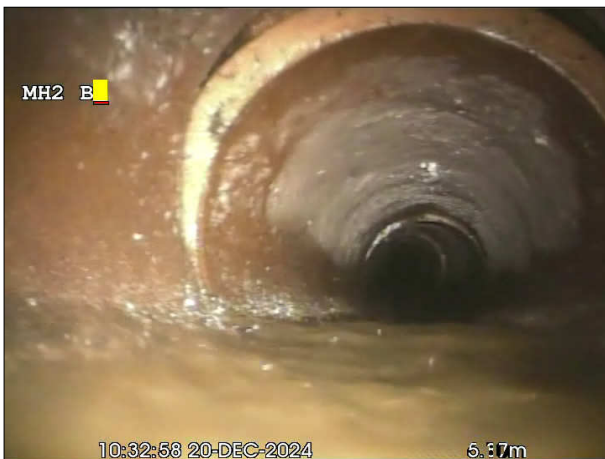
| 1:93 | position | code | observation | counter | photo | grade |
|---|---|---|---|---|---|---|
| | 5.90 | JDM | Joint displaced. Medium | 00:00:00 | 5_11a | (Struct) 1 |

Photo: 5\_11a, 00:00:00  
5.9m, Joint displaced. Medium

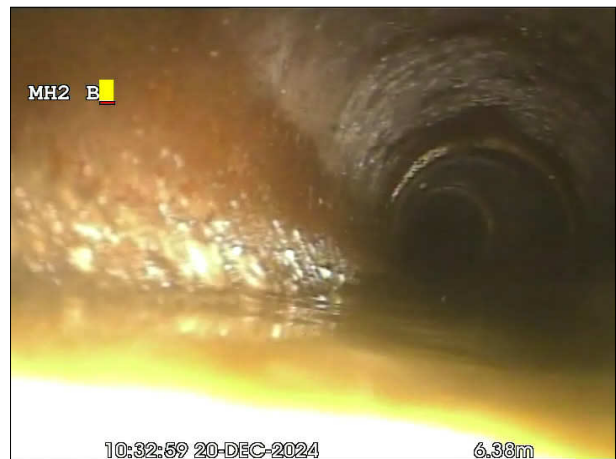
| 1:93 | position | code | observation | counter | photo | grade |
|---|---|---|---|---|---|---|
| | 6.30 | JDM | Joint displaced. Medium | 00:00:00 | 54_12a | (Struct) 1 |

Photo: 54\_12a, 00:00:00  
6.3m, Joint displaced. Medium

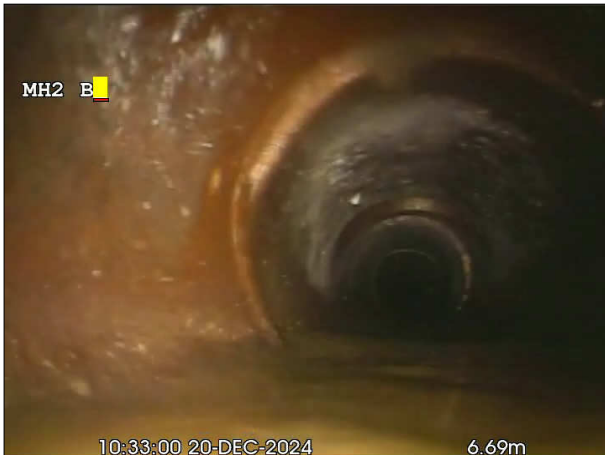
| 1:93 | position | code | observation | counter | photo | grade |
|---|---|---|---|---|---|---|
| | 6.70 | WL | Water level, 10 % height/diameter | 00:00:00 | 5_13a | (Serv) 0 |

Photo: 5\_13a, 00:00:00  
6.7m, Water level, 10 % height/diameter

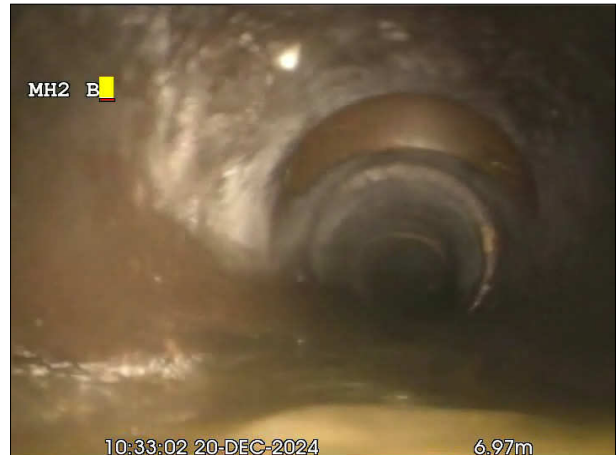
| 1:93 | position | code | observation | counter | photo | grade |
|---|---|---|---|---|---|---|
| | 7.10 | JN | Junction at 12 o'clock, dia 150 mm | 00:00:00 | 5_14a | (Constr) 0 |

Photo: 5\_14a, 00:00:00  
7.1m, Junction at 12 o'clock, dia 150 mm

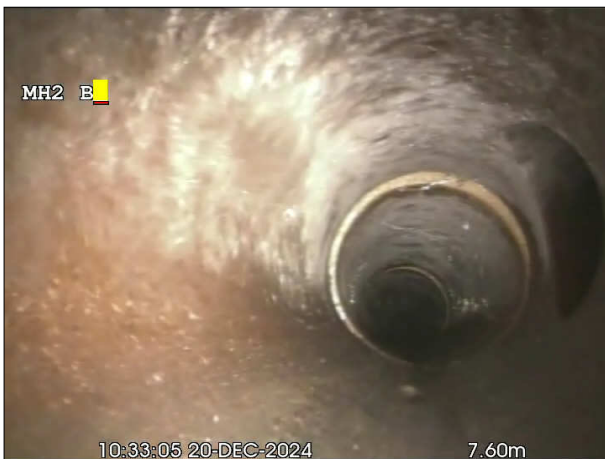
| 1:93 | position | code | observation | counter | photo | grade |
|---|---|---|---|---|---|---|
| | 7.70 | JN | Junction at 03 o'clock, dia 100 mm | 00:00:00 | 5_15a | (Constr) 0 |

Photo: 5\_15a, 00:00:00  
7.7m, Junction at 03 o'clock, dia 100 mm

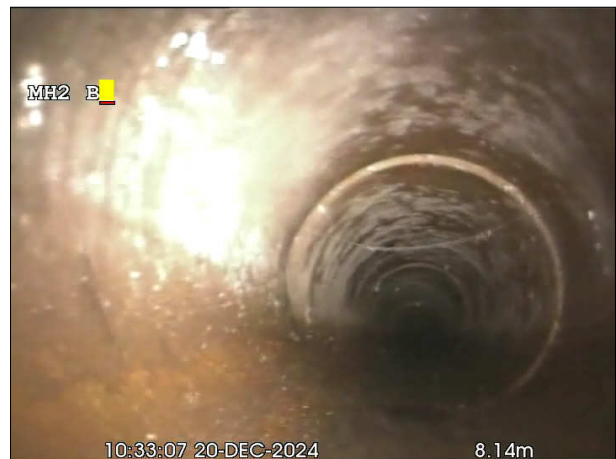
| 1:93 | position | code | observation | counter | photo | grade |
|---|---|---|---|---|---|---|
| | 8.10 | JDM | Joint displaced. Medium | 00:00:00 | 55_16a | (Struct) 1 |

Photo: 55\_16a, 00:00:00  
8.1m, Joint displaced. Medium

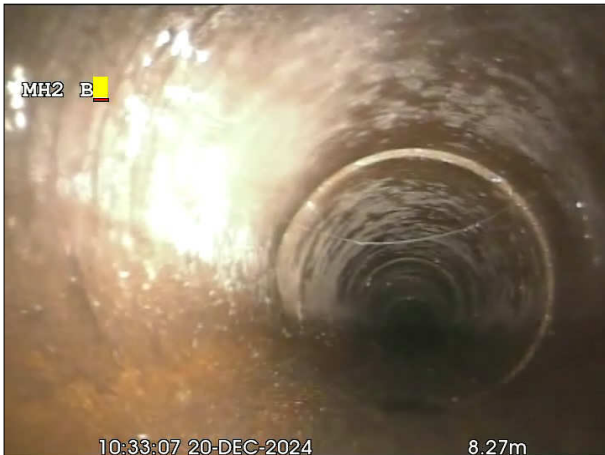
| 1:93 | position | code | observation | counter | photo | grade |
|---|---|---|---|---|---|---|
| | 8.30 | WL | Water level, 5 % height/diameter | 00:00:00 | 5_17a | (Serv) 0 |

Photo: 5\_17a, 00:00:00  
8.3m, Water level, 5 % height/diameter

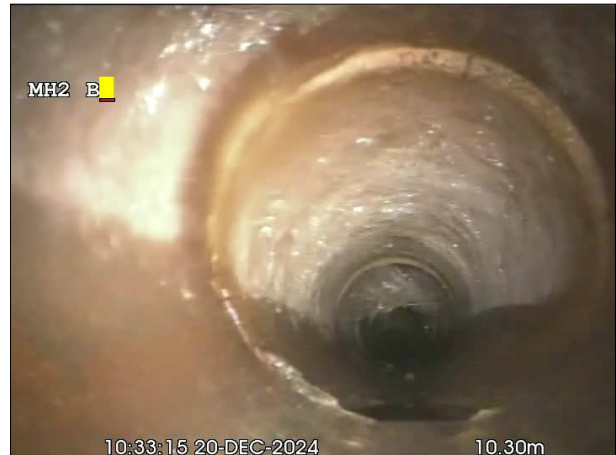
| 1:93 | position | code | observation | counter | photo | grade |
|---|---|---|---|---|---|---|
| | 10.00 | GP | General Condition photograph | 00:00:00 | 5_18a | (Misc) 0 |

Photo: 5\_18a, 00:00:00  
10m, General Condition photograph

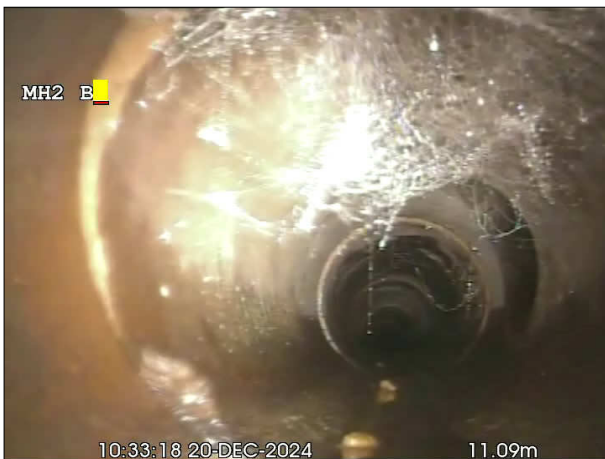
| 1:93 | position | code | observation | counter | photo | grade |
|---|---|---|---|---|---|---|
| | 11.20 | JN | Junction at 03 o'clock, dia 150 mm | 00:00:00 | 5_19a | (Constr) 0 |

Photo: 5\_19a, 00:00:00  
11.2m, Junction at 03 o'clock, dia 150 mm

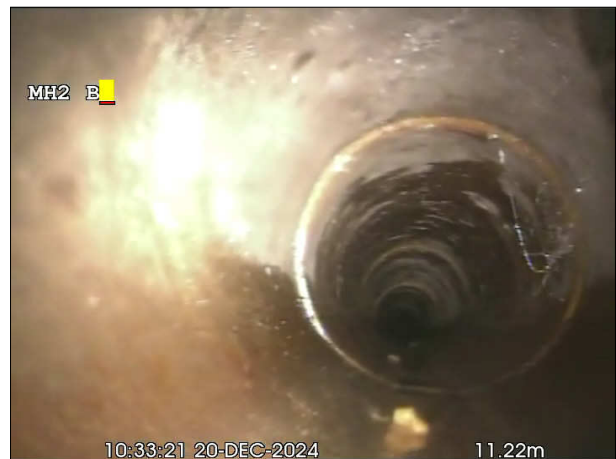
| 1:93 | position | code | observation | counter | photo | grade |
|---|---|---|---|---|---|---|
| | 11.20 | JDM | Joint displaced. Medium | 00:00:00 | 57_20a | (Struct) 1 |

Photo: 57\_20a, 00:00:00  
11.2m, Joint displaced. Medium

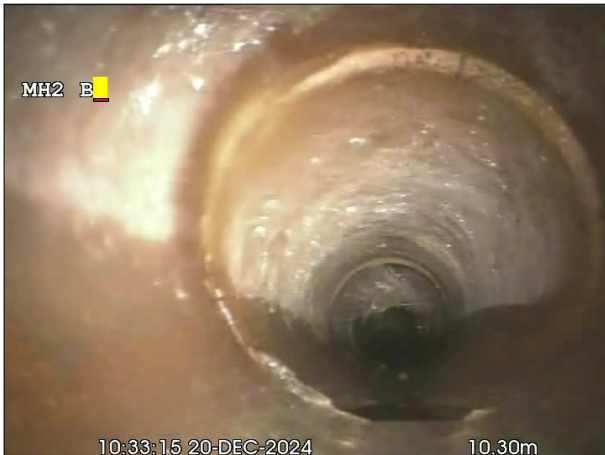
| 1:93 | position | code | observation | counter | photo | grade |
|---|---|---|---|---|---|---|
| | 11.30 | JDM | Joint displaced. Medium, | 00:00:00 | 5_21a | (Struct) 1 |

Photo: 5\_21a, 00:00:00  
11.3m, Joint displaced. Medium,

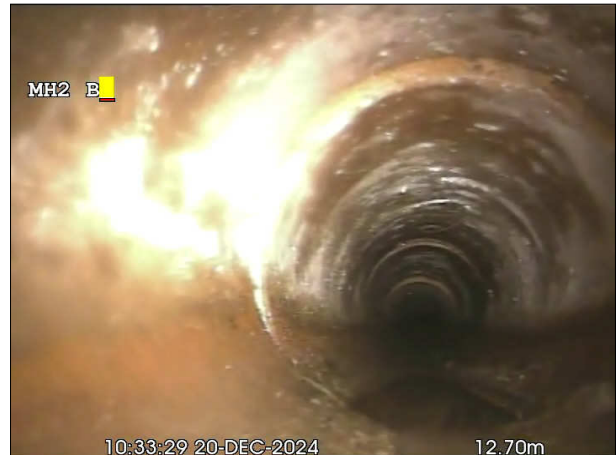
| 1:93 | position | code | observation | counter | photo | grade |
|---|---|---|---|---|---|---|
| | 13.00 | JDM | Joint displaced. Medium | 00:00:00 | 58_22a | (Struct) 1 |

Photo: 58\_22a, 00:00:00  
13m, Joint displaced. Medium

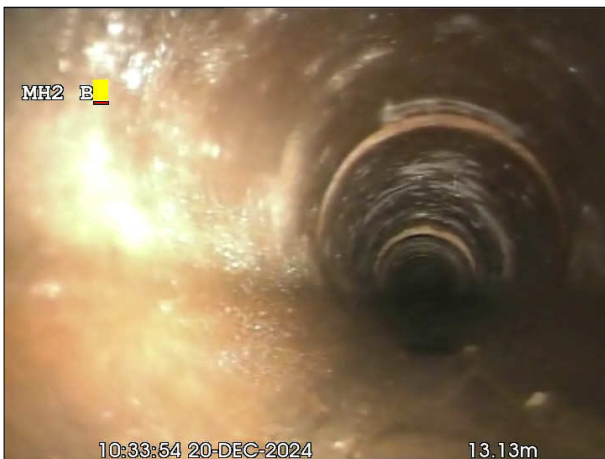
| 1:93 | position | code | observation | counter | photo | grade |
|---|---|---|---|---|---|---|
| | 13.10 | JDM | Joint displaced. Medium | 00:00:00 | 59_23a | (Struct) 1 |

Photo: 59\_23a, 00:00:00  
13.1m, Joint displaced. Medium

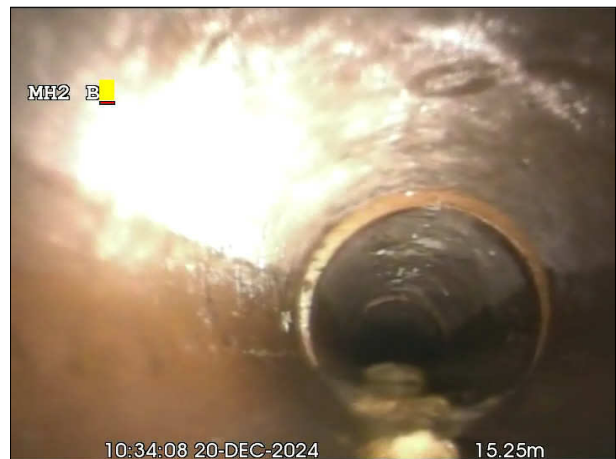
| 1:93 | position | code | observation | counter | photo | grade |
|---|---|---|---|---|---|---|
| | 15.00 | GP | General Condition photograph | 00:00:00 | 5_24a | (Misc) 0 |

Photo: 5\_24a, 00:00:00  
15m, General Condition photograph

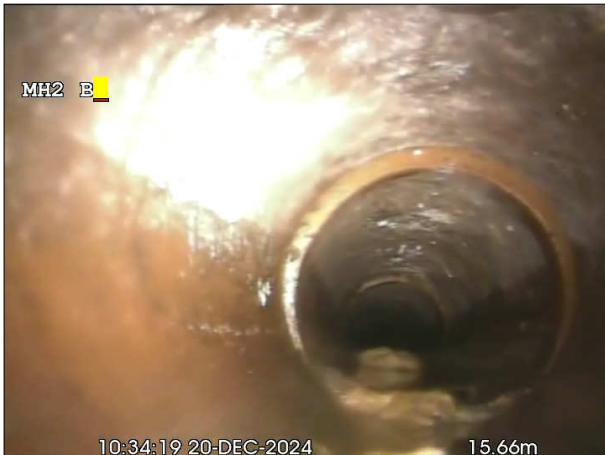
| 1:93 | position | code | observation | counter | photo | grade |
|---|---|---|---|---|---|---|
| | 15.70 | JDM | Joint displaced. Medium, | 00:00:00 | 60_25a | (Struct) 1 |

Photo: 60\_25a, 00:00:00  
15.7m, Joint displaced. Medium,

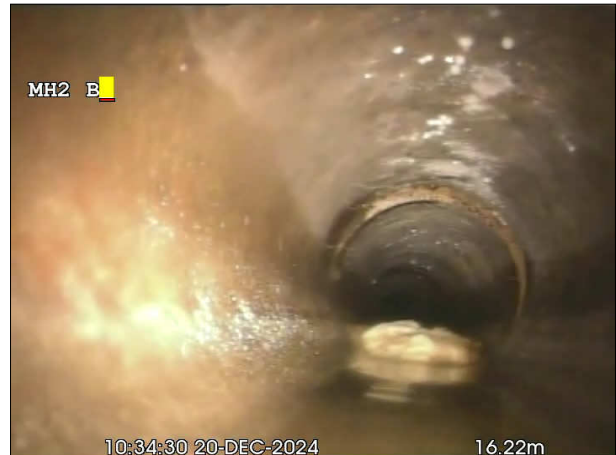
| 1:93 | position | code | observation | counter | photo | grade |
|---|---|---|---|---|---|---|
| | 16.20 | JDM | Joint displaced. Medium | 00:00:00 | 61_26a | (Struct) 1 |

Photo: 61\_26a, 00:00:00  
16.2m, Joint displaced. Medium

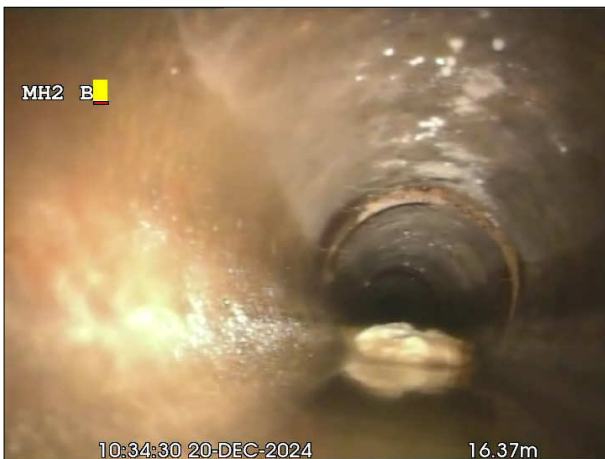
| 1:93 | position | code | observation | counter | photo | grade |
|---|---|---|---|---|---|---|
| | 16.50 | S2 DE | Debris, 15 % cross-sectional area loss, Start | 00:00:00 | 5_27a | (Serv) 1 |

Photo: 5\_27a, 00:00:00  
16.5m, Debris, 15 % cross-sectional area loss, Start

MH2B

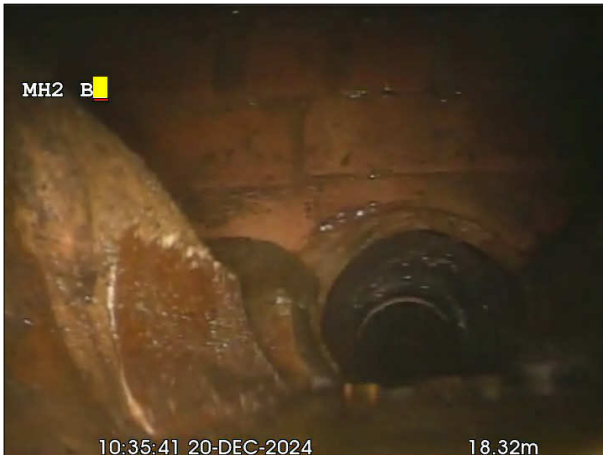
| 1:93 | position | code | observation | counter | photo | grade |
|---|---|---|---|---|---|---|
| | 18.30 | F2 DE | Debris, 15 % cross-sectional area loss, Finish | 00:00:00 | 5_30a | (Serv) 1 |

Photo: 5\_30a, 00:00:00  
18.3m, Debris, 15 % cross-sectional area loss, Finish

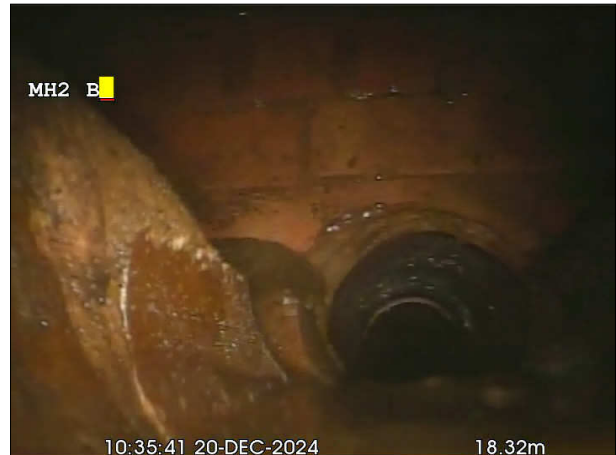
| 1:93 | position | code | observation | counter | photo | grade |
|---|---|---|---|---|---|---|
| | 18.30 | F3 CU | Camera Underwater, Finish, Remark: Loss of Vision | 00:00:00 | 64_31a | (Misc) 0 |

Photo: 64\_31a, 00:00:00  
18.3m, Camera Underwater, Finish, Remark: Loss of Vision

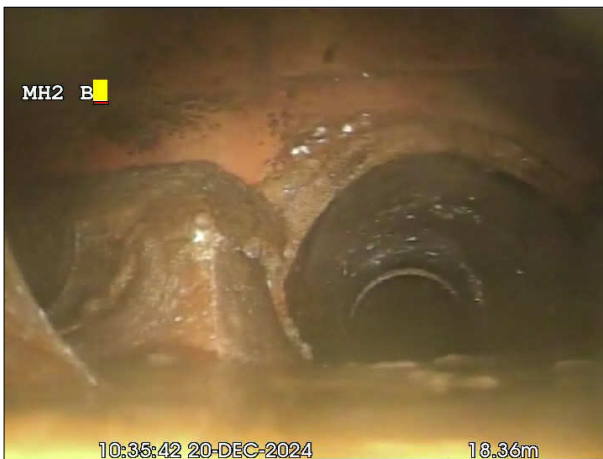
| 1:93 | position | code | observation | counter | photo | grade |
|---|---|---|---|---|---|---|
| | 18.35 | FH | Finish Survey, Remark: Man Hole Reached | 00:00:00 | 5_32a | (Misc) 0 |

Photo: 5\_32a, 00:00:00  
18.35m, Finish Survey, Remark: Man Hole Reached
