JAE/11827  
4 December 2023

RE: Grosvenor Building, Cavendish Street, Manchester

Thomasons received instruction from Simon Glass of Turner & Townsend on behalf of Manchester Metropolitan University to inspect and comment on cracking defects noted to the north elevation of the Grosvenor Building on Cavendish Street, Manchester.

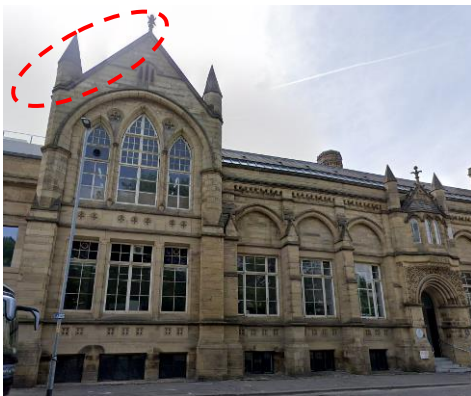
East gable of north elevation

At the eastern side of the east gable similar cracking was noted between the pinnacle and the apex of the gable. This was not as pronounced as that noted at the western side. On this gable it was also noted that there was some gapping between the coping stones of the gable.

The outward movement of the pinnacle is likely to be the result of a combination of spreading of the arch and downward sliding of the coping stones on the steep gable. We understand that when explored it was found that the fixing holes in the top of the coping stones contained no indication of there ever having been any fixings down into the apex of the gable. It will therefore be prudent to stitch down the coping stones using 10mm Helifix CemTie anchors in order to prevent further sliding; this should be undertaken to both gables.

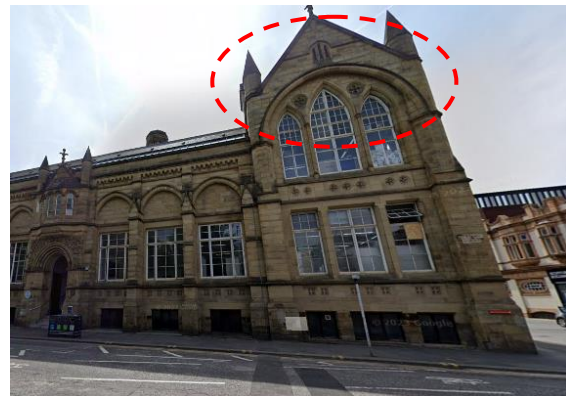
West gable of north elevation

During our inspection we noted that there was a gap between the back of the arch in the west gable which had previously been filled and had substantially lost its fill. The variation in width of the gap, together with loss of mortar fill, indicated that this gap was not an original feature and that it has continued to move.

At the western end of the gable there was a stone pinnacle. Cracking had occurred between the side of the pinnacle and the apex of the gable; this had been repointed by the time of our inspection but photographs provided for our consideration showed that this cracking had previously been slate packed and repointed. It was evident from the earlier photographs that this cracking was continuing to open.

The cause of the outward movement of the arch of the west gable is most probably due to insufficient tying between the outer stone leaf and the inner leaf of the wall. It is anticipated that this movement will continue, albeit slowly, unless measures are taken to arrest this movement. We concur with Curtins that Helifix anchors will be suitable products to use in this situation. If the gap was not present we would recommend the use of CemTies but we are concerned that there could be a significant loss of grout in this gap; we therefore consider that the appropriate product for this location will be the Helifix SockFix installed at an angle and extending 450mm up into the wall behind the arch.

As the outward movement of the pinnacle appears to be of an ongoing nature it is considered that it should be stitched back to the apex of the gable. We consider that the appropriate anchors for this will be 16mm Helifix SockFix anchors in 40mm holes. Two anchors should be installed from the western (Higher Ormond Street) elevation; the anchors should be angled upwards across the crack and extend at an angle slightly lower than the line of the coping.
