Date: 1<sup>st</sup> July 2025  
Reference: 15-974 V22

## GARDEN VALIDATION – BENNETT STREET

| <b>Project Number:</b> | 15-974 |
| <b>Plots:</b> | 160-172 |

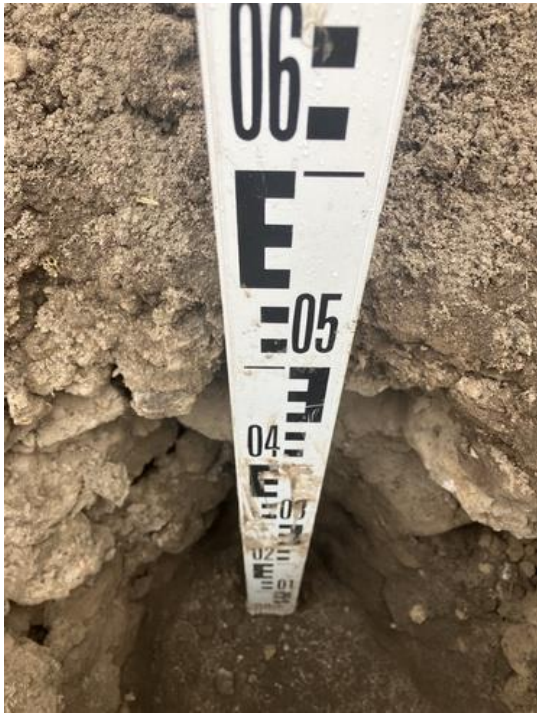
Photo 1

| <b>Depth of Cover System Materials (record the depth and support with Photos down the hole )</b> | 600 |
| <b>Depth of Topsoil (mm)</b> | 150 |
| <b>Depth of Subsoil (mm)</b> | 450 |

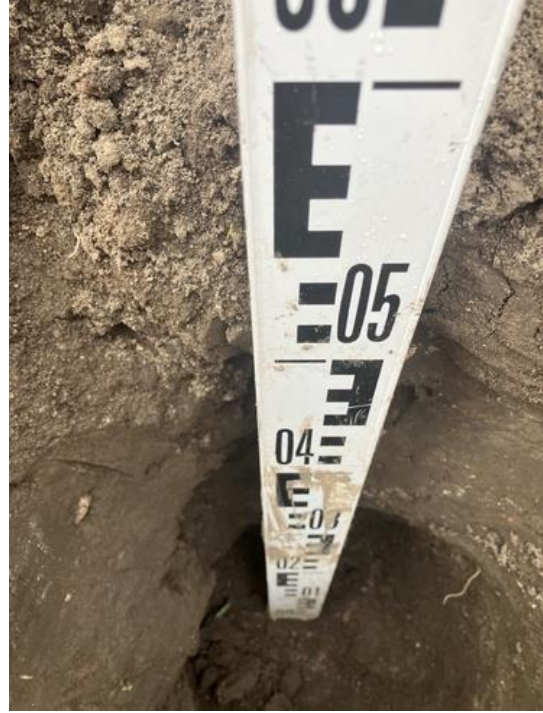
Photo 6

600

150

450

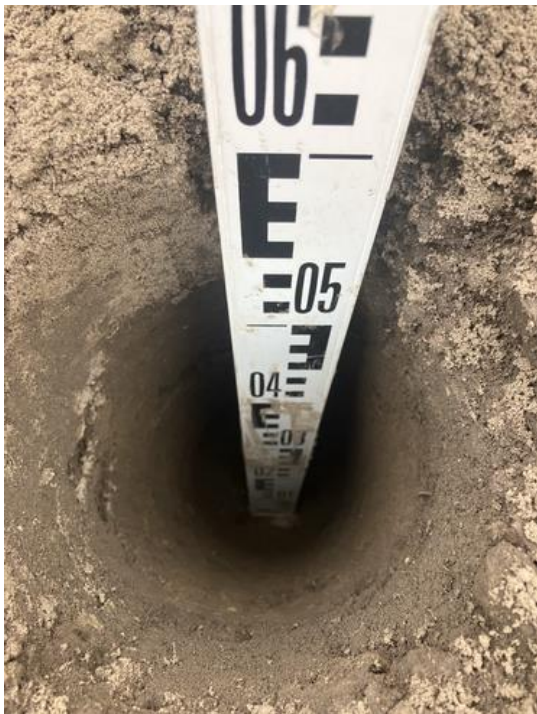
Photo 19

| Depth of Cover System Materials (record the depth and support with Photos down the hole ) | 600 |
| Depth of Topsoil (mm) | 150 |
| Depth of Subsoil (mm) | 450 |

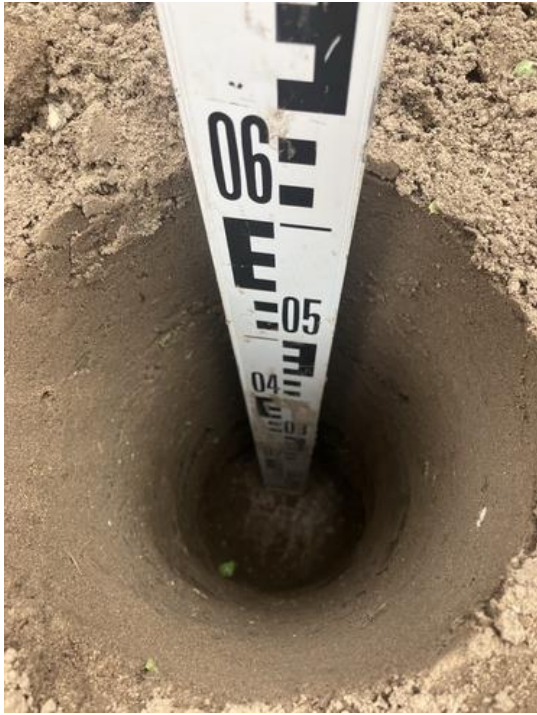
Photo 25

600

150

450

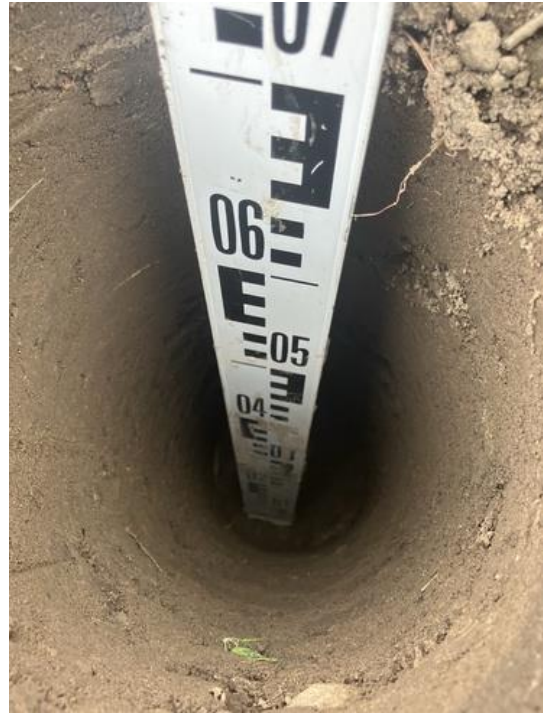
Photo 30

700

200

500

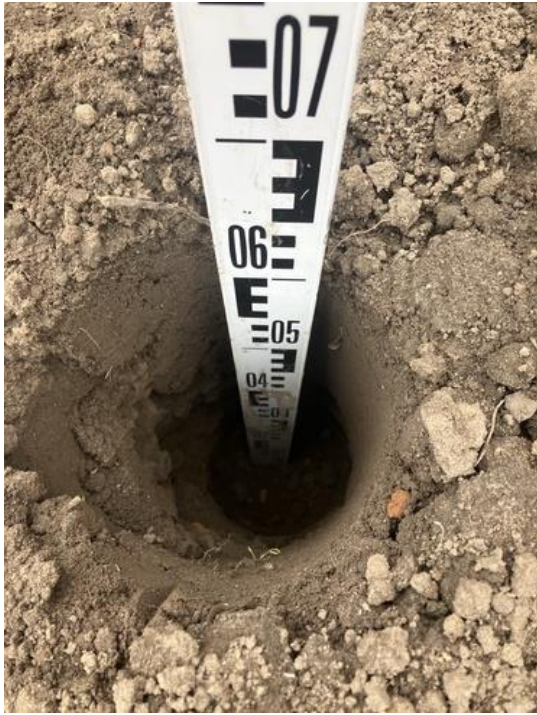
Photo 37

600

| <b>Depth of Topsoil (mm)</b> | 150 |

| <b>Depth of Subsoil (mm)</b> | 450 |

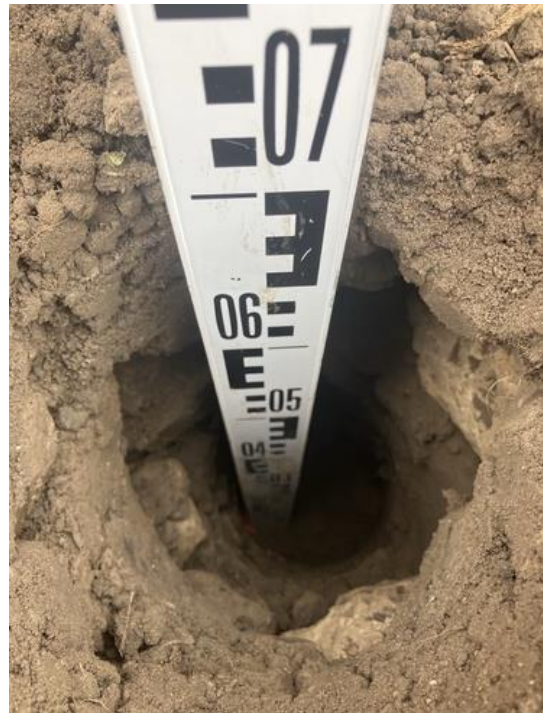
Photo 44

700

200

500

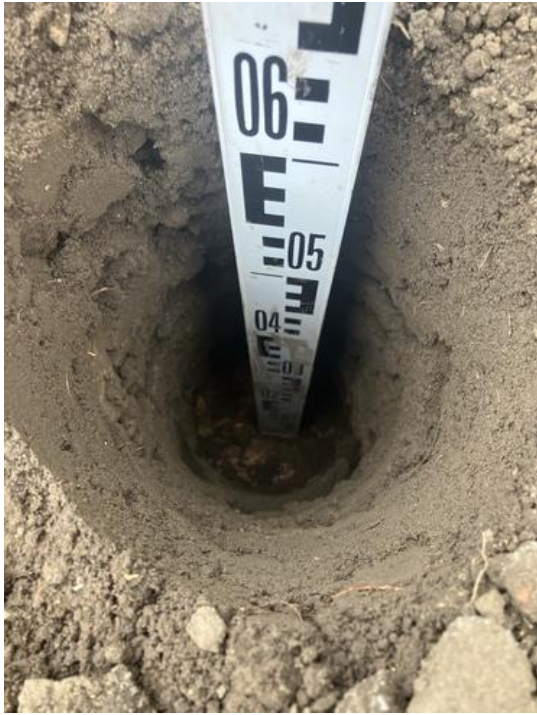
Photo 49

| Depth of Cover System Materials (record the depth and support with Photos down the hole ) | 600 |
| Depth of Topsoil (mm) | 150 |
| Depth of Subsoil (mm) | 450 |

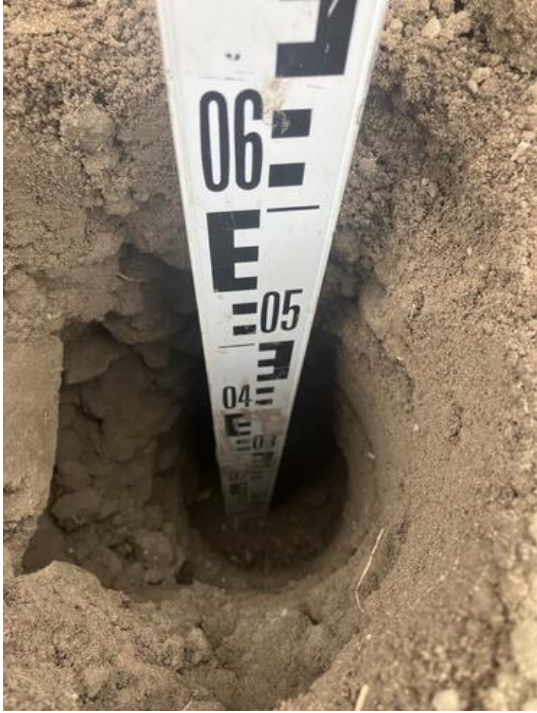
Photo 54

| Depth of Cover System Materials (record the depth and support with Photos down the hole ) | 600 |
| Depth of Topsoil (mm) | 150 |
| Depth of Subsoil (mm) | 450 |

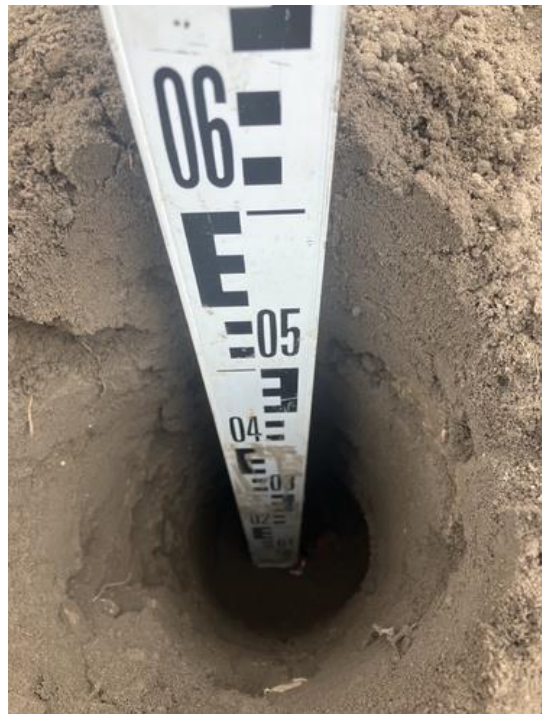
Photo 64

600

150

450

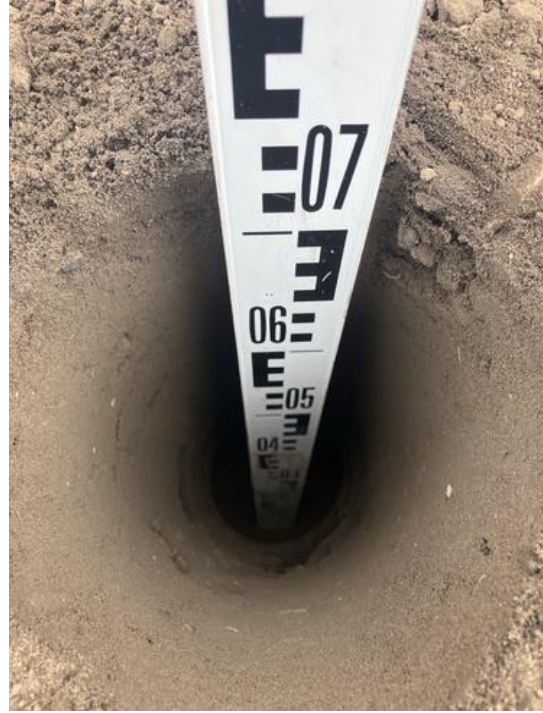
Photo 70

700

200

500
