Structural Opinion – Unsafe Condition and  
Recommended Demolition of  
65 & 67 Little Lever Street, 25 & 27 Holdsworth Street  
and 56 & 58 Lever Street. Manchester.

STRUCTURAL ENGINEERS REPORT

25599/PMH/KLH  
9<sup>th</sup> October 2025

# NXQ Lever Street, Manchester Structural Statement for Planning

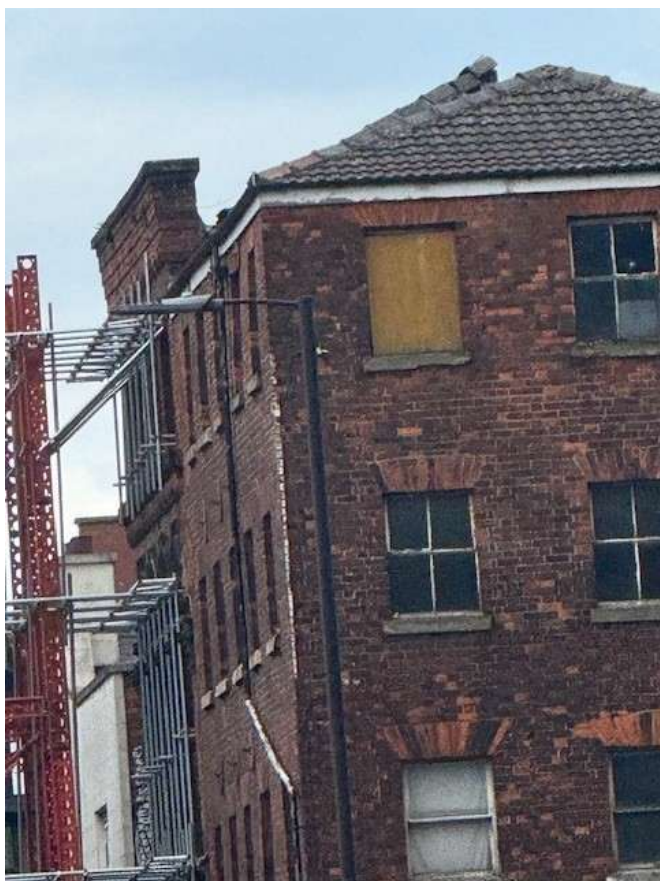
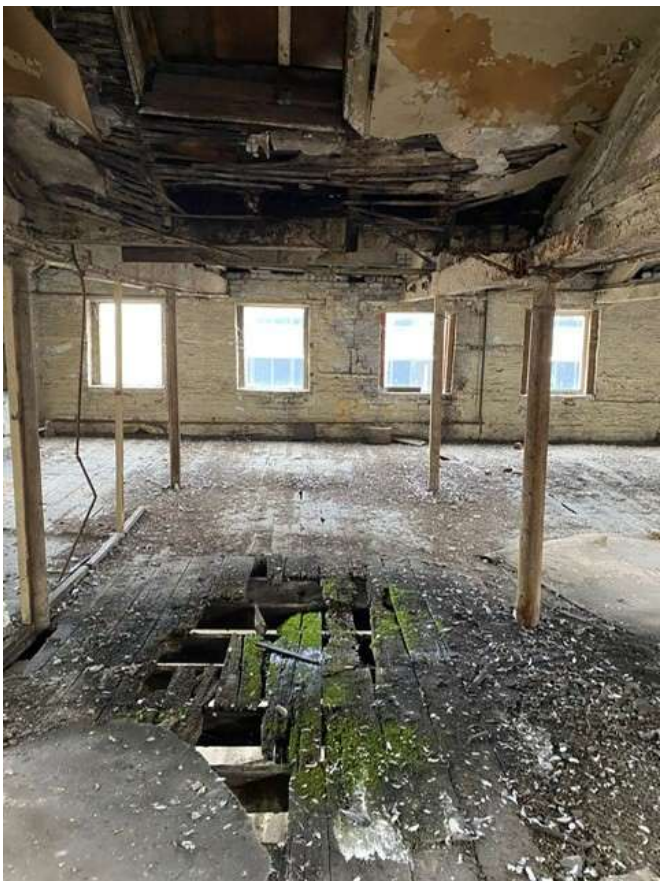
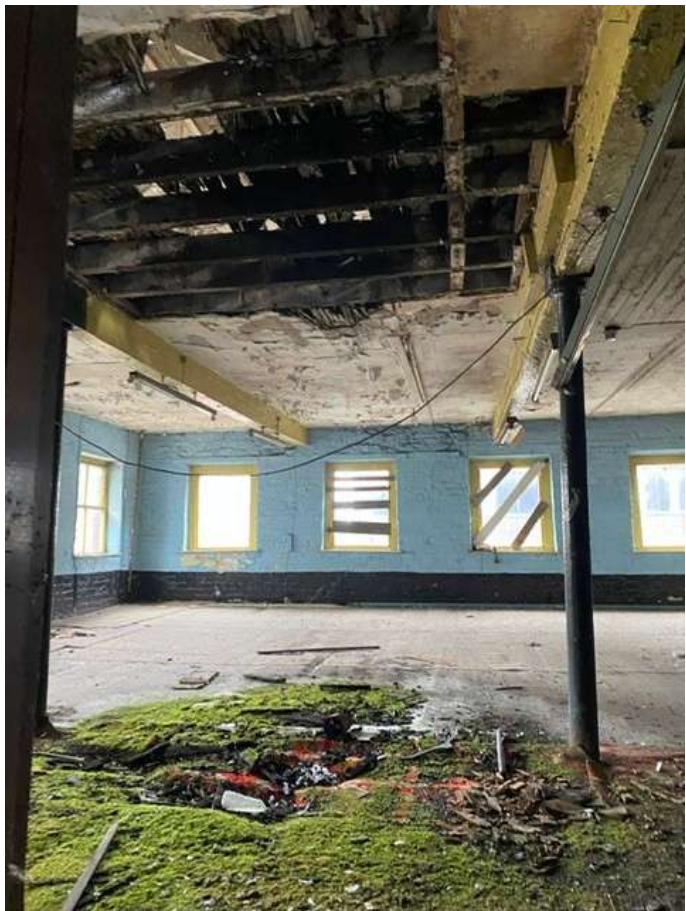
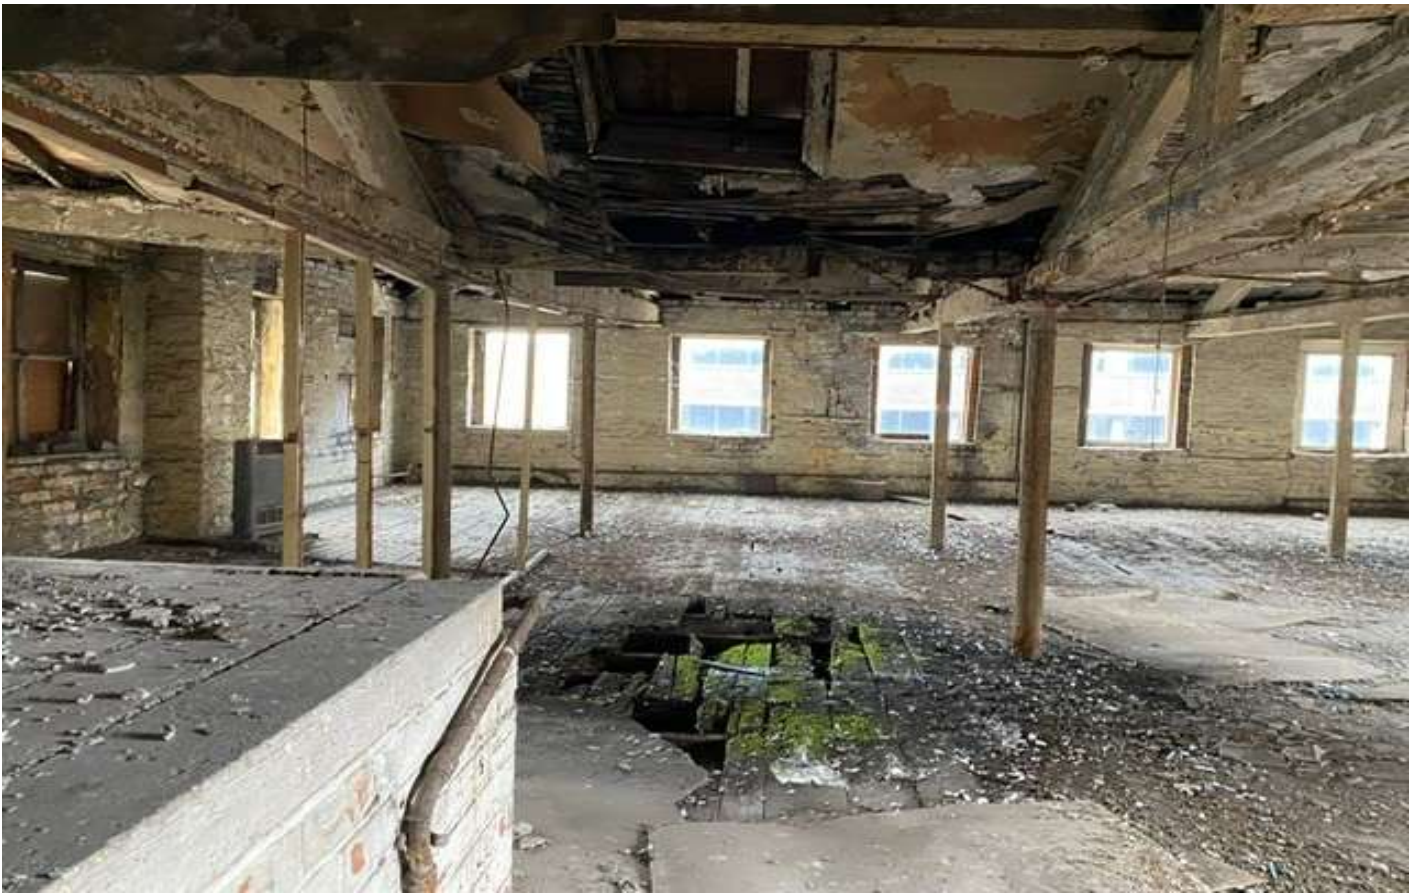
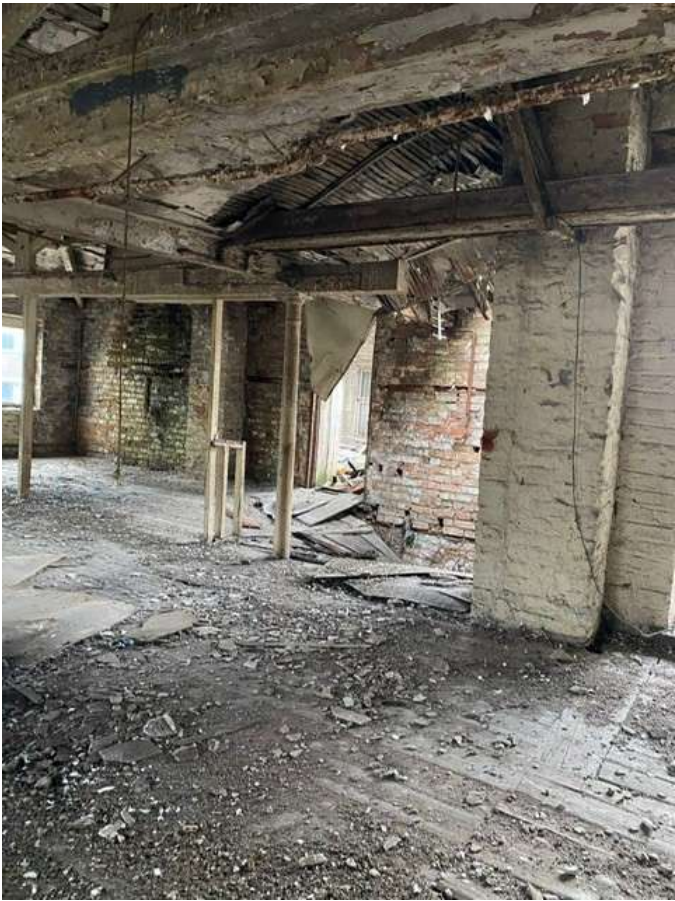
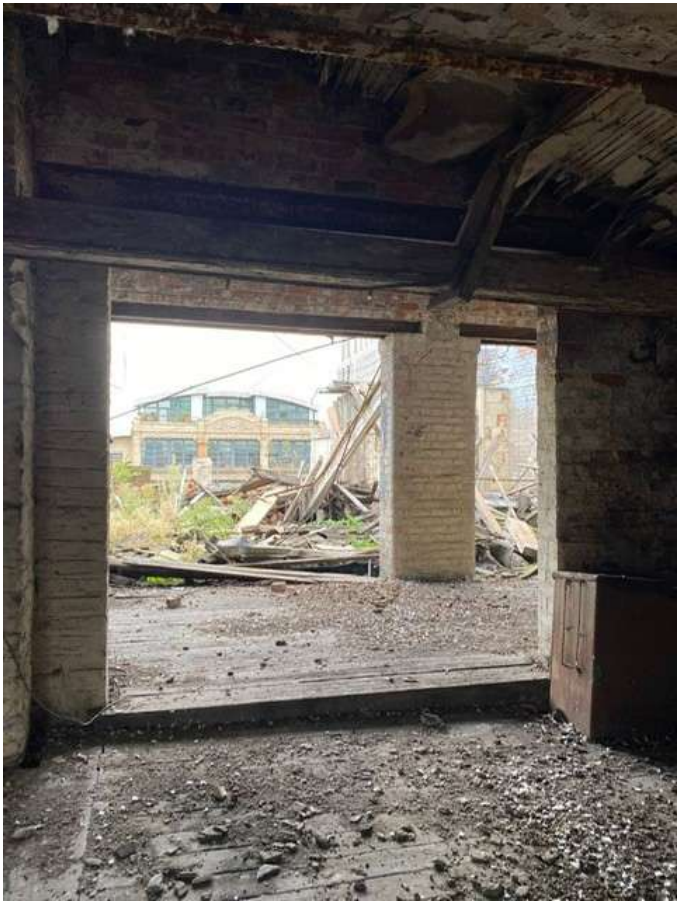
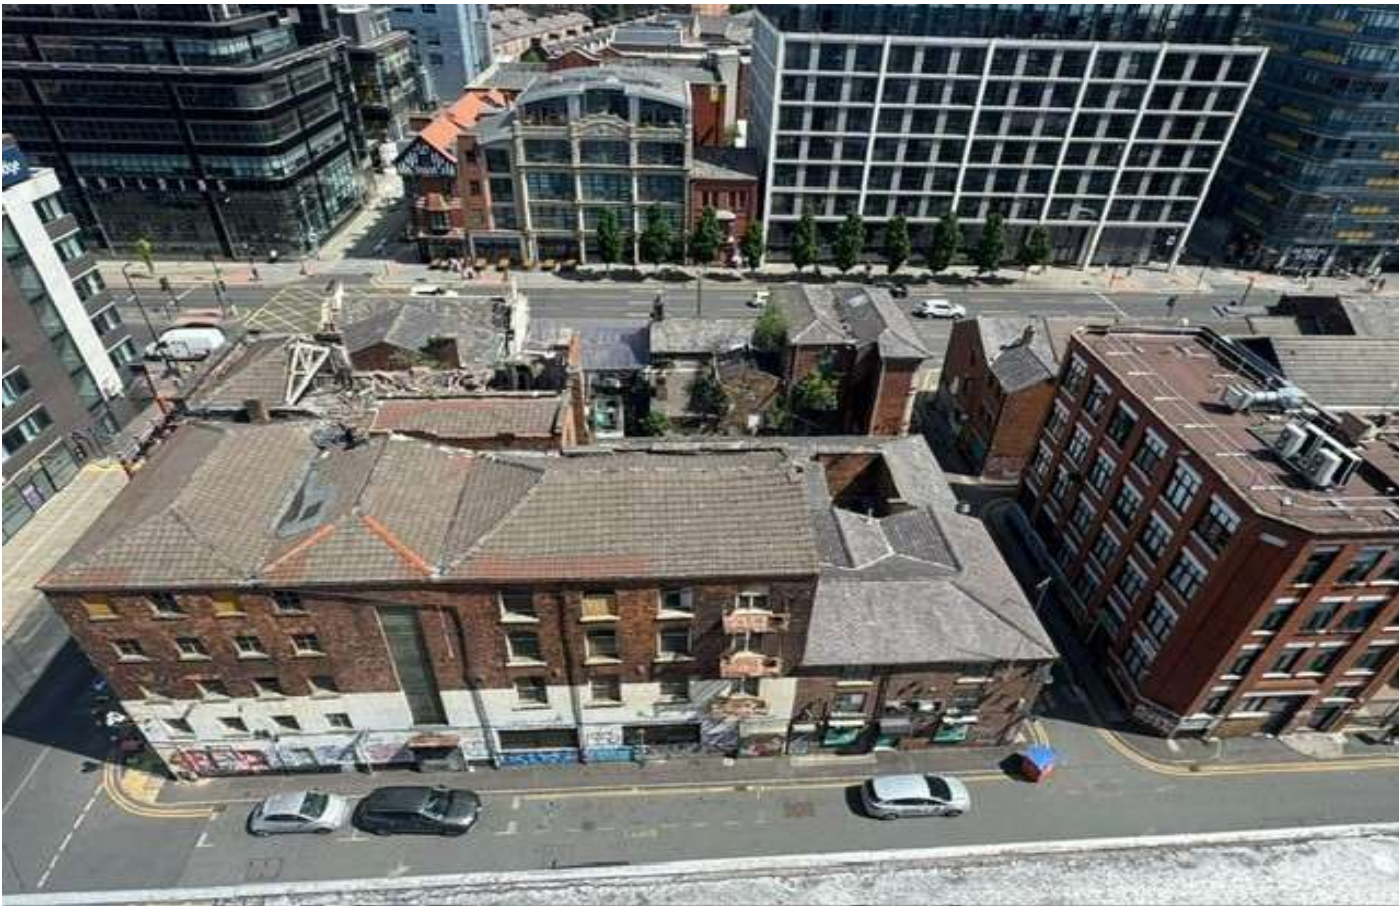
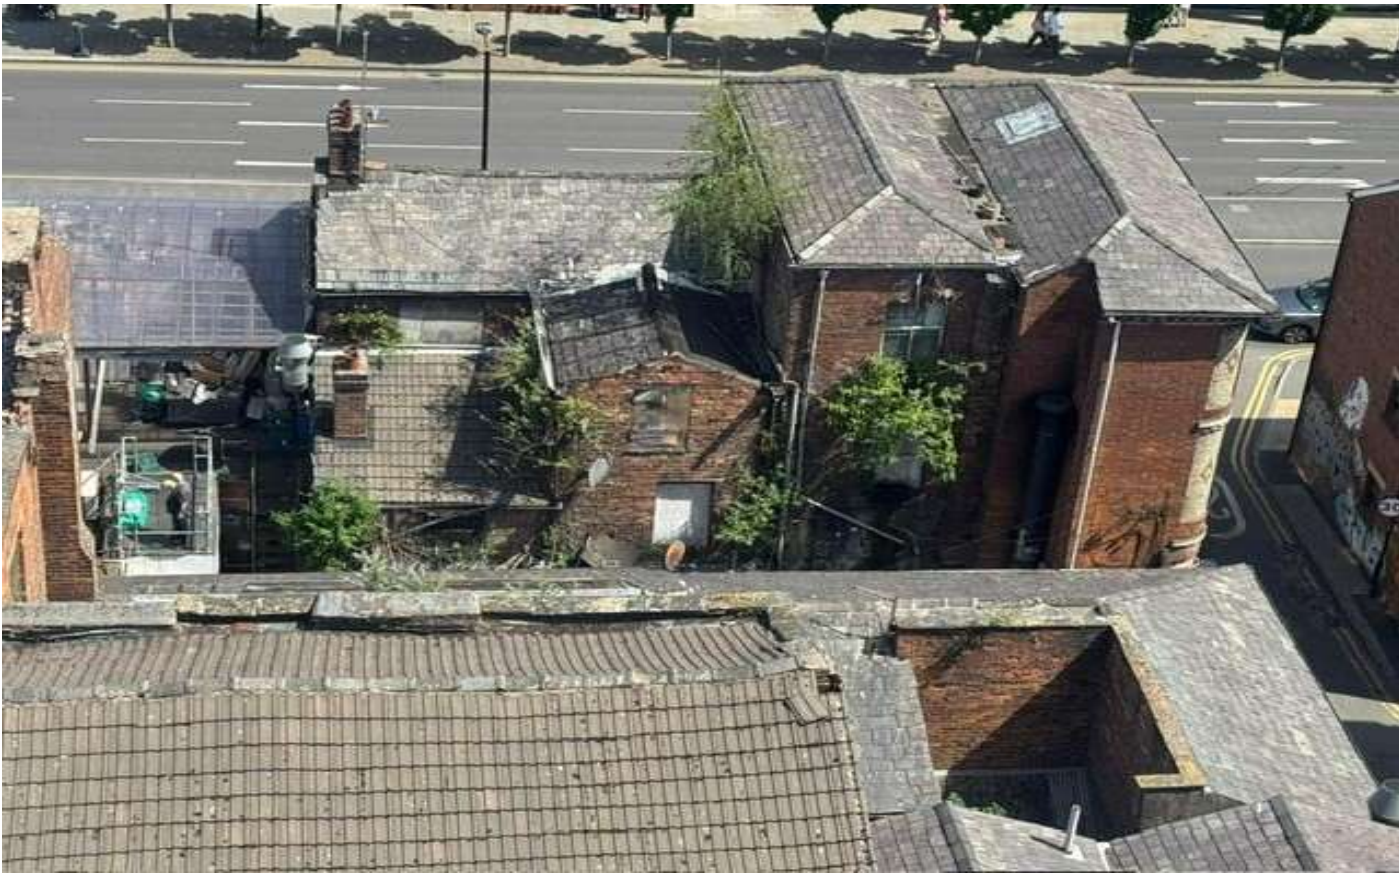
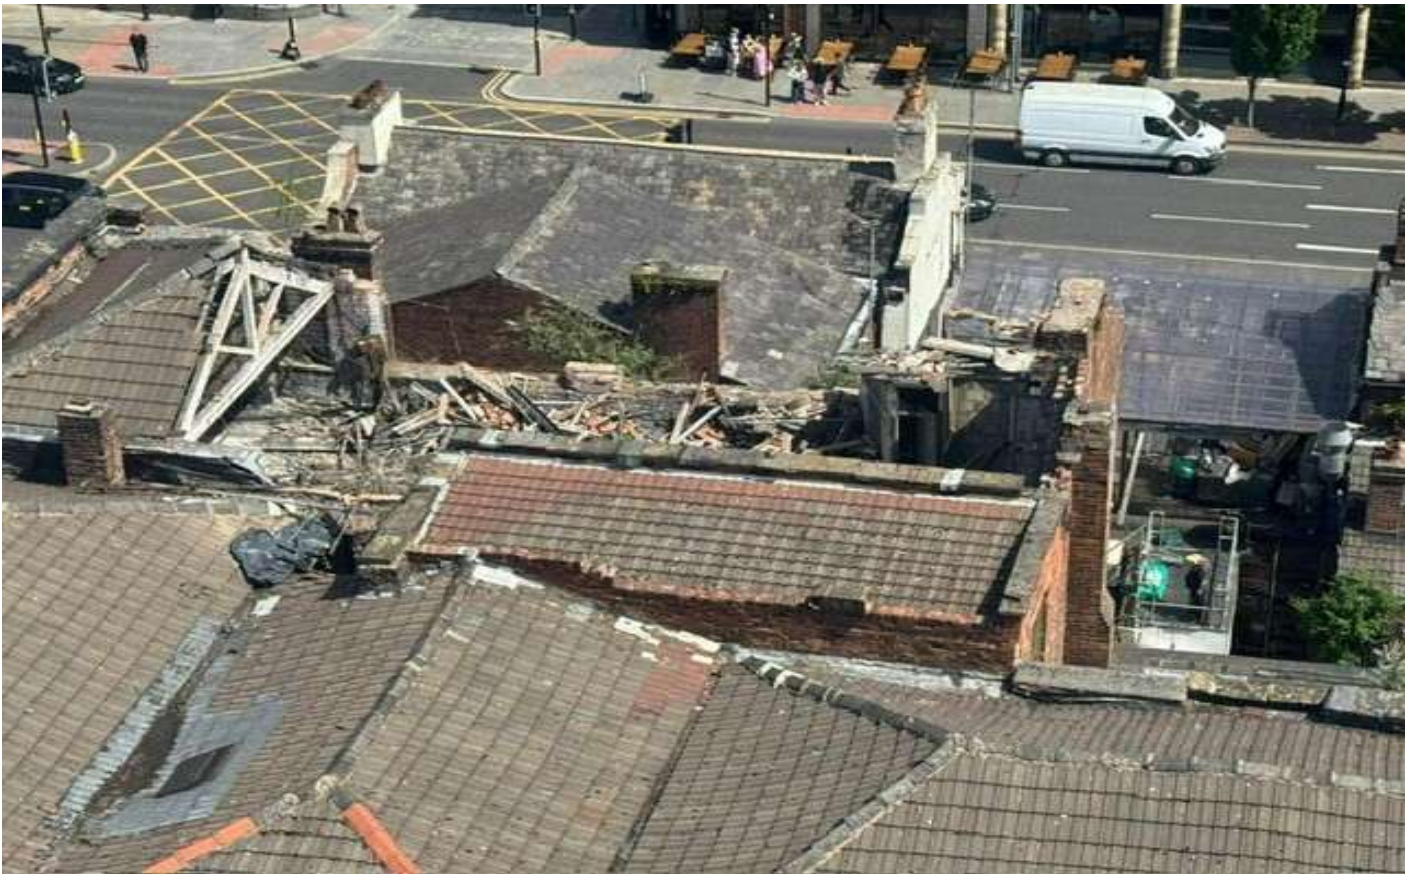
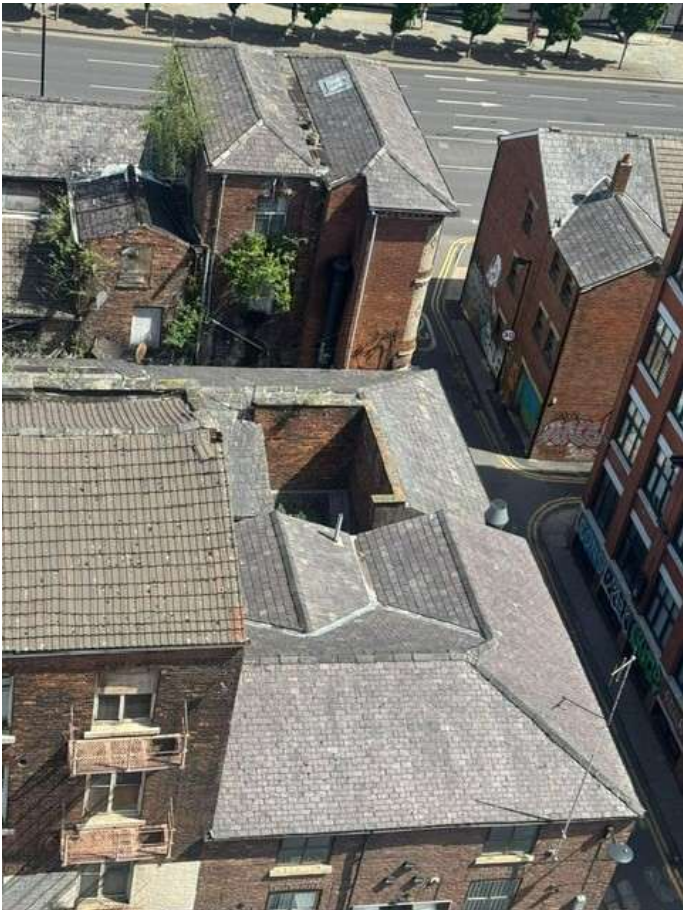
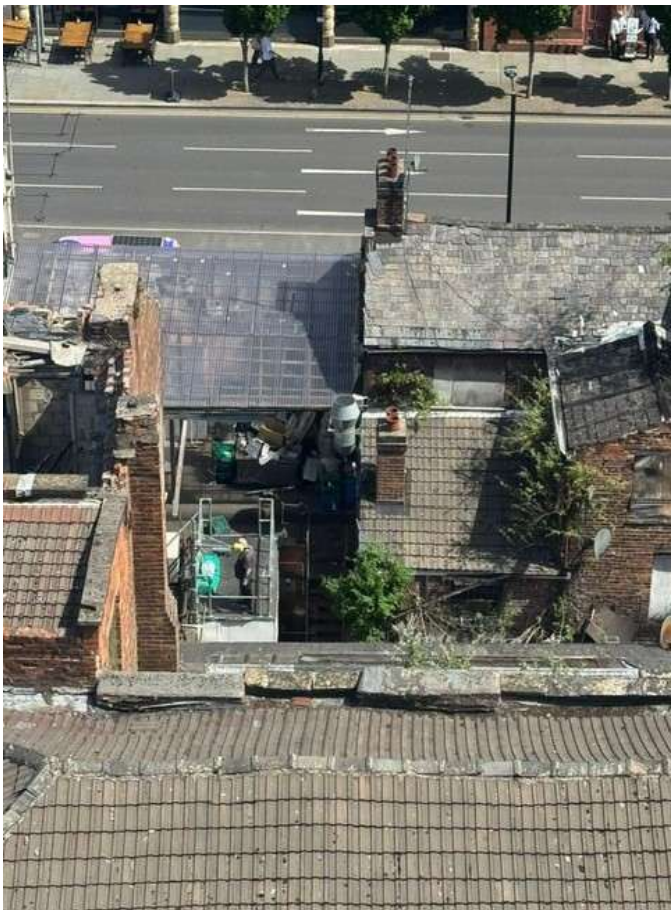
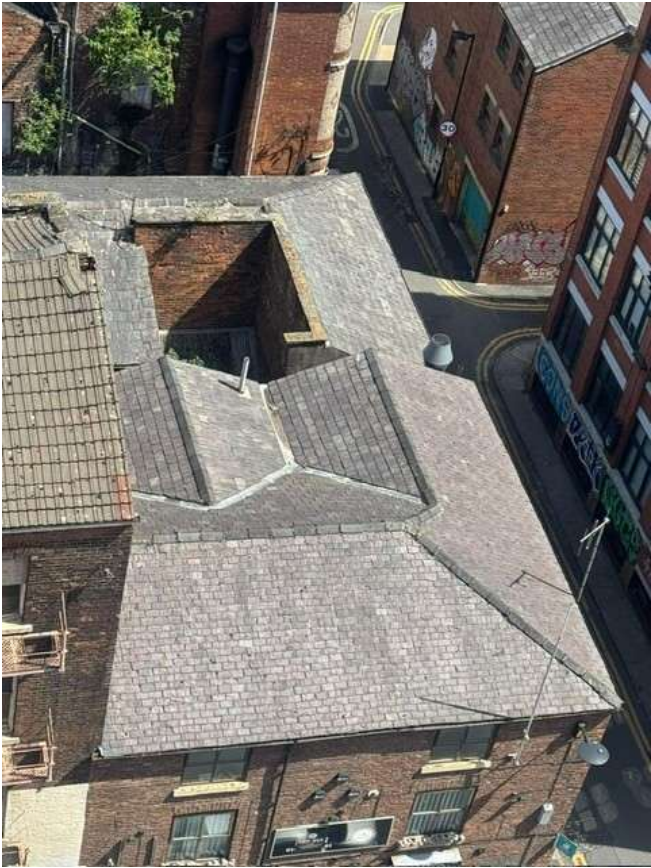
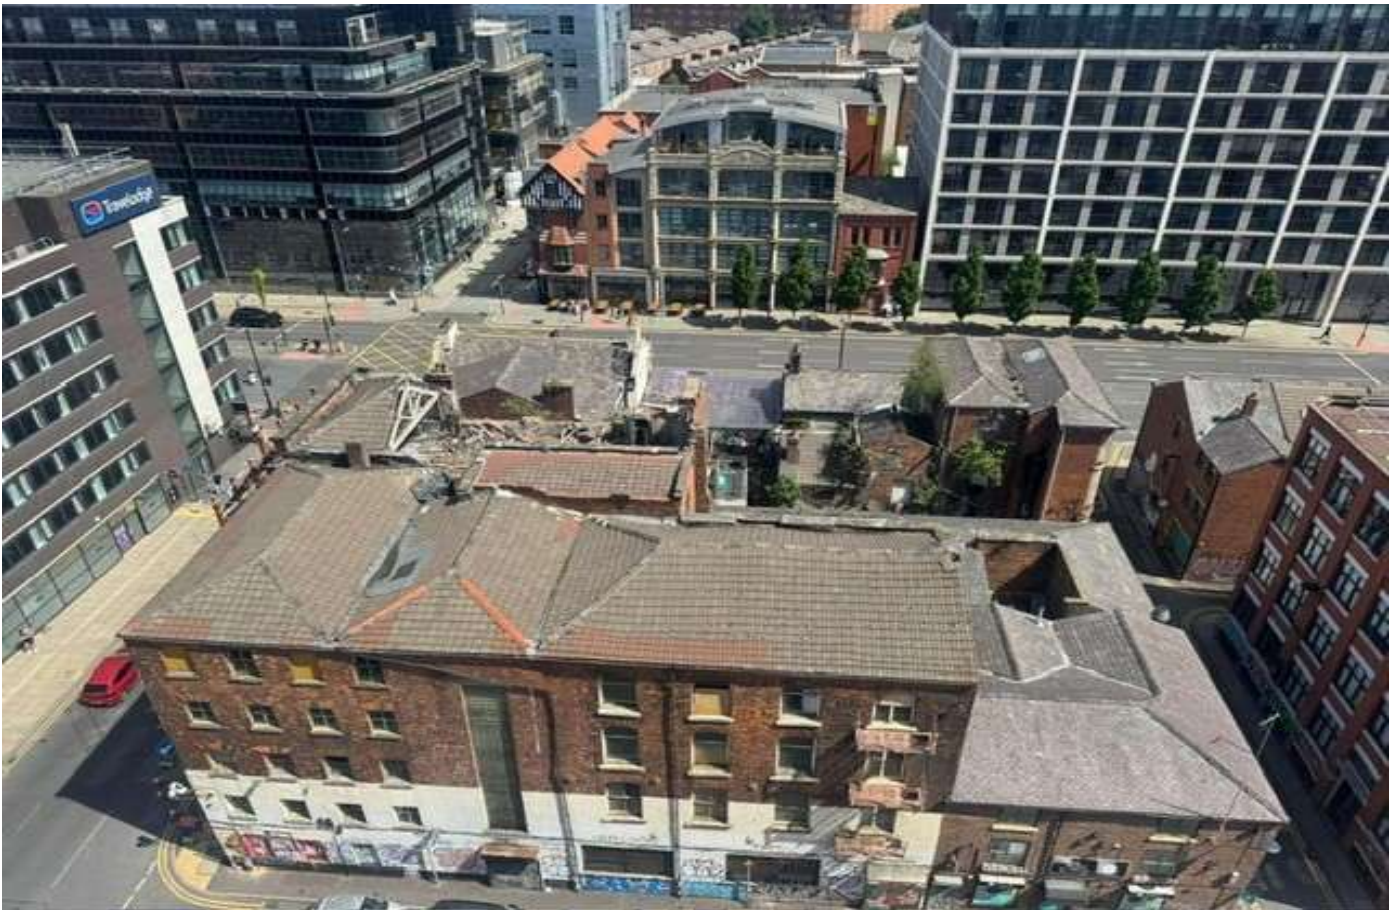
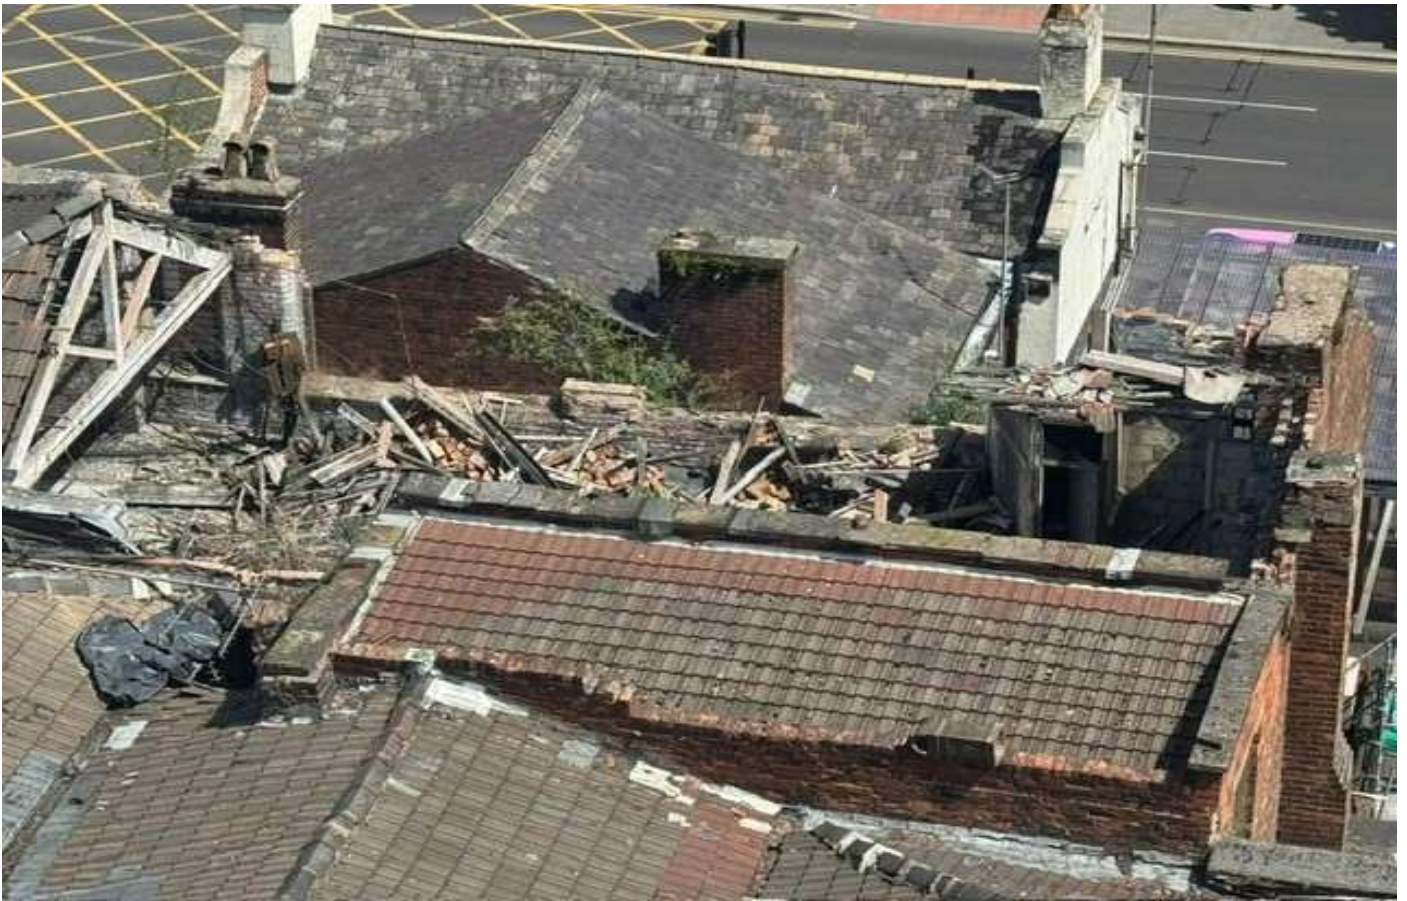
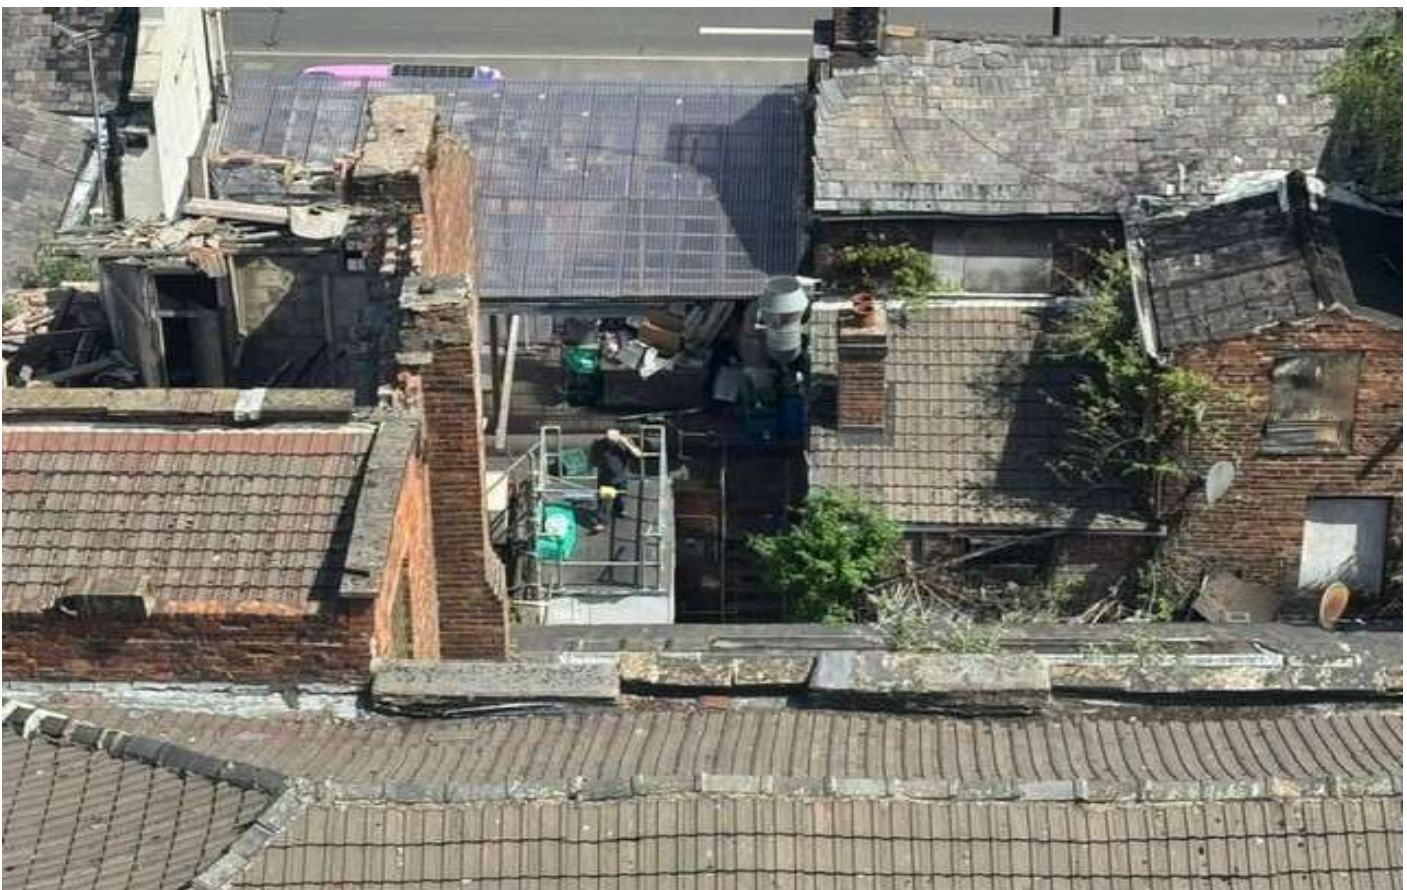
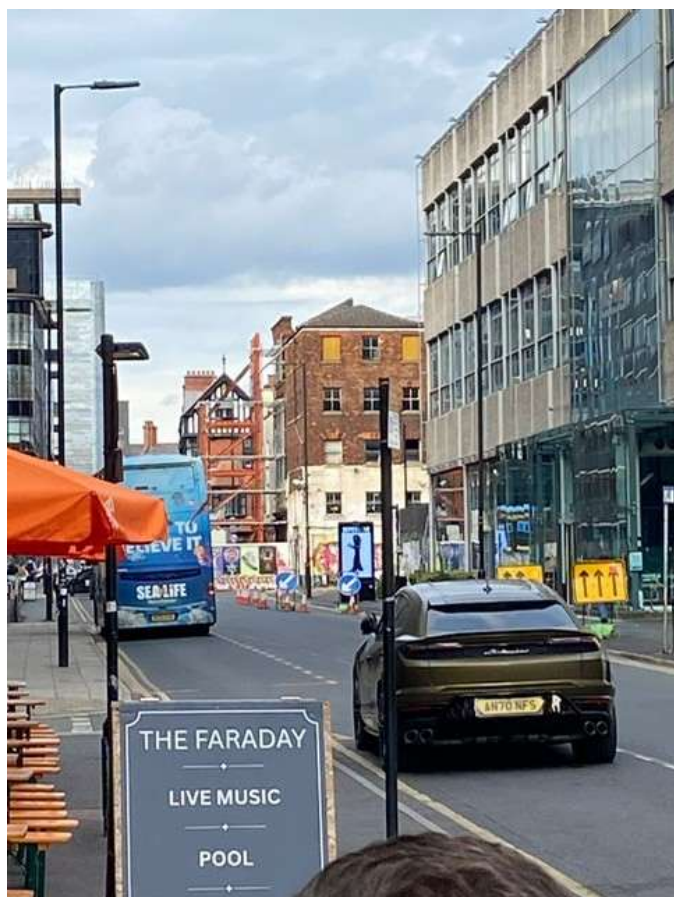
Significant structural distress is evident throughout, including partial roof collapses, unsafe and collapsed timber floors, loose and unstable masonry, and damp and deteriorated basement structures. Access was undertaken with great caution due to the high risk of further collapse, as recorded in the attached photographic evidence.

The demolition of these buildings is imperative both for reasons of public safety and to enable future redevelopment of the site. To safely access the area, demolition should commence at the corner of Holdsworth Street and Little Lever Street, facilitating controlled removal of the internal structure while retaining the designated façades in accordance with the development proposal. All demolition will need to be by remote means. A demolition method statement reflecting this is attached.

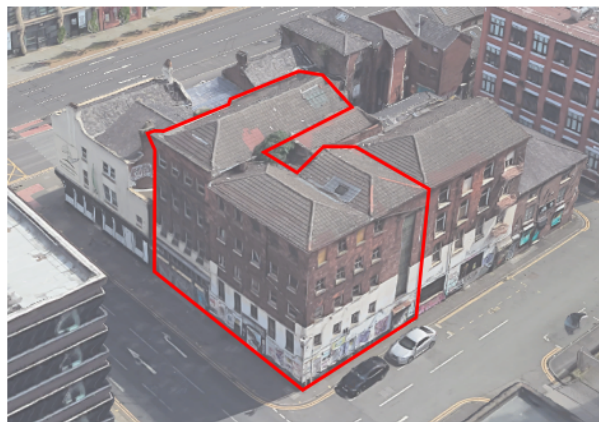
**Figure 4 - Plot 6 and 7 surveyed by GJA**

- Façade walls show signs of movement. Differential settlement cracks present to façade walls.
- Out of plumb verticality issues and bowing is present.
- Remediation of the bowing with cast iron lateral restraints and pattress plates installed in several locations. Pattress plates have varying forms which suggests these were installed over many years proving ongoing issues with structural movement.
- Cills and arch lintels show signs of settlement (from alterations to the buildings or foundation movement).
- Typical brickwork deterioration present.
- Poor roof drainage system likely leading to water ingress and blockage issues.

GJA deemed the structure “not unsafe” at the time of the inspection (2017) but left unchecked could lead to further deterioration that could compromise the stability of the building.

GJA concluded that detailed intrusive surveys would be required to establish the extent of remedial works required to make the buildings fit for purpose. Upper floors were recommended to be restricted from access which is currently in place at the time of writing. GJA also shared the opinion that the buildings are completely beyond repair and should be demolished, due to the excessive cost and complexities of remediation, in addition to significant temporary works scheme.
