Michael BEARDWOOD  
SCP

# SCP/250744/DSR/02 - HIGHER OPENSHAW CONSERVATIVE CLUB

Monday, 21 July 2025

Prepared For Designing Architects\_A

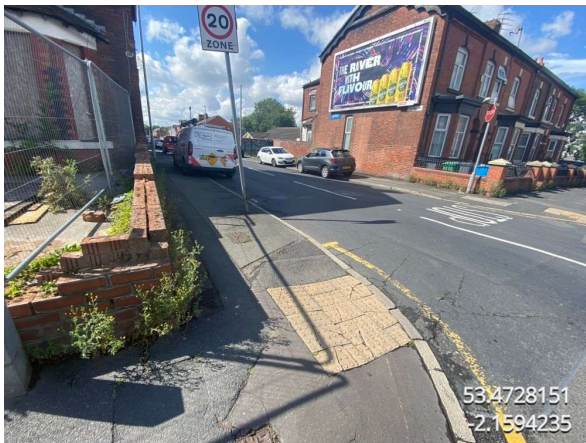
### **PICTURE 1**

Severely damaged tactiles giving rise to possible trip hazards due to overrunning of the corner. Carriageway surfacing showing evidence of failure. Damaged road sign post (corrosion and leaning). Kerbs in need of remediation and new signpost recommended.

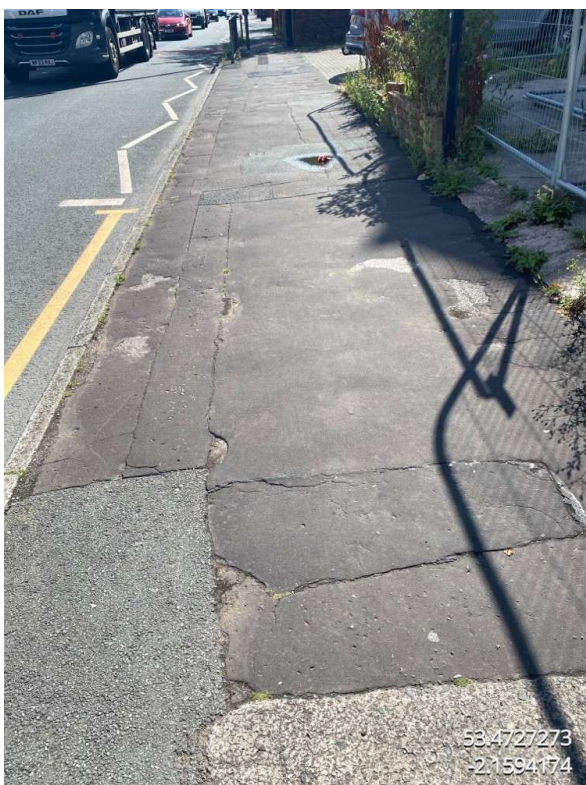
### **PICTURE 2**

Multiple instances of footway scarring throughout with frequent patches. Longitudinal fractures are also frequent. Potentially sign of subsurface defects due to water penetration.

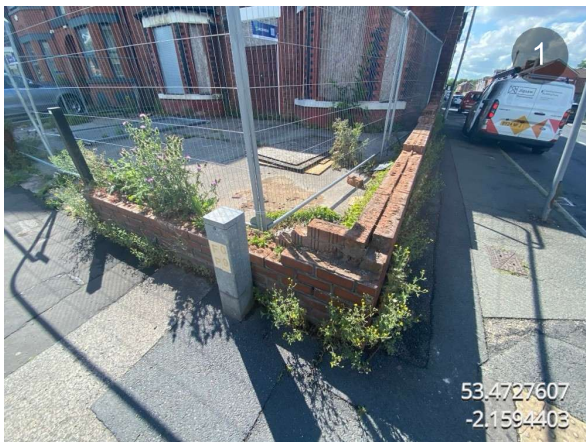
### PICTURE 3

External wall of site completely damaged with vegetation growing throughout. Potential to undermine existing structure.

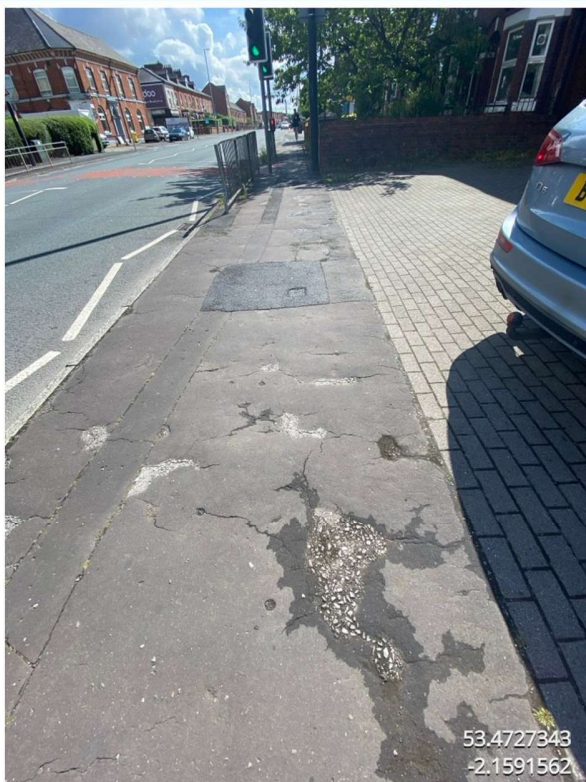
### PICTURE 4

Multiple instances of delamination. Base course exposed in many areas. Further evidence of potential frost erosion.

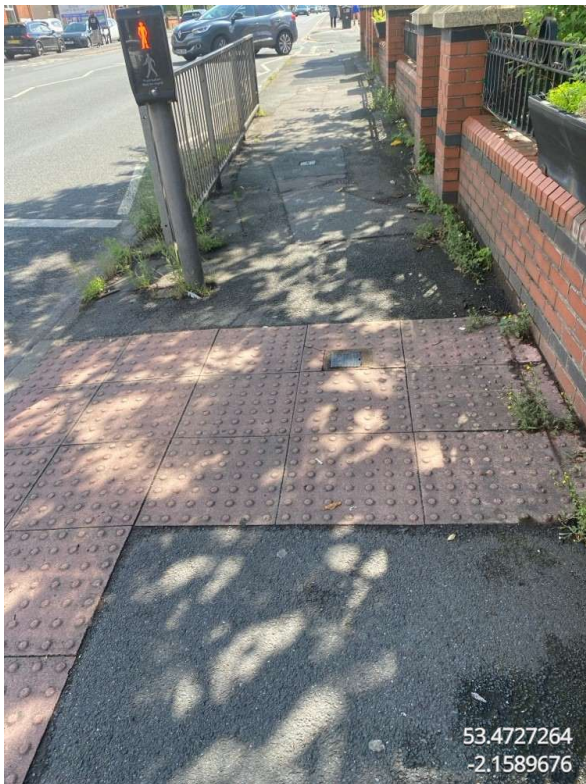
**PICTURE 5**

Multiple areas of vegetation growth through surface course with surface cracking evident in multiple locations. Possible subsurface defects. Recommend repairs as necessary. May require further intervention of subsurface defects identified.

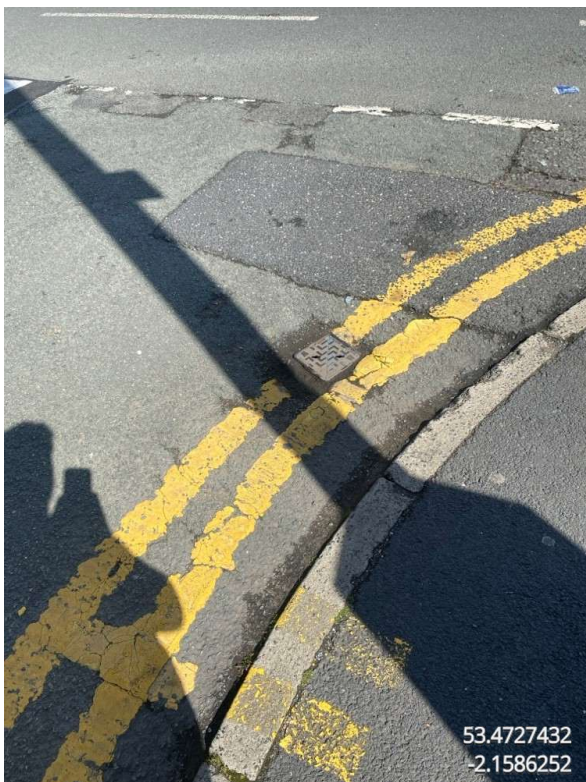
**PICTURE 6**

Sunken valve on junction with Delamere St, potential that infrastructure below ground level could be affected.

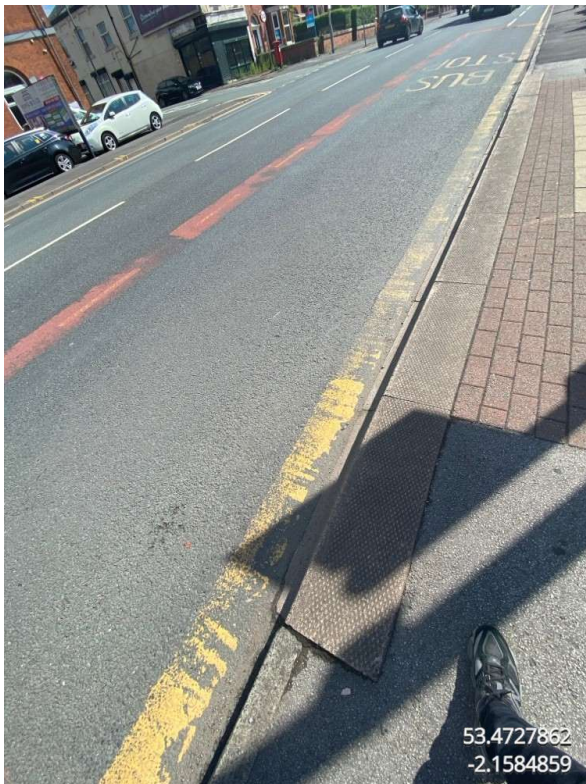
### **PICTURE 7**

Carriageway in general good condition throughout. Bus stop shown adjacent to Delamere St. Road markings showing wear.

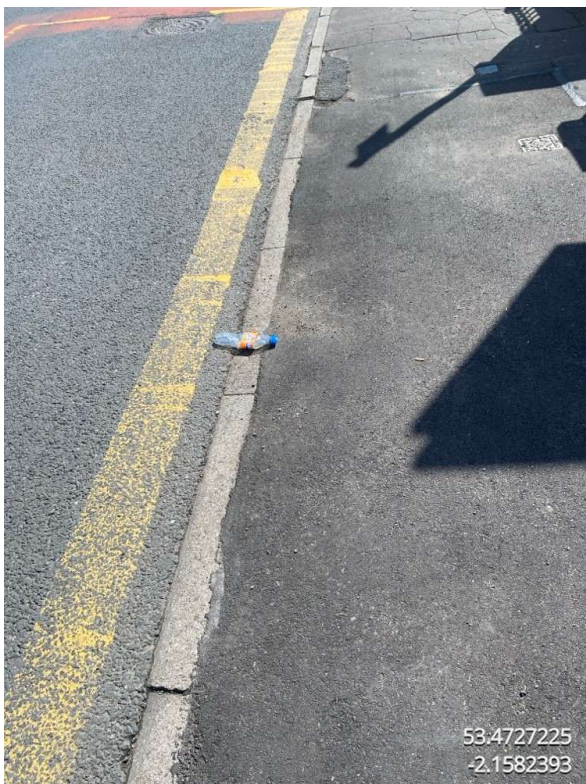
### **PICTURE 8**

Sunken bullnose kerb showing low spots potentially causing damage to foundation.

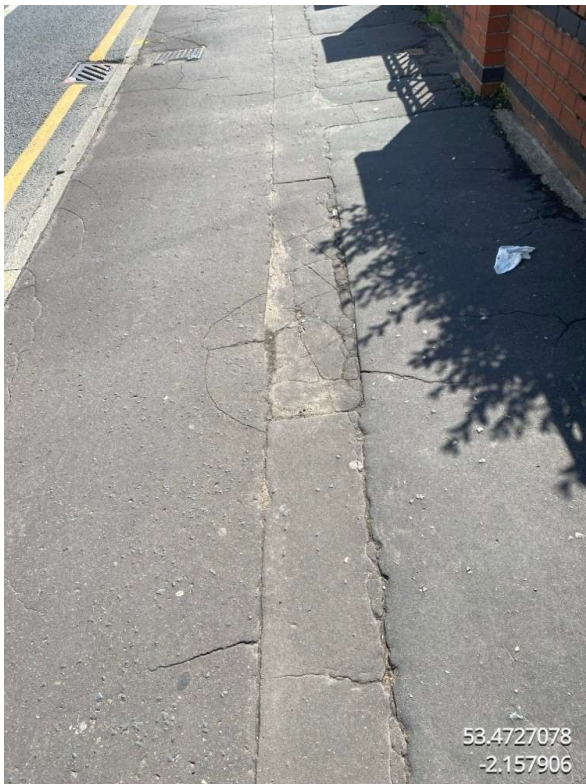
### **PICTURE 9**

Failure of previous works resulting in fractures and cracking as shown. Further fractures and cracking occur throughout extents of survey. Further deterioration likely to result in potential trip hazards.

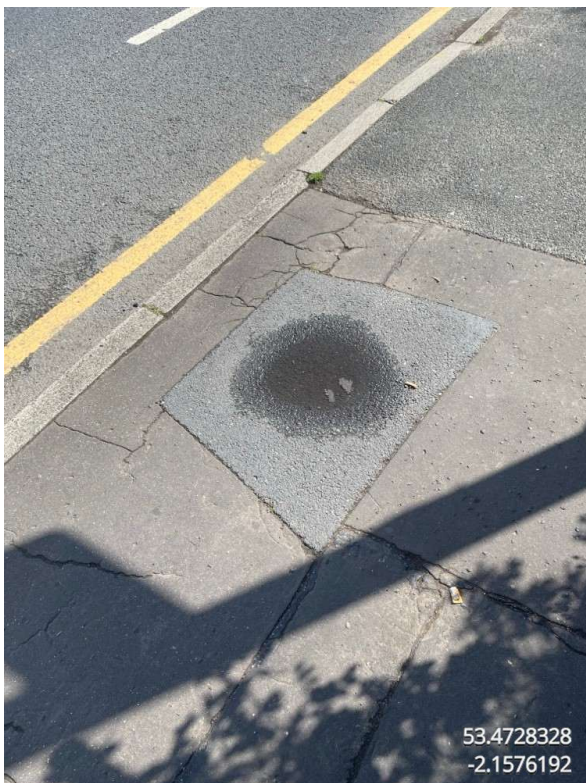
### **PICTURE 10**

Sunken flexible pavement showing low spots and ponding. Potential for further deterioration in future.

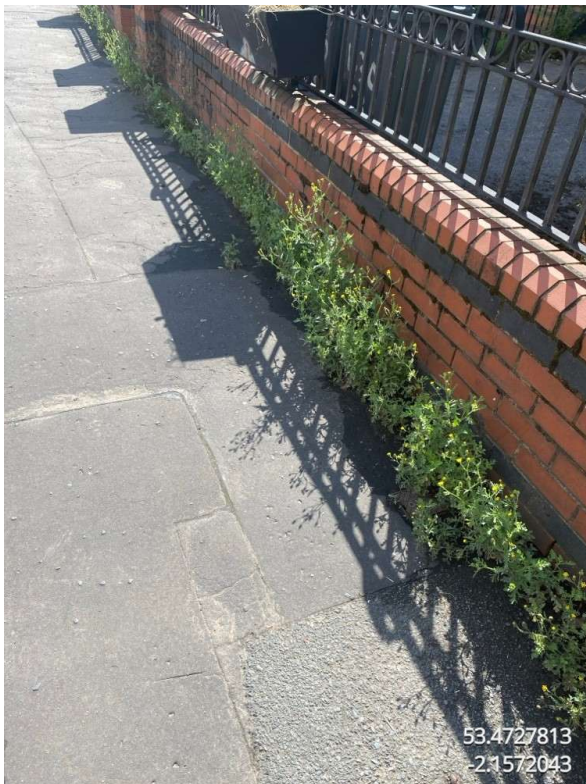
**PICTURE 11**

Vegetation growth shown here occurs at all external property walls in varying severities. Clearance recommended to be provided by relevant authorities.

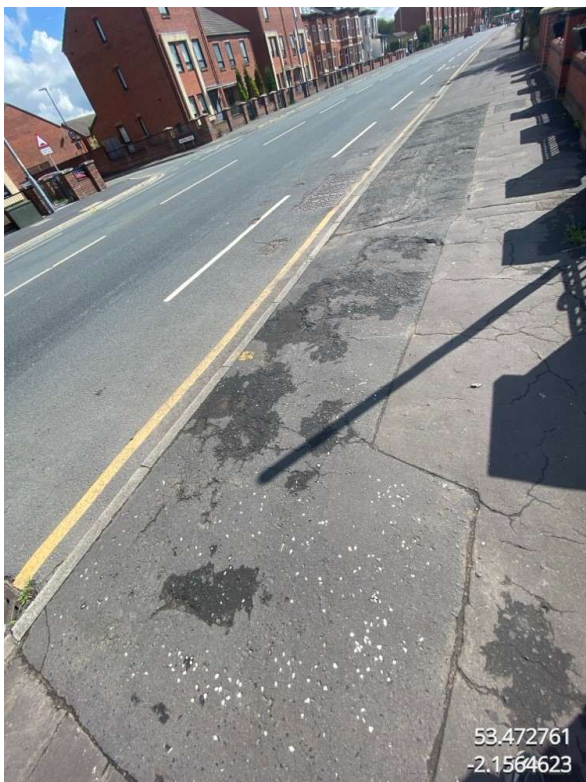
**PICTURE 12**

Particularly severe surface course fretting shown indicating material defect. Previous repairs do not appear to have been sealed adequately and will allow water ingress with the potential for freeze-thaw issues in future.

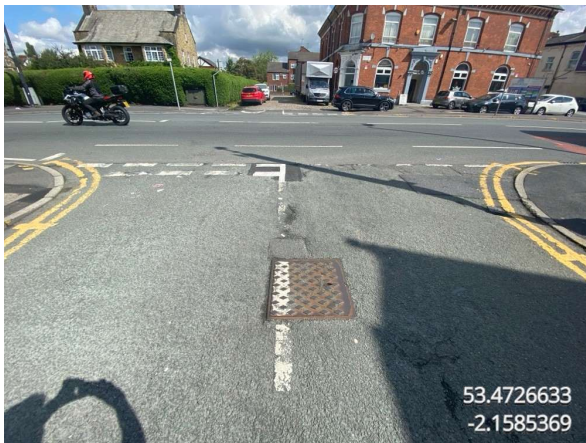
### PICTURE 13

Delamere Street junction road markings showing significant wear along with some surface scarring. Recommend renewal of markings.

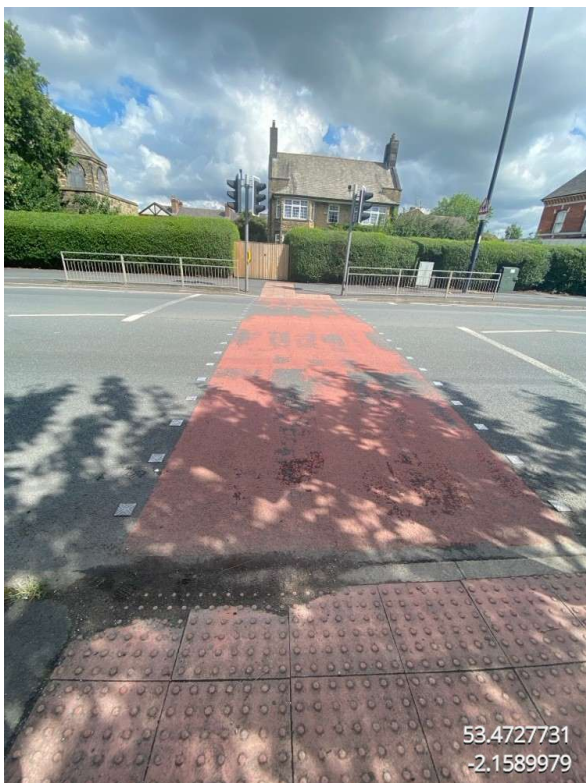
### PICTURE 14

Condition of pedestrian crossing near site. Evidence of ponding indicated on left side of tactiles and fretting/wear of red surfacing. Recommend resetting of kerbs to alleviate ponding. Crossing surfacing should be considered for renewal under routine maintenance.

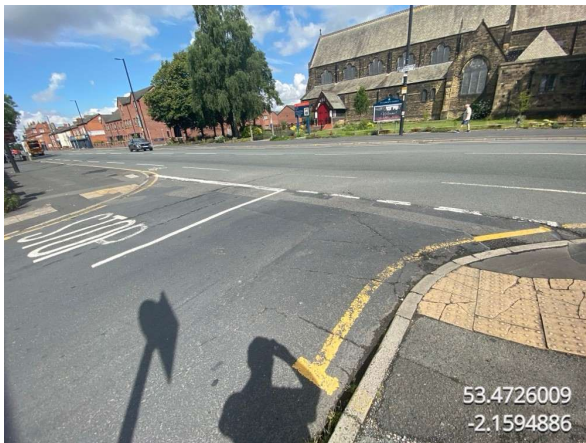
### PICTURE 16

Damaged tactile paving flags at the Capital Road junction could be a trip hazard, with low footpath behind kerb and some tyre markings present. Indications of kerb overrun. Kerbs and tactiles should be repaired/replaced.

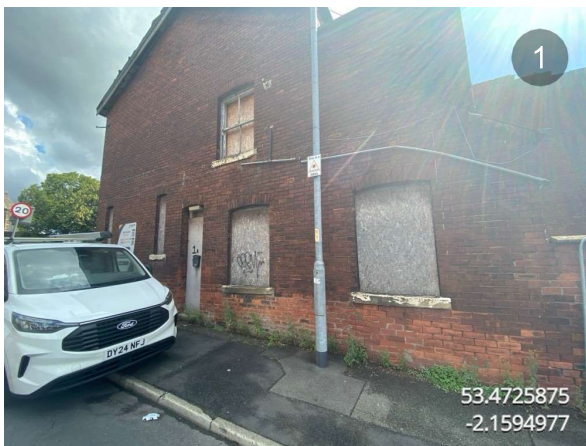
### PICTURE 17

Record of condition of side access to site for the attention of all relevant parties.

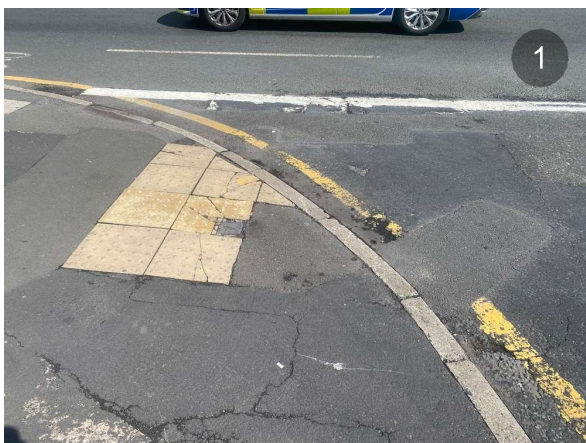
### PICTURE 18

Tactile flagging on west side of Capital Road damaged and incomplete. Does not adhere to standards and should be repaired/replaced. Footway around tactiles showing signs of numerous previous repairs and cracking.

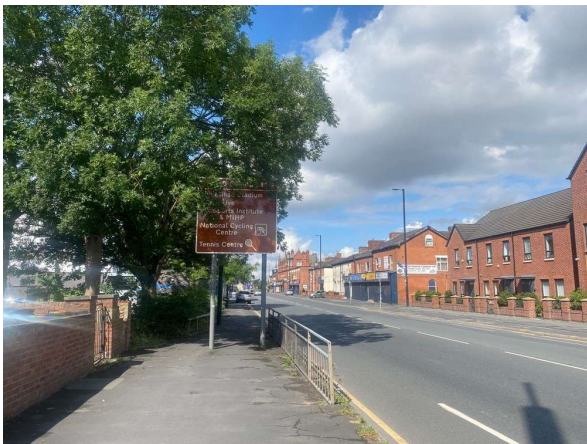
**PICTURE 19**

Footway between Capital Road & Abbey Hey Lane shows signs of previous works that have been poorly carried out, resulting in subsidence and cracking of adjacent paved area.

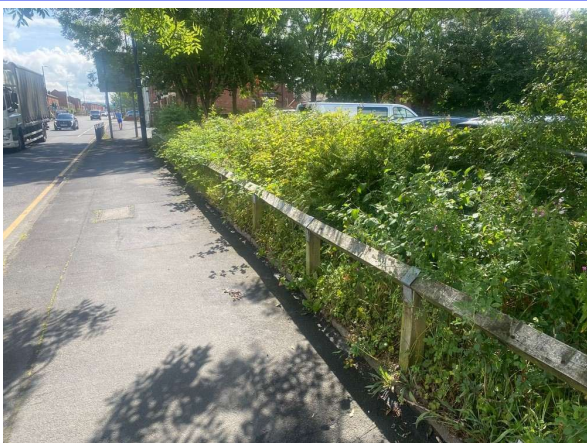
**PICTURE 20**

Vegetation overgrowth obstructing vision of ADS. Recommend clearance.

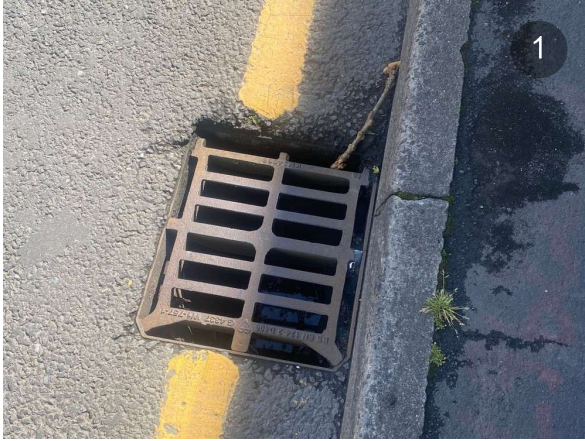
## PICTURE 22

Most gulleys along the surveyed path appeared to be in reasonable condition, some appear to be in need of cleansing/jetting to clear any blockages. Would recommend CCTV survey to be carried out along survey extents.

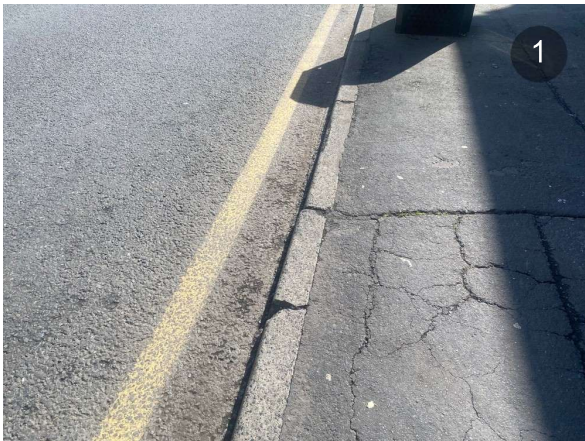
## PICTURE 23

Footpath between Abbey Hey Lane and Vine Street is in poor condition, with multiple intrusions and repairs throughout. High level of surface cracking also present. This footpath is likely to deteriorate further and inspection is recommended, with possible further intervention to binder course materials being suspected.

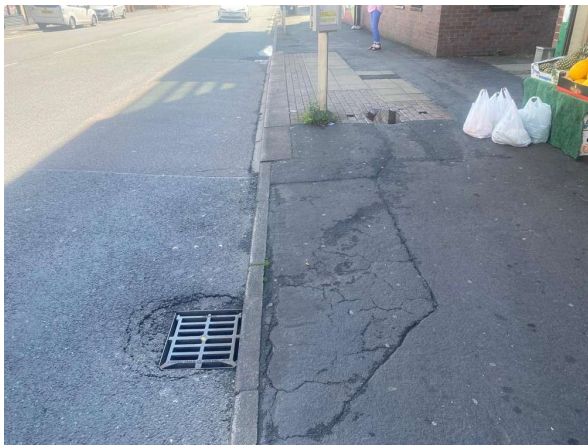
#### **PICTURE 24**

Sunken gulley located near bus stop adjacent to Barber Street. This appears to also extend to subsidence behind the kerblines. Possible washout of material. Recommend further investigation, with resetting ironworks and localised resurfacing as a minimum. Bus stop showing signs of ponding and requires remediation works.

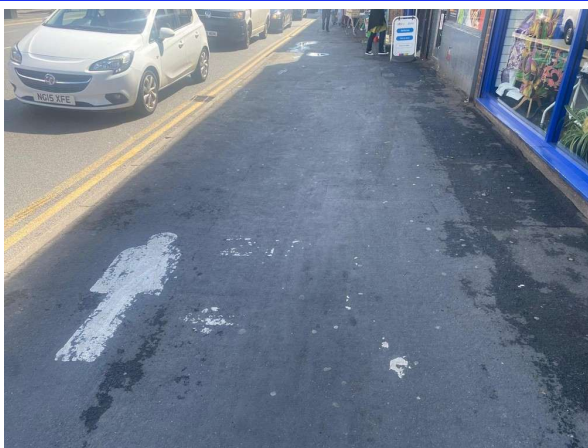
#### **PICTURE 25**

Redundant Footway marking shown here, recommend clearance

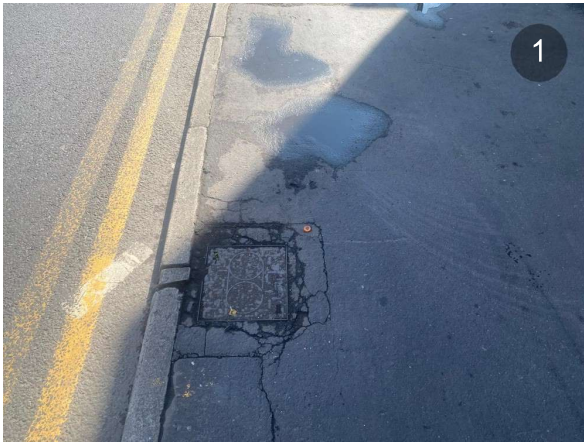
## PICTURE 26

Multiple low spots and sunken ironworks shown between Vine Street and Barber Street, with damage to existing kerblines. Suspect kerb overrunning.

Recommend resetting kerbs and all ironworks, with repairs to surfacing as necessary.
