# Fire Safety Works

Project:  
Presbytery: Fabric upgrade, fire alarm & emergency lighting.

## Boiler Room Ceiling Repairs

SJ-BTP-00-E/P-DR-A-4118\_FSW/DS01

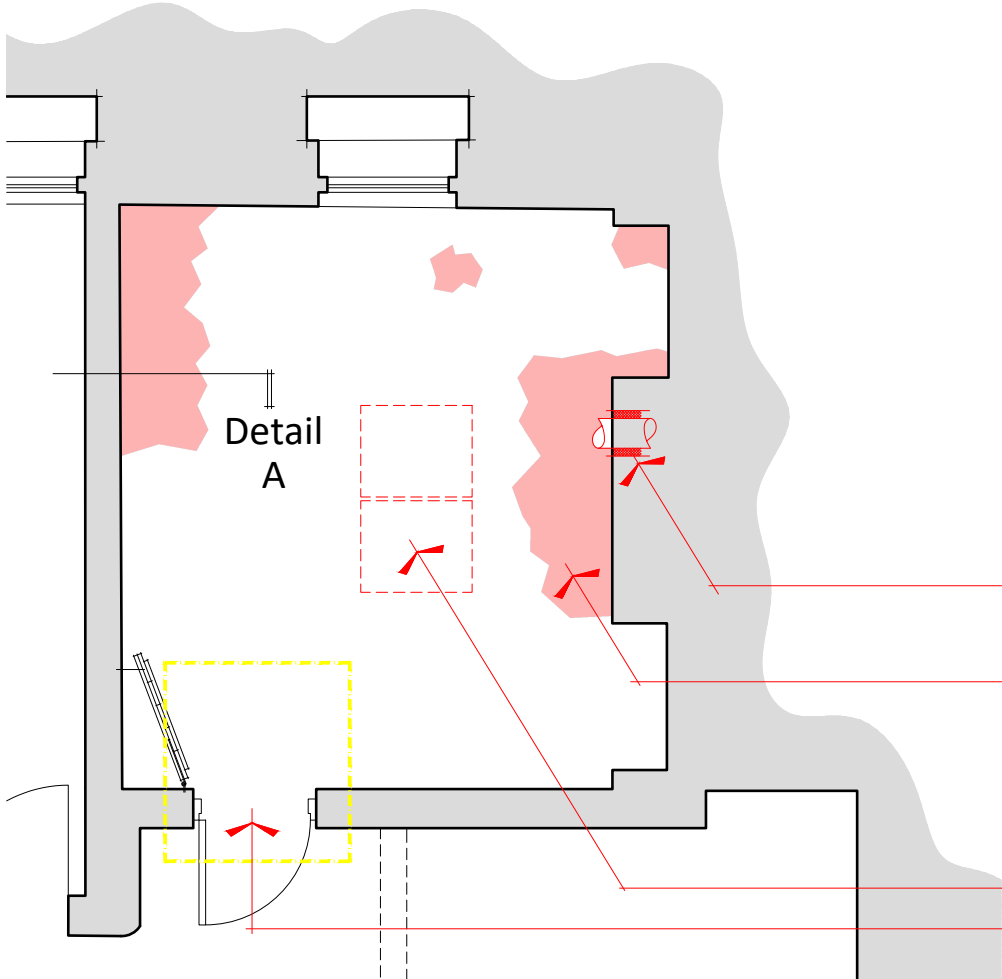
Boiler Room Ceiling Plan (1:50 @ A3)

Approximate areas of damaged lath & plaster shown in red shading.

Approximate position of boilers.

Once original plasterwork has been repaired and is suitably cured/dried, the ceiling is to be underlined with 12.5 mm Gyproc Fireline Board screw fixed through to the existing floor joists. Allow for framing out around the recently installed heating pipework/supporting framework. Allow for intumescent sealant to the perimeter of the ceiling & wall junction and to fire stop any service penetrations in the new ceiling.

Include for new 1hr fire resistant solid core plywood faced door to receive paint finish. Existing door removed and stored in adjacent northeast store area for possible future use elsewhere. (see drawing SJ-BTP-00-E/P-DR-A-4118\_FSW/02A).

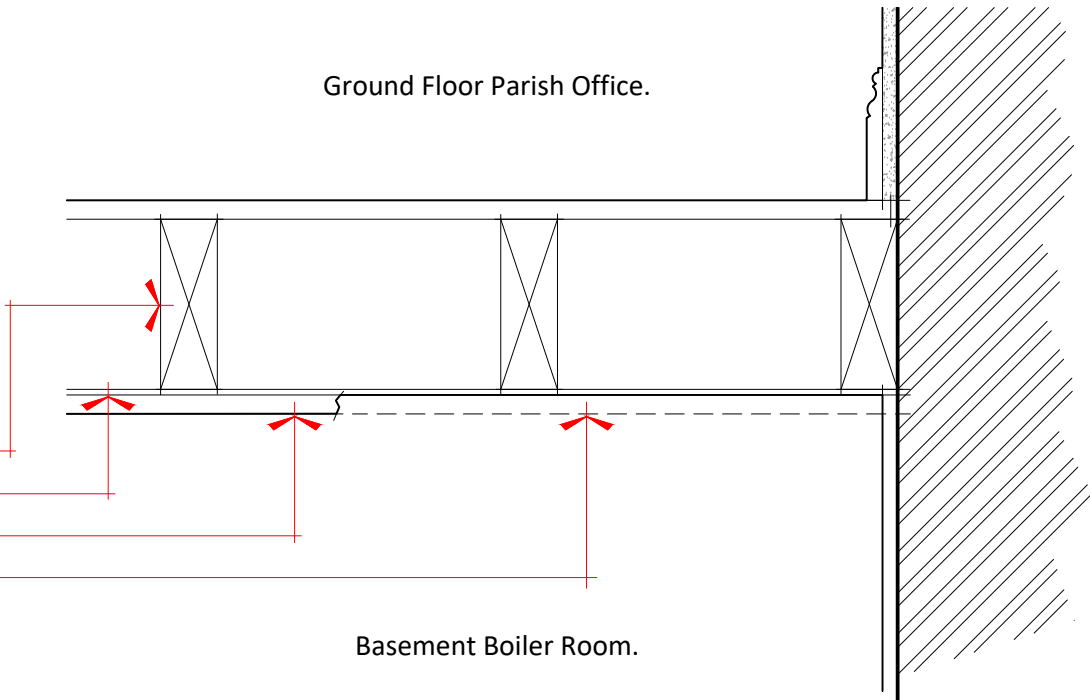
Detail A thru' existing (1:10 @ A3)

Original ceiling is formed in traditional lath and plaster where the laths (oak/chestnut) are fixed at right angles (east/west) to the ground floor joists (north/south). In a number of locations, the plaster has become detached or damaged as the original material has dried out and its adhesion to the laths has diminished.

Existing damaged/lost plaster.
