CIS Tower,  
Miller Street,  
Manchester.  
M60 0AL.

## CIS Tower Refurbishment.

Recording Strategy and Photographic Audit of internal & external features.

# APPENDIX 32 – Roof Level.

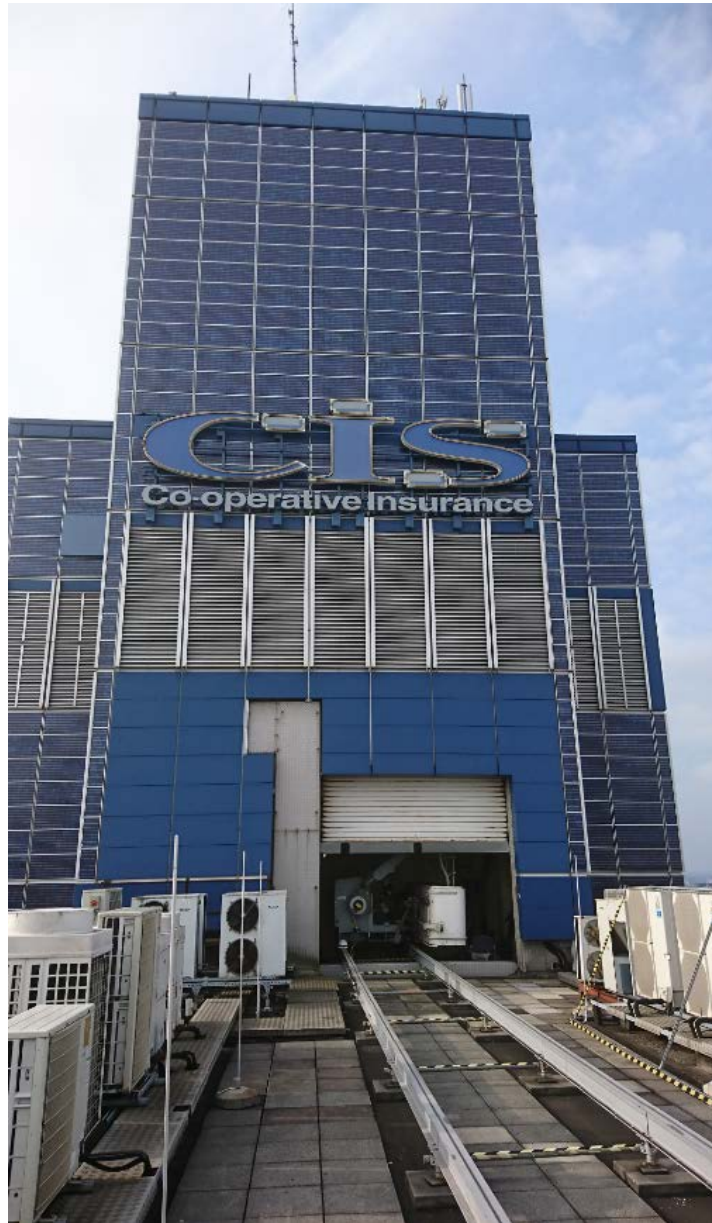
**RL-01** Looking south from the parapet, showing the details of the applied signage and photovoltaic cells as well as the track access to the lift tower.

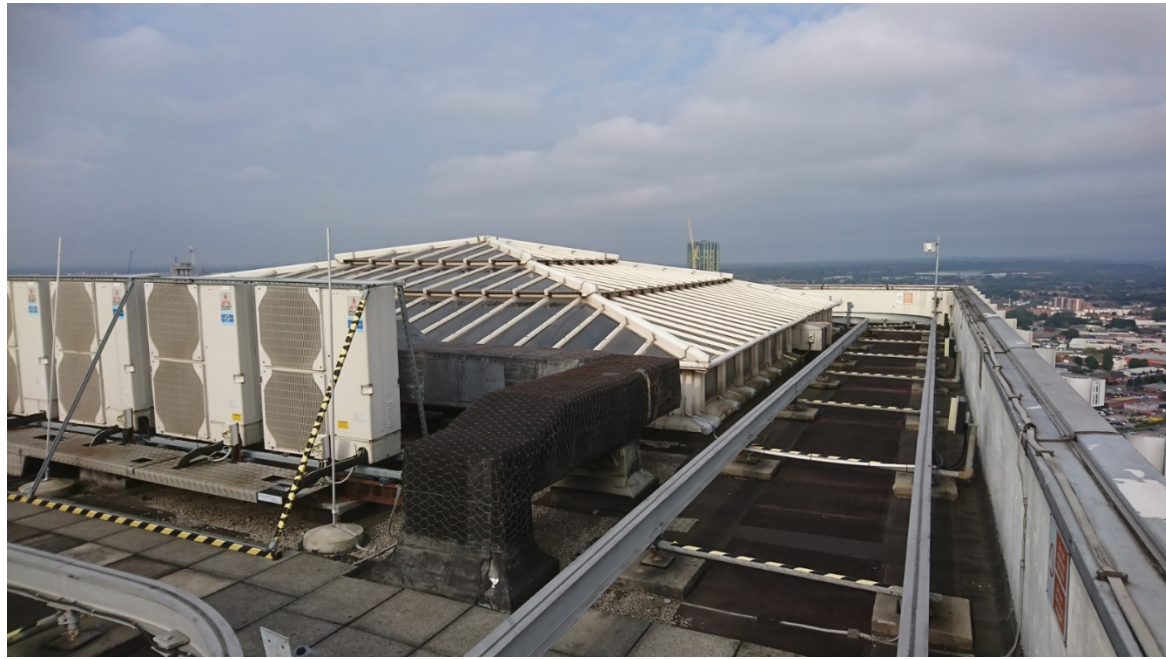
**RL-02** Looking south-west from the parapet showing the track-bed for the window access plant and glazed pyramid roof lighting the west-side of level 25 below.

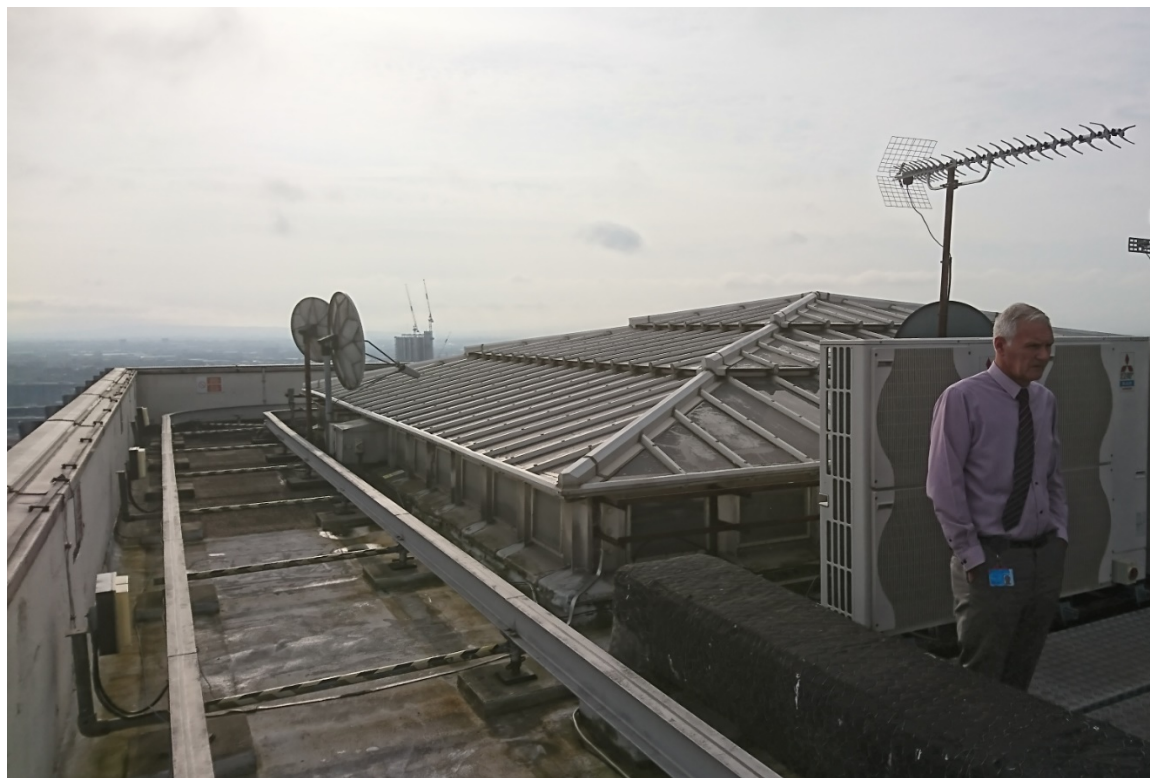
**RL-03** Looking south-east from the parapet showing the track-bed for the window access plant and glazed pyramid roof lighting the east-side of level 25 below.

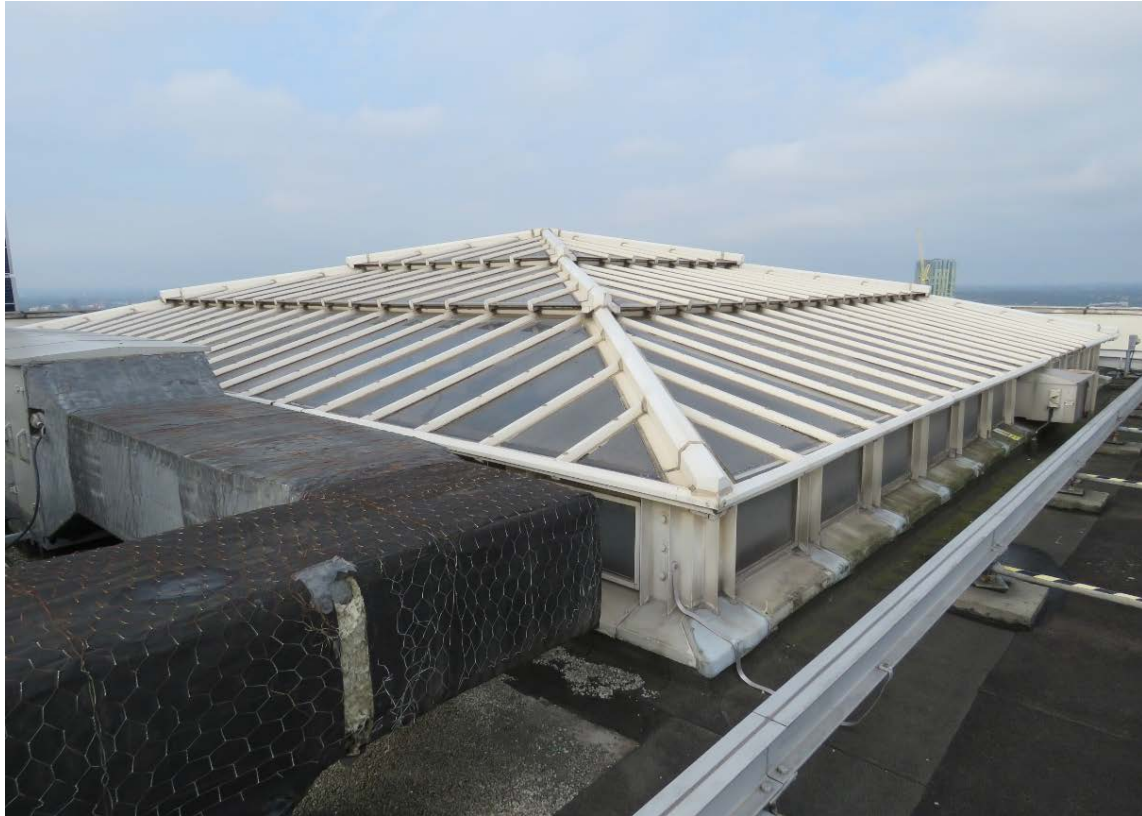
**RL-04** Looking north from the south parapet showing detail of the structure of the glazed pyramid roof.

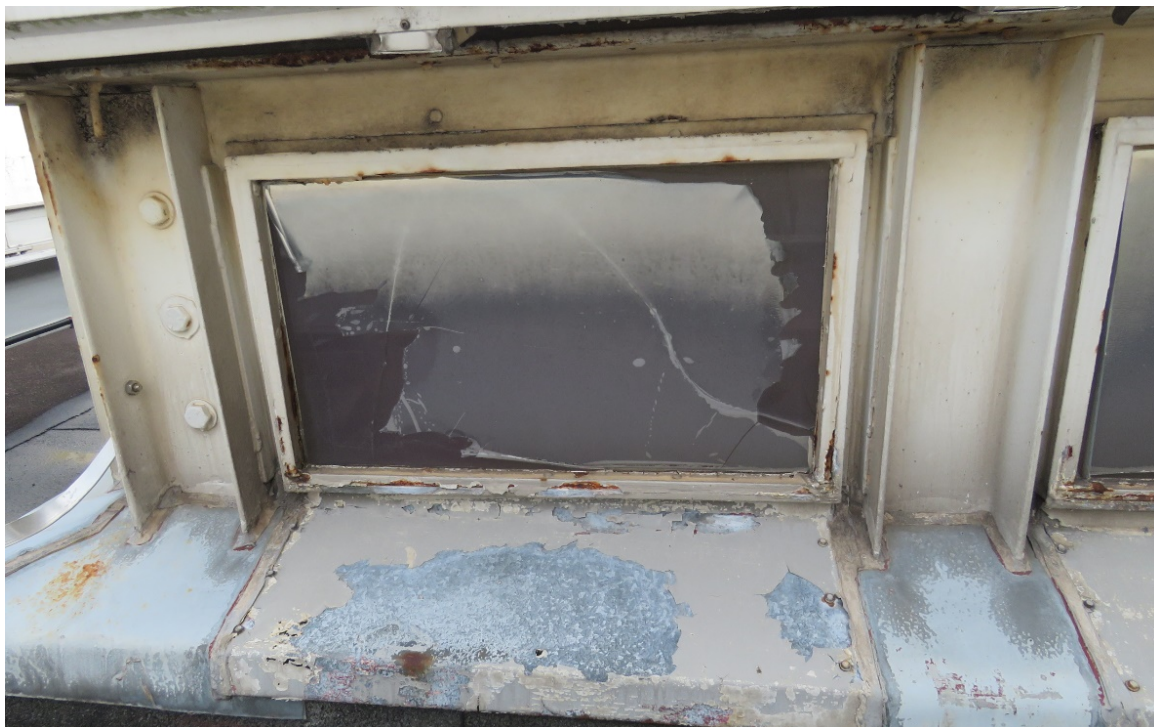
**RL 05** Detail of the original upstand and clerestory glazing of the pyramid roof, showing the failing, applied protective film.

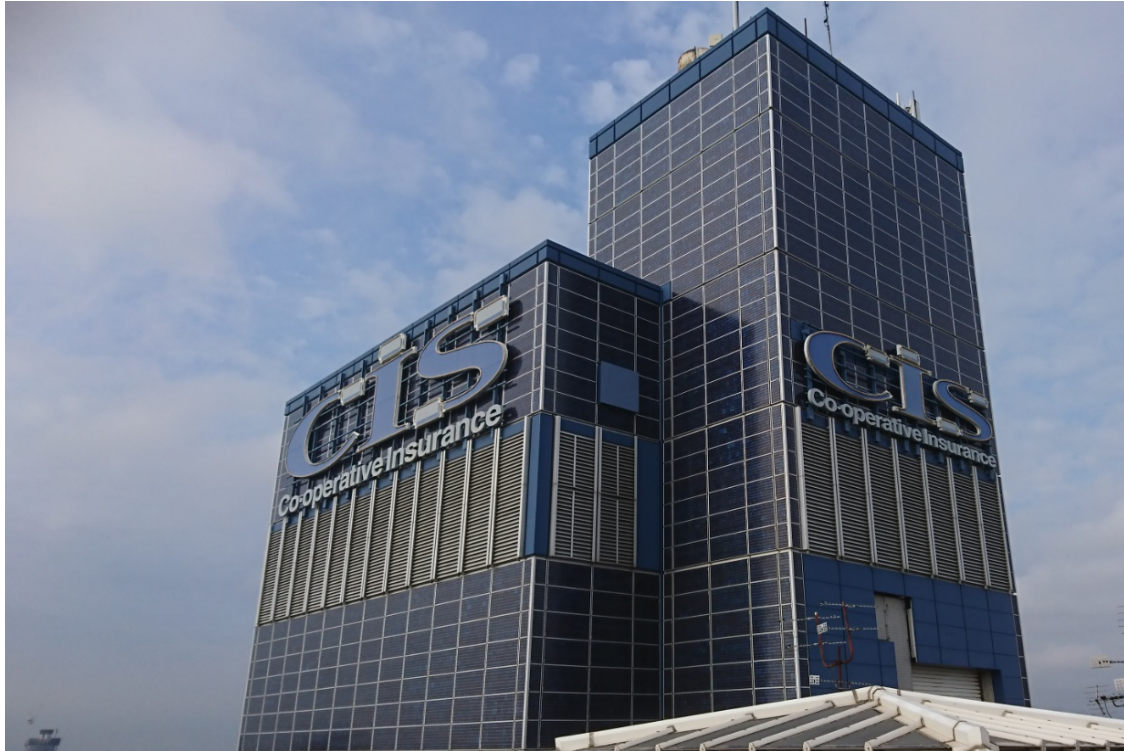
**RL-06** Looking south-west from the south-east corner at the detail of the cladding of the service tower and signage.

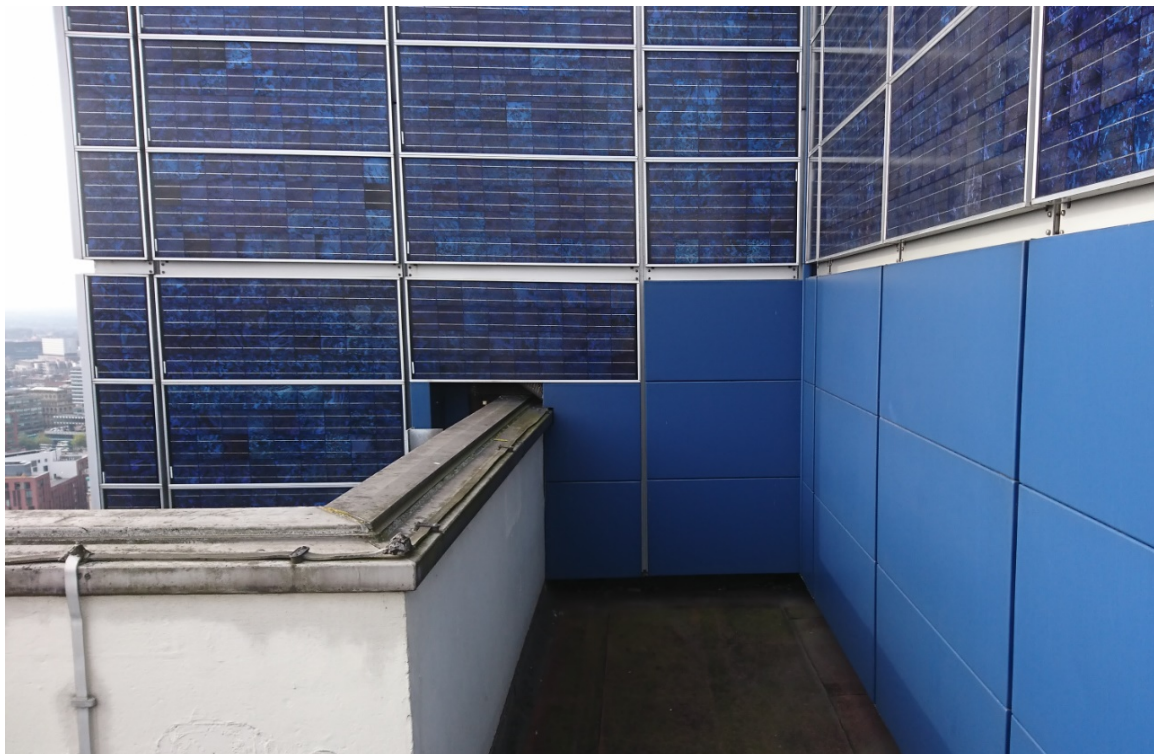
**RL-07** Looking south showing the detail of the parapet, lightning conductor, photovoltaic panels and lower level cladding.

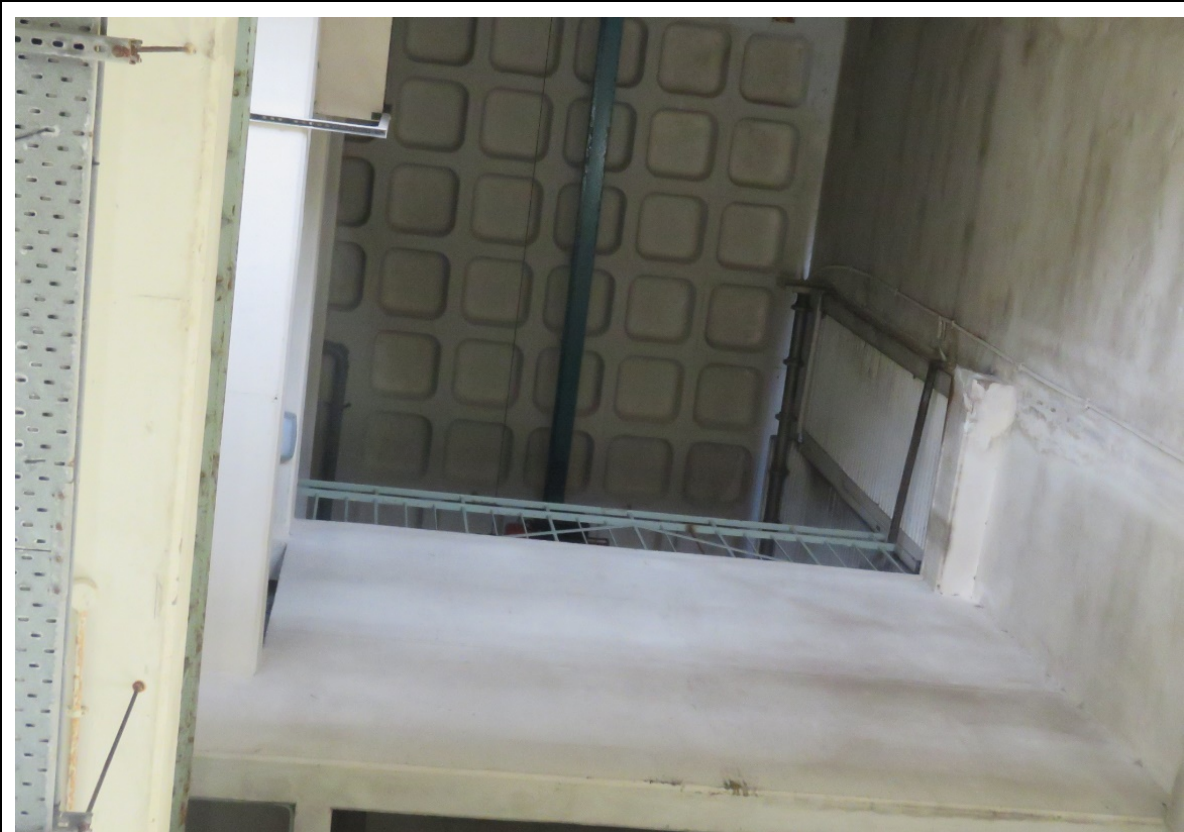
**RL-08** Looking up the service tower to the coffered concrete roof above the lift overrun.

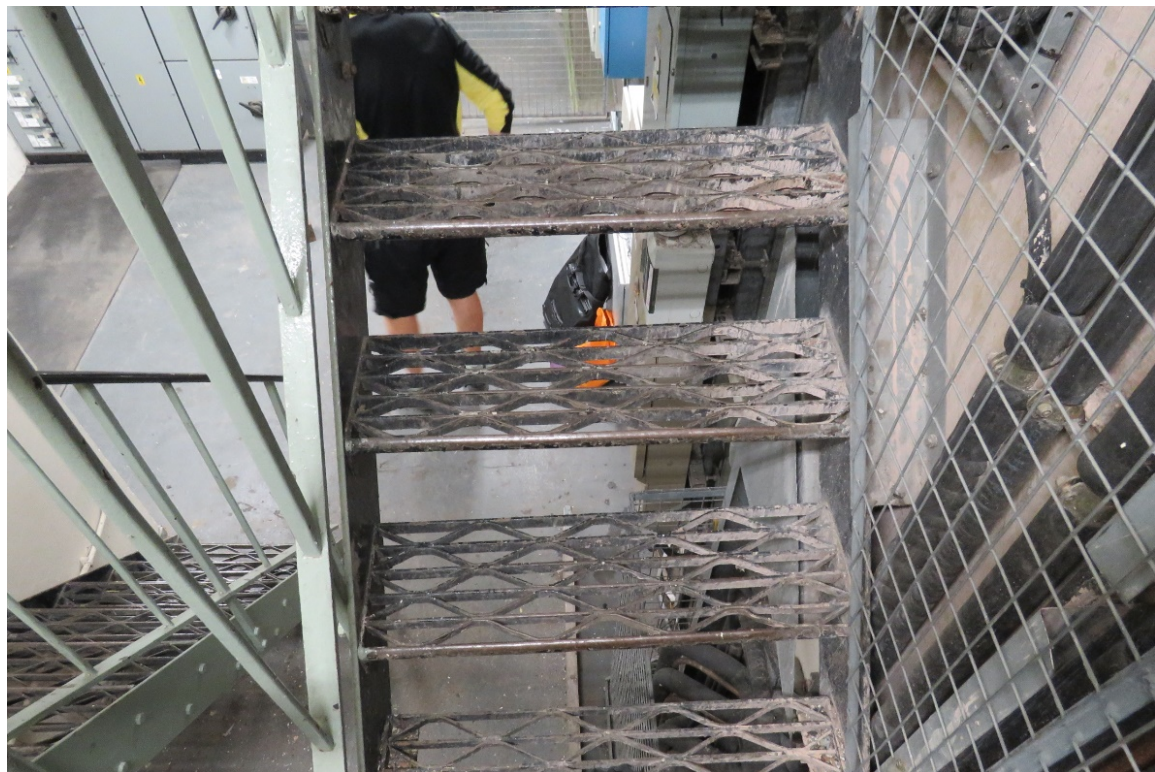
**RL-09** Detail of stairs to the service tower roof.
