MAY 2025

## HERITAGE STATEMENT

**COOP BUILDING, 93 NORTHMOOR ROAD,  
LONGSIGHT, MANCHESTER, M12 5RT**

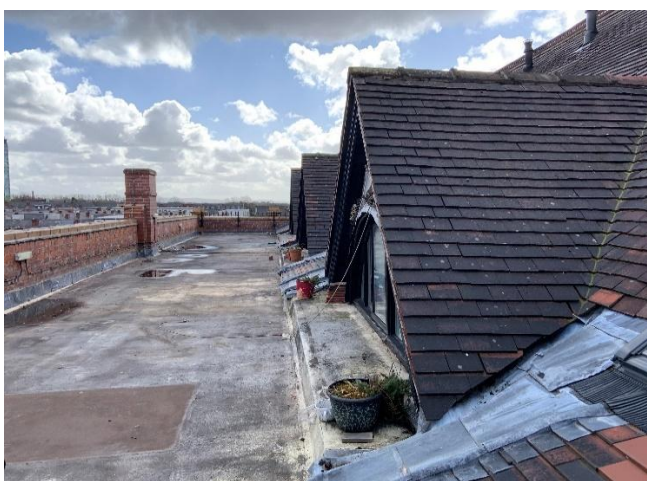
View of rear flat roof and pitched roof

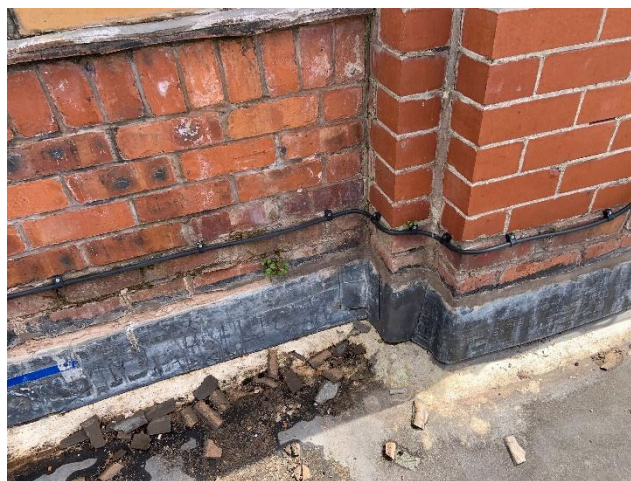
View of rear parapet wall and loose flashings.

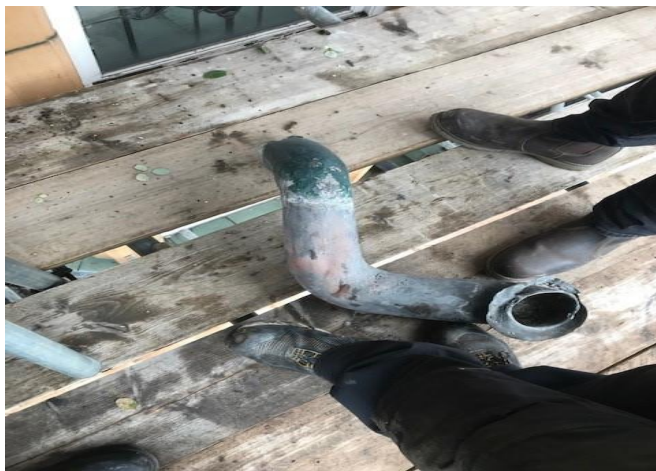
Image 73: Investigations to front elevation revealed, section of lead pipe required renewal.

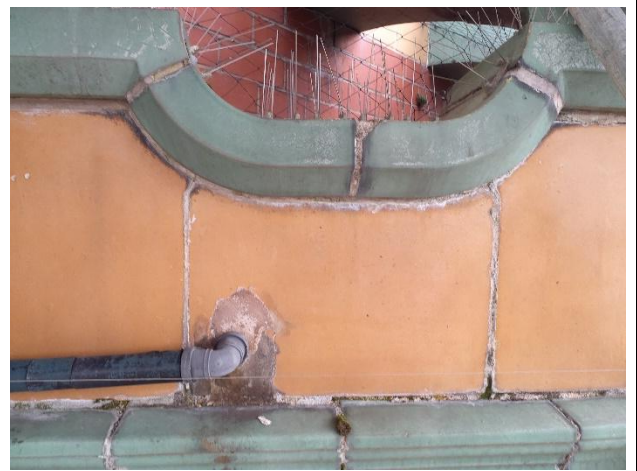
Image 74: Staining around bay roof drainage pipe.

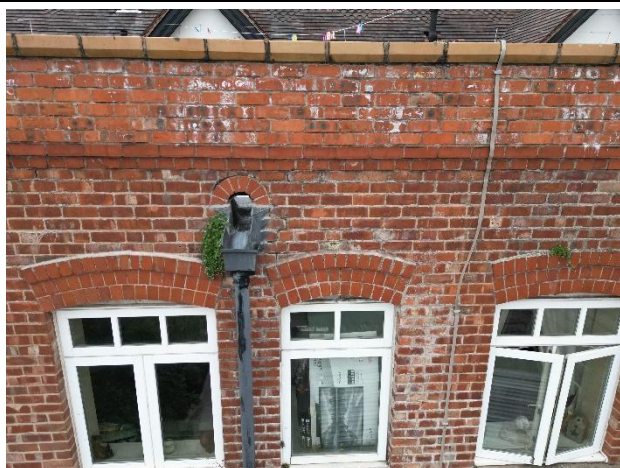
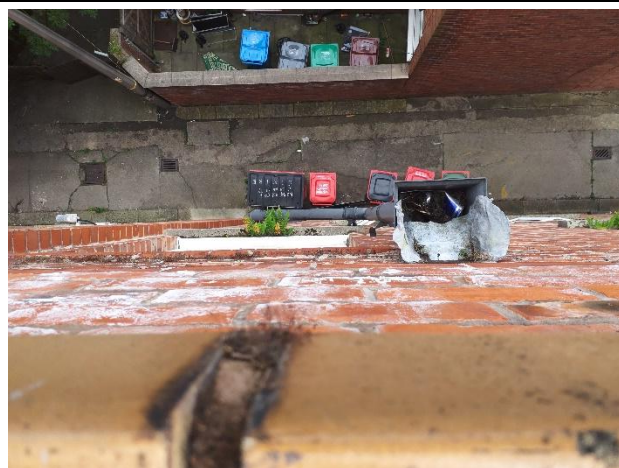
Image 76: Debris in rainwater hoppers at rear.

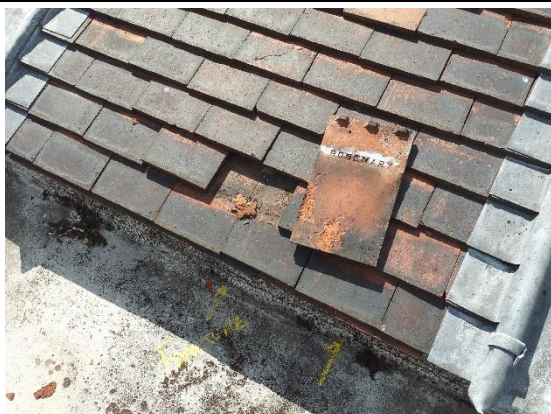
Image 77: Typical frost damage to rosemary tiles

1. Renewal of all clay tiled roof coverings complete to pitched roof areas. Include removal and renewal of tile coverings, underfelts, battens and roof vents as applicable. Existing geometric patterning within the tile roof covering is to be reproduced to match existing formations and ornate clay ridge tiles are to be retained. Estimated Roof Area – 400m<sup>2</sup>

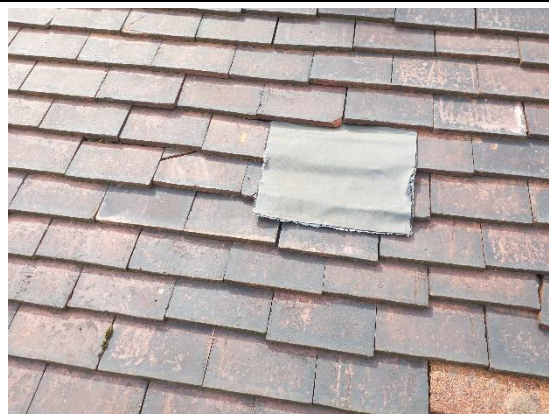
Image 78: Poor quality repairs to tile coverings.
