68-70 OLDHAM STREET, NORTH-WEST FACADE  
EXTERNAL OBSERVATIONS

70 OLDHAM STREET, NORTH-EAST FACADE ON WARWICK STREET  
EXTERNAL OBSERVATIONS

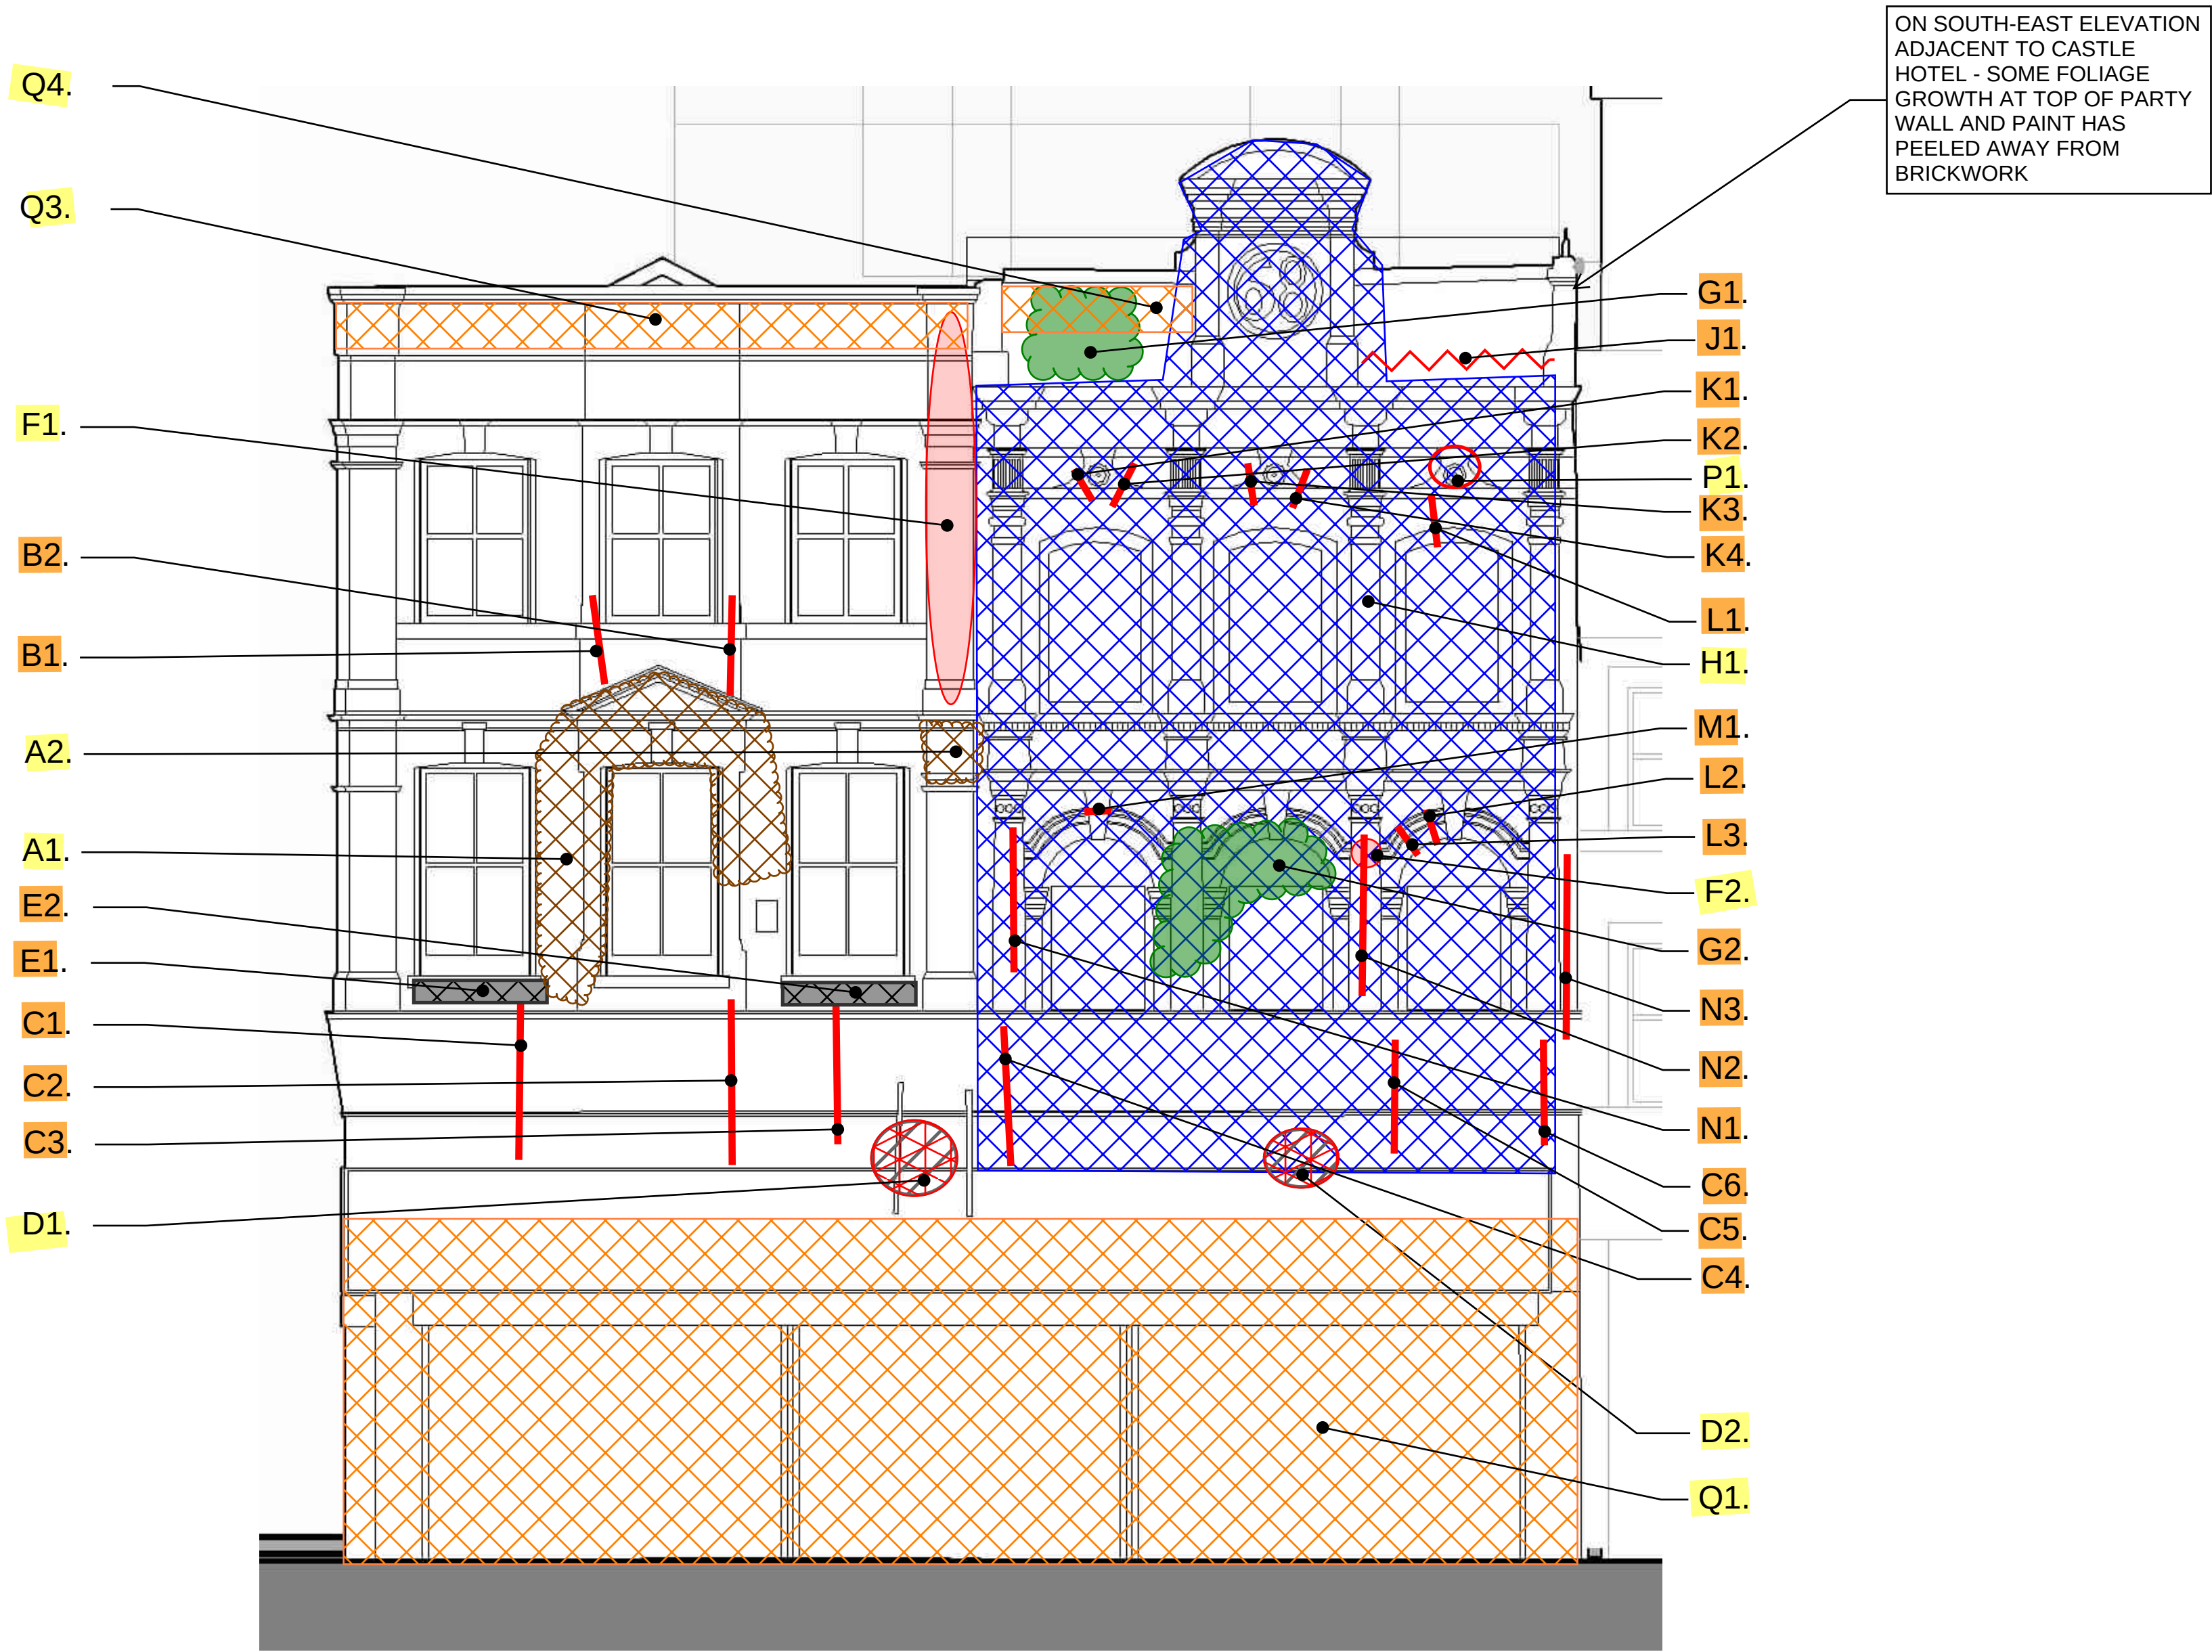
A1 - A2. PAINT HAS BEEN STRIPPED FROM BRICKWORK  
B1 - B2. VERTICAL CRACK IN BRICKWORK  
C1 - C6. VERTICAL CRACK IN PLASTER / CONCRETE RENDER  
D1 - D2. MISSING TILES  
E1 - E2. STAINING BELOW WINDOWS INDICATING DAMP BRICKWORK  
F1 - F2. PAINT / RENDER PEELING AWAY FROM BRICKWORK  
G1 - G4. FOLIAGE GROWTH THROUGH FACADE.  
H1. NETTING IN PLACE (ASSUMED TO STOP FALLING RENDER)  
J1. HORIZONTAL CRACK IN RENDER (POSSIBLY THROUGH TO BRICKWORK)  
K1 - K4. VERTICAL CRACKS IN ORNATE PLASTER OVER WINDOWS  
L1 - L3. VERTICAL CRACKS IN LINTELS (CLEAR IN RENDER, MAY BE TRHOUGH TO BRICKWORK ARCH LINTELS)  
M1. HORIZONTAL CRACK THROUGH ORNATE KEYSTONE IN ARCH LINTELS

N1 - N3. VERTICAL CRACK IN ORNATE FACADE COLUMNS  
P1. ORNATE MOULDING OVER RIGHT-MOST WINDOW AT SECOND FLOOR MISSING  
Q1 - Q2. GRAFFITI ON STEEL ROLLER SHUTTERS AND RENDER (OVER TILES) ABOVE1. SECTION OF BRICKWORK APPEARS TO BE A REPLACEMENT - THOUGHT TO BE WHERE CHIMNEY HAS BEEN REMOVED.  
S1. ROUGH AND UNEVEN BRICKWORK / RENDER PEELING AWAY FROM BRICKWORK.  
T1 - T2. INTERNAL PLASTER BROKEN OFF BRICKWORK WALL  
U1 - U2 (**AND GENERAL COMMENT INTERNALLY**). DAMP AND MOULD GROWTH ON RETURN WALL AT CENTRE OF FACADE, AT ROOF AND FLOORS ADJACENT TO FACADE, AND TO INTERNAL FACE OF FACADE BRICKWORK.  
V1-V2. CRACK IN PLASTER AND BRICKWORK NOT TOOTHED IN PROPERLY IN RETURN WALL  
W1. MINOR CRACKS BELOW AND BETWEEN WINDOW SILLS  
X1. CRACKS IN RETURN WALL AT CENTRE OF FACADE.  
Y1. DAMAGE TO EXISTING TIMBER ROOF CAUSING RAINWATER PENETRATION  
Z1. TIE TOD FROM BACK OF NO.68 FACADE TO PITCHED ROOF.
