## **PHOTOGRAPHS**

**COOP BUILDING, 93 NORTHMOOR ROAD, LONGSIGHT, MANCHESTER,  
M12 5RT**

Rider Levett Bucknall

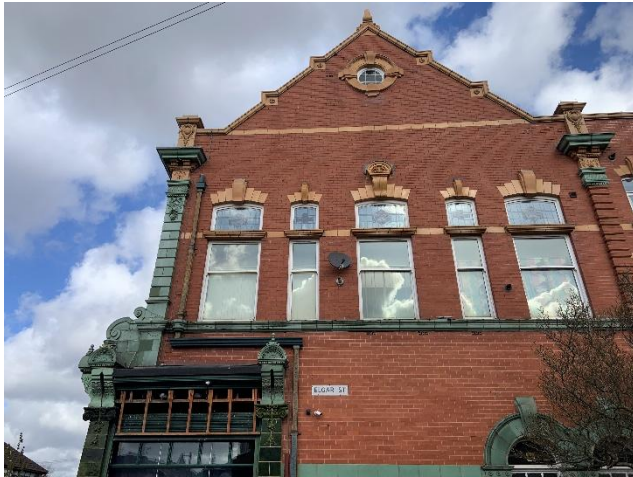
1 View of existing upper windows - Elgar Street

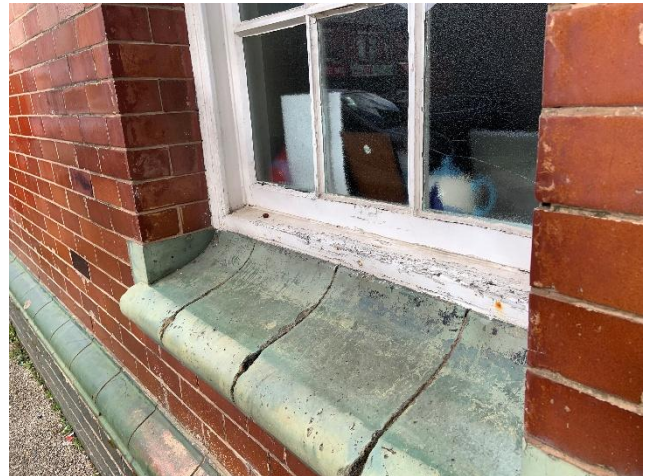
2 round floor windows to be overhauled

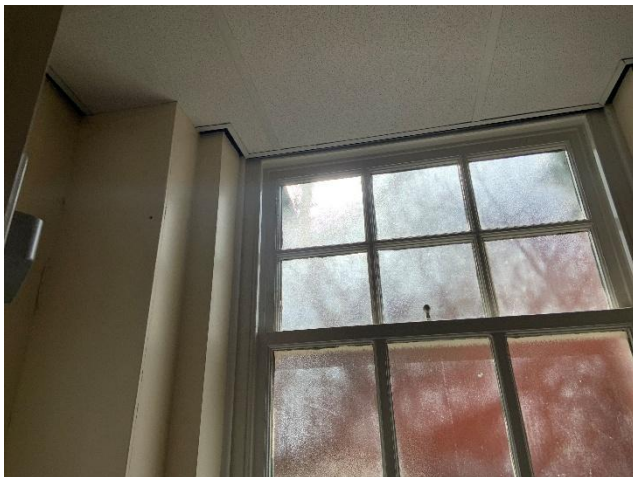
3 View of ground floor windows internally

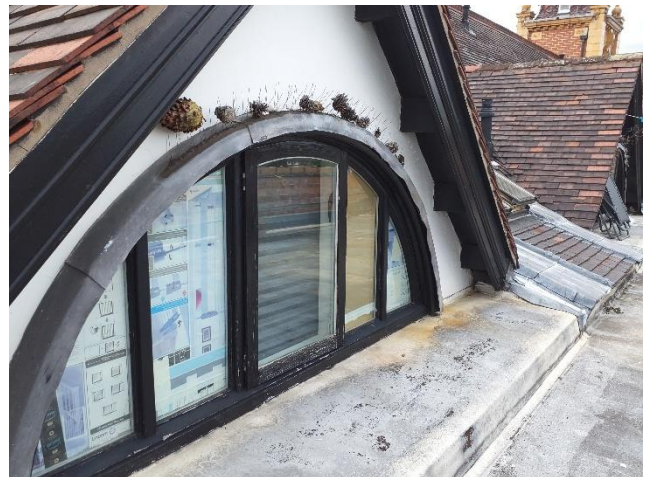
4. Arched windows to rear flat roof

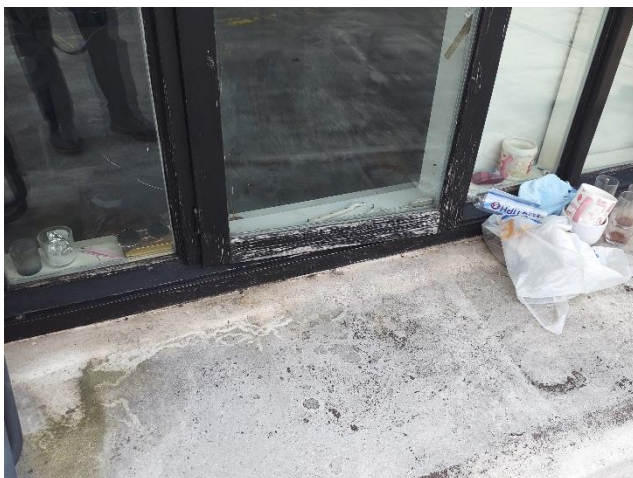
5 Flaking paint to rear dormer windows

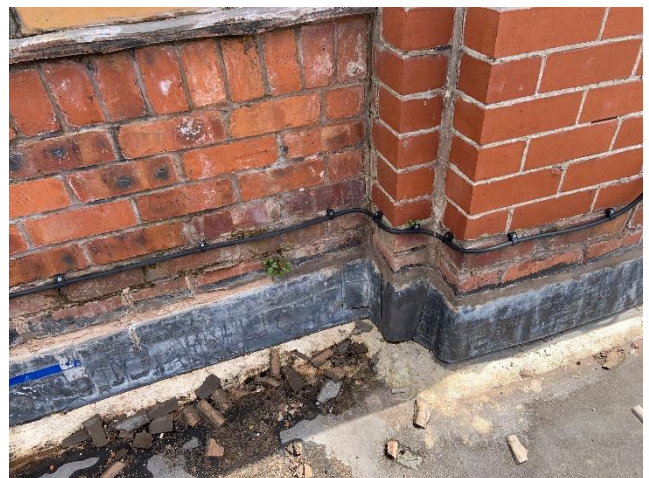
6 Dampness and pointing failing to rear parapet

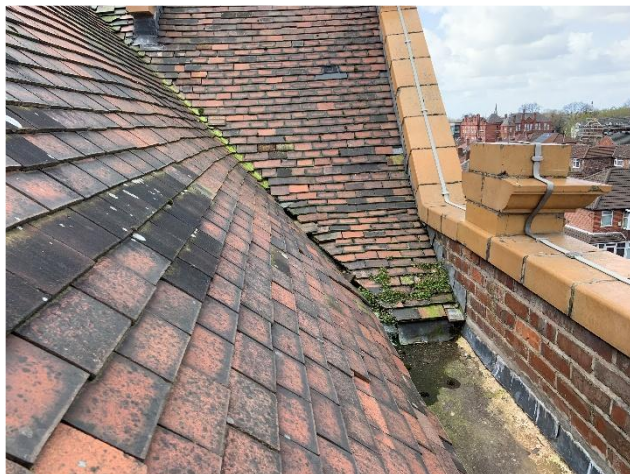
7. Broken and loose tiling to rear pitched roof

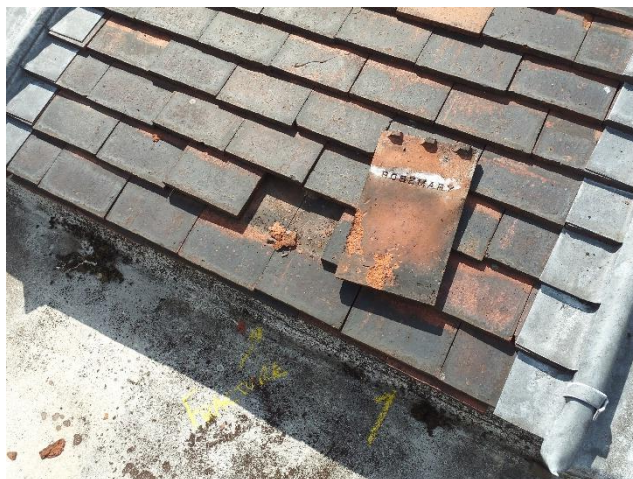
8. Frost damage to roof tiles

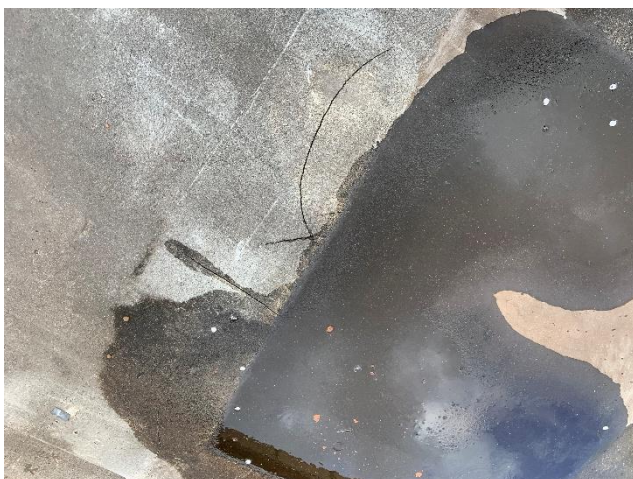
9. Typical cracking to rear asphalt roof covering

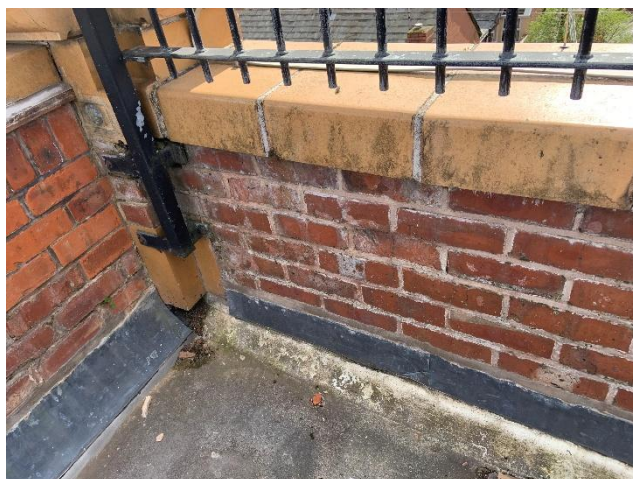
10. Perished brickwork to rear parapet walls

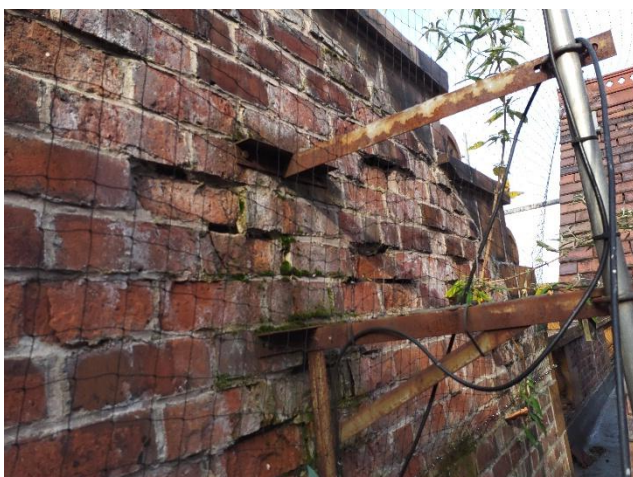
11. Perished brickwork to rear of front pediment

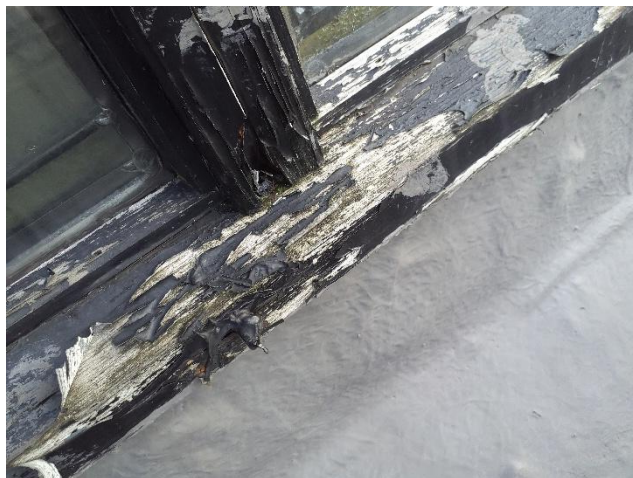
12. Poor condition to front door windows

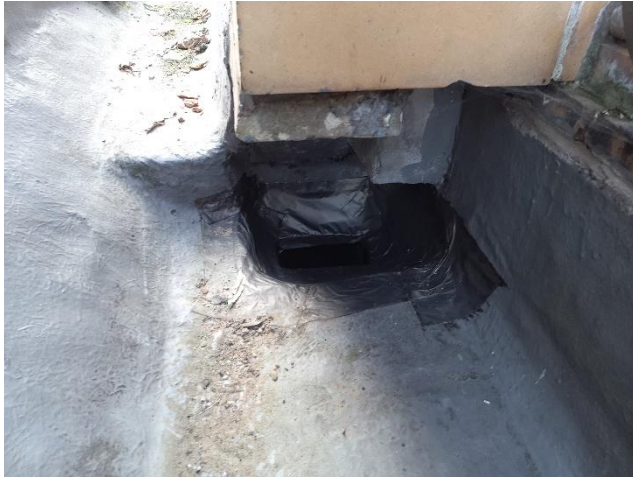
13 Historic repairs, front box gutter

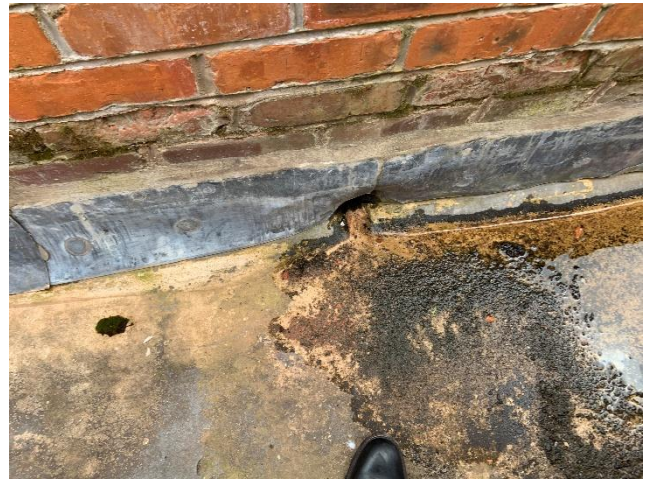
14 Poor drainage to rear flat roof

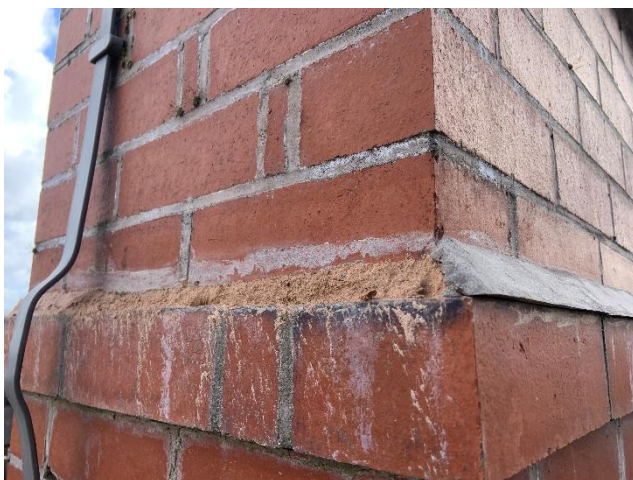
15 Poor pointing repairs to rear chimney

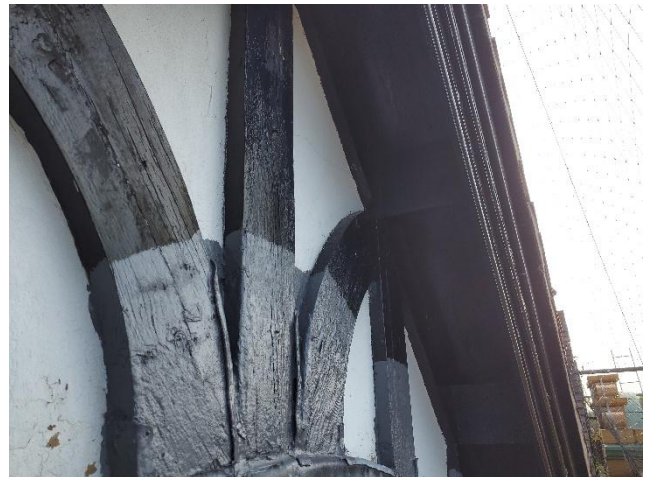
16 Mock tudor timber elements poor condition - Front
