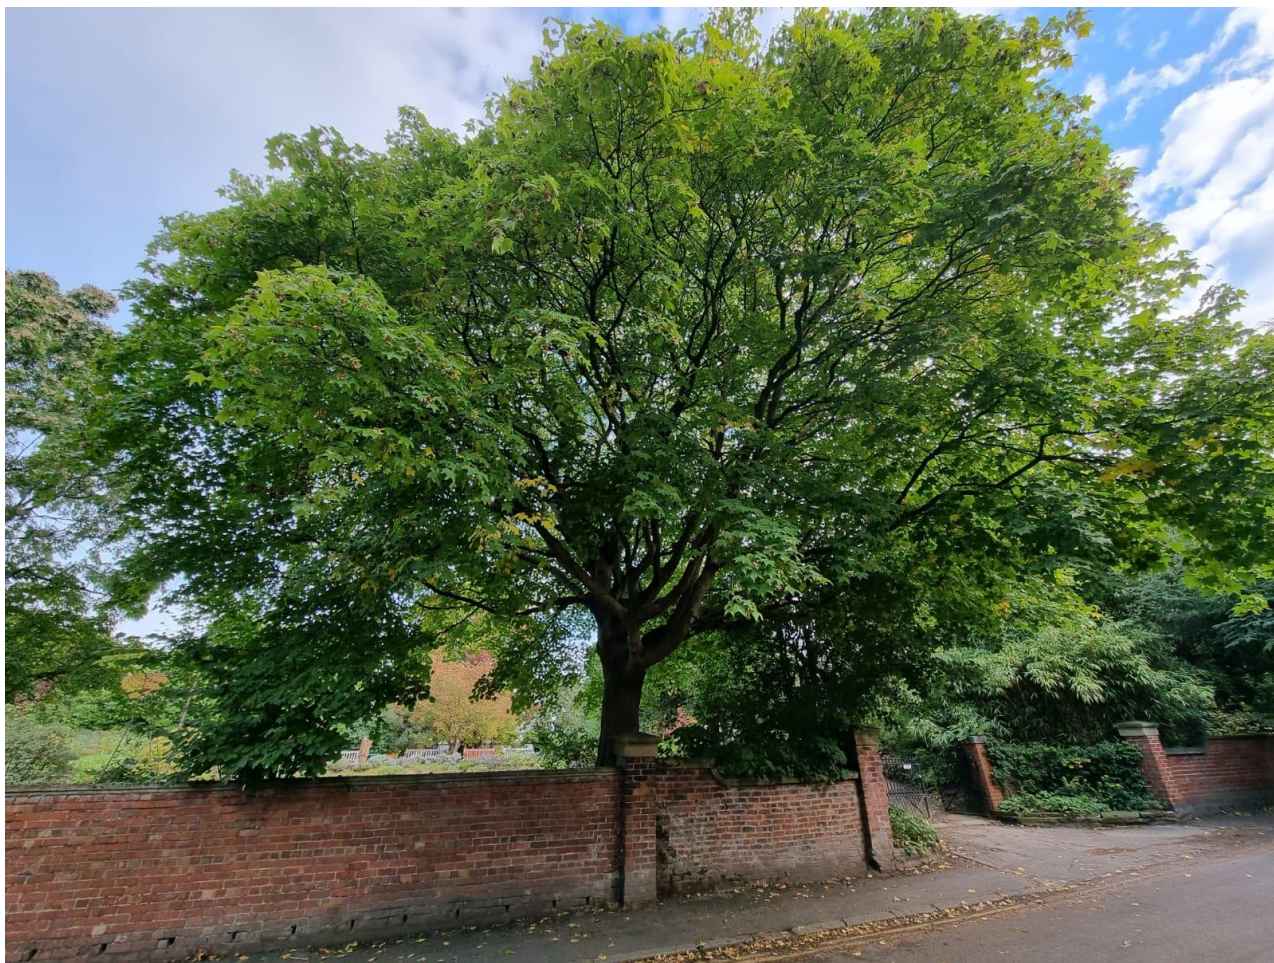
**Photo 1:** Photograph taken on Stenner Lane facing the Western perimeter boundary retaining wall to Fletcher Moss Art Gallery. Photo shows section of wall to be dismantled and rebuilt adjacent the large Field Maple Tree.

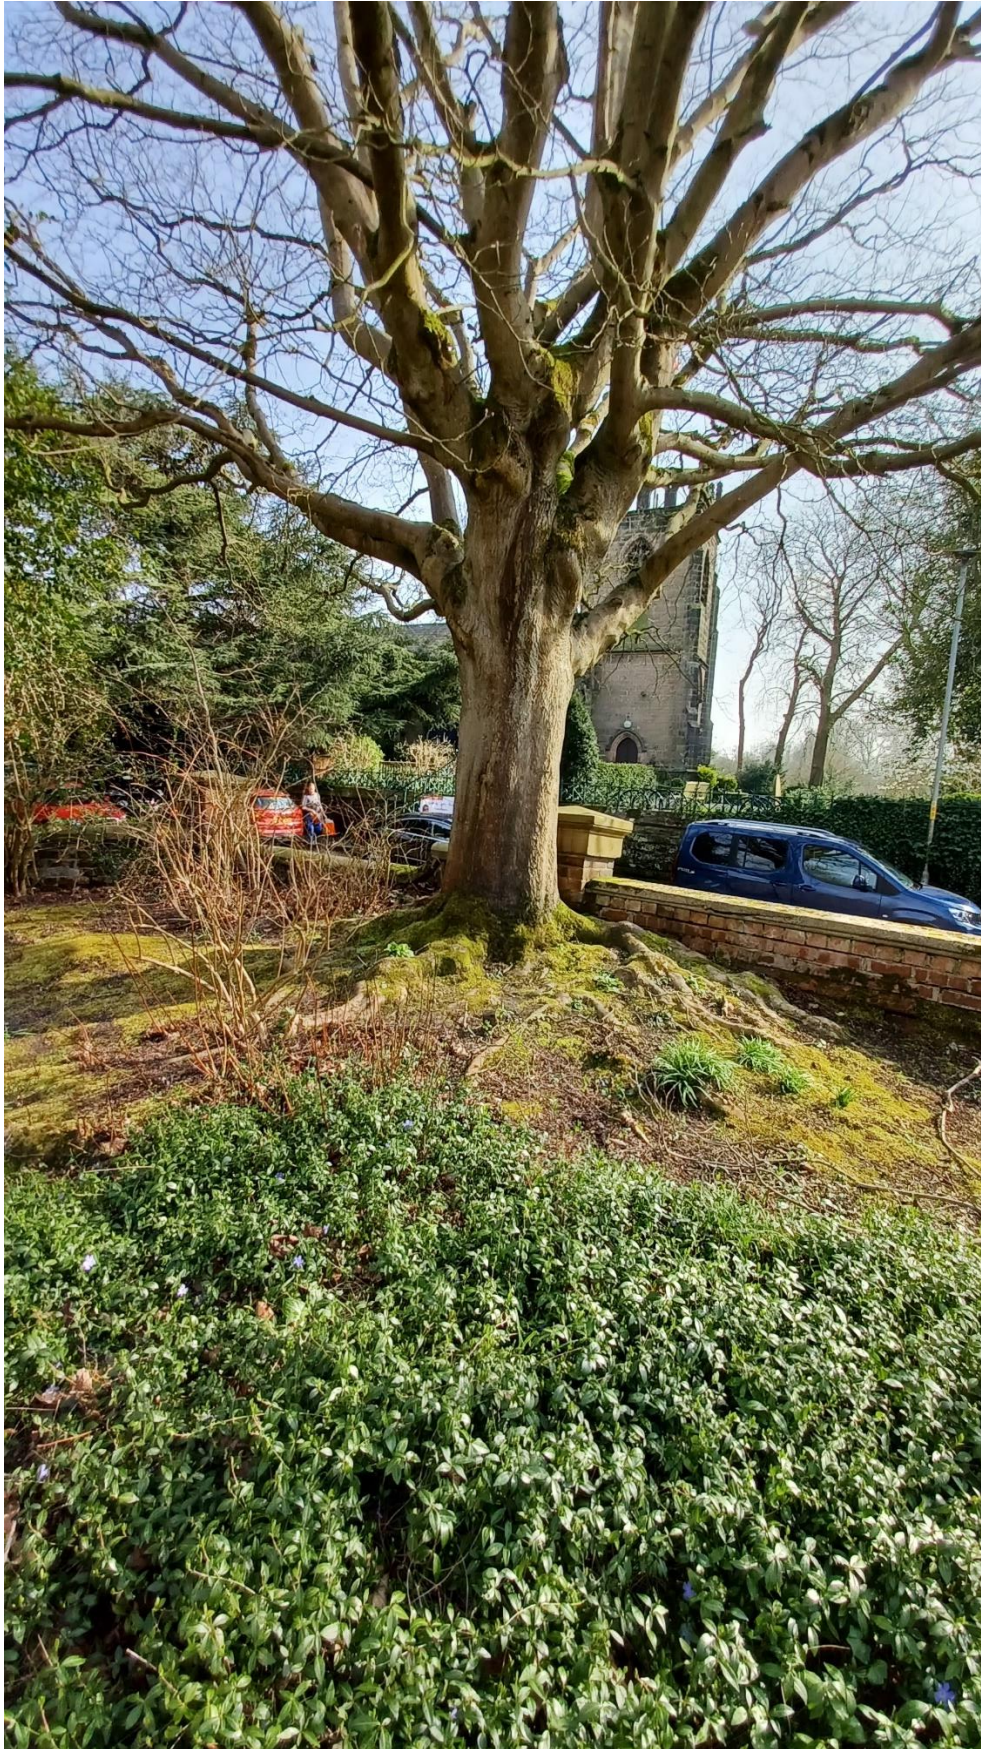
**Photo 2:** Root system at ground level and parapet wall from inside Parsonage Gardens.

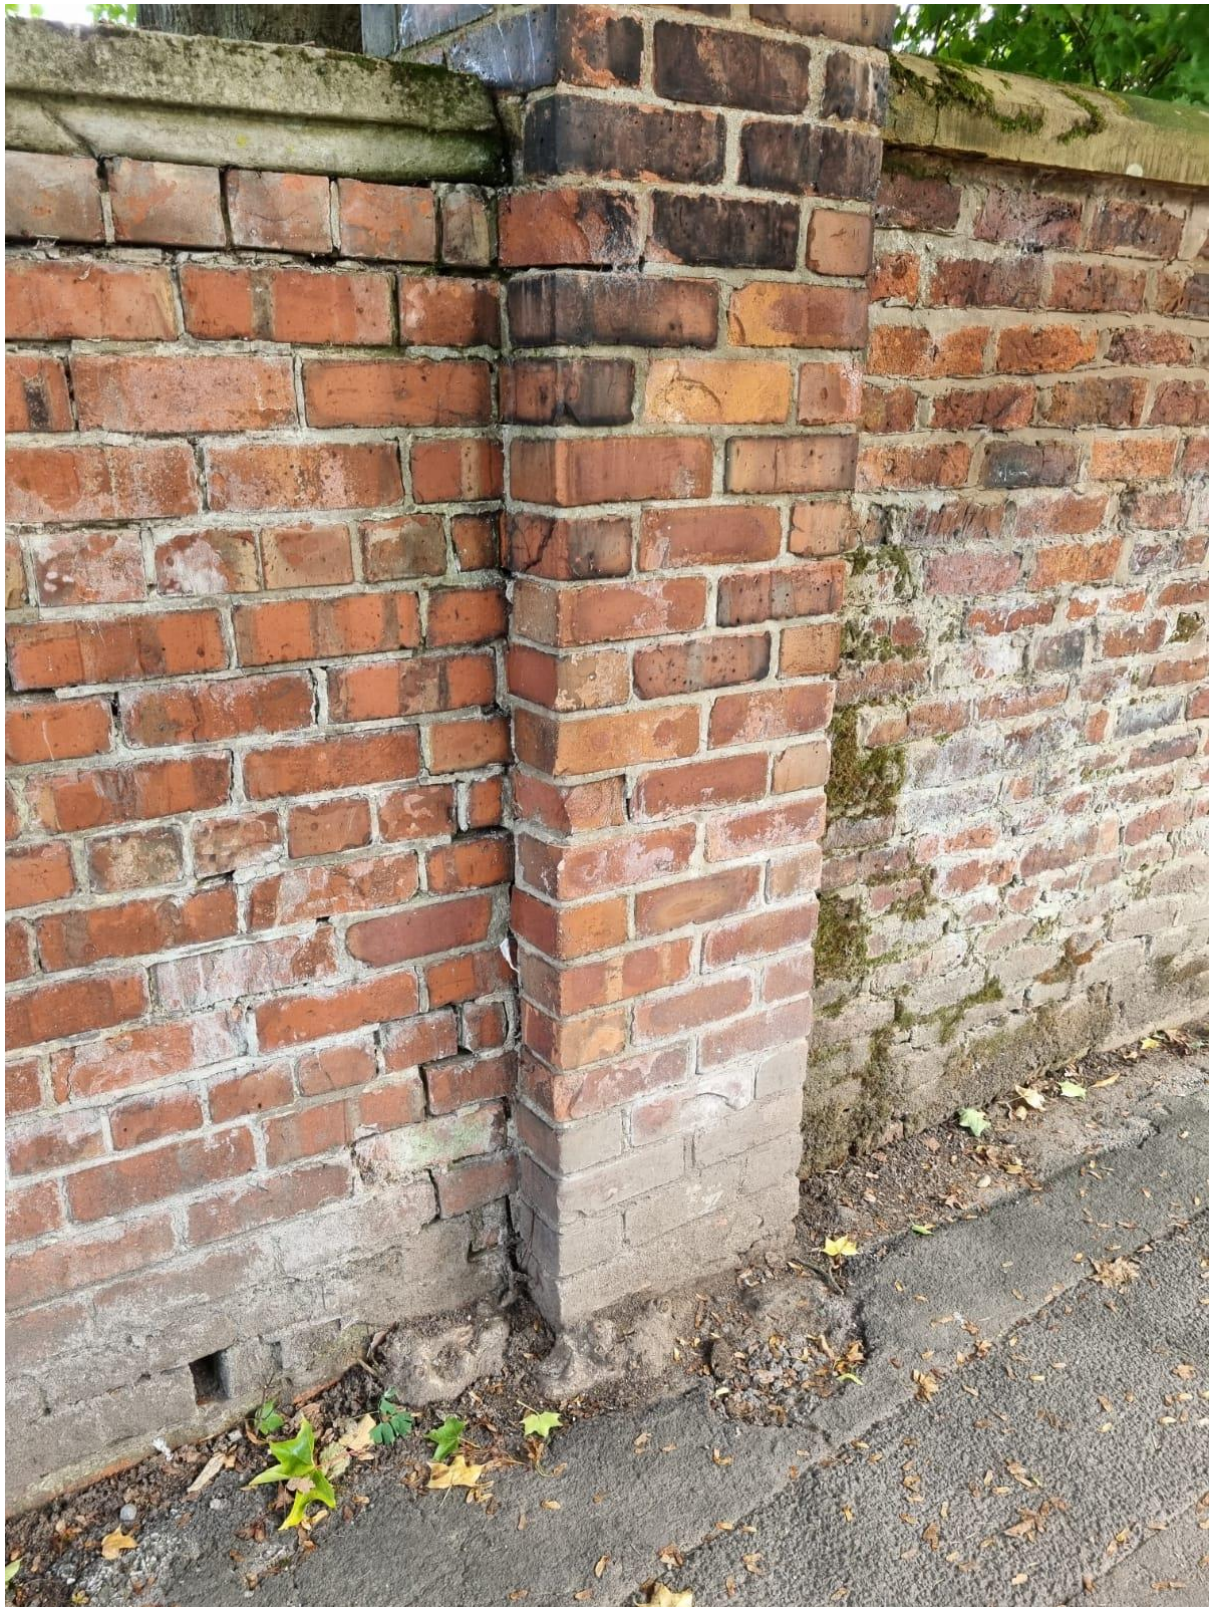
**Photo 3:** Photograph shows pier adjacent Field Maple tree and the two different brick bonds either side, English Garden Wall bond and Stretcher bond.

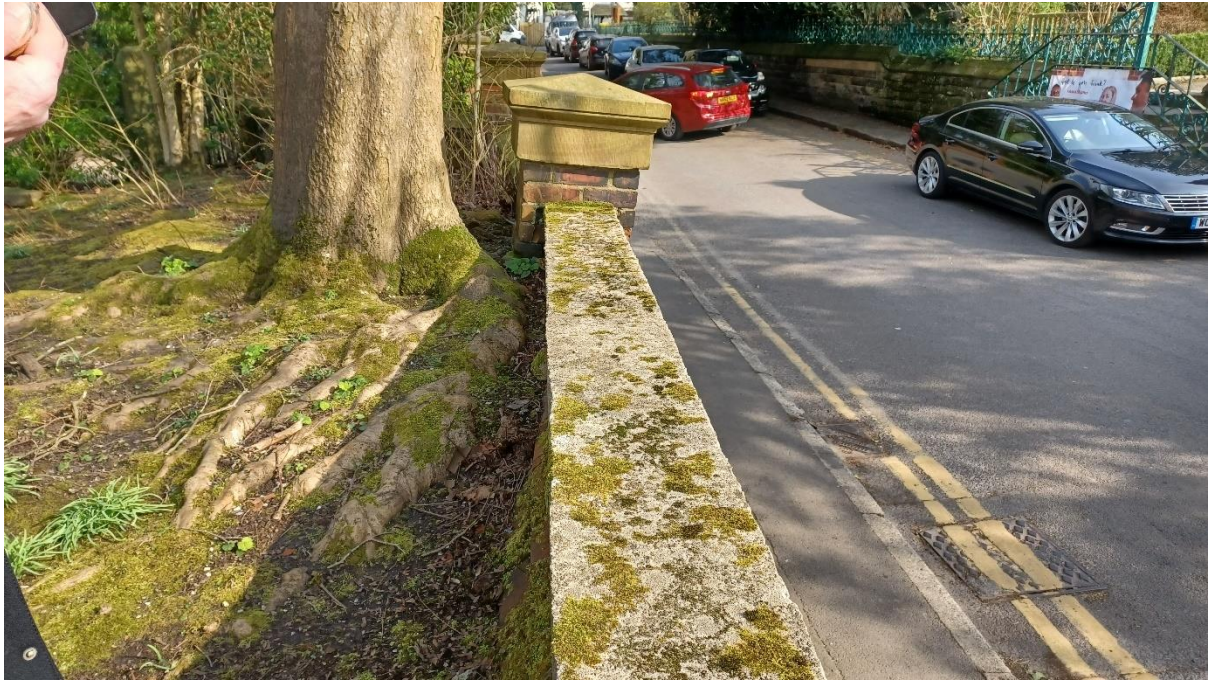
**Photo 4:** Photograph of the leaning boundary / retaining wall. Photo shows the roots behind the wall are pushing the wall at parapet level.

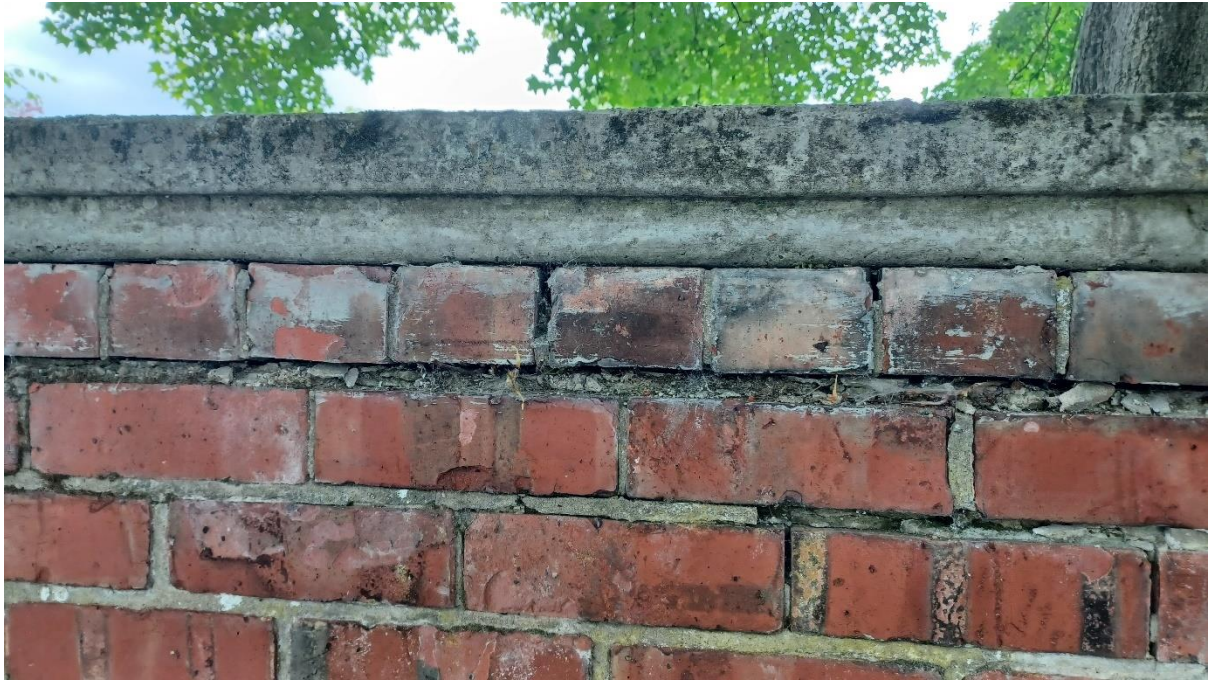
**Photo 5:** Photograph shows the cast insitu concrete coping on top of the boundary wall and tree roots growing between the brick mortar joints.

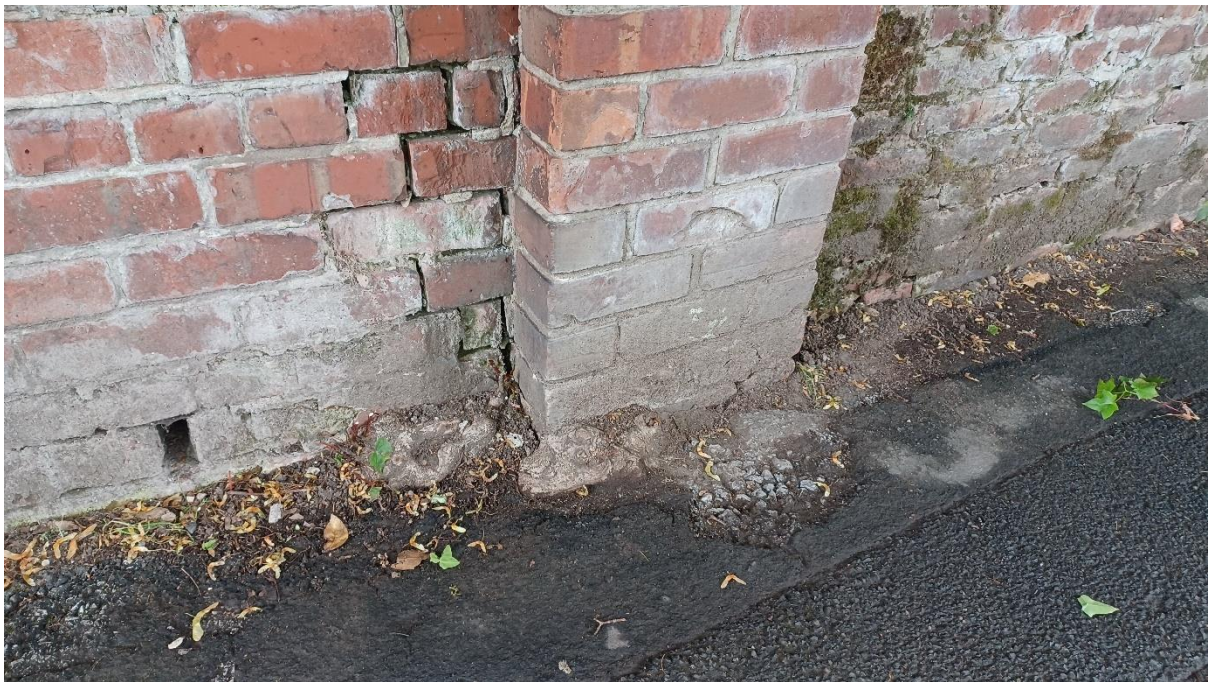
**Photo 6:** Roots at ground / footpath level at base of pier adjacent Field Maple Tree.

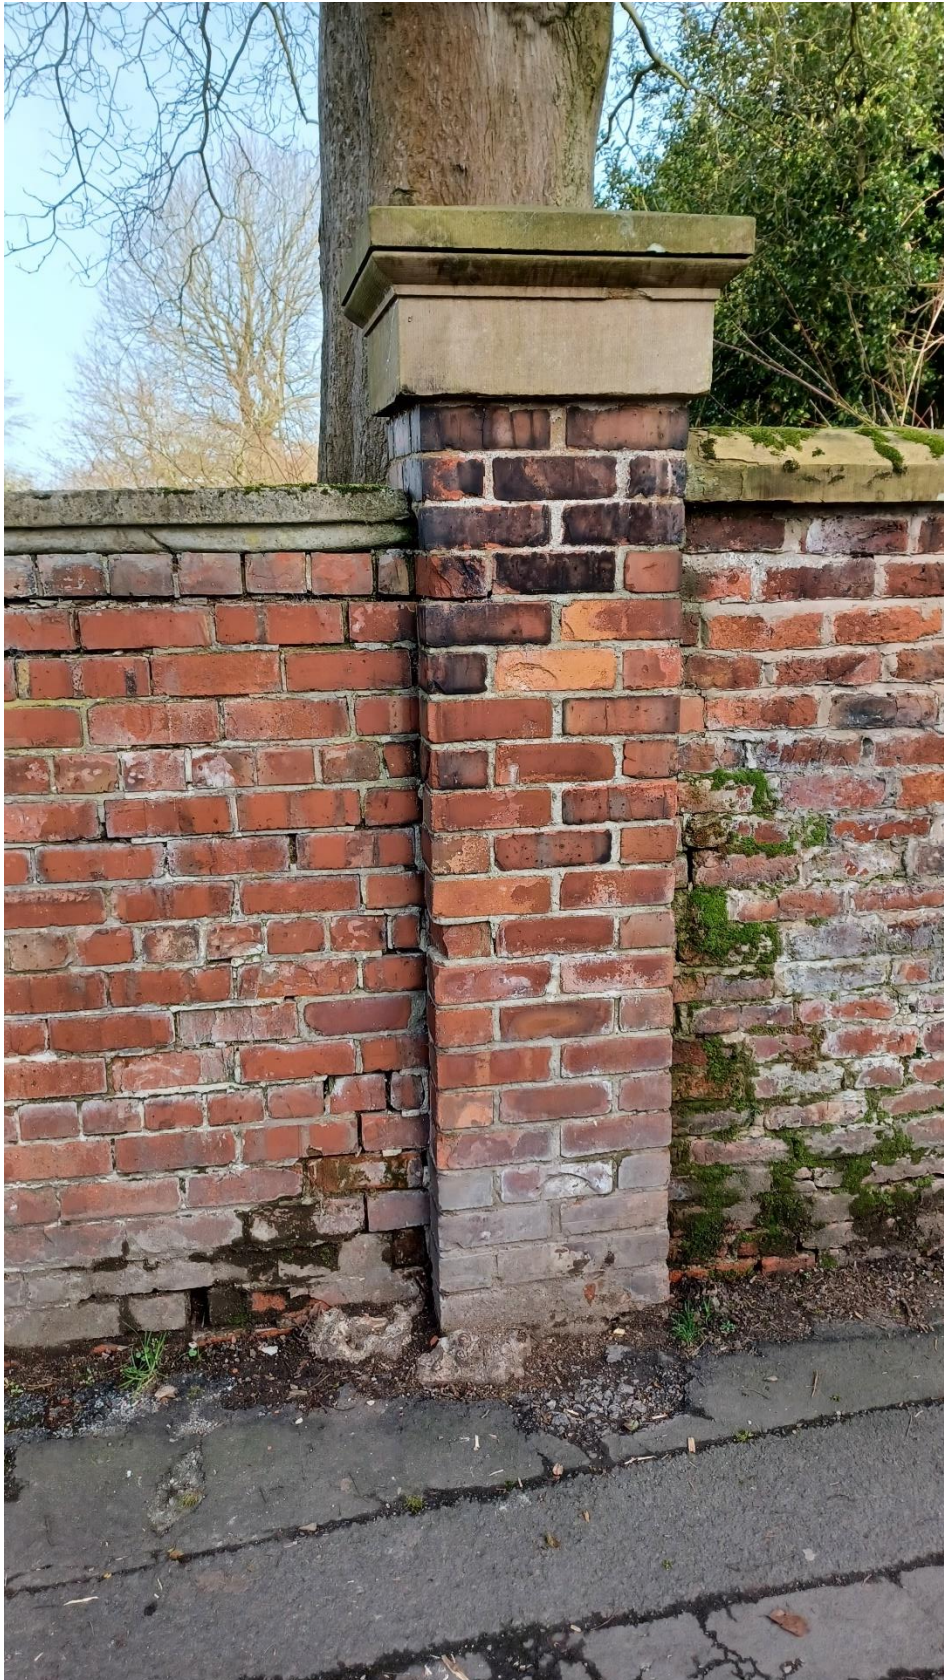
**Photo 7:** Photograph shows the existing copings, left side newer concrete coping, pier coping and original curved coping on right hand side.

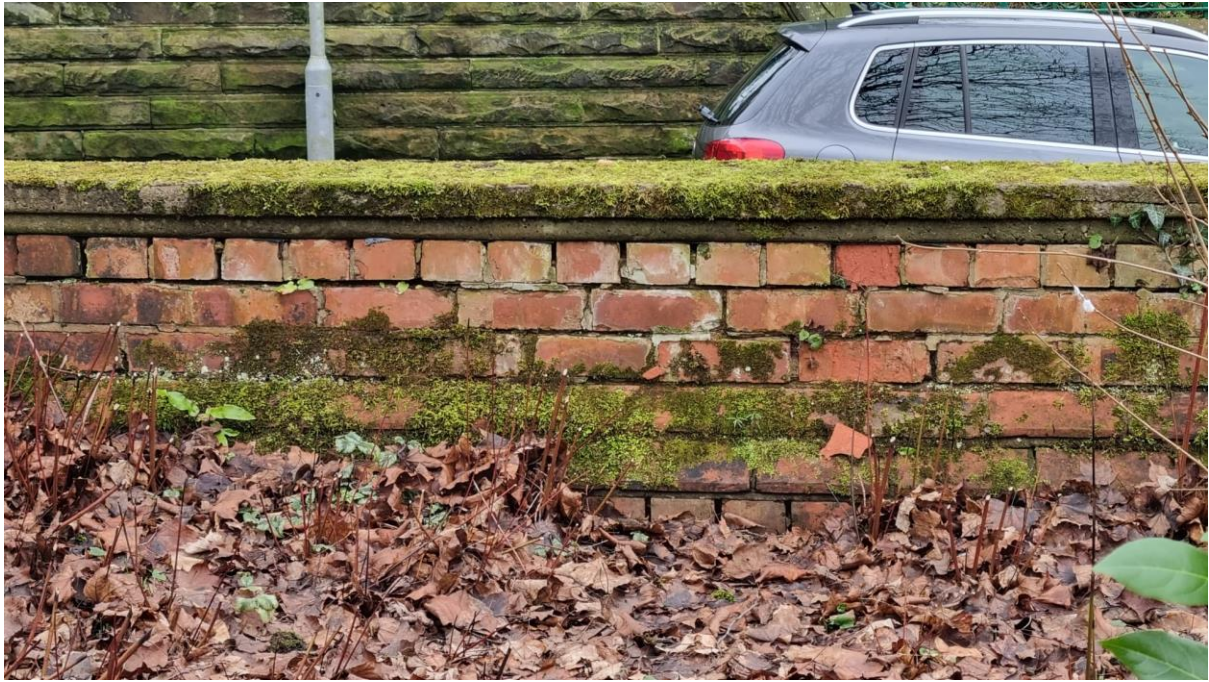
**Photo 8:** Photograph shows the parapet wall section on the Parsonage Garden side.

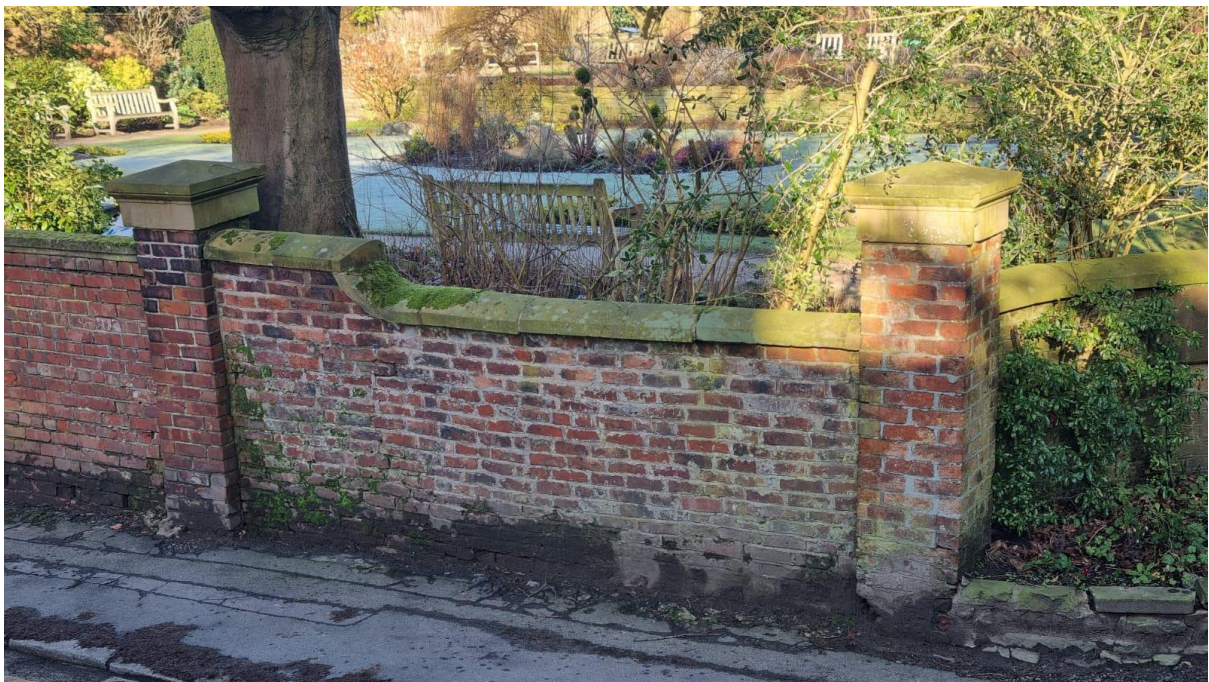
**Photo No.9:** Photograph shows the section of wall between the two piers with original coping stones.

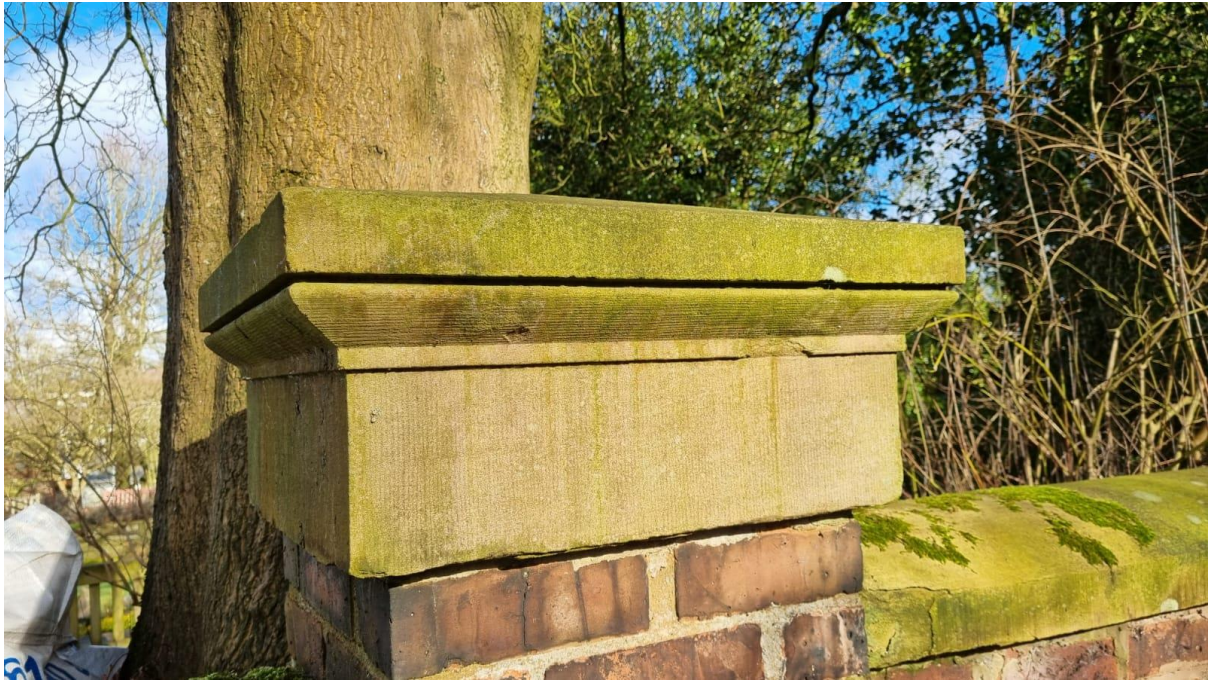
**Photo No.10:** Photograph shows the existing pier coping.
