## CIS Tower Refurbishment.

Recording Strategy and Photographic Audit of internal & external features.

# APPENDIX 29 – LEVEL 23. INTERNAL.

Planning Permission ref: 126118/FO/2020. Condition 29.

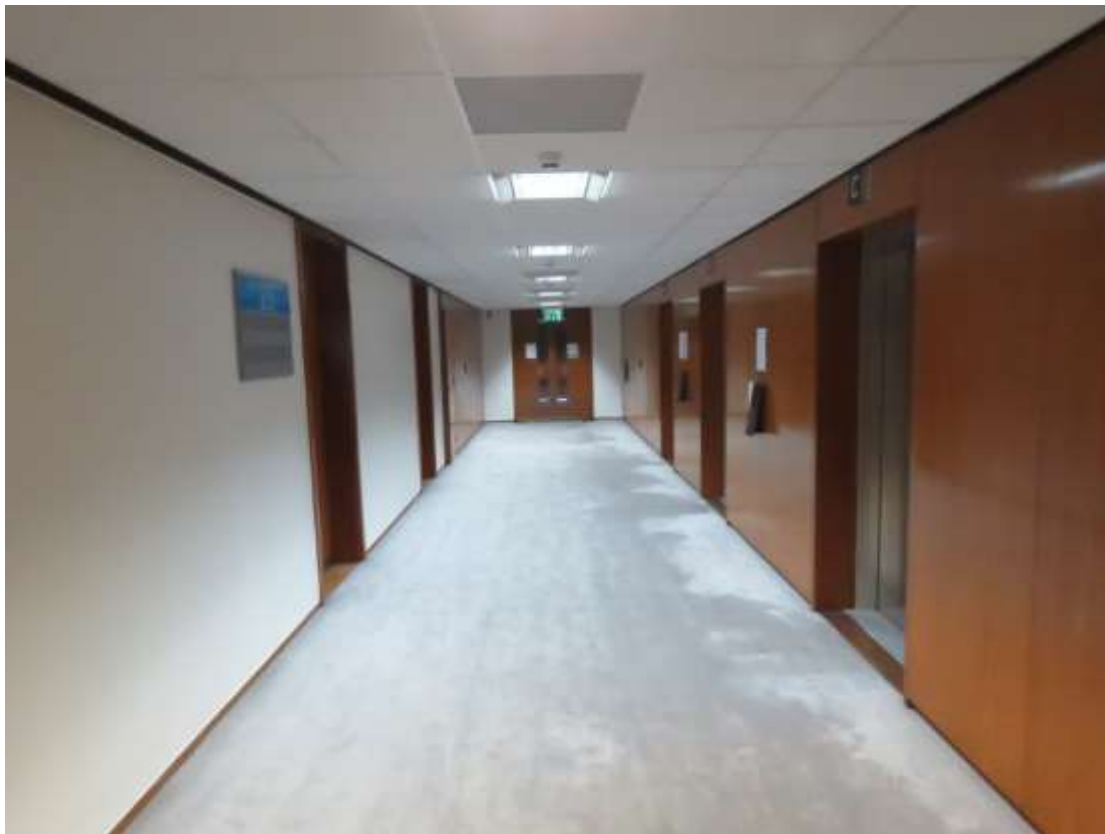
**23-01** View through lift lobby looking north.

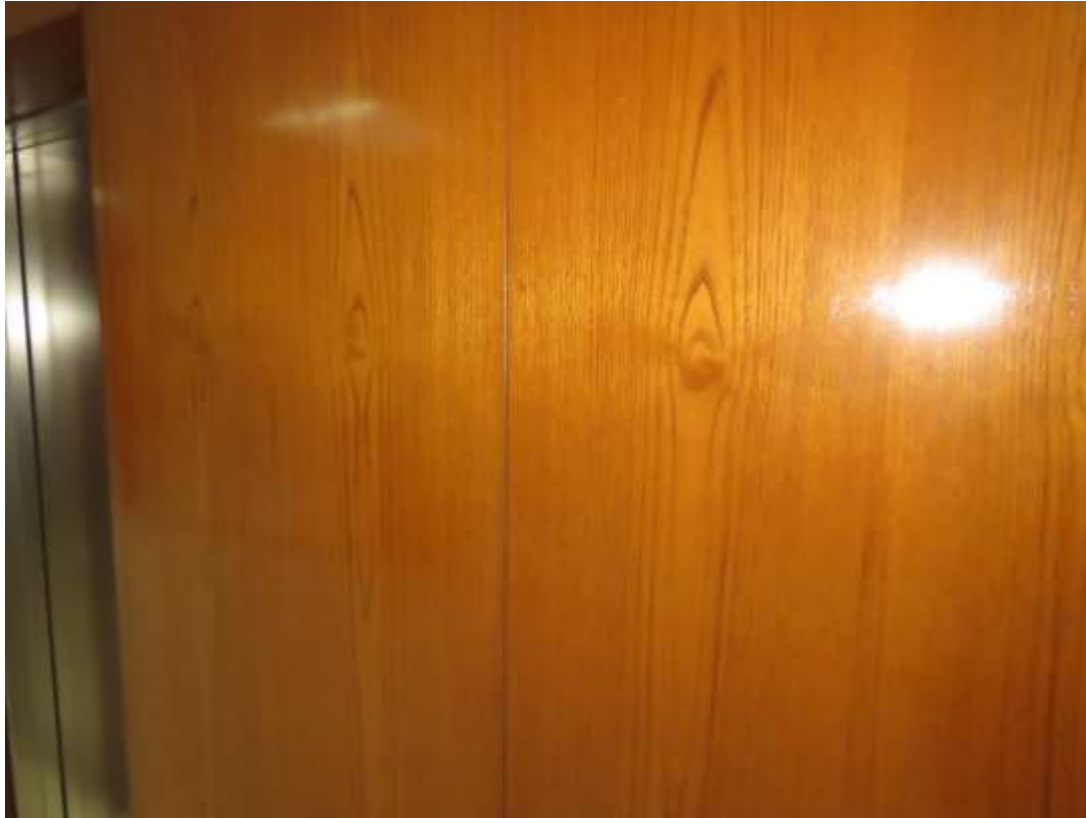
**23-02** View of original timber panelling in lift lobby.

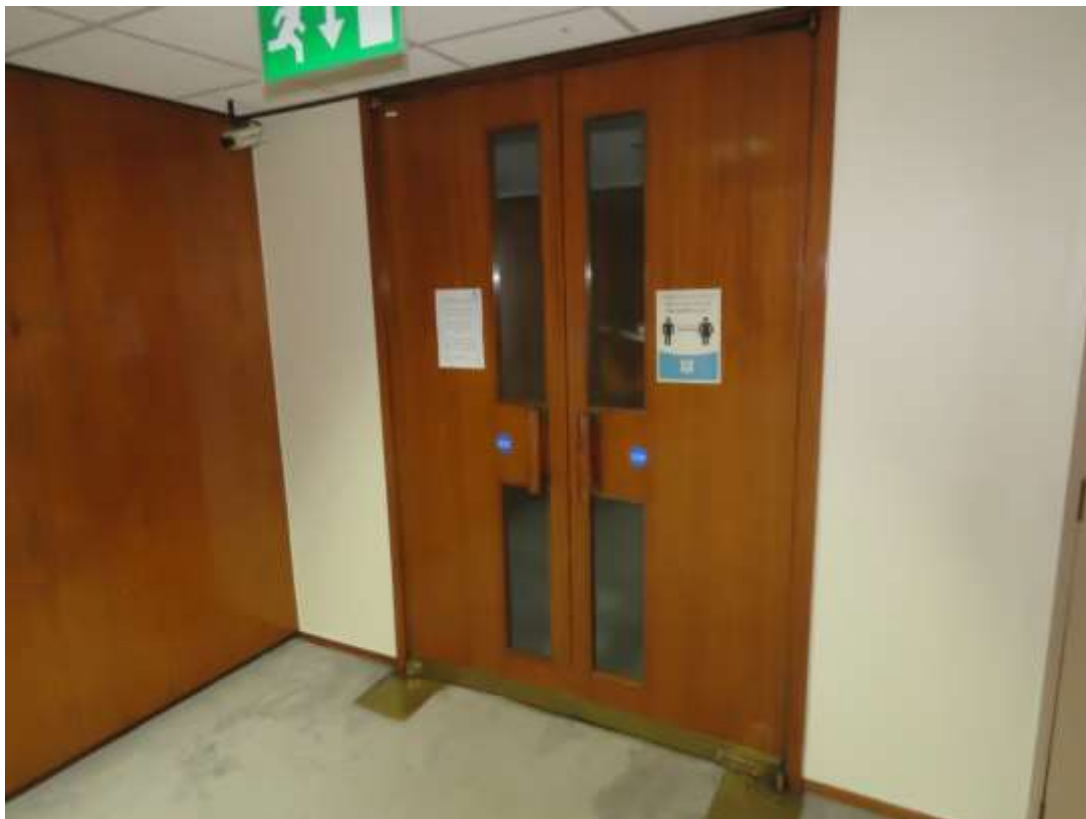
**23-03** View of original timber double doors to office space.

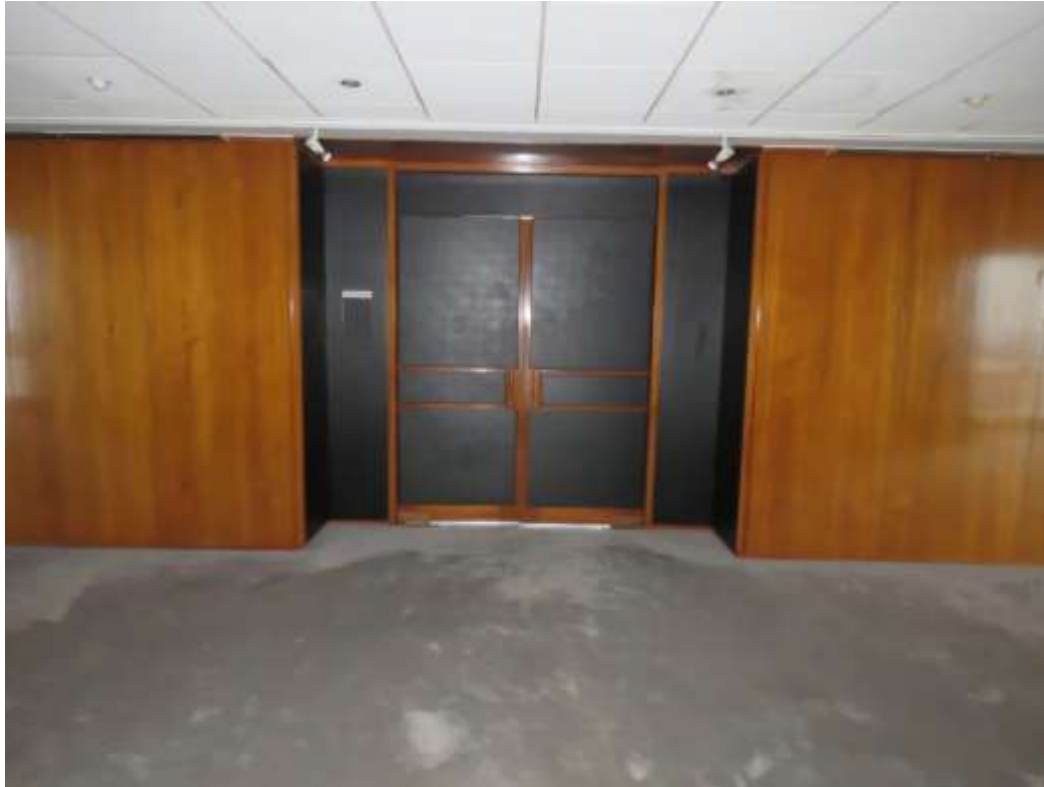
**23-04** View as you enter the foyer of the double doors leading to the board room. The doors have been covered with an insulated suede covering to improve acoustic performance and provide privacy between the board room foyer.

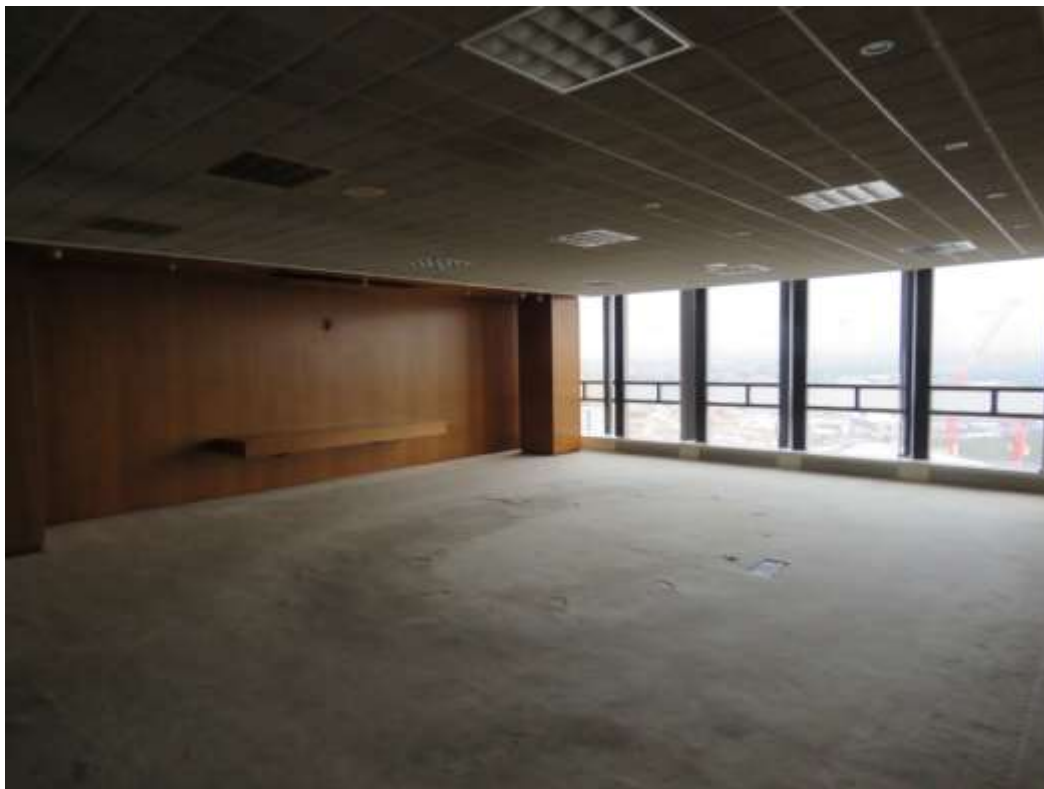
**23-05** View north in the board room..

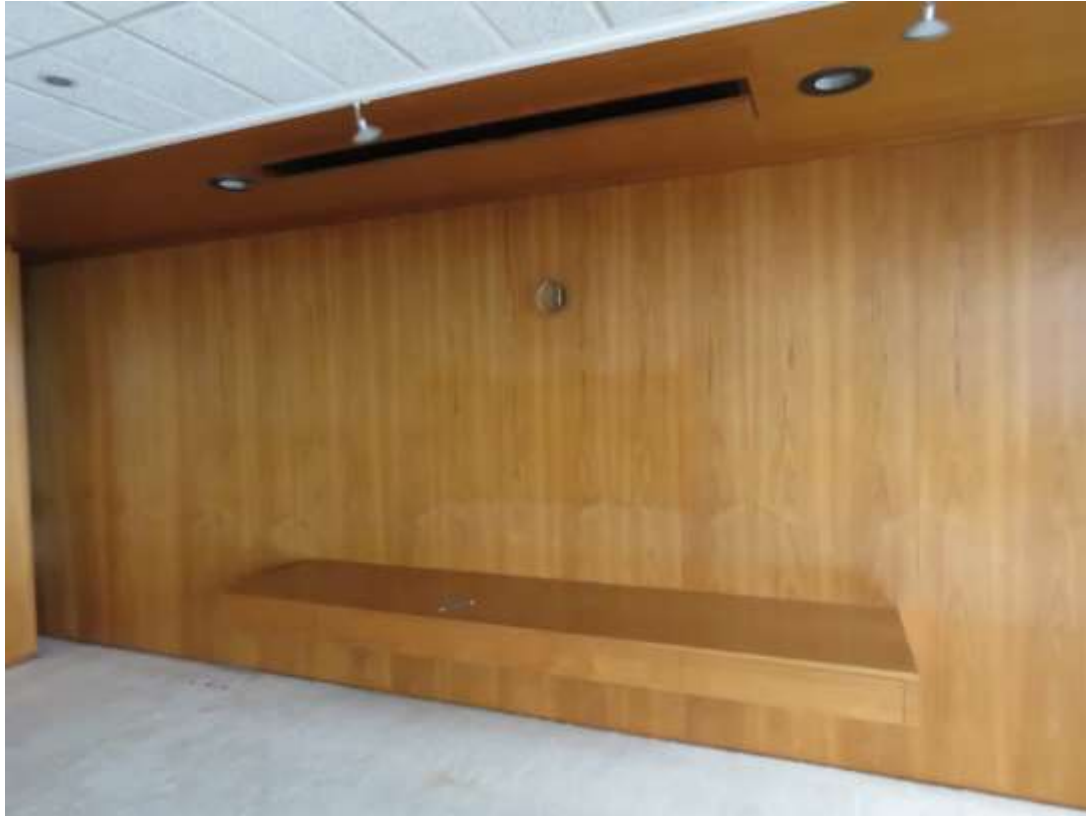
**23-06** View of wall panelling with drop down presentation screen from ceiling visible.

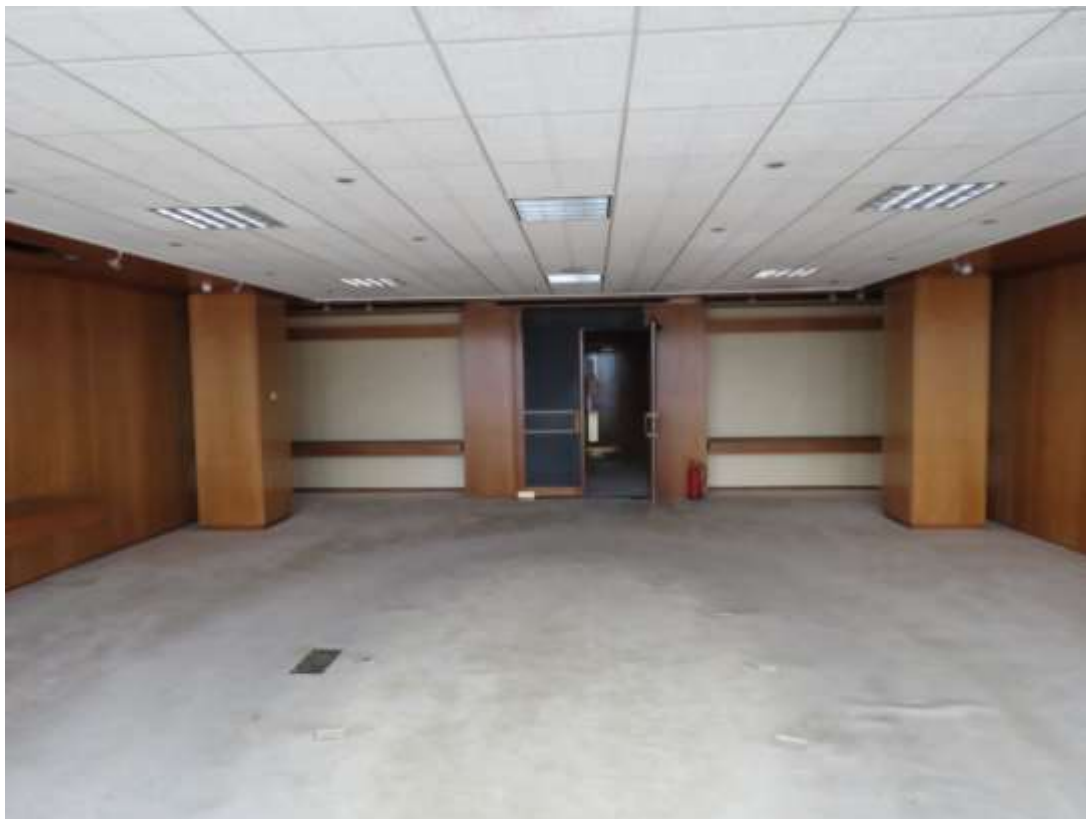
**23-07** View south across board room.

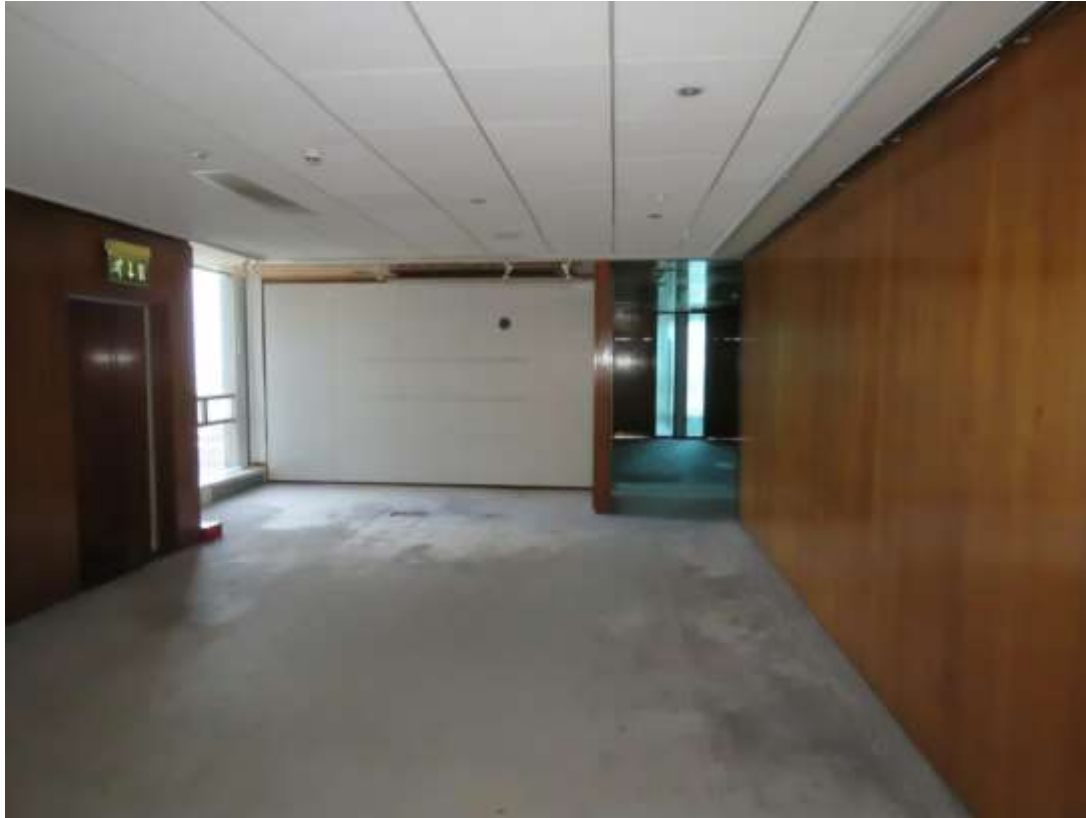
**23-08** View within foyer looking west towards the secretary desk, now removed.

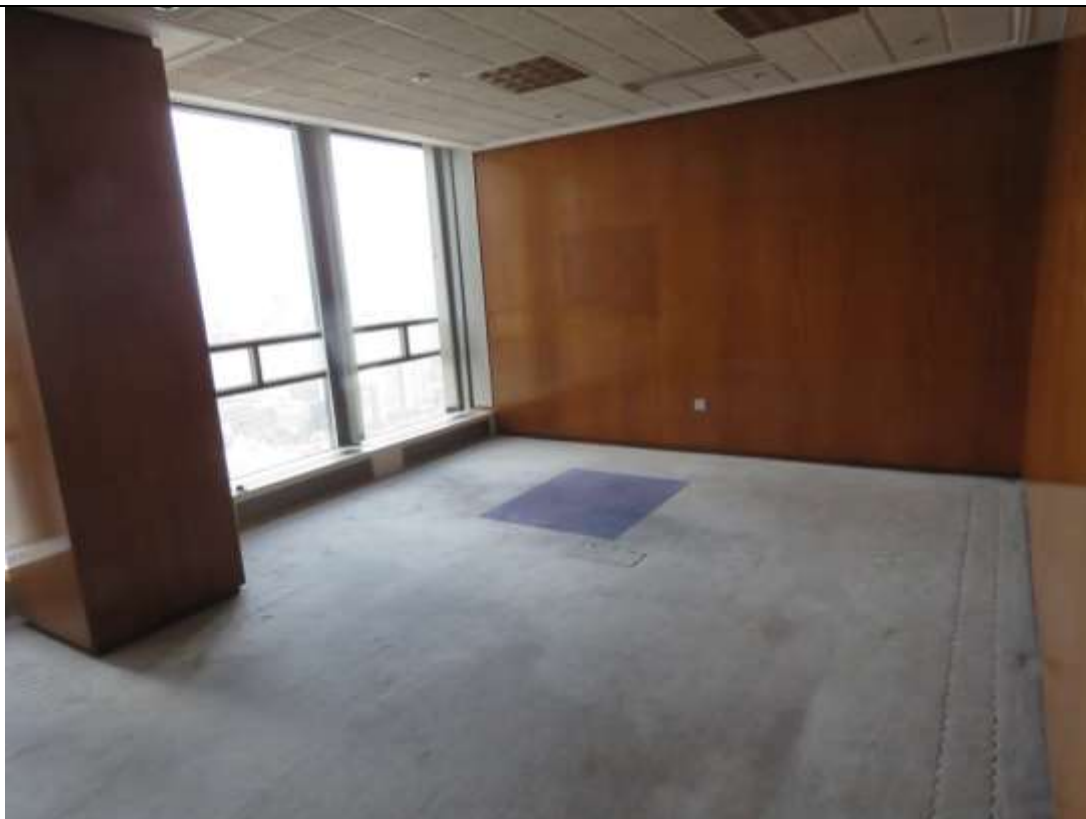
**23-09** View within "office 1" on original plans.

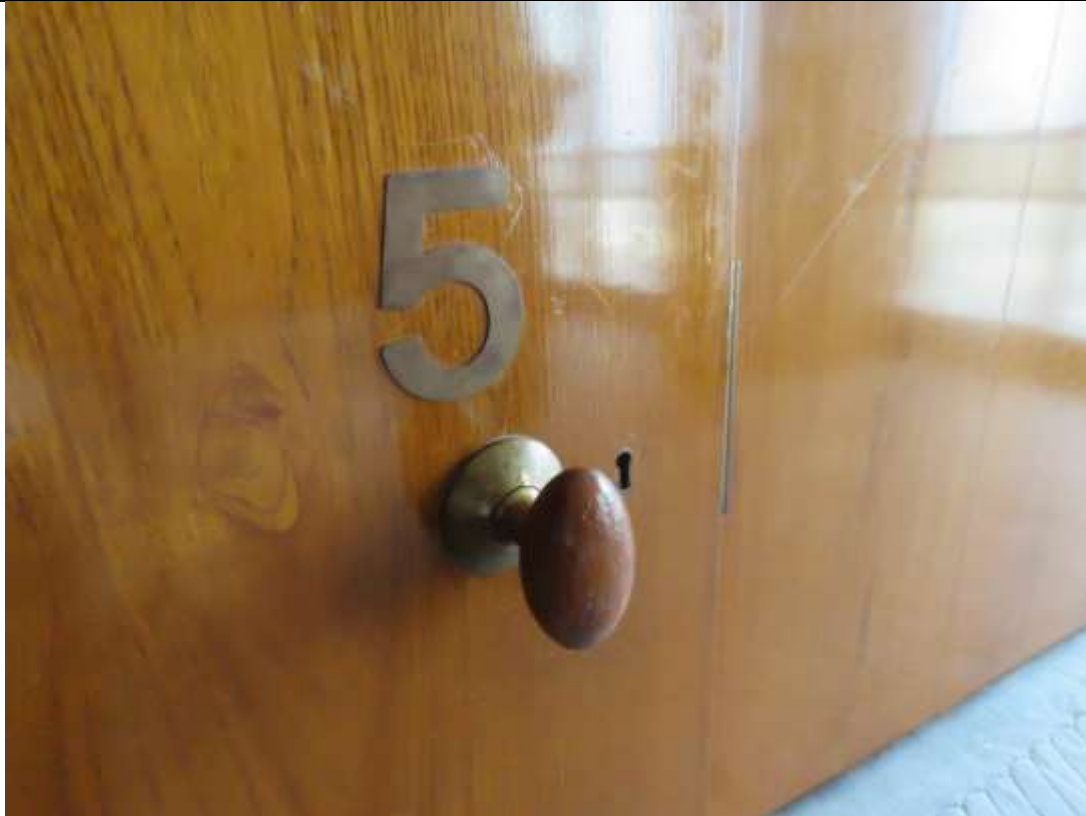
**23-10** Original door handle and brass room number

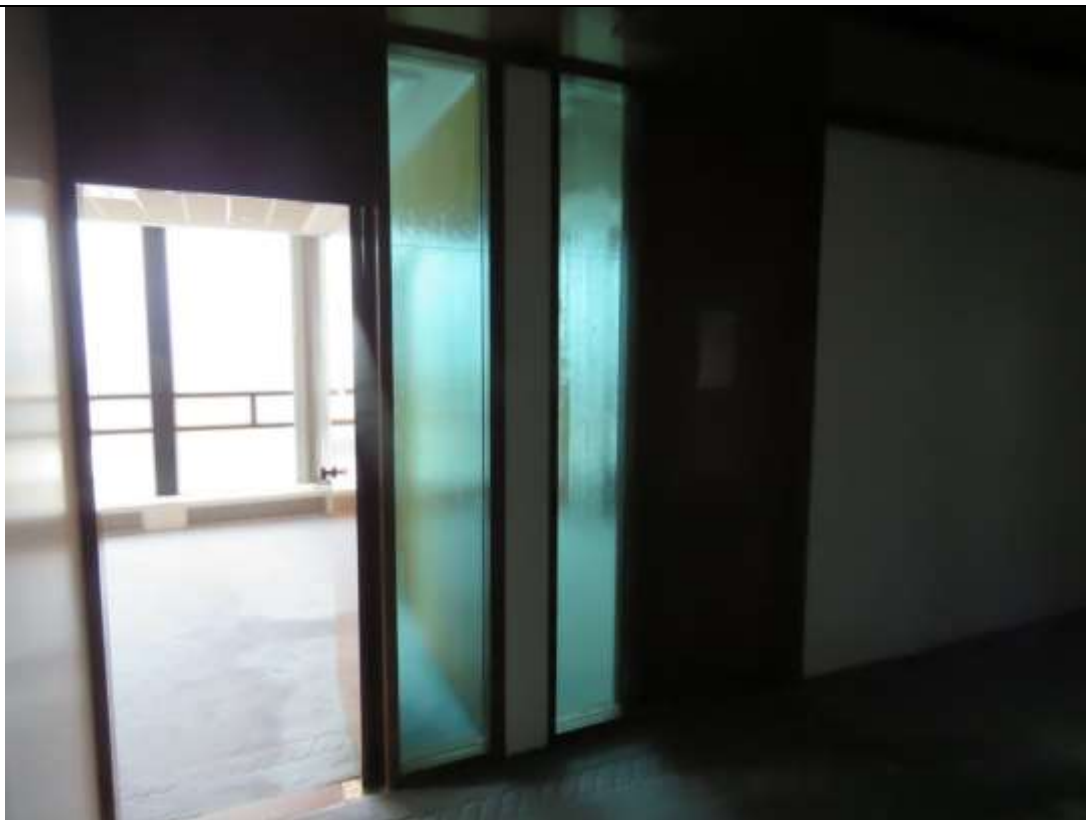
**23-11** View of blue obscured glazed panel adjacent to office doors.

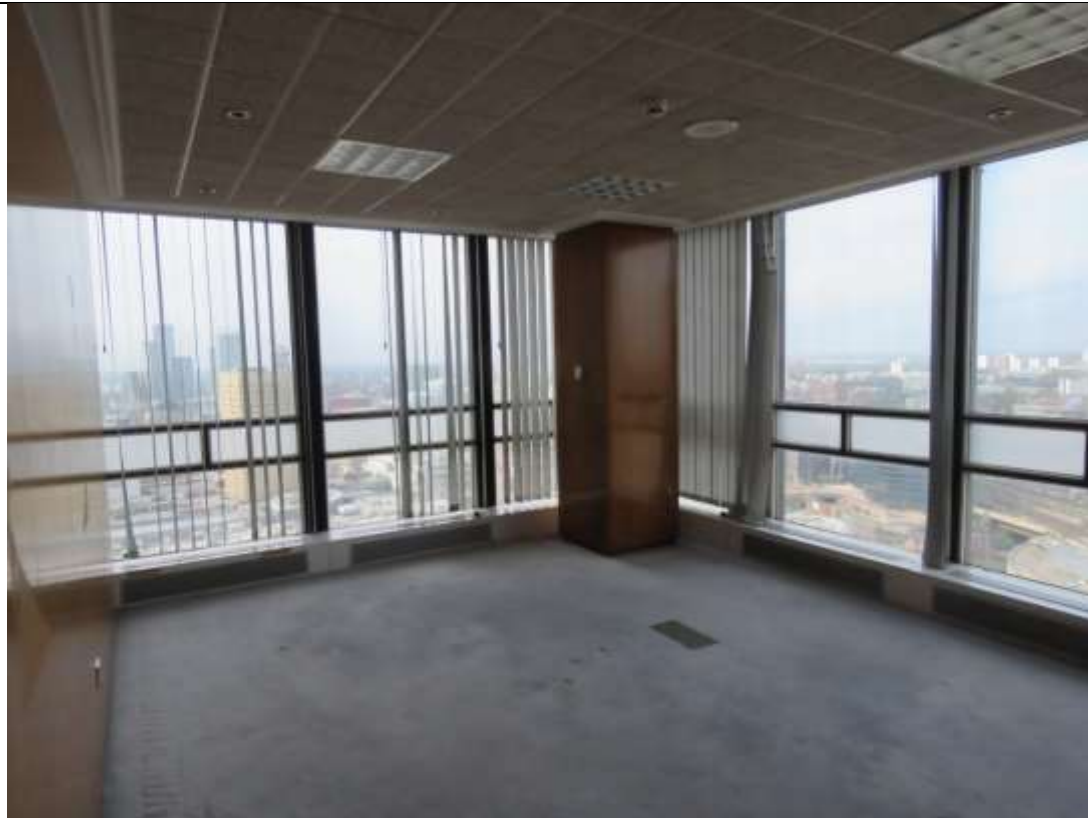
**23-12** View within corner office looking west which was the assistant general managers office.

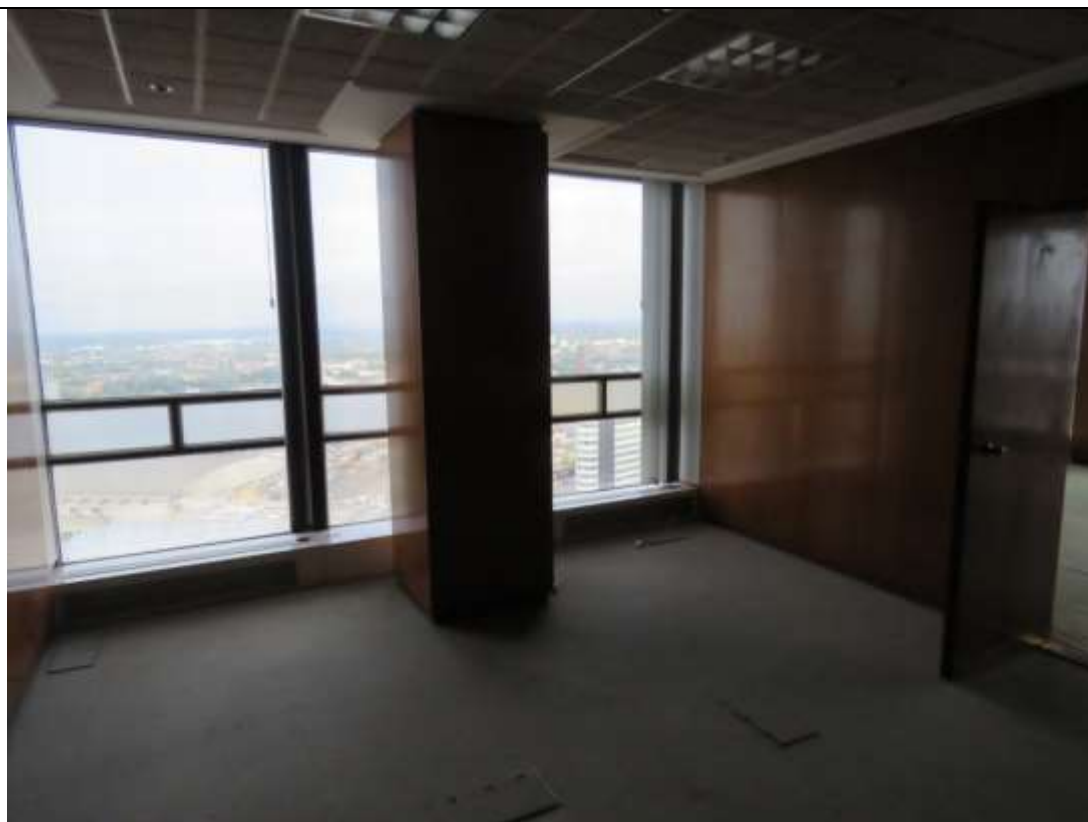
**23-13** View within middle office looking west originally used by the general managers and assistant general managers secretaries.

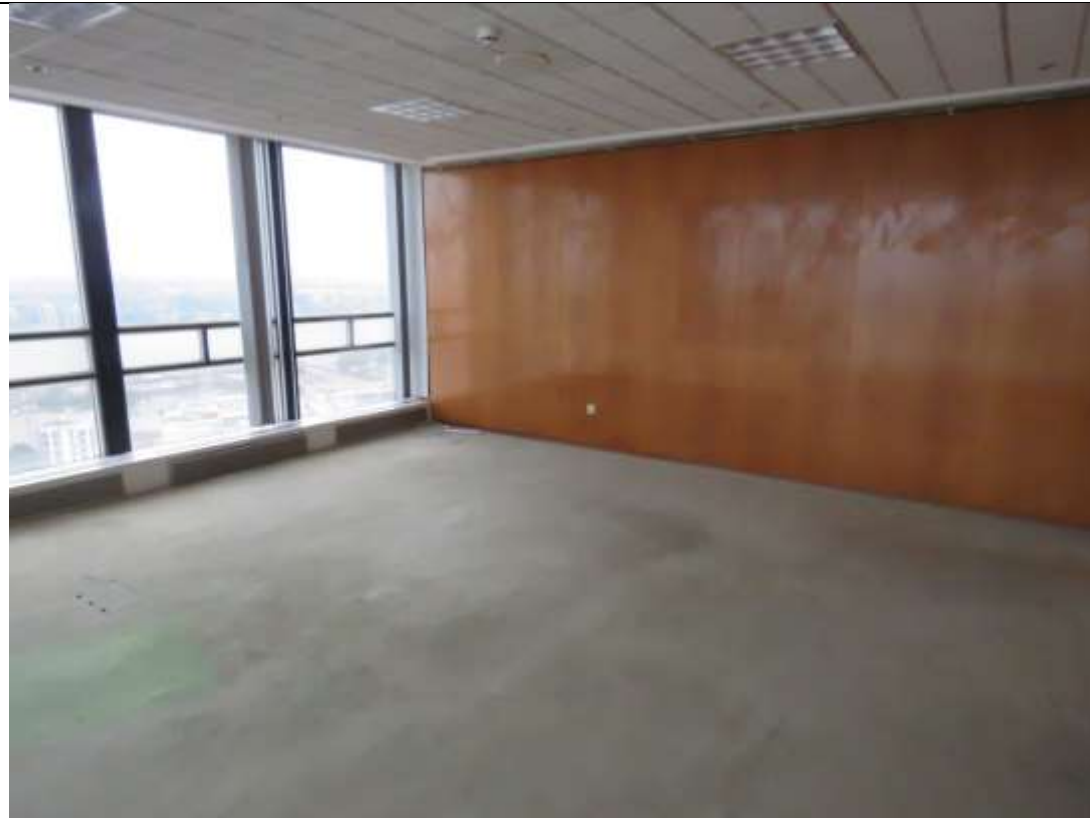
**23-14** View in corner office of the General Manager looking north east towards Miller Street.

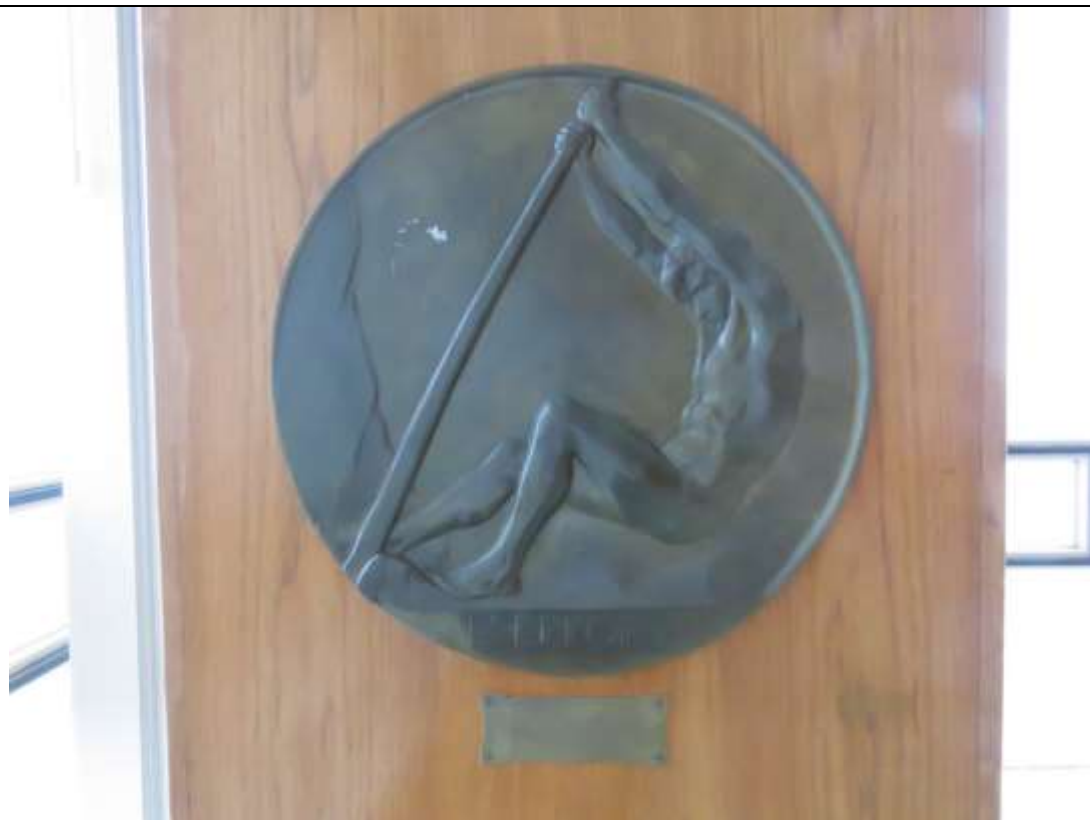
**23-15** View of one of two surviving artworks to the office floors titled "L'effort" by Josue Dupon, 1962.

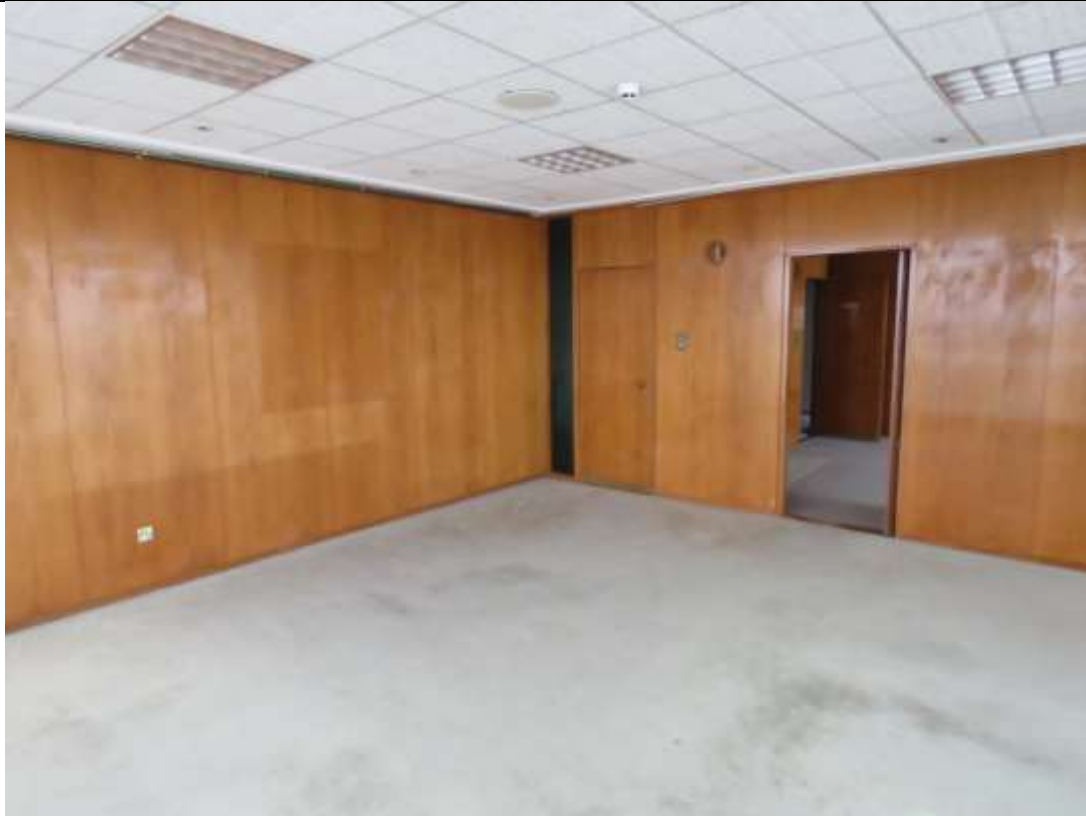
**23-16** View south in the General Managers office.

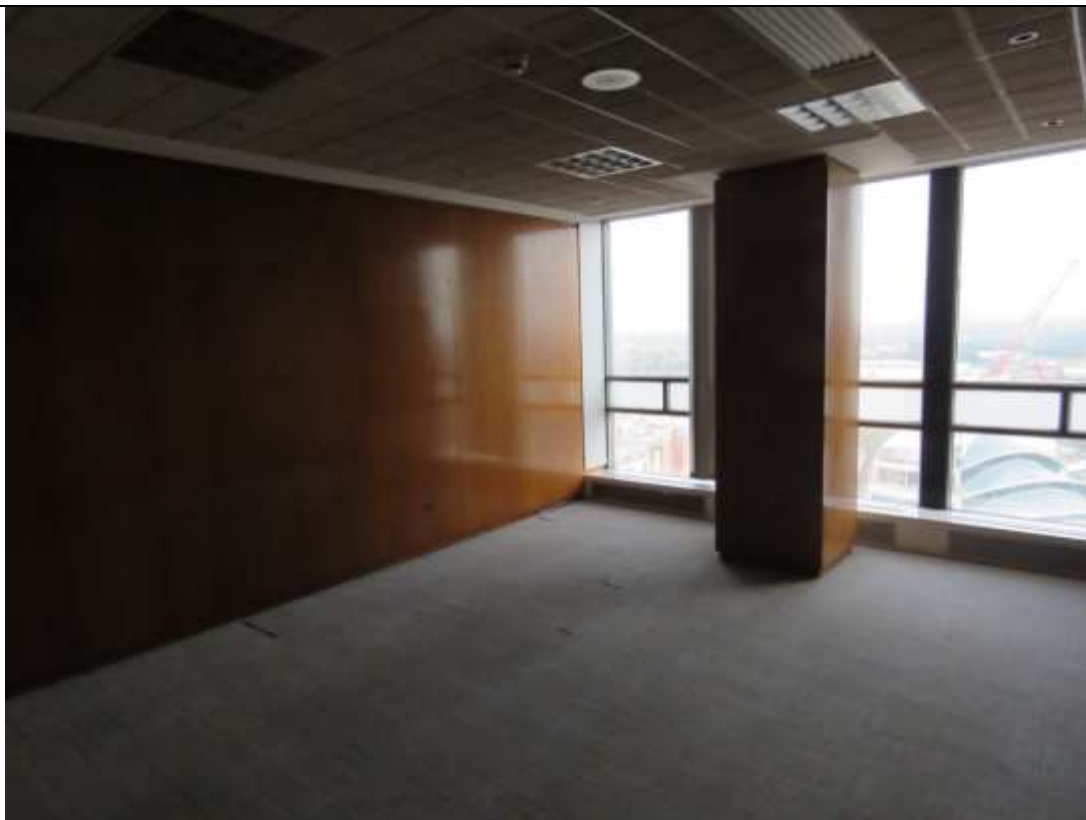
**23-17** View north in "office 2" on original plan.

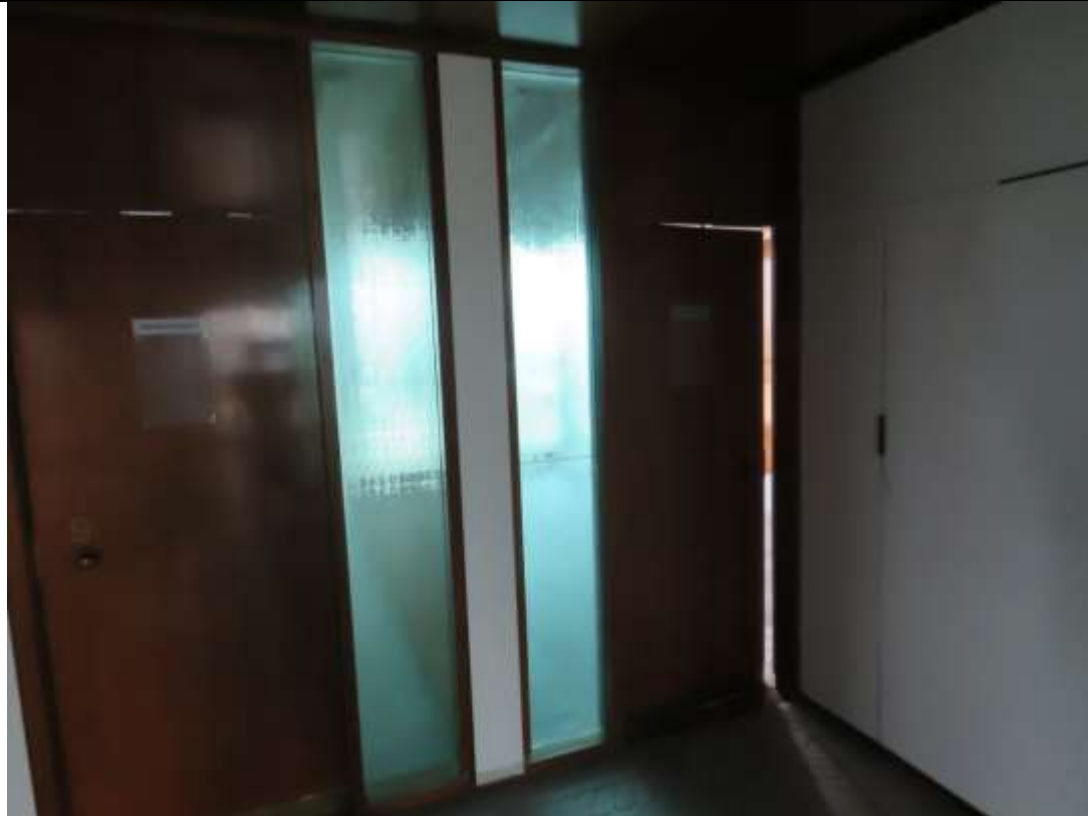
**23-18** View of glazed panels and doors to offices 2 and 3.

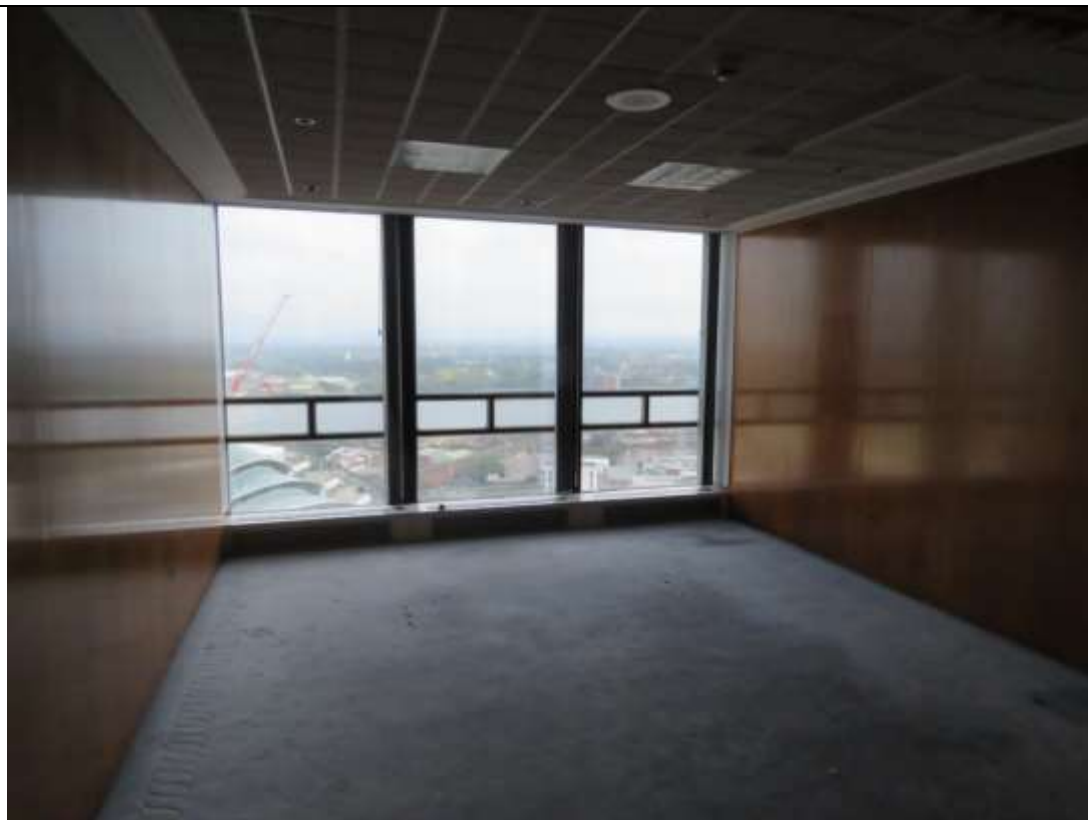
**23-19** View north in office 3 towards Miller Street.

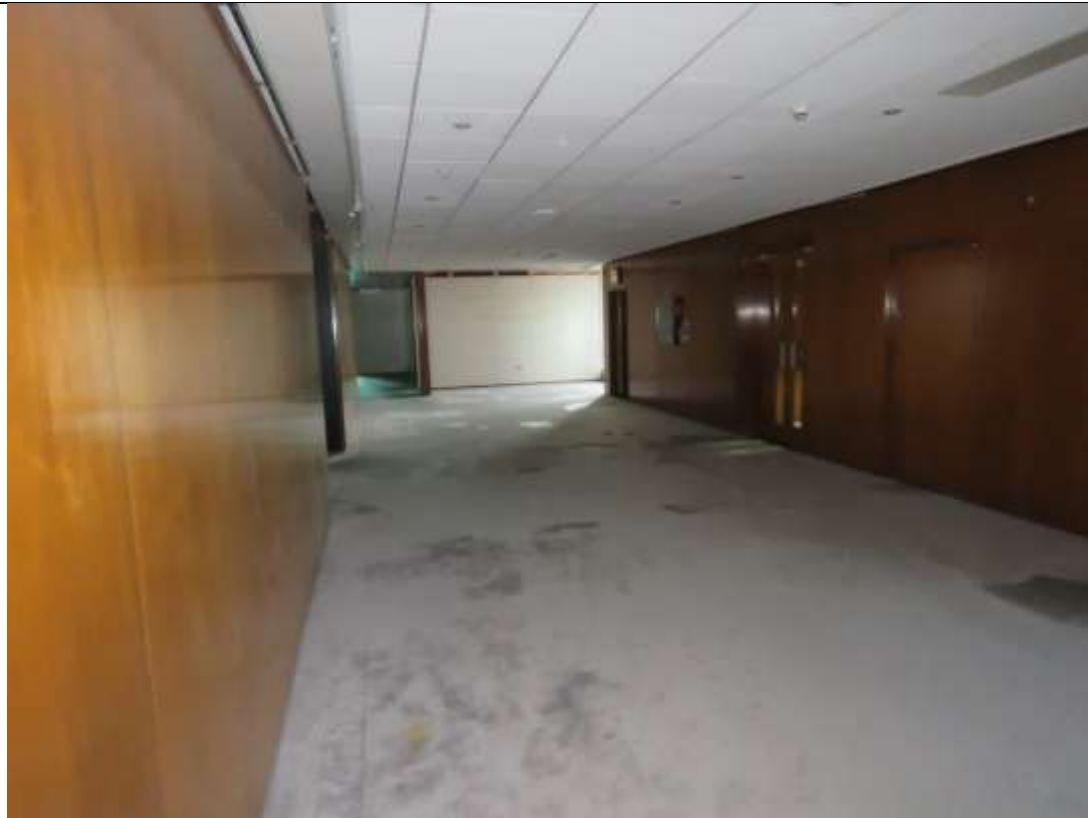
**23-20** View east across the foyer.

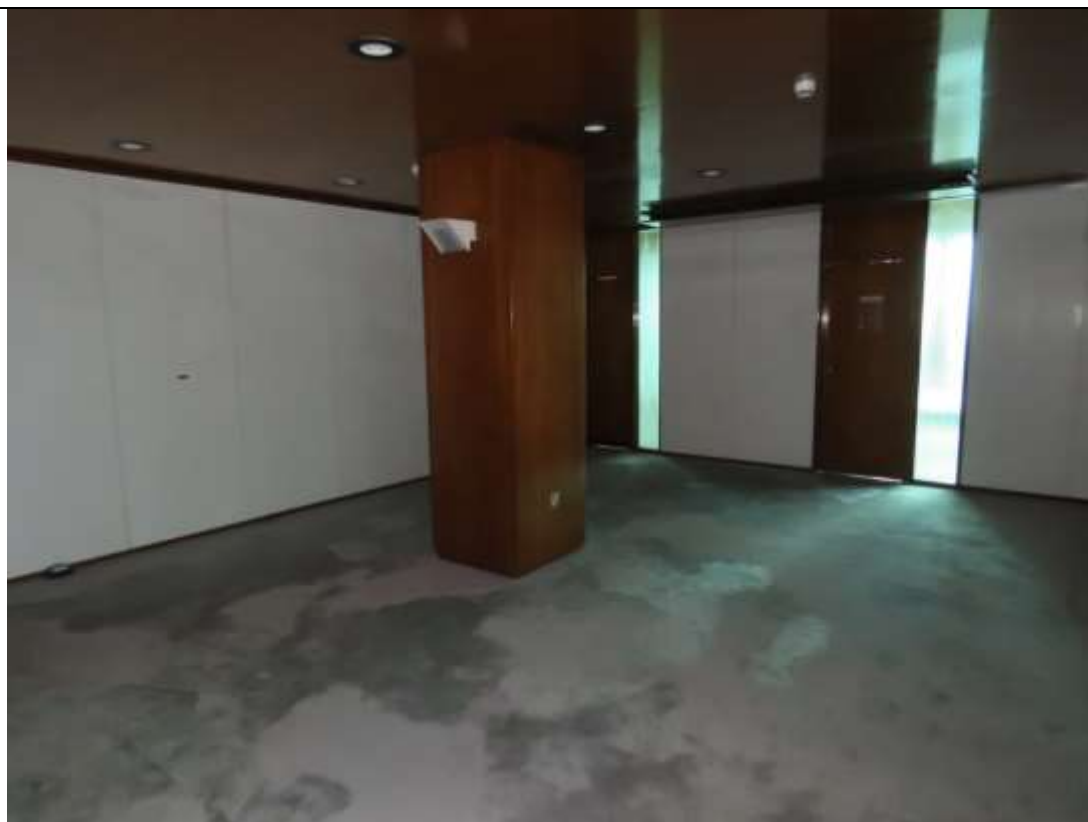
**23-21** View in east vestibule.

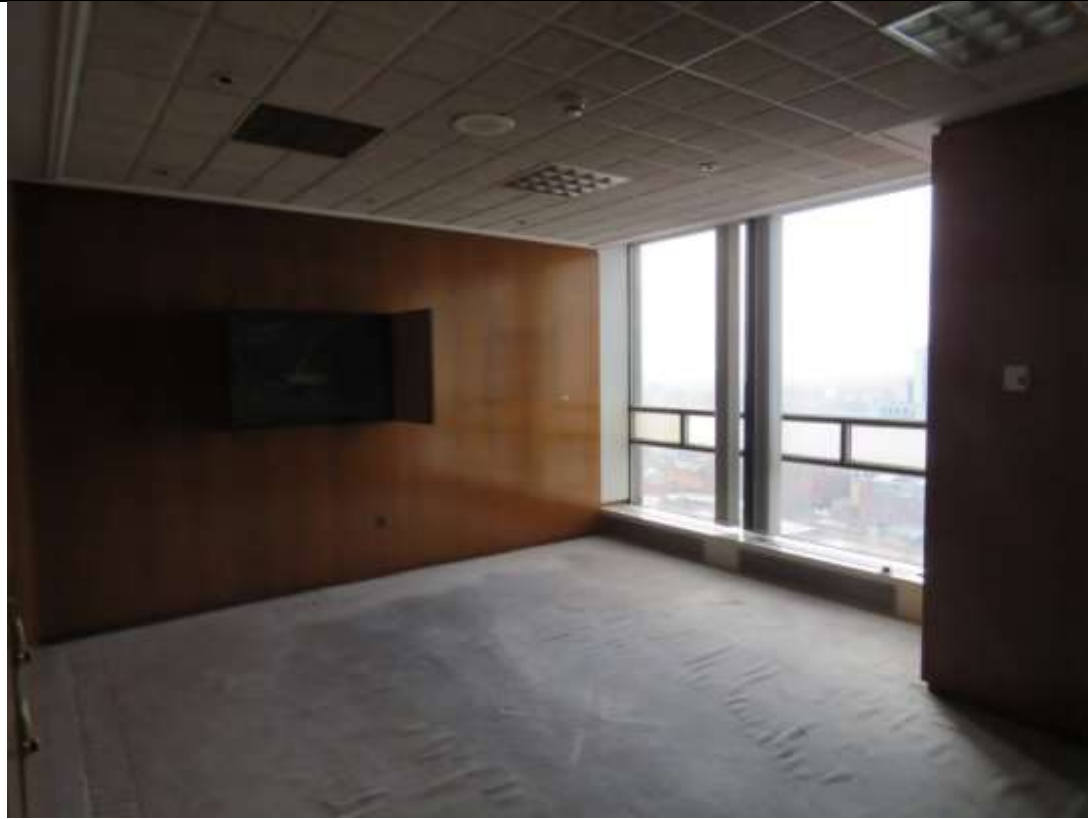
**23-22** View east in “Committee Room 1” showing built in chalk boards that are present in every meeting room.

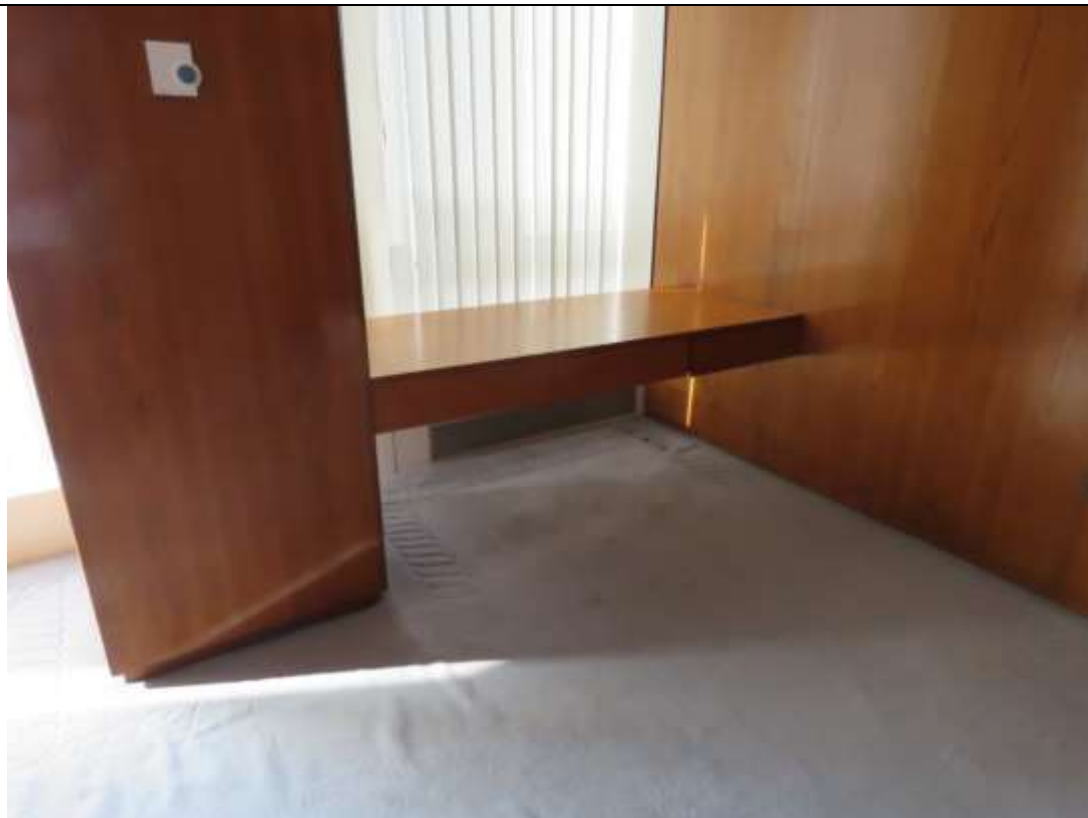
**23-23** Built-in shelf / desk to committee room 1.

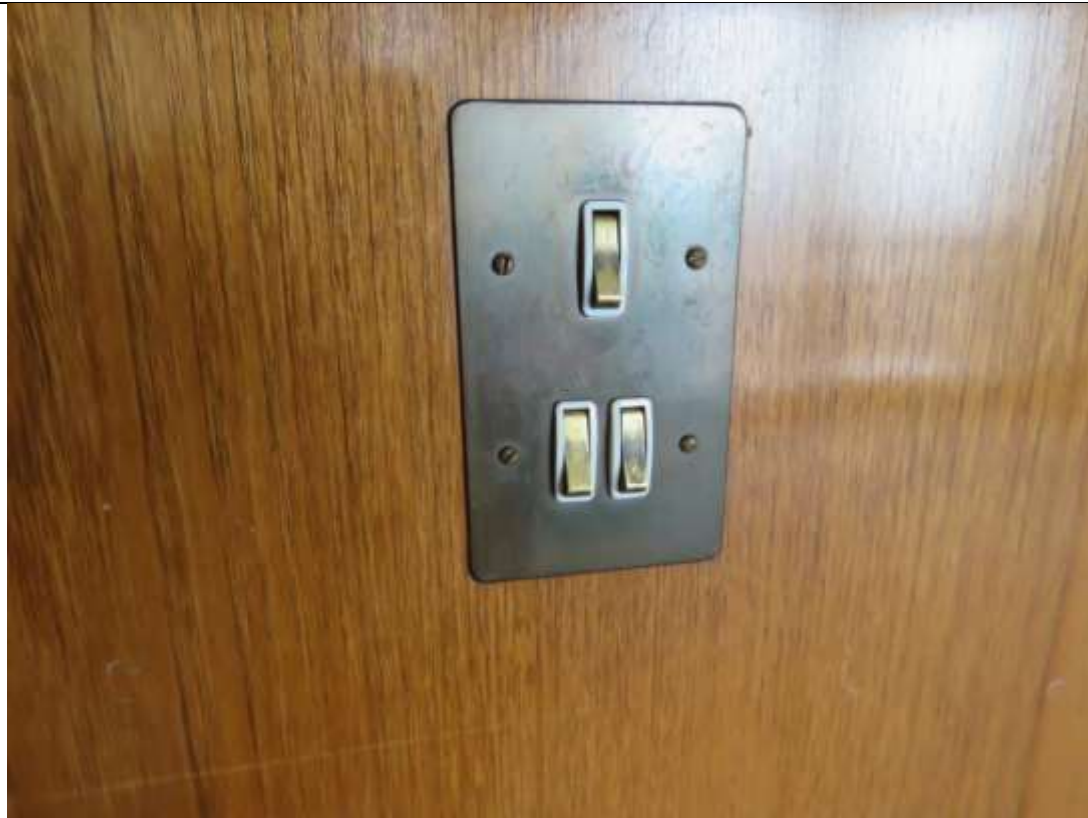
**23-24** Original brass light switch plate.

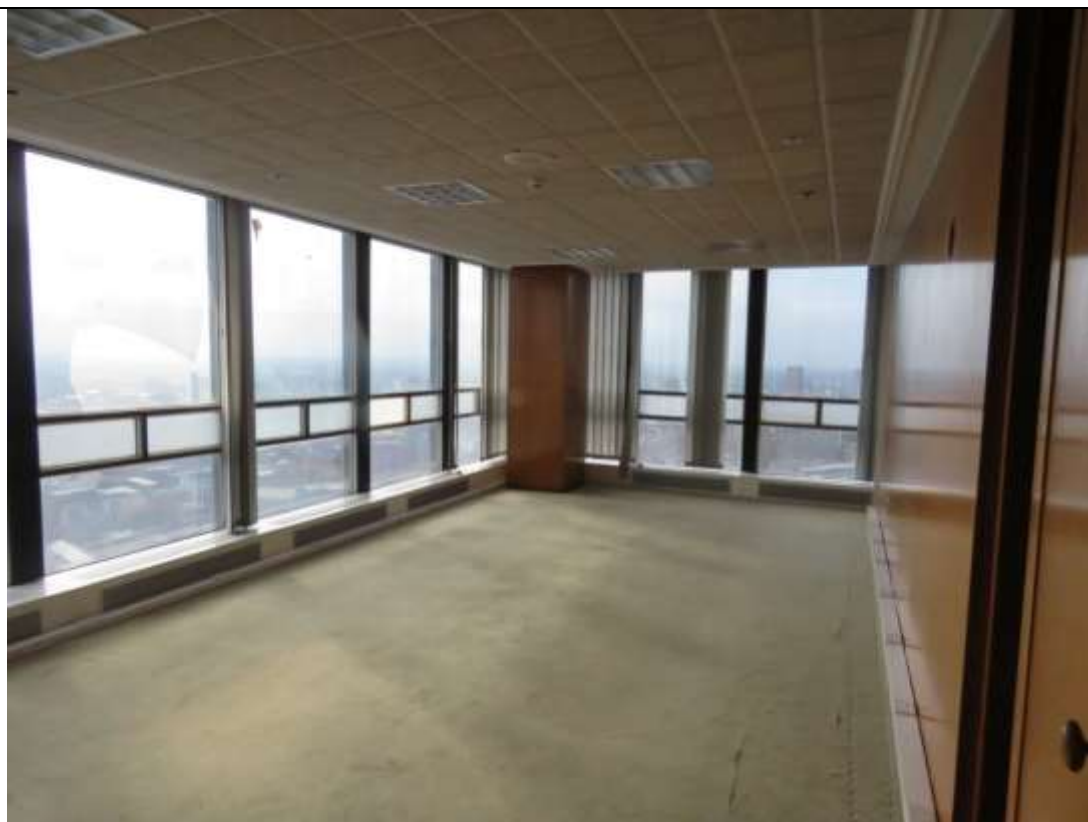
**23-25** View south in the “lounge”.
