## CIS Tower Refurbishment.

Recording Strategy and Photographic Audit of internal & external features.

# APPENDIX 29 – LEVEL 23. INTERNAL.

Planning Permission ref: 126118/FO/2020. Condition 29.

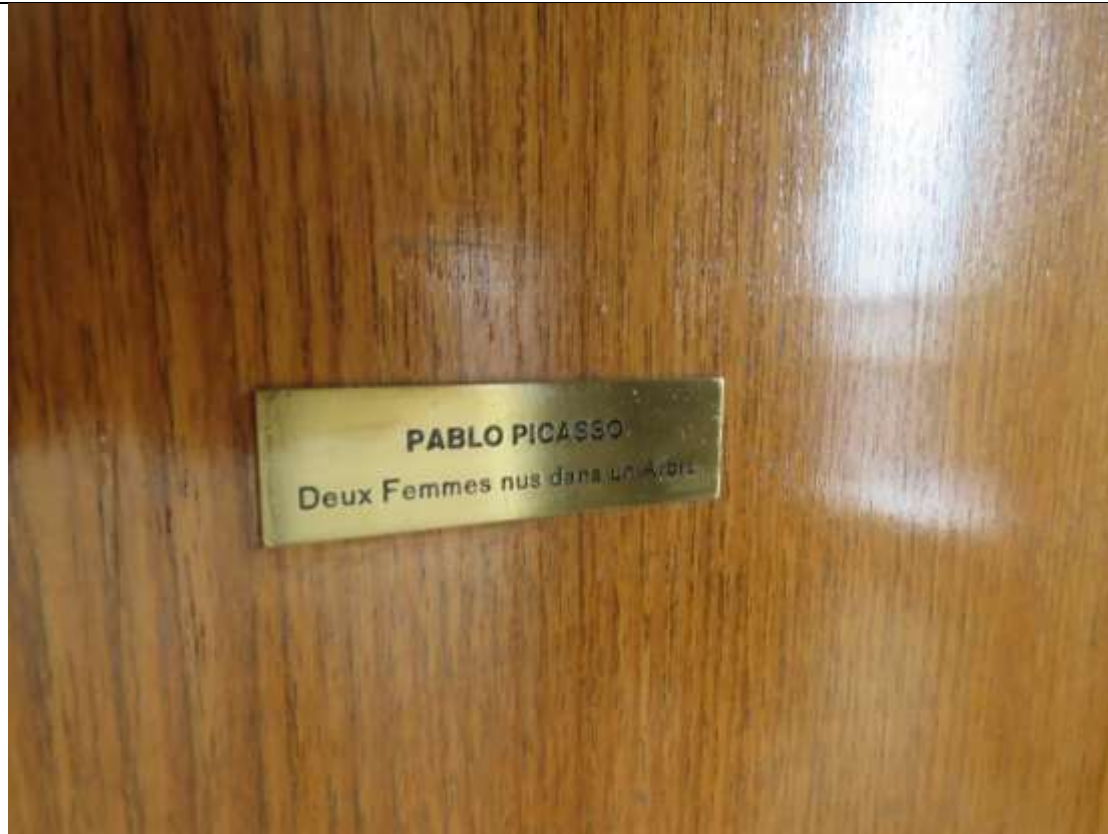
**23-26** Plaque within lounge of artwork now removed. A number of plaques survive across the floor to columns.

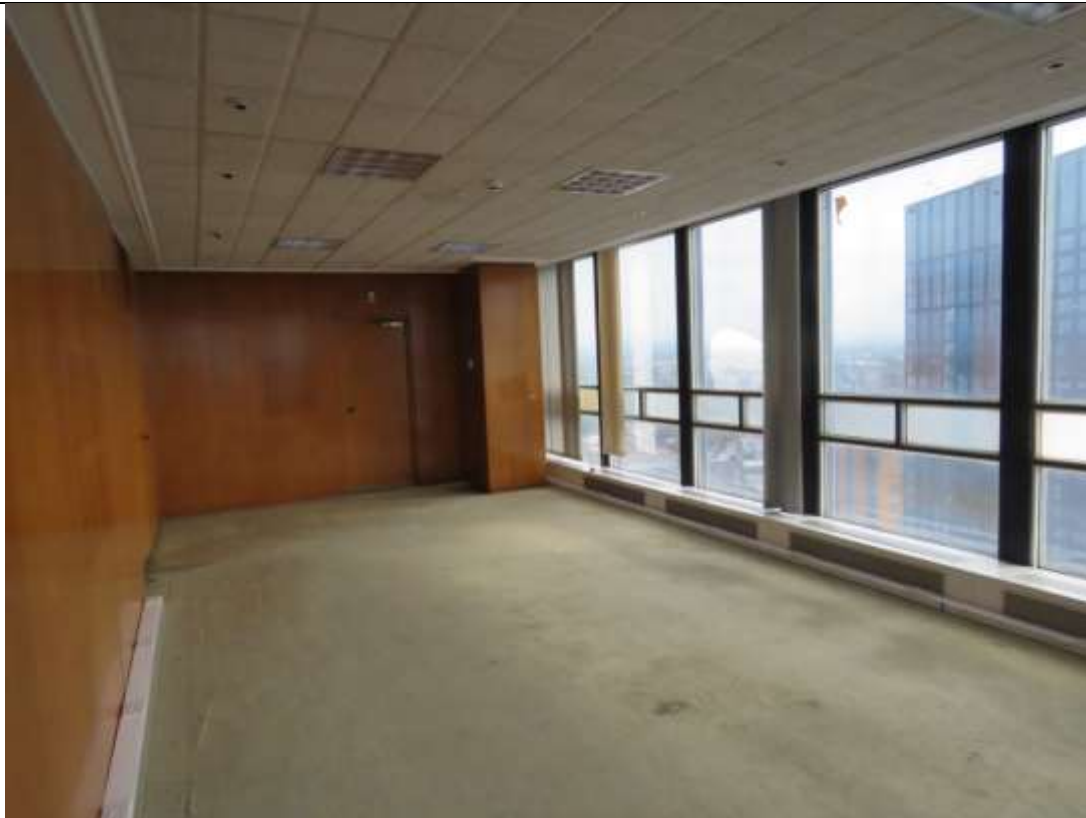
**23-27** View north in lounge.

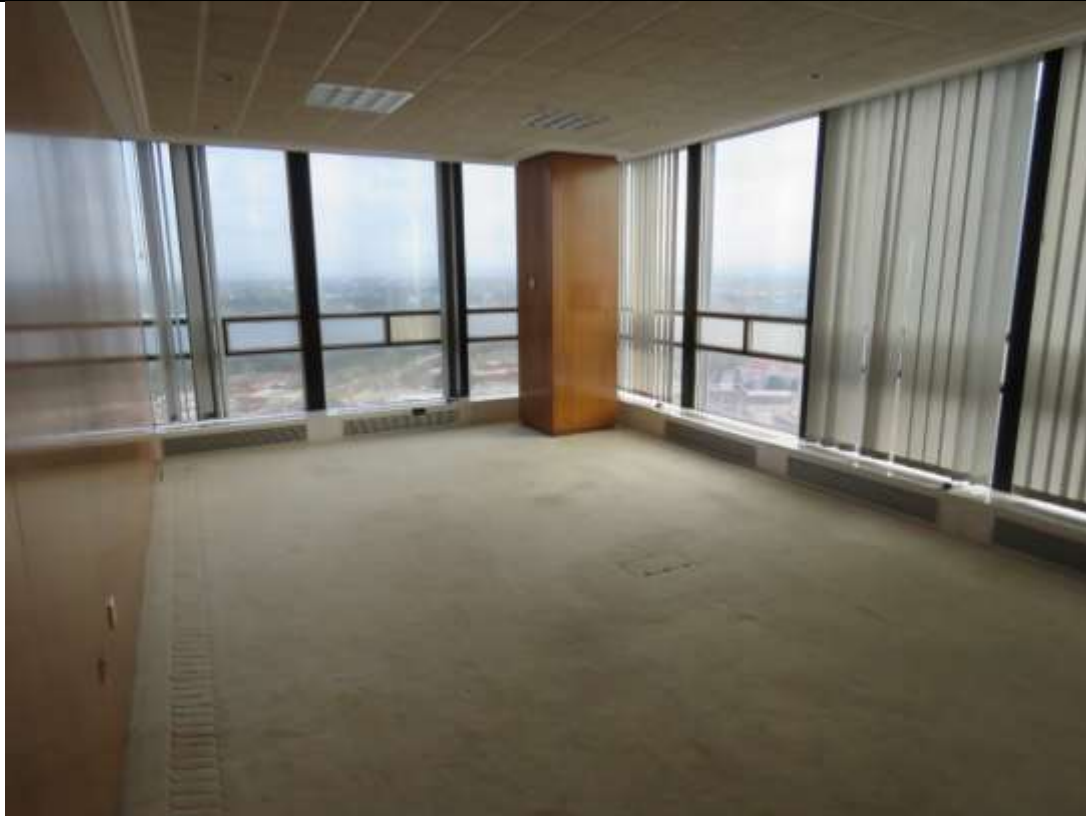
**23-28** View north in chairman's office.

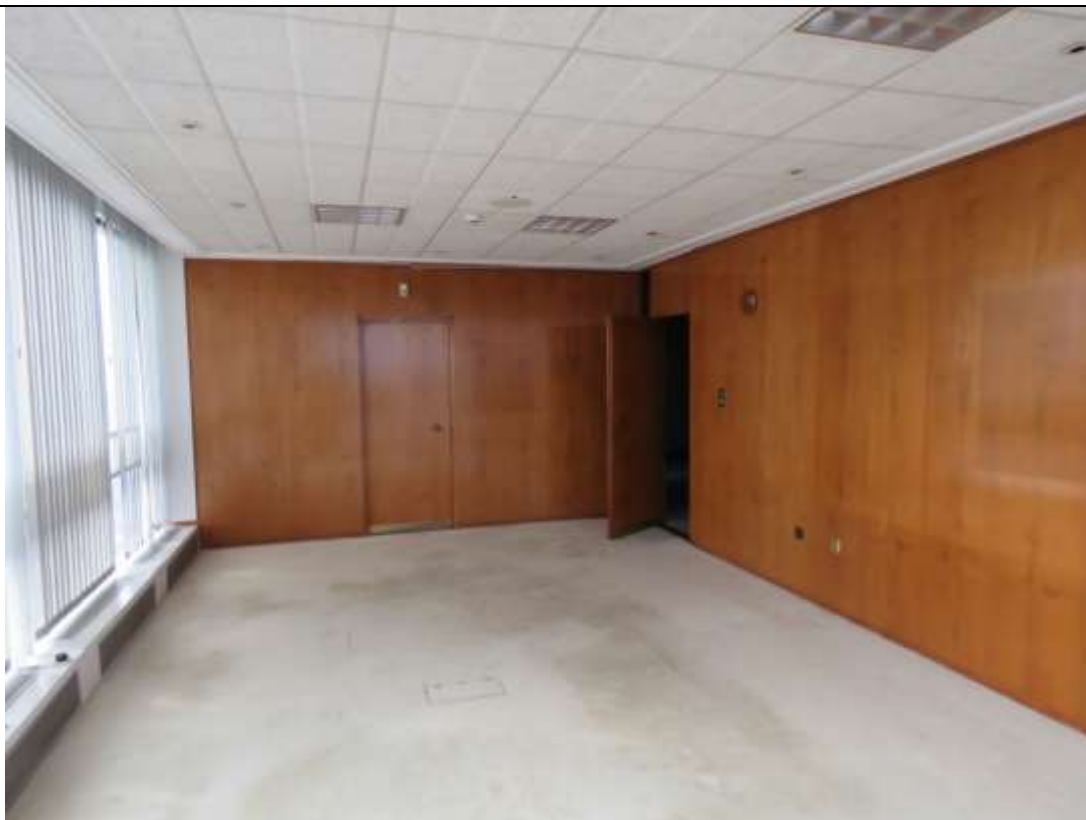
**23-29** View south in chairman's office.

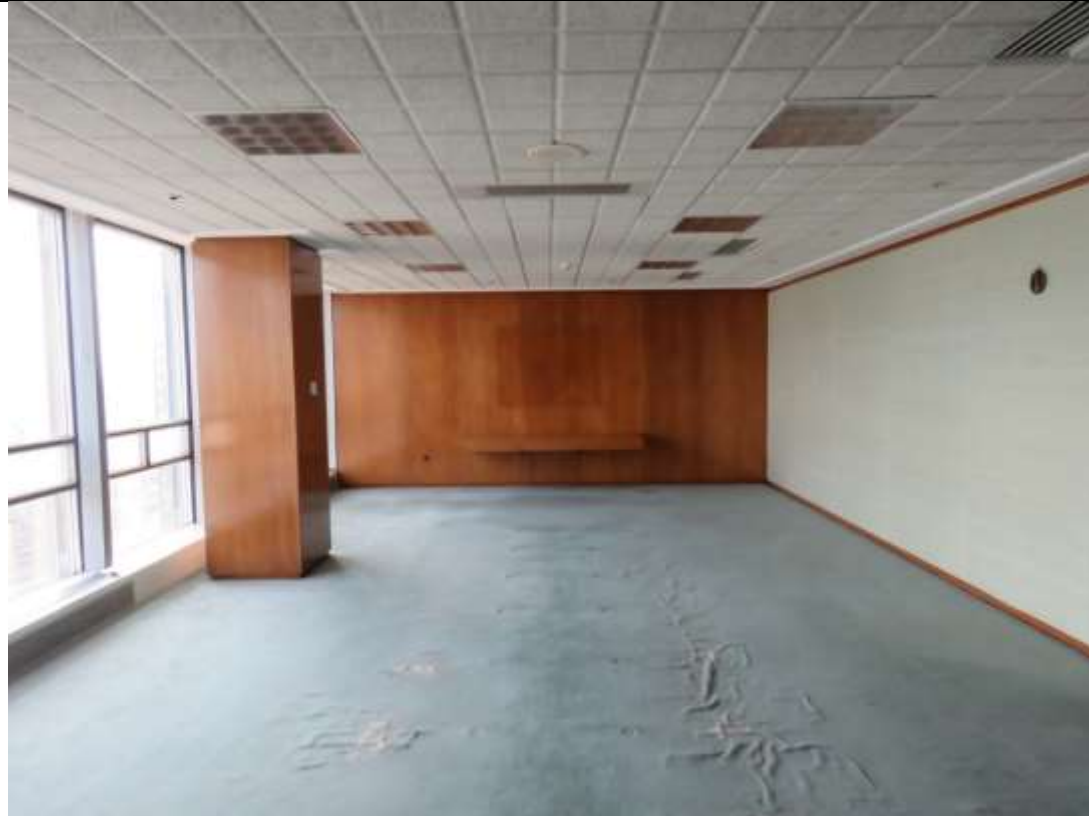
**23-30** View east in “committee room 2”.

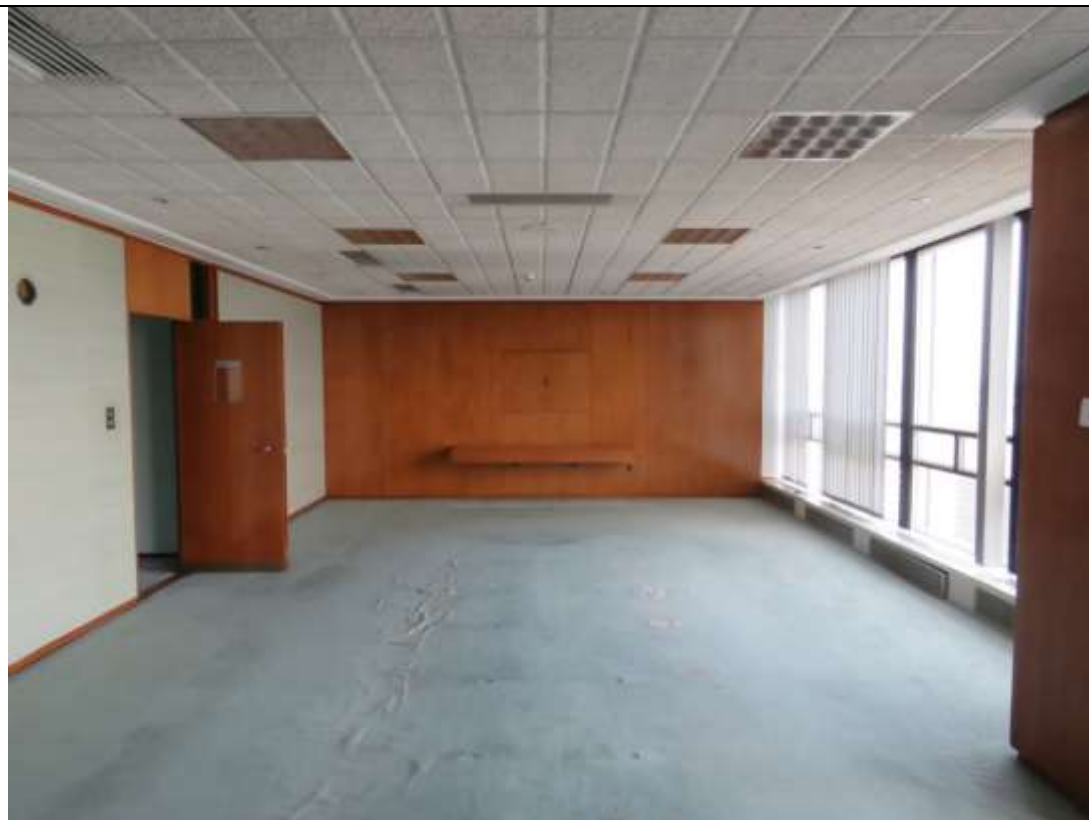
**23-31** View west in committee room 2 with built in shelf and chalk board.

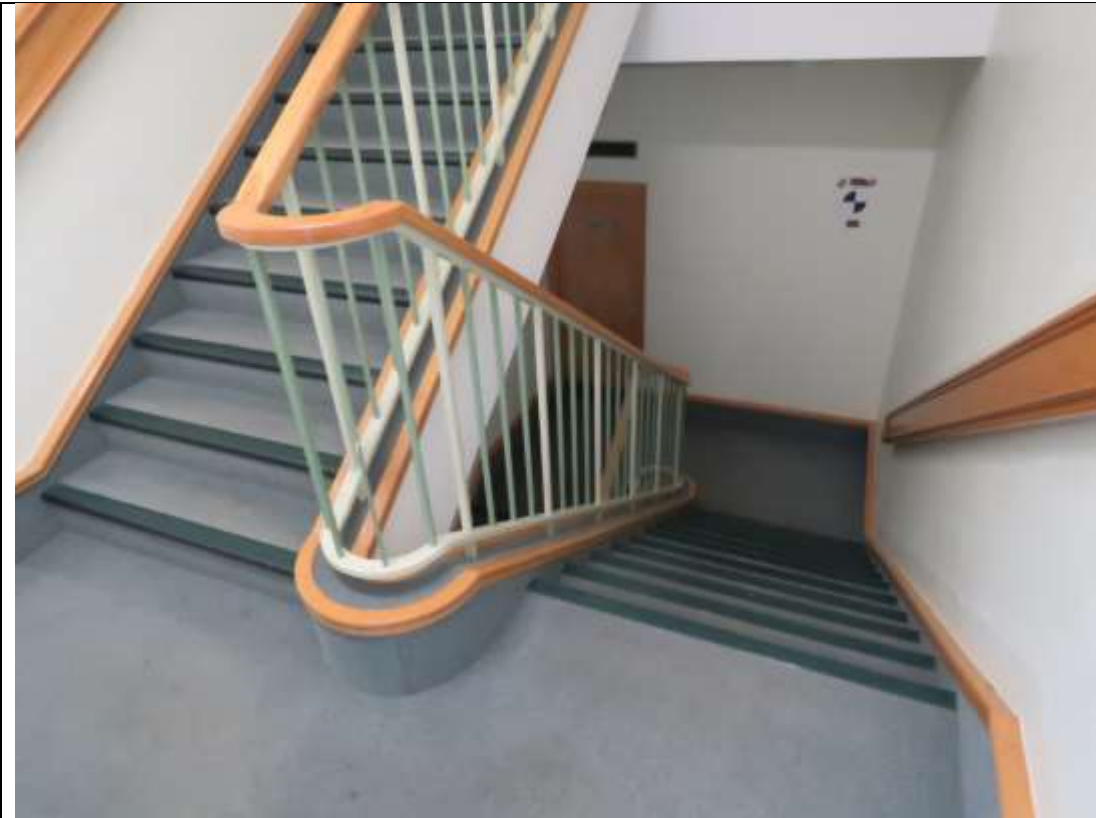
**23-32** View in eastern stairwell.

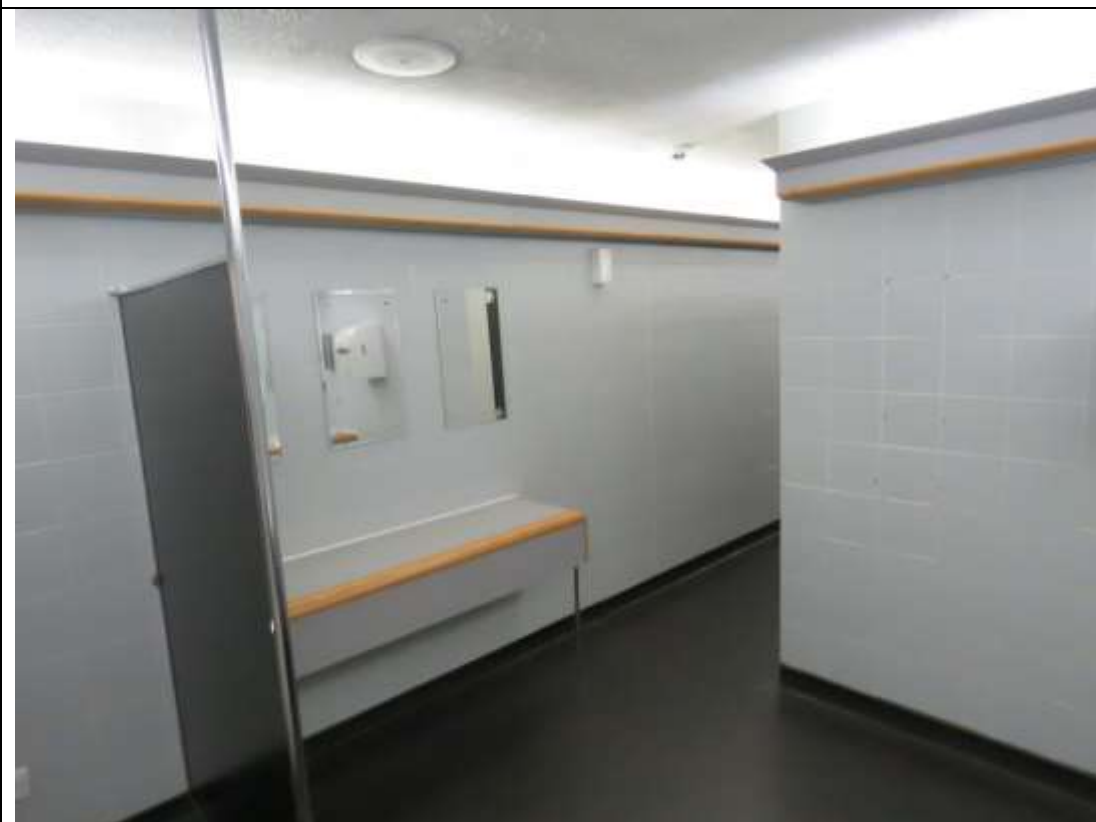
**23-33** View in ladies toilet looking towards vanity unit and mirrors.

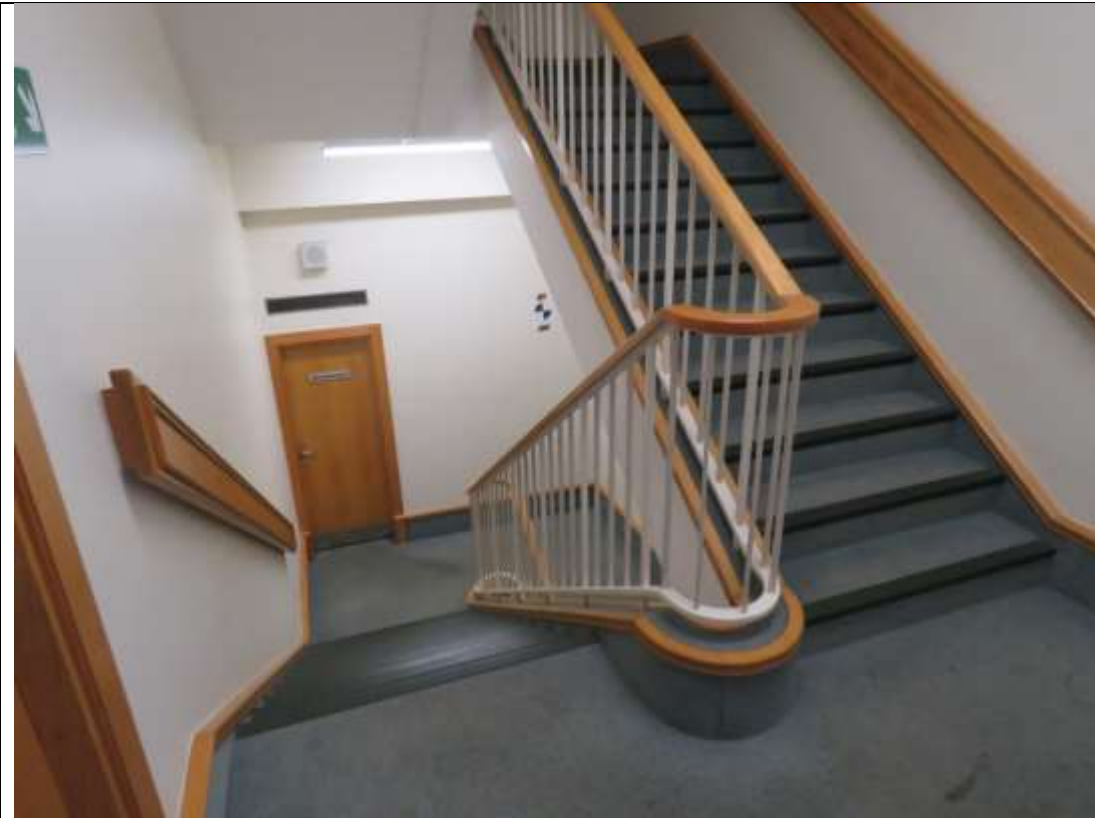
**23-34** View in western stairwell.

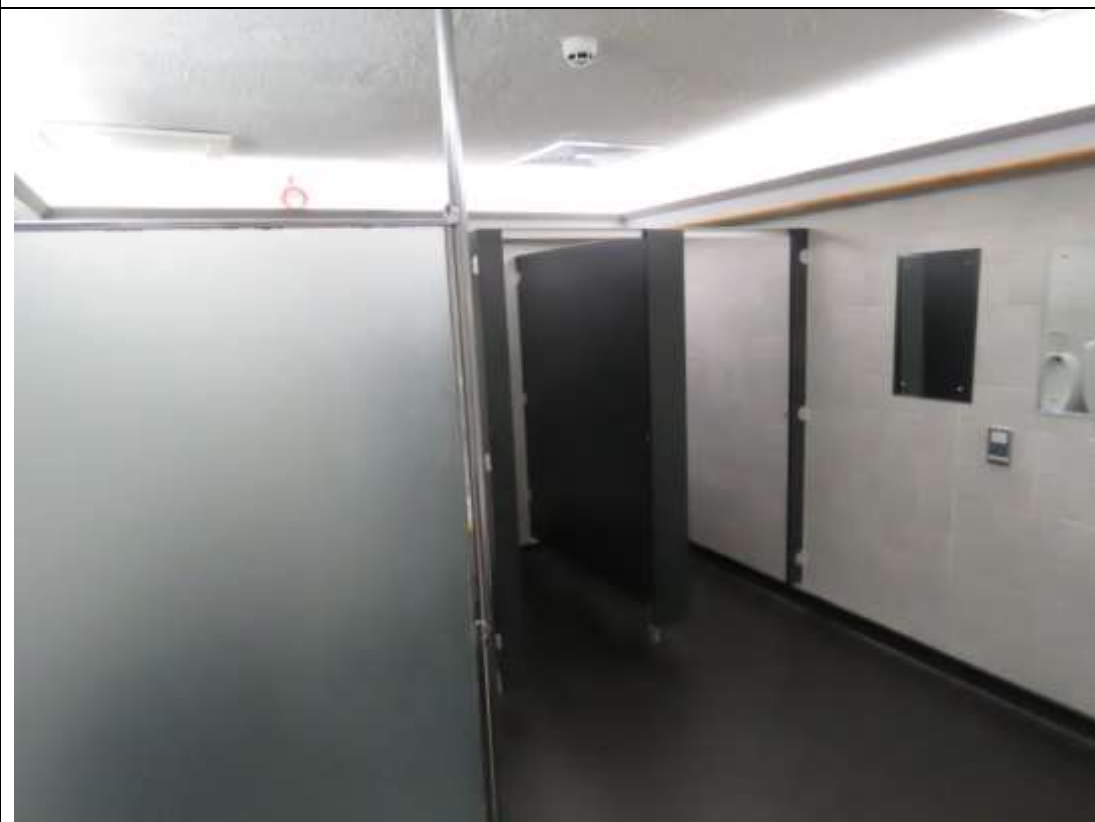
**23-35** View in male toilet with original obscured glass screen and non-original cubicles.
