Your Ref: Pheonix Ironworks  
Our Ref: 9801

**RE: PHEONIX IRONWORKS**

I would report that we undertook a nesting bird survey at the above site on the 17<sup>th</sup> April 2025.

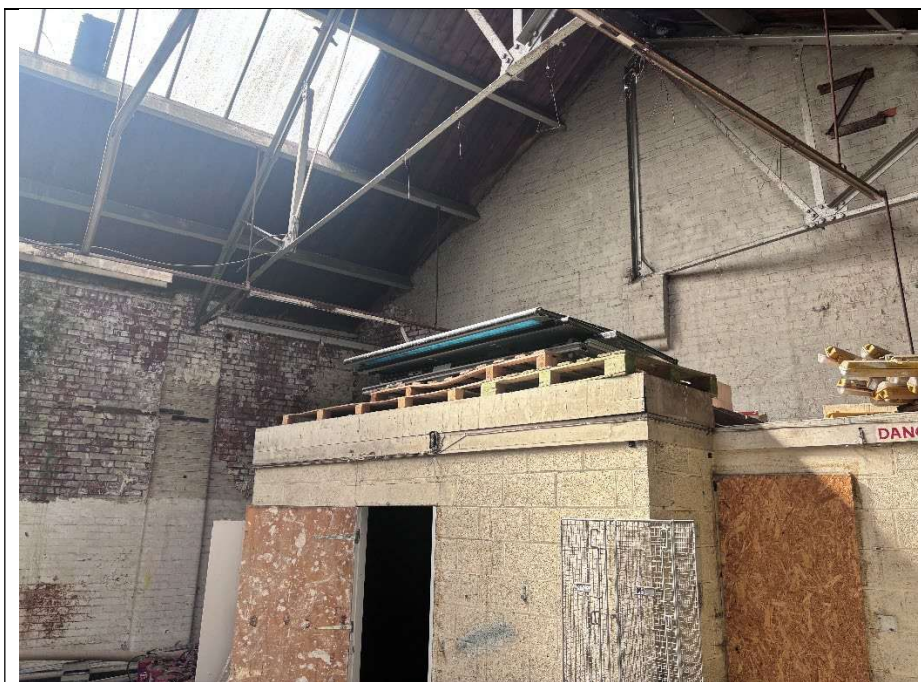
Internally the building is open and light with glass skylights. Several areas of glass are missing, allowing Feral Pigeons (*Columba livia domestica*) access to the internal space. Numerous lines of droppings were noted on the floor, under exposed steel work in the roof from roosting. Four Feral Pigeons were recorded inside the building at the time of survey. These exited via the roof openings and did not show any signs of nest protection behaviour.

**Internally no nests could be found.**

Internal rooms are open and light

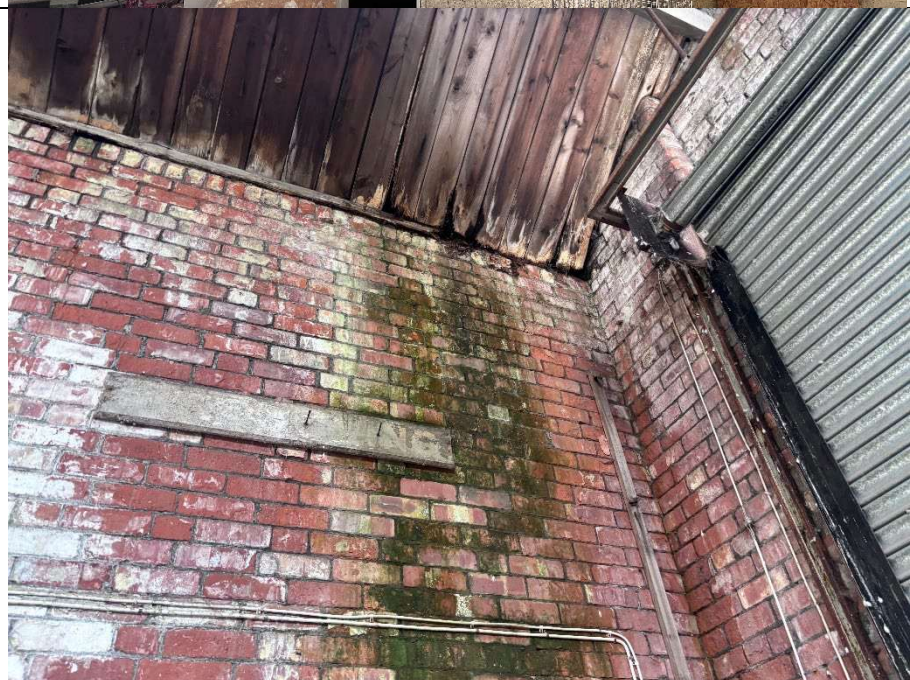
The external brick work appears to be in fair condition, an no nest sites were found. Numerous slipped slates were noted during a drone survey of the roof, but these areas were noted to be running with water, being damp and cold.

Missing slates on roof result in water running down the walls

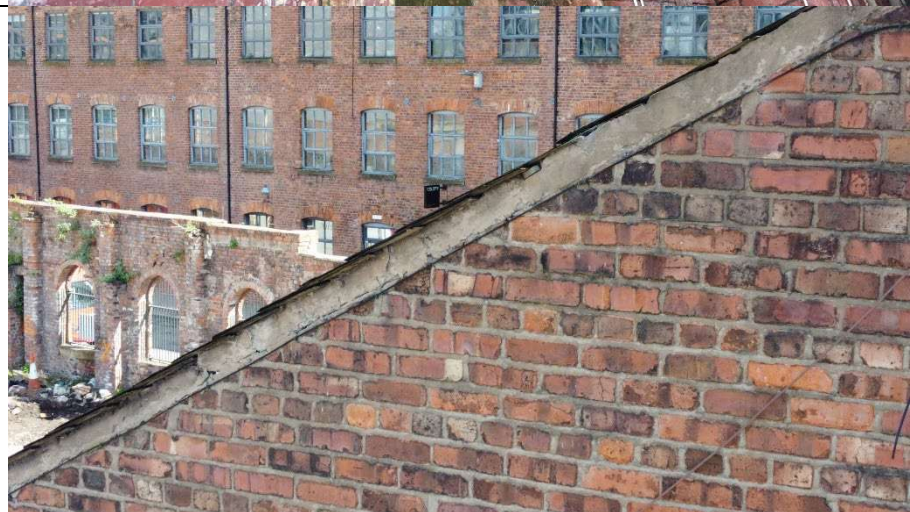
**No evidence of nesting by birds externally could be found.**

Roof verges lack gaps and cracks suitable for nesting birds such as House Sparrow (*Passer domesticus*)
