CIS Tower,  
Miller Street,  
Manchester.  
M60 0AL.

## CIS Tower Refurbishment.

Recording Strategy and Photographic Audit of internal & external features.

# APPENDIX 7 – LEVEL 01 INTERNAL.

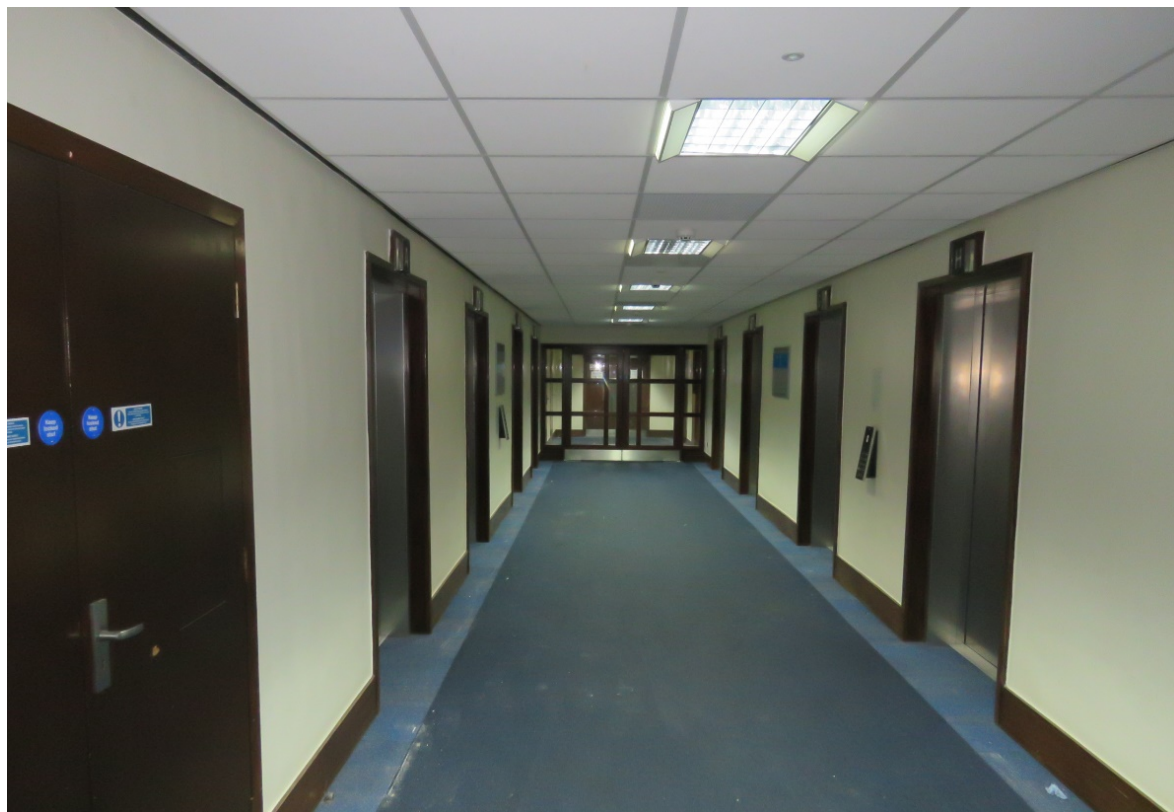
**01-01** Looking south along the entrance lobby toward the fire lobby and podium office entrance.

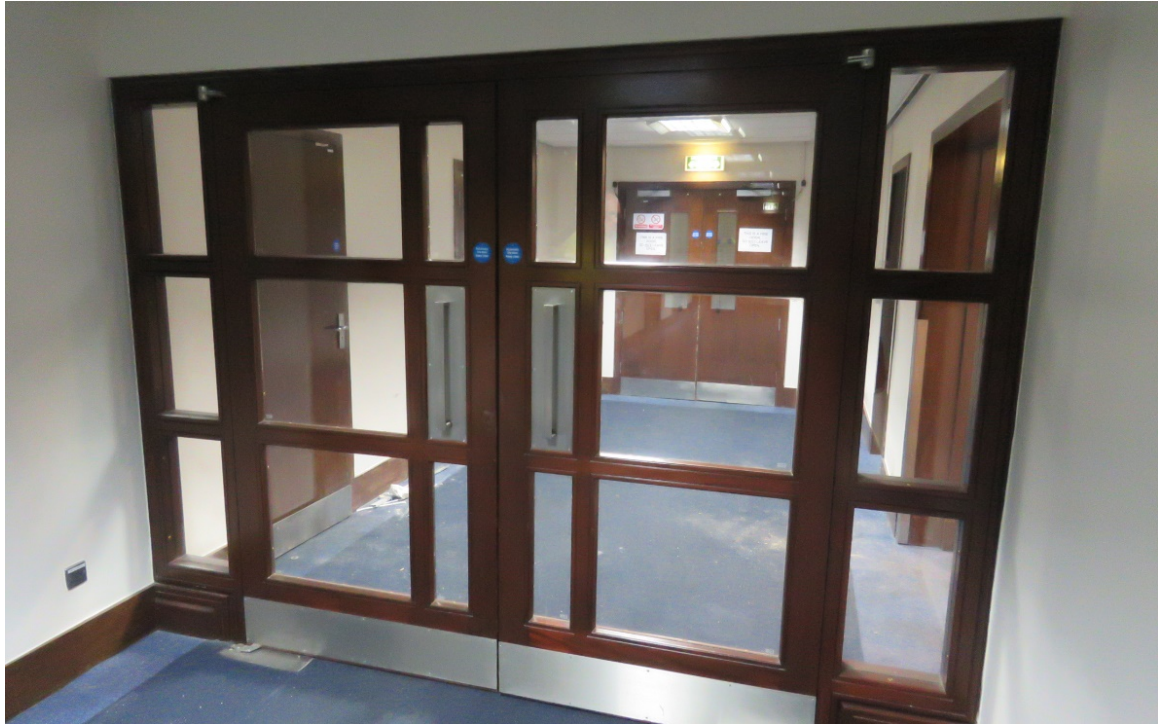
**01-02** Looking north through the inserted fire lobby door toward the tower office entrance.

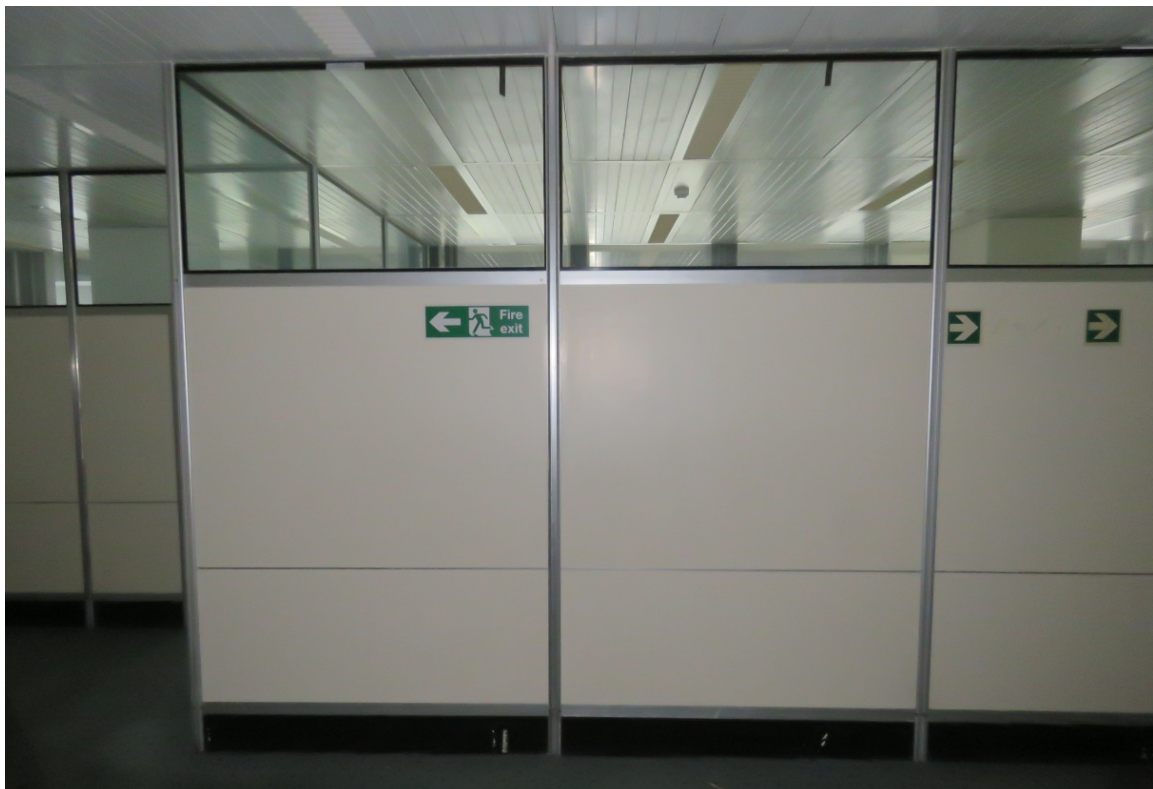
**01-03** Looking north from the office entrance at the original partitions which enclose the offices under the portico.

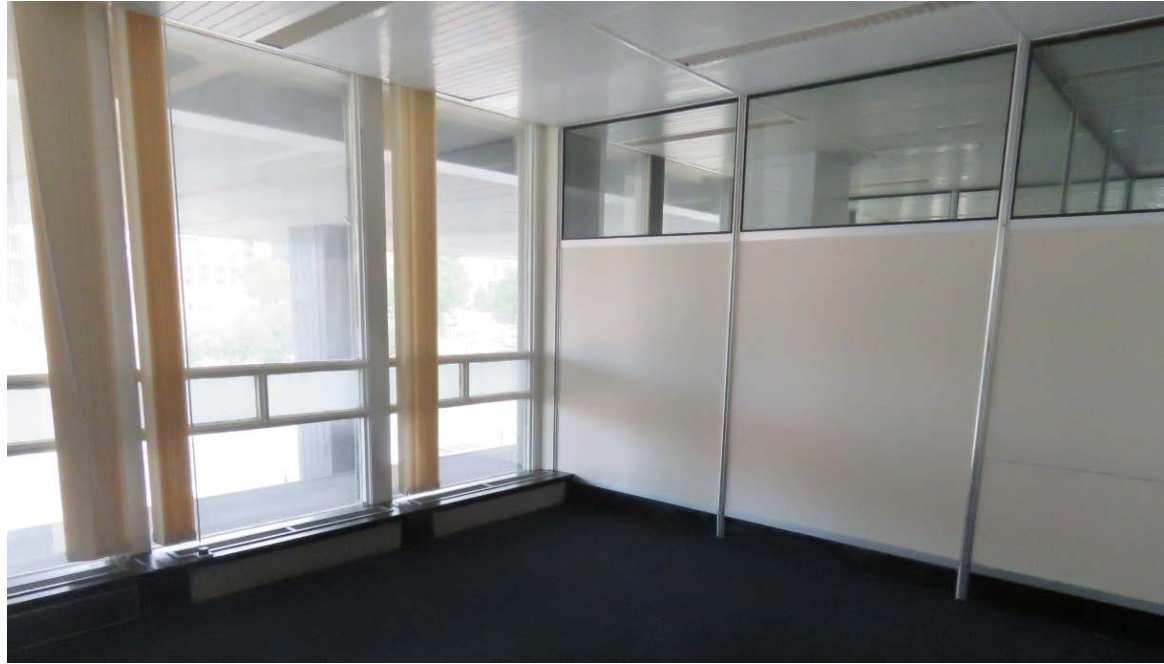
**01-04** Looking north-east at the surviving original office partitions and the portico.

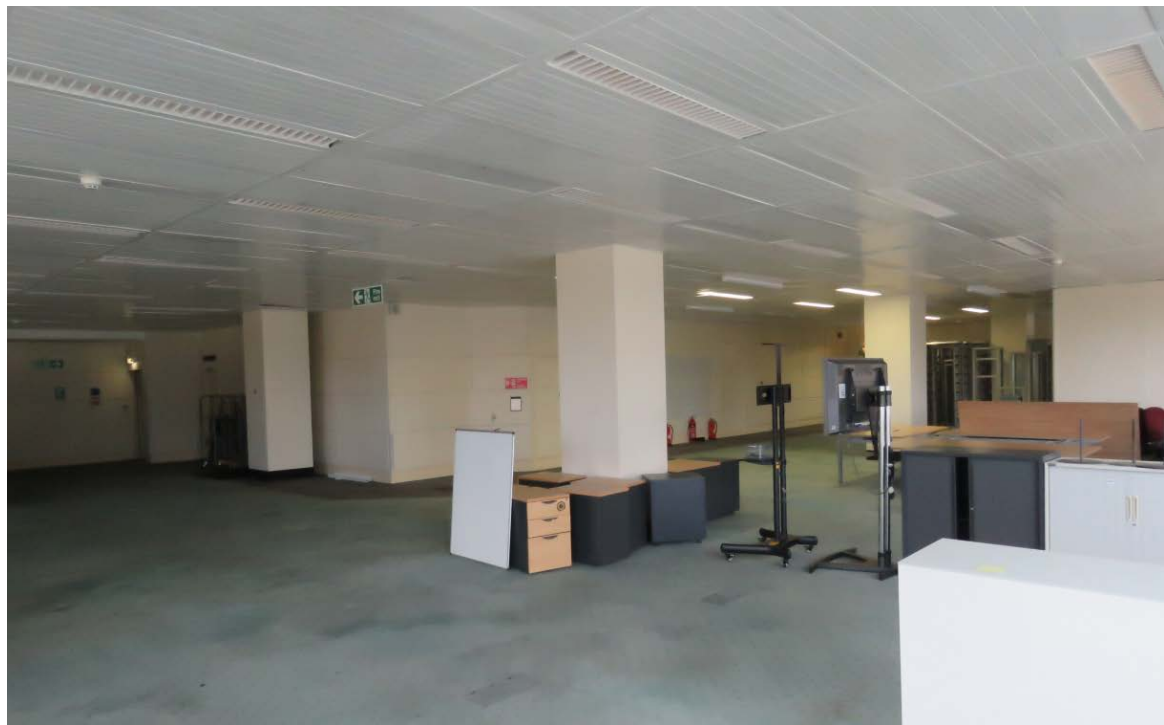
**01-05** Looking south-east across the tower office floor.

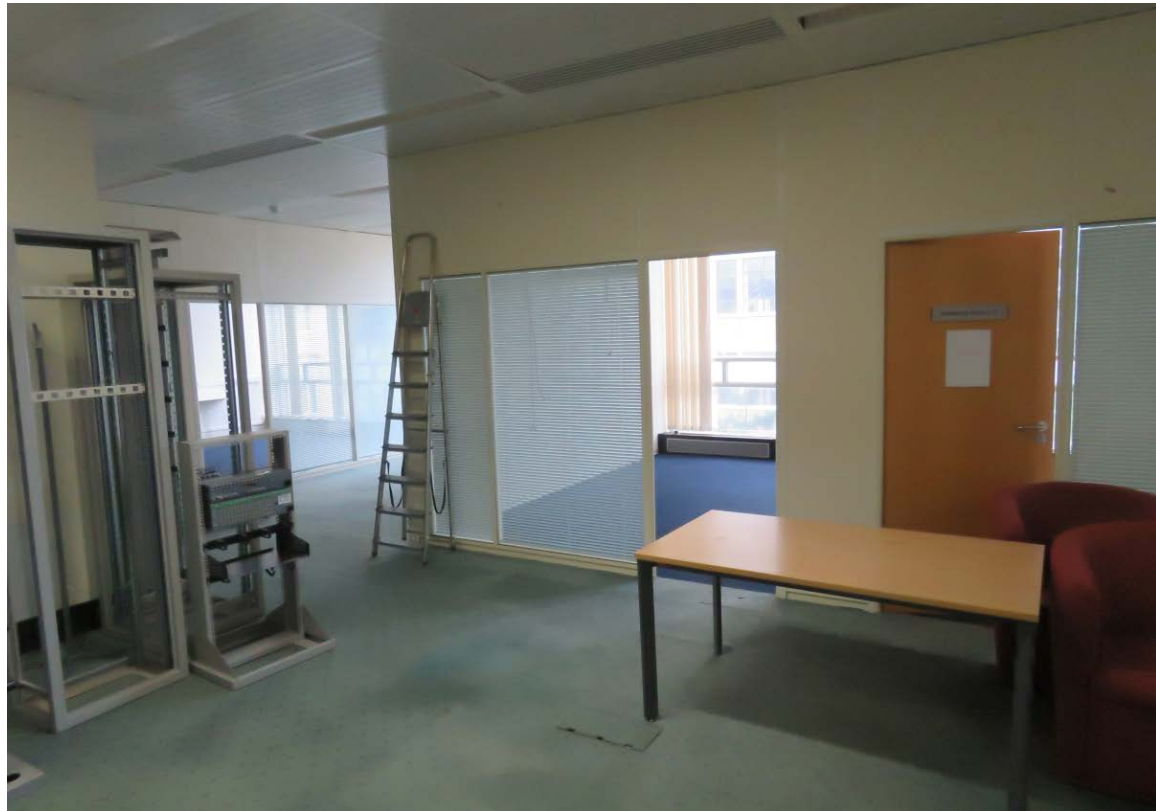
**01-06** Looking south-west toward the inserted offices enclosing the Dantzig Street frontage.

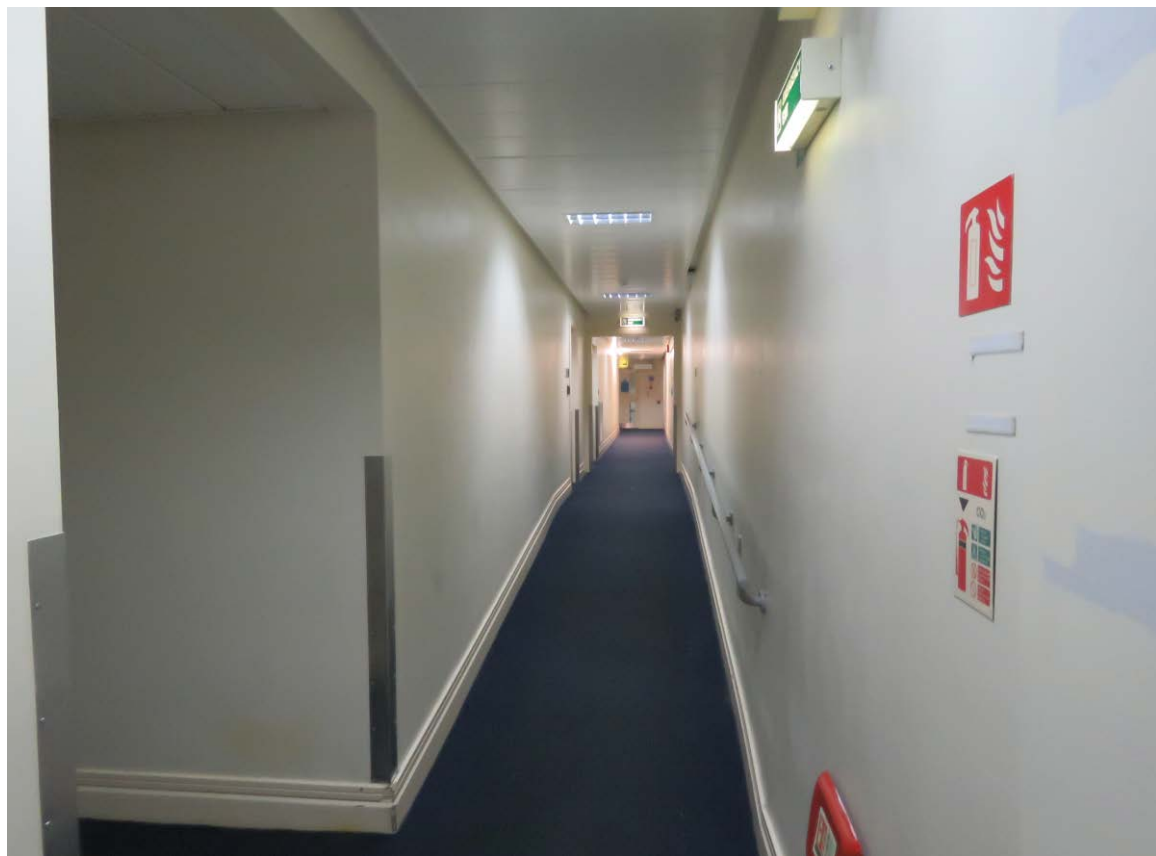
**01-07** Looking south along the inserted west corridor, enclosed by non-original offices.

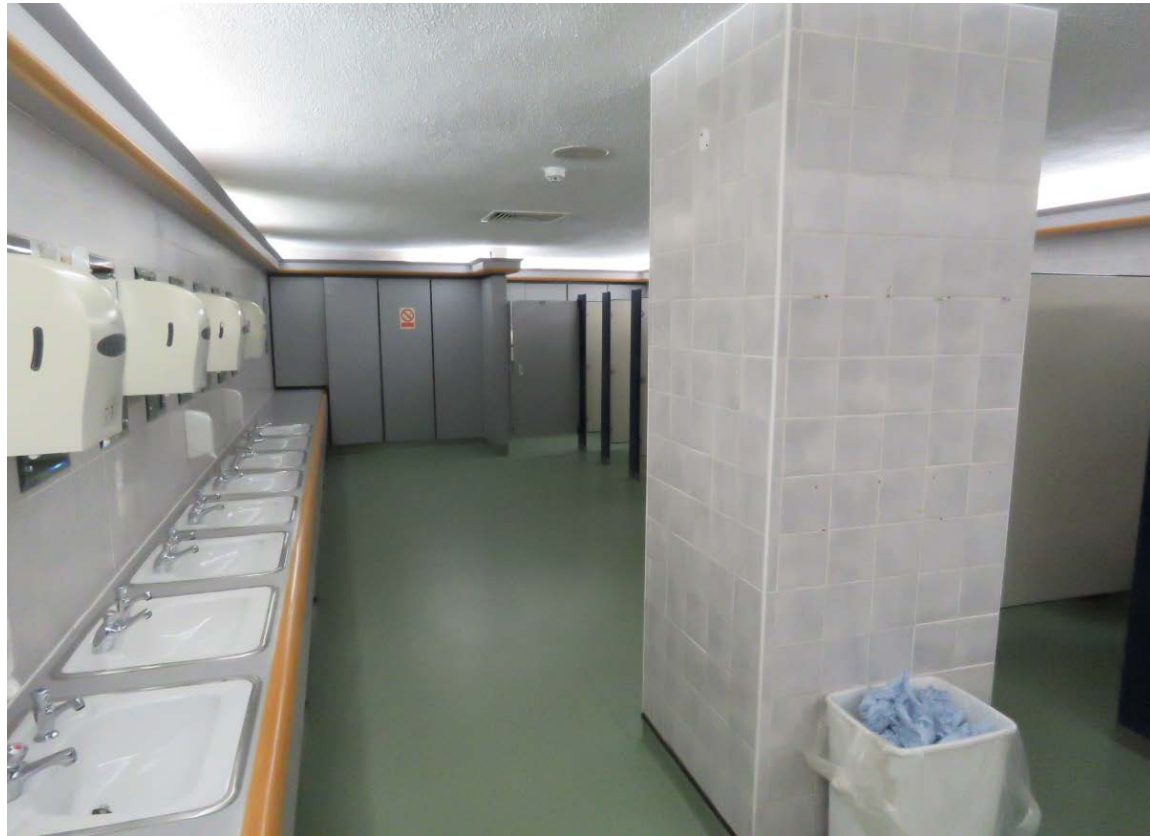
**01-08** The west ladies' toilets, including partial surviving original cubicles.

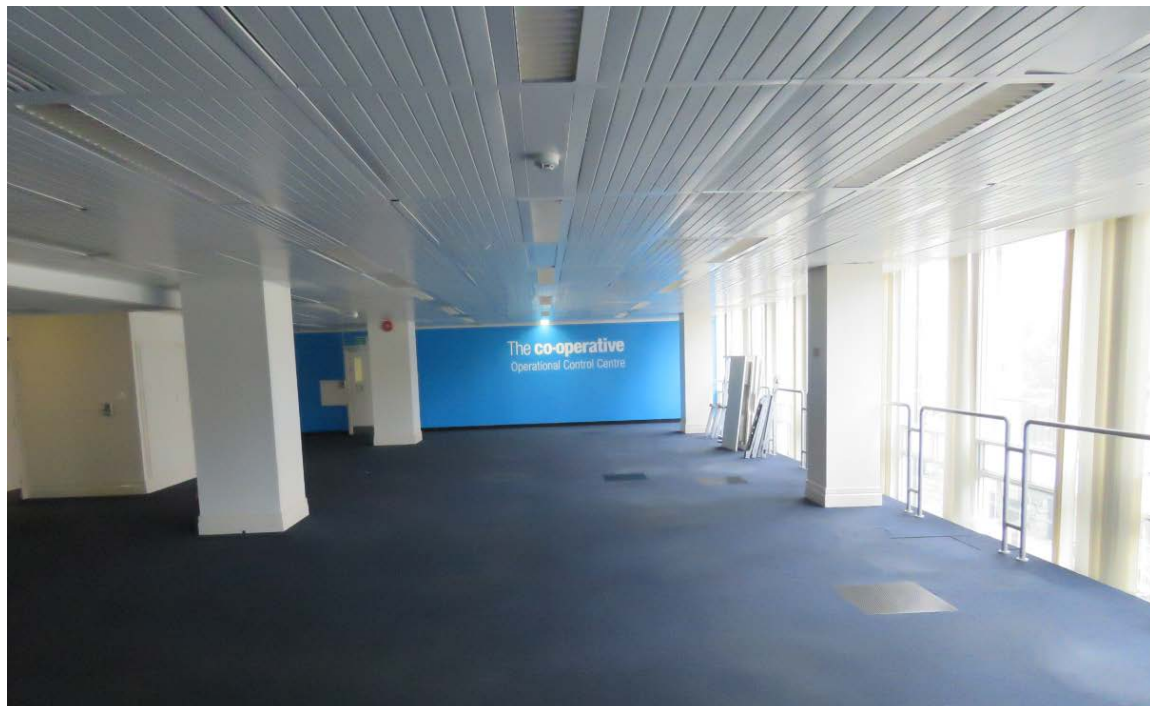
**01-09** Looking south across the inserted office, with raised access floor, which is stepped back from the windows, requiring the handrails. Weathermaster is below the raised access floor.

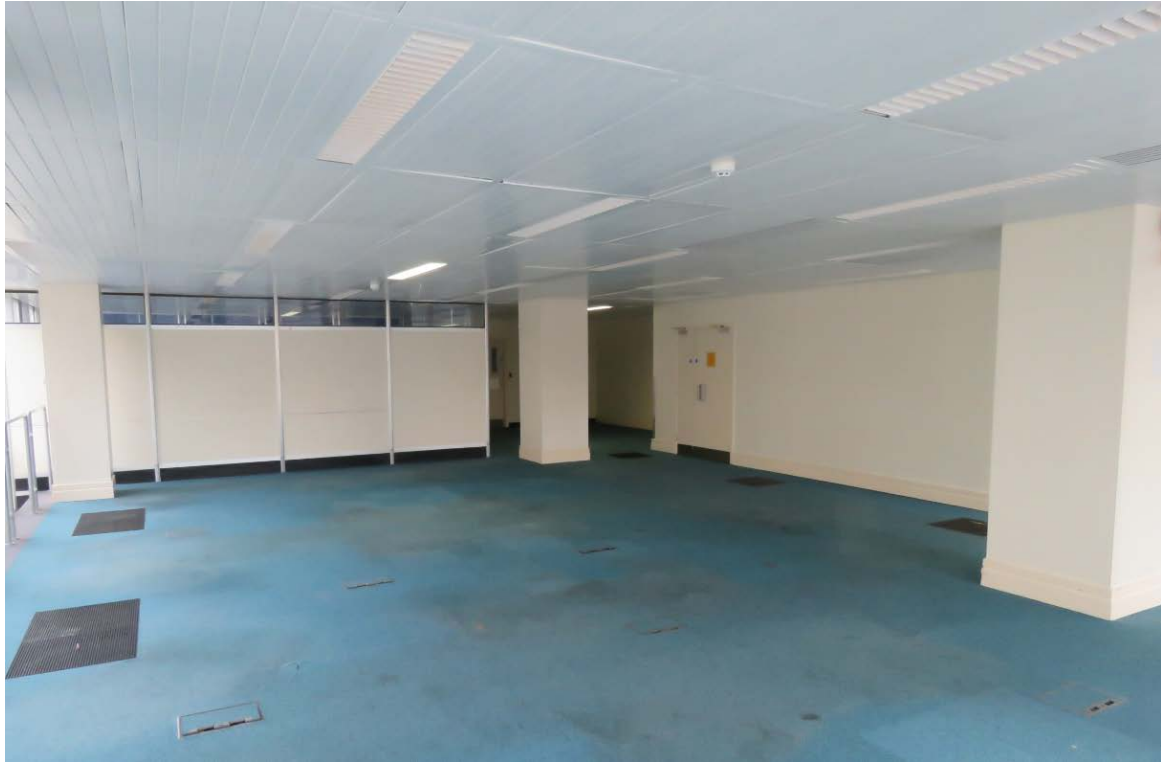
**01-10** Looking north-east towards the inserted offices, showing the raised access floor. Skirtings to the columns and handrails are non-original. Floor approximately 300mm above original level.

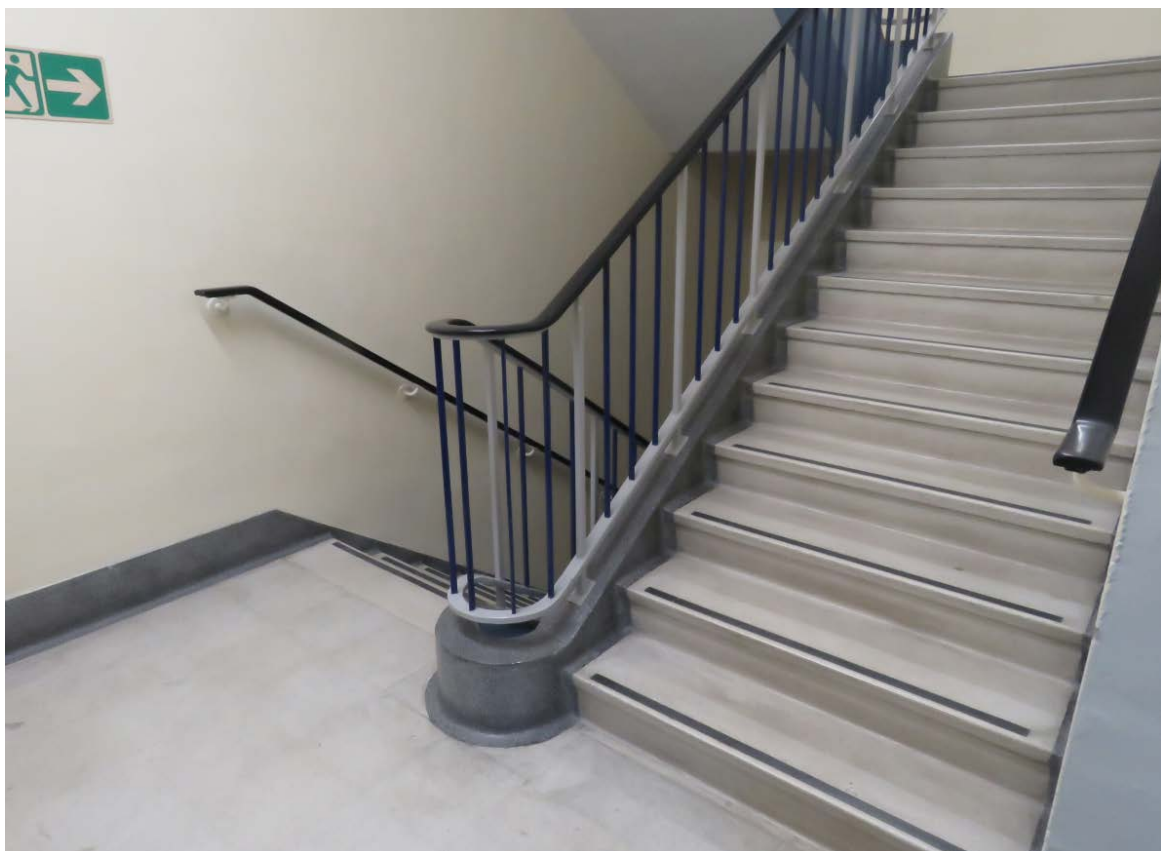
**01-11** The south-west stairs.

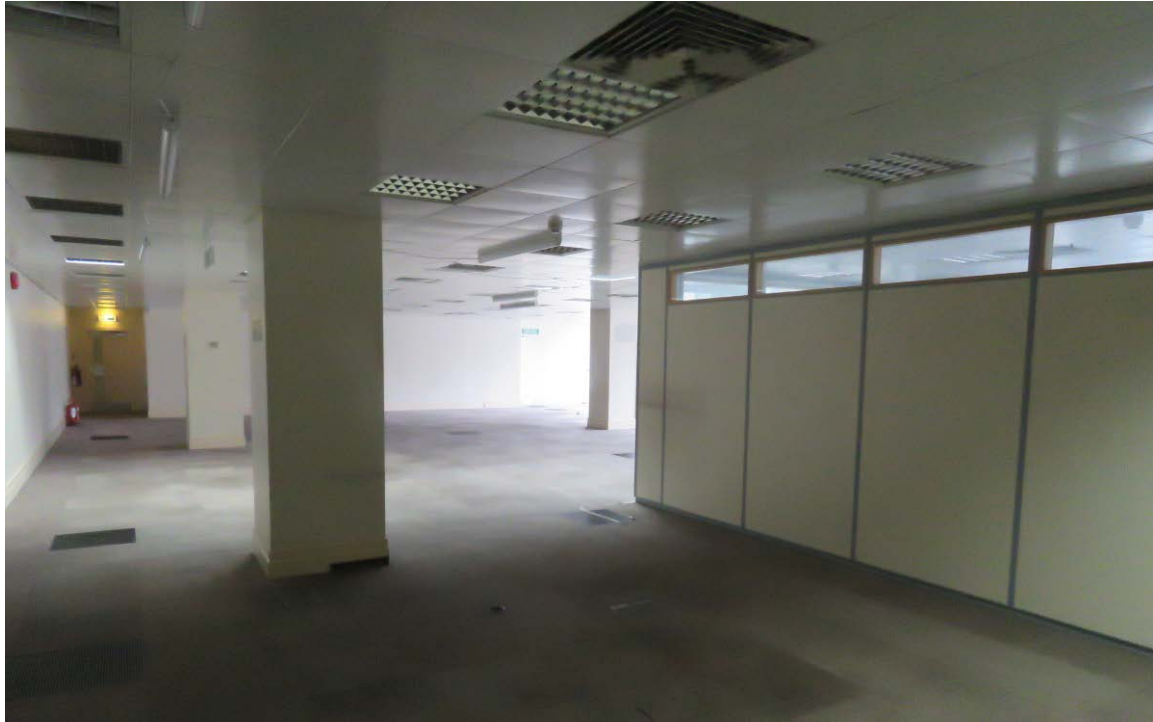
**01-12** Looking east across the podium floor, showing the inserted offices.

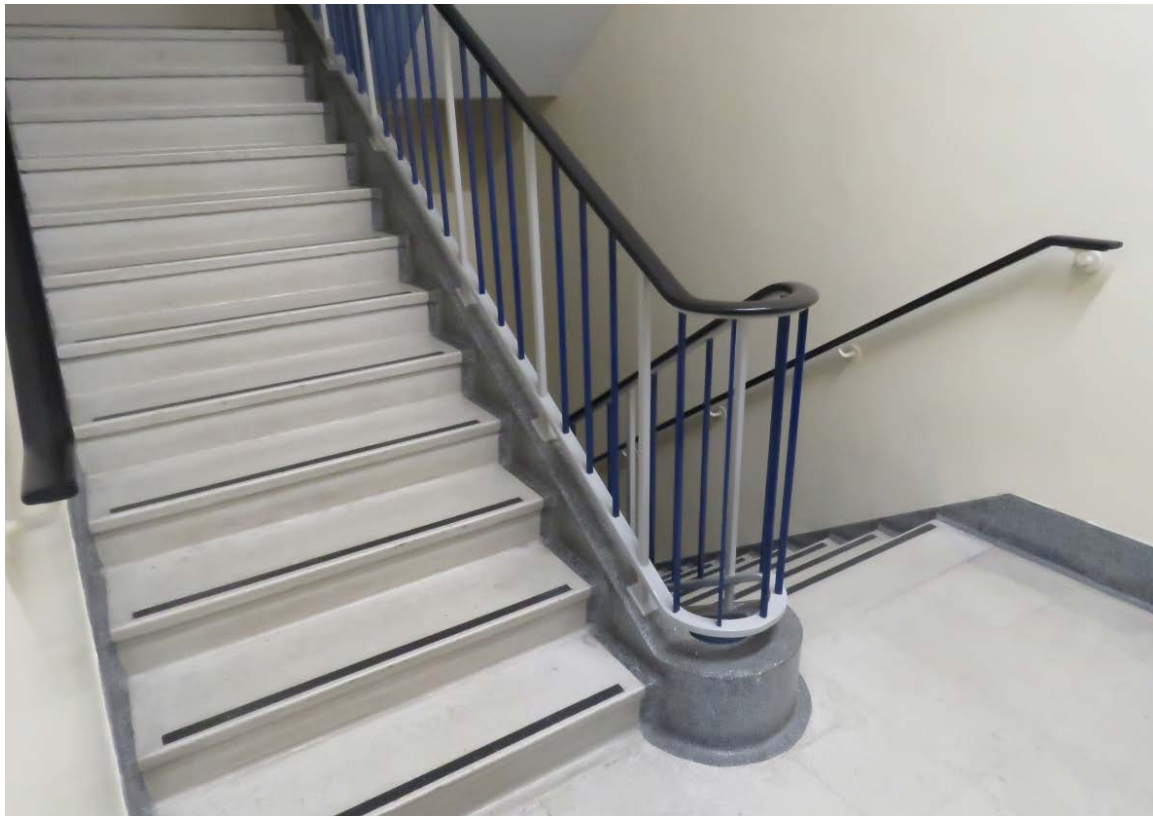
**01-13** The south-east stairs.

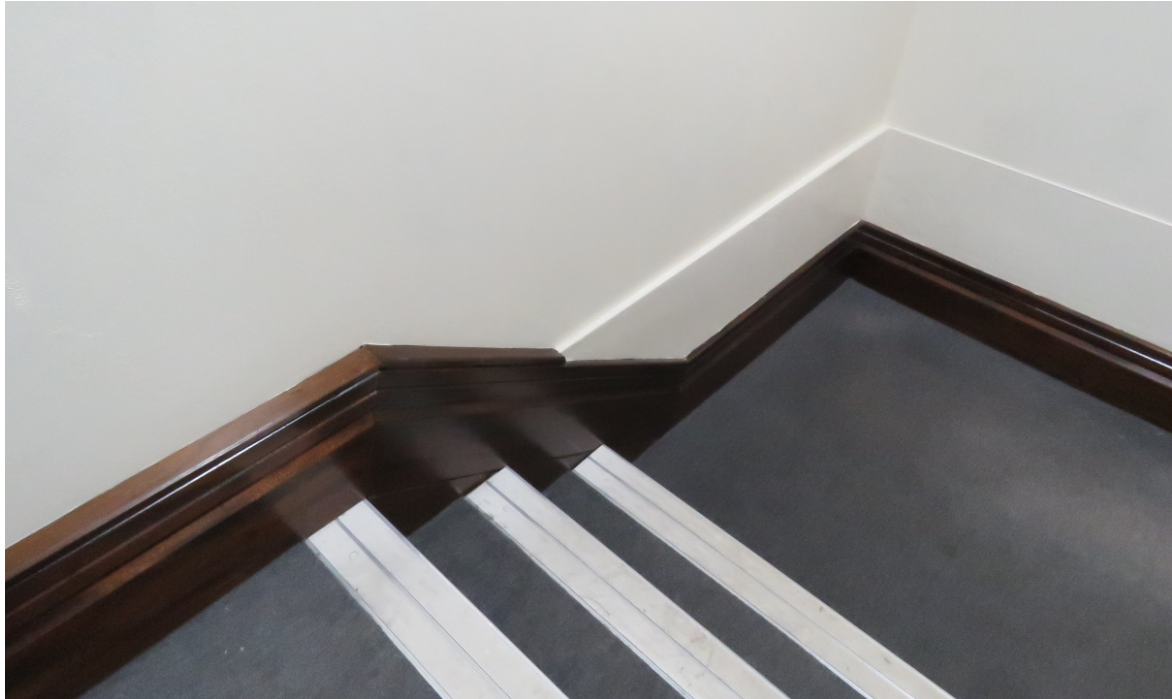
**01-14** Detail of surviving skirting in the added stair lobby south-east stair lobby. The fire lobby was added as an extension to the corridor and to accommodate the raised access floor.

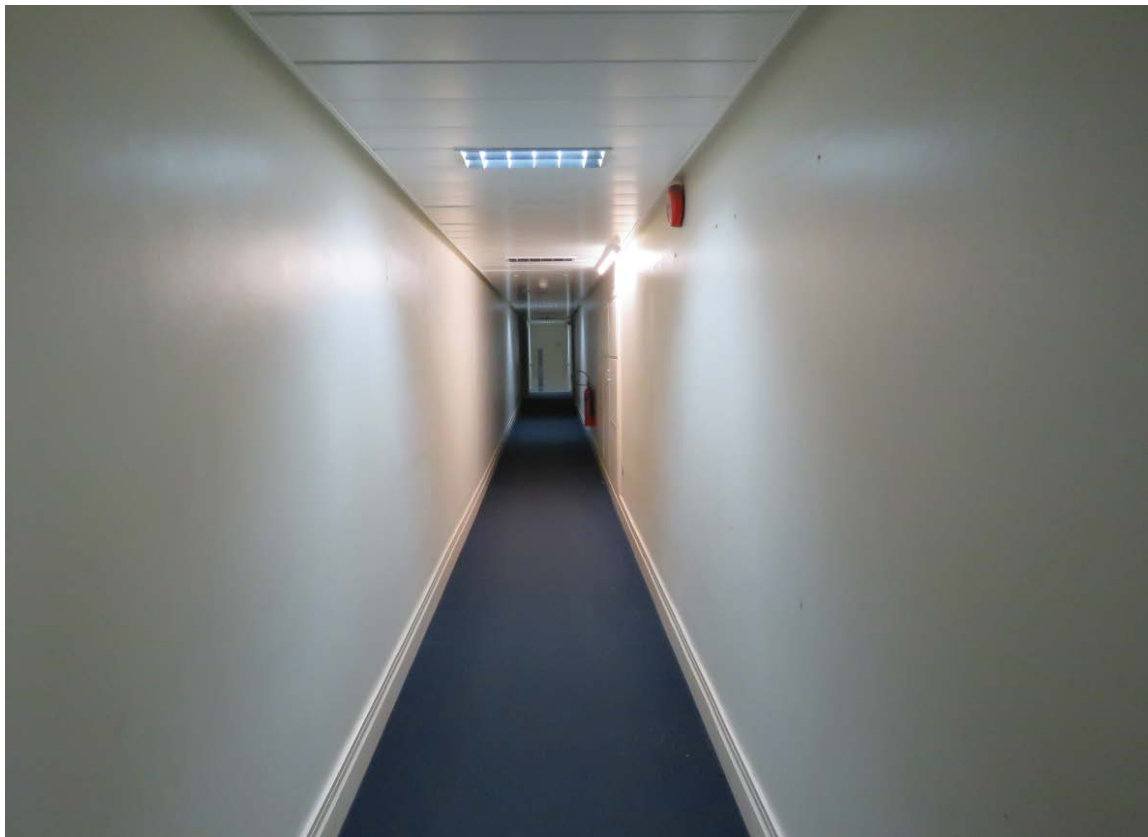
**01-15** The inserted east corridor and ramp looking north.

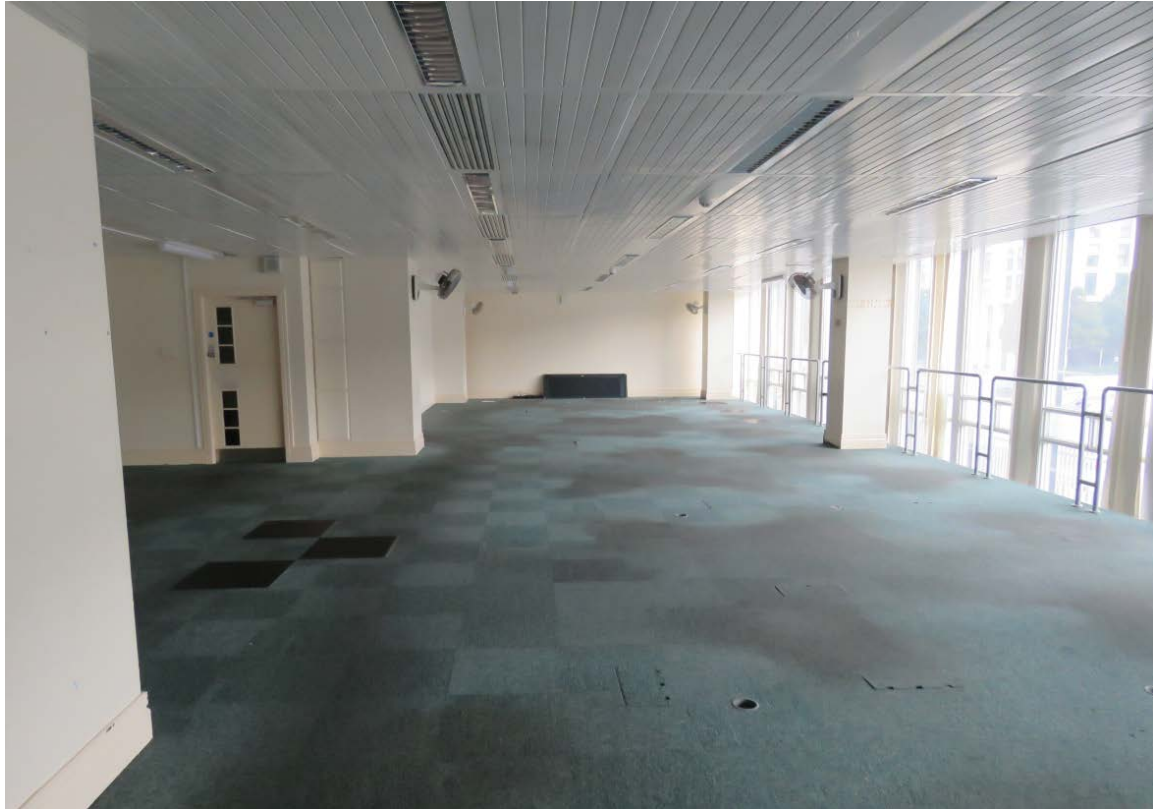
**01-16** Looking north across the raised access floor of the enclosed office. Handrails and partitions are non-original, as is the raised access floor.

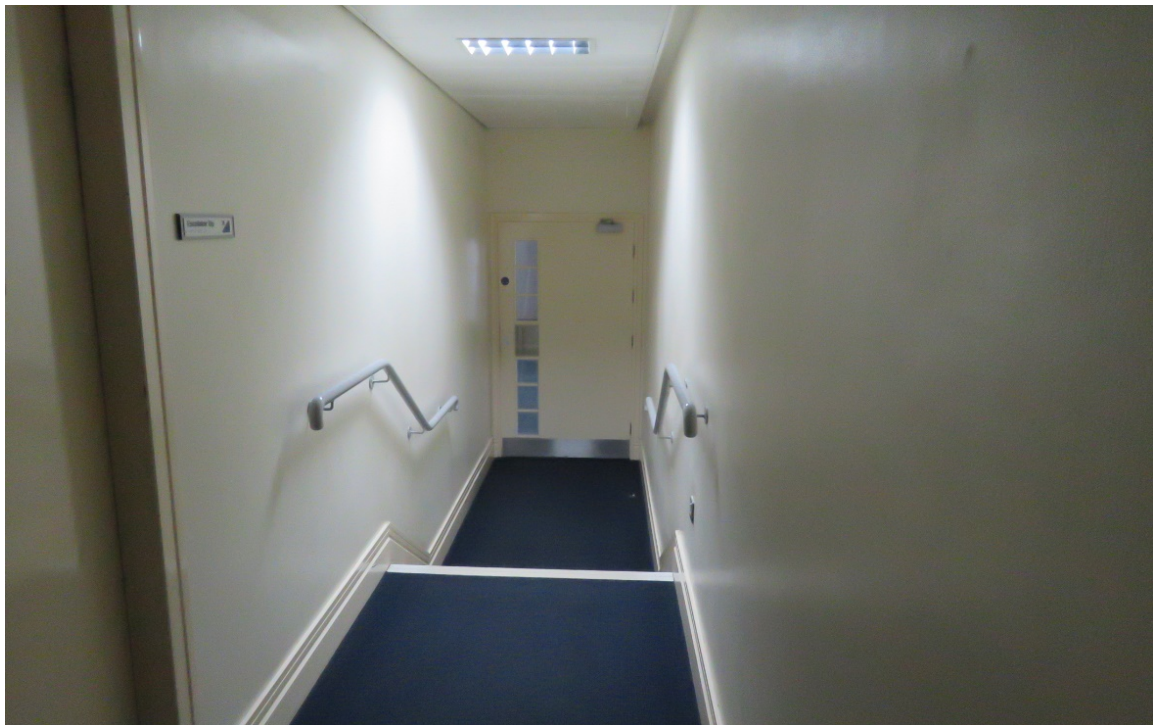
**01-17** Looking north along the east corridor showing the step down to the tower office level.

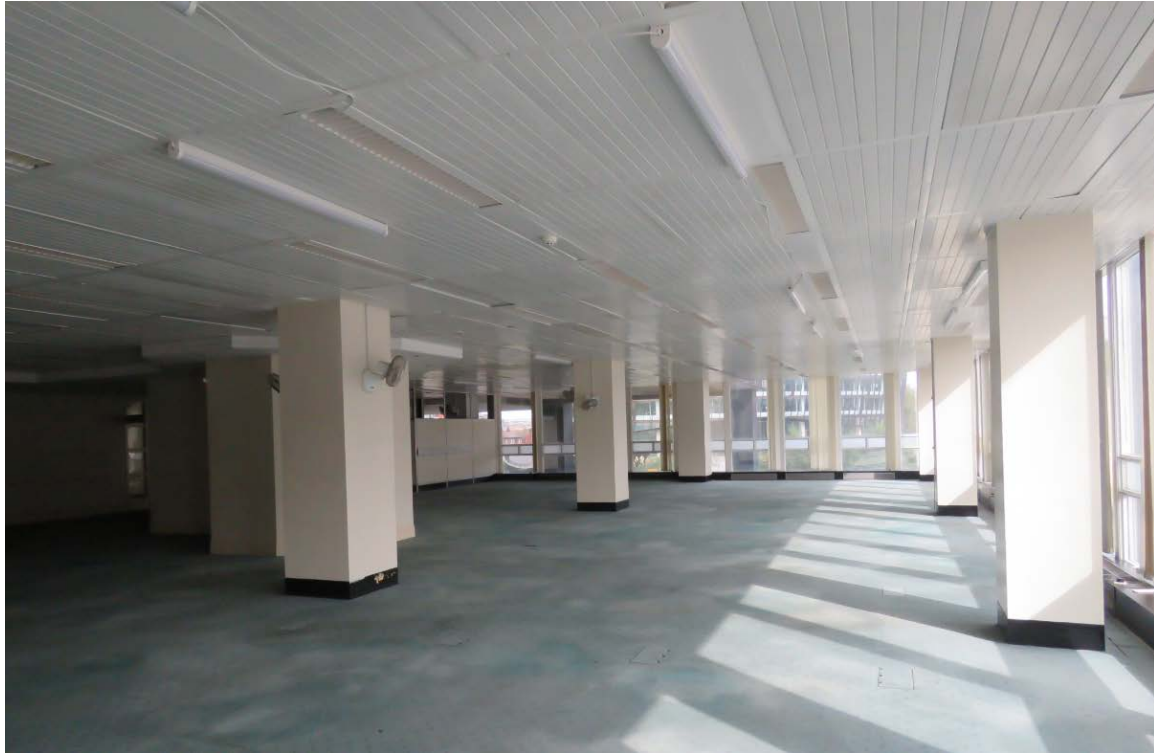
**01-18** Looking north towards the portico across the tower office floor. Note the increased proportions as the floor level is at the original level.

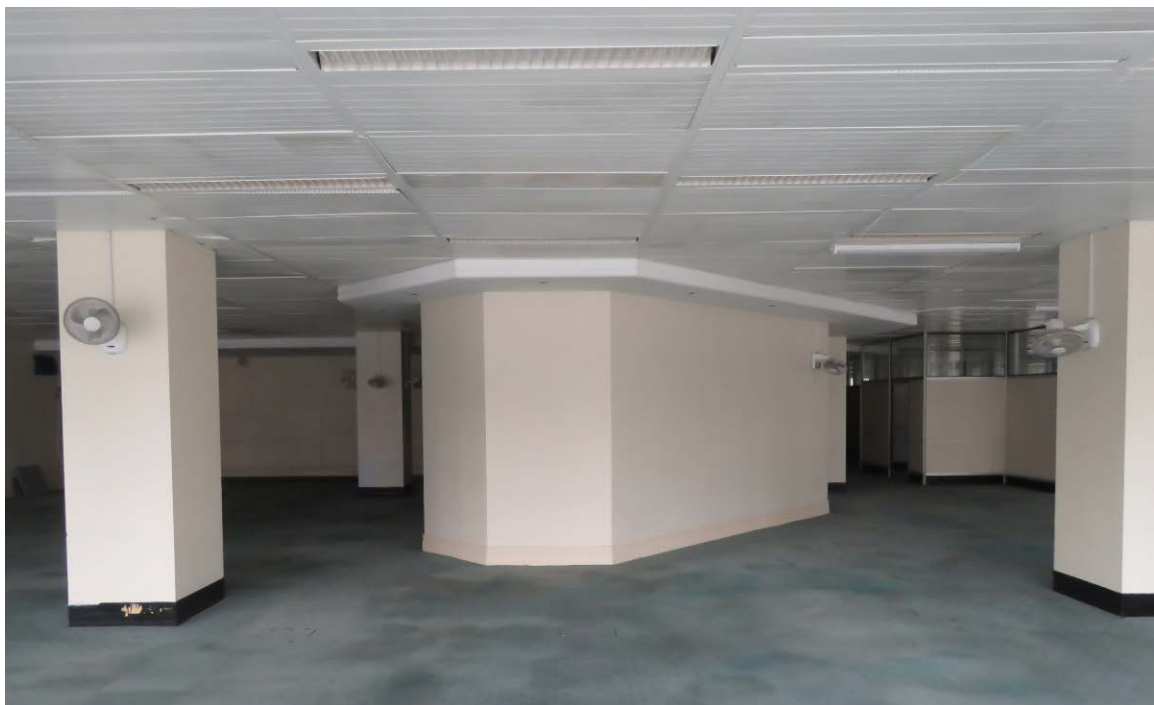
**01-19** Looking west across the tower office toward the inserted enclosure of the north-east escape stairs.

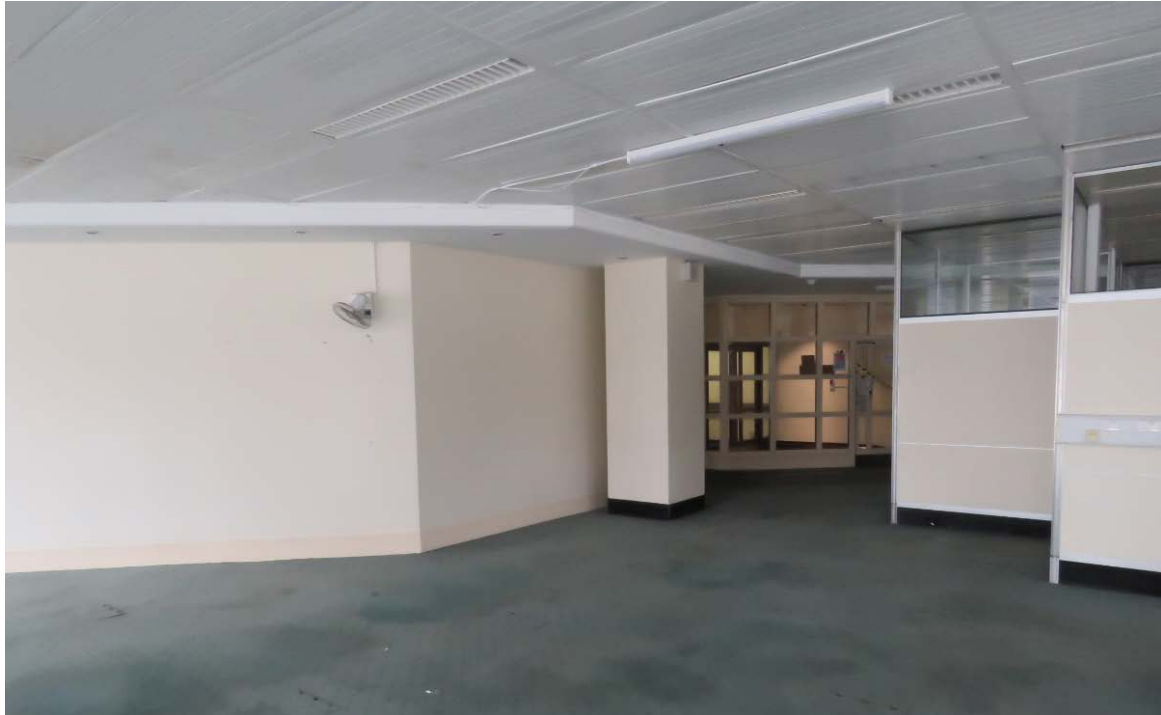
**01-20** Looking west across the tower towards the inserted stairs and showing the screen enclosure of the additional escalator fire screen.

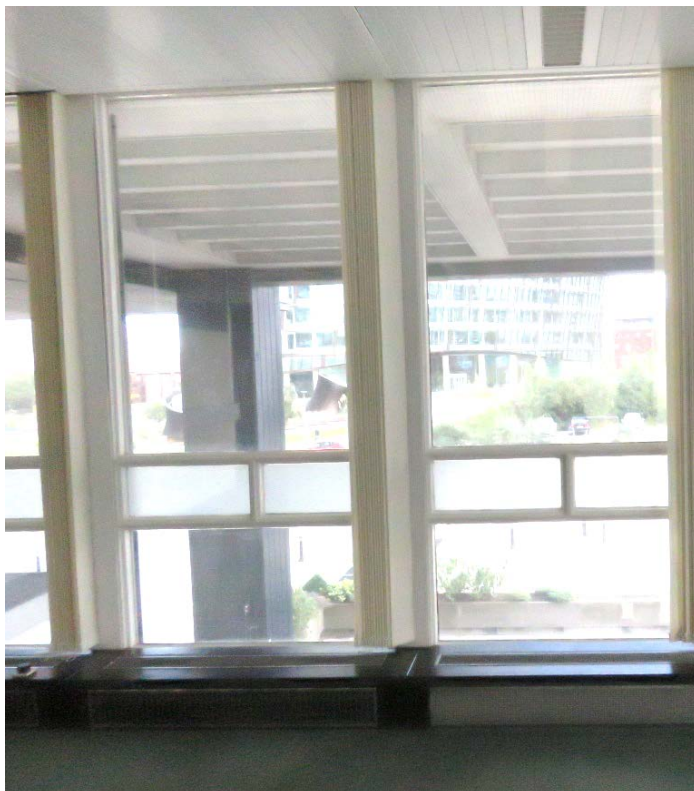
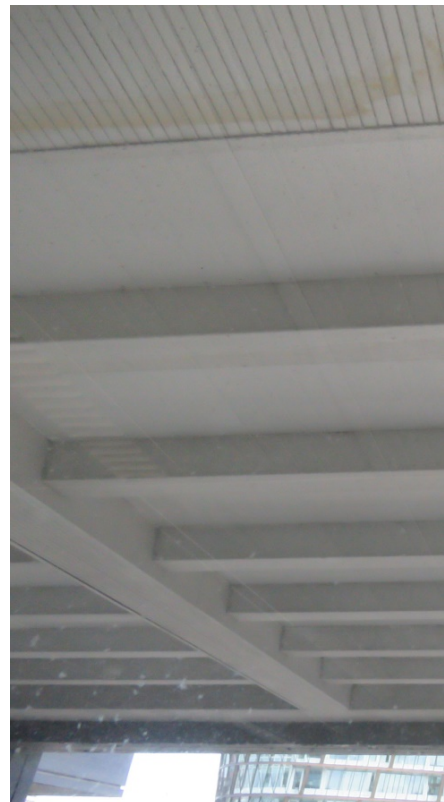
**01-21a and 01-21b** Looking north from the tower office showing the perimeter Weathermaster, the fenestration pattern (painted white) and the exposed concrete of the portico's soffit.

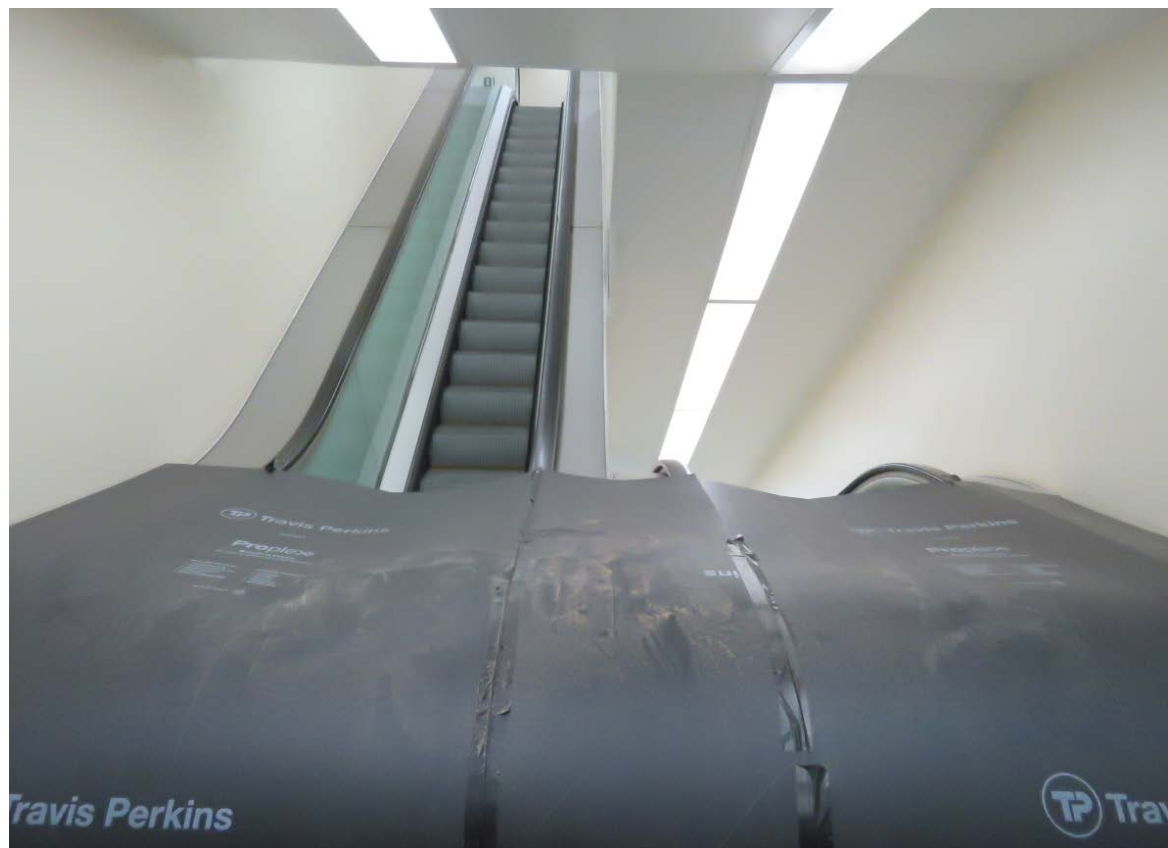
**01-22** The currently decommissioned escalators, looking south.

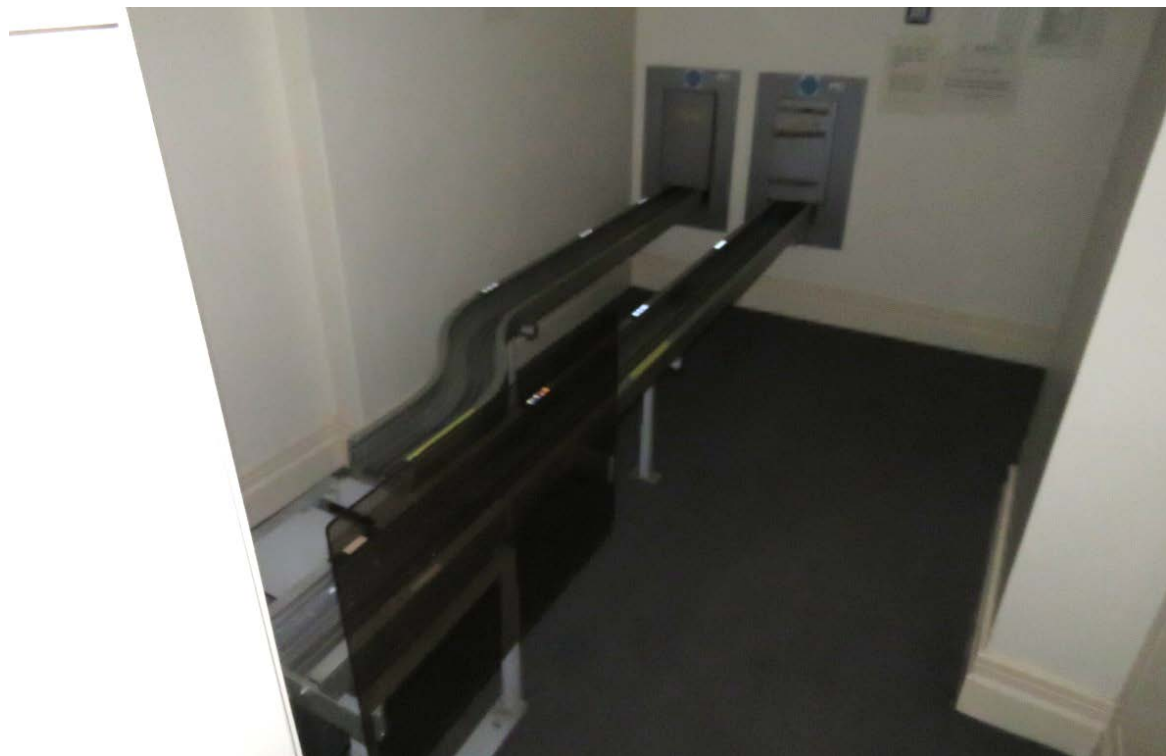
**01-23** The twin track Telelift system.

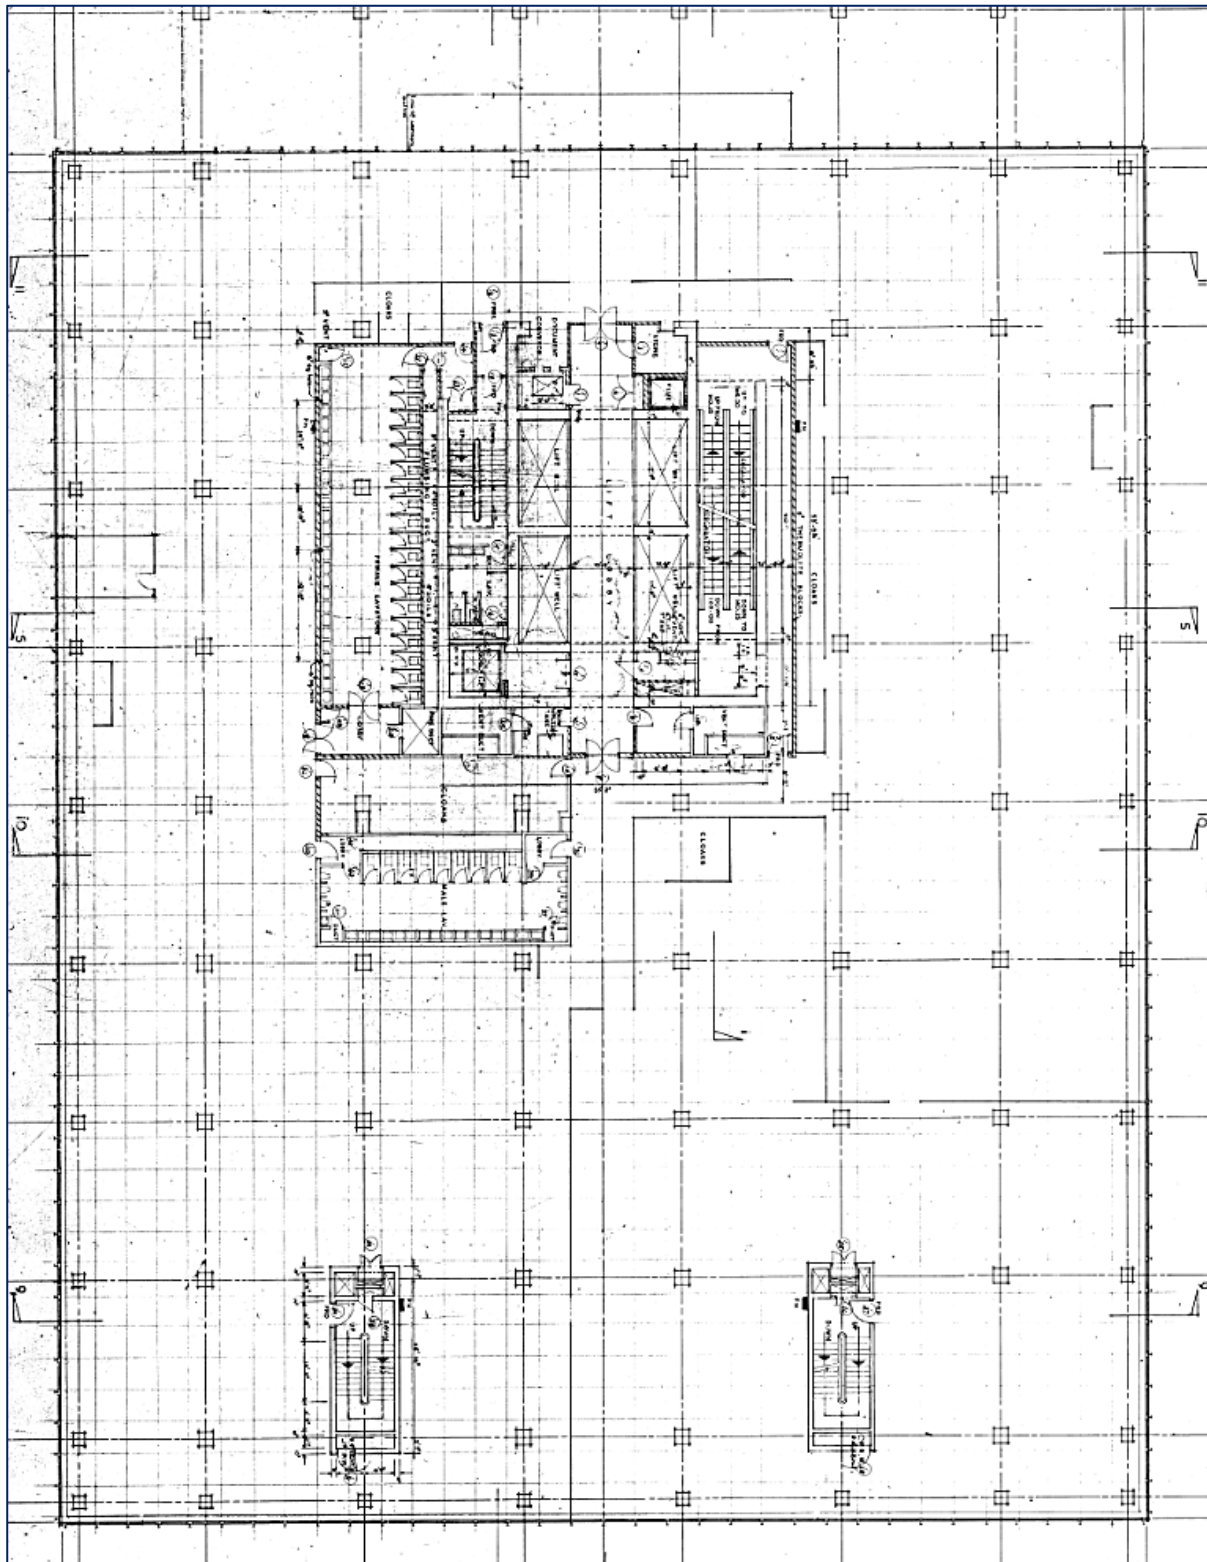
**Figure 2.** The 1962 floor plan for comparison with Figure 1. Note the lack of compartmentalisation or fire lobbies to the south-east and south-west stairs.
