# Manchester Art Gallery

Athenaeum Basement [Ref: 141639/JO/2024]  
Discharge of Condition 3c, 3d, 5a, 5b & 5c  
External Grates & Lintel Repairs  
June 2025

Project name: Manchester Art Gallery  
Project number: 9604  
Client: Manchester City Council | Manchester Art Gallery

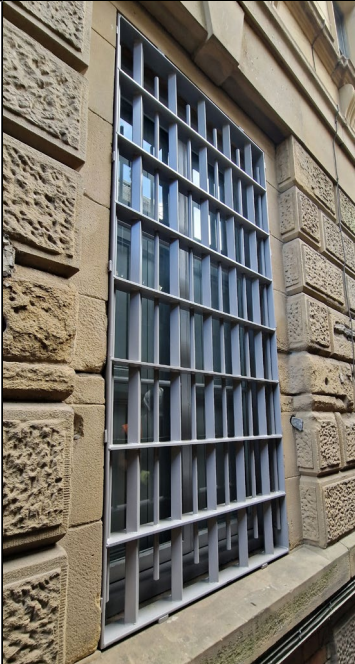
| No. | Item | Material and Finish | Photograph | Submitted to | Relevant dates | Comments / Feedback |
|---|---|---|---|---|---|---|
| 1 | Mock up sample of installed SR4 rated security bars | Grille: Mild steel, PPC finish in RAL 7036 Matt | | Michael Pearson [Planning Officer] & Paul Mason [Conservation Officer]<br><br>Manchester City Council | Window bars installation sample viewed during site meeting on 30/04/25 | Sample accepted - agreed for all window bars to be installed with fixings located to the rear face of the bar. |

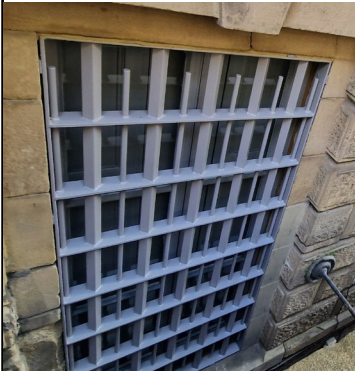
| No. | Item | Material and Finish | Photograph | Submitted to | Relevant dates | Comments / Feedback |
|---|---|---|---|---|---|---|
| 2 | Mock up sample of installed SR4 rated security bars with dry pack mortar | Dry pack mortar: Composition: 1 part Portland cement: 3 parts well graded sand. Colour: Buff Height: 10mm | | | | |

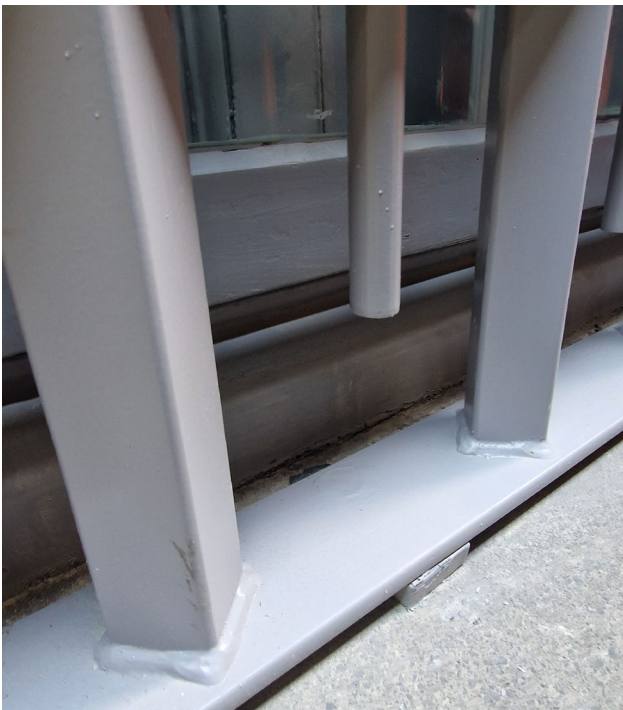
Figure 1 Photograph showing painted fixing to lower plate

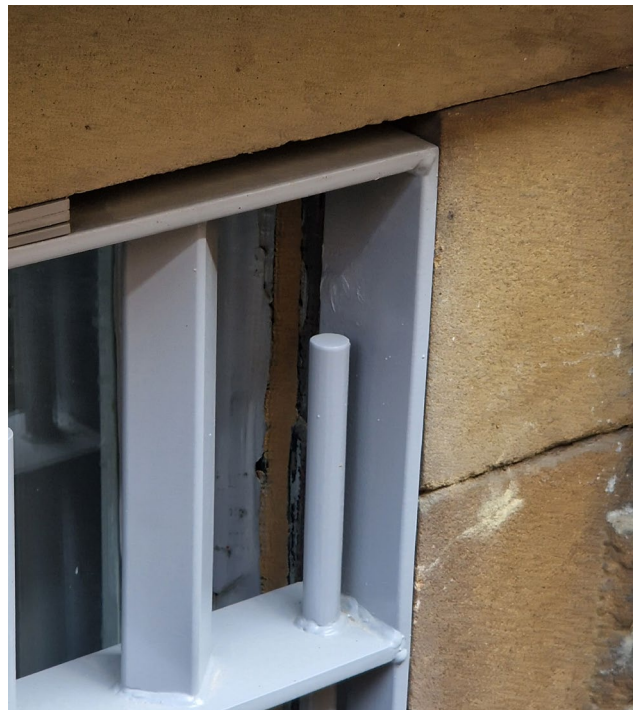
Figure 2 Photograph showing painted fixing to side plates, positioned to rear of bars

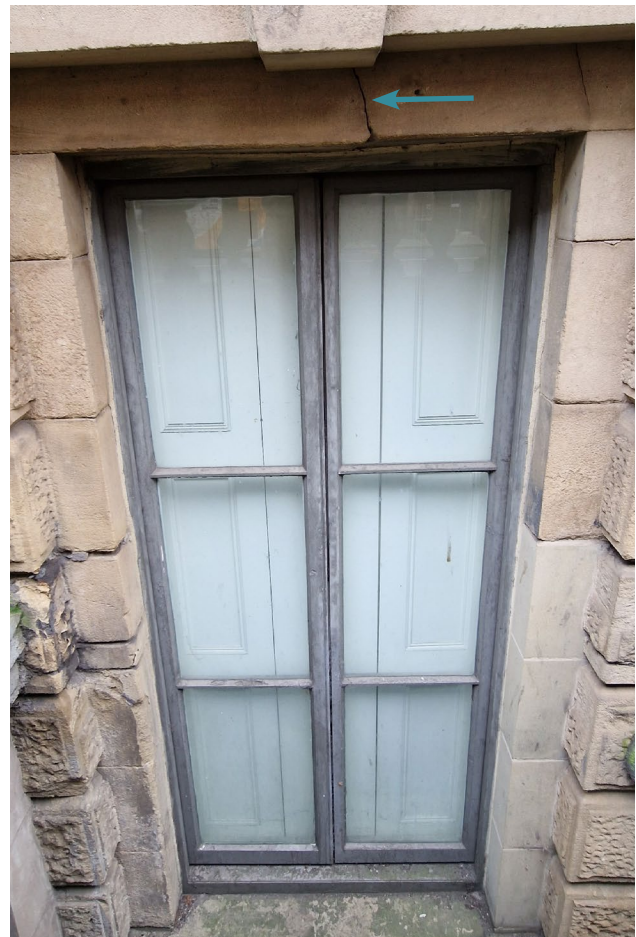
Figure 4 WIN-010 with failed lintel highlighted

The following works apply to windows WIN-004 (George St) and WIN-010 (Princess St) where the new metal security grilles are proposed to stabilise the failed lintels. Further information on the nature of the defects to these lintels can be found in Appendix A, alongside assessment of the proposed stabilisation method in Appendix B.

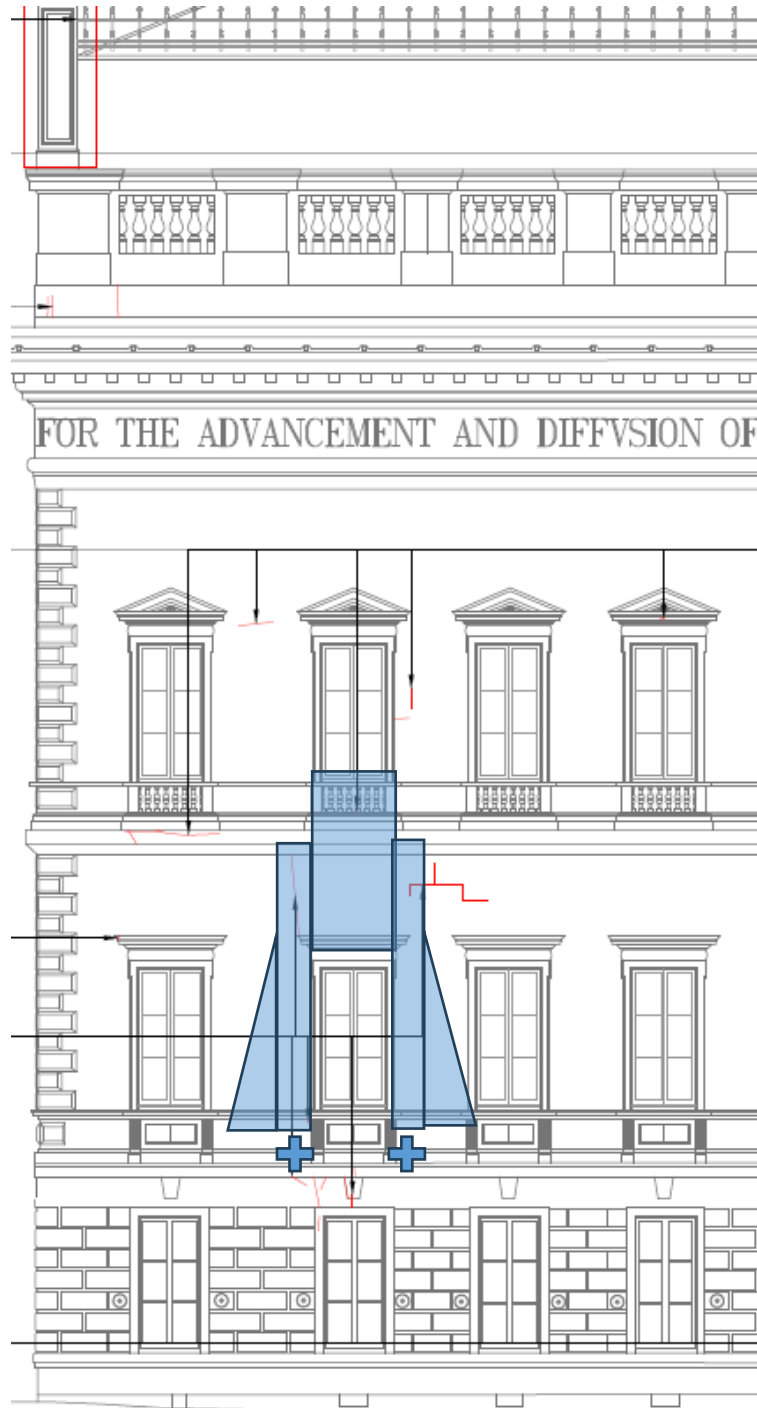
Figure 1 - Loaded area to be supported by TW

Outer Leaf thickness taken as 250mm, based on site assessment. Due to historic movement, corbelling has been assessed to be occurring.

Shaded area =  $18.5\text{m}^2$ . Based on sandstone density  $25\text{kN/m}^3$ , **load to each prop position is 57kN (SLS).**

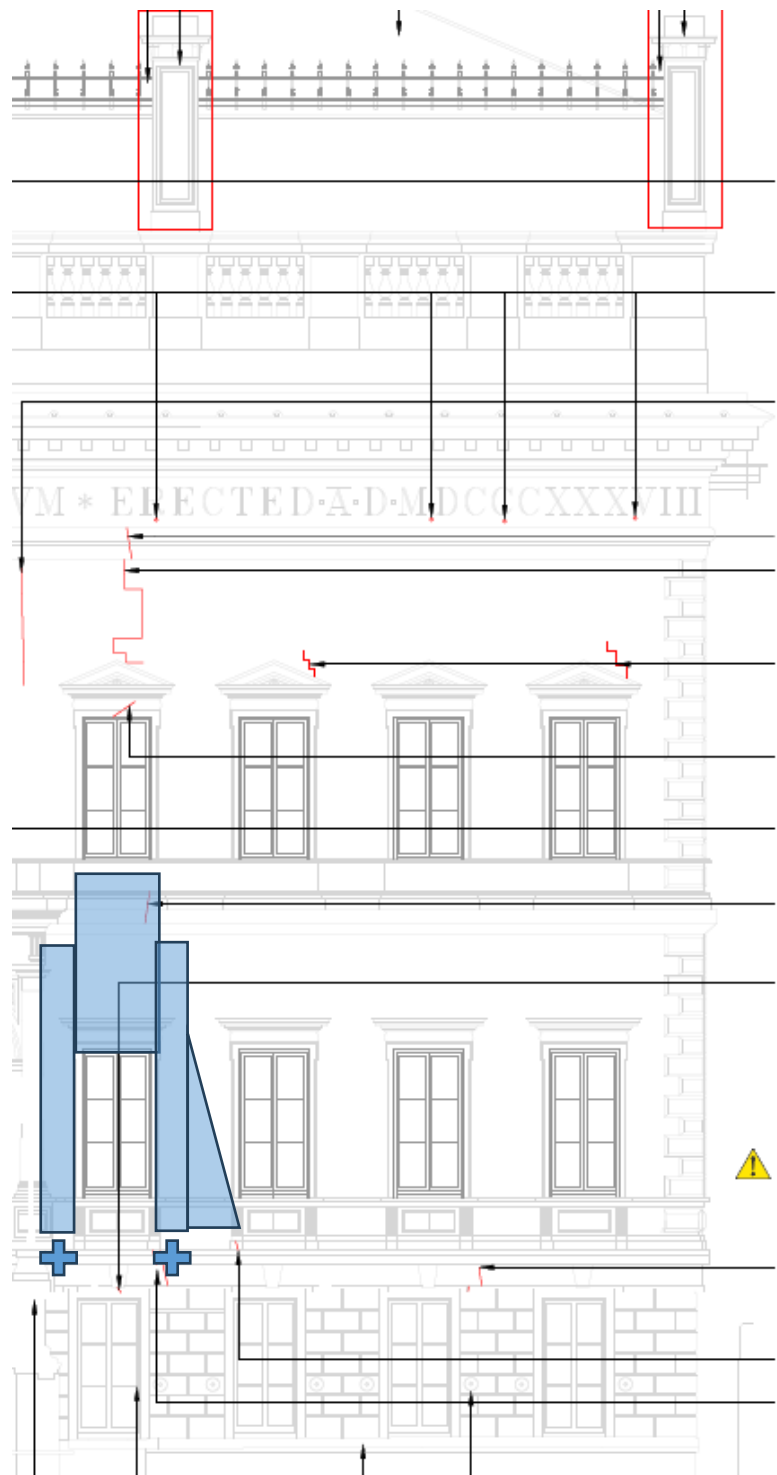
Figure 2 - Loaded area to be supported by TW

Outer Leaf thickness taken as 250mm, based on site assessment.

Due to historic movement, corbelling assessed to be occurring.

Shaded area =  $14\text{m}^2$ . Based on sandstone density  $25\text{kN/m}^3$ , **load to each prop position is 45kN (SLS).**

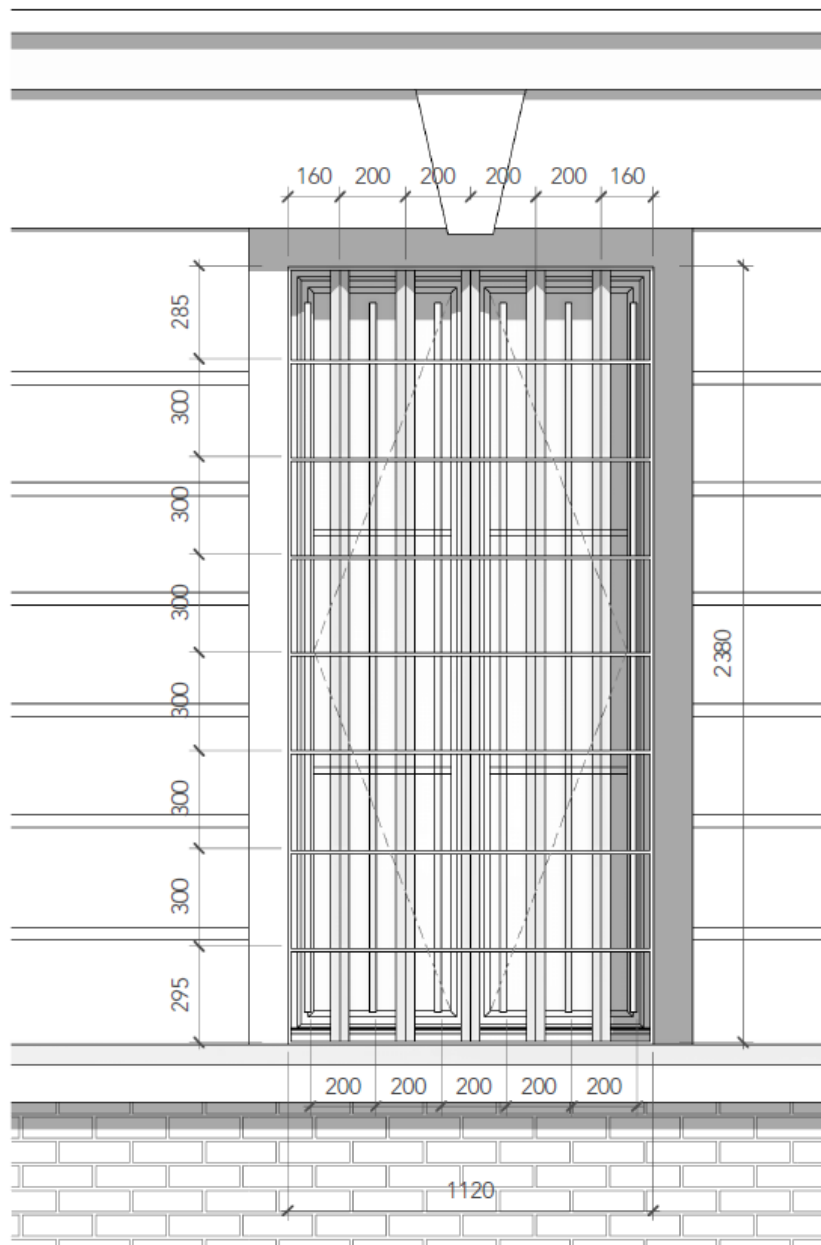
Figure 3 - Extract from Architectural Drawing - MAG-BUT-08-B2-DR-A-31-0001

The steel grille is proposed to be positioned directly under the lintel to form the security barrier. As described in previous reports, the lintel is supported by the window frame, so the intention is to replicate this and support with the security grille, as it is much more robust.

Due to the costs and complexity of full replacement, it is recommended to proceed with a long-term stabilisation method (i.e. option 2). This is in line with conservation approaches, and reduces the amount of work required to be undertaken to the Listed fabric to a minimum.

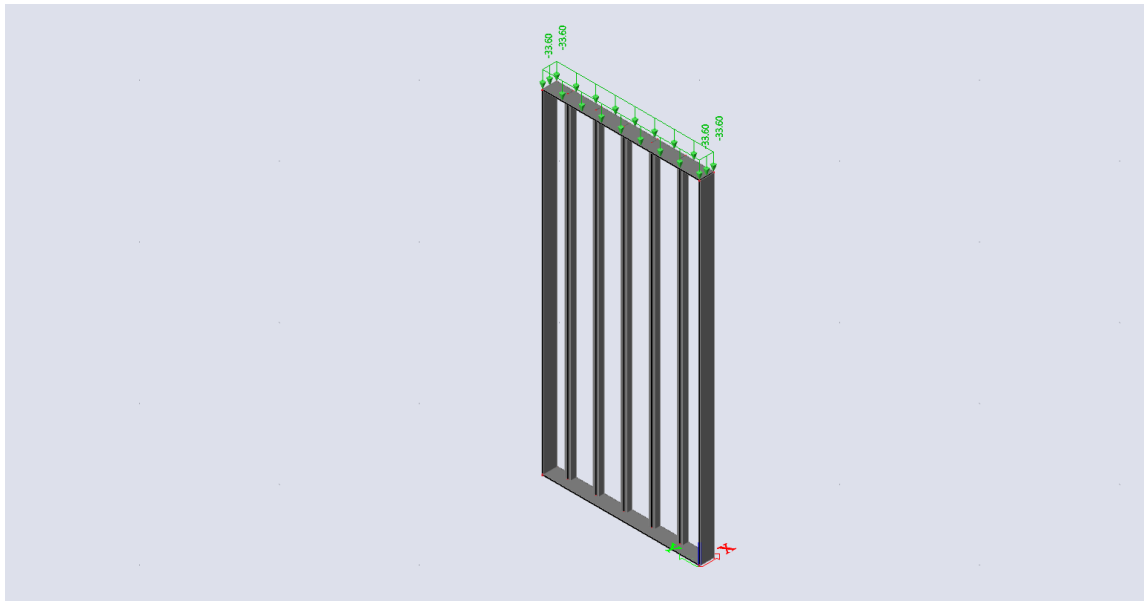
The grille has been checked under a vertical load equivalent to the full stone area above the lintel being supported. This is conservative but ensures there is sufficient capacity in the grilles to continue to undertake their primary function.

Figure 4 - Applied Load to grille

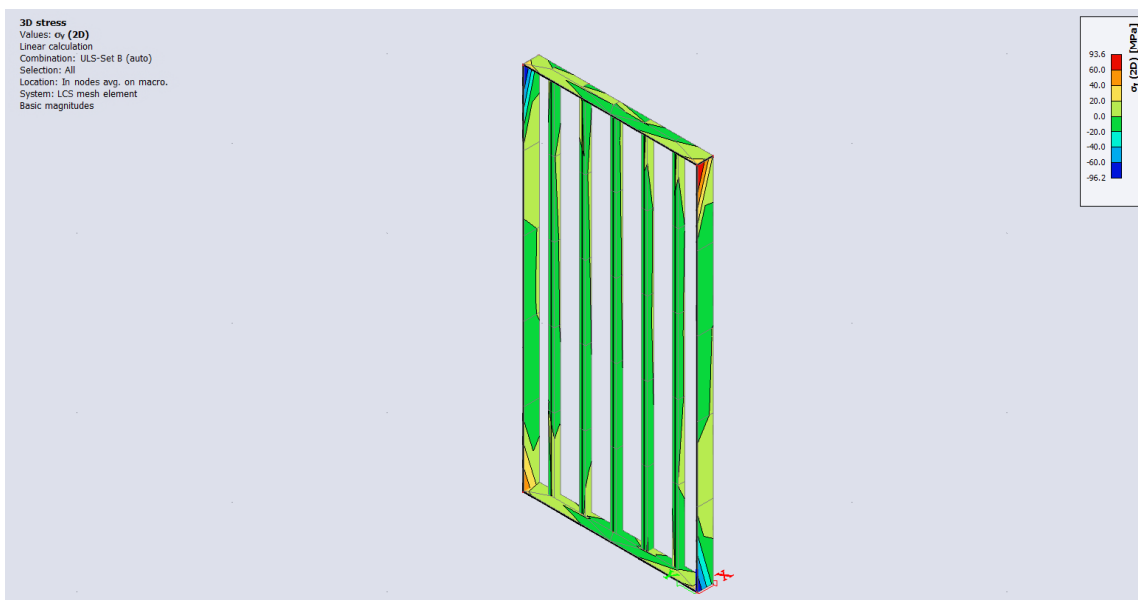
Figure 5 - Maximum Stress under Load

The peak stress is less than 100MPa, which is much less than the capacity of the proposed plates. This is under a conservatively high load.

Deflection is negligible due to the regular nature of the vertical bars.
