PROJECT  
68-70 OLDHAM STREET

TITLE  
FACADE INTERNAL OBSERVATIONS

DRAWING No. 2044-01-CIV-XX-XX-SK-S-0002

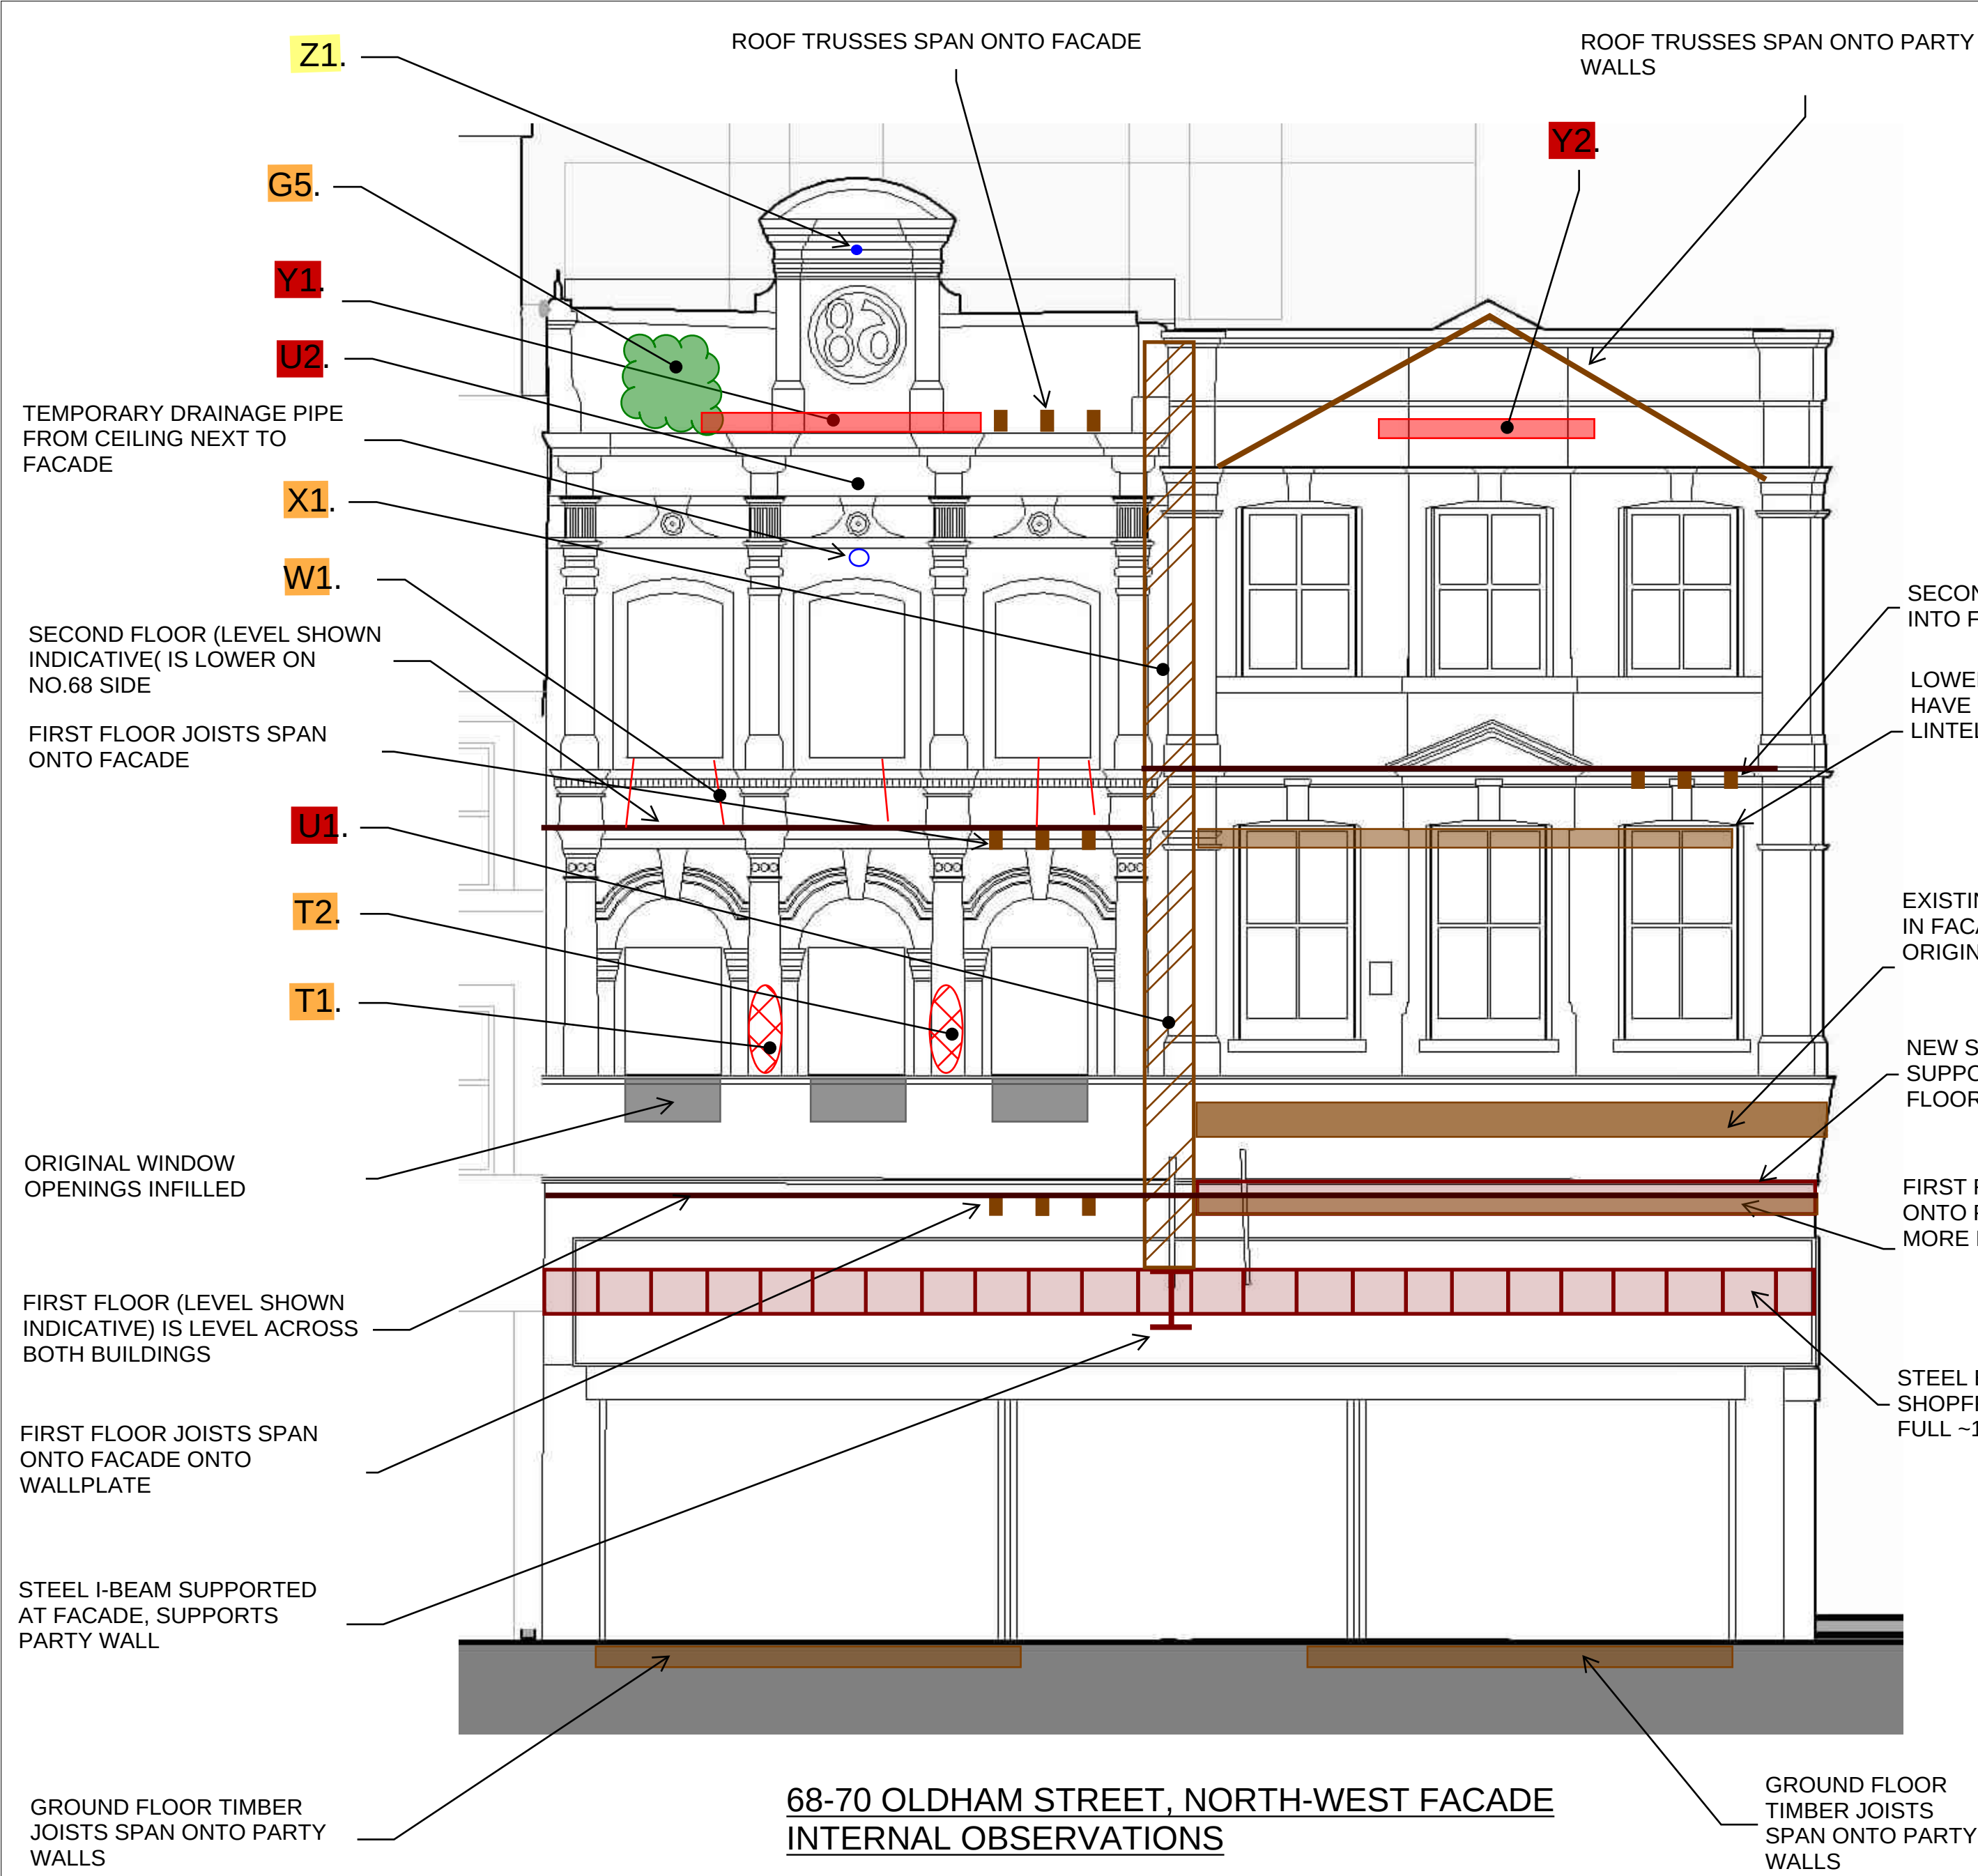
68-70 OLDHAM STREET, NORTH-WEST FACADE  
INTERNAL OBSERVATIONS

- A1 - A2. PAINT HAS BEEN STRIPPED FROM BRICKWORK  
B1 - B2. VERTICAL CRACK IN BRICKWORK  
C1 - C6. VERTICAL CRACK IN PLASTER / CONCRETE RENDER  
D1 - D2. MISSING TILES  
E1 - E2. STAINING BELOW WINDOWS INDICATING DAMP BRICKWORK  
F1 - F2. PAINT / RENDER PEELING AWAY FROM BRICKWORK  
G1 - G4. FOLIAGE GROWTH THROUGH FACADE.  
H1. NETTING IN PLACE (ASSUMED TO STOP FALLING RENDER)  
J1. HORIZONTAL CRACK IN RENDER (POSSIBLY THROUGH TO BRICKWORK)  
K1 - K4. VERTICAL CRACKS IN ORNATE PLASTER OVER WINDOWS  
L1 - L3. VERTICAL CRACKS IN LINTELS (CLEAR IN RENDER, MAY BE THROUGH TO BRICKWORK ARCH LINTELS)  
M1. HORIZONTAL CRACK THROUGH ORNATE KEYSTONE IN ARCH LINTELS

- N1 - N3. VERTICAL CRACK IN ORNATE FACADE COLUMNS  
P1. ORNATE MOULDING OVER RIGHT-MOST WINDOW AT SECOND FLOOR MISSING  
Q1 - Q2. GRAFFITI ON STEEL ROLLER SHUTTERS AND RENDER (OVER TILES) ABOVE1. SECTION OF BRICKWORK APPEARS TO BE A REPLACEMENT - THOUGHT TO BE WHERE CHIMNEY HAS BEEN REMOVED.  
S1. ROUGH AND UNEVEN BRICKWORK / RENDER PEELING AWAY FROM BRICKWORK.  
T1 - T2. INTERNAL PLASTER BROKEN OFF BRICKWORK WALL  
U1 - U2 (**AND GENERAL COMMENT INTERNALLY**). DAMP AND MOULD GROWTH ON RETURN WALL AT CENTRE OF FACADE, AT ROOF AND FLOORS ADJACENT TO FACADE, AND TO INTERNAL FACE OF FACADE BRICKWORK.  
V1-V2. CRACK IN PLASTER AND BRICKWORK NOT TOOTHED IN PROPERLY IN RETURN WALL  
W1. MINOR CRACKS BELOW AND BETWEEN WINDOW SILLS  
X1. CRACKS IN RETURN WALL AT CENTRE OF FACADE.  
Y1. DAMAGE TO EXISTING TIMBER ROOF CAUSING RAINWATER PENETRATION  
Z1. TIE ROD FROM BACK OF NO.68 FACADE TO PITCHED ROOF.
