Phase I Geoenvironmental Site Assessment  
Grey Mare Lane Site 1, Manchester

Reference: 16-908-R1  
Date: June 2023

# PHASE I GEOENVIRONMENTAL SITE ASSESSMENT

Land off Grey Mare Lane  
Beswick  
Manchester  
M11 3TF

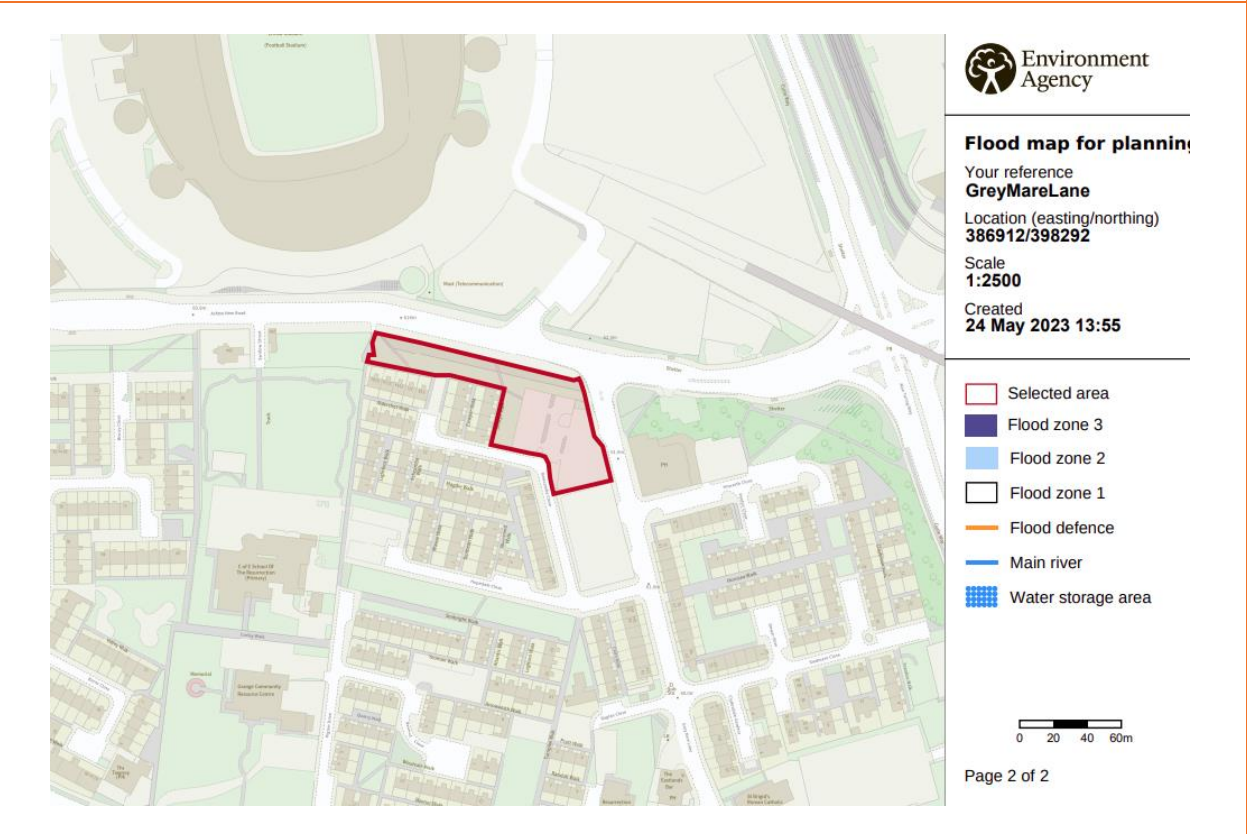
**FIGURE 4.1 EA FLOOD RISK MAP**

The site is predominantly located within a currently defined area deemed as not being at risk from river, coastal or surface water flooding. Small areas within the site boundary are defined as having a medium risk of surface water flooding. A record associated with surface water flooding may relate to drains not be able to cope of an extreme rainfall event. It is recommended that any drains at the site be subject to regular maintenance.

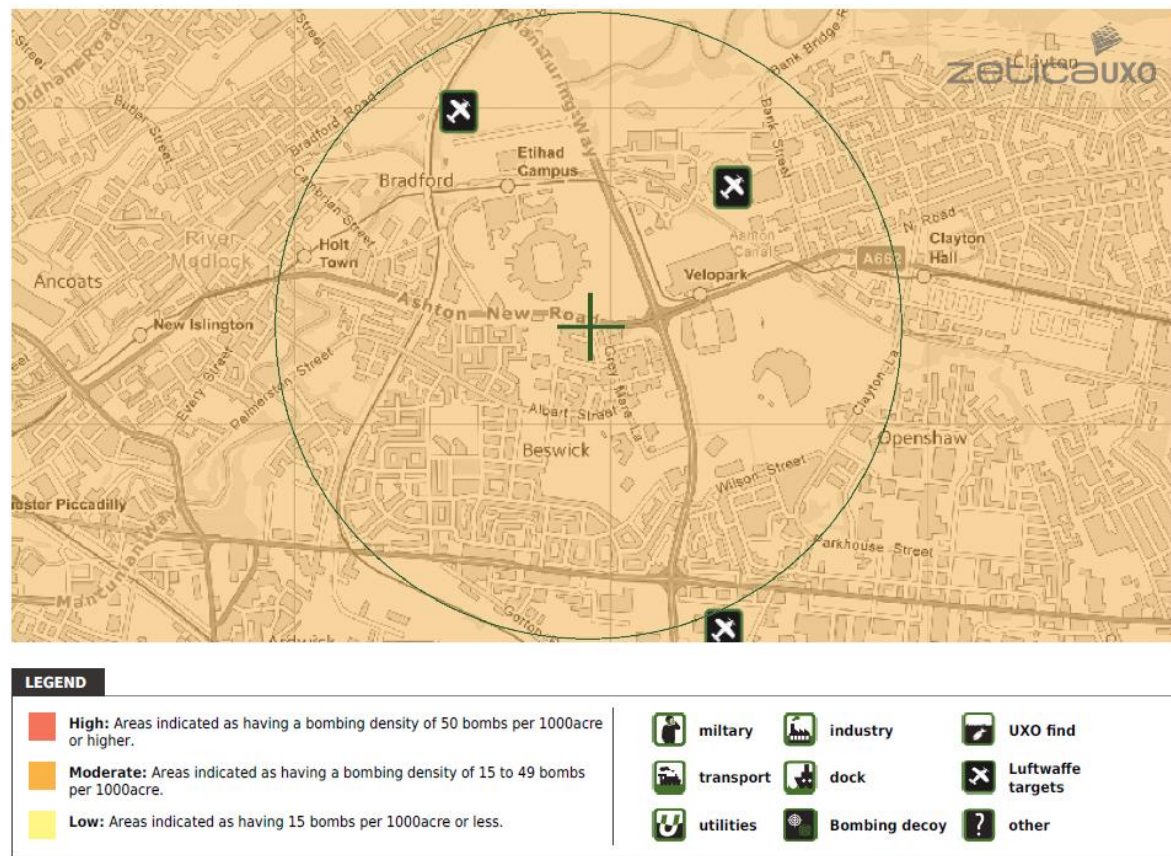
FIGURE 4.2 ZETICA UXO RISK MAP

The regional unexploded bomb risk map from Zetica (2014) indicates that the Site is in an area at moderate risk from possible unexploded ordnance (UXO) resulting from the Second World War. The Zetica UXO Risk Map is presented in Figure 4.2.

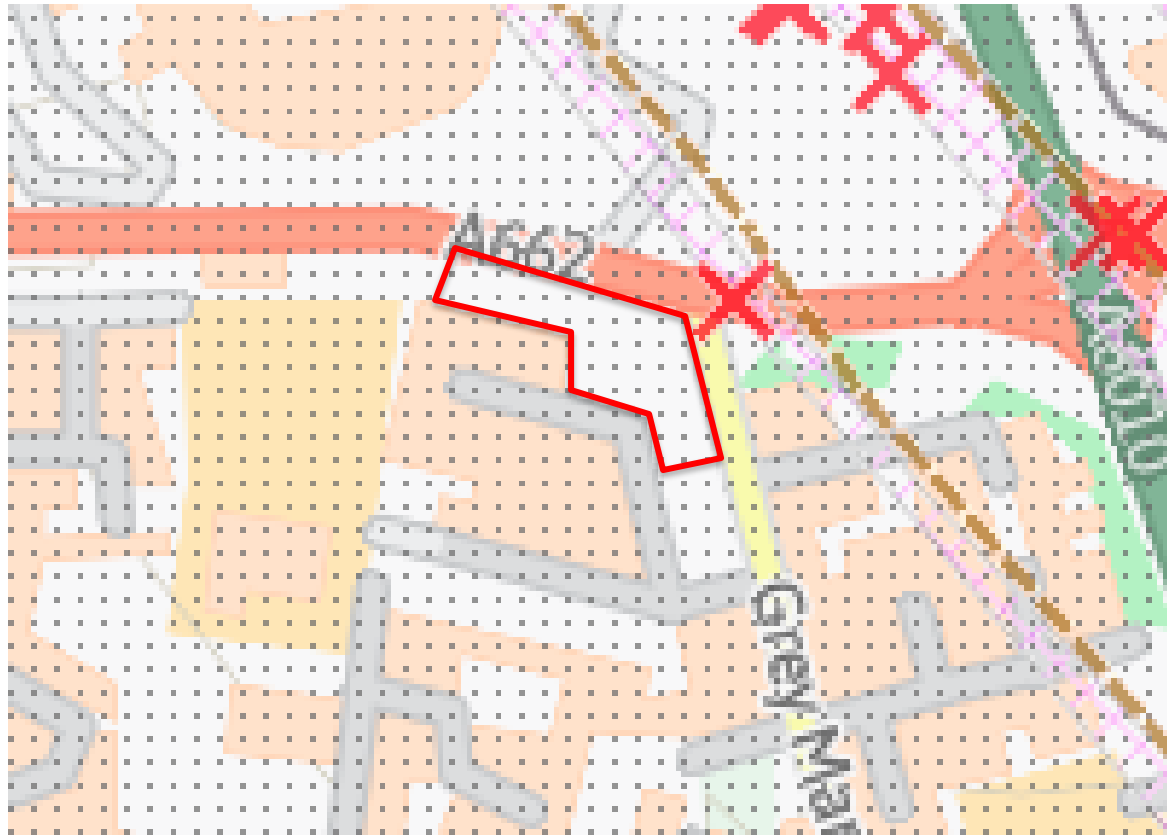
FIGURE 5.1 EXCERPT OF THE COAL AUTHORITY ONLINE VIEWER

In the first instance, E3P has reviewed the Coal Authority Online Viewer and an excerpt of this is presented as Figure 5.1. This map shows that the site lies within a high-risk development area. Furthermore, there are coal seams to the north-east of the site, which may dip below the Site. The map also identifies a disused mine shaft to the north-east of the site.

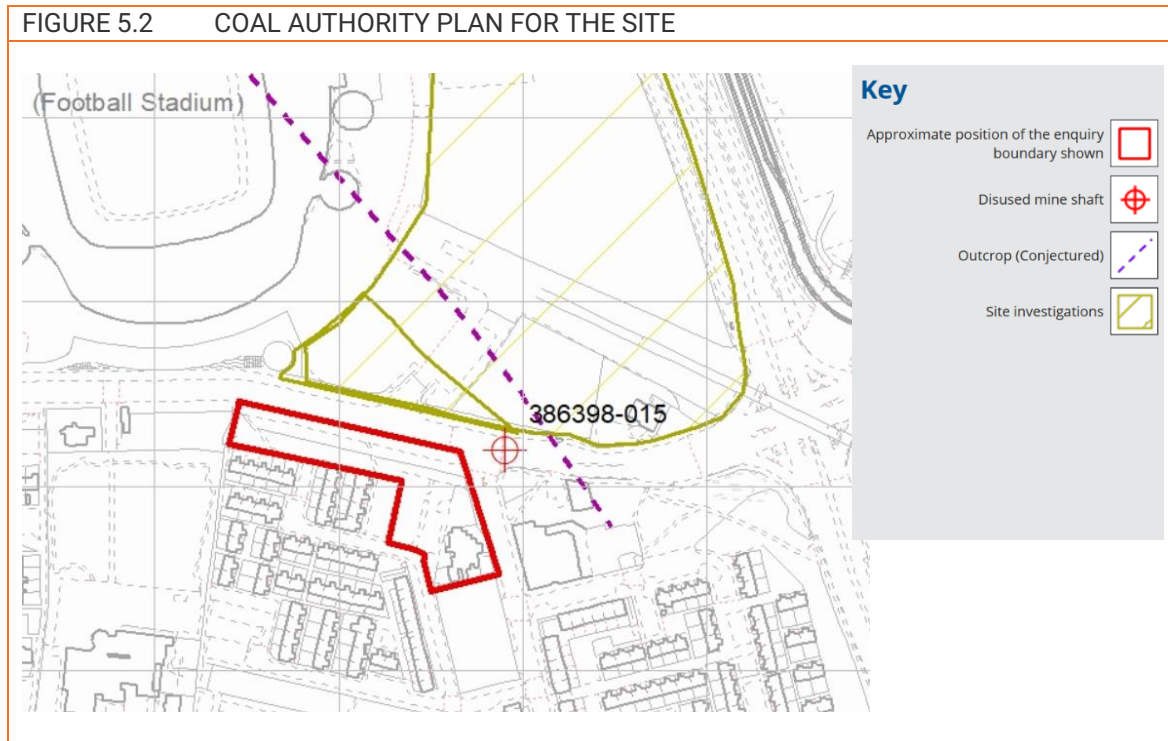
FIGURE 5.2 COAL AUTHORITY PLAN FOR THE SITE

The Coal Authority plan referenced: MR-LARGE-PLOT-51003357117001-1684942335019 shows there is a mine shaft (Ref: 386398-015) to the north east of the site. This mine shaft is noted to be disused, and known to have been capped.

The Bradford Colliery is noted to the northeast of the site, with an outcrop running northwest – southeast to the north of the site.

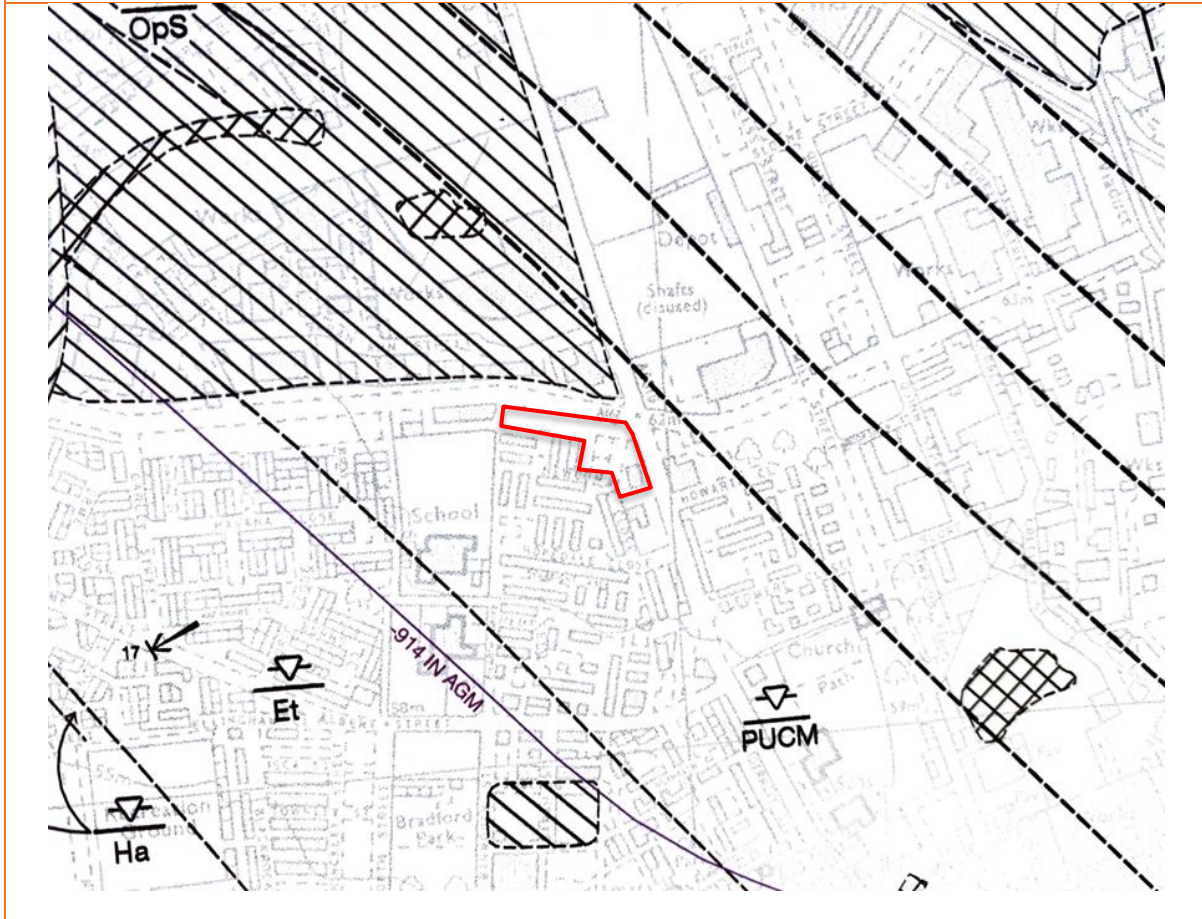
FIGURE 5.3 PHOTOGRAPH OF THE 1:10,000 PLAN FOR THE SITE

Figure 5.3 is a photograph of the 1:10,000 plan for the site which shows a coal outcrop to the north-east of the subject site and which is recorded to dip below the site.

This seam would therefore potentially pose a risk to the subject site.

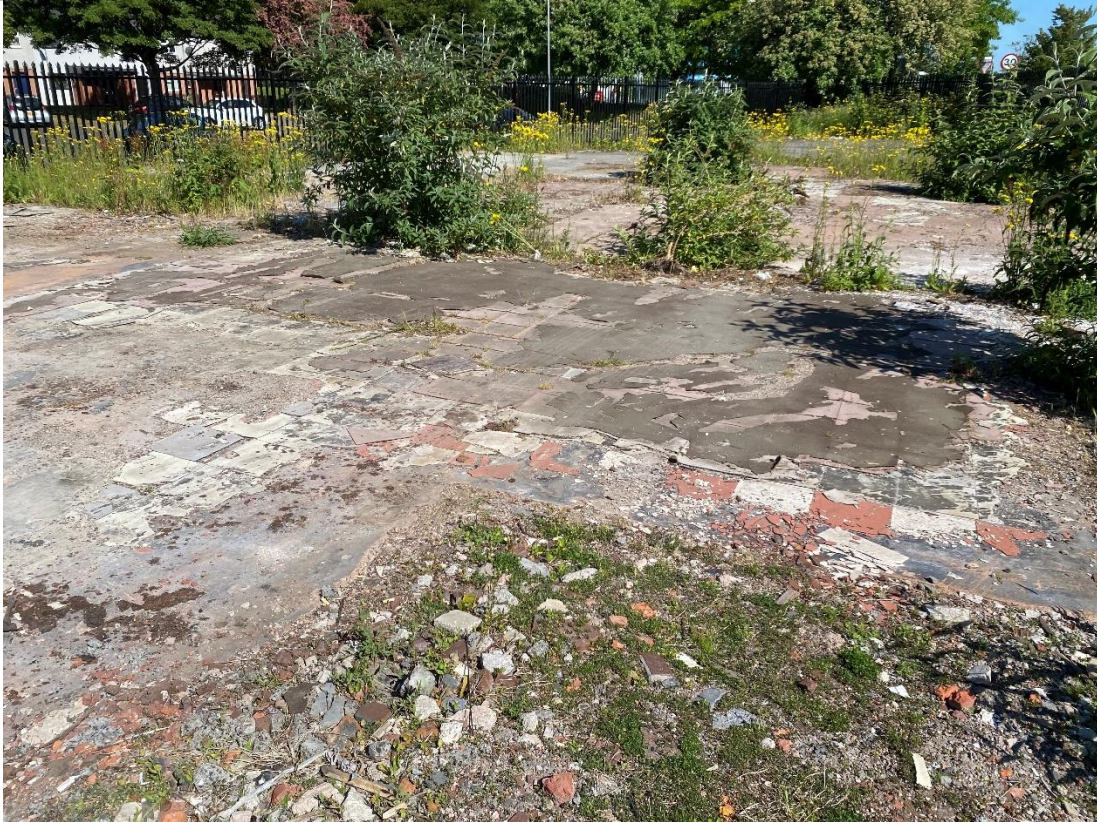
| <b>Initial Geotechnical Assessment</b> | <p>Historical slabs and foundations are present in the centre of the site associated with the previous use as a public house. Furthermore, relict foundations are likely to be encountered in the north of the site, on the site of the old theatre. All existing underground foundations and obstructions beneath the proposed development will require grubbing out in their entirety, however it is considered that most of this hard material will be suitable for reuse in construction once excavated and processed.</p> <p>As the proposed development is a high-rise apartment block, a piled foundation solution may be required socketed into the underlying bedrock. Further investigation should be undertaken to assess the strength and suitability of the bedrock for piling. However, should any coal workings require grouting beneath the site, piled foundations may not be suitable.</p> |

**PLATE 1**      **CENTRAL SECTOR – RELICT FOUNDATIONS AND SLAB**

| <b>Civil and Structural</b> | <p>All existing underground foundations and obstructions beneath the proposed development will require grubbing out in their entirety and backfilling with a suitably engineered fill to create a suitable development platform.</p> <p>There is potential for shallow groundwater to be present as perched groundwater due to the site being underlain by impermeable glacial till. If shallow groundwater is encountered localised dewatering may be required during the construction phase.</p> |
