Date: 5th June 2024  
Reference: 15-974 V7

## GAS MEMBRANE VALIDATION – BENNETT STREET

| <b>Project Name:</b> | Bennett Street |
| <b>Plot:</b> | 136-138 and 147-148 |

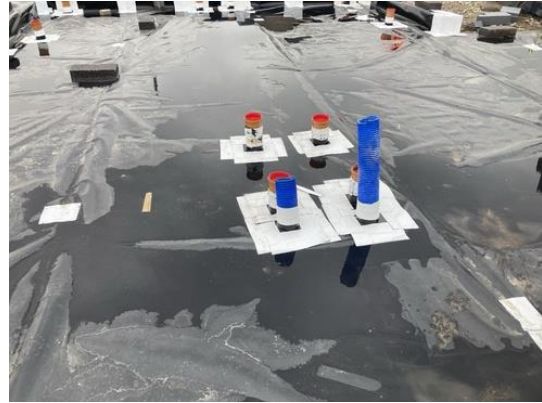
Photo 1

| Gas Membrane Condition: Open punctures, tears, rips, stretching, Presence of debris, Repairs, Signs of weakness such as raised or sunken indentations, Protection plan in place to restrict access to laid gas membrane? IF FAIL DESCRIPTION IN ACTIONS AND PHOTOS REQUIRED | Pass |

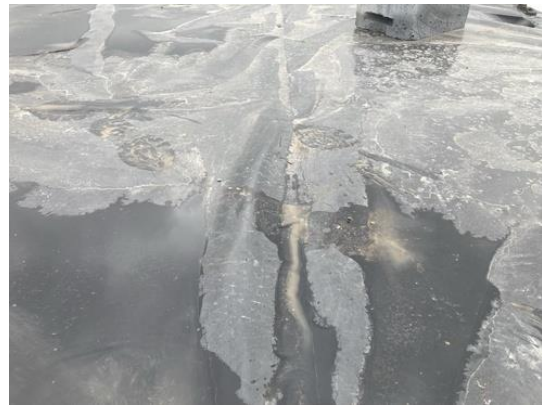
Photo 7

| Are welds complete? | Yes |

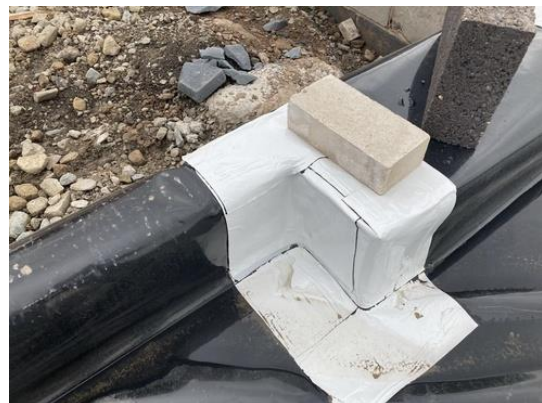
Photo 11

| Are Joints lapped and sealed in accordance with manufacturer's requirements/ specification? | Yes |

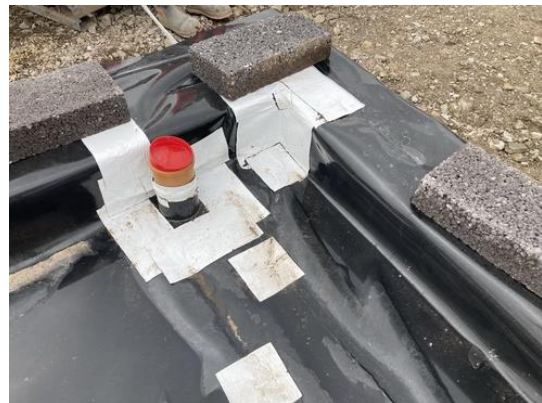
Photo 29

**Corners / Internal joints: Check all corners are correctly formed or contractor has used preformed corners.**

Pass

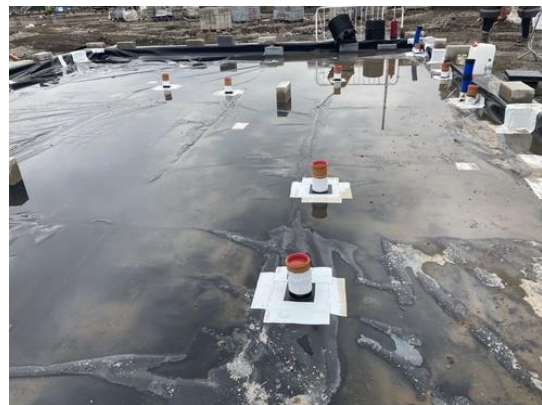
Photo 45

Gas Membrane Condition: Open punctures, tears, rips, stretching, Presence of debris, Repairs, Signs of weakness such as raised or sunken indentations, Protection plan in place to restrict access to lain gas membrane? IF FAIL DESCRIPTION IN ACTIONS AND PHOTOS REQUIRED

Pass
