## **PHASE 1 SITE INVESTIGATION**

**LAND AT  
CLUB STREET  
OPENSHAW  
MANCHESTER  
M11 1HR**

**DOCUMENT REFERENCE: 42163R3  
ISSUED REV A  
NOVEMBER 2023**

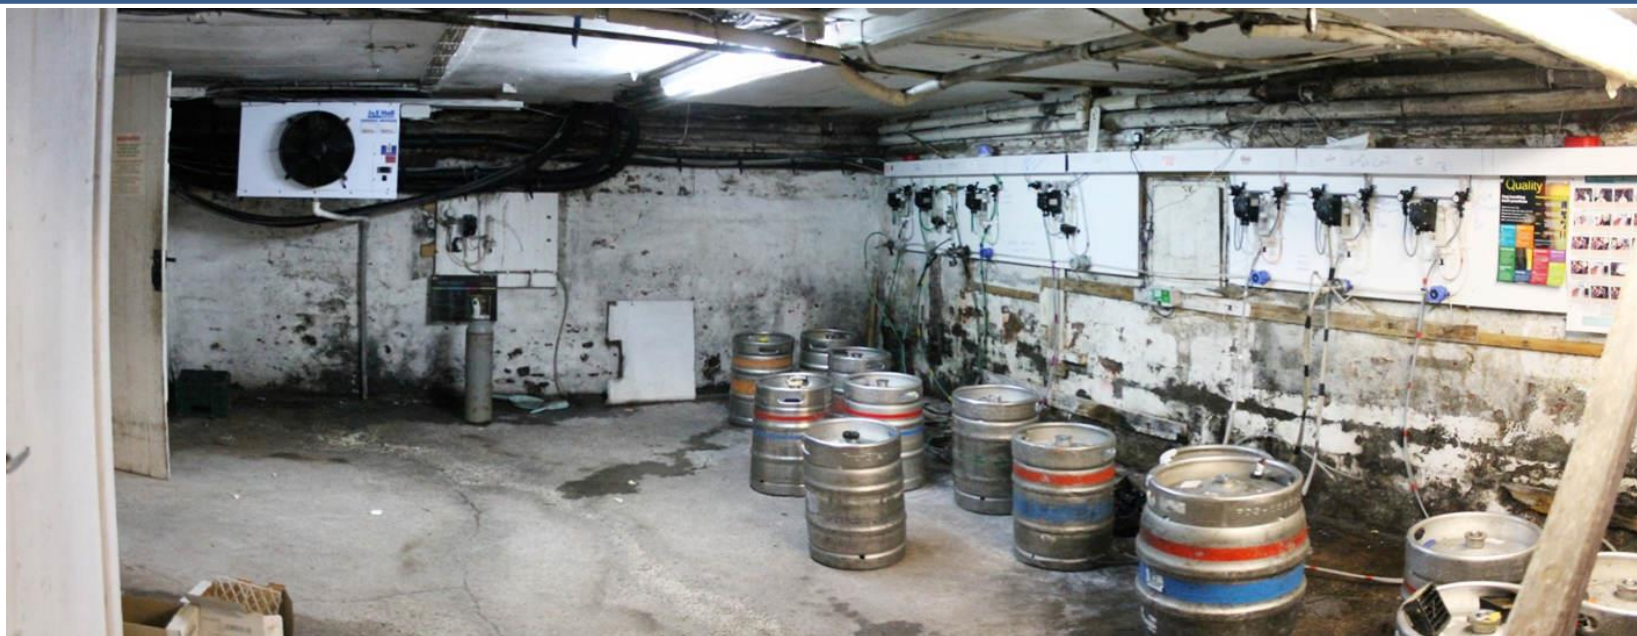
The main building includes a bar area and a cellar beneath most of the original structure. The cellar was damp, but without standing water at the time of the walkover. The building has gas central heating and is connected to mains water and drainage.

Photo 13, July 2021: Area 1: Main club building basement area 1

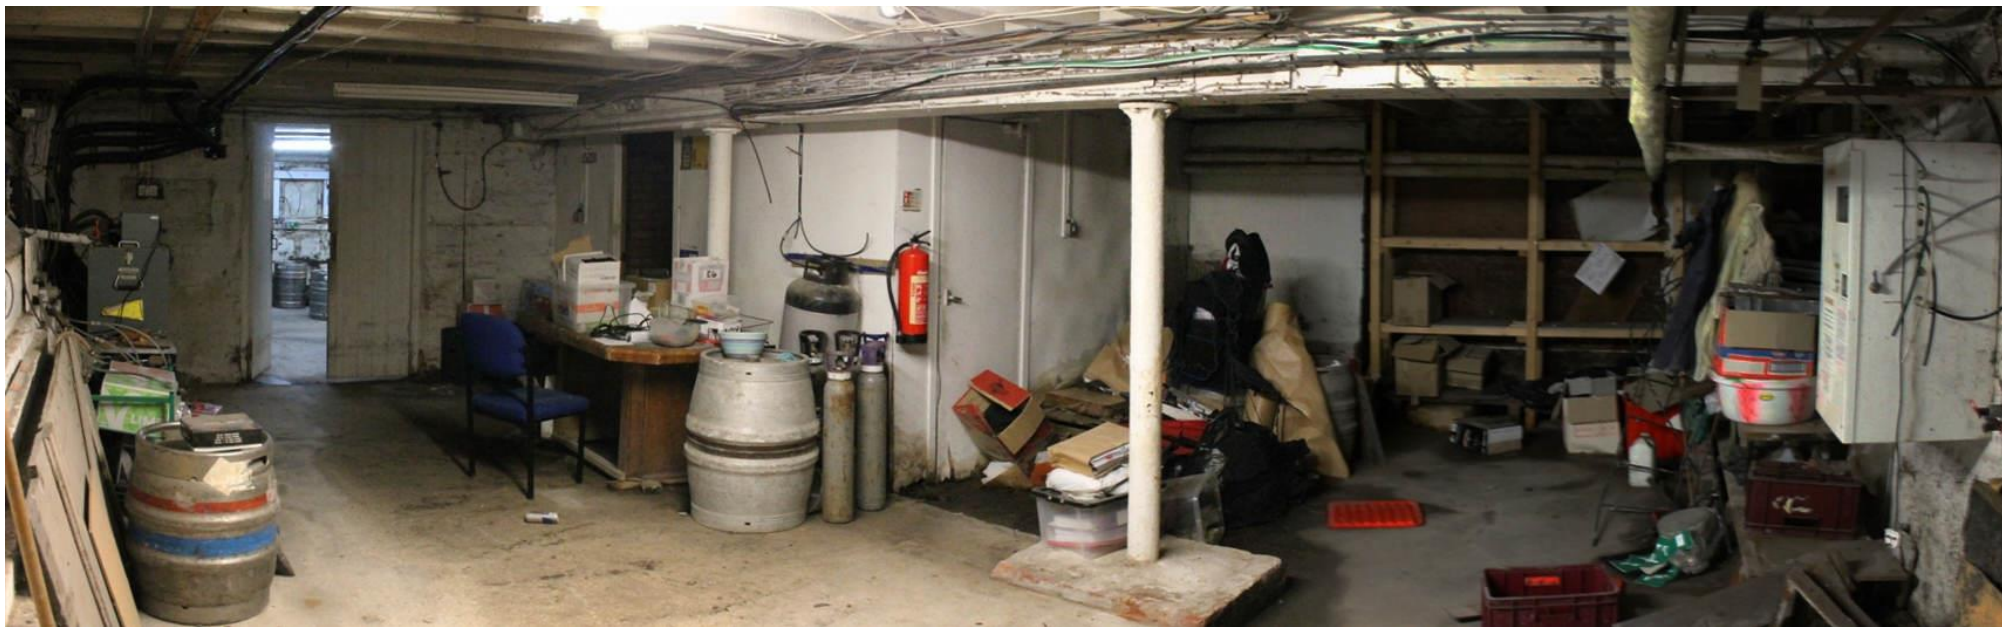
Photo 14, July 2021: Area 1: Main club building basement area 2

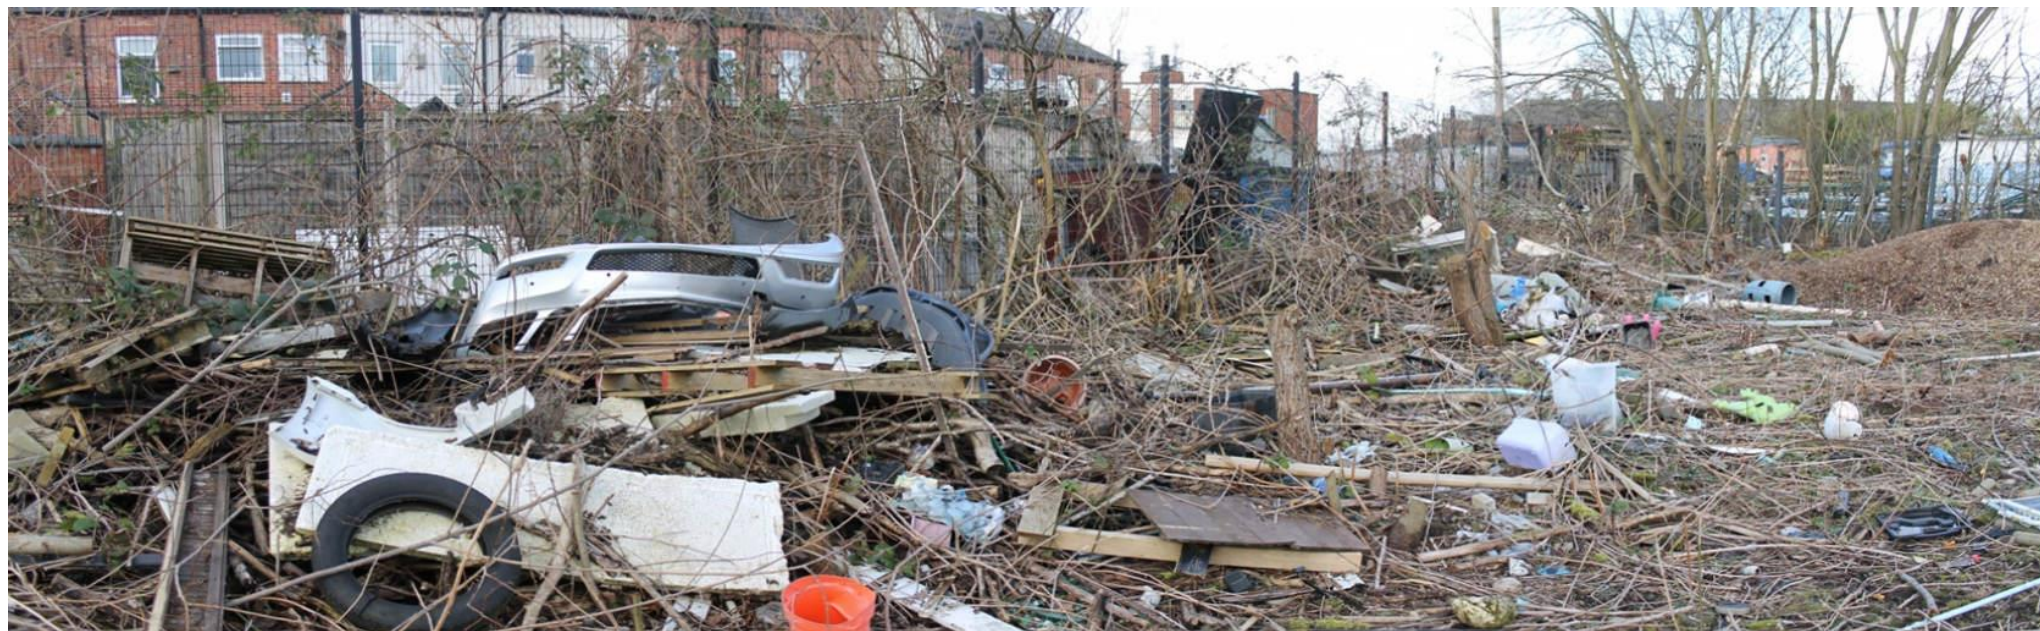
- A northern undeveloped and un-surfaced area with scrub vegetation where trees have been recently removed. This part of the site has been subject to fly tipping of a wide variety of household waste including car parts and domestic waste, predominantly along the western boundary.
- A southern area, also un-developed and un-surfaced but where small scrubby trees have yet to be cleared. Minor fly tipping has occurred in this part of the site.

Photo 18, February 2022: Area 3: Fly tipping along the western site boundary

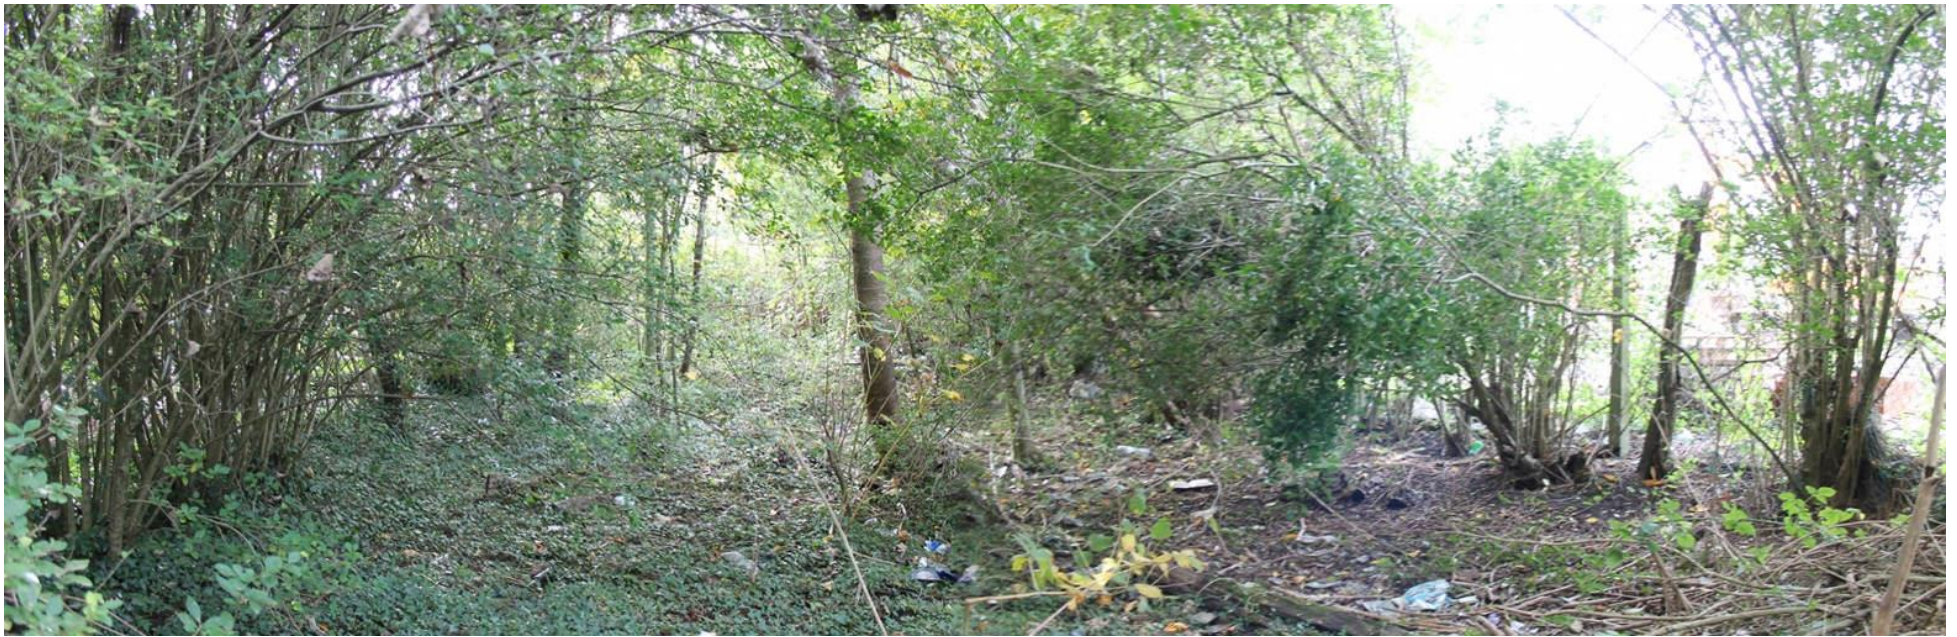
Photo 21, October 2023: Area 3: Overgrown areas to the east of Club Street

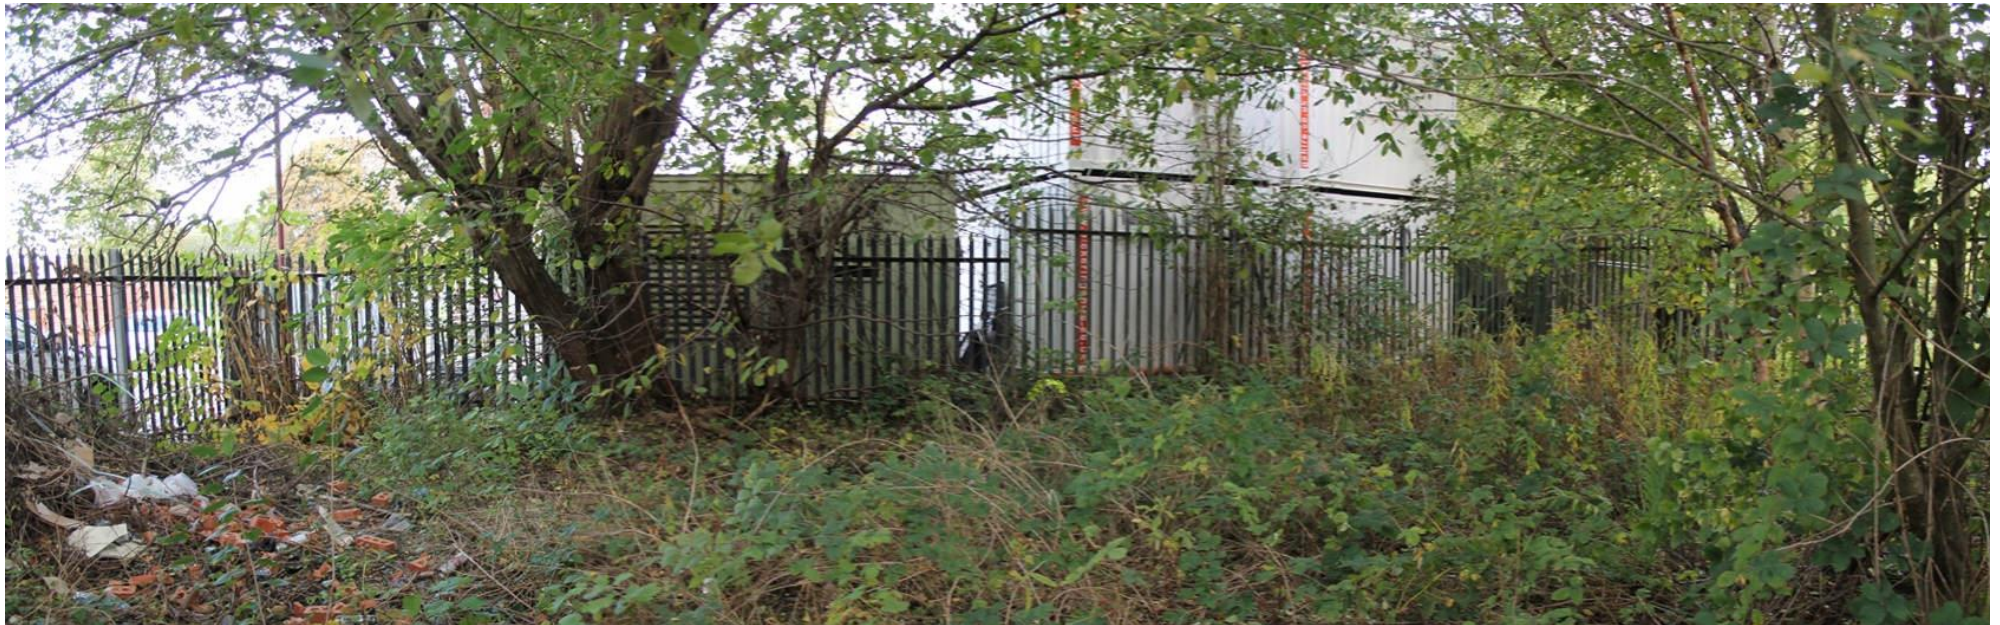
Photo 22, October 2023: Area 3: Overgrown areas to the east of Club Street

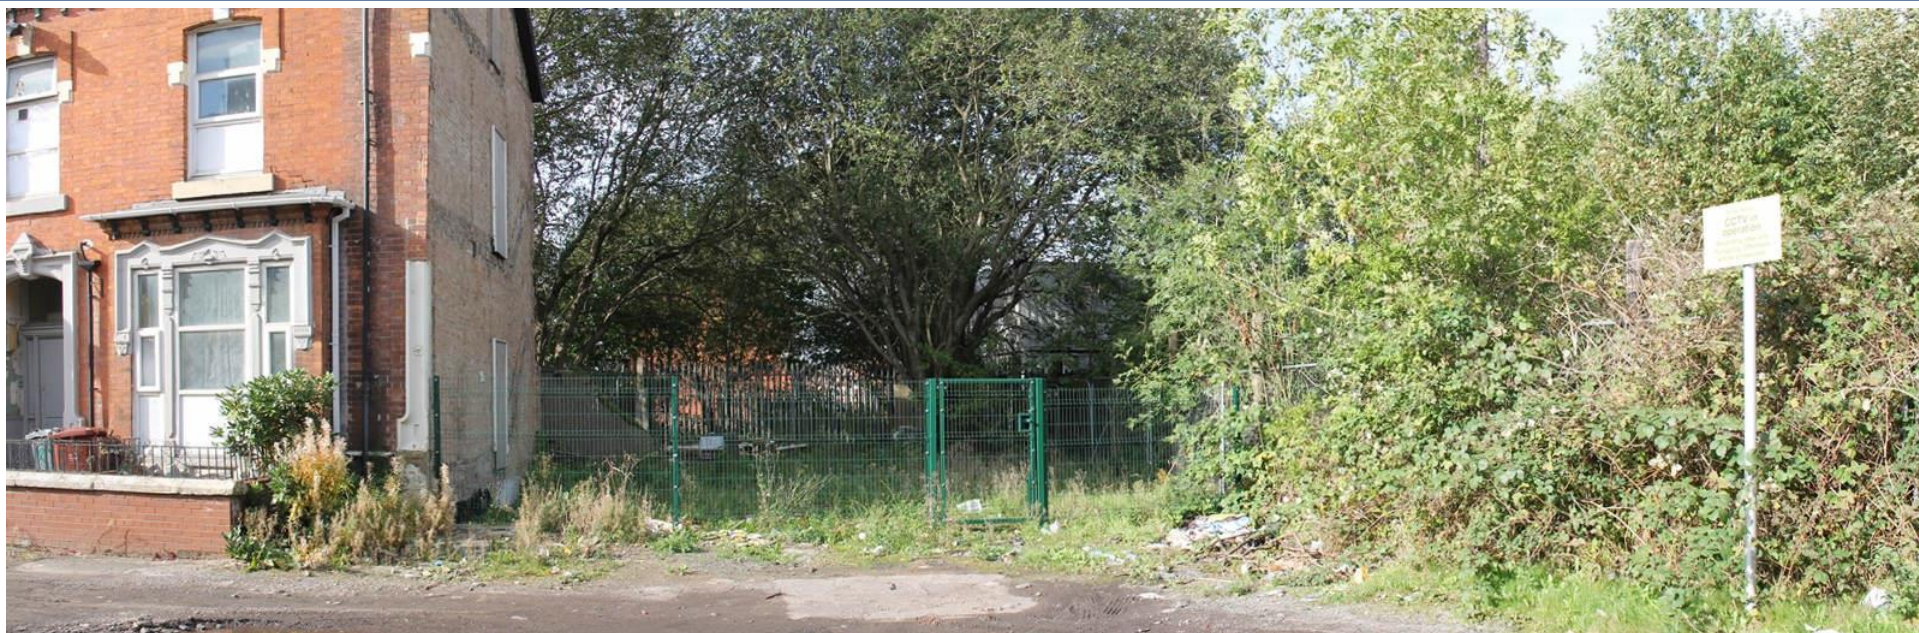
No underground structures were noted in Area 3, but it is possible that the recently demolished house had a basement that may have been infilled. No bulk liquid storage was observed. Other than potential ACMs, as noted above, no visual or olfactory evidence to suggest the presence of ground contamination was observed.

Photo 23, October 2023: Area 3: Site of the demolished house at the end of Gransmoor Ave looking west

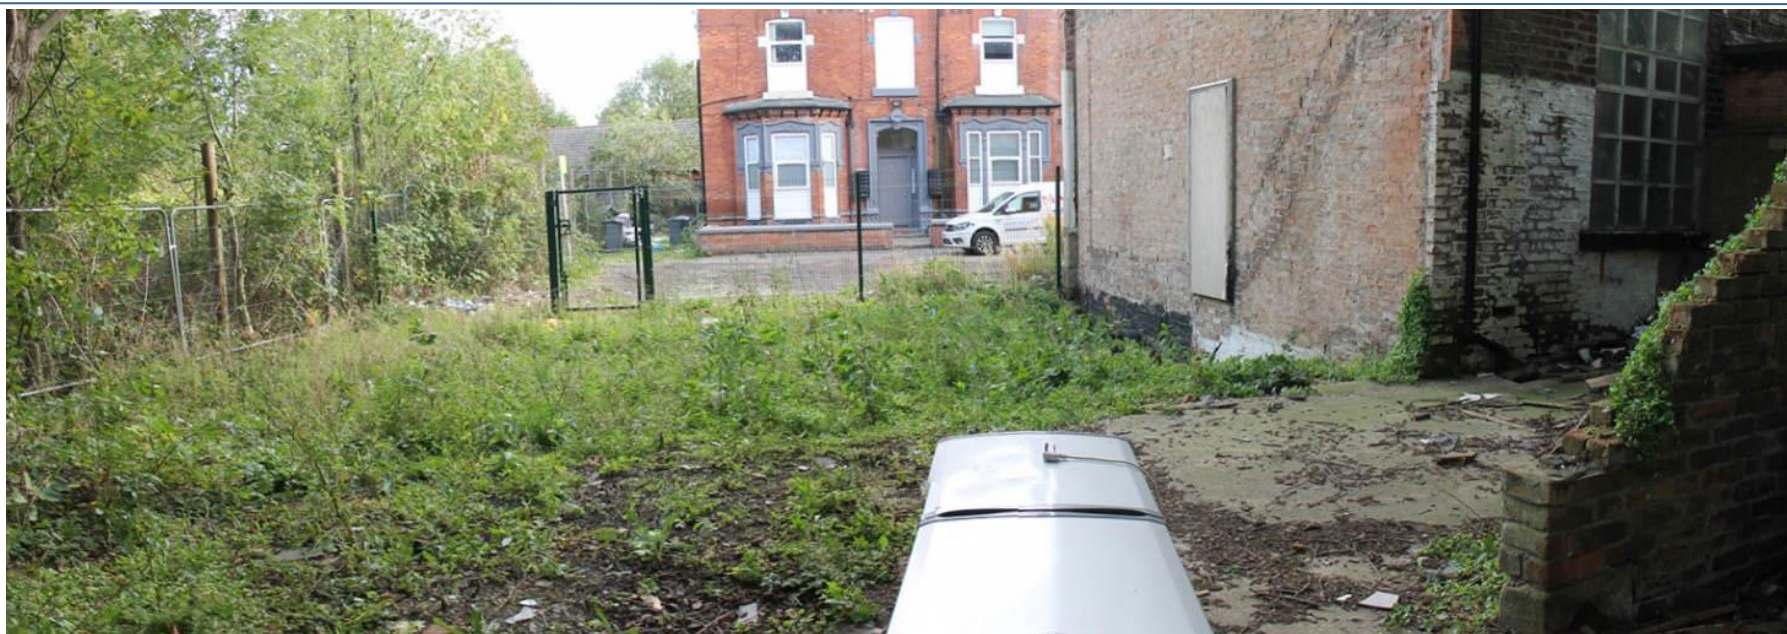
Photo 24, October 2023: Area 3: Site of the demolished house at the end of Gransmoor Ave looking east

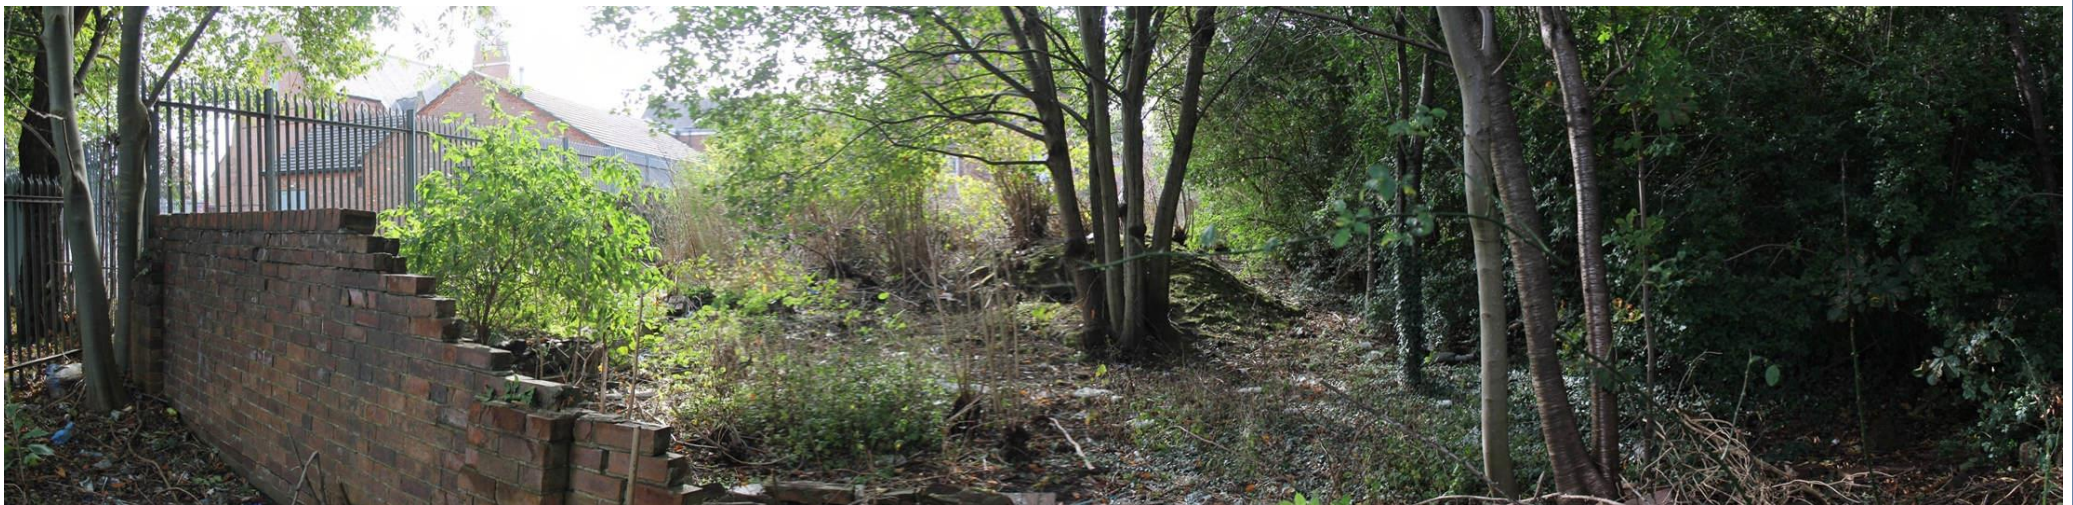
Photo 26, October 2023: Area 3: Remnant structures in the north-east of the site
