## 68-70 Oldham Street, Manchester

### Façade Condition and Heritage Report

## Façade Condition and Heritage Report

| <b>Report Reference</b> | 2044-01 |

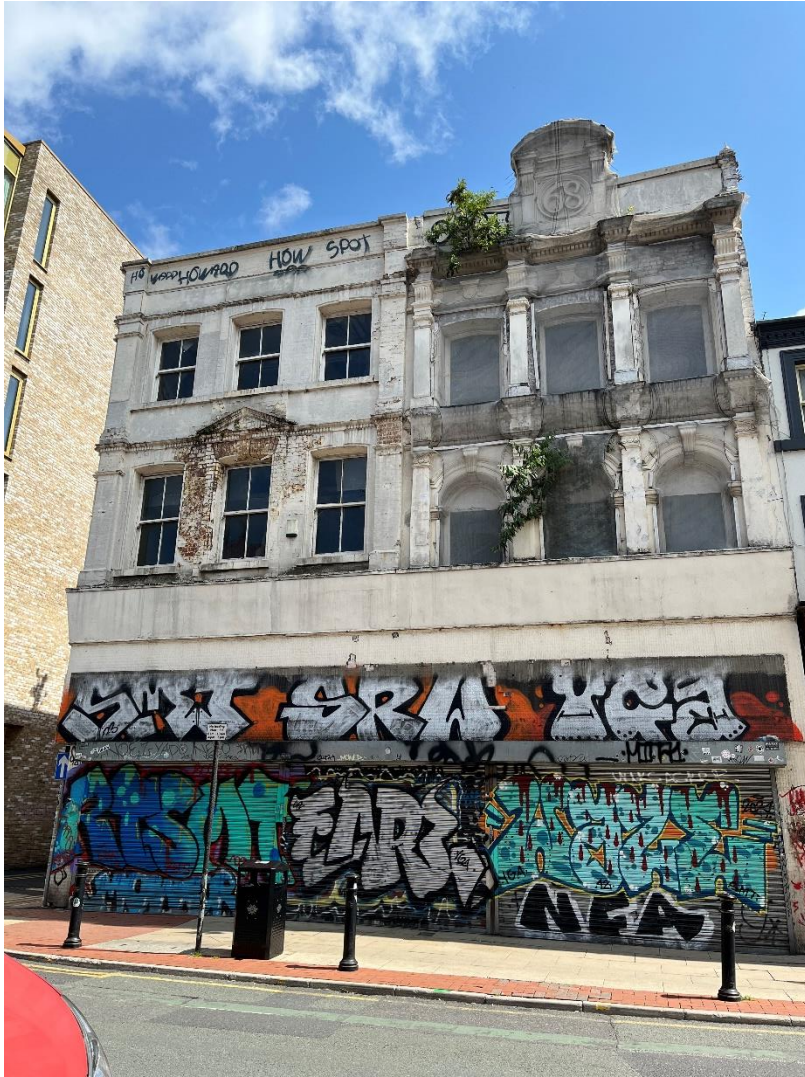
The external brickwork appears to be in generally good condition with some minor-moderate cracking. There is foliage growth through the façade in some areas and paint has peeled off or been stripped back. There is a net over the façade of No.68 at upper levels, presumably to protect from falling plaster / render at street level. There is graffiti at ground level and parapet level.

Figure 6: Oldham Street façade

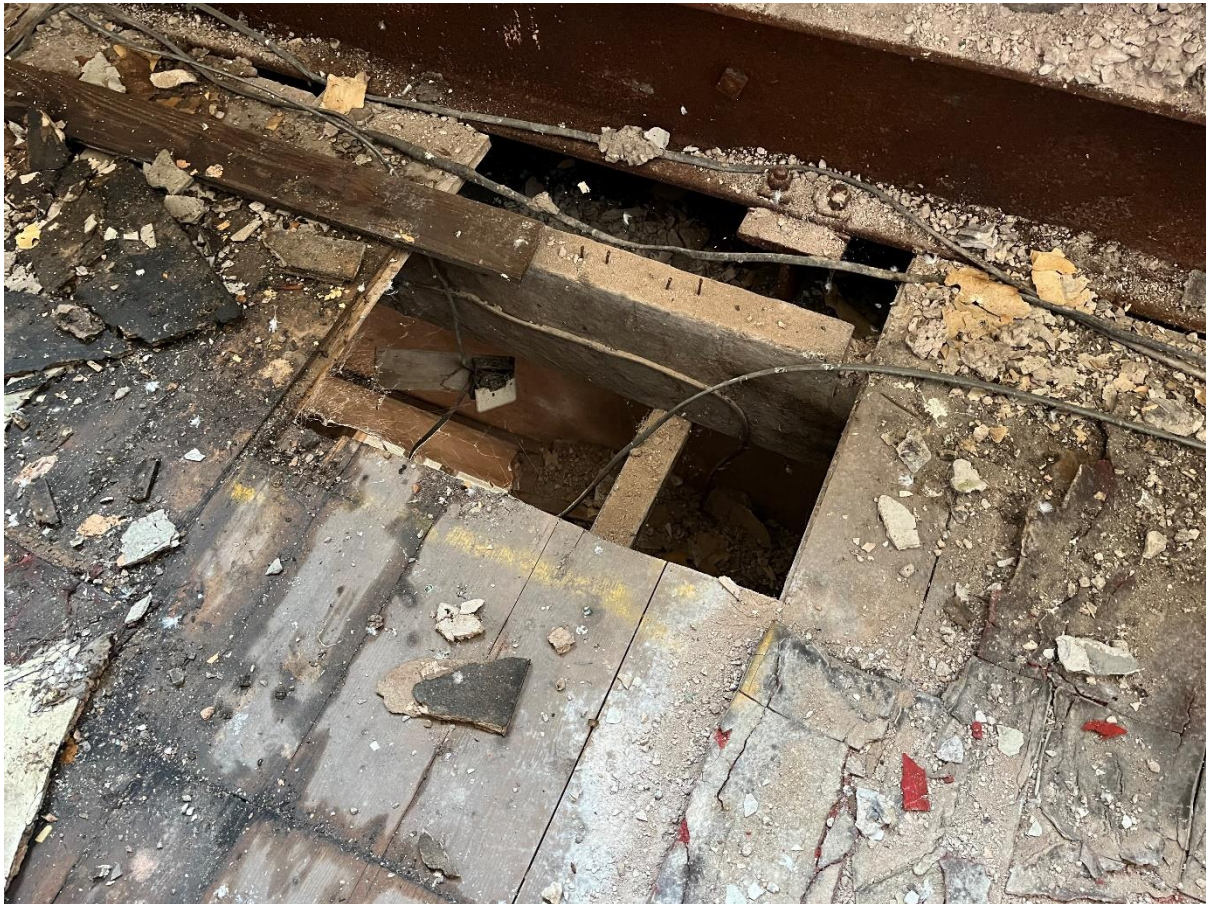
The span direction of the floor and roof structures could generally be identified. In No.68, all floor joists and roof trusses excluding the ground floor joists appear to span into the façade wall. In No.70, the second floor joists appear to span into the façade wall however the other floor joists and roof trusses appear to span parallel to the façade. At first floor, the joists that appear parallel coincide with where the floor has been dropped to align with the floor of No.68.

*Figure 7: No.70 First Floor joist*

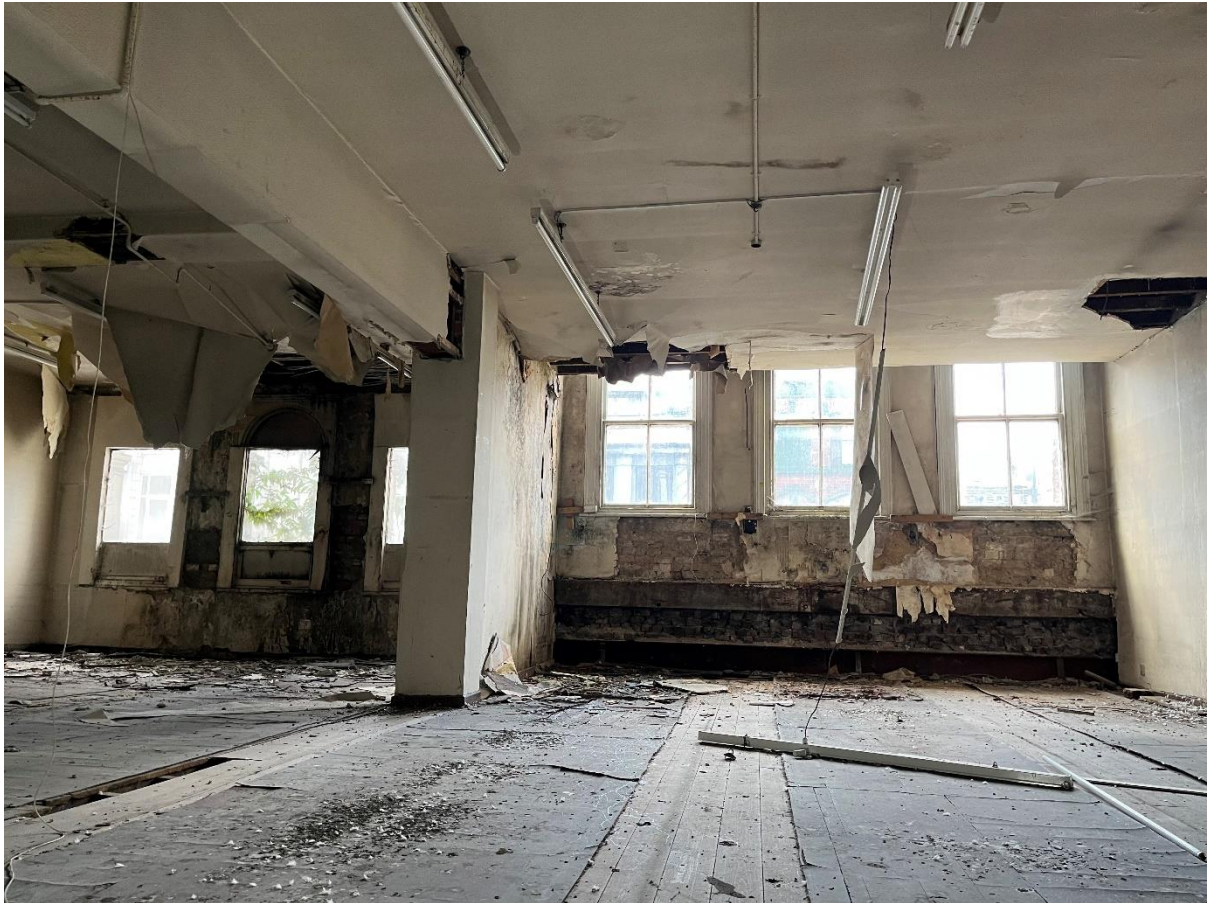
At first floor, the floor level across the two original buildings is now the same. A timber beam is still visible in the façade of No.70 showing the original first floor level.

*Figure 8: First Floor*

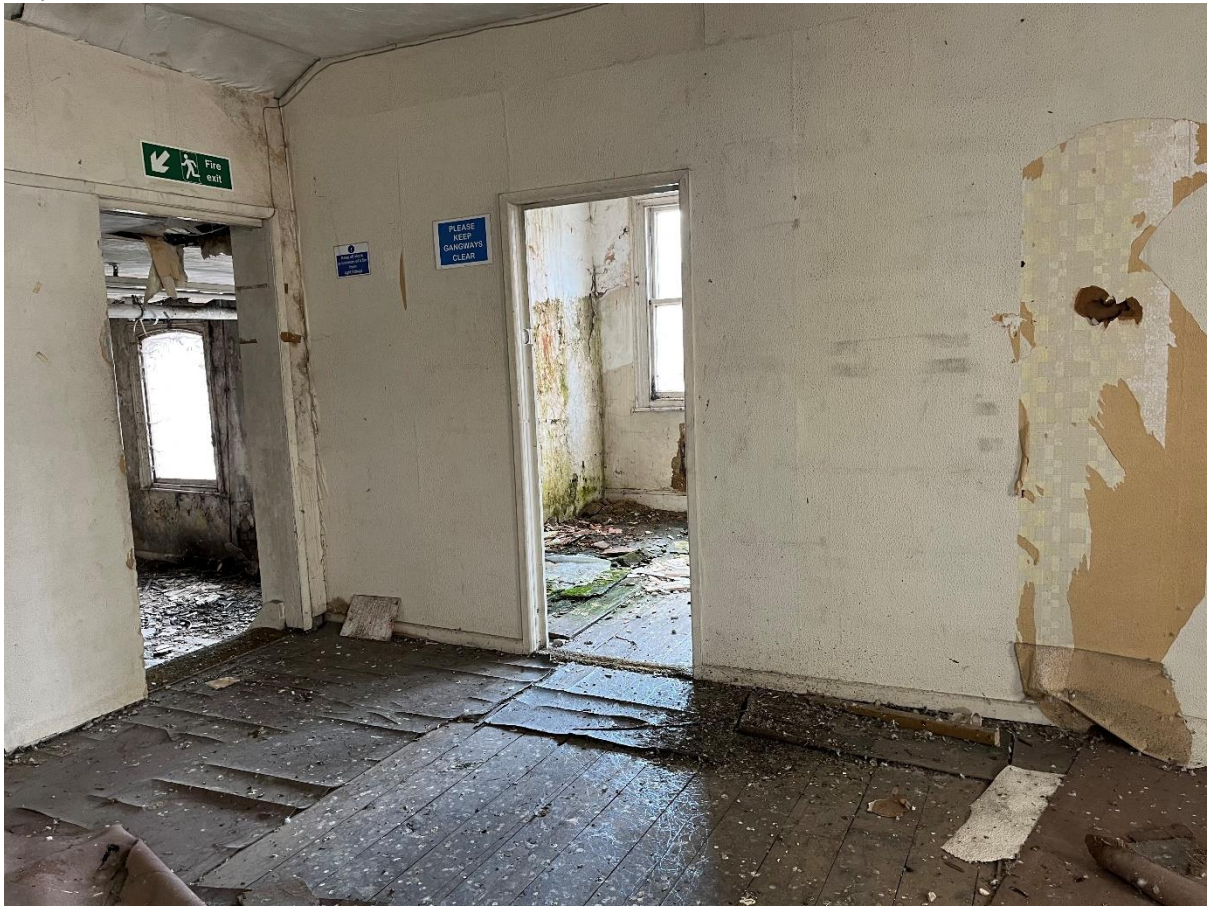
At second floor, the original floor levels have been maintained across the buildings therefore there is a step down from No.70 into No.68.

*Figure 9: Second Floor*

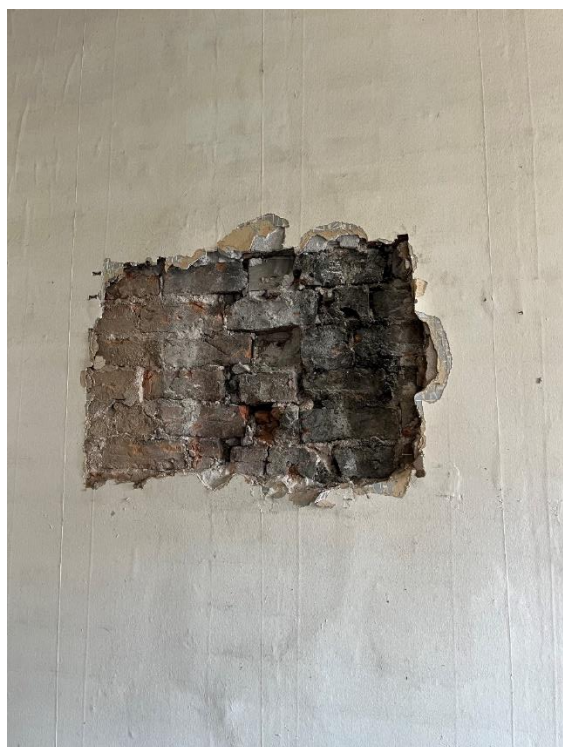
On the party wall between No.68 and the Castle Hotel, there appears to be two different ages of brickwork within the wall however the different sections appear to be toothed in together.

Figure 10: First Floor level - Party wall with No.68 and Castle Hotel

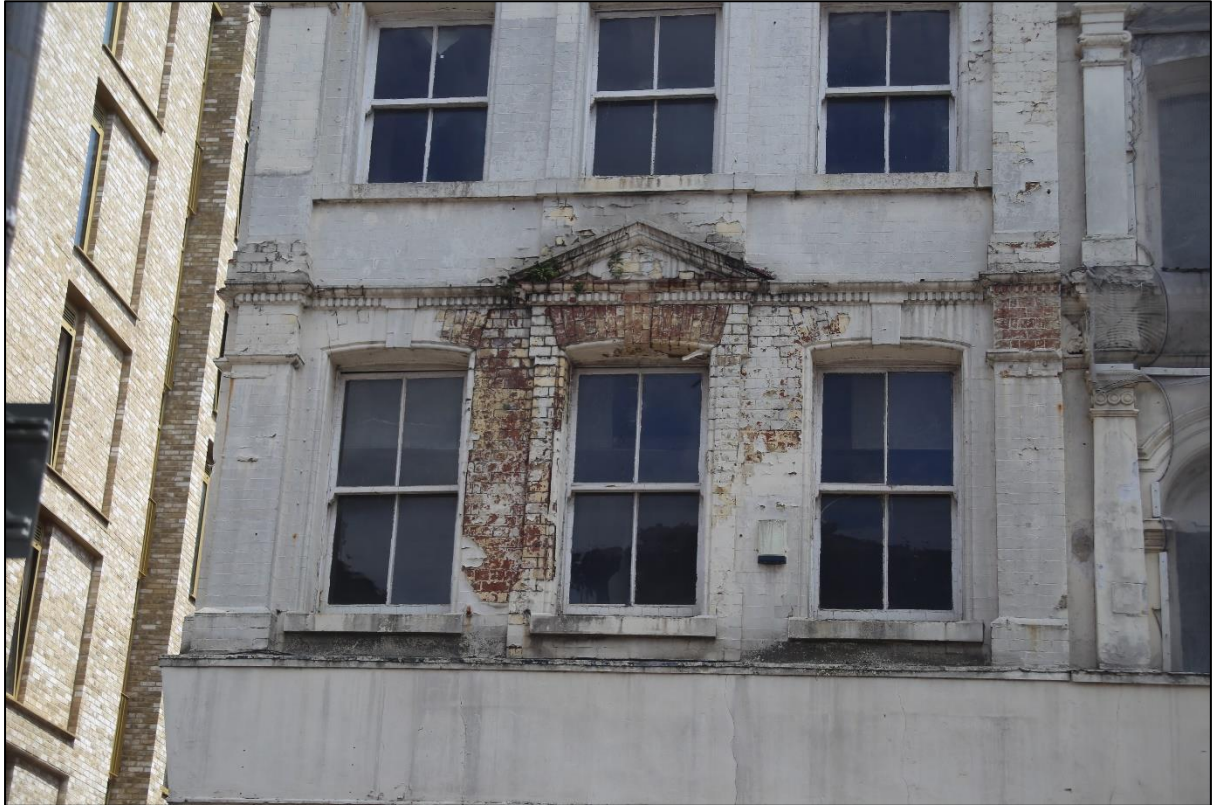
No.70 is situated approximately a quarter of a floor level above No.68 (Figure 15) and is less ornate. The floor is of three bays with two outer pilasters with simple Tuscan Order capitals (Figure 15). The three window apertures comprise flat arched brick heads with a projecting keystone and chamfered projecting stone sills (Figure 15). The reveals contain round-edged moulding openings and house a four-light timber-framed sash window with simple ogee cyma recta window horns. The clear glass glazing is most likely original to the window frame. The central window contains a triangular pediment with the reveals projecting out approximately 12mm ( $\frac{1}{2}$ ins). A dentil band is situated above the keystones of the window heads and continues around the outer pilasters (Figure 15).

*Figure 15: Detail of the first floor of the north-west façade of No.70, facing south-east*

The windows to each of the upper floors to both No.68 and No.70 should be retained. The timber window frames are currently in a fair condition and all glazing is intact. The pilasters to both properties are in a poor condition but should be retained with the rendering to each cleaned. The render to the second-floor window heads should be replaced with the same type of render. Above the south-western window to the first floor of No.68, there is a projecting mould missing that should be replaced. This was originally the same design as those above the other windows to this level.

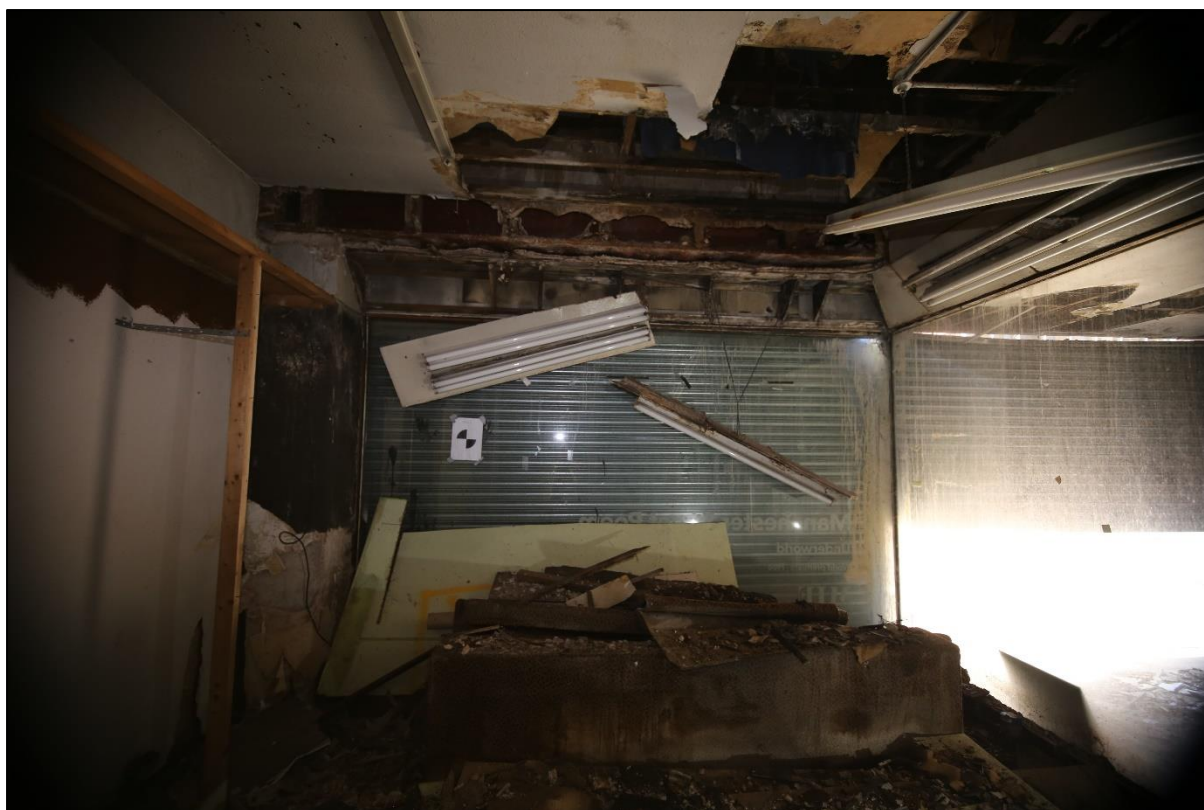
Internally, the ground floor of the façade contains no historical elements of the earlier Victorian shop frontage (Figure 20). The upper floors are supported by a rolled steel I-section beam at ceiling height of the ground floor. It was not possible to record any rolling stamp to the web during the initial site visit, however doing the future soft strip programme of the properties, this might be uncovered. The only historical element that is extant is a brick pier situated to the south-east end of the north-eastern wall. This consists of a two-brick course wide pier with lime mortar that projected into the room (Figure 21).

*Figure 20: General the mid-20th-century shopfront to the ground floor of No.68, facing north-west*

Externally, the ground floor to both properties is a mid-20<sup>th</sup>-century shop front therefore holds no historical value. The 20<sup>th</sup>-century intervention to this should be removed and the heritage-led replacement should be constructed. The early on-site works should remove the roller shutter doors and be replaced with hoarding. A graphic design could be used on the hoarding, or a local street artist could be commissioned to provide some temporary artwork. The tiles above the shutter mechanism and the advertising board above should also be removed during the main phase of works.

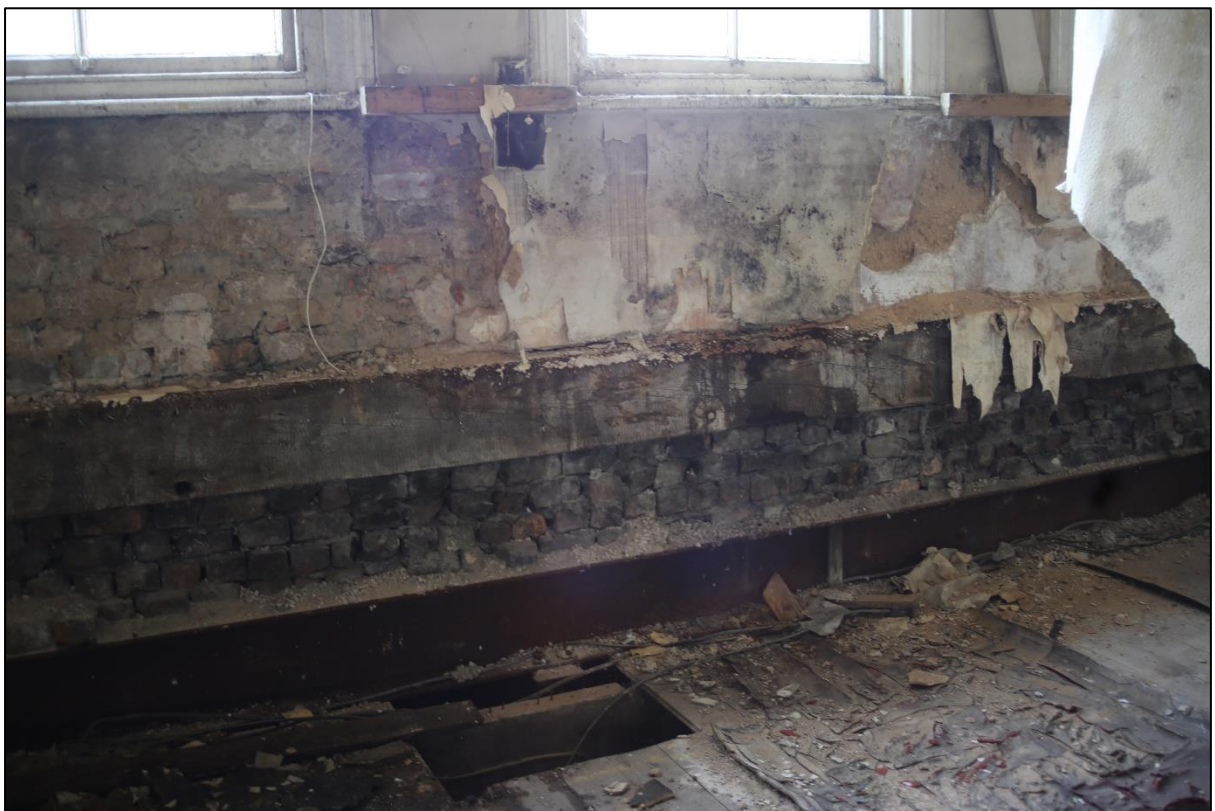
The first floor to No.70 contains three windows comprising flat internal timber sills and moulded timber architraves (Figure 23). The heads to each are obscured by a later suspended ceiling. The floor level of this building was lowered from the original position. This lowering exposed a timber beam with an inserted rolled steel I-section beam below. Between the two beams is four courses of irregular bond brickwork (Figure 24).

*Figure 24: ]The timber beam within the façade of No.70, facing north*

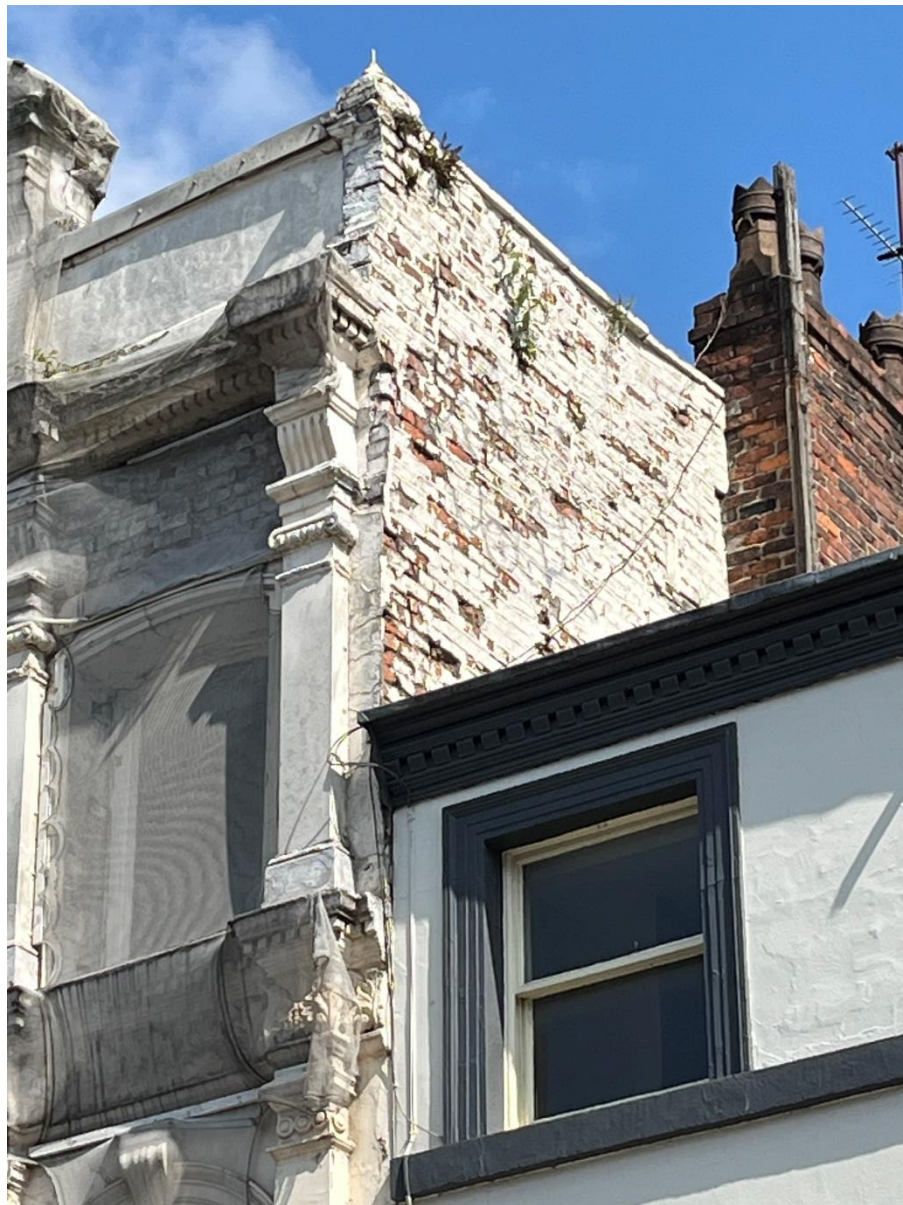
*Figure 27: Facade of party wall between No.68 and Castle Hotel*

The scaffold to No.68 is required to restrain the tall parapet section by temporarily bracing it back to the scaffold, for the temporary period between removal of the existing roof tie and installation of a new permanent restraint bracket.
