## CCTV Inspection Report

**BENNETT STREET, MANCHESTER, M12 5NL**

**23/07/2025**

**Job Number: BENNETT STREET, MANCHESTER, M12 5NL 23.07.25**

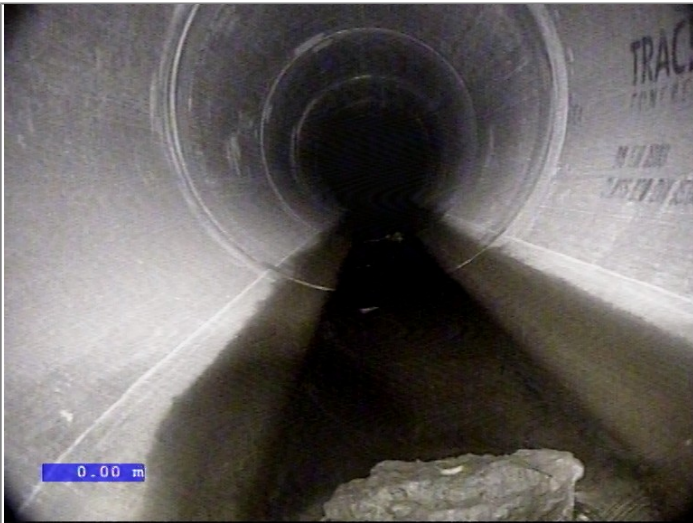
Start node type, manhole, reference S101

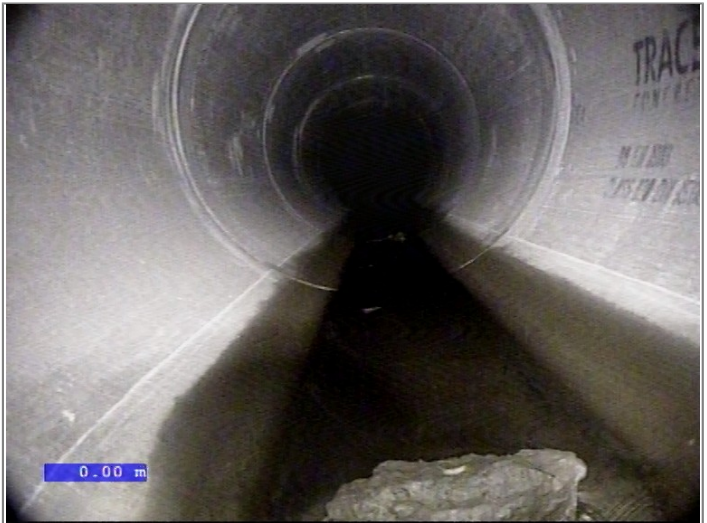
Water level 5% height/diameter

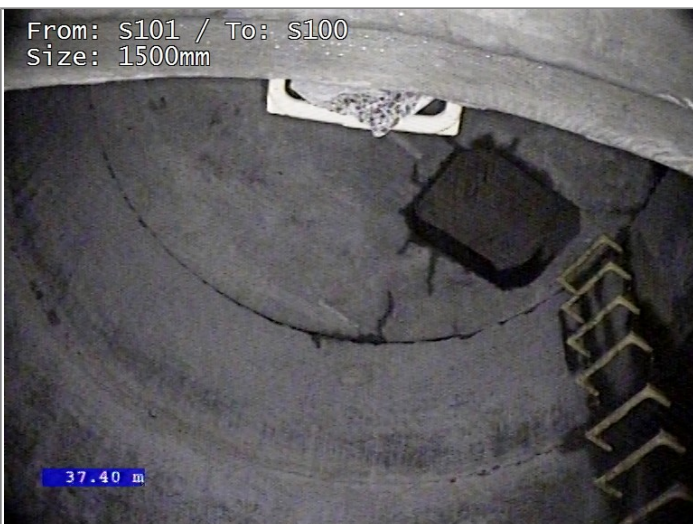
Finish node type, manhole, reference S100

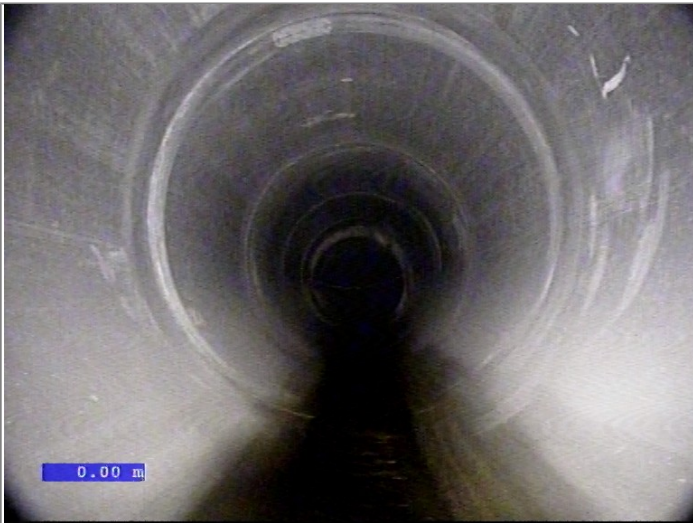
Start node type, manhole, reference S101

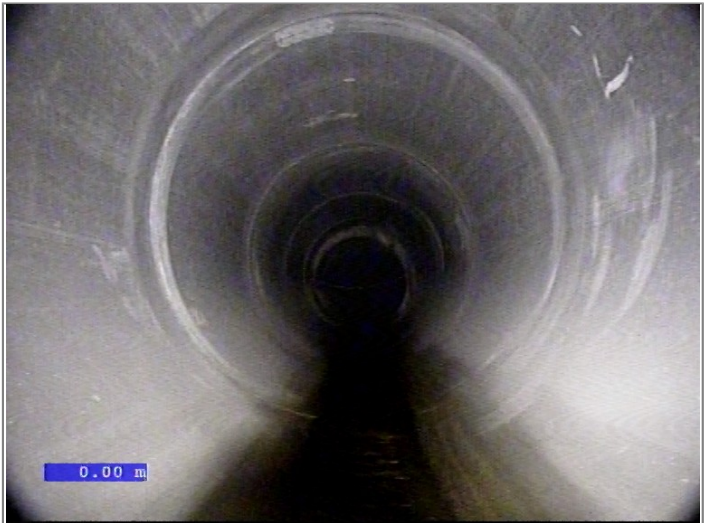
Water level 5% height/diameter

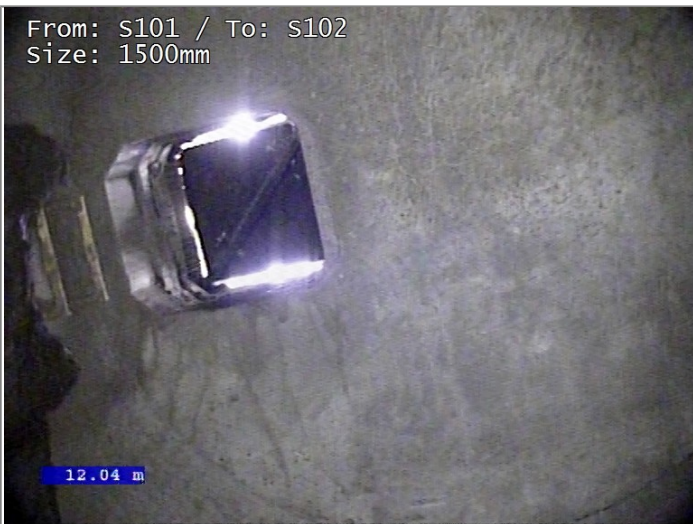
Finish node type, manhole, reference S102

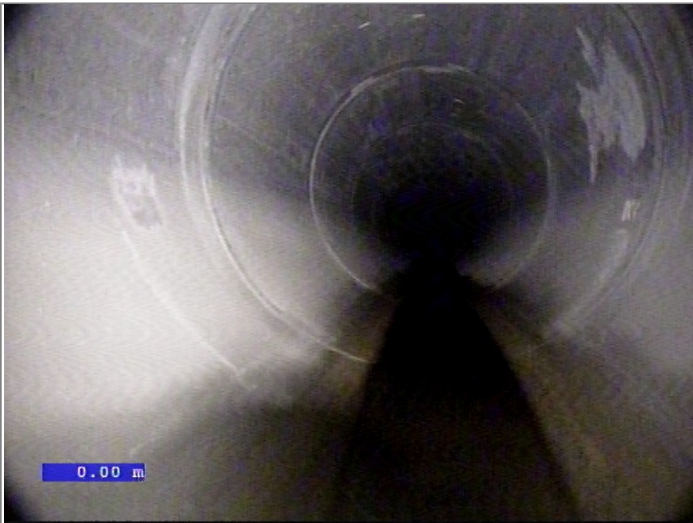
Start node type, manhole, reference S102

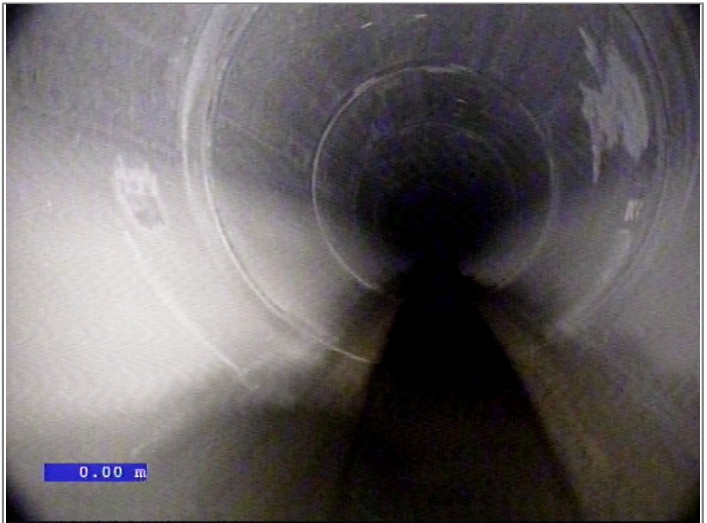
Water level 5% height/diameter

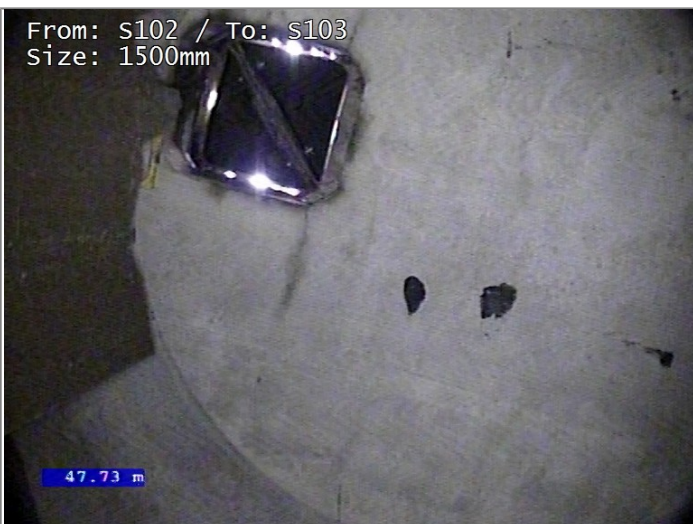
Finish node type, manhole, reference S103

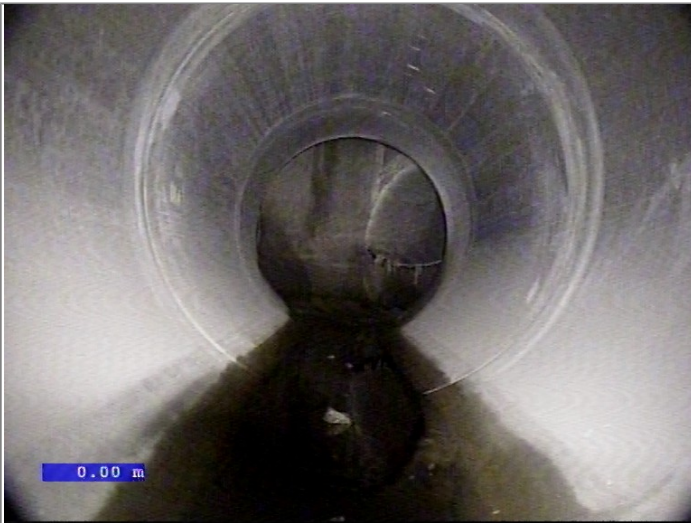
Start node type, manhole, reference S103

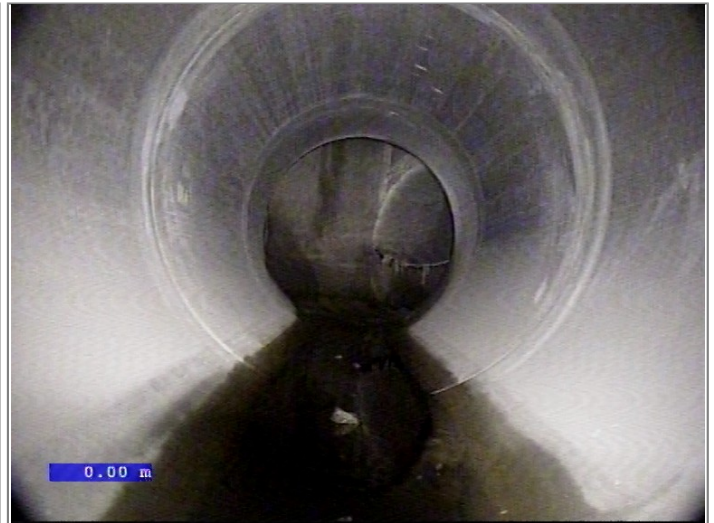
Water level 5% height/diameter

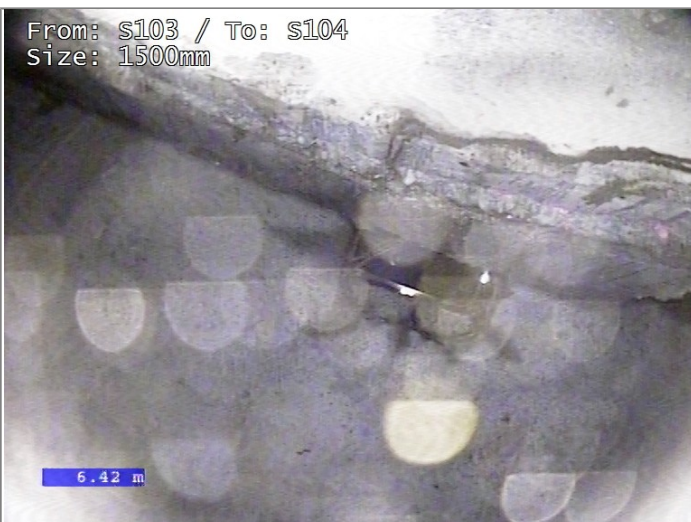
Finish node type, manhole, reference S104

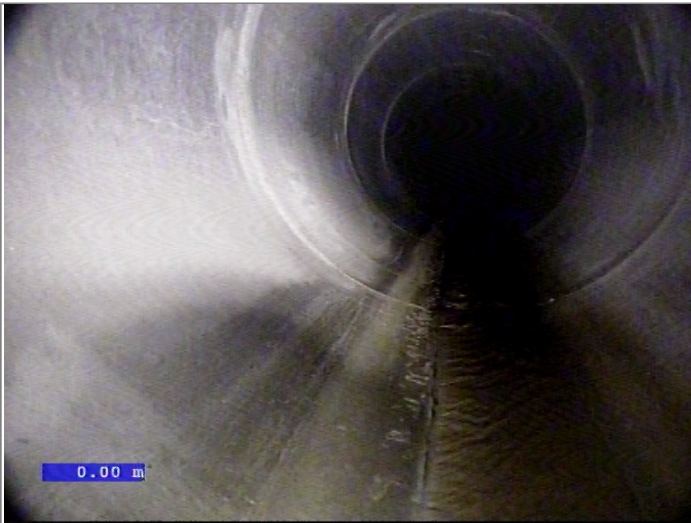
Start node type, manhole, reference S104

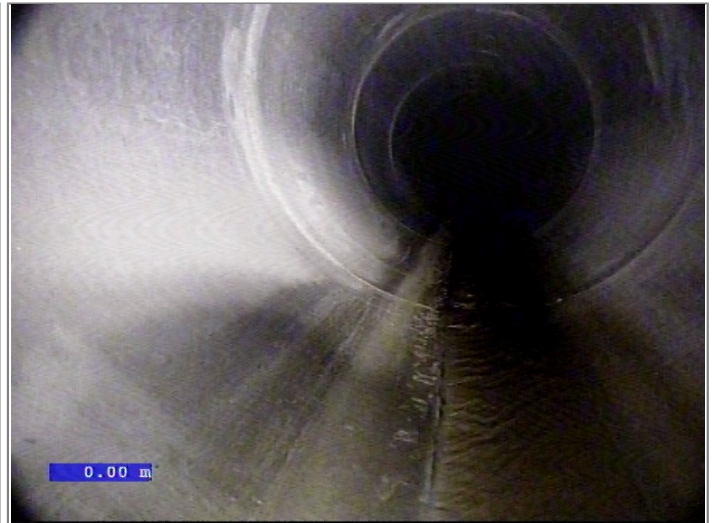
Water level 5% height/diameter

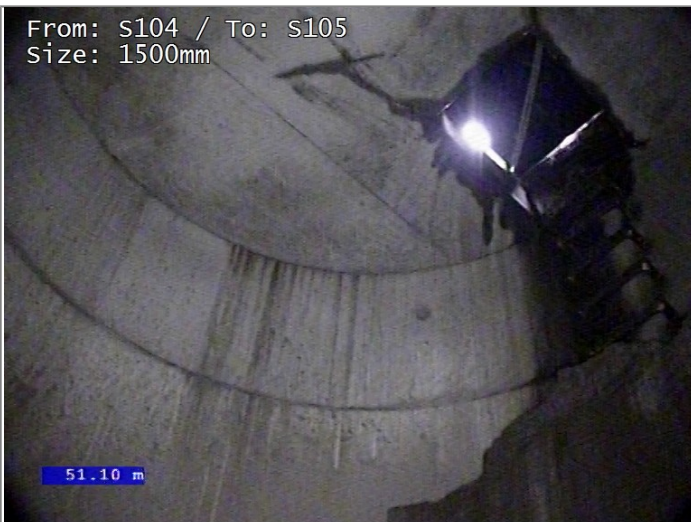
Finish node type, manhole, reference S105

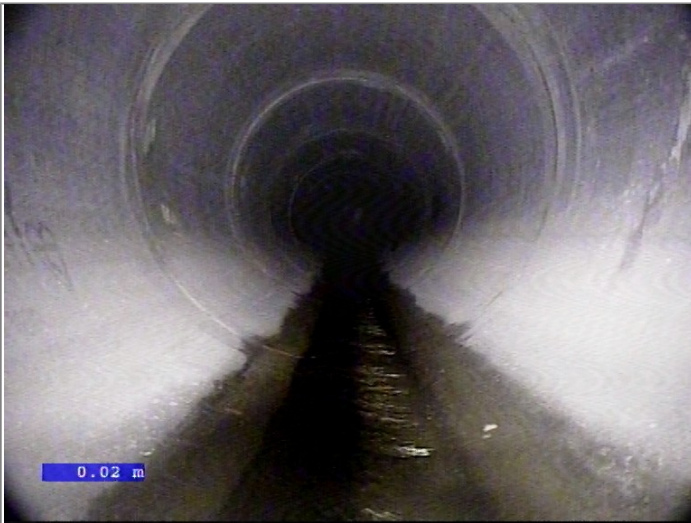
Start node type, manhole, reference S105

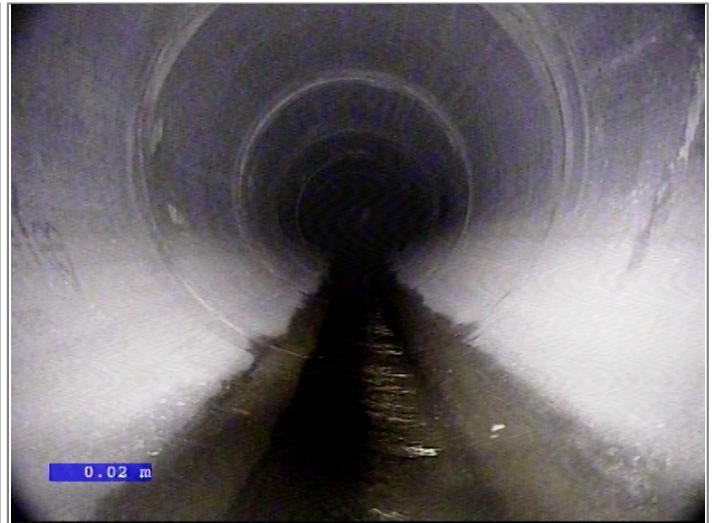
Water level 5% height/diameter

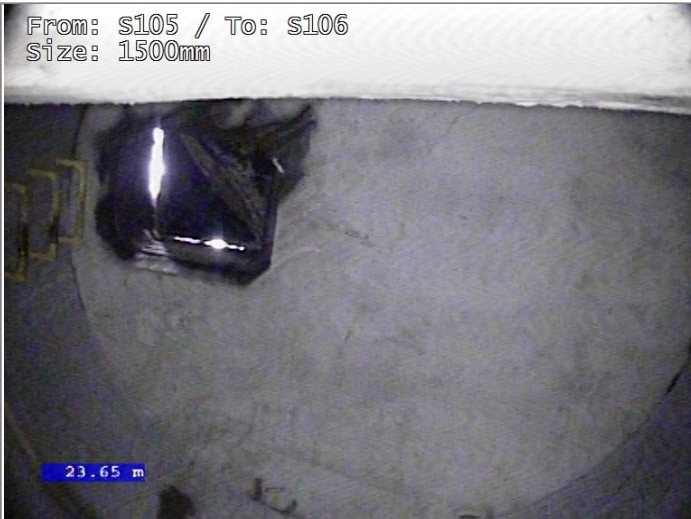
From: S105 / To: S106  
Size: 1500mm

Finish node type, manhole, reference S106

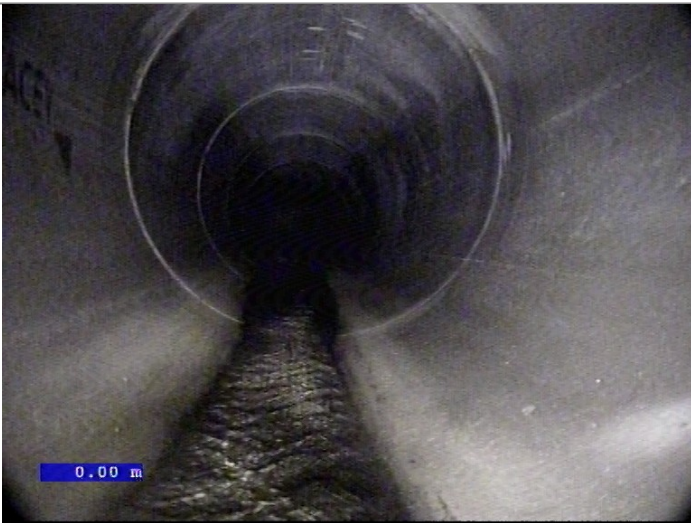
Start node type, manhole, reference S106

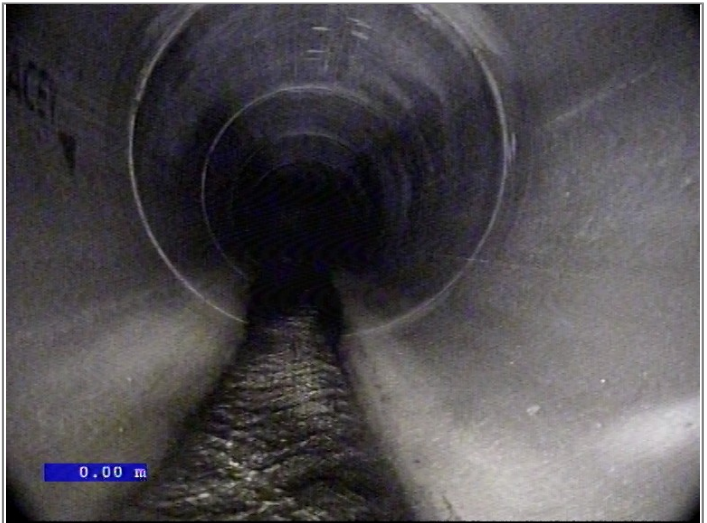
Water level 5% height/diameter

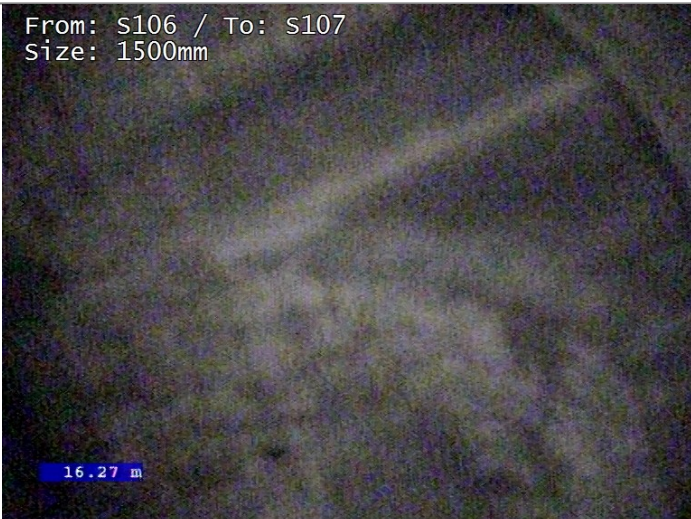
From: S106 / To: S107  
Size: 1500mm

| Start Node Ref:S106 I/L : metres | | | | | | |
|---|---|---|--|---|---|--|
| 16.27 | SA | Survey abandoned - Remark: CCTV UNABLE TOMPSS 15% SILT. CLEANING REQUIRED | | 12676129 | Comment / 0 | |

Survey abandoned - Remark: CCTV UNABLE TOMPSS 15% SILT.  
CLEANING REQUIRED

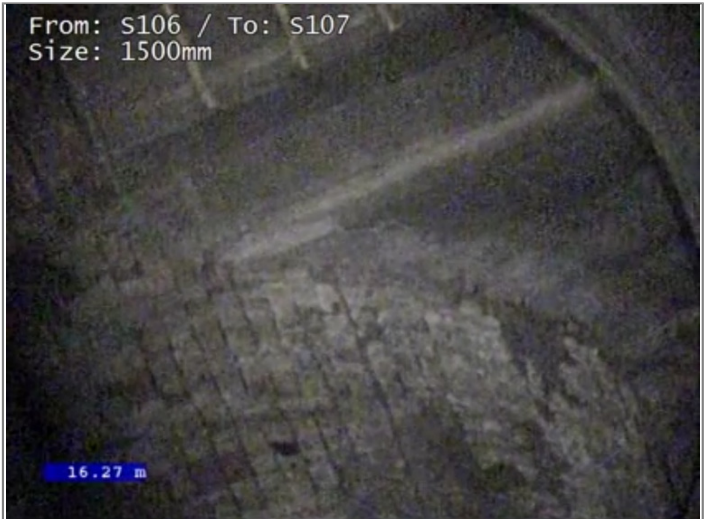
From: S106 / To: S107  
Size: 1500mm

S107 in view
