# Air Monitoring Certificate

Kellon Homes  
Bennett Street  
Manchester  
M12 5ED

| Scope of works: | Inspectas to undertake near source and personal air monitoring during the enclosure setup for the removal of thermal insulation to pipe run in a duct. | | | |
| Date of works: | 09 Dec 2024 | | | |

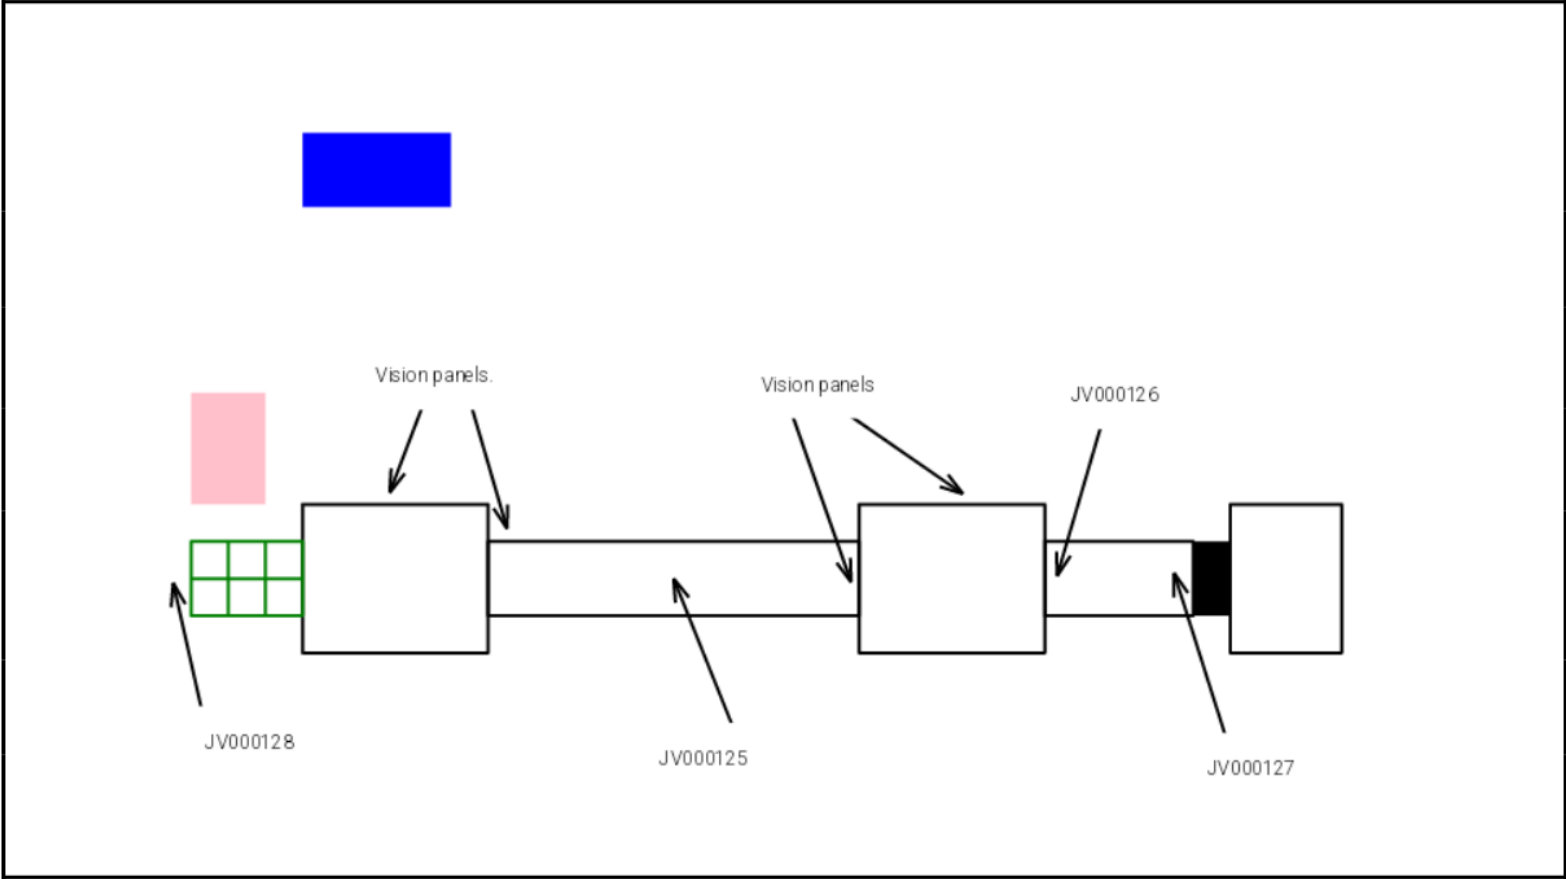
Appendix 1 - Site Plan

| 1 | NS | Above the enclosure. / JV000125 | HF82318 | C242 | 09:44 | 8.2 | 10:44 | 8.2 | 60 | 492 | 4.5 | 196 | 0.002 | 0.010 | <0.010 |
| 2 | NS | Outside enclosure / JV000126 | HF83570 | C243 | 09:42 | 8.2 | 10:43 | 8.2 | 61 | 500 | 2.5 | 192 | 0.001 | 0.010 | <0.010 |
| 3 | NS | Outside NPU location. / JV000127 | HF82217 | C257 | 09:40 | 8.2 | 10:40 | 8.2 | 60 | 492 | 3.0 | 196 | 0.002 | 0.010 | <0.010 |
| 4 | NS | Outside airlock baglock. / JV000128 | HF84151 | C196 | 09:36 | 8.2 | 10:36 | 8.2 | 60 | 492 | 4.0 | 196 | 0.002 | 0.010 | <0.010 |
