## CIS Tower Refurbishment.

Recording Strategy and Photographic Audit of internal & external features.

# APPENDIX 30 – LEVEL 24. INTERNAL.

Planning Permission ref: 126118/FO/2020. Condition 29.

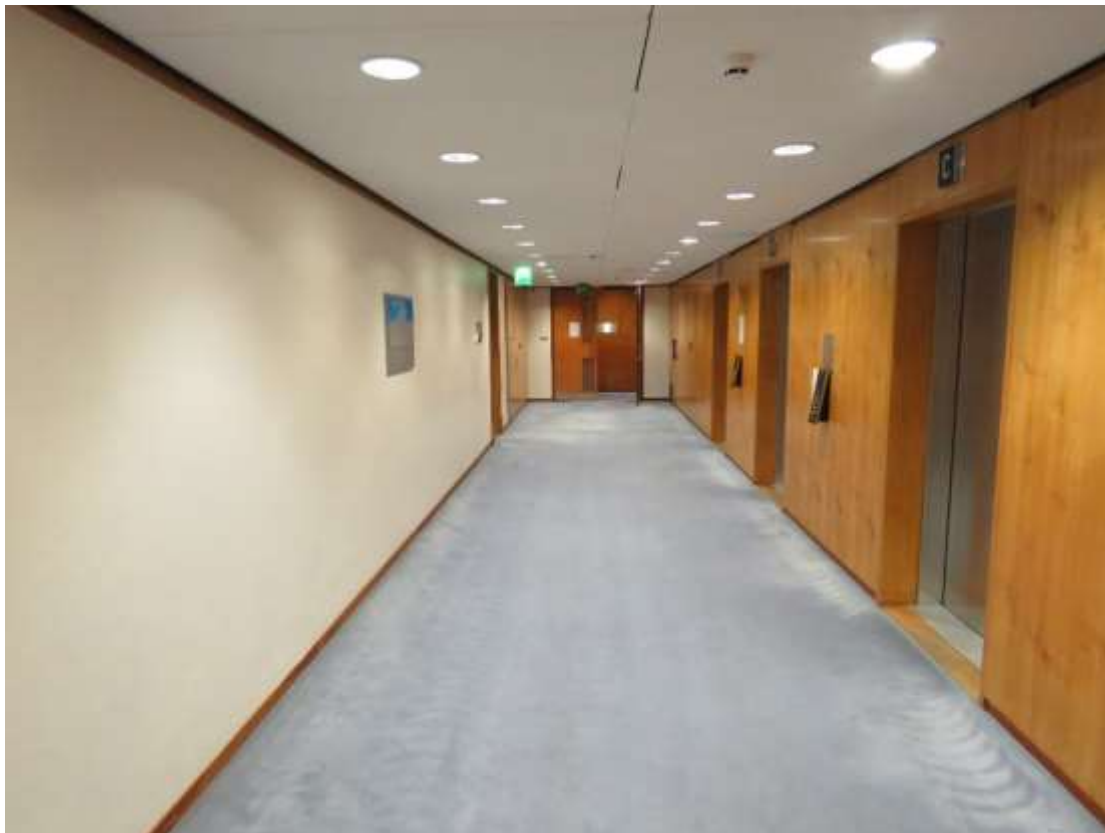
**24-01** View of the lift lobby with cherry veneer panelling.

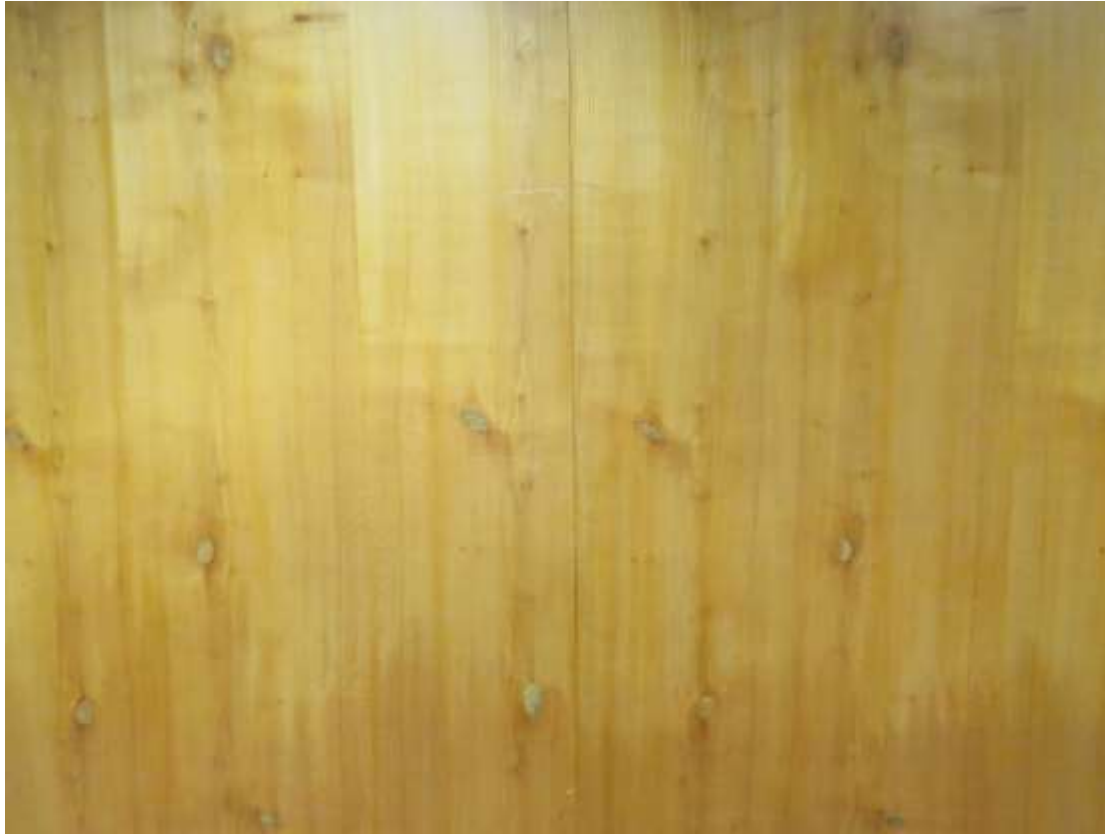
**24-02** Close up view of cherry panelling to lift lobby.

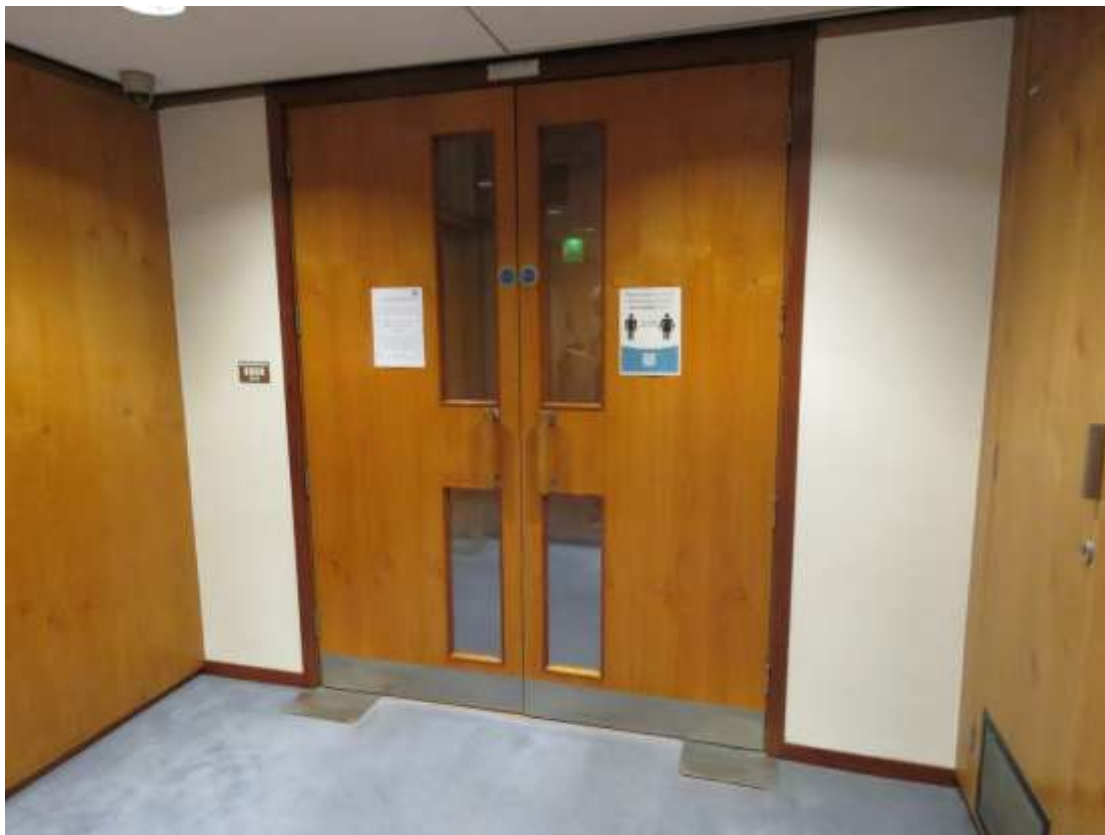
**24-03** View of double doors between the lift lobby and foyer.

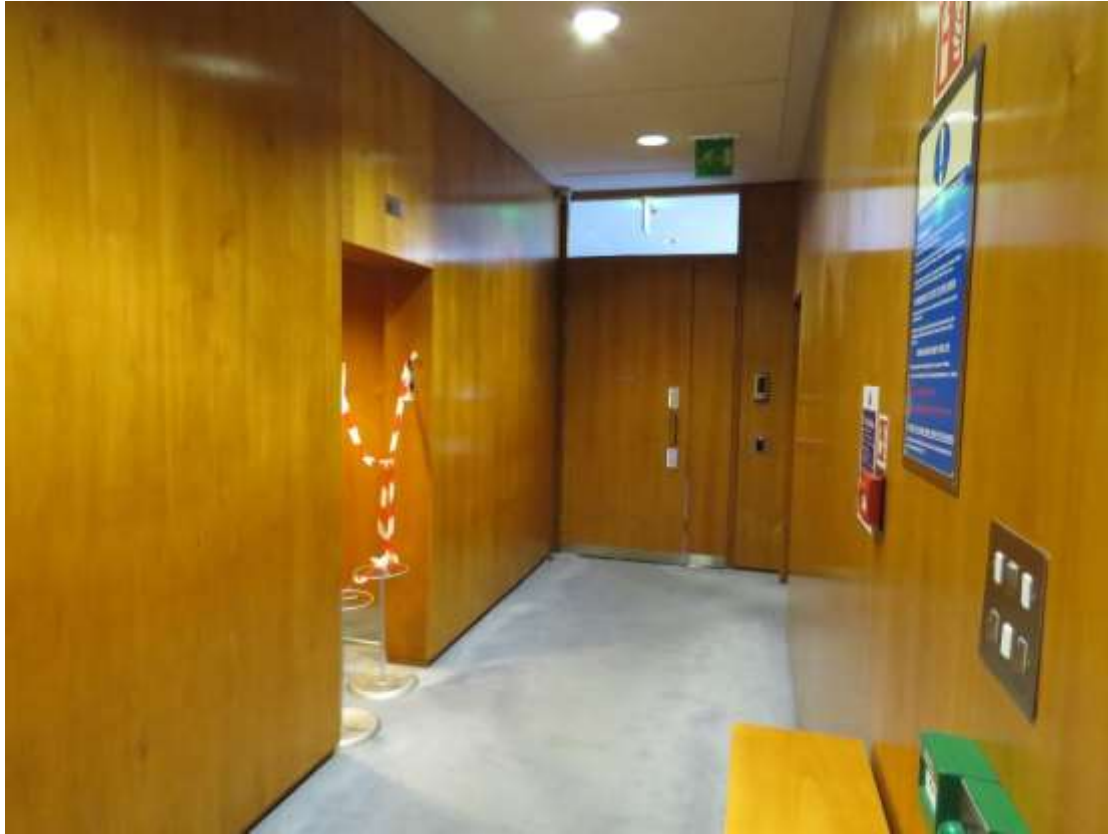
**24-04** View east in foyer

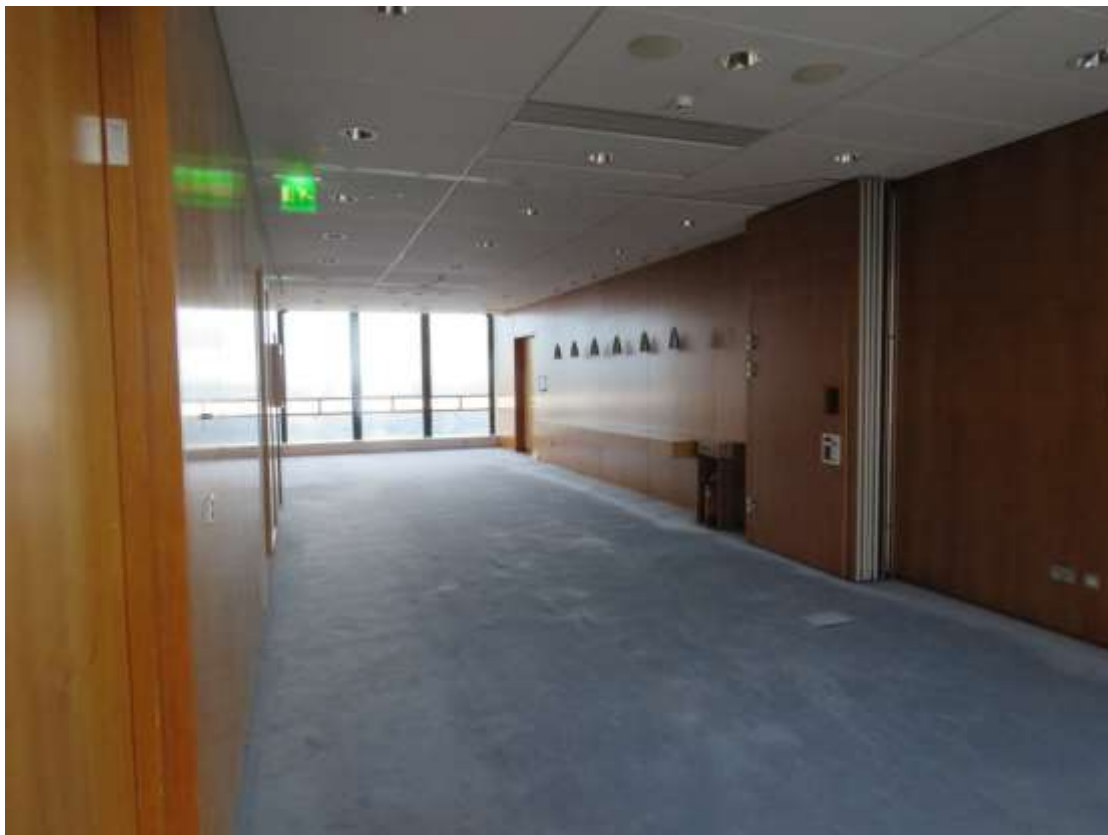
**24-05** View north in ante-chamber outside the committee / board room.

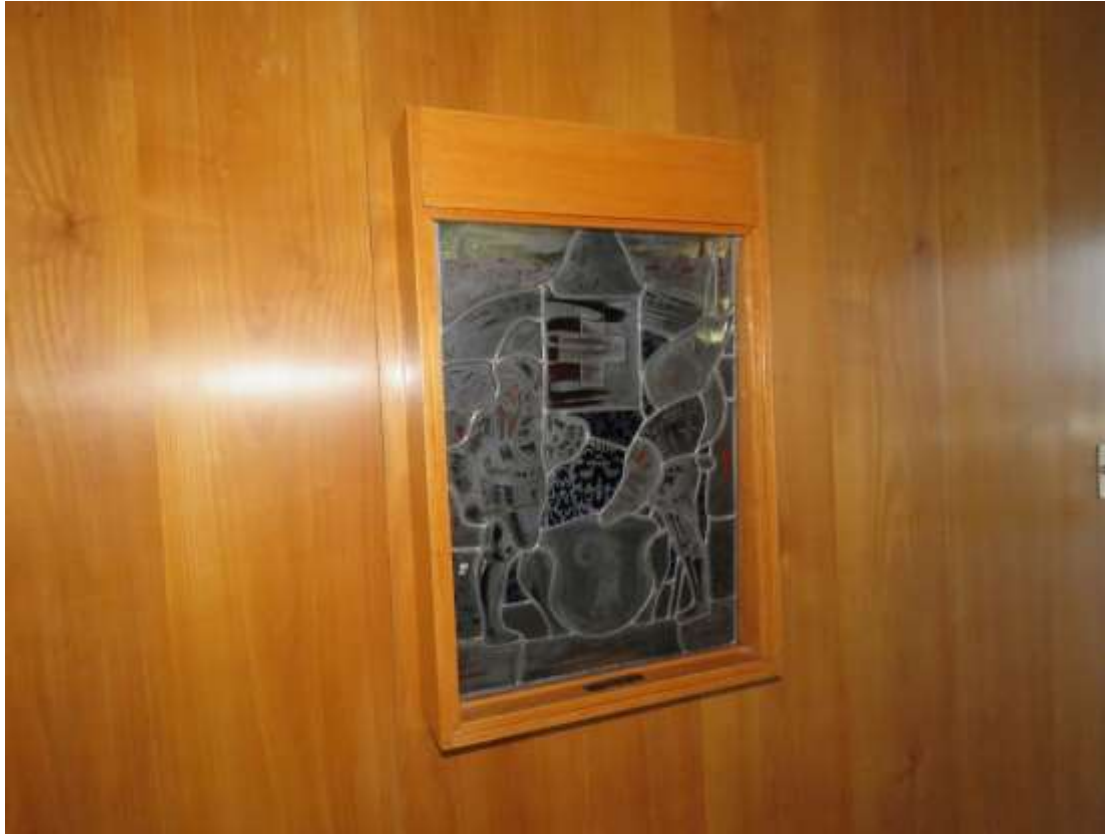
**24-06** Original leaded and painted glass panel gifted from a co-operative in Switzerland.

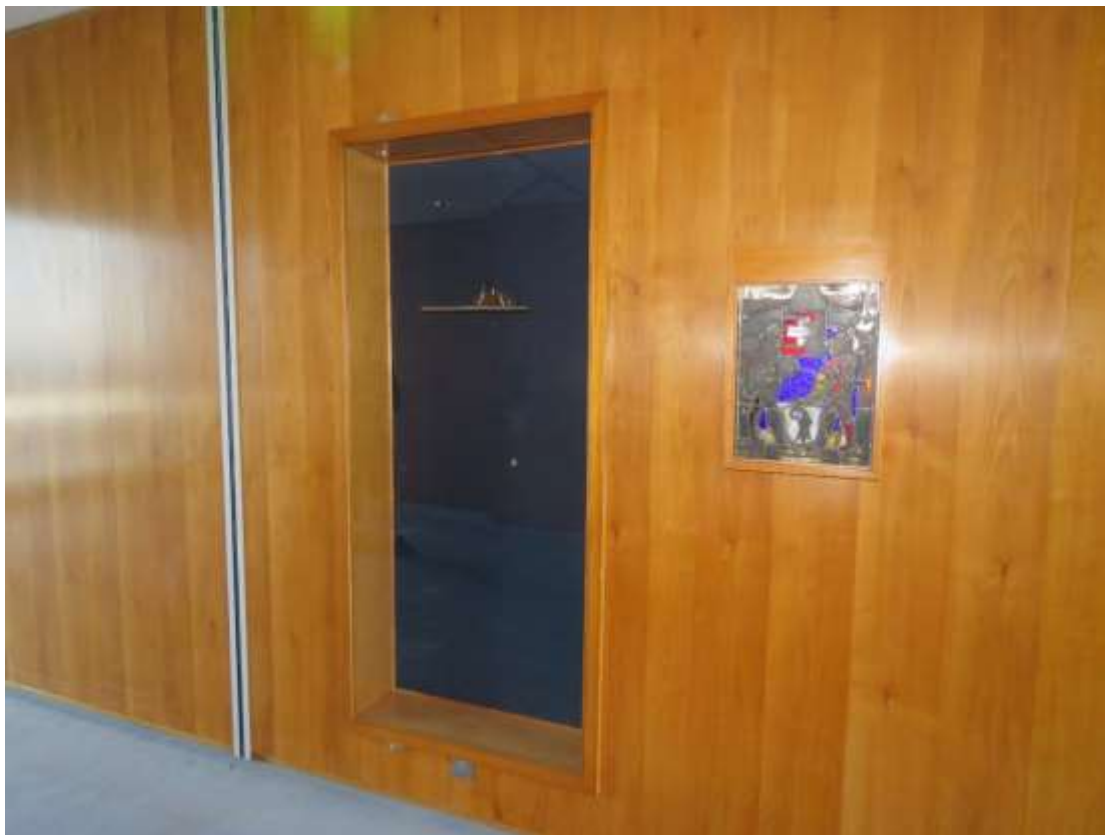
**24-07** View of built in glass cabinet to partition.

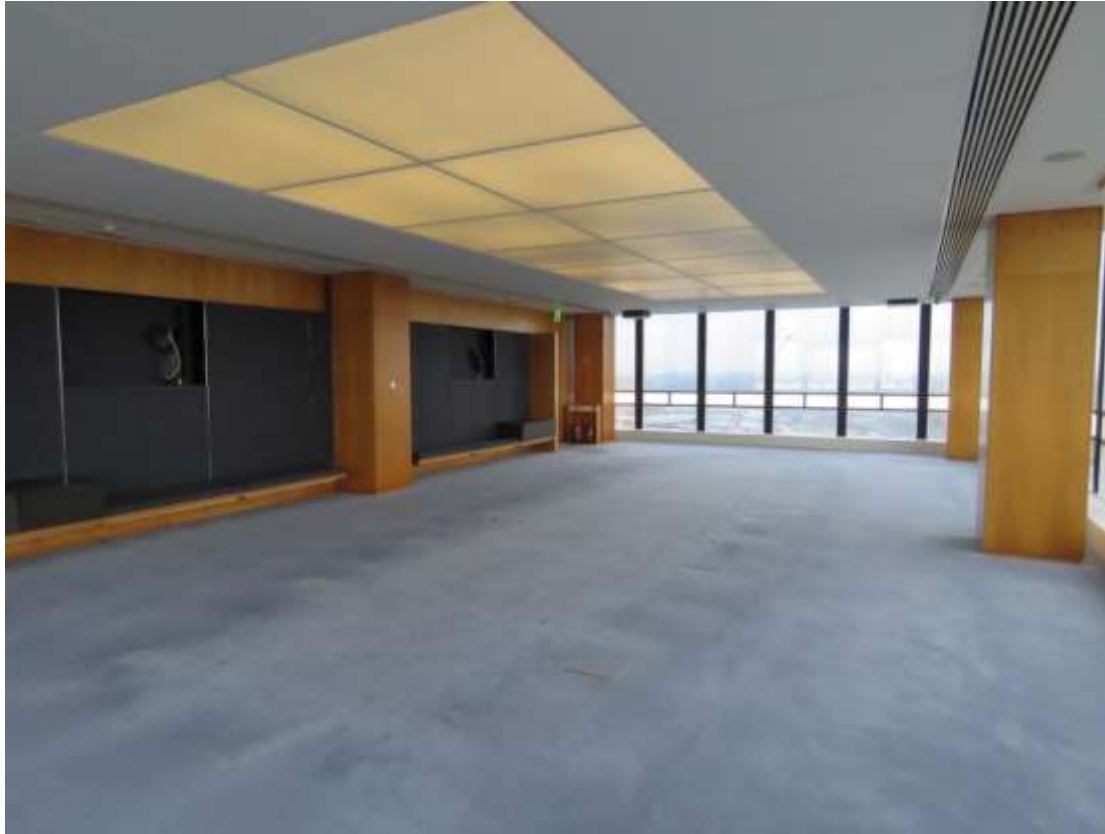
**24-08** View north in committee / board room.

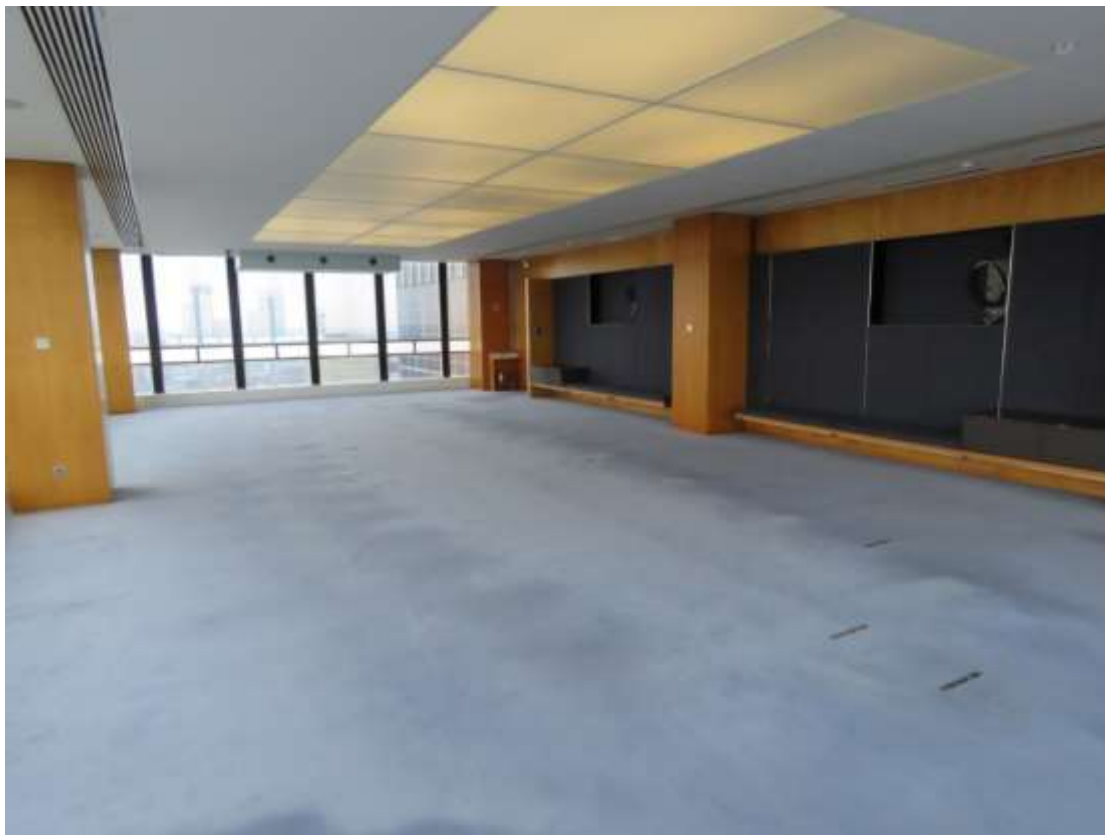
**24-09** View south in committee / board room.

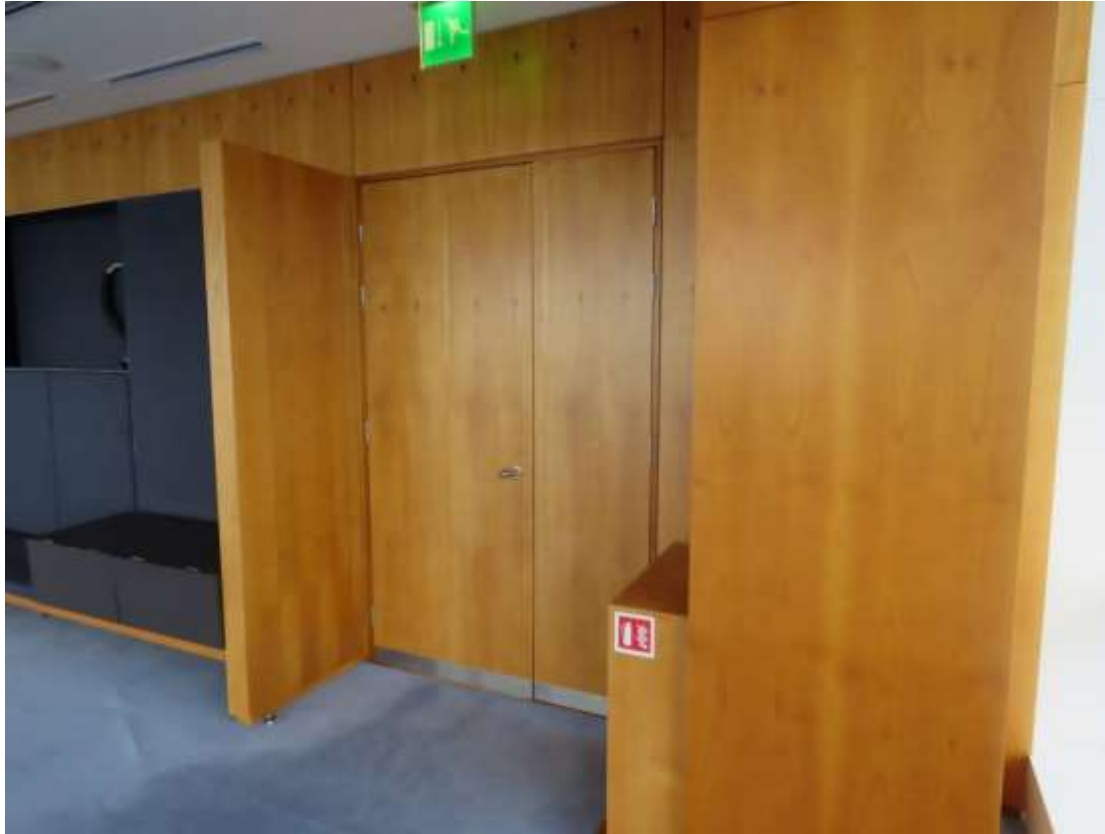
**24-10** View of high quality timber panelling and doors (non-original).

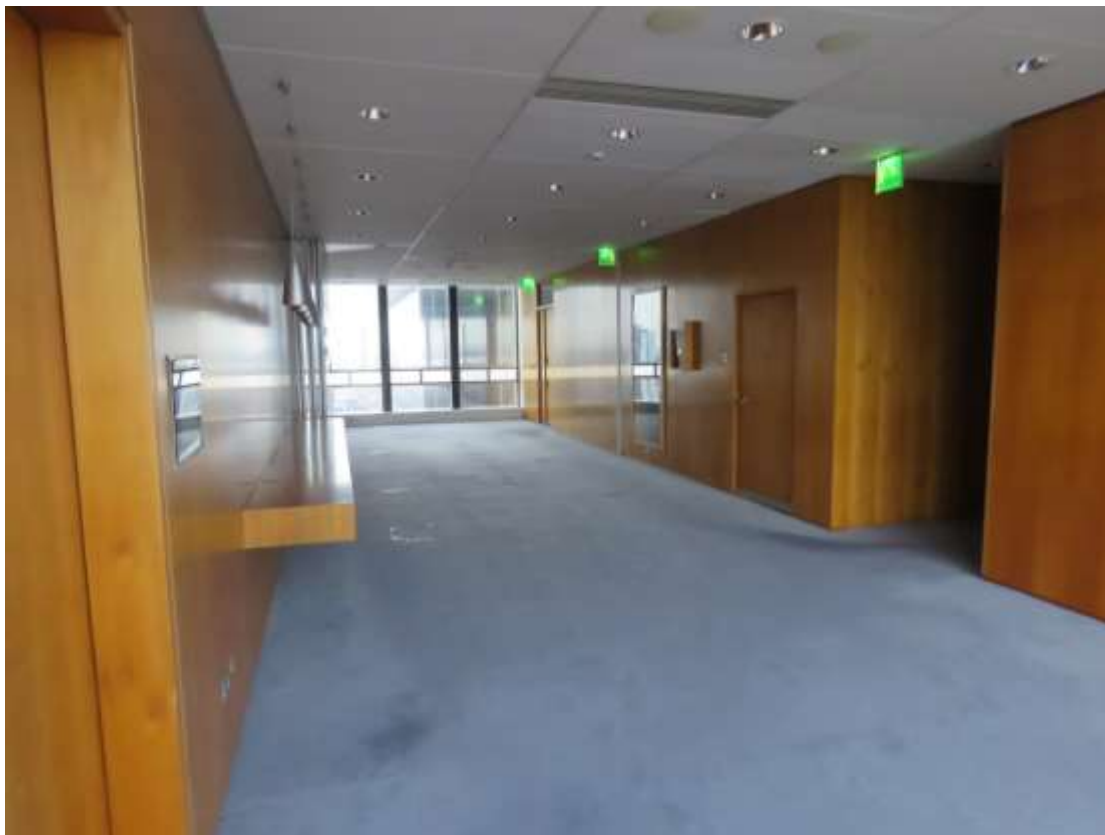
**24-11** View south in ante-chamber outside the committee / board room.

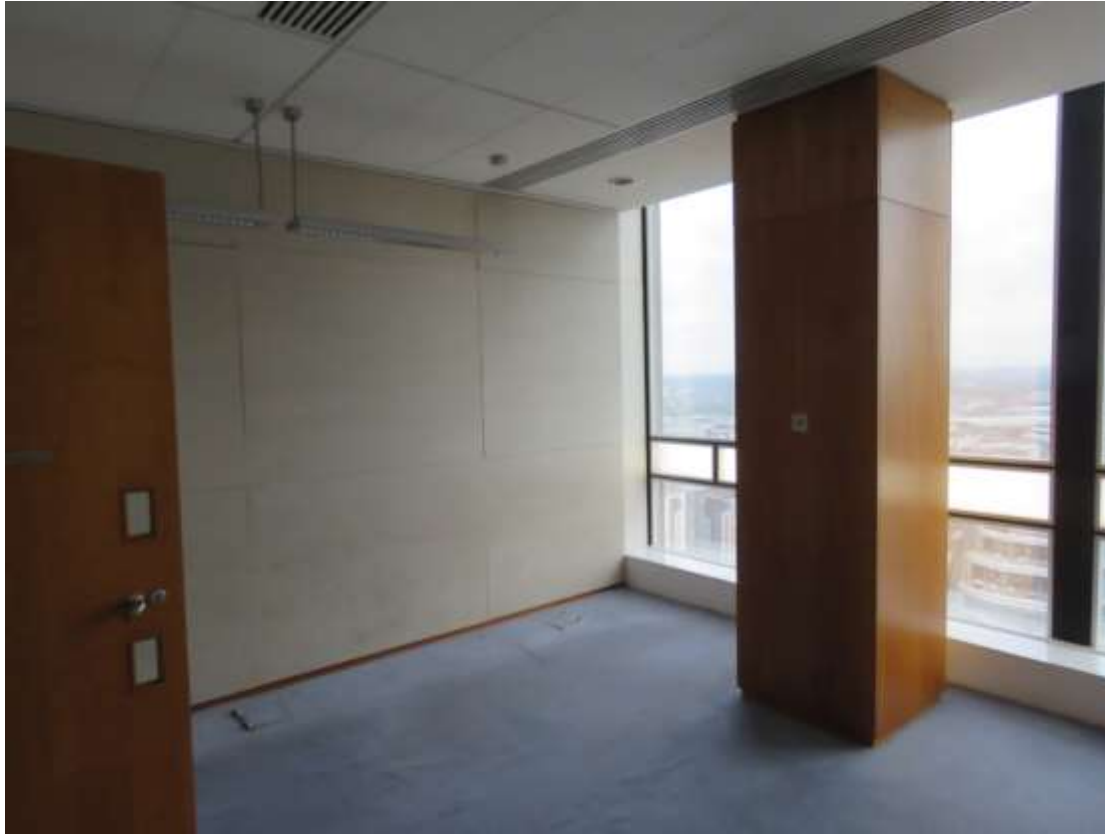
**24-12** View within office with partition covered with white panelling.

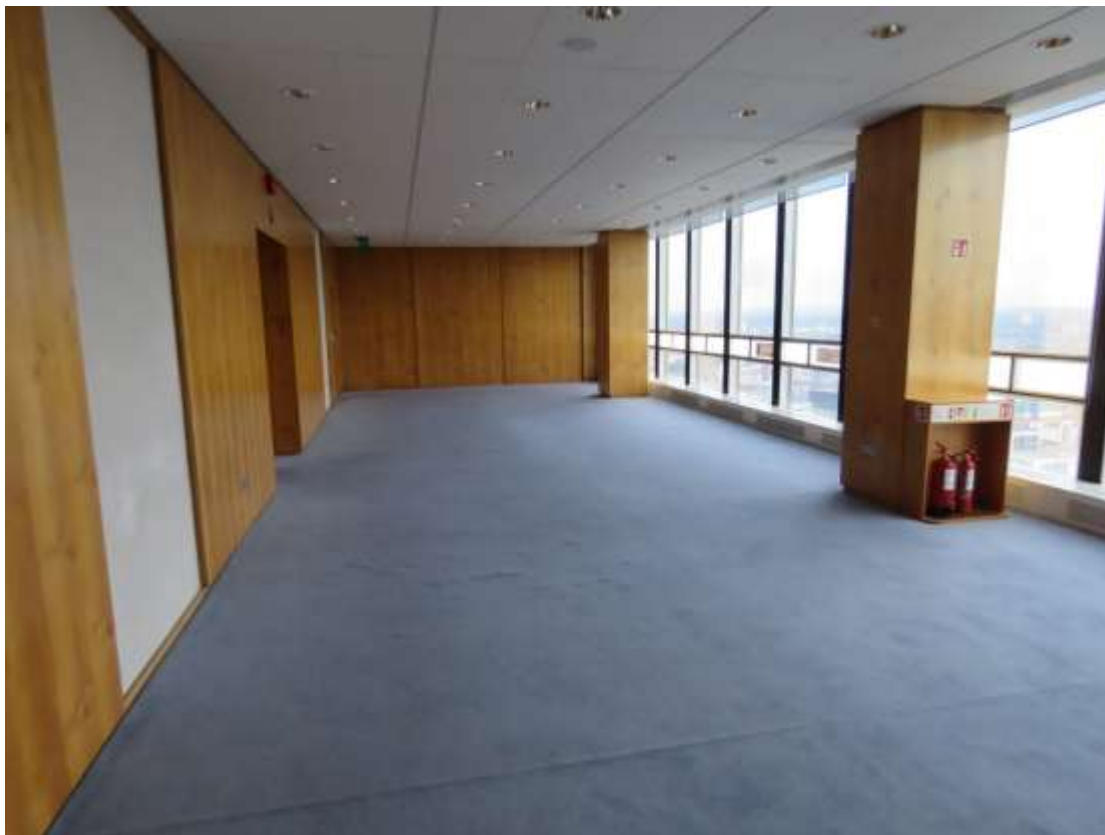
**24-13** View west in meeting room.

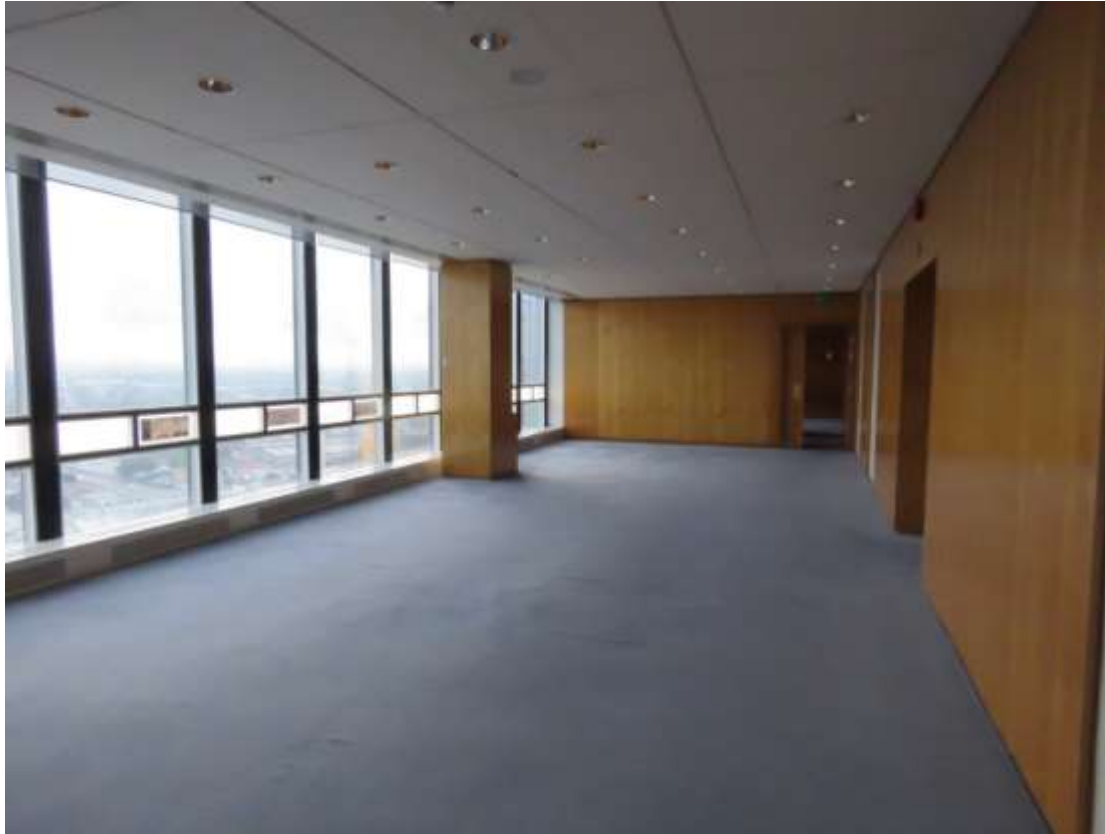
**24-14** View east in meeting room.

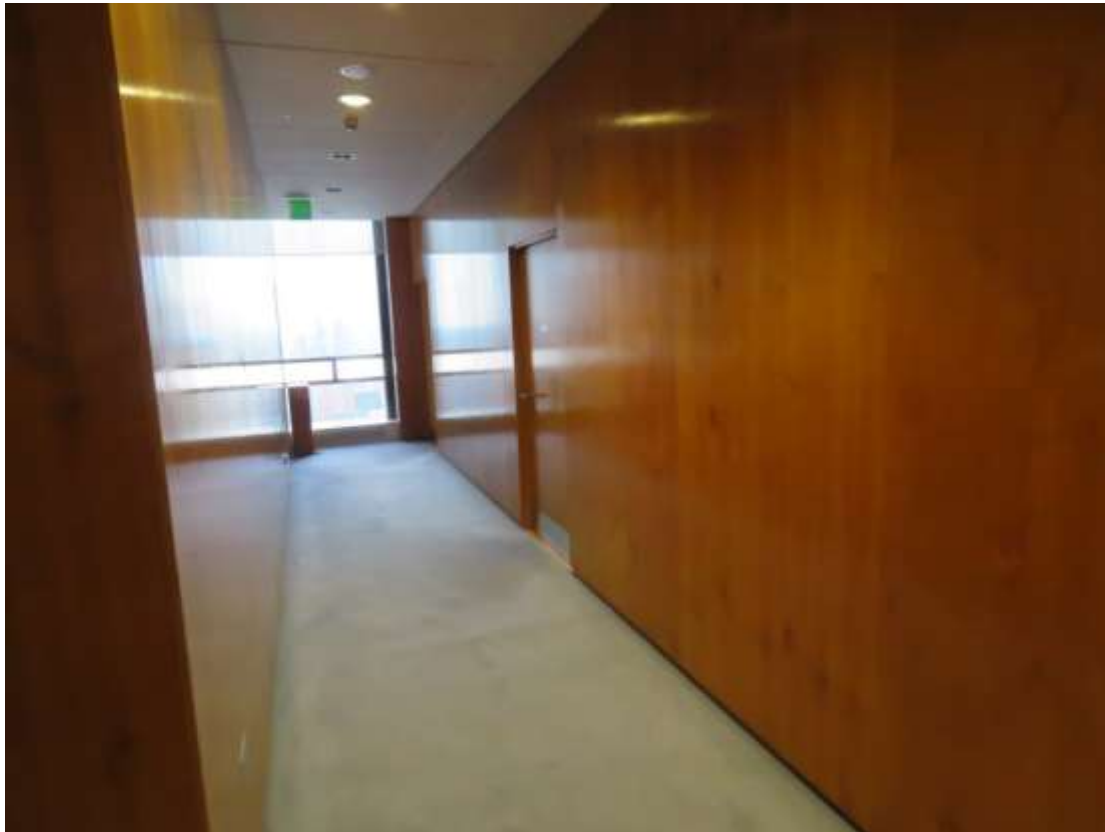
**24-15** View south along corridor between kitchen and dining rooms.

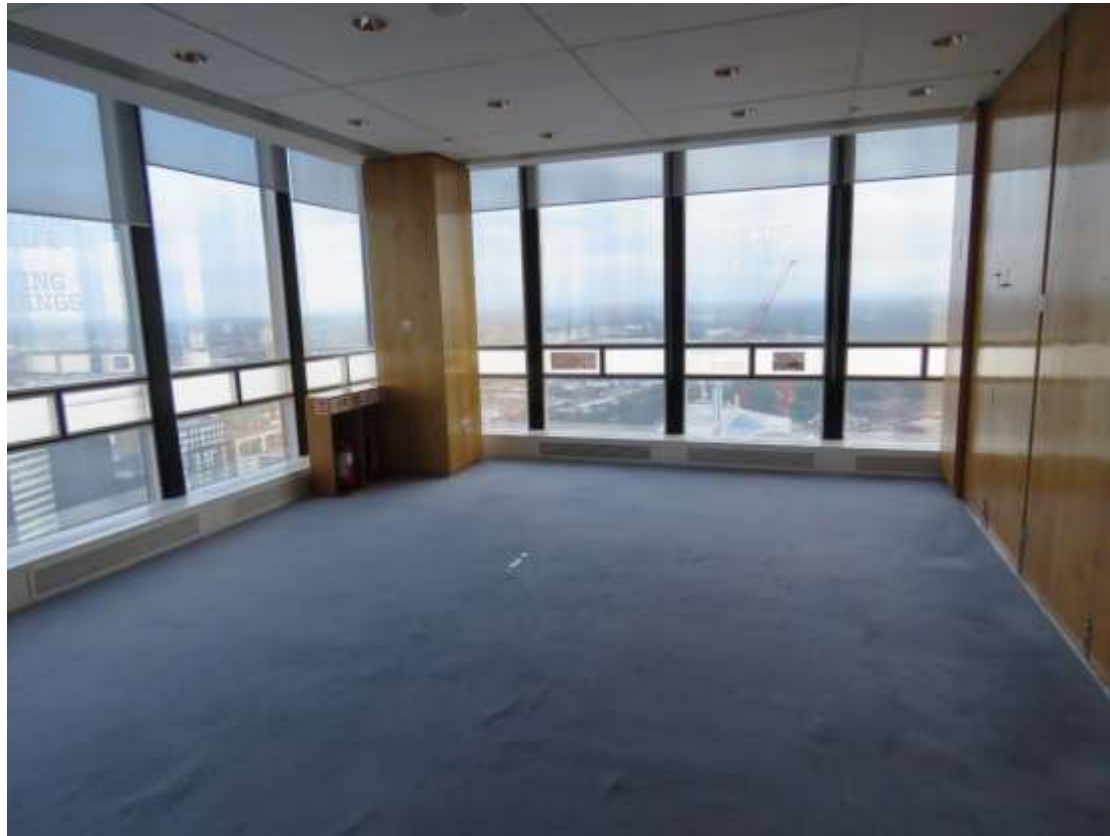
**24-16** Looking north in the northernmost dining space out towards Miller Street.

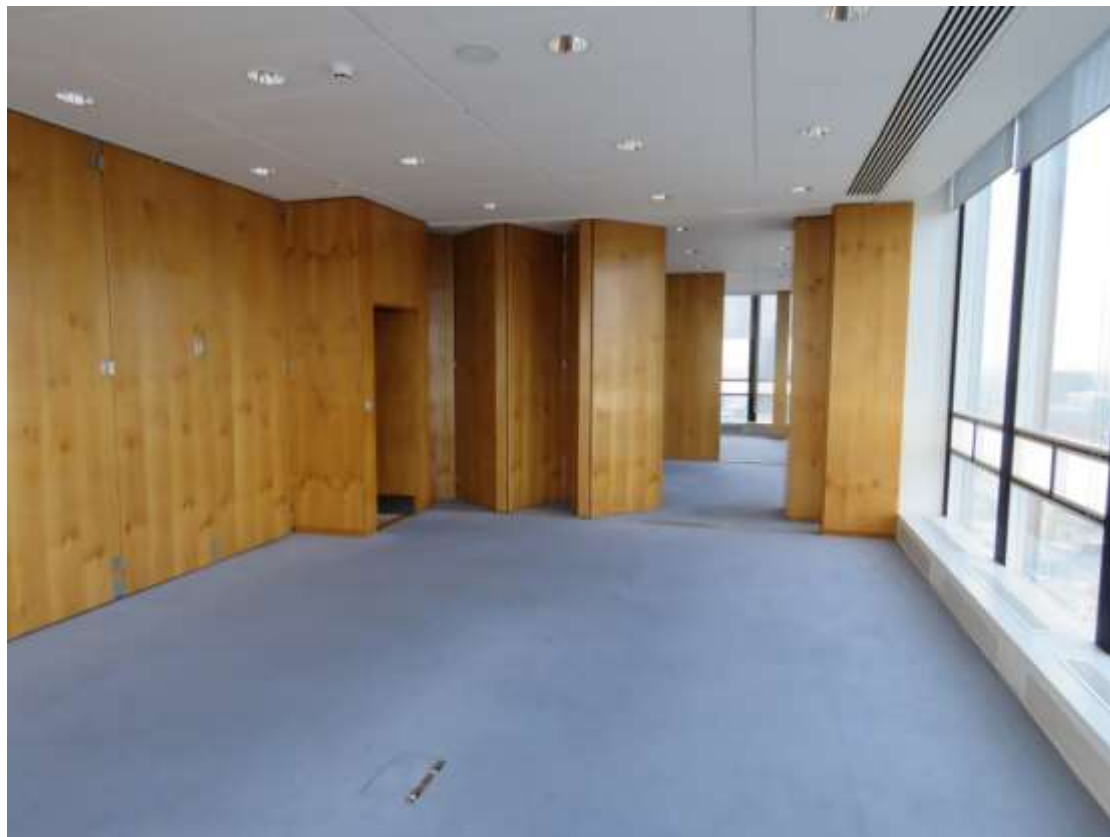
**24-17** Looking south through the dining spaces with folding partitions.

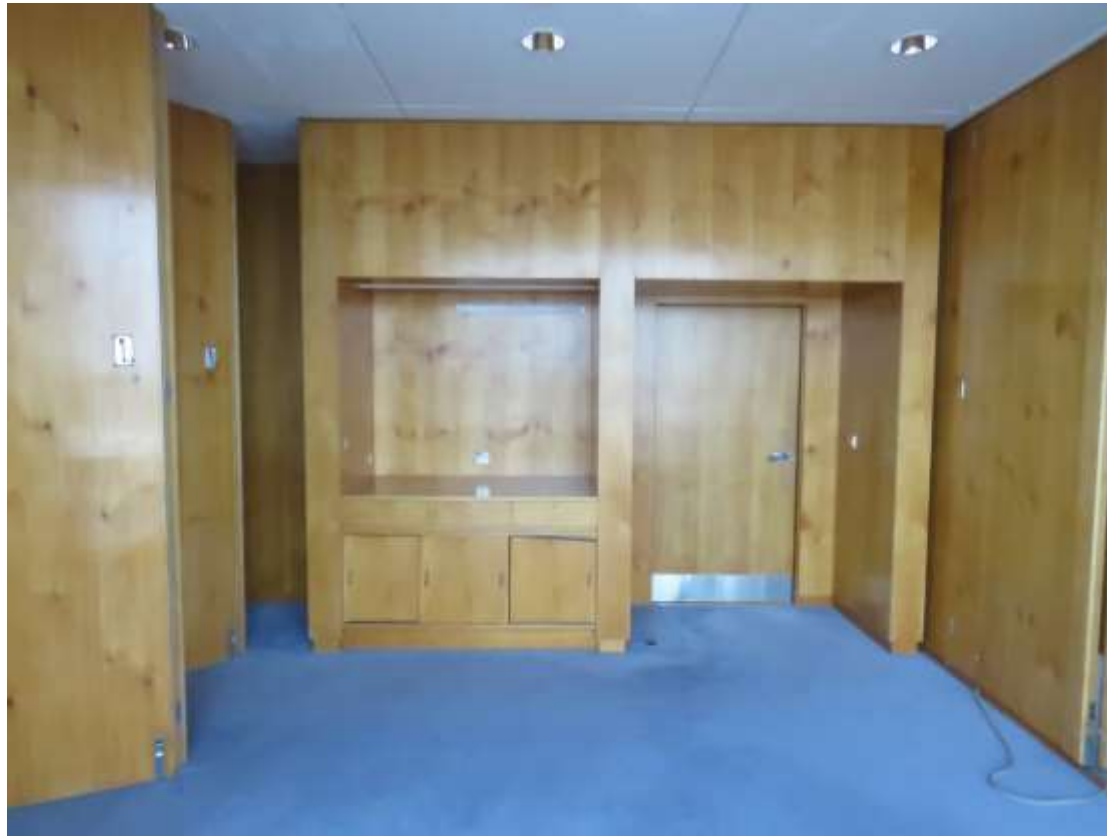
**24-18** View of servery and cupboard in central dining space.

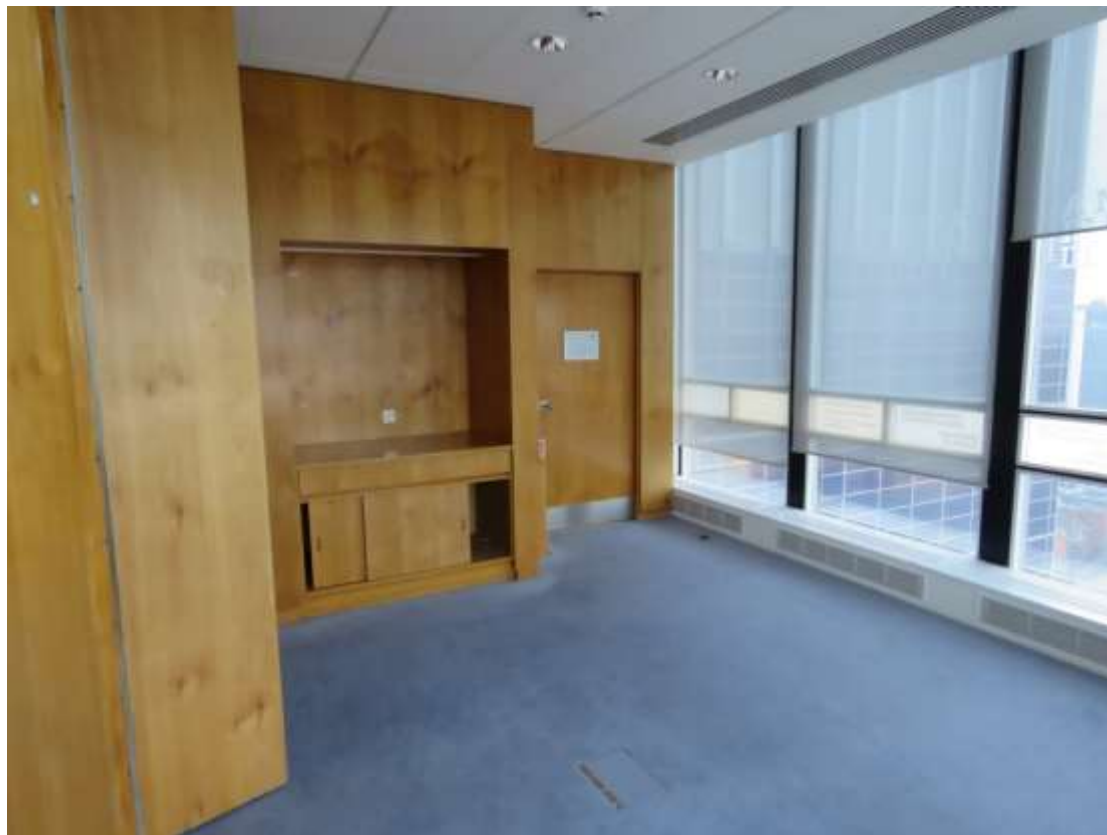
**24-19** View of servery and cupboard in southern dining space.

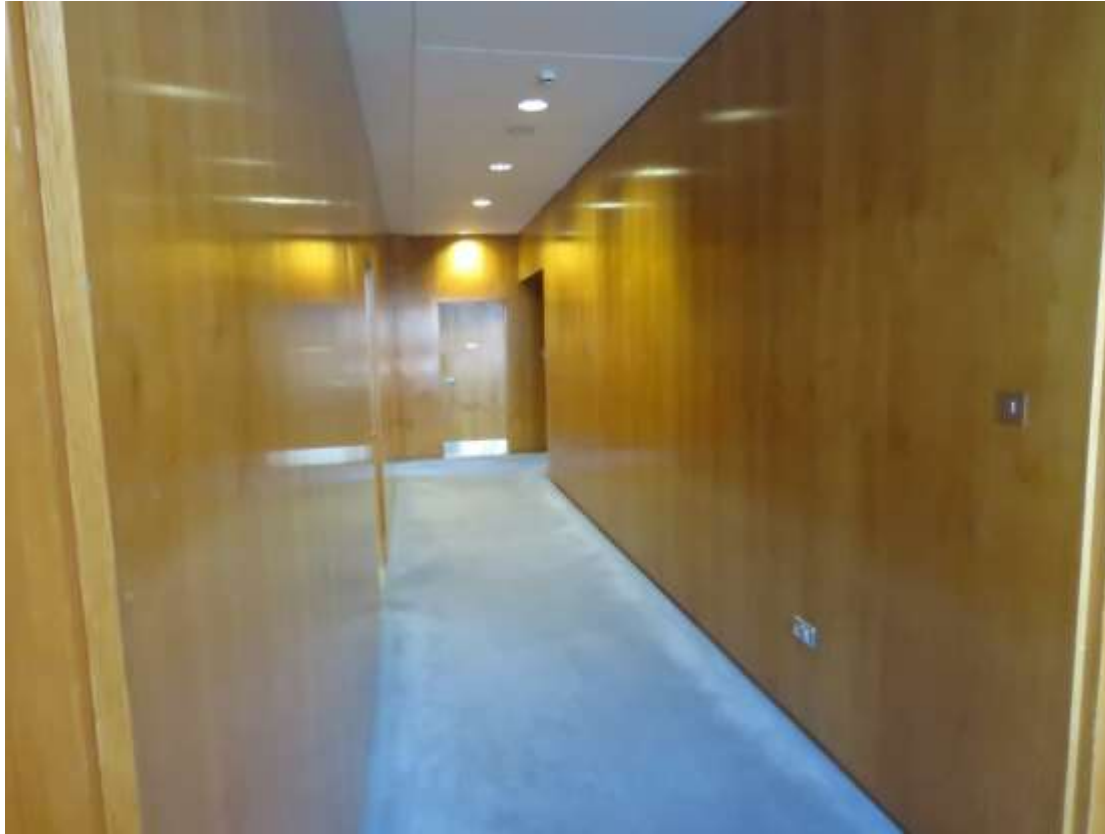
**24-20** View north along corridor between dining spaces and kitchen.

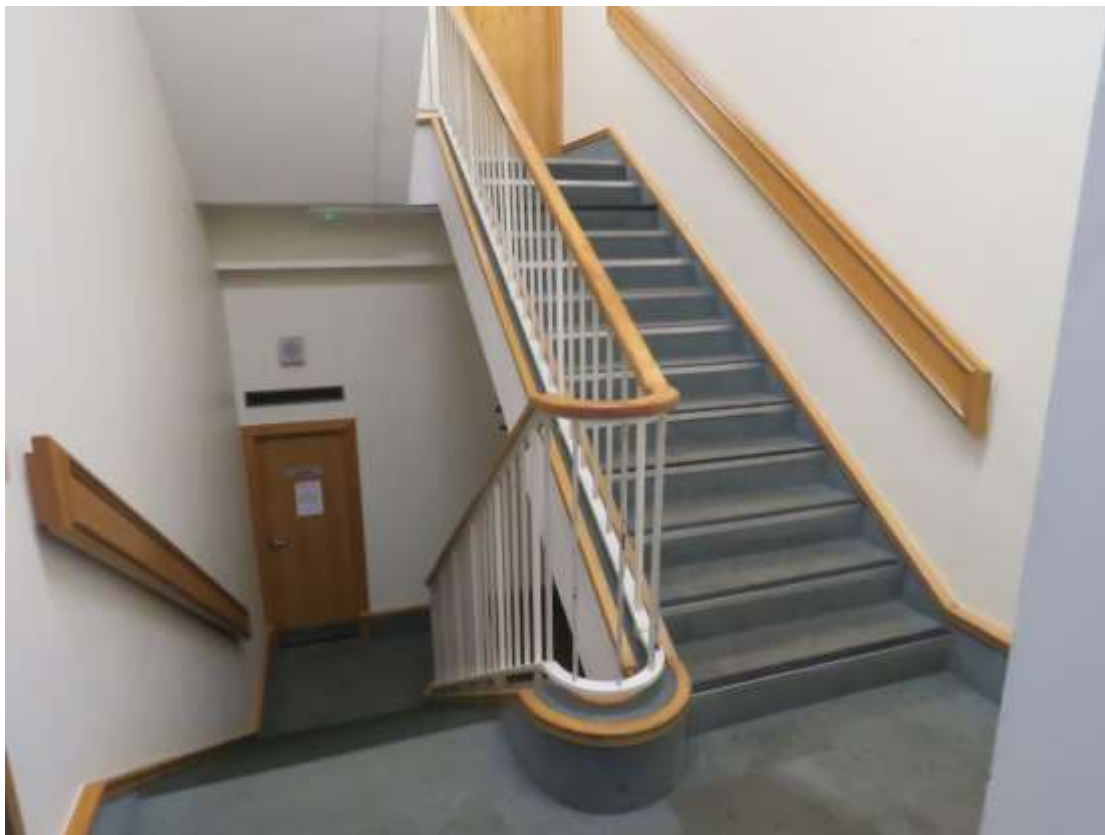
**24-21** View within western stairwell.

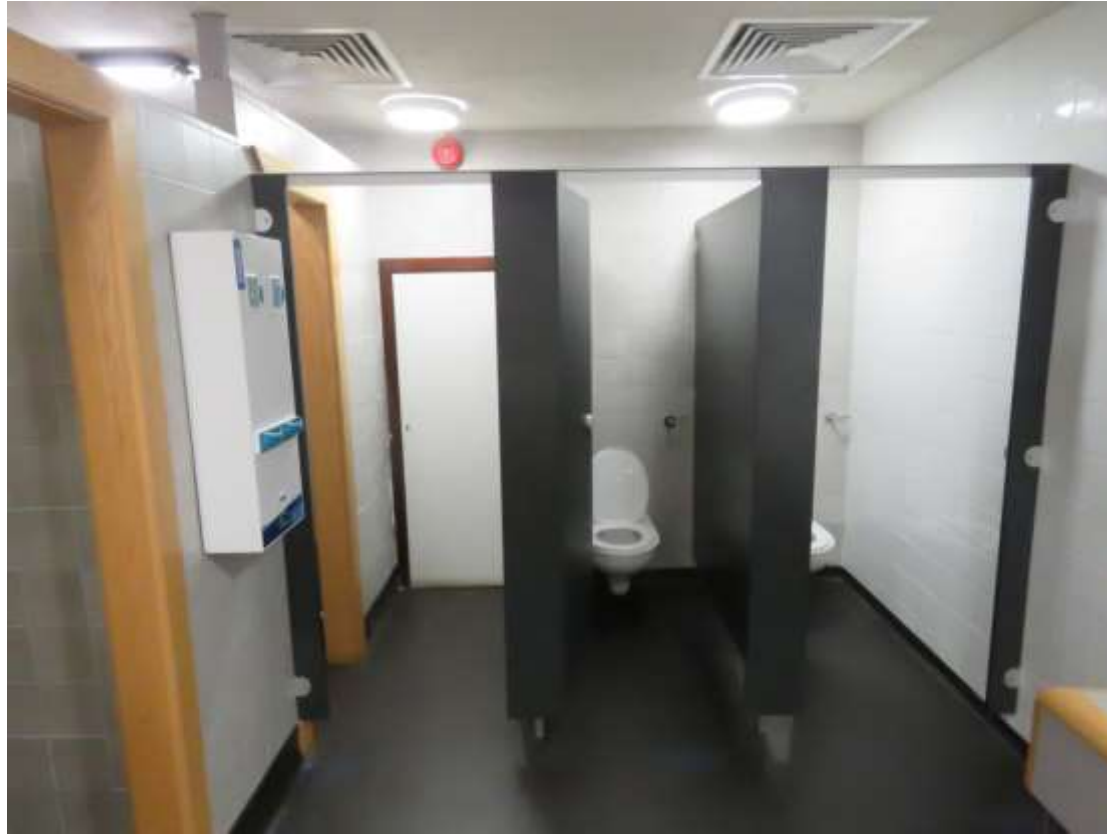
**24-22** View within female WC and shower.

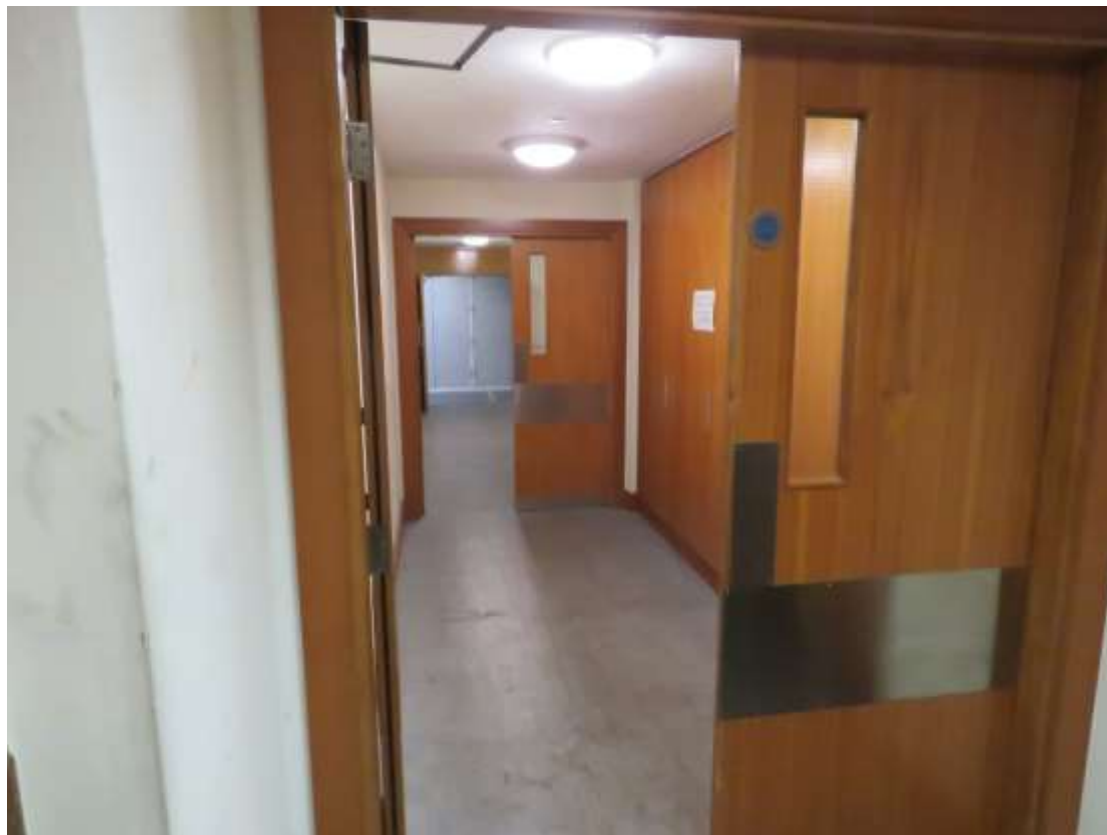
**24-23** View south to cloak store and beyond towards the service tower.

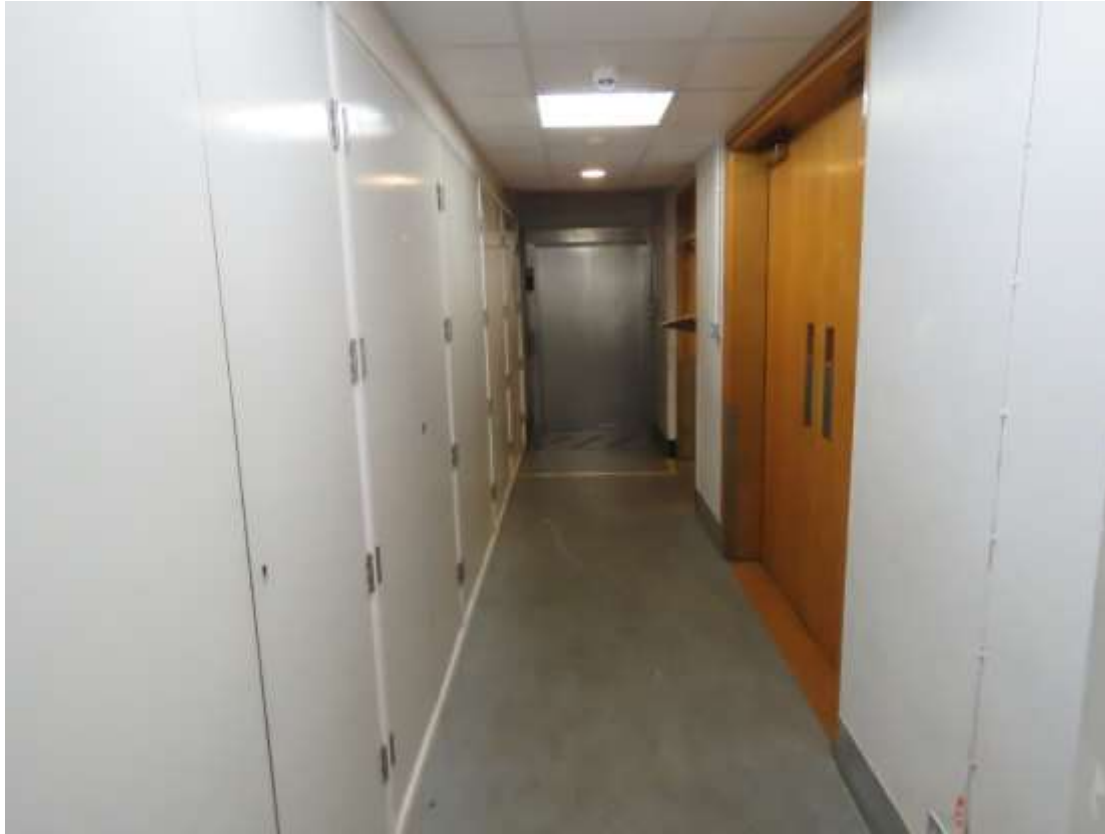
**24-24** View west in service tower with riser cabinets.
