## CIS Tower Refurbishment.

Recording Strategy and Photographic Audit of internal & external features.

# APPENDIX 30 – LEVEL 24. INTERNAL.

Planning Permission ref: 126118/FO/2020. Condition 29.

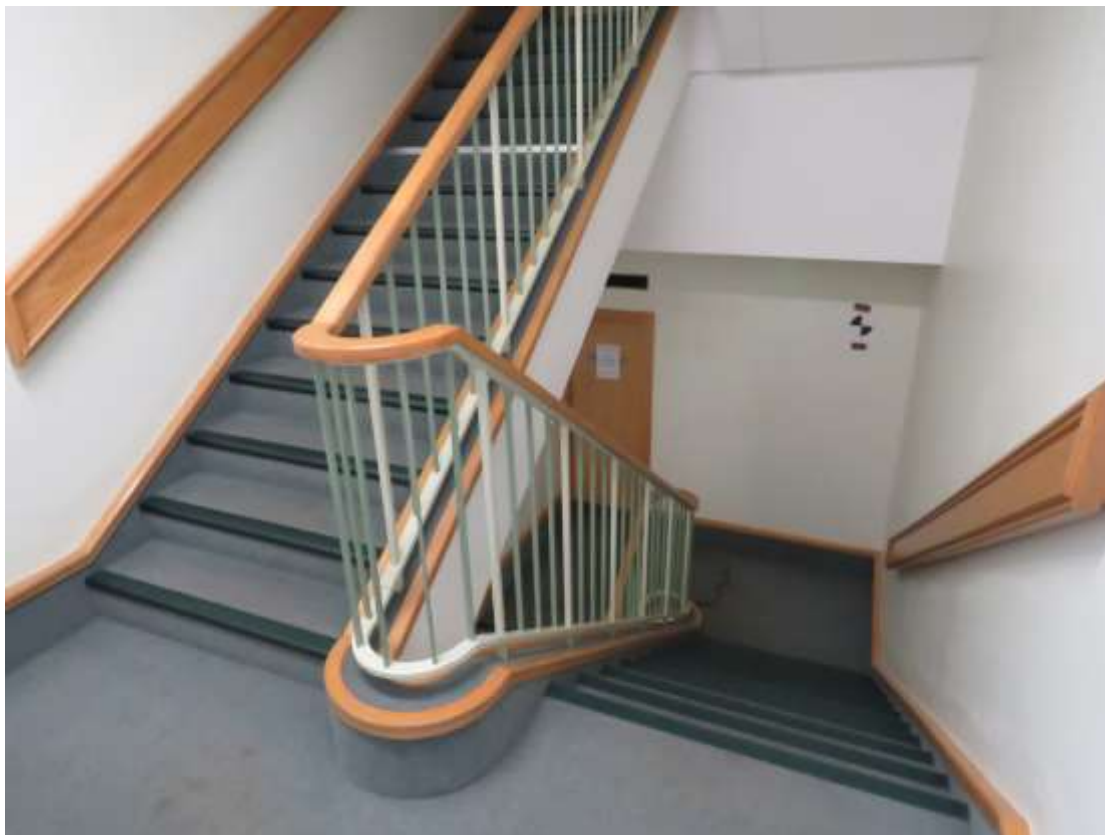
**24-25** View within eastern stairwell.

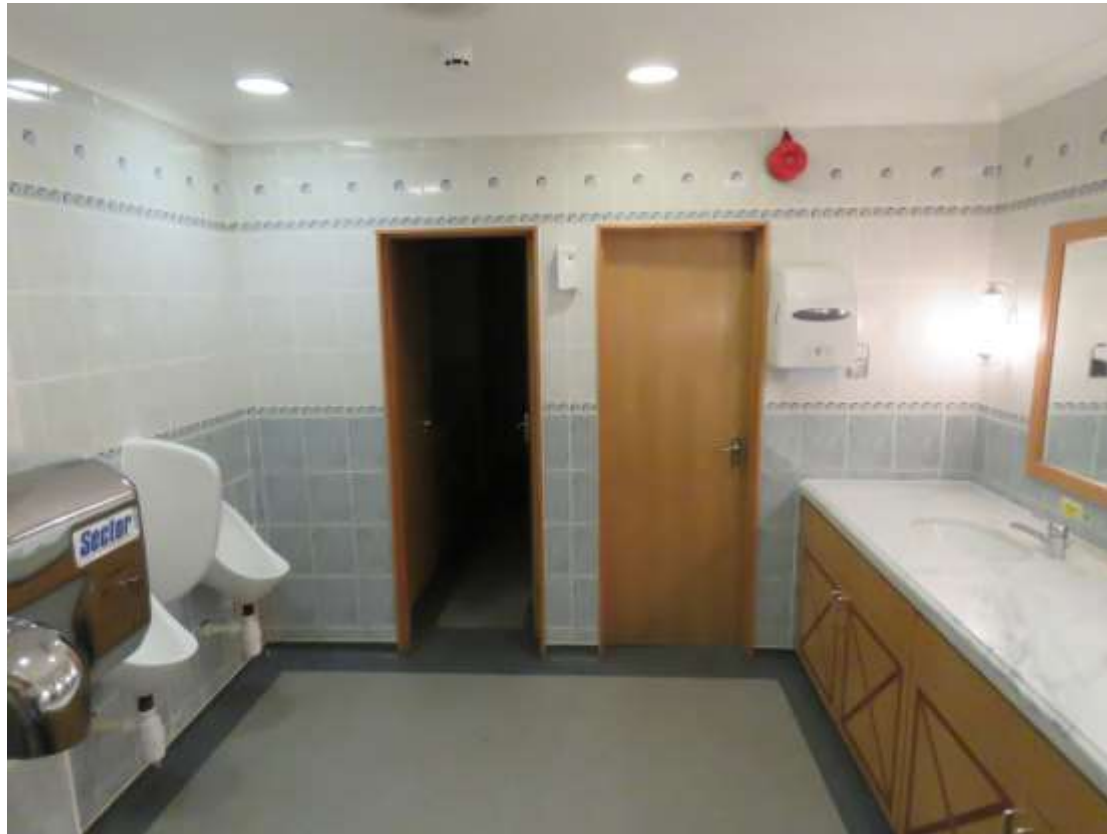
**24-26** View of male WC.

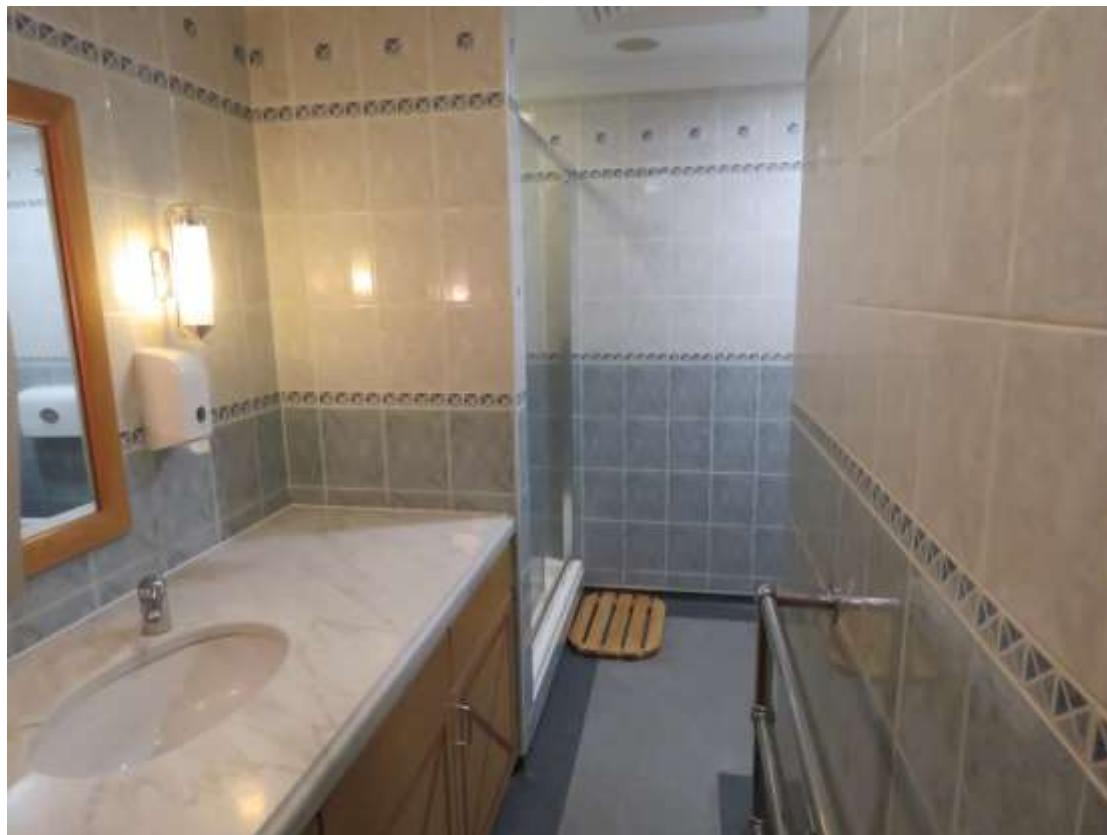
**24-27** View of male shower room.
