# **Drainage Strategy for Discharge of Planning Conditions 10 and 11**

**Project:** 35 Liverpool Road, Manchester, M3 4NQ

**Planning Ref:** 131047/FO/2021

# CCTV Report

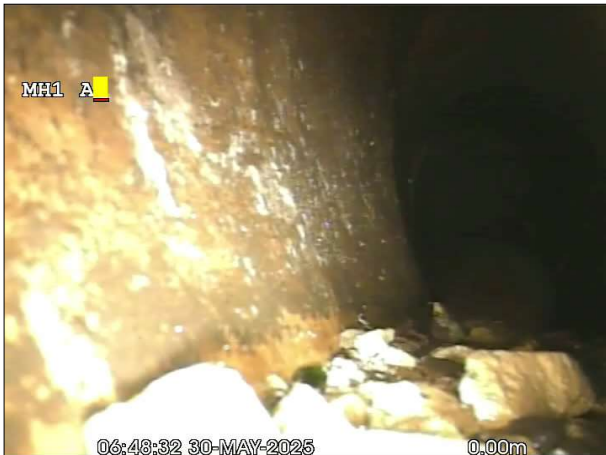
Photo: 4\_4a, 00:00:00  
0.05m, Debris, 5 % cross-sectional area loss

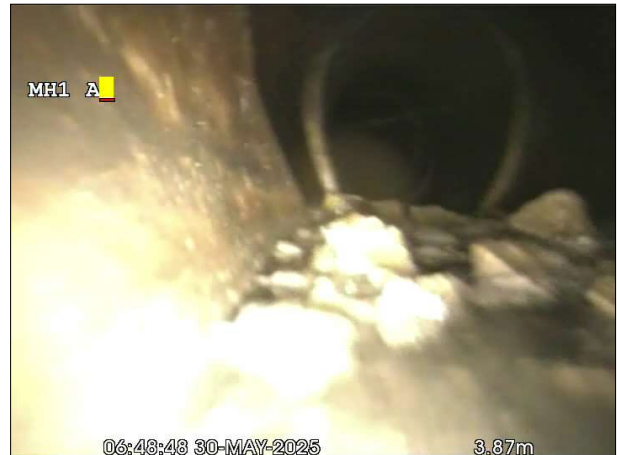
Photo: 5\_5a, 00:00:00  
3.9m, Debris, 10 % cross-sectional area loss

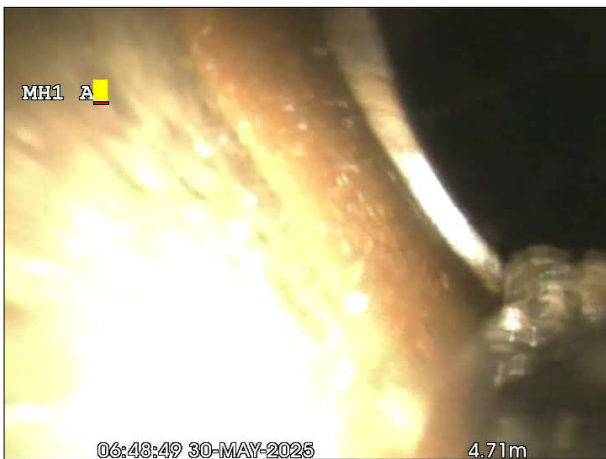
Photo: 6\_6a, 00:00:00  
4.8m, Joint displaced. Medium

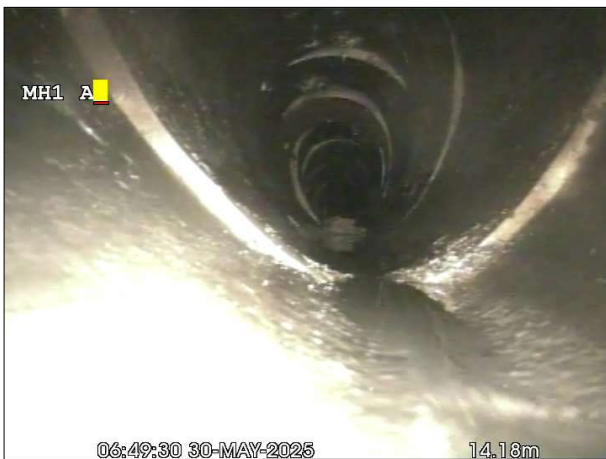
Photo: 11\_10a, 00:00:00  
14.3m, Joint displaced. Medium

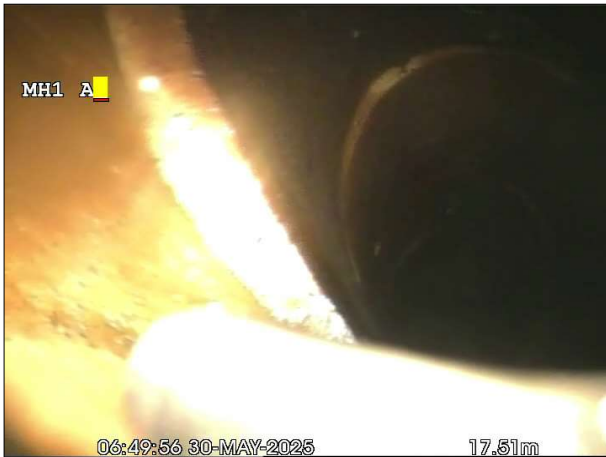
Photo: 1\_12a, 00:00:00  
17.5m, Joint displaced. Medium

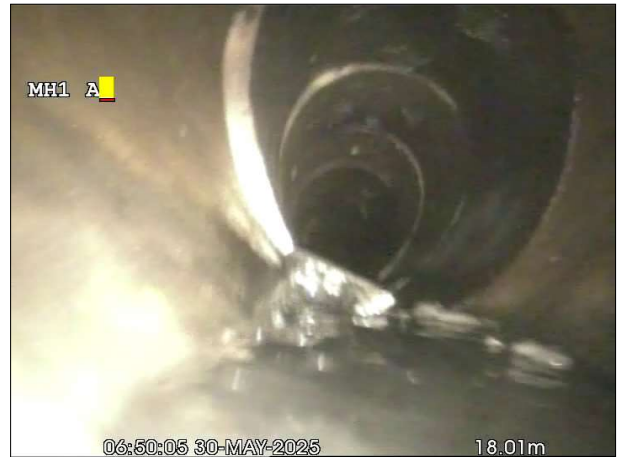
Photo: 1\_12b, 00:00:00  
17.5m, Joint displaced. Medium

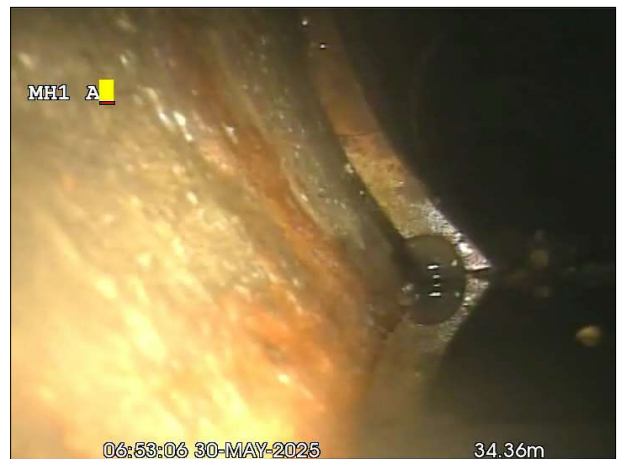
Photo: 1\_17a, 00:00:00  
34.5m, Joint displaced. Medium

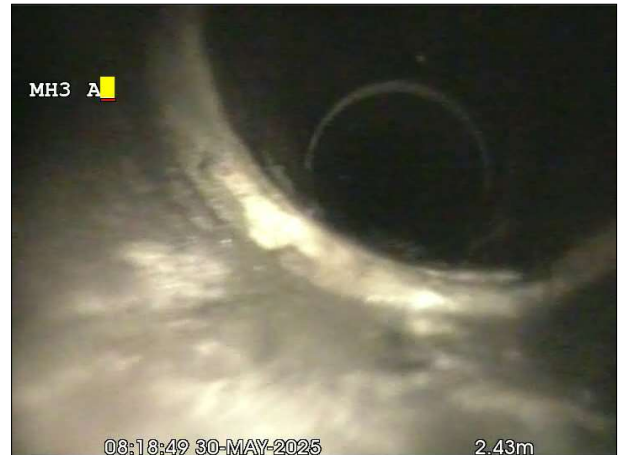
Photo: 25\_5a, 00:00:00  
2.5m, Joint displaced. Medium

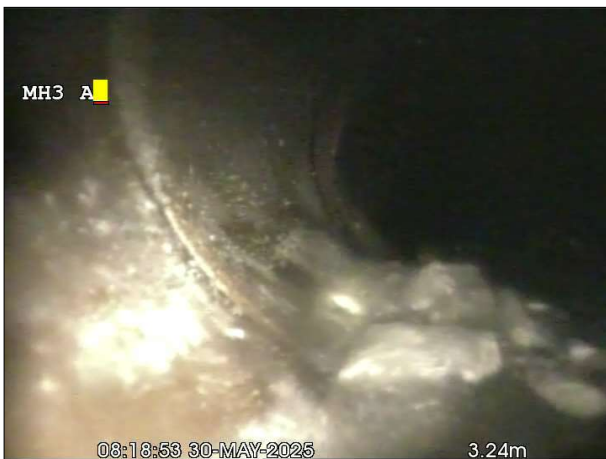
Photo: 26\_6a, 00:00:00  
3.3m, Debris, 10 % cross-sectional area loss

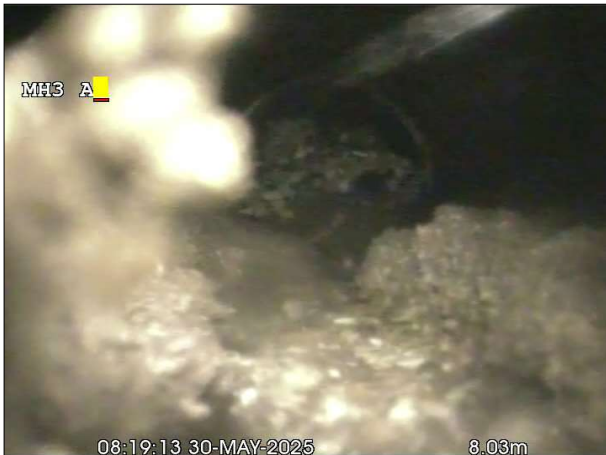
Photo: 31\_11a, 00:00:00  
8.8m, Debris, 95 % cross-sectional area loss

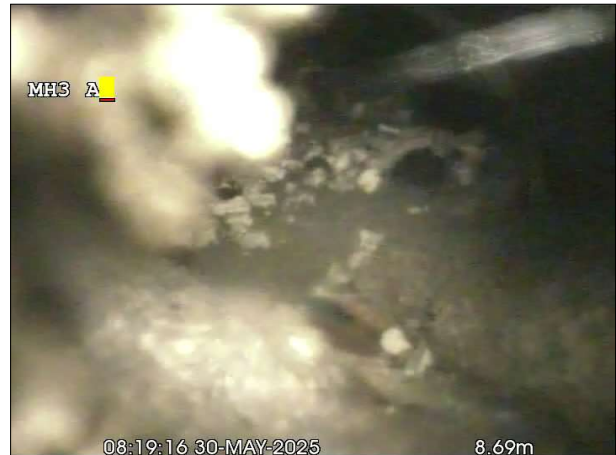
Photo: 31\_11b, 00:00:00  
8.8m, Debris, 95 % cross-sectional area loss

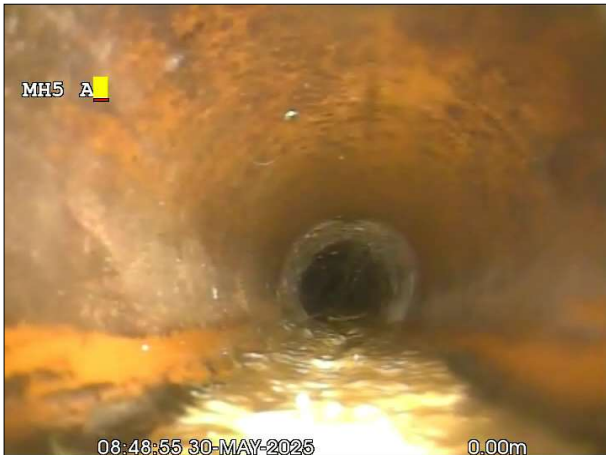
Photo: 58\_4a, 00:00:00  
0.1m, Debris grease, from 05 to 07 o'clock, 5 %  
cross-sectional area loss

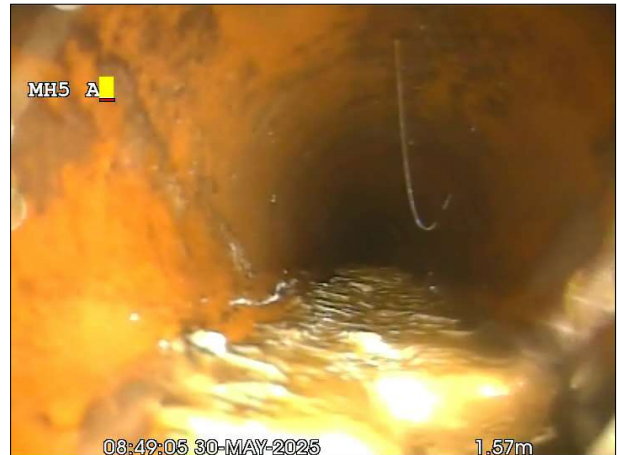
Photo: 59\_5a, 00:00:00  
1.6m, Debris grease, from 05 to 07 o'clock, 10 %  
cross-sectional area loss

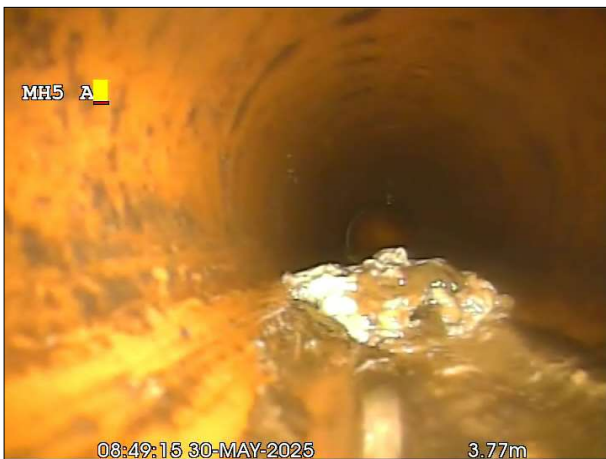
Photo: 60\_6a, 00:00:00  
4m, Debris grease, from 04 to 08 o'clock, 20 %  
cross-sectional area loss

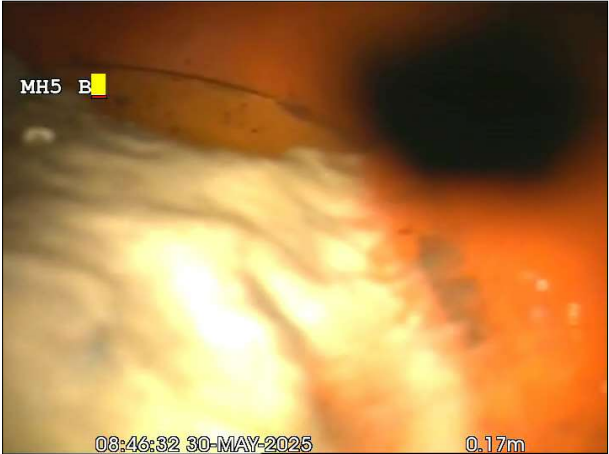
Photo: 69\_6a, 00:00:00  
0.2m, Survey abandoned, Remark: Unable to survey beyond this point due to deviation.

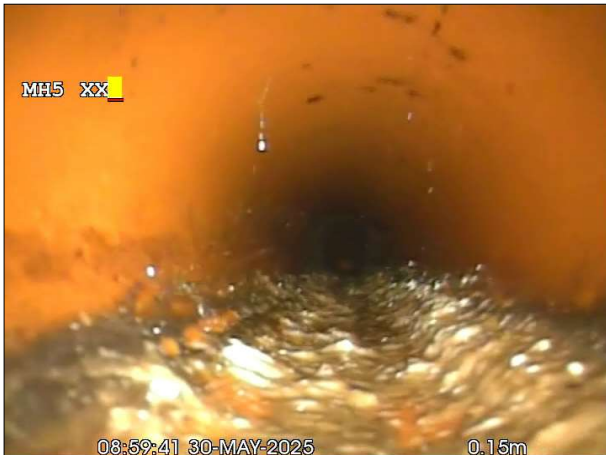
Photo: 74\_4a, 00:00:00  
0.1m, Debris grease, from 05 to 07 o'clock, 5 % cross-sectional area loss

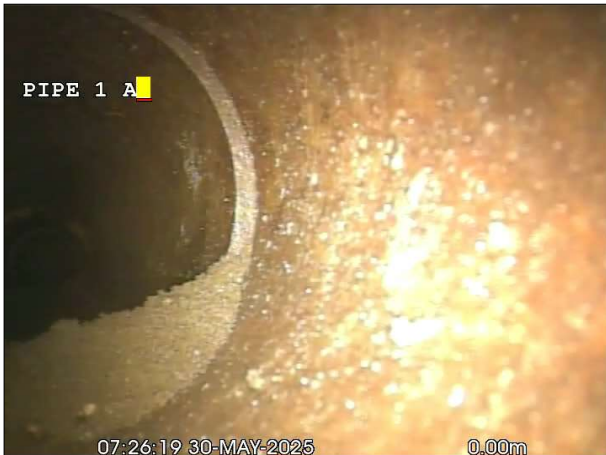
Photo: 82\_4a, 00:00:00  
0.2m, Debris, 20 % cross-sectional area loss

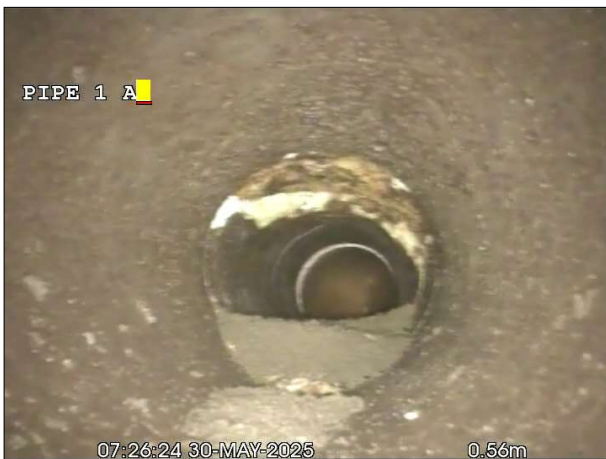
Photo: 9\_6a, 00:00:00  
0.7m, Debris, 40 % cross-sectional area loss

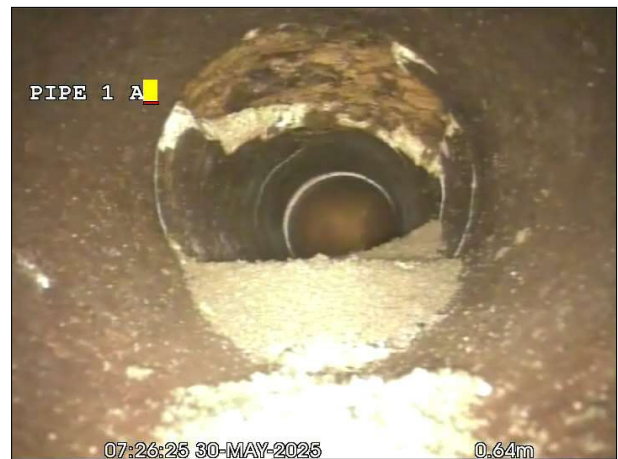
| 1:50 | position | code | observation | counter | photo | grade |
|---|---|---|---|---|---|---|
| | 0.80 | SSL | Surface damage, spalling large, from 10 to 02 o'clock | 00:00:00 | 9_7a | (Struct) 4 |

Photo: 9\_7a, 00:00:00  
0.8m, Surface damage, spalling large, from 10 to 02 o'clock

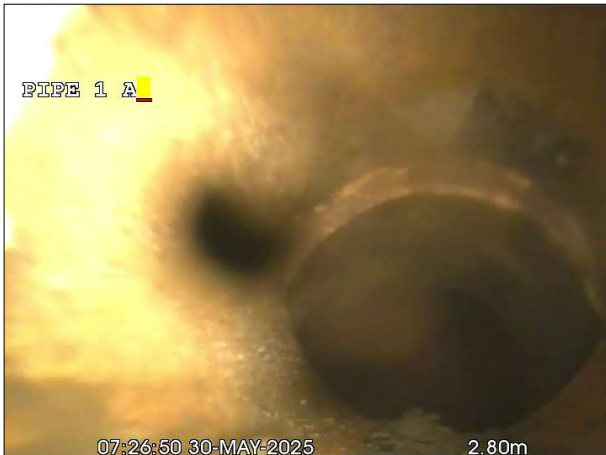
Photo: 9\_9a, 00:00:00  
2.9m, Joint displaced. Large

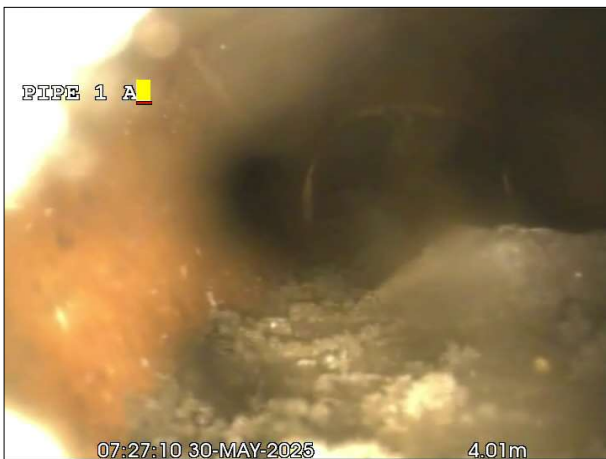
Photo: 9\_13a, 00:00:00  
4m, Debris, 30 % cross-sectional area loss

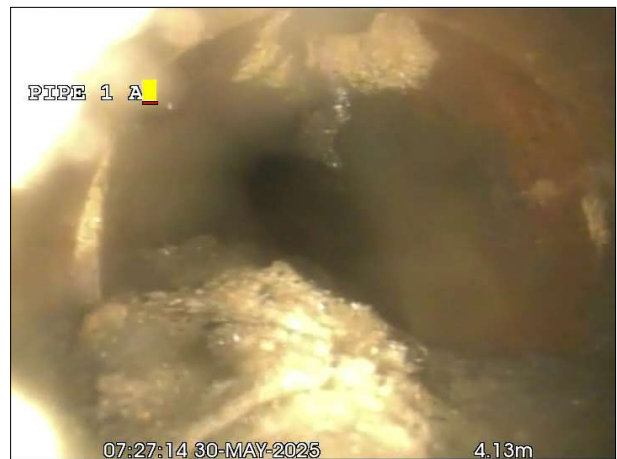
Photo: 9\_14a, 00:00:00  
4.1m, Debris, 40 % cross-sectional area loss

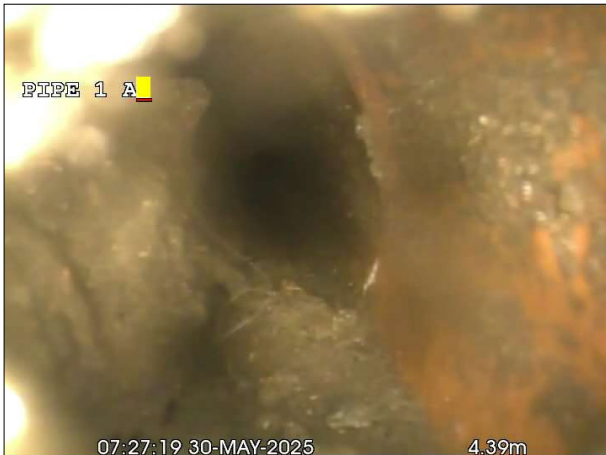
Photo: 9\_15a, 00:00:00  
4.4m, Debris, 80 % cross-sectional area loss

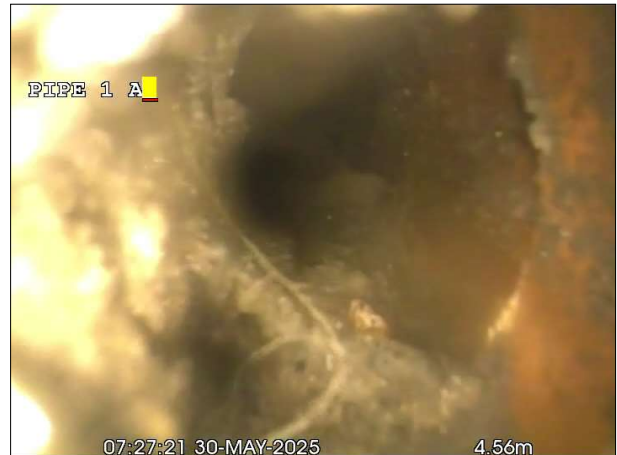
Photo: 9\_15b, 00:00:00  
4.4m, Debris, 80 % cross-sectional area loss

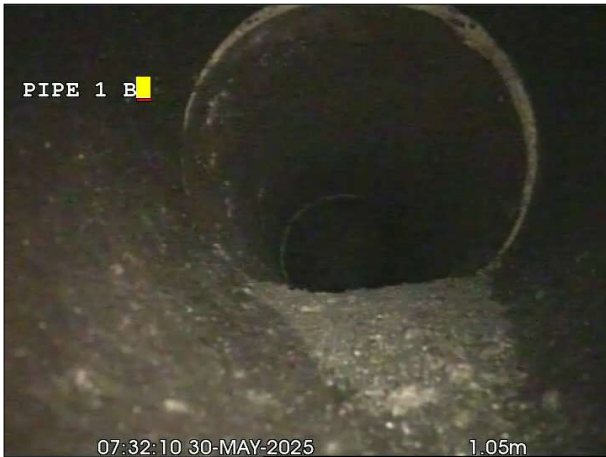
Photo: 100\_5a, 00:00:00  
 1.1m, Debris, 10 % cross-sectional area loss
