# BS5837 Tree Survey

17 Didsbury Park  
Didsbury  
Manchester  
M20 5LH

November 2024

| <b>Site</b> | 17 Didsbury Park, Didsbury, Manchester, M20 5LH |

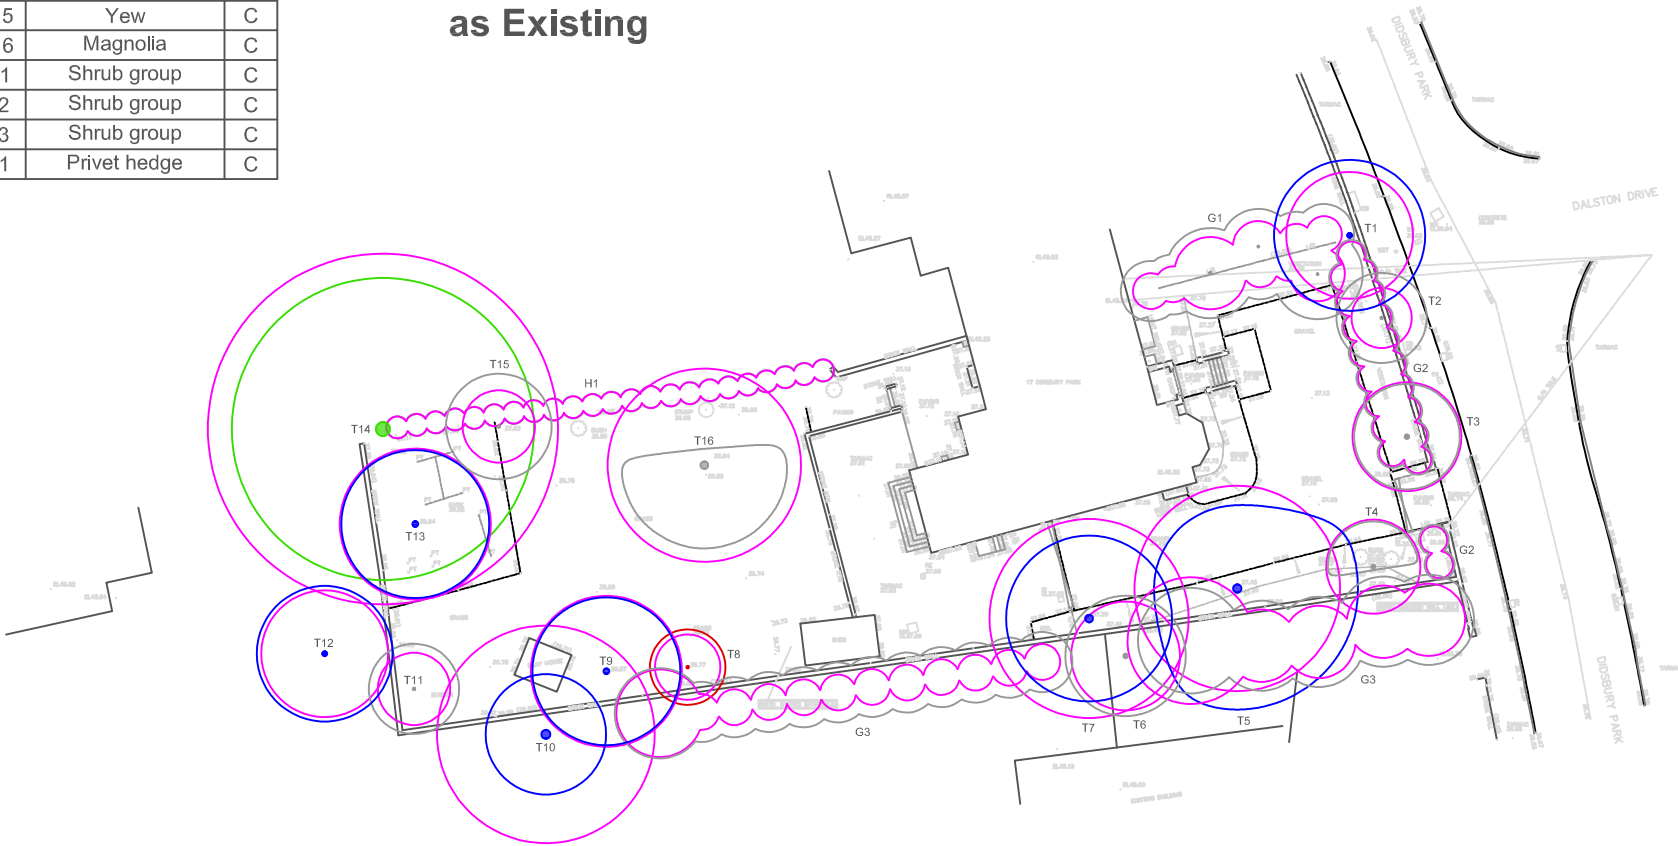
**Drawing:** LTC303-TSP

- The survey identified 16 individual trees, three groups of trees and a hedge, which were located both within the site and on areas of immediately adjacent land.

- One tree was categorised as high quality (A-category), seven trees were categorised as moderate quality (B-category), seven trees, the groups and the hedge were categorised as low quality (C-category), and one tree was categorised as unsuitable for retention (U-category) due to its limited remaining life expectancy.
