# Inspection Report

Project Name: Upper Campfield  
Start Date:  
Client: T J M Projects Limited  
Jackson Street  
St Helens

| Project Name | Project Number | Project Date |
|---|---|---|
| Upper Campfield | | 20/08/2024 |

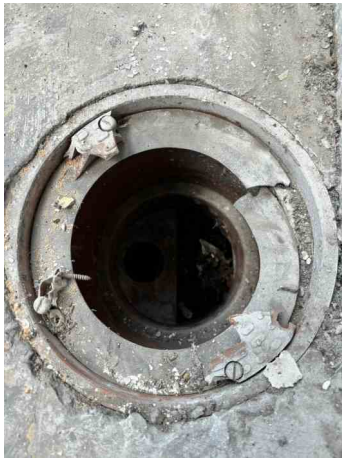
| Scale: | 1:56 | Position [m] | Code | Observation | MPEG | Photo | Grade |
|---|---|---|---|---|---|---|---|
| | | 0.00 | REM | General remark: Broken Access Lid Requires Replacement | | RWP5X_5<br>599972a-8<br>60a-463b- | |

RWP5X\_5599972a-860a-463b-8a4b-9bf7521c9f5e\_20240905\_103716.jpg, 0.00 m  
General remark, Broken Access Lid Requires Replacement

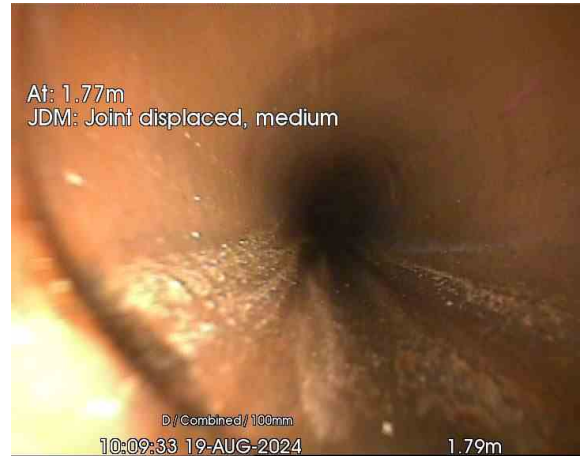
At: 1.77m  
JDM: Joint displaced, medium  
D:/Combined/100mm  
10:09:33 19-AUG-2024 1.79m  
4\_1-82m\_100933.jpg, 00:00:16, 1.82 m  
Joint displaced, medium

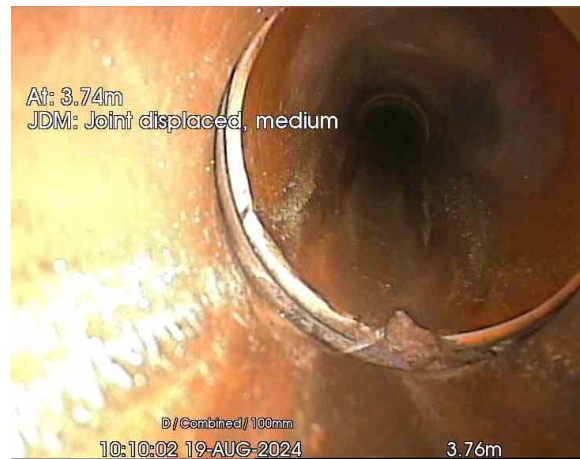
At: 3.74m  
JDM: Joint displaced, medium  
D:/Combined/100mm  
10:10:02 19-AUG-2024 3.76m  
4\_3-76m\_101002.jpg, 00:00:34, 3.76 m  
Joint displaced, medium

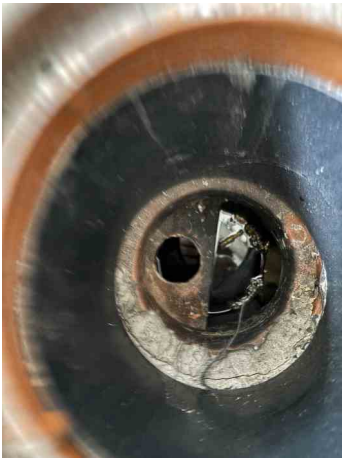
| Scale: | 1:59 | Position [m] | Code | Observation | MPEG | Photo | Grade |
|---|---|---|---|---|---|---|---|
| | | 0.00 | REM | General remark: Broken Access Cover Needs Replacement | | RWP8X_a<br>d5343f8-c<br>d06-4858- | |

RWP8X\_ad5343f8-cd06-4858-a02e-798d3058c832\_2024090  
5\_113446.jpg, 0.00 m  
General remark, Broken Access Cover Needs Replacement

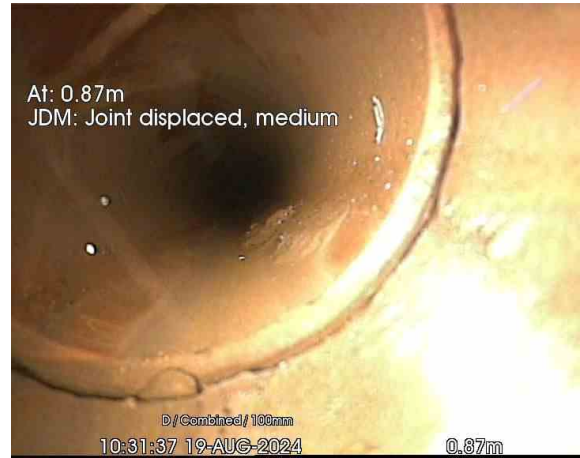
5\_0-87m\_103137.jpg, 00:00:16, 0.87 m  
Joint displaced, medium

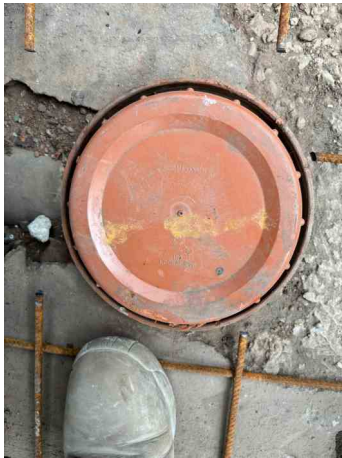
| Scale: | 1:50 | Position [m] | Code | Observation | MPEG | Photo | Grade |
|---|---|---|---|---|---|---|---|
| | | 0.00 | REM | General remark: Broken Access Cover Needs Replacement | | RWP10X_5029c86c-830b-4f51- | |

RWP10X\_5029c86c-830b-4f51-9694-0b2e8bad07b9\_20240905\_113458.jpg, 0.00 m  
General remark, Broken Access Cover Needs Replacement

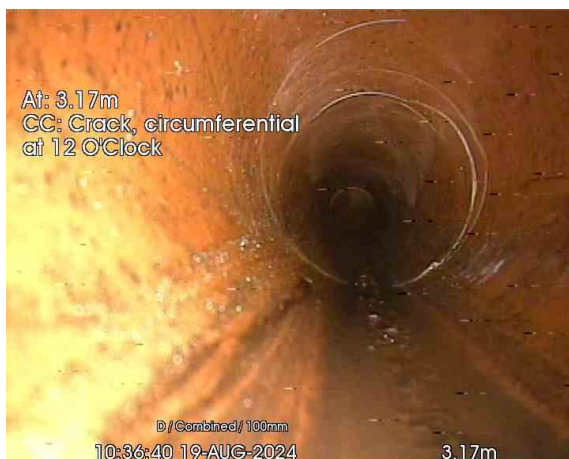
| Scale: | 1:50 | Position [m] | Code | Observation | MPEG | Photo | Grade |
|---|---|---|---|---|---|---|---|
| | | 3.17 | CC | Crack, circumferential at 12 o'clock | 00:00:42 | 6_3-17m_103640.jpg | 2 / 2 |

6\_3-17m\_103640.jpg, 00:00:42, 3.17 m  
Crack, circumferential at 12 o'clock

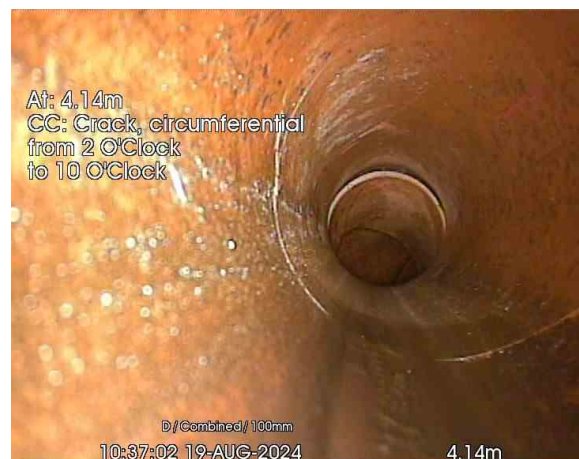
| Scale: | 1:50 | Position [m] | Code | Observation | MPEG | Photo | Grade |
|---|---|---|---|---|---|---|---|
| | | 4.14 | CC | Crack, circumferential from 2 o'clock to 10 o'clock | 00:00:52 | 6_4-14m_103702.jpg | 2 / 2 |

6\_4-14m\_103702.jpg, 00:00:52, 4.14 m  
Crack, circumferential from 2 o'clock to 10 o'clock

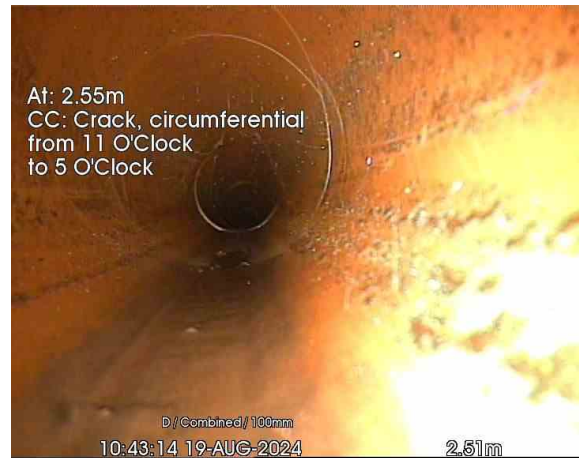
| Scale: | 1:50 | Position [m] | Code | Observation | MPEG | Photo | Grade |
|---|---|---|---|---|---|---|---|
| | 2.51 | CC | Crack, circumferential from 11 o'clock to 5 o'clock | | 00:00:27 | 7_2-51m_104314.jpg | 2 / 2 |

7\_2-51m\_104314.jpg, 00:00:27, 2.51 m  
Crack, circumferential from 11 o'clock to 5 o'clock

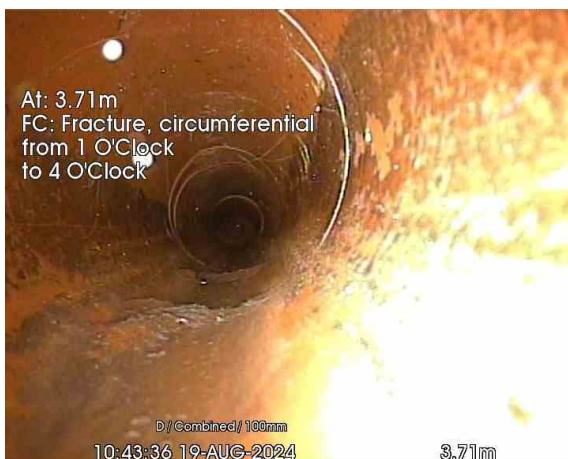
| Scale: | 1:50 | Position [m] | Code | Observation | MPEG | Photo | Grade |
|---|---|---|---|---|---|---|---|
| | 3.71 | FC | Fracture, circumferential from 1 o'clock to 4 o'clock | | 00:00:40 | 7_3-71m_104336.jpg | 3 / 2 |

7\_3-71m\_104336.jpg, 00:00:40, 3.71 m  
Fracture, circumferential from 1 o'clock to 4 o'clock

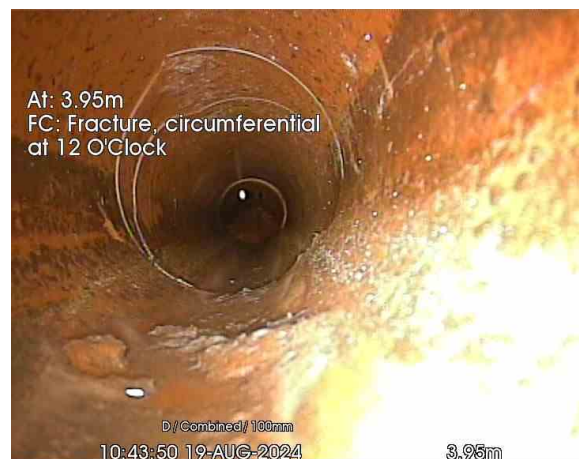
| Scale: | 1:50 | Position [m] | Code | Observation | MPEG | Photo | Grade |
|---|---|---|---|---|---|---|---|
| | 3.95 | FC | Fracture, circumferential at 12 o'clock | | 00:00:48 | 7_3-95m_104350.jpg | 3 / 2 |

7\_3-95m\_104350.jpg, 00:00:48, 3.95 m  
Fracture, circumferential at 12 o'clock

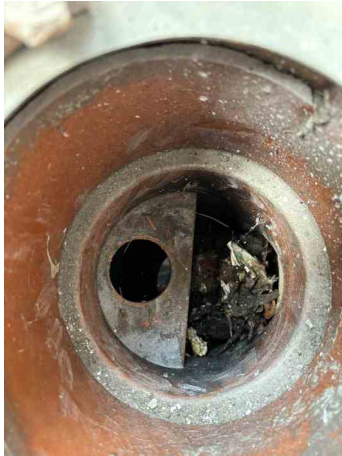
| Scale: | 1:50 | Position [m] | Code | Observation | MPEG | Photo | Grade |
|---|---|---|---|---|---|---|---|
| | 0.00 | REM | General remark: Broken Access Cover Needs Replacement | | | RWP13X_91cde4ee-e51f-48cb- | |

RWP13X\_91cde4ee-e51f-48cb-b6a5-6c27560fd97b\_20240905\_113519.jpg, 0.00 m  
General remark, Broken Access Cover Needs Replacement

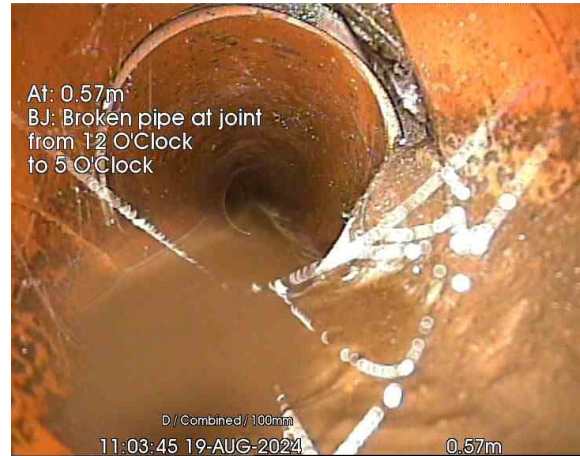
| Scale: | 1:50 | Position [m] | Code | Observation | MPEG | Photo | Grade |
|---|---|---|---|---|---|---|---|
| | 0.57 | BJ | Broken pipe at joint from 12 o'clock to 5 o'clock | | | 00:00:20 | 9_0-57m_110345.jpg |

9\_0-57m\_110345.jpg, 00:00:20, 0.57 m  
Broken pipe at joint from 12 o'clock to 5 o'clock

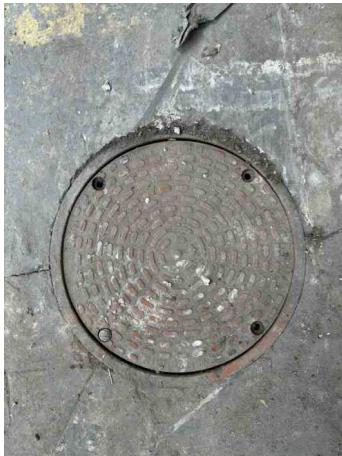
| Scale: | 1:50 | Position [m] | Code | Observation | MPEG | Photo | Grade |
|---|---|---|---|---|---|---|---|
| | | 0.00 | REM | General remark: Broken Access Cover Needs Replacement | | RWP14X_2ad96ba6-5eff-4e72- | |

RWP14X\_2ad96ba6-5eff-4e72-90f0-200b78f6413f\_20240905\_113532.jpg, 0.00 m  
General remark, Broken Access Cover Needs Replacement

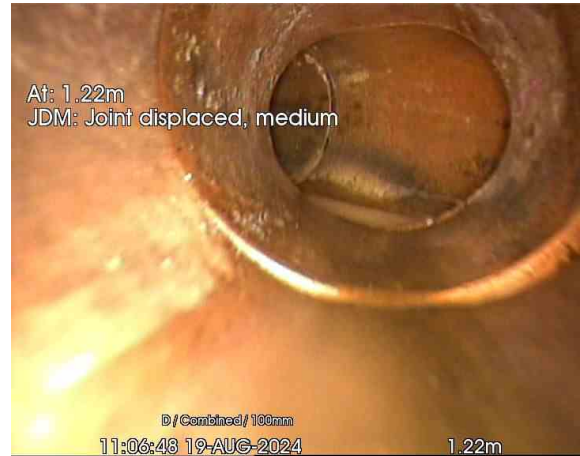
At: 1.22m  
JDM: Joint displaced, medium  
D/Combined/100mm  
11:06:48 19-AUG-2024  
10\_1-22m\_110648.jpg, 00:00:15, 1.22 m  
Joint displaced, medium

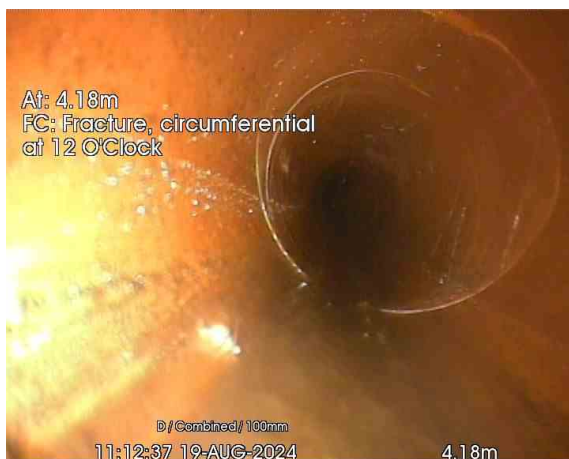
| Scale: | 1:61 | Position [m] | Code | Observation | MPEG | Photo | Grade |
|---|---|---|---|---|---|---|---|
| | | 4.18 | FC | Fracture, circumferential at 12 o'clock | 00:00:47 | 12_4-18m_111237.jpg | 3 / 2 |

12\_4-18m\_111237.jpg, 00:00:47, 4.18 m  
Fracture, circumferential at 12 o'clock

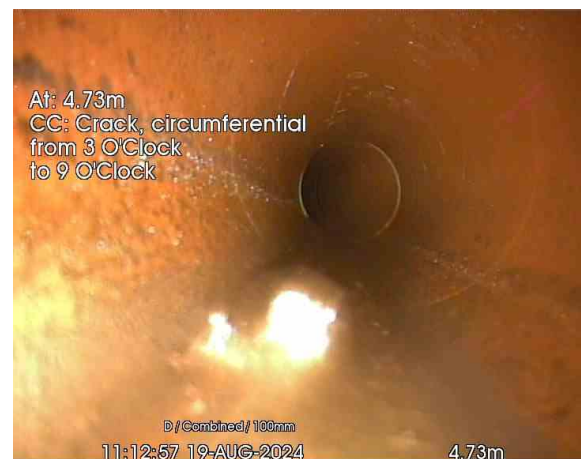
| Scale: | 1:61 | Position [m] | Code | Observation | MPEG | Photo | Grade |
|---|---|---|---|---|---|---|---|
| | | 4.73 | CC | Crack, circumferential from 3 o'clock to 9 o'clock | 00:01:00 | 12_4-73m_111257.jpg | 2 / 2 |

12\_4-73m\_111257.jpg, 00:01:00, 4.73 m  
Crack, circumferential from 3 o'clock to 9 o'clock

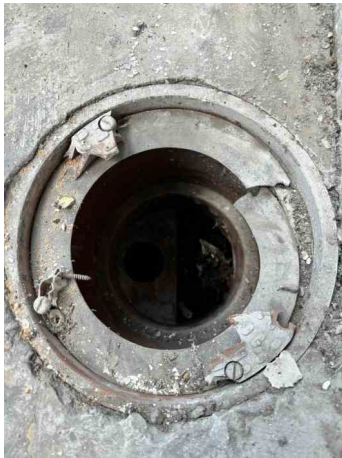
| Scale: | 1:50 | Position [m] | Code | Observation | MPEG | Photo | Grade |
|---|---|---|---|---|---|---|---|
| | | 0.00 | REM | General remark: Broken Access Lid Requires Replacement | | RWP4X_1<br>4e26aba-f<br>e25-430a- | |

RWP4X\_14e26aba-fe25-430a-8fea-baaf2b465467\_20240905\_113613.jpg, 0.00 m  
General remark, Broken Access Lid Requires Replacement

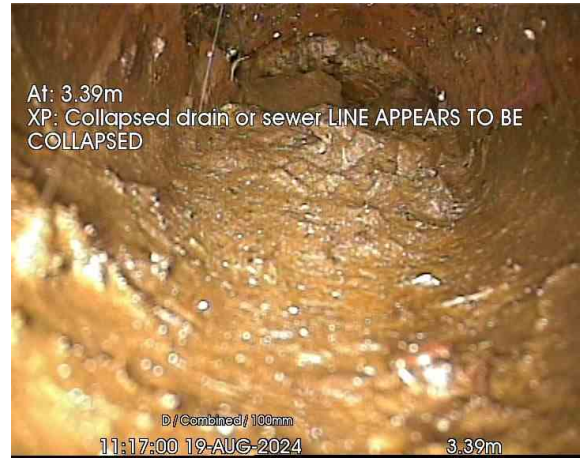
13\_3-39m\_111700.jpg, 00:00:51, 3.39 m  
Collapsed drain or sewer, LINE APPEARS TO BE COLLAPSED

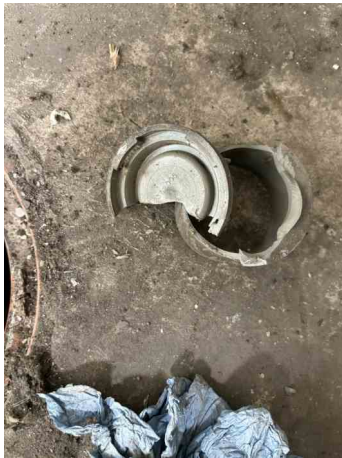
| Scale: | 1:50 | Position [m] | Code | Observation | MPEG | Photo | Grade |
|---|---|---|---|---|---|---|---|
| | | 0.00 | REM | General remark: Broken Access Lid Requires Replacement | | RWP16X_c5d723e4-e0a0-48a6 | |

RWP16X\_c5d723e4-e0a0-48a6-a805-8d378c865f74\_20240905\_114107.jpg, 0.00 m  
General remark, Broken Access Lid Requires Replacement

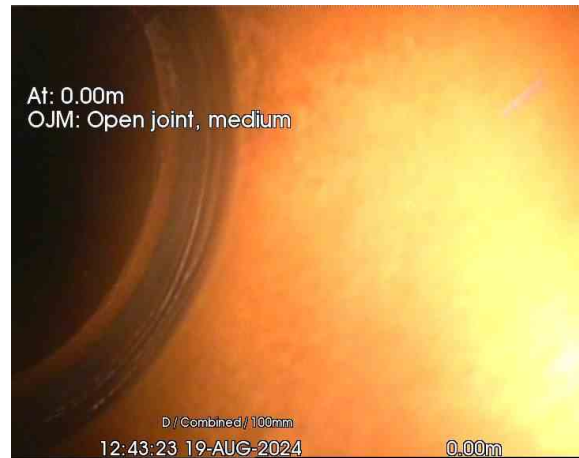
At: 0.00m  
OJM: Open joint, medium  
D//Combined/ 100mm  
12:43:23 19-AUG-2024 0.00m  
14\_0-00m\_124323.jpg, 00:00:07, 0.00 m  
Open joint, medium

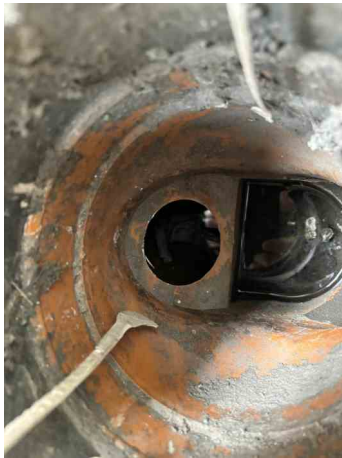
| Scale: | 1:72 | Position [m] | Code | Observation | MPEG | Photo | Grade |
|---|---|---|---|---|---|---|---|
| | | 0.00 | REM | General remark: Broken Access Lid Requires Replacement | | RWP6X_2<br>7b0f978-2<br>436-42f0-8 | |

RWP6X\_27b0f978-2436-42f0-810a-20b1eb942aa4\_20240905\_114227.jpg, 0.00 m  
General remark, Broken Access Lid Requires Replacement

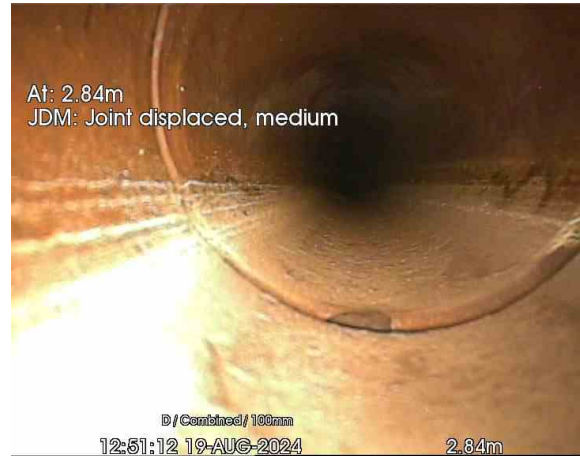
15\_2-84m\_125112.jpg, 00:00:32, 2.84 m  
Joint displaced, medium

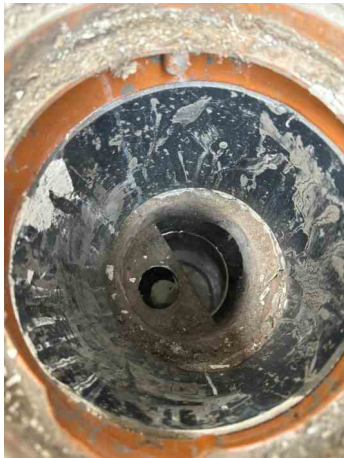
| Scale: | 1:50 | Position [m] | Code | Observation | MPEG | Photo | Grade |
|---|---|---|---|---|---|---|---|
| | | 0.00 | REM | General remark: Broken Access Lid Requires Replacement | | RWP17X_907a7d9f-f82-4447-b | |

RWP17X\_907a7d9f-ff82-4447-b876-72ac78f6b15f\_20240905\_114840.jpg, 0.00 m  
General remark, Broken Access Lid Requires Replacement

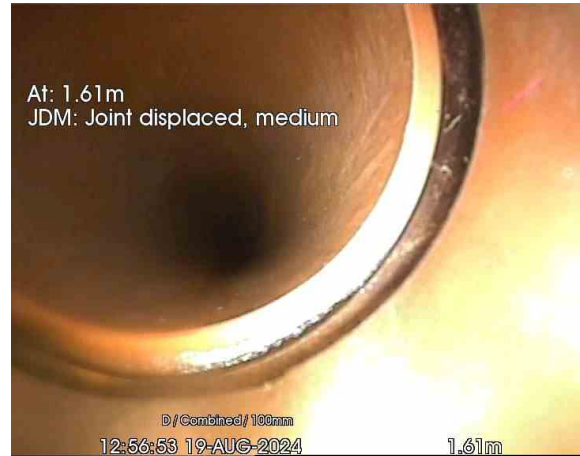
16\_1-61m\_125653.jpg, 00:00:18, 1.61 m  
Joint displaced, medium

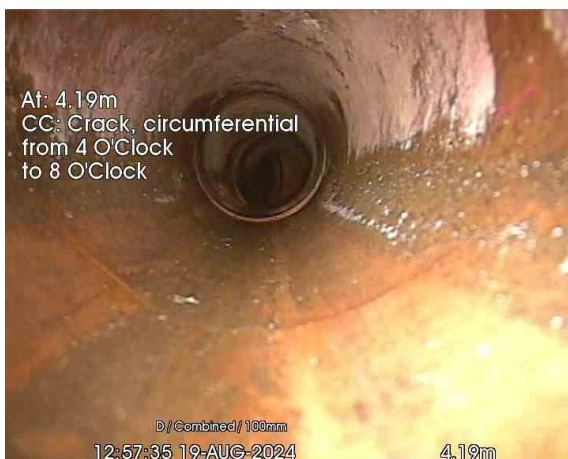
| Scale: | 1:50 | Position [m] | Code | Observation | MPEG | Photo | Grade |
|---|---|---|---|---|---|---|---|
| | | 4.19 | CC | Crack, circumferential from 4 o'clock to 8 o'clock | 00:00:49 | 16_4-19m_125735.jpg | 2 / 2 |

16\_4-19m\_125735.jpg, 00:00:49, 4.19 m  
Crack, circumferential from 4 o'clock to 8 o'clock

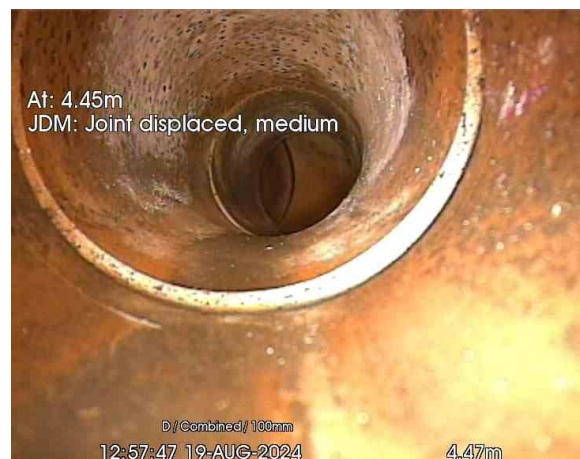
16\_4-47m\_125747.jpg, 00:00:55, 4.47 m  
Joint displaced, medium

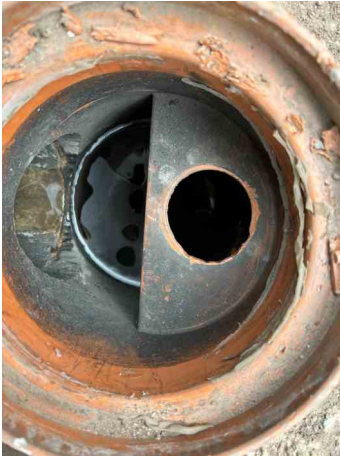
| Scale: | 1:50 | Position [m] | Code | Observation | MPEG | Photo | Grade |
|---|---|---|---|---|---|---|---|
| | | 0.00 | REM | General remark: Broken Access Lid Requires Replacement | | RWP7X_a<br>4eca916-7<br>136-412f-b | |

RWP7X\_a4eca916-7136-412f-b775-93861f9280f0\_20240905\_114853.jpg, 0.00 m  
General remark, Broken Access Lid Requires Replacement

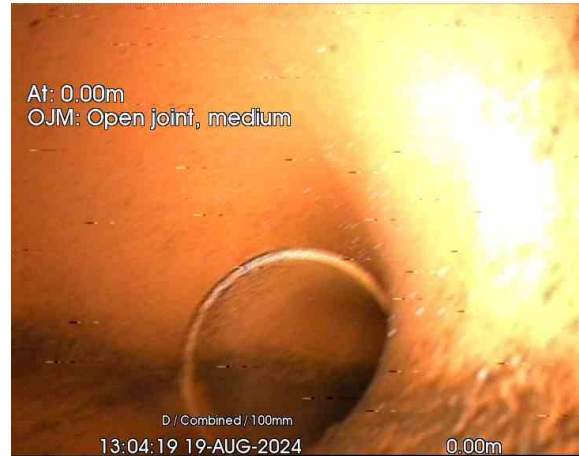
17\_0-00m\_130419.jpg, 00:00:05, 0.00 m  
Open joint, medium

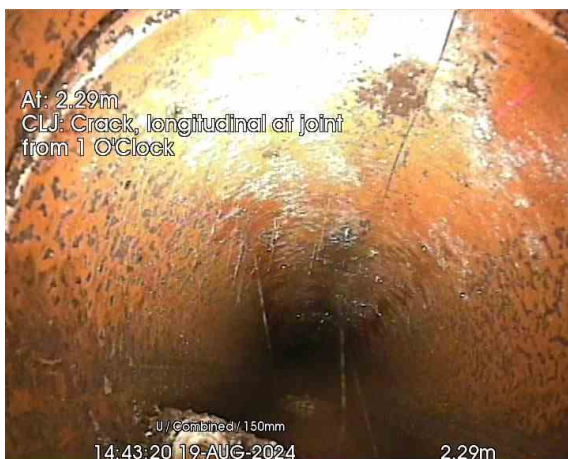
| Scale: 1:130 | Position [m] | Code | Observation | MPEG | Photo | Grade |
|---|---|---|---|---|---|---|
| | 2.29 | CLJ | Crack, longitudinal at joint at 1 o'clock | 00:00:22 | 18_2-29m_144320.j pg | 2 / 2 |

18\_2-29m\_144320.jpg, 00:00:22, 2.29 m  
Crack, longitudinal at joint at 1 o'clock

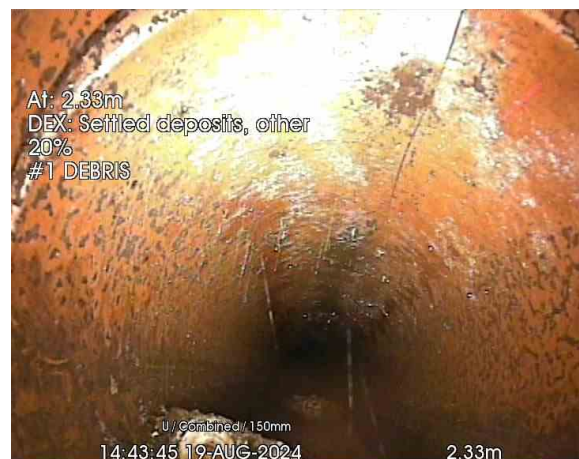
18\_2-33m\_144345.jpg, 00:00:24, 2.33 m  
Settled deposits, other, 20% cross-sectional area loss, start, DEBRIS

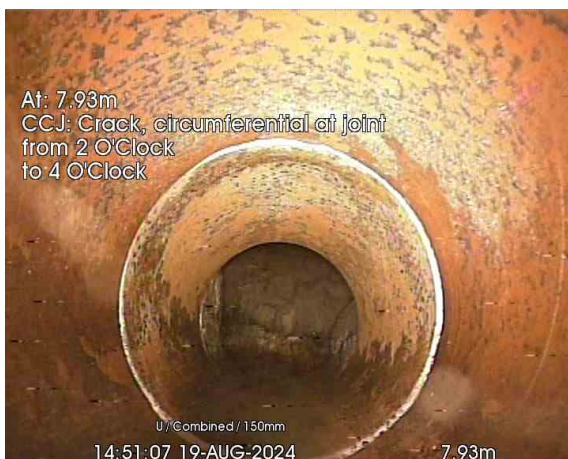
19\_7-93m\_145107.jpg, 00:01:21, 7.93 m  
Crack, circumferential at joint from 2 o'clock to 4 o'clock

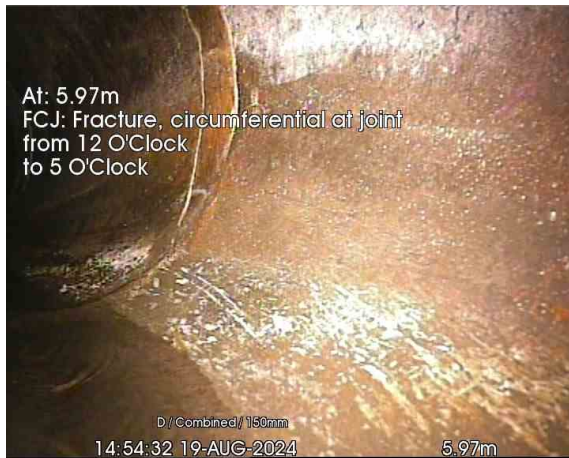
| Scale: 1:129 | Position [m] | Code | Observation | MPEG | Photo | Grade |
|---|---|---|---|---|---|---|
| | 5.97 | FCJ | Fracture, circumferential at joint from 12 o'clock to 5 o'clock | 00:00:59 | 20_5-97m_145432.jpg | 3 / 2 |

20\_5-97m\_145432.jpg, 00:00:59, 5.97 m  
Fracture, circumferential at joint from 12 o'clock to 5 o'clock

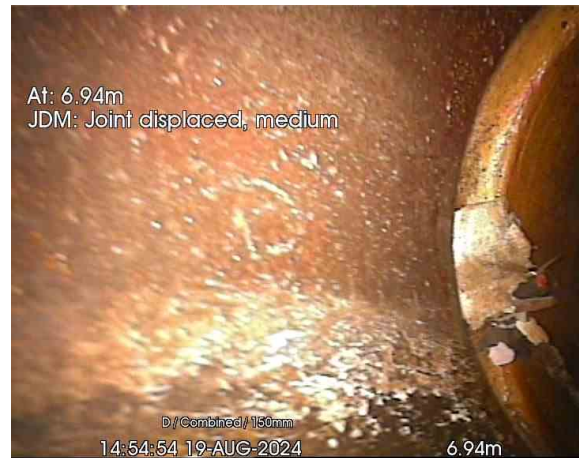
20\_6-94m\_145454.jpg, 00:01:10, 6.94 m  
Joint displaced, medium

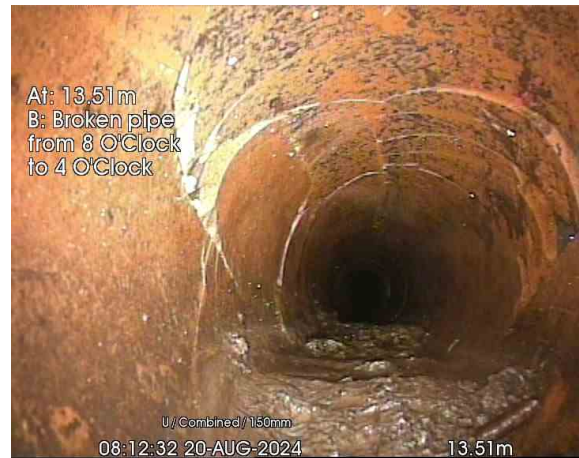
21\_13-51m\_081232.jpg, 00:01:46, 13.51 m  
Broken pipe from 8 o'clock to 4 o'clock

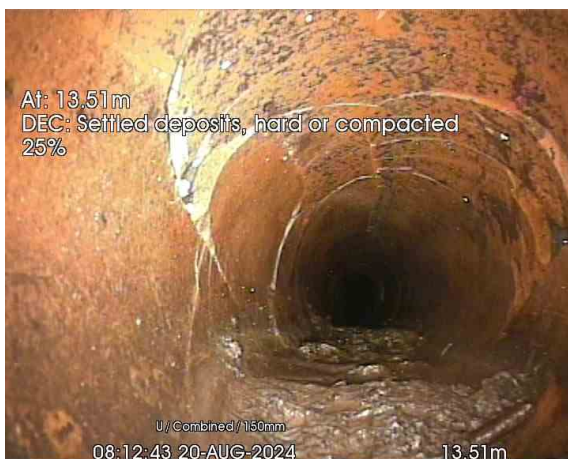
21\_13-51m\_081243.jpg, 00:01:49, 13.51 m  
Settled deposits, hard or compacted, 25% cross-sectional area loss

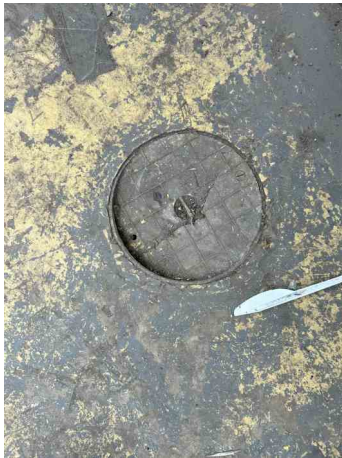
| Scale: | 1:50 | Position [m] | Code | Observation | MPEG | Photo | Grade |
|---|---|---|---|---|---|---|---|
| | | 0.00 | REM | General remark: Broken Access Lid Requires Replacement | | RWP15X_f2e56978-4e56-48f7- | |

RWP15X\_f2e56978-4e56-48f7-bcb2-de8d70743969\_20240905\_115028.jpg, 0.00 m  
General remark, Broken Access Lid Requires Replacement

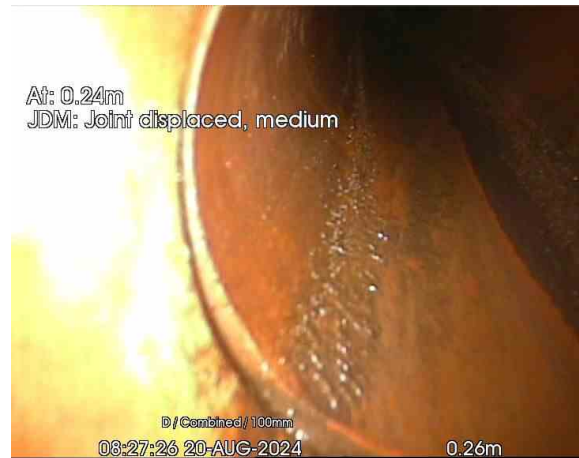
24\_0-28m\_082726.jpg, 00:00:06, 0.28 m  
Joint displaced, medium

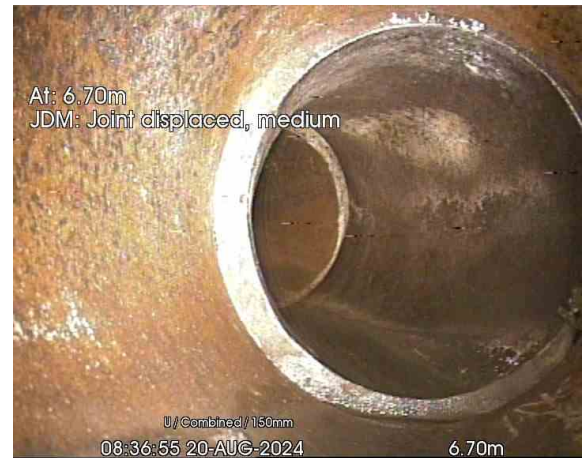
25\_6-70m\_083655.jpg, 00:00:43, 6.70 m  
Joint displaced, medium

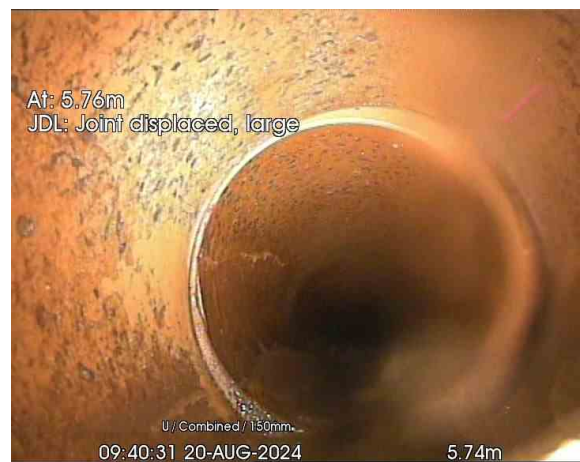
28\_5-74m\_094031.jpg, 00:00:53, 5.74 m  
Joint displaced, large

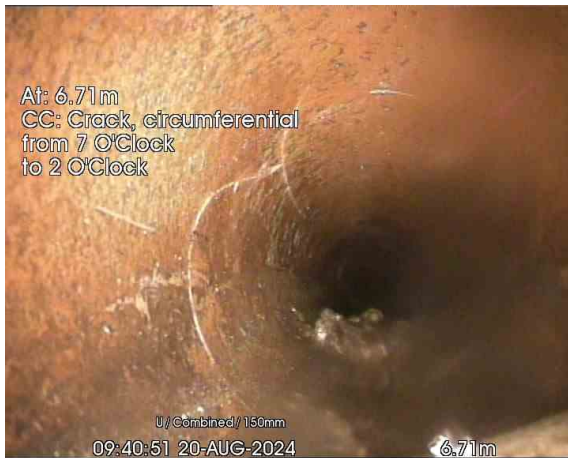
| Scale: 1:165 | Position [m] | Code | Observation | MPEG | Photo | Grade |
|---|---|---|---|---|---|---|
| | 6.71 | CC | Crack, circumferential from 7 o'clock to 2 o'clock | 00:01:03 | 28_6-71m_094051.jpg | 2 / 2 |

28\_6-71m\_094051.jpg, 00:01:03, 6.71 m  
Crack, circumferential from 7 o'clock to 2 o'clock

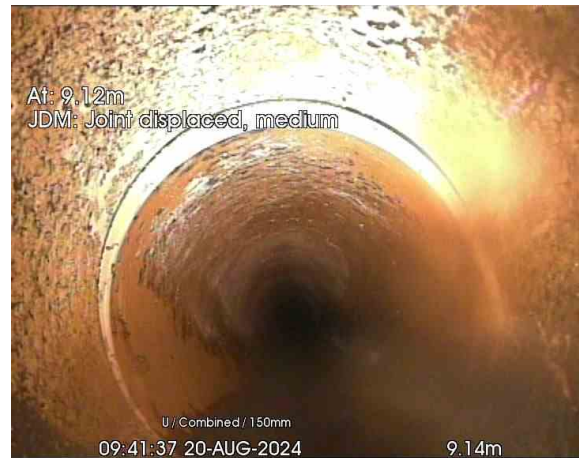
28\_9-14m\_094137.jpg, 00:01:34, 9.14 m  
Joint displaced, medium

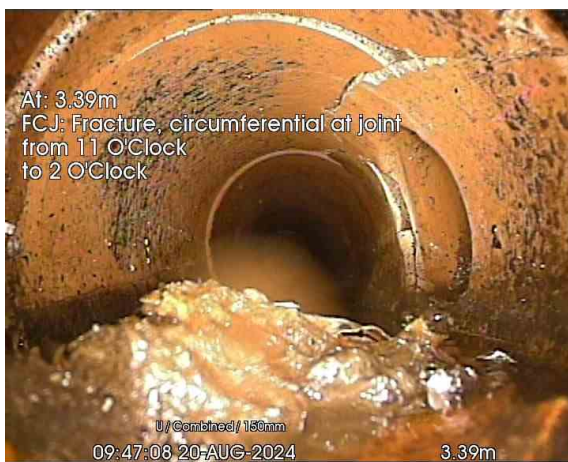
| Scale: | 1:50 | Position [m] | Code | Observation | MPEG | Photo | Grade |
|---|---|---|---|---|---|---|---|
| | 3.39 | FCJ | | Fracture, circumferential at joint from 11 o'clock to 2 o'clock | 00:00:41 | 29_3-39m_094708.jpg | 3 / 2 |

29\_3-39m\_094708.jpg, 00:00:41, 3.39 m  
Fracture, circumferential at joint from 11 o'clock to 2 o'clock

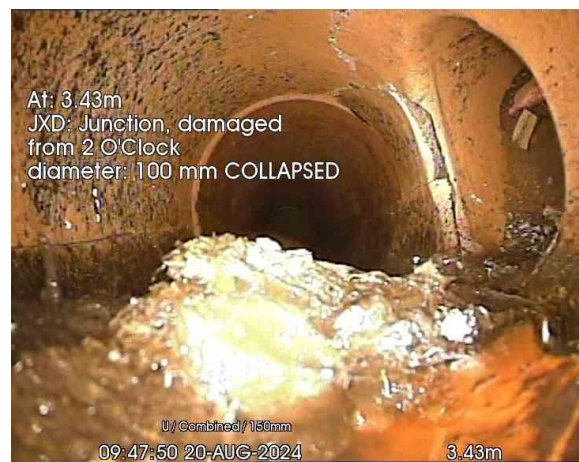
| Scale: | 1:50 | Position [m] | Code | Observation | MPEG | Photo | Grade |
|---|---|---|---|---|---|---|---|
| | 3.43 | JXD | | Junction, damaged at 2 o'clock, 100mm dia: COLLAPSED | 00:01:07 | 29_3-43m_094750.jpg | |

29\_3-43m\_094750.jpg, 00:01:07, 3.43 m  
Junction, damaged at 2 o'clock, 100mm dia, COLLAPSED

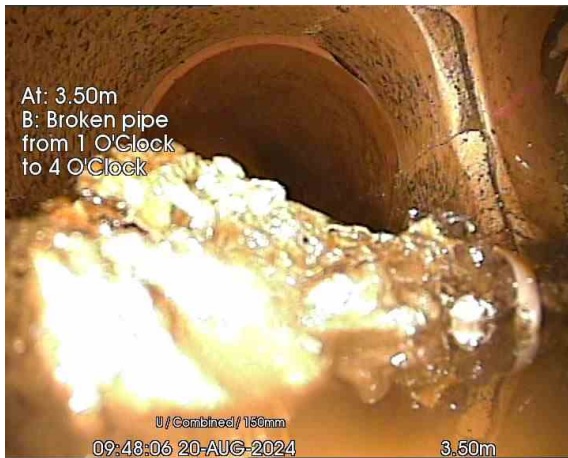
29\_3-50m\_094806.jpg, 00:01:11, 3.50 m  
Broken pipe from 1 o'clock to 4 o'clock

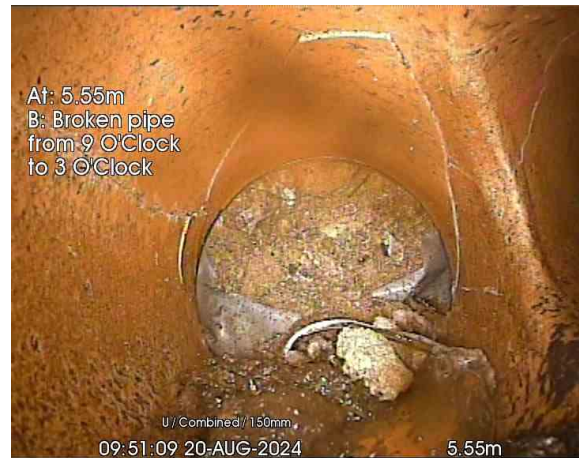
29\_5-55m\_095109.jpg, 00:02:43, 5.55 m  
Broken pipe from 9 o'clock to 3 o'clock

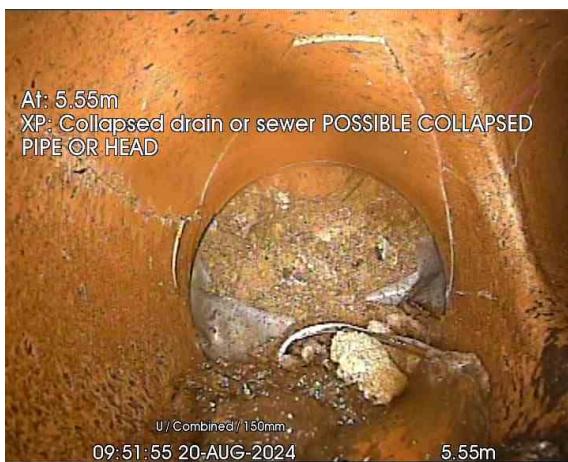
29\_5-55m\_095155.jpg, 00:02:50, 5.55 m  
Collapsed drain or sewer, 95% cross-sectional area loss,  
COLLAPSED PIPE
