**GAS MEMBRANE VALIDATION**

| <b>Site Name:</b> Belle Vue | <b>Project Number:</b> 12-123 |
| <b>Company Name:</b> Countryside Properties | <b>Date:</b> 24-09-2022 |
| Ground Gas Risk Assessment: <b>Characteristic Situation 2 / Amber 1</b> | |

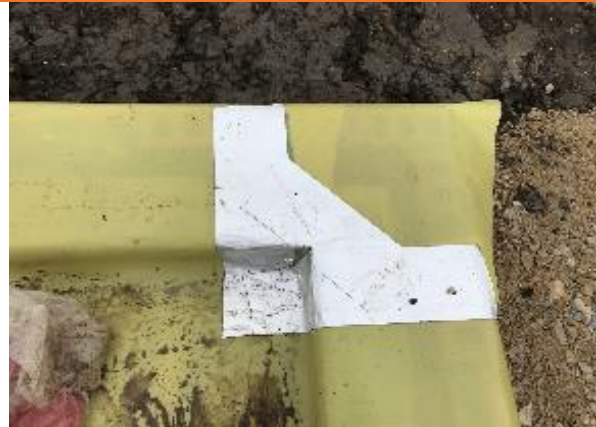
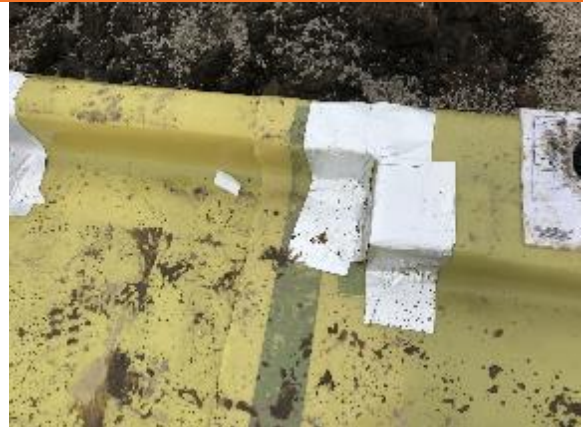
**Verification of Joints and Seals-Good Condition**

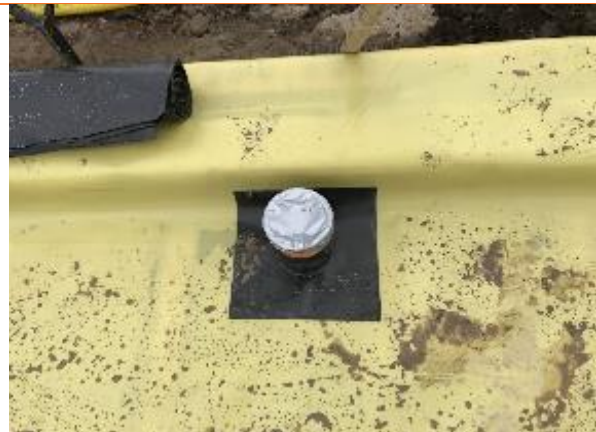
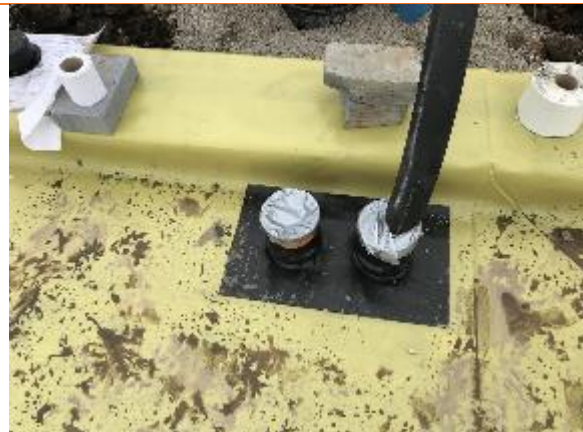
**Verification of Service Penetrations-Good Condition**

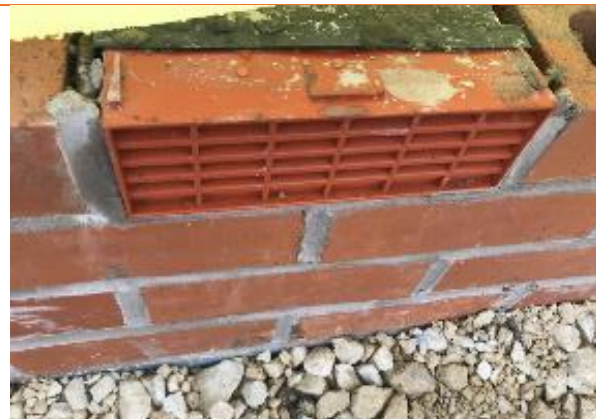
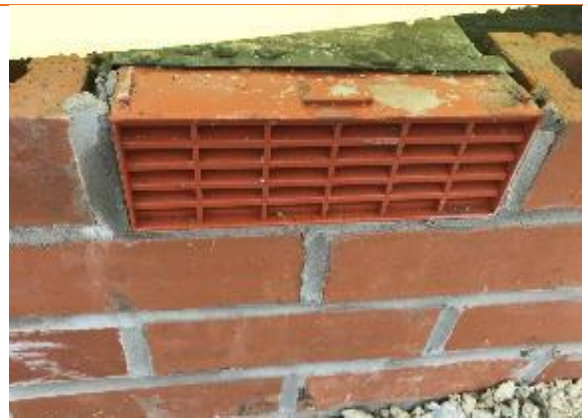
**Verification of Ventilation-Good Condition**

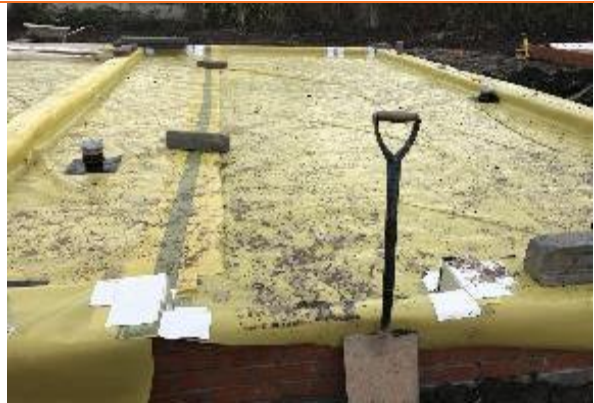
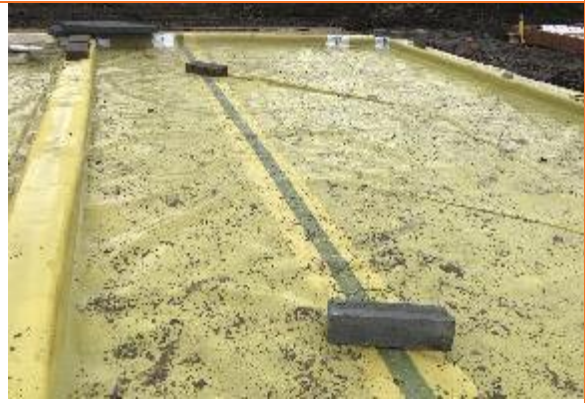
**Plot - 197**

**General Condition of Membrane-Good Condition**
