Date: 22<sup>nd</sup> November 2024  
Reference: 15-974 V22

## GAS MEMBRANE VALIDATION – BENNETT STREET

| <b>Project Name:</b> | Bennett Street |
| <b>Client:</b> | Kellen Homes |

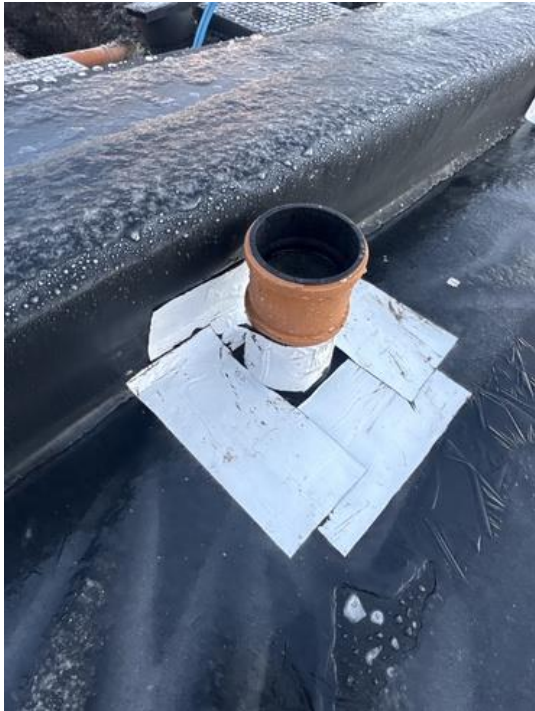
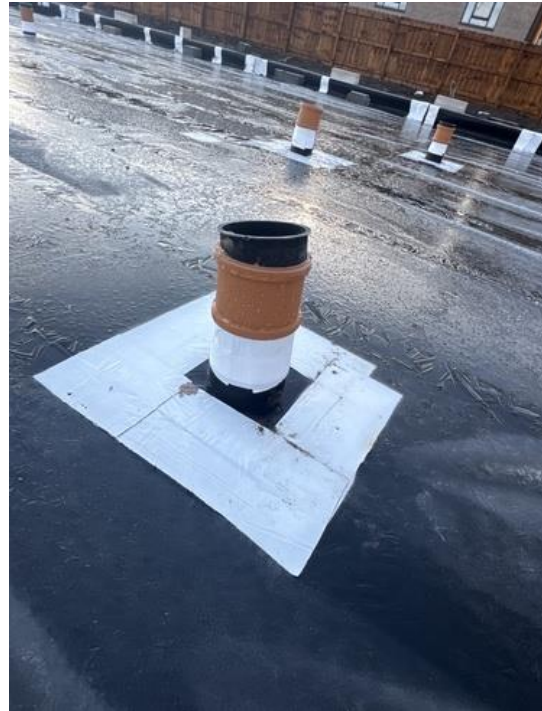
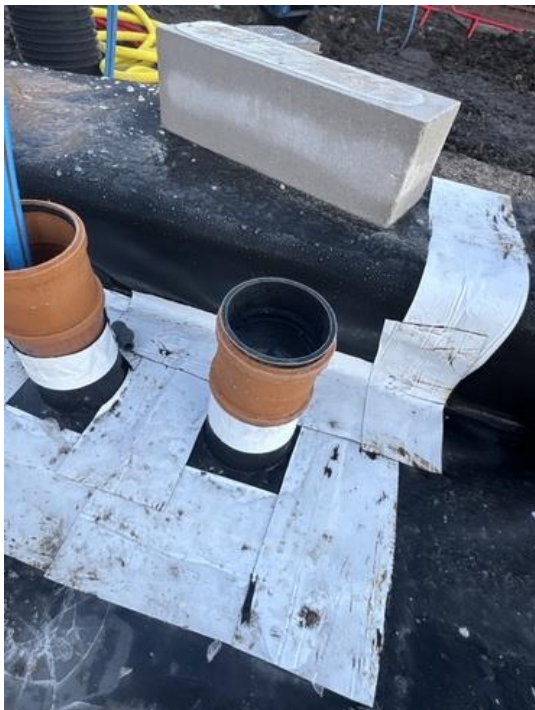
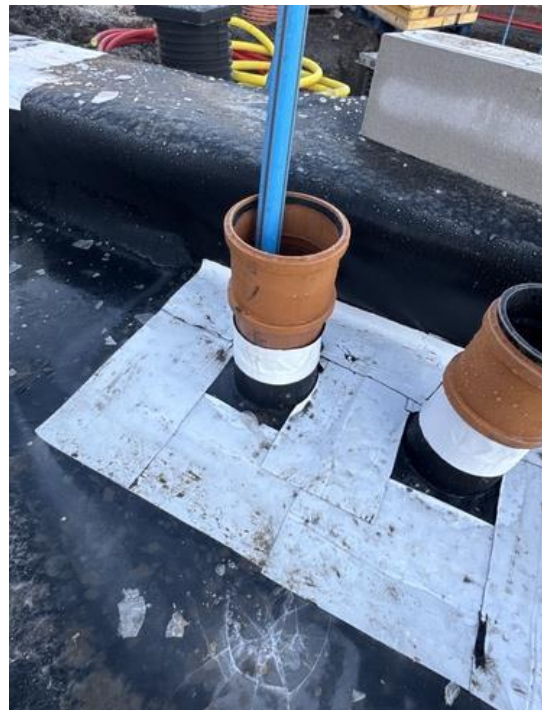
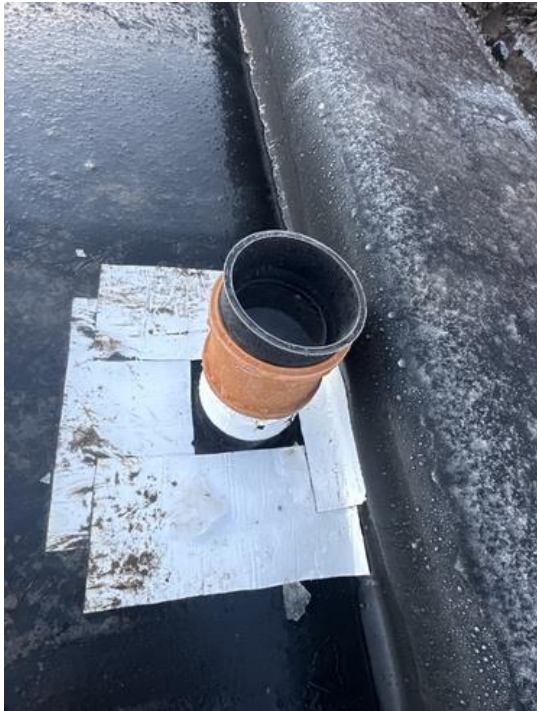
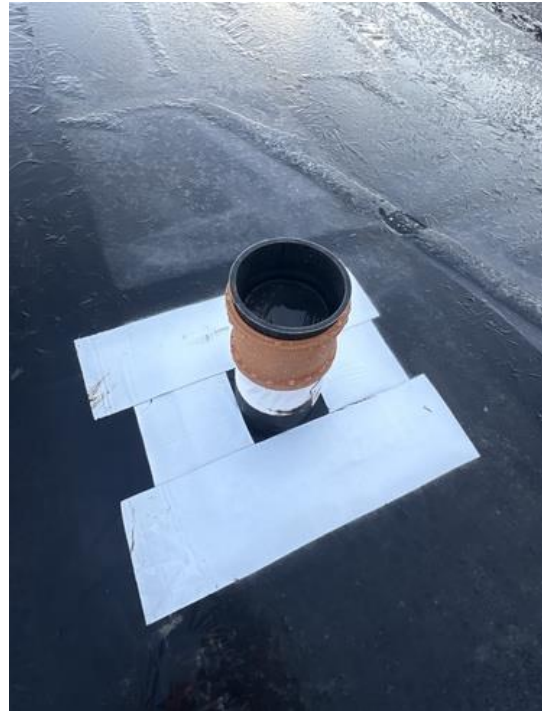
| <b>Service entries seals: Top hats seal arrangements fixed around service entries? Use of Jubilee clips or Bitumastic Sealant</b> | Pass |

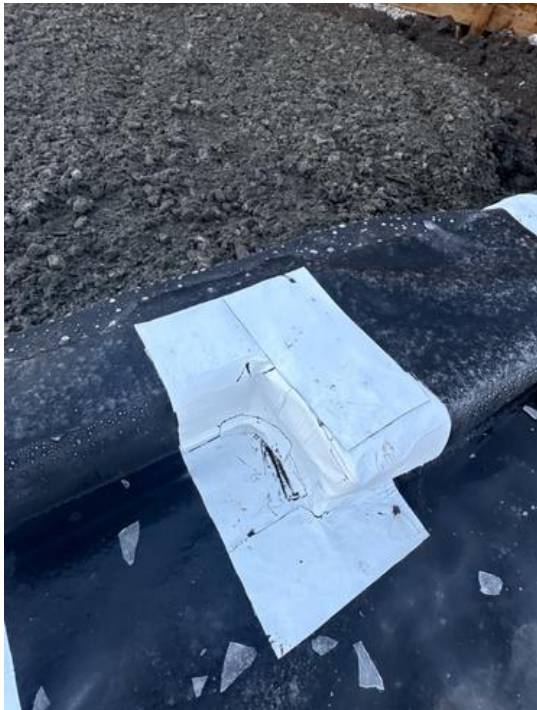
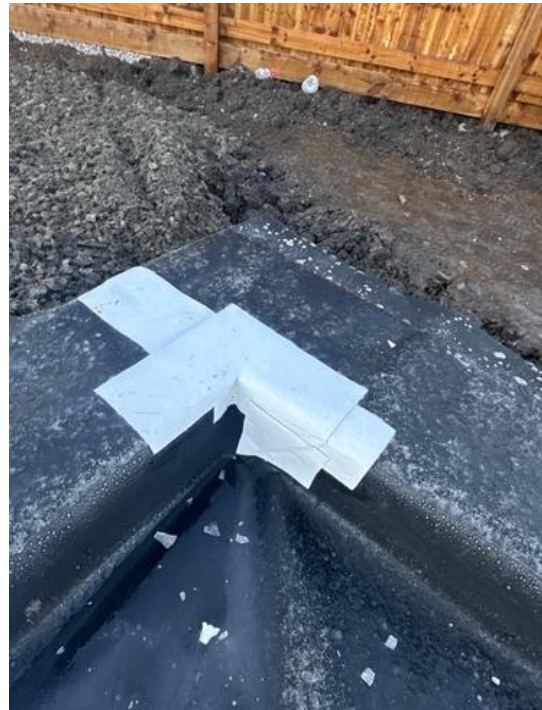
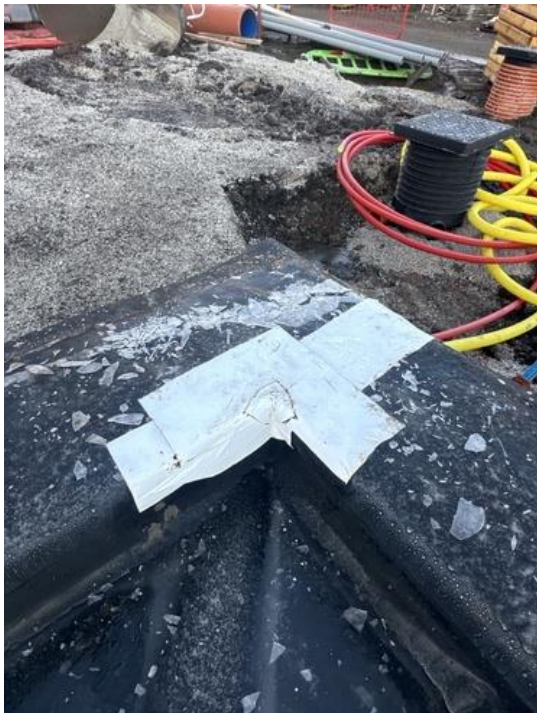
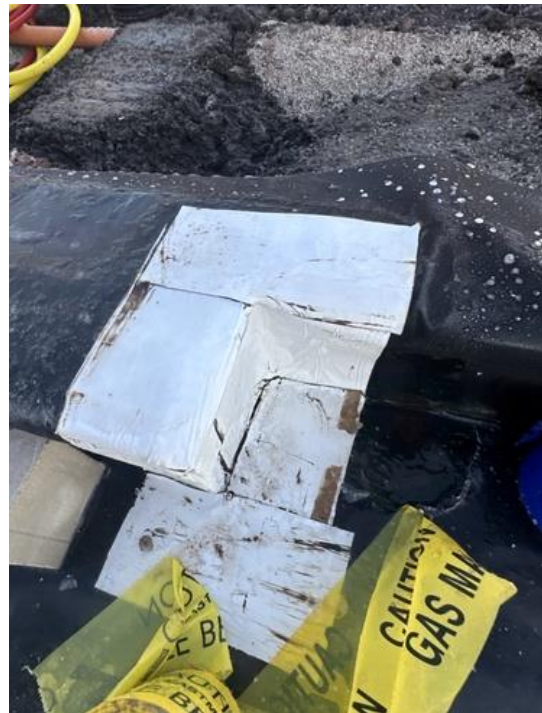
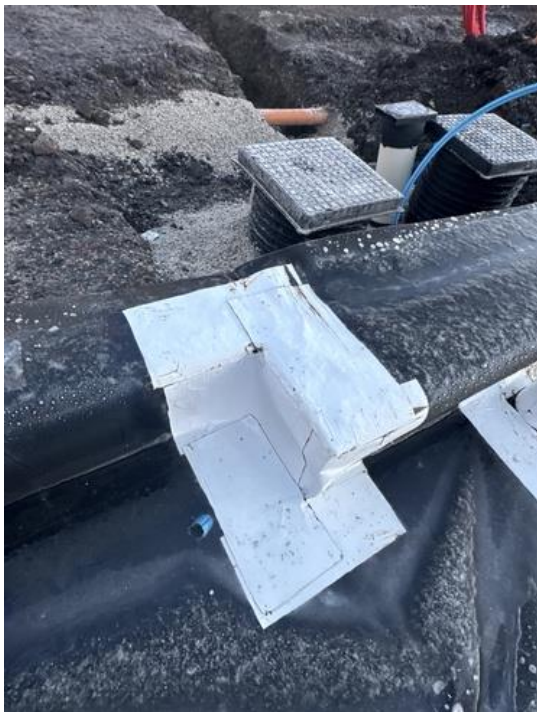
| <b>Corners / Internal joints: Check all corners are correctly formed or contractor has used preformed corners.</b> | Pass |

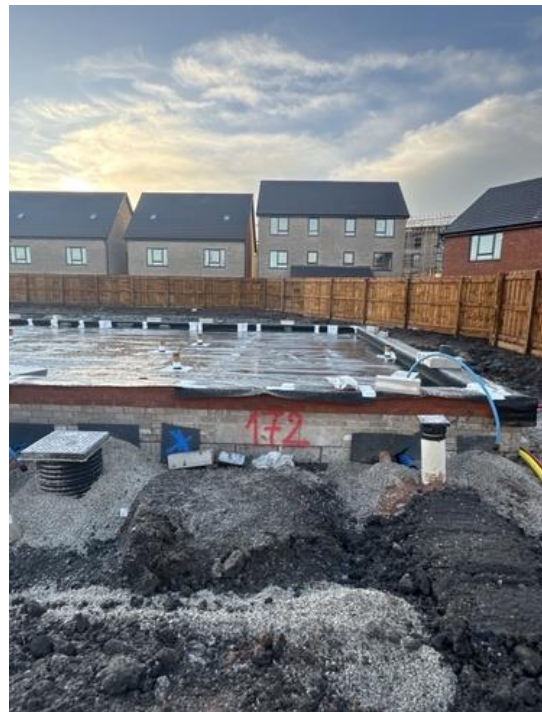
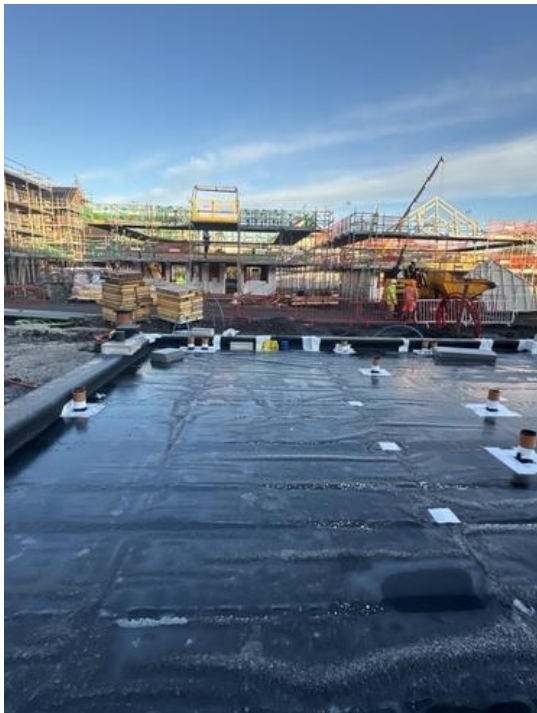
| Extent of Coverage: Is the membrane covering the entire plot? Does membrane span over outside walls? | Yes |

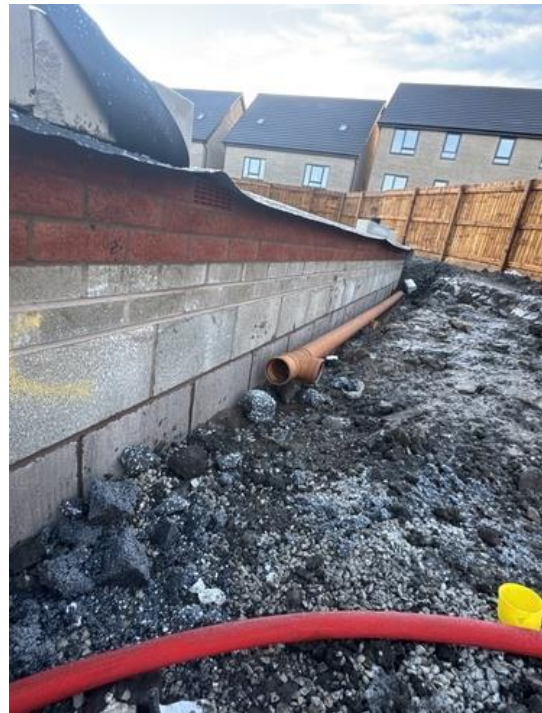
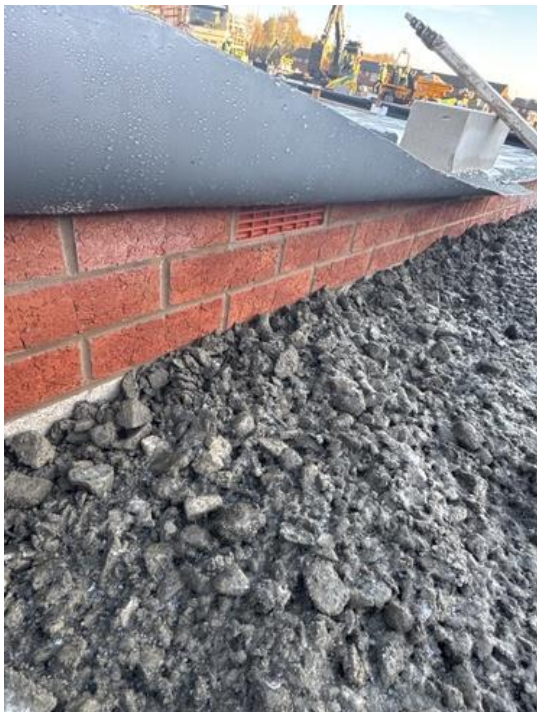
| External Wall Air bricks: Numbers, size. positions as design drawing? (Minimum of 3 walls) | Pass |

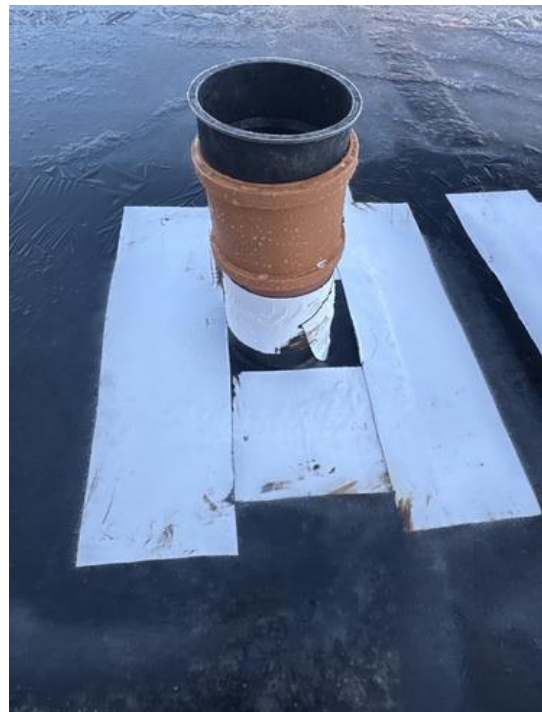
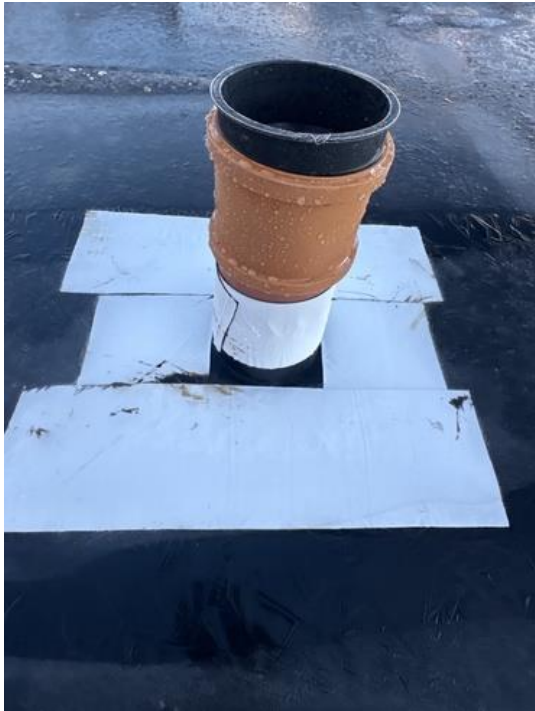
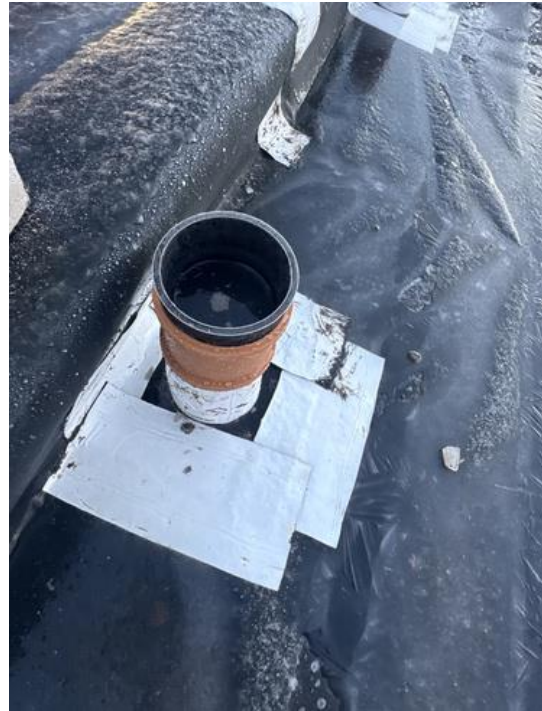
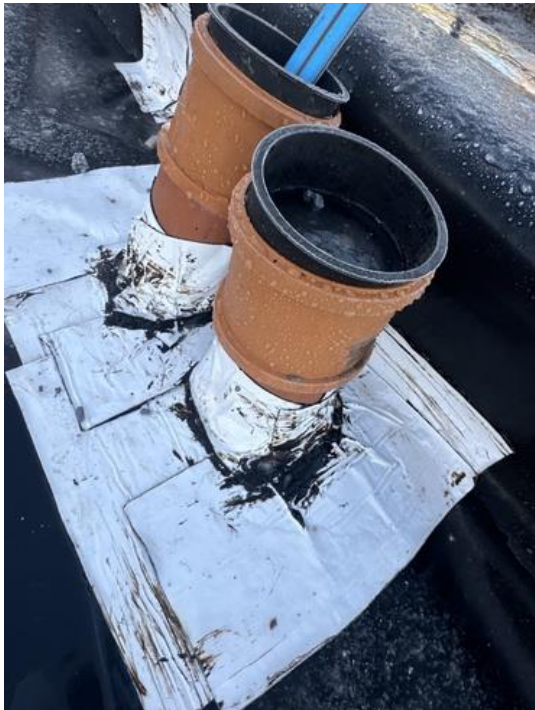
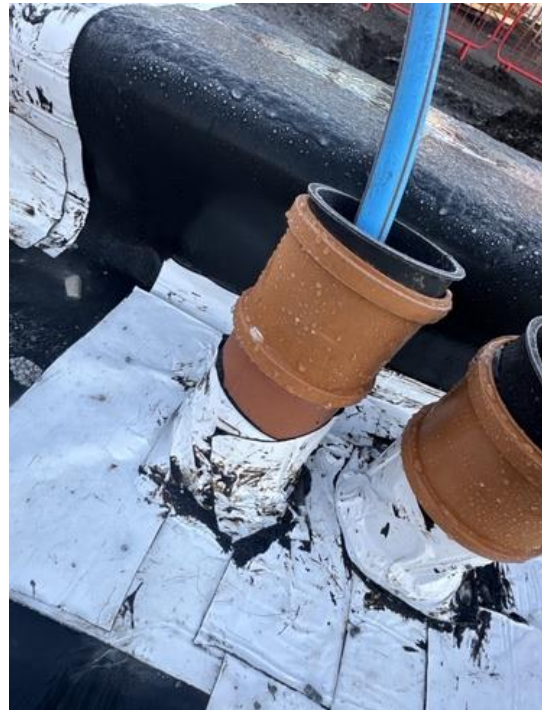
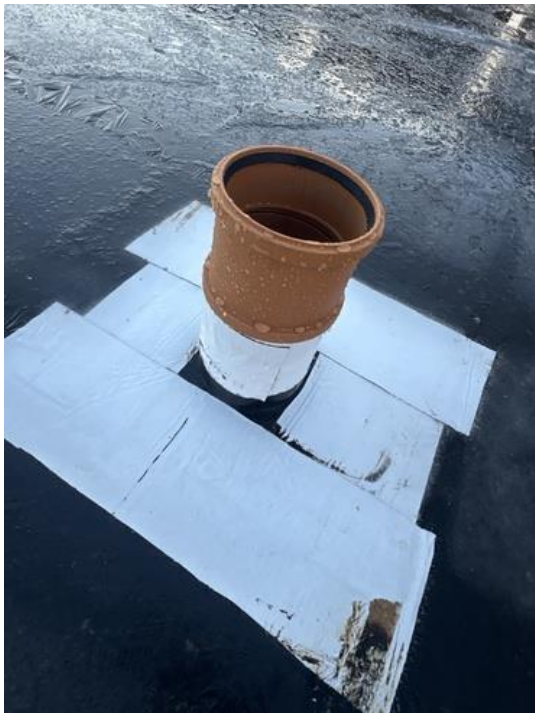
**Service entries seals: Top hats seal arrangements fixed around service entries? Use of Jubilee clips or Bitumastic Sealant**

Pass

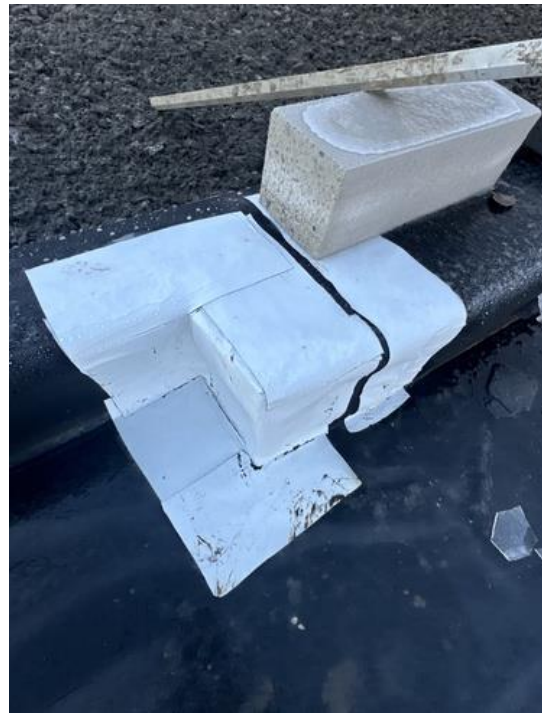
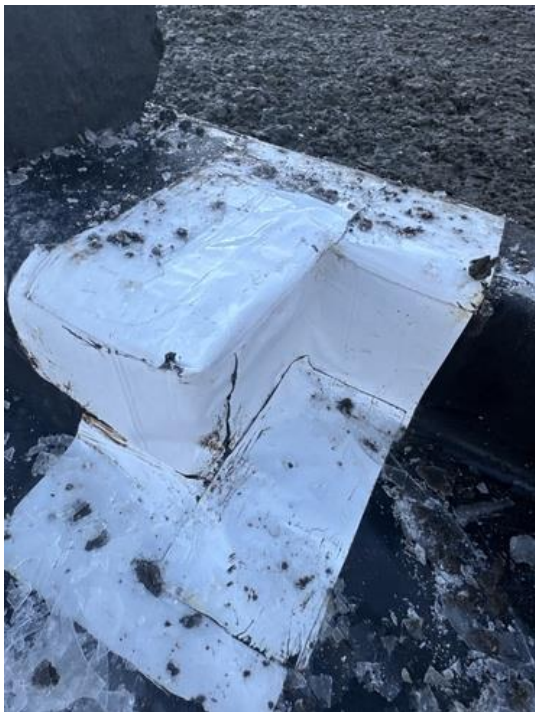
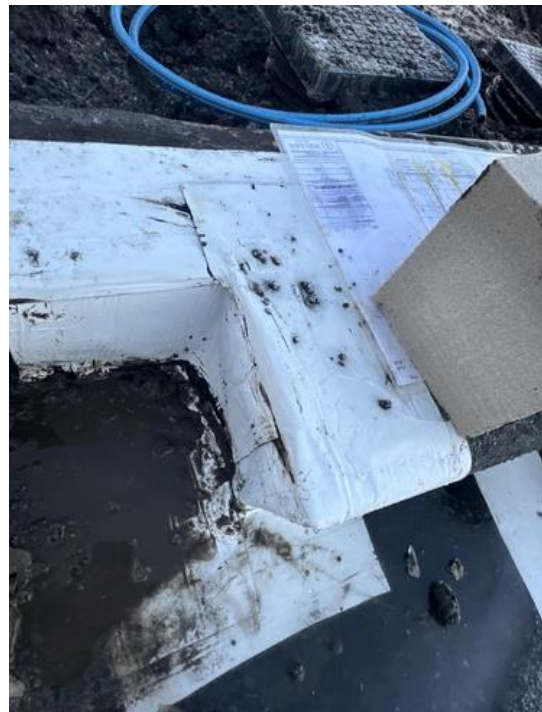
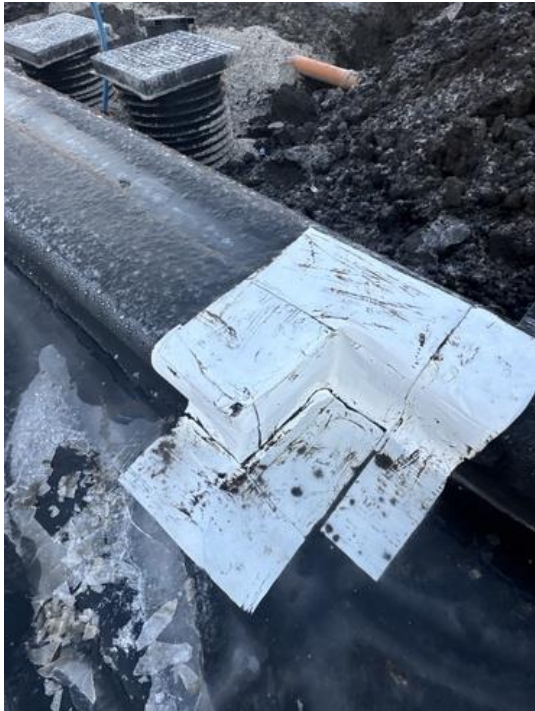
**Corners / Internal joints: Check all corners are correctly formed or contractor has used preformed corners.**

Pass

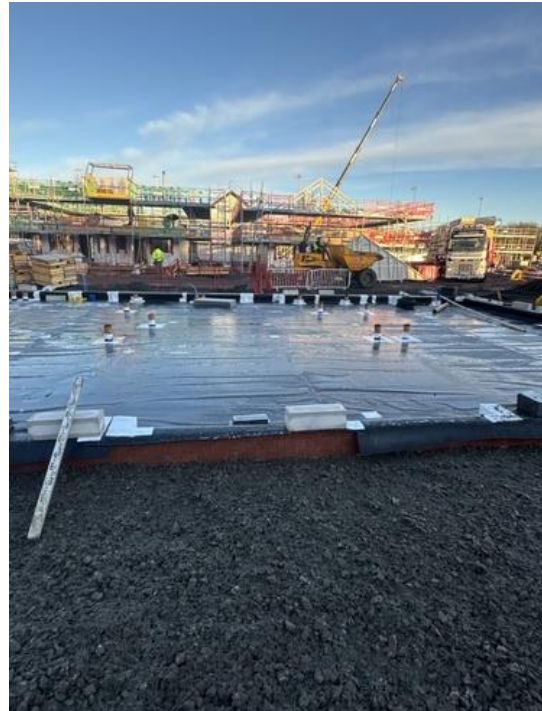
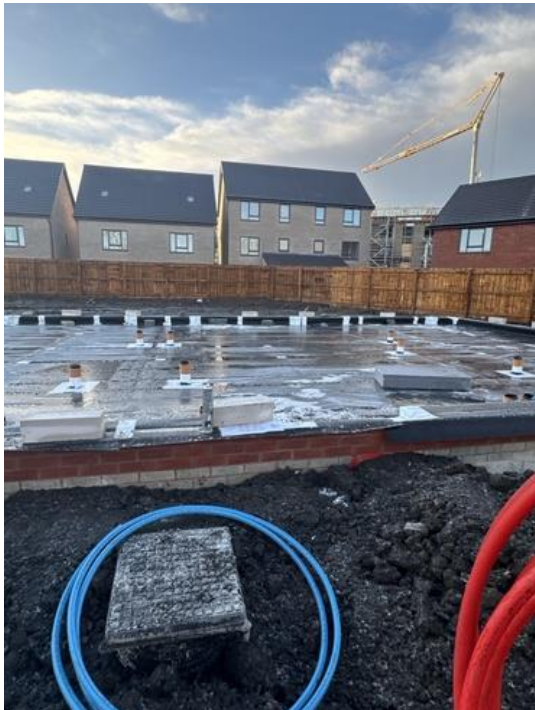
**Extent of Coverage: Is the membrane covering the entire plot? Does membrane span over outside walls?**

Yes

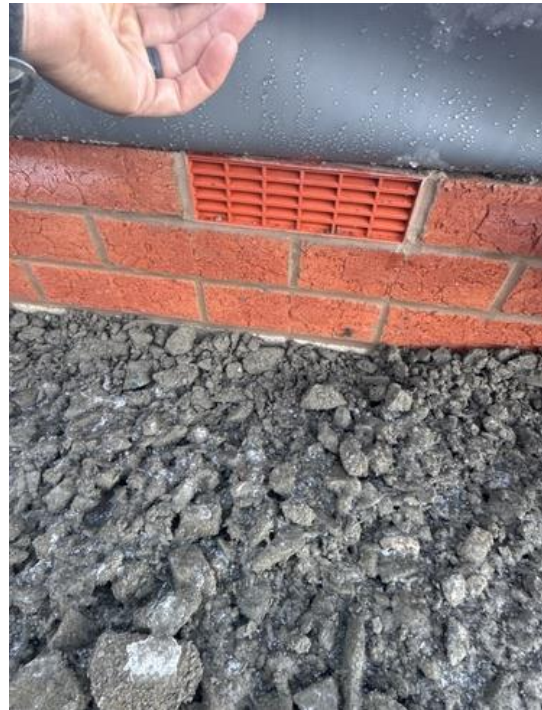
Photo 28

**External Wall Air bricks: Numbers, size. positions as design drawing? (Minimum of 3 walls)**

Pass

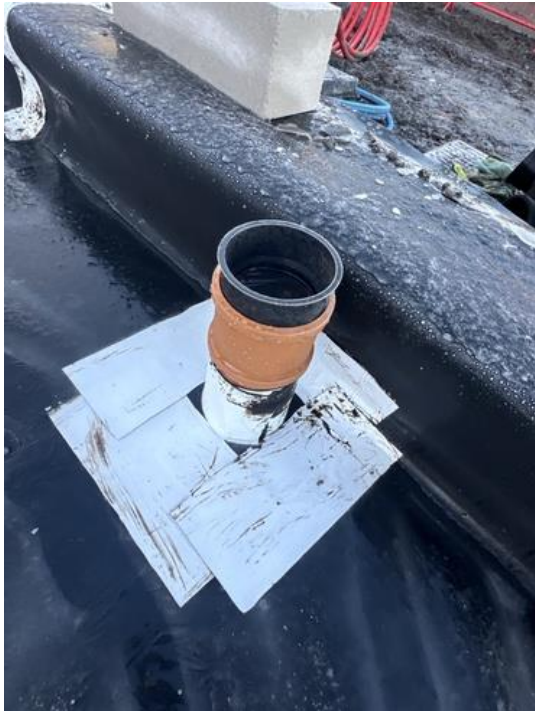
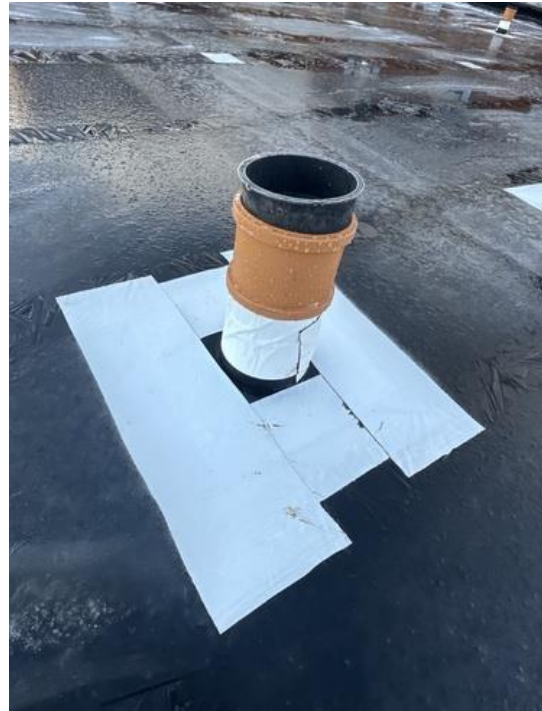
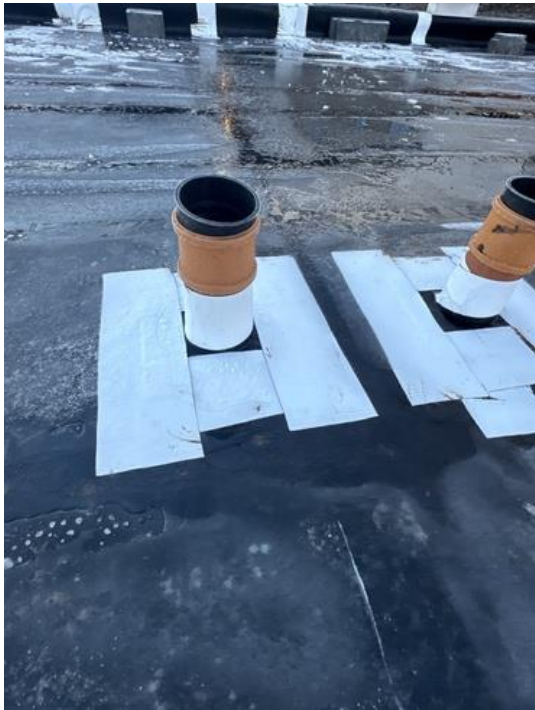
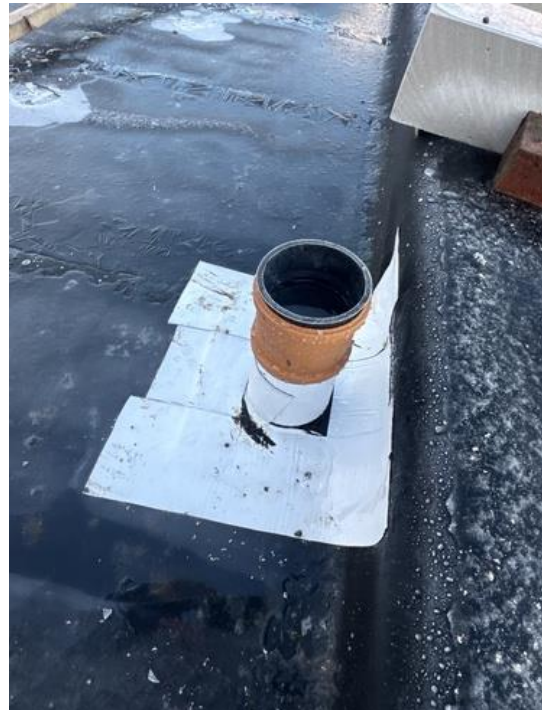
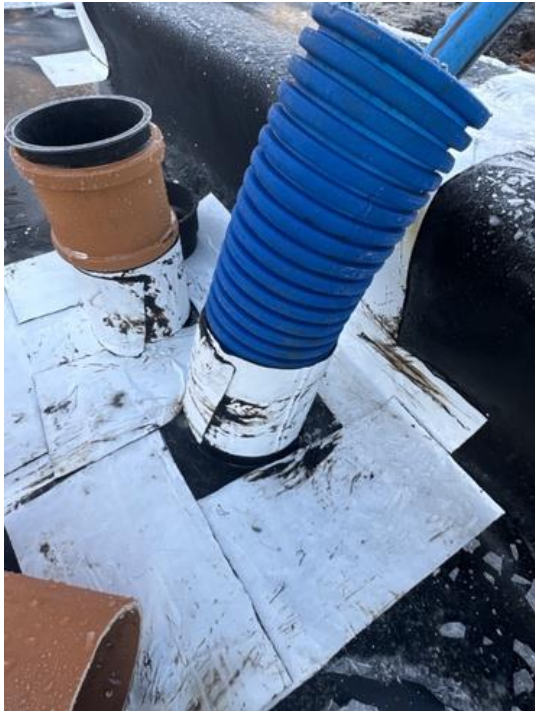
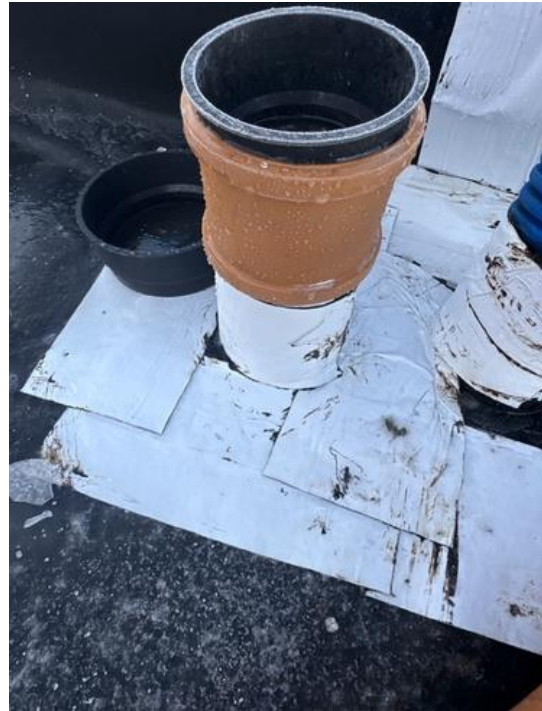
**Service entries seals: Top hats seal arrangements fixed around service entries? Use of Jubilee clips or Bitumastic Sealant**

Pass

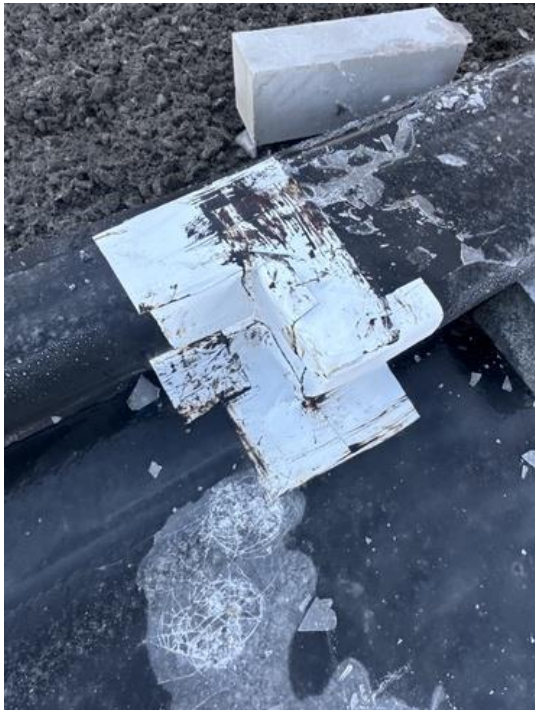
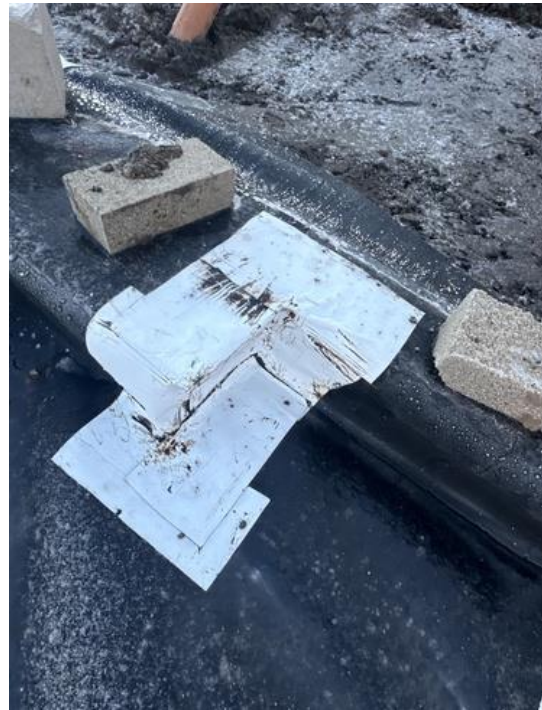
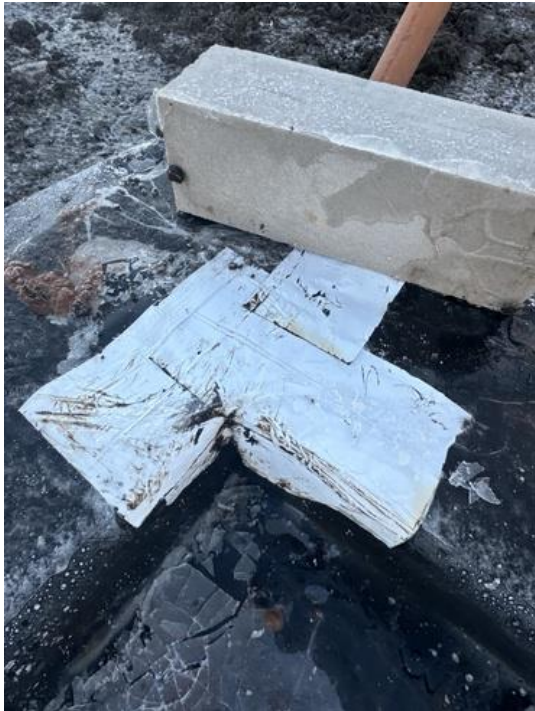
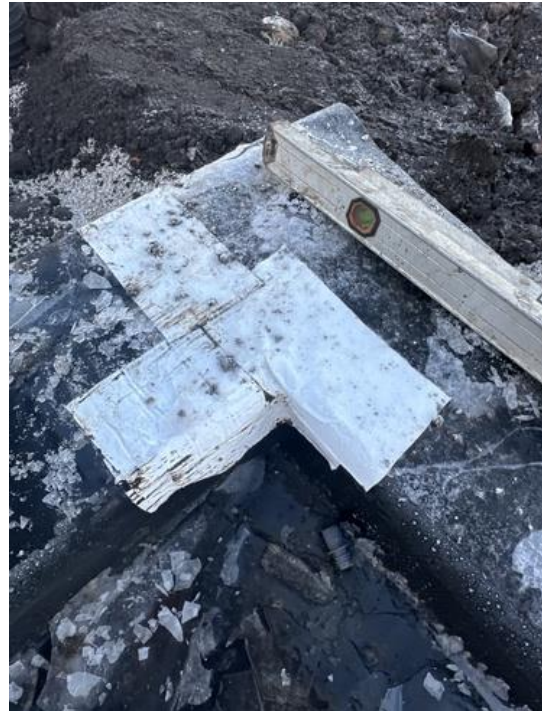
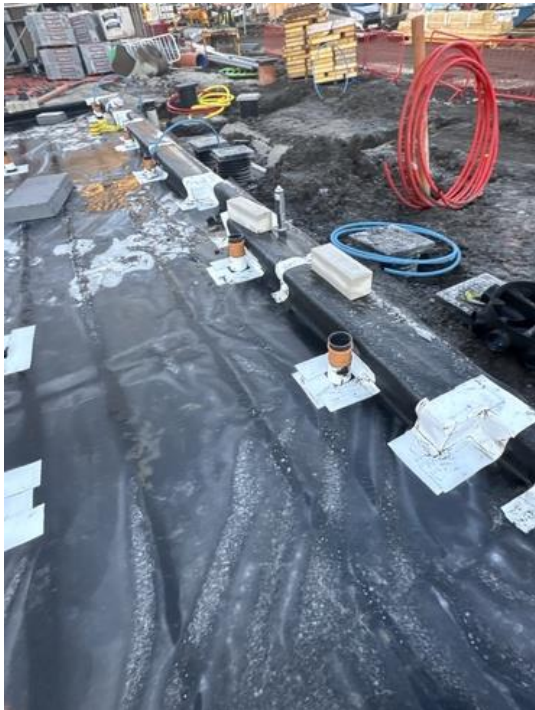
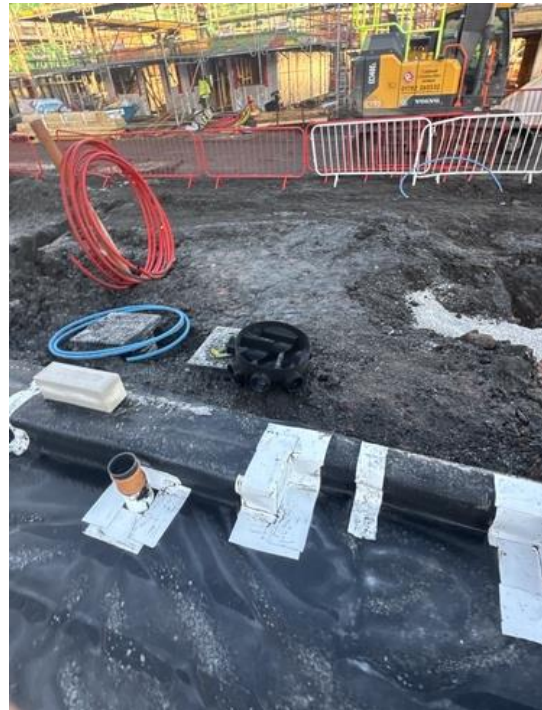
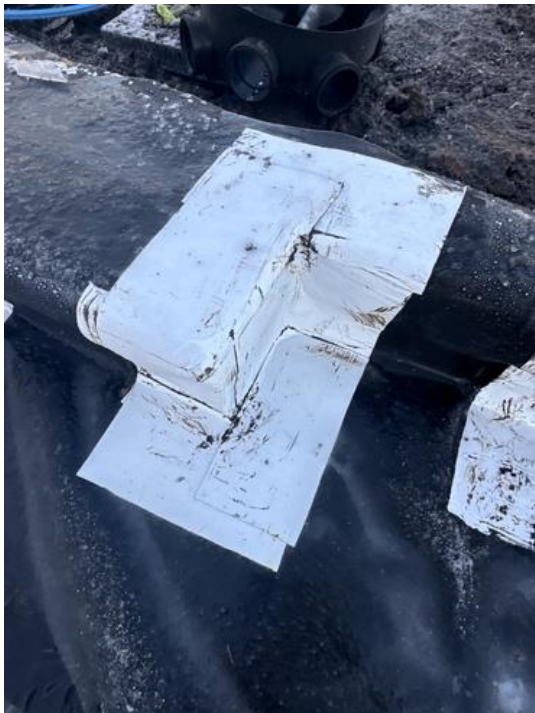
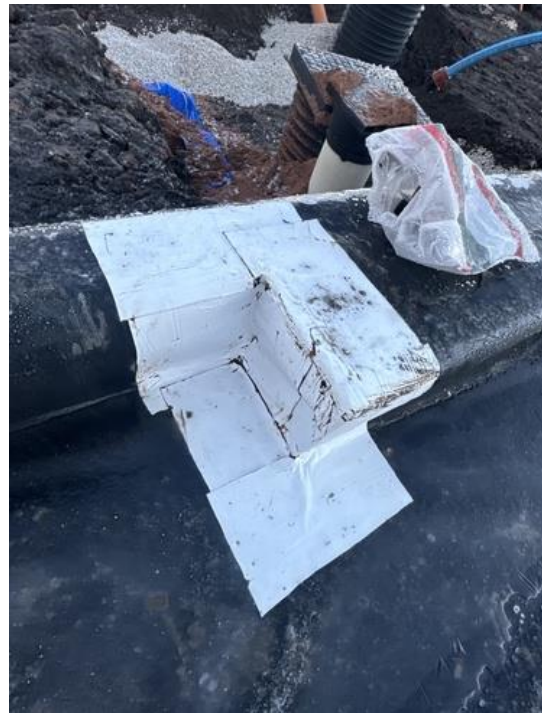
**Corners / Internal joints: Check all corners are correctly formed or contractor has used preformed corners.**

Pass

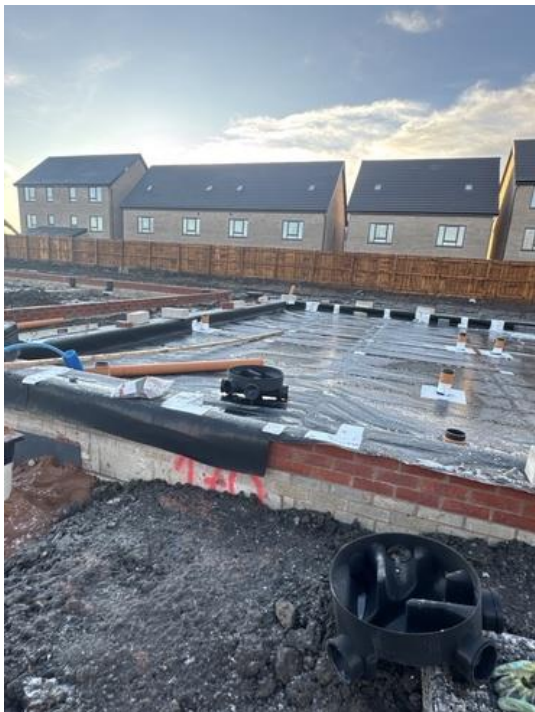
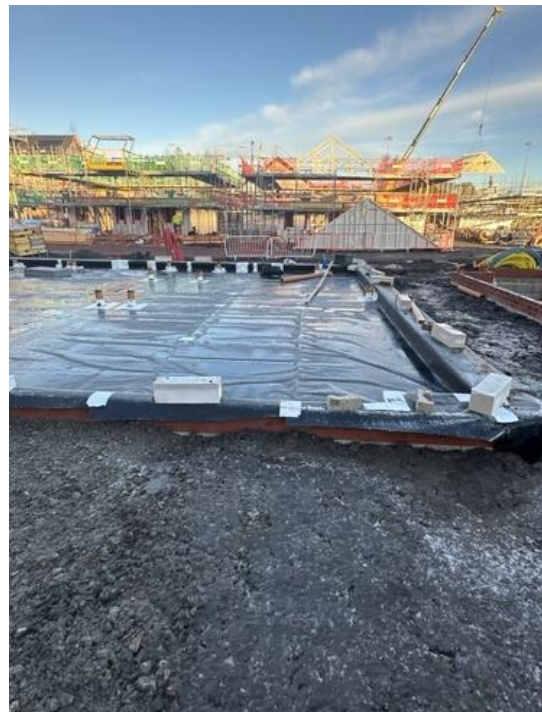
**Extent of Coverage: Is the membrane covering the entire plot? Does membrane span over outside walls?**

Yes

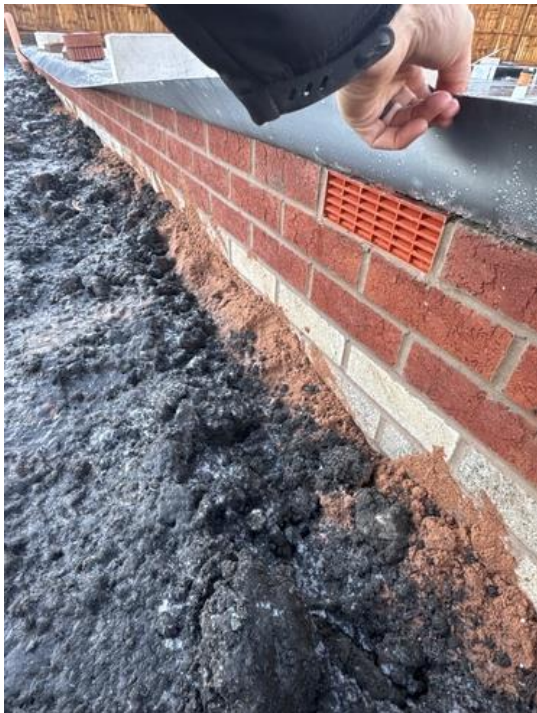
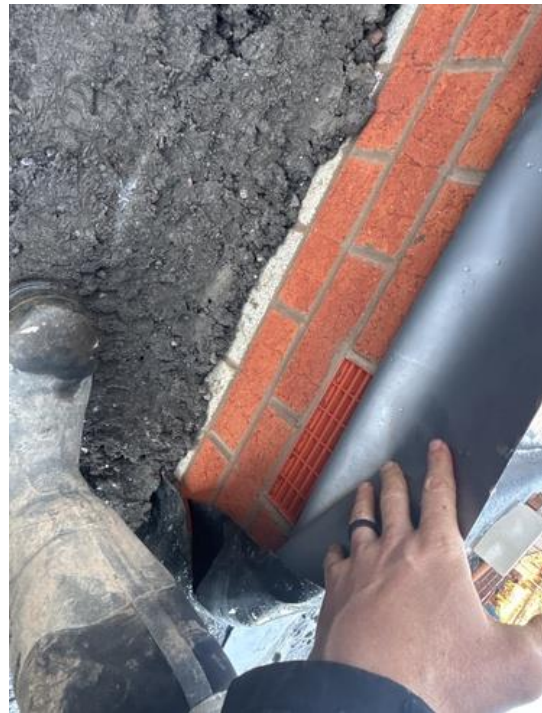
**External Wall Air bricks: Numbers, size. positions as design drawing? (Minimum of 3 walls)**

Pass

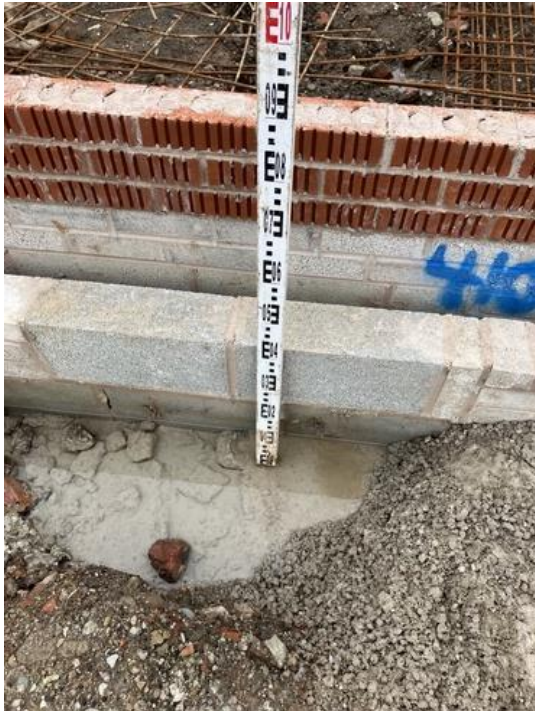
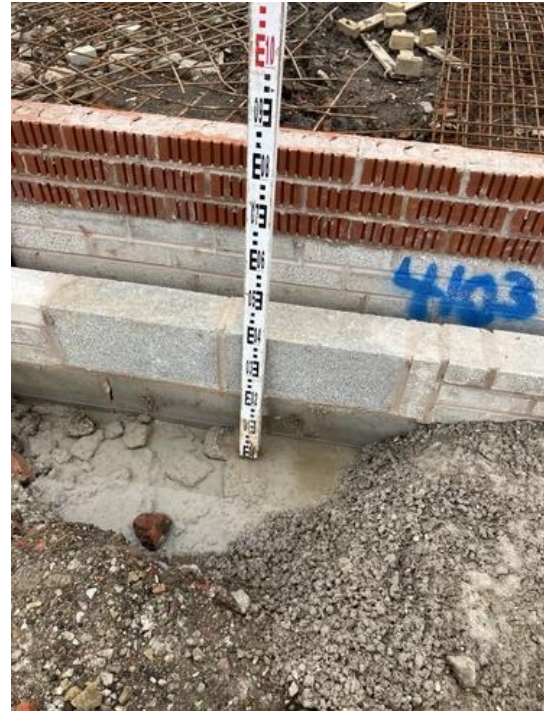
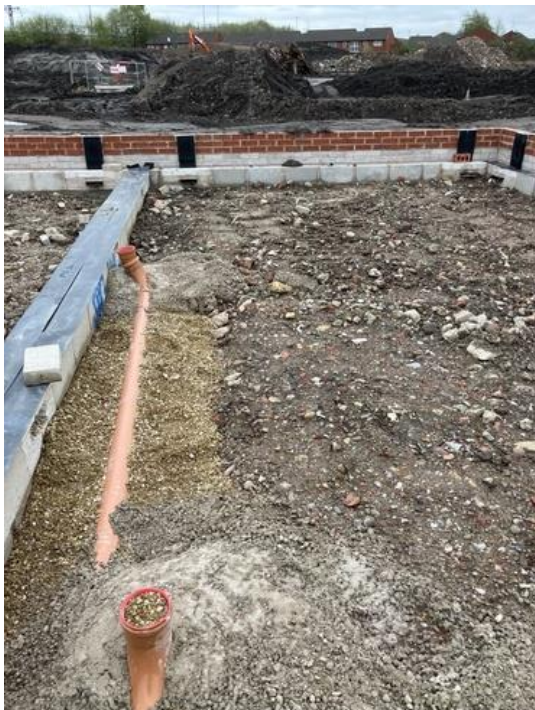
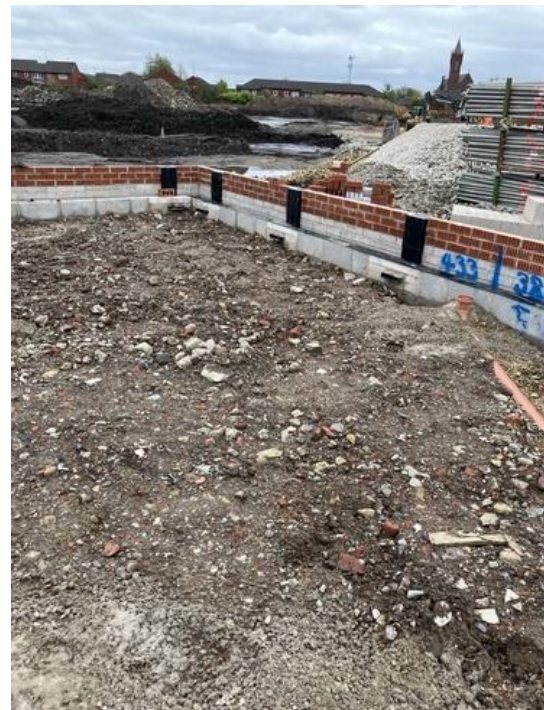
### Is the void clear?

Yes

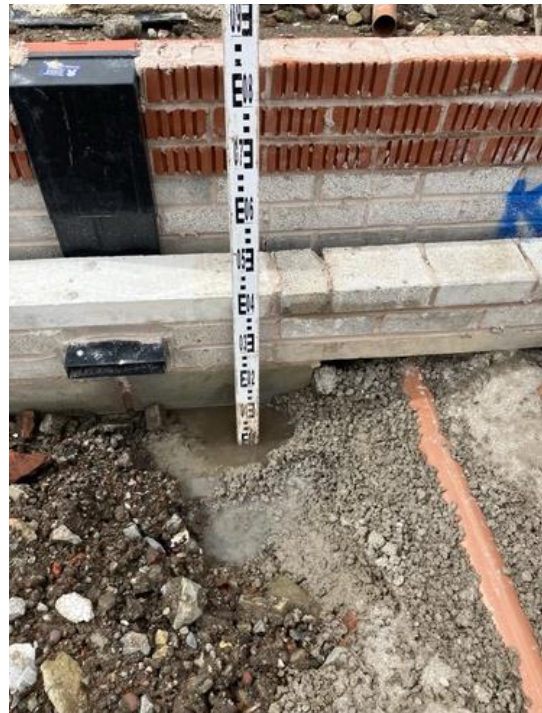
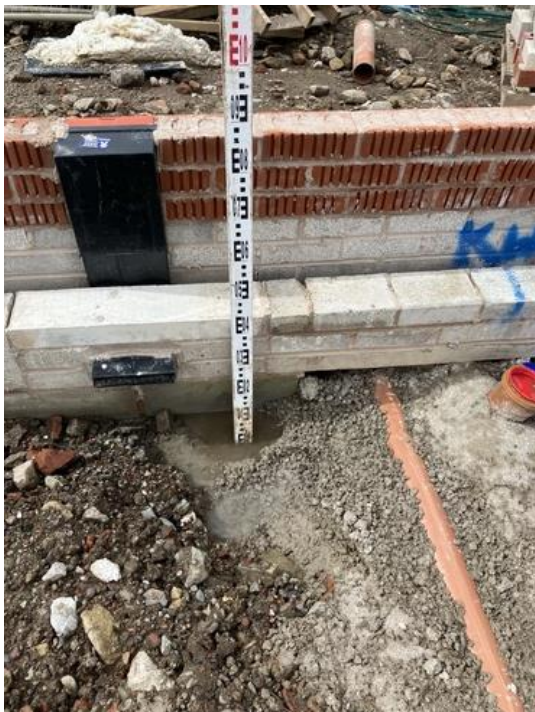
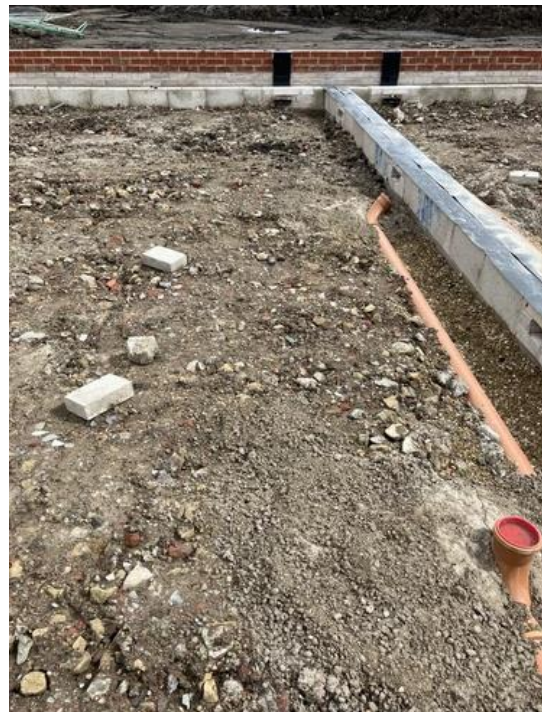
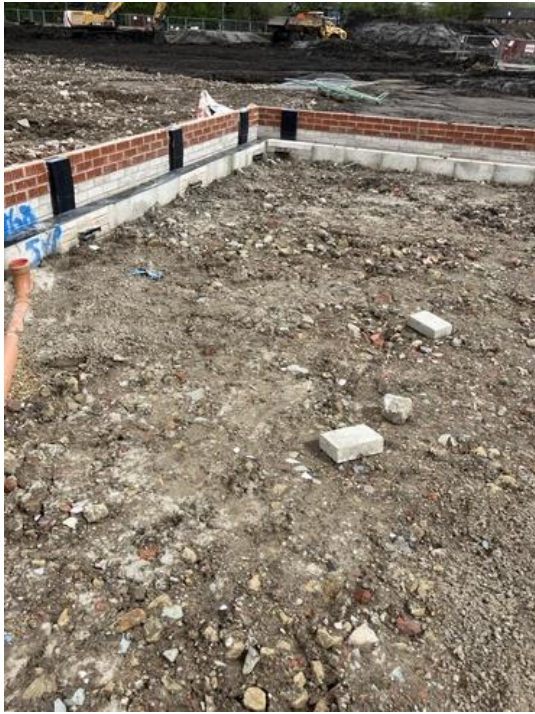
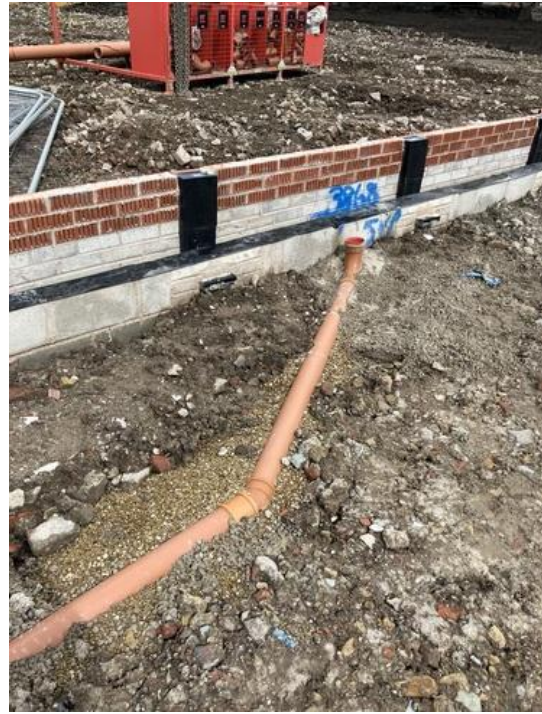
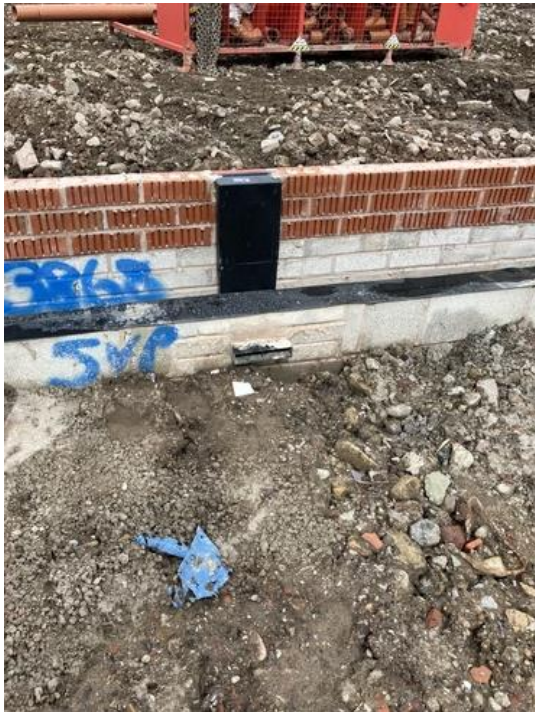
### Is the void clear?

Yes

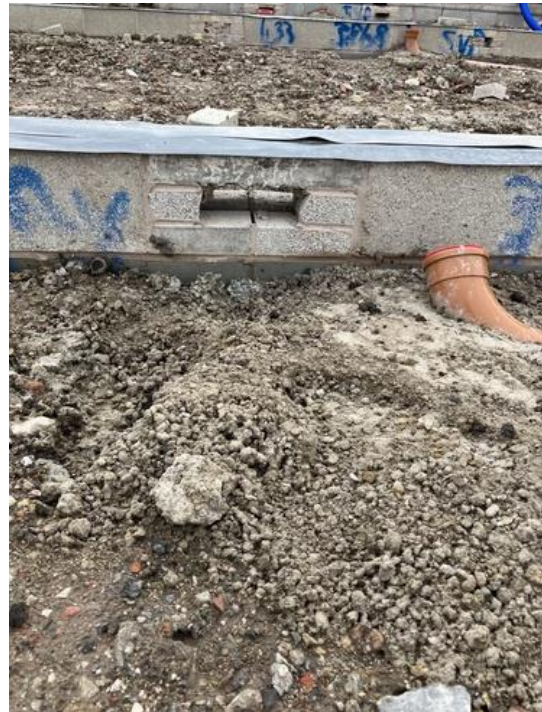
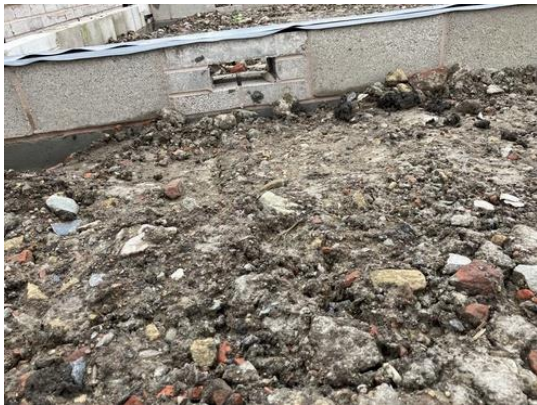
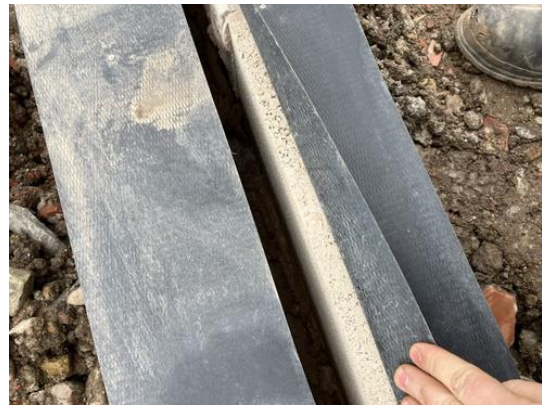
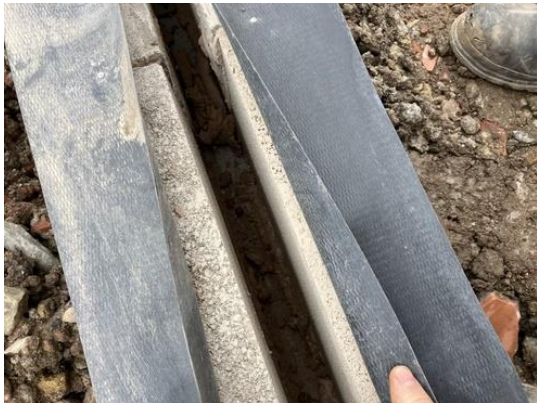
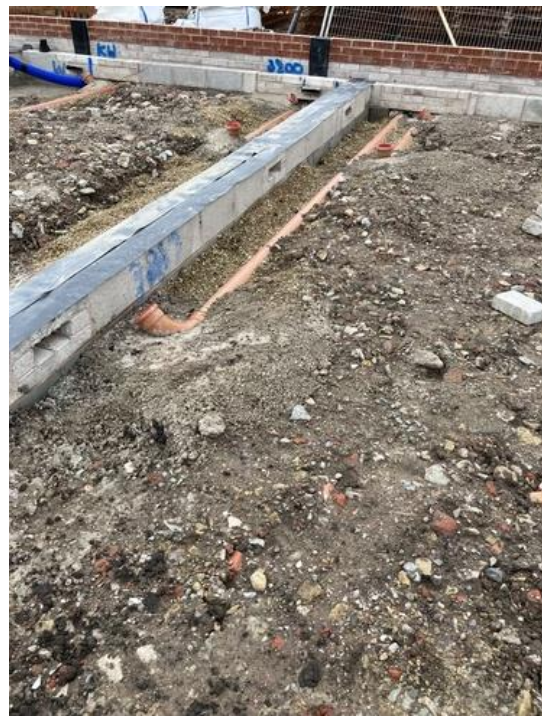
Depth of Void

300

Are Sleeper Walls Vented?

Yes
