# LARKE RISE, DIDSBURY - INSPECTION OF PALATINE ROAD BOUNDARY WALL

25.136

Wednesday, 11 June 2025

Larke Rise, West Didsbury, Manchester, M20 2UL

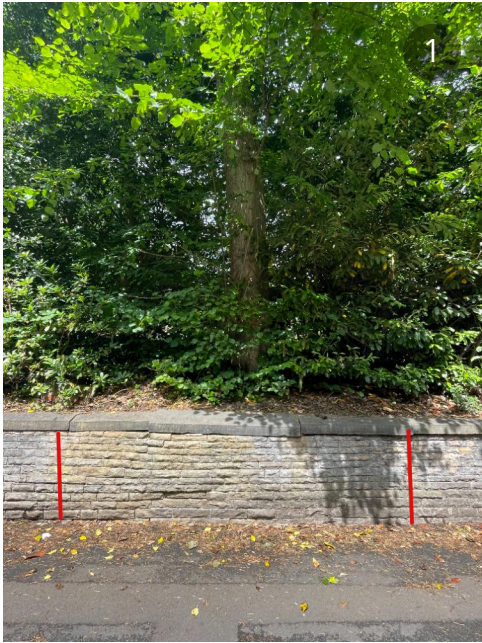
The boundary wall is a retaining wall between Larke Rise and Palatine Road is approximately 300 mm thick with solid stone coping stones, and appears to be around 100 years old. The wall shows signs of distortion in a number of places, with the most significant movement occurring in front of a very well-established lime tree of approximately 22m height, as shown in the photos below. The wall is retaining to all of its height of approximate 1.4m high and is acting as a mass retaining wall, in that the weight of the wall what retains the earth and forces from behind it. There are no weepholes in the lower third of the wall suggesting that there is some form of drainage to reduce the hydrostatic pressure of water building behind the wall. The extents of the damage are shown by the red lines shown on pic 1.

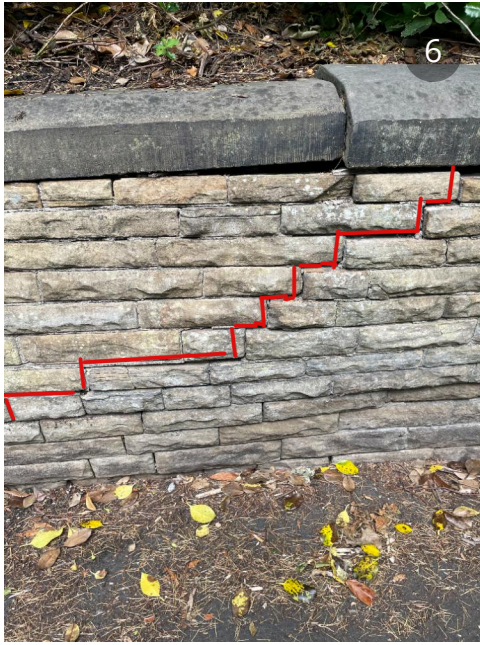
At this location, the wall has buckled on the joint of the coping stones and has bellied by approximately 100 - 120 mm from its original position. There is stepped cracking mainly through the joints of the stone to the outer skin (pic 6) and the coping stones are now misaligned. The coping stones will likely require some mechanical means of lifting as the centre one is very substantial.

Rebuilding this section of the wall would require at least three coping stones to be removed, the wall to be taken down and rebuilt using the existing stone. The foundation may be damaged and may need to be re-

built but the damage is focused higher up as though the tree is leaning on the wall rather than heaving through the foundation and splitting the wall in half. It may be possible to put a thicker, heavier inner skin of blockwork such as dense concrete trench blocks but this will only be possible if room can be made on the tree side of the wall as the front boundary line needs to be maintained. This would require cutting some of the trees root base back to create room for a thicker wall (with more mass to resist the forces from the tree).

Fitting a new drain to the rear of the wall would allow any hydrostatic pressure to dissipate but this would simply be a section of slotted drain to the rear of this section of wall and would not provide any drainage to the remainder of the wall. It may also be sensible to remove the earth from behind the section of wall re-built and fill with cleaned stone to allow water to drain down behind the wall to encourage the water down below the wall rather to rest behind it.

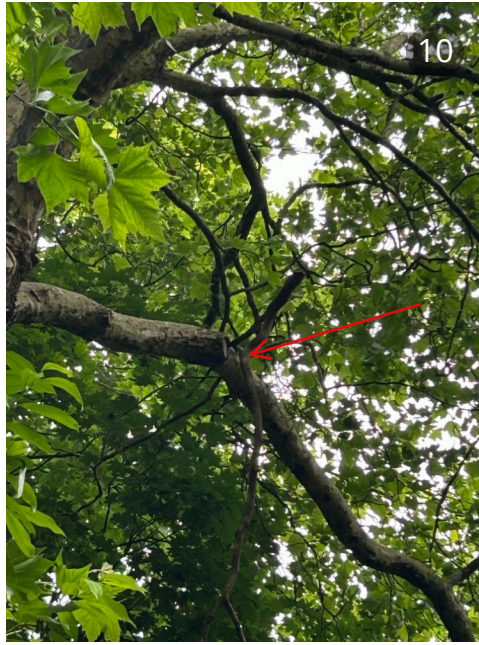
The tree to the right-hand side of the lime tree (pics 10) has been trimmed back but there is a broken branch that has been cut from the tree which is hanging from a bough (pic 10, red arrow). This branch should be safely removed before it falls onto the road.

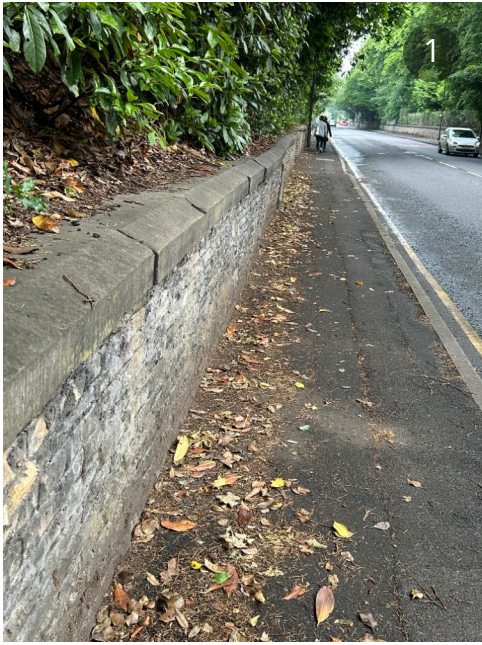
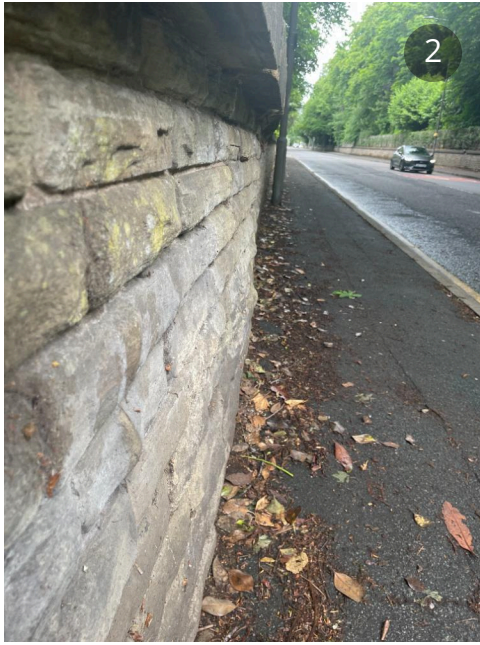
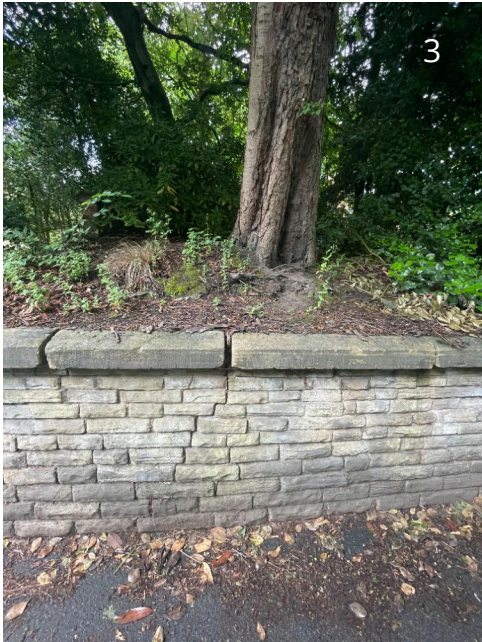
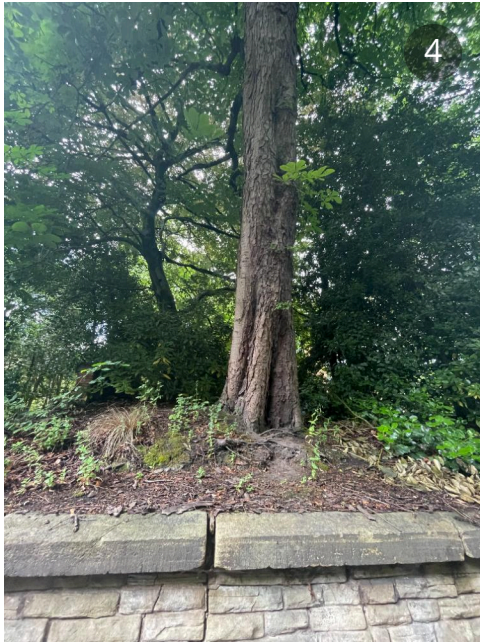
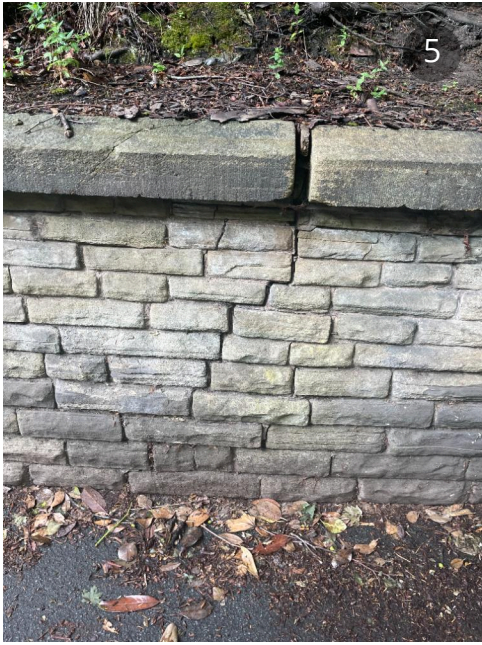
There are at least two other areas where the wall is deforming in a similar manner and this may continue to happen due to the size and proximity of the large deciduous trees behind the wall (pics 1-5). These are not as severe as the present area but the wall appears to be built the same way and as the trees continue to grow it is likely that they will force the wall out further. Looking at the left-hand corner of the wall, on the junction between Palatine Road and Mersey Road, there seem to be many self-seeded trees growing closely together. These trees are likely to grow to the same size as the the larger trees in this area and could cause similar issues in the future, especially since they are all so close together. It is advised that the tree risk assessment should consider these trees and the density of their growth and their value to the context of the crop of trees and make recommendations for thinning or removal (pics 6,7&8).
