Date: 16<sup>th</sup> September 2024  
Reference: 15-974 V15

## GAS MEMBRANE VALIDATION – BENNETT STREET

| <b>Project Number:</b> | 15-974 |
| <b>Plot:</b> | 139 - 146 |

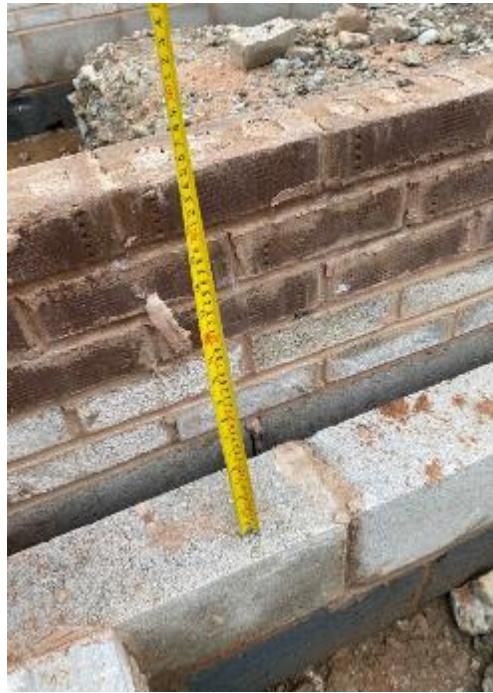
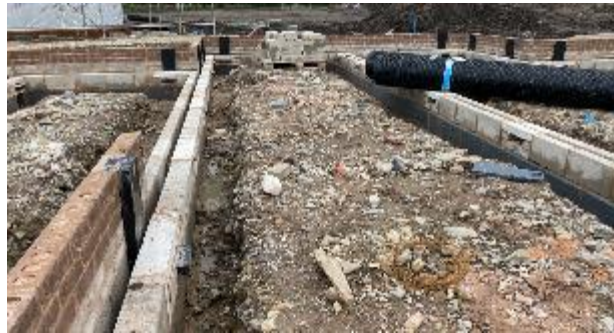
Plot 139

As per the Build Phase Contamination Risk Mitigation Strategy (report ref: 15-974-R5), sub-floor voids require inspection and validation at 50% ratio of substructures completed. E3P undertook subfloor void inspections for Plots 139-146 on 29<sup>th</sup> May 2024, inspections confirmed there was a minimum void space of 150 mm for each plot. Validation photographs included within this letter.

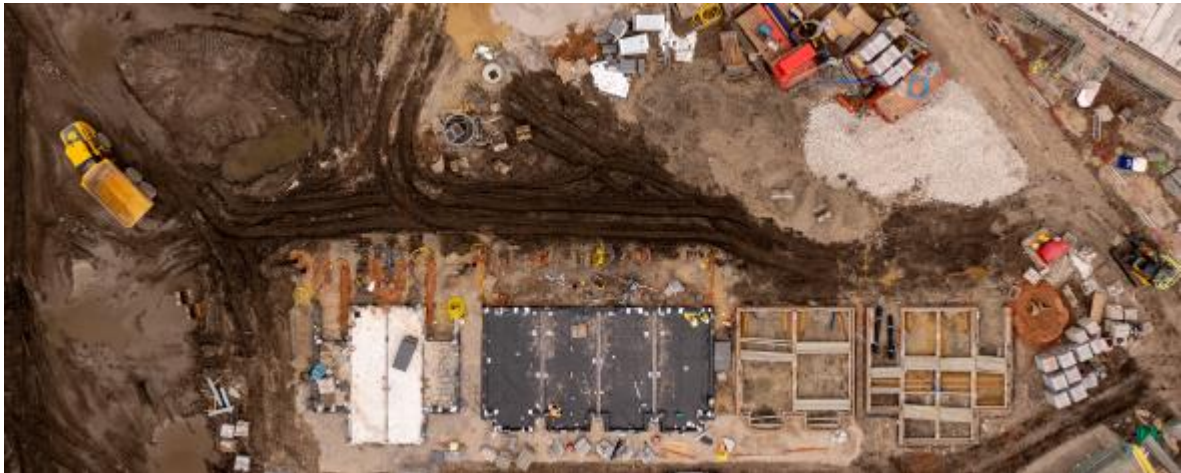
Membranes installed on plots 143 - 146

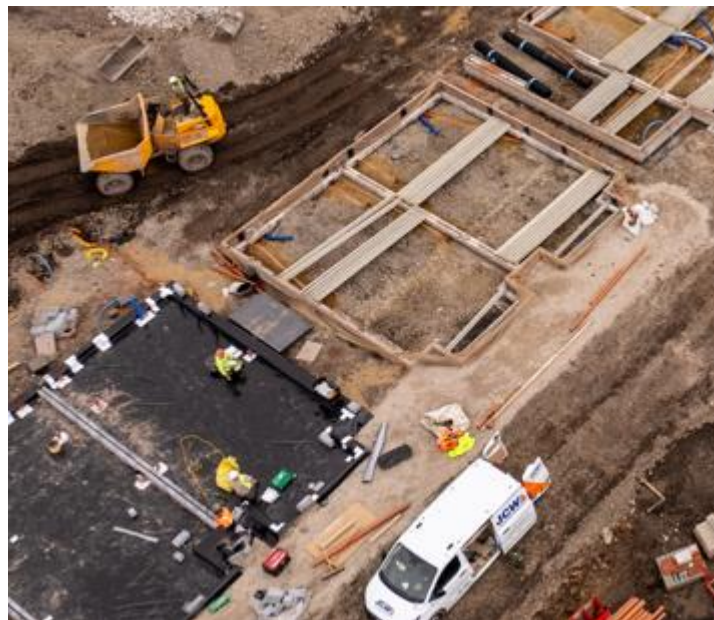
Membranes installed on plots 139-140 with JCW on site installing gas membranes

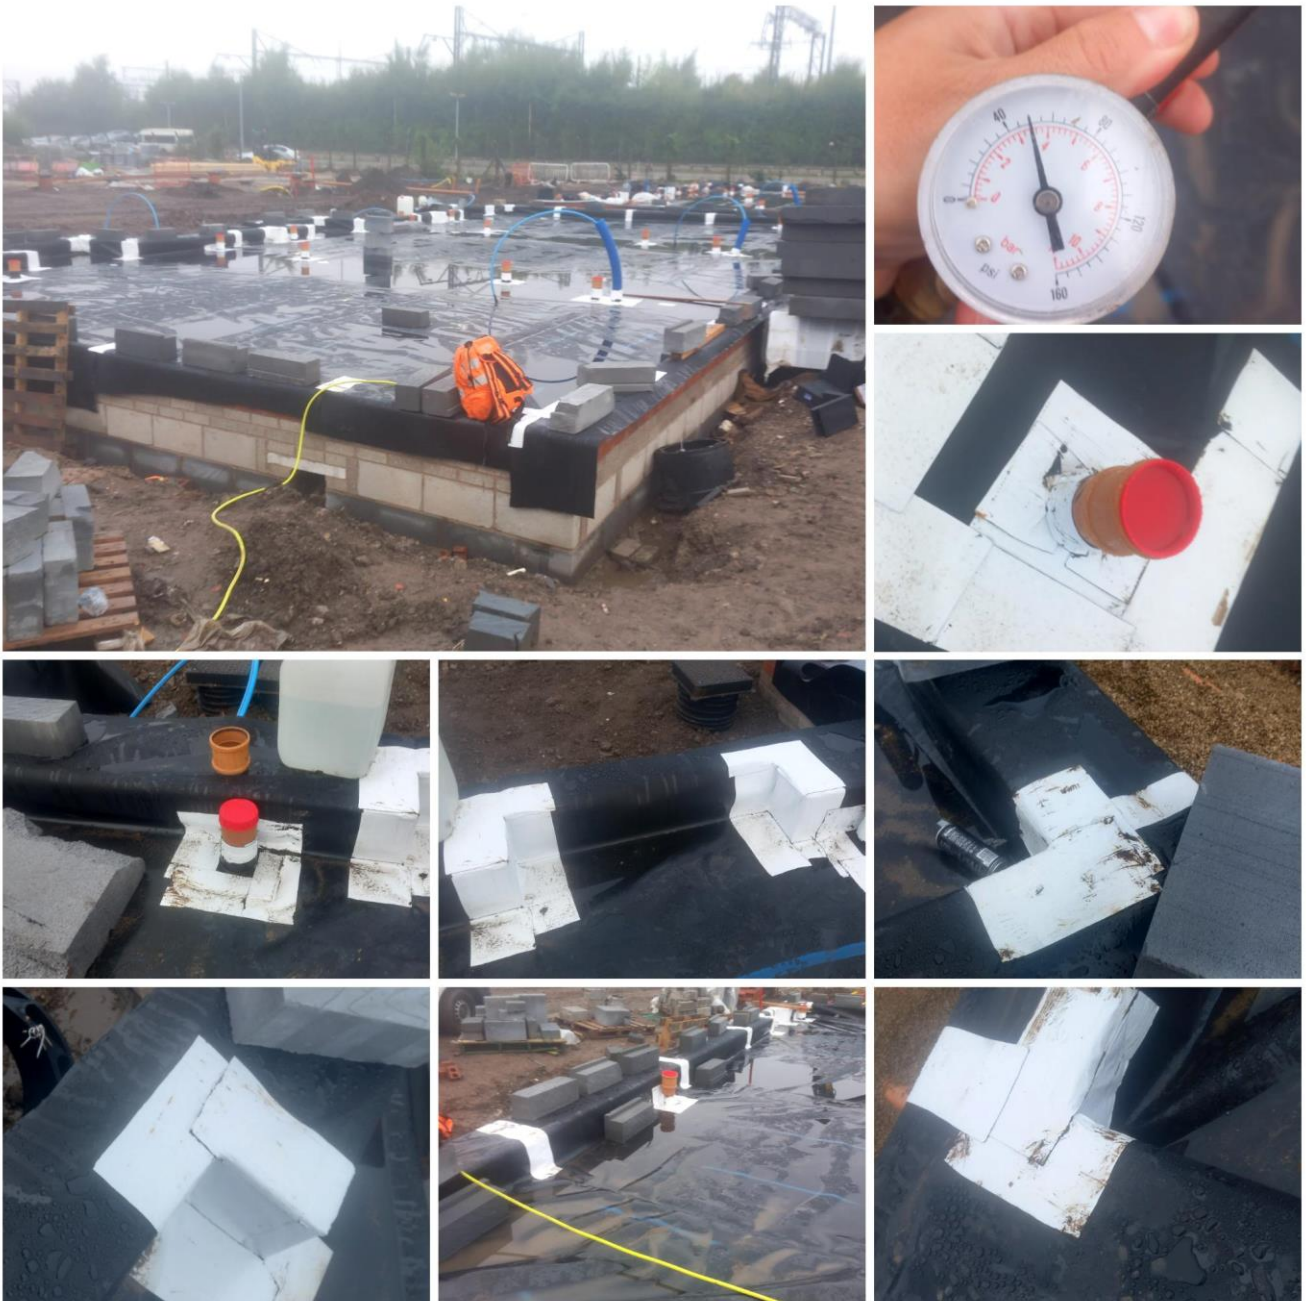
Plots 105 – 107:

On plots 105 – 111 Juta GP Titan Flex Gas Membrane (Black) and GP SAM (white) had been installed on the plot base, up over the cavity and to the edge of the outer brickwork. The pipe penetrations / service entries, corners and doorways, were sealed in situ with Juta GR SAM detailing Tape

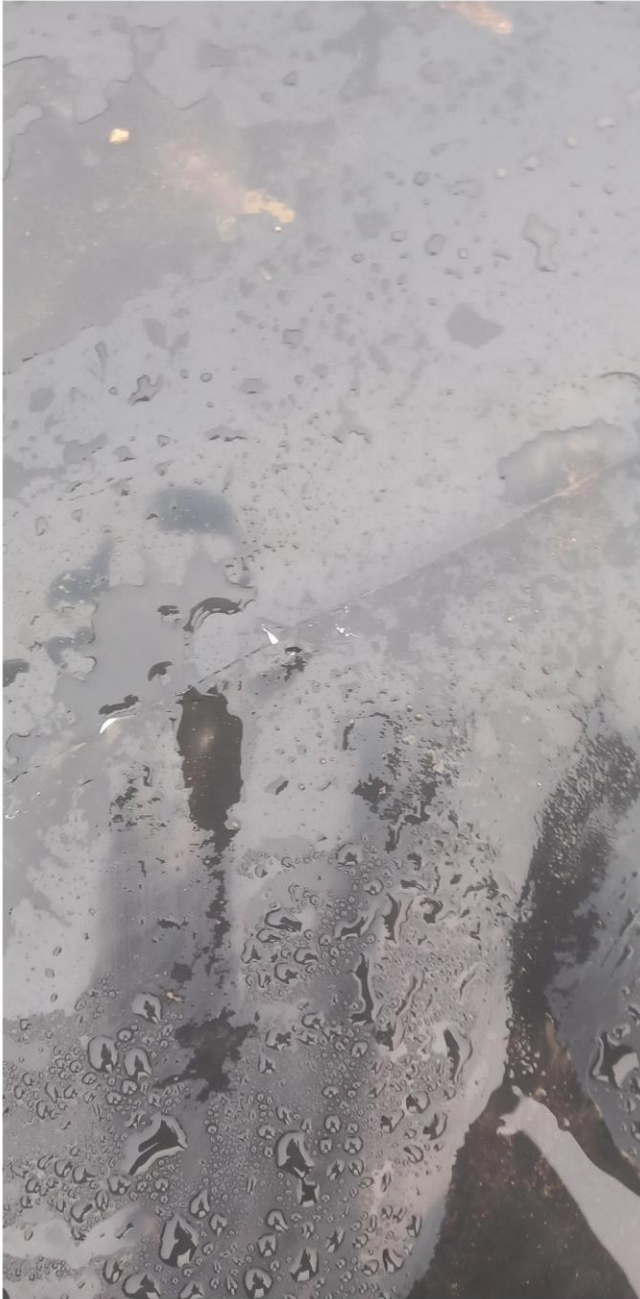
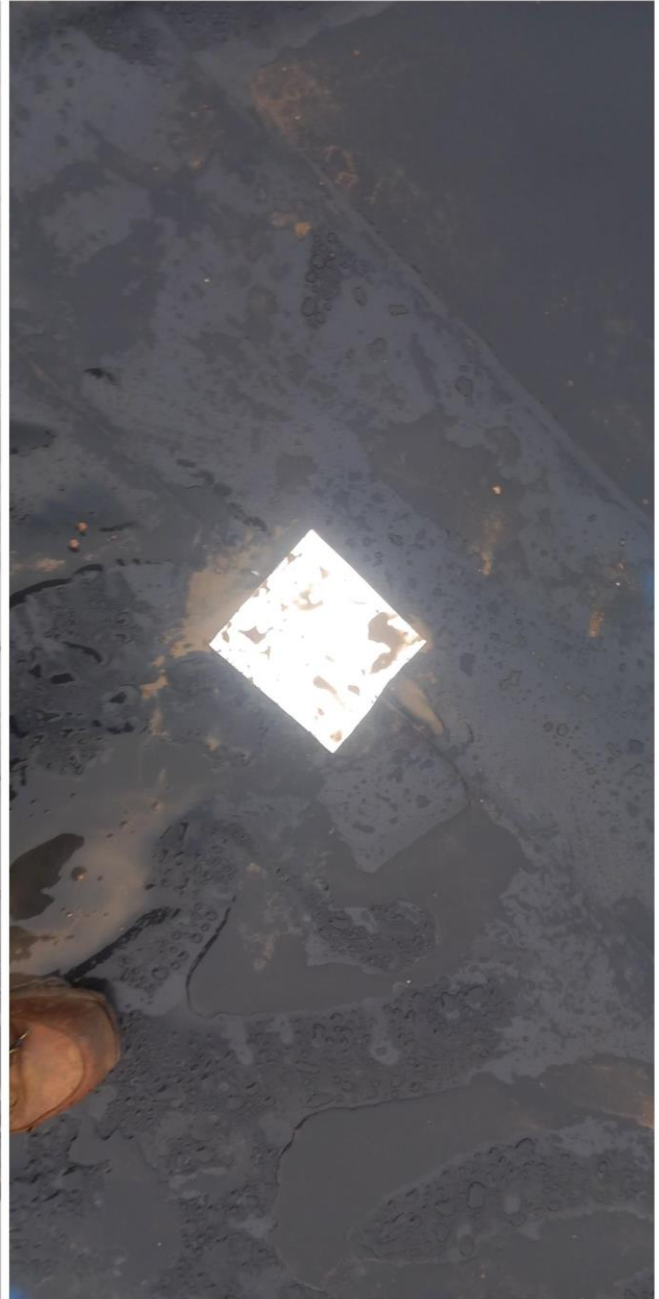
The membrane joints were welded together. All joints were air lanced at a constant 50 psi. One (1) small burn hole was found on plot 105 that was patch repaired during my site visit.

Repair carried out on plot 105:

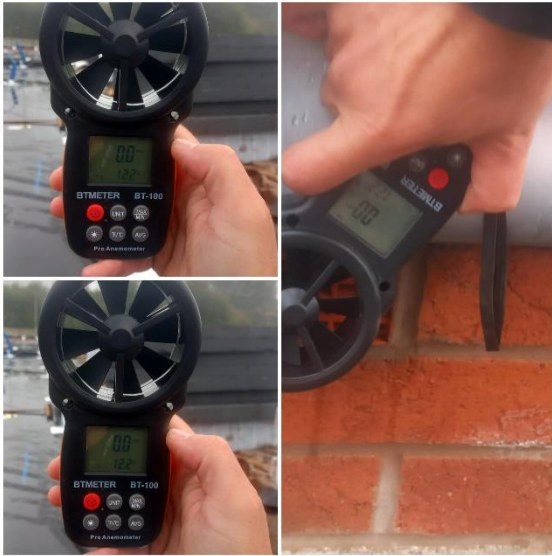
Air flow too low to register on anemometer 0.0kmh.

Air flow test:

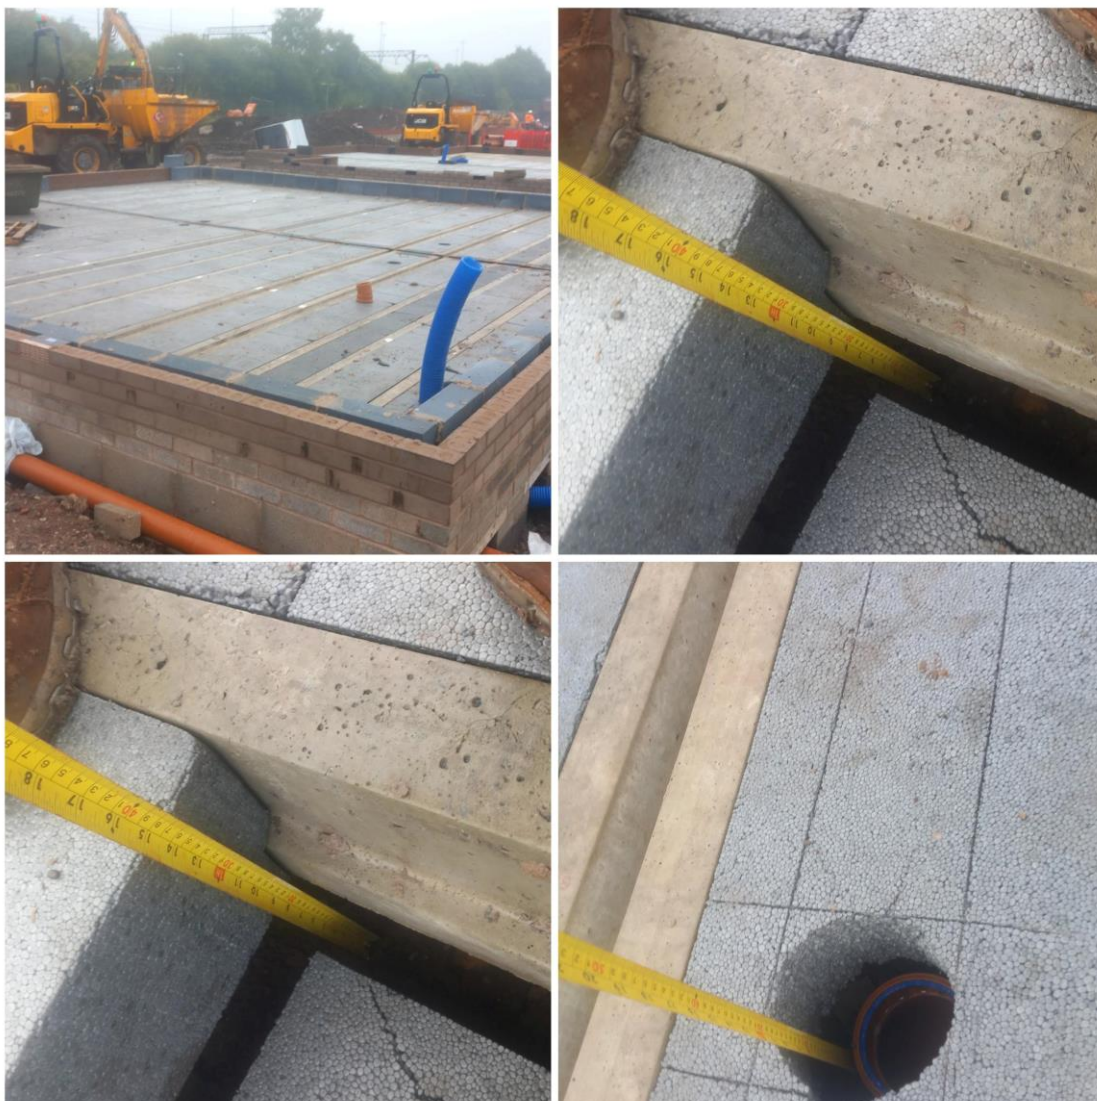
Void space measured on a future plot between 150mm – 200mm.

Example of subfloor void measurement (plot 104 & 103):

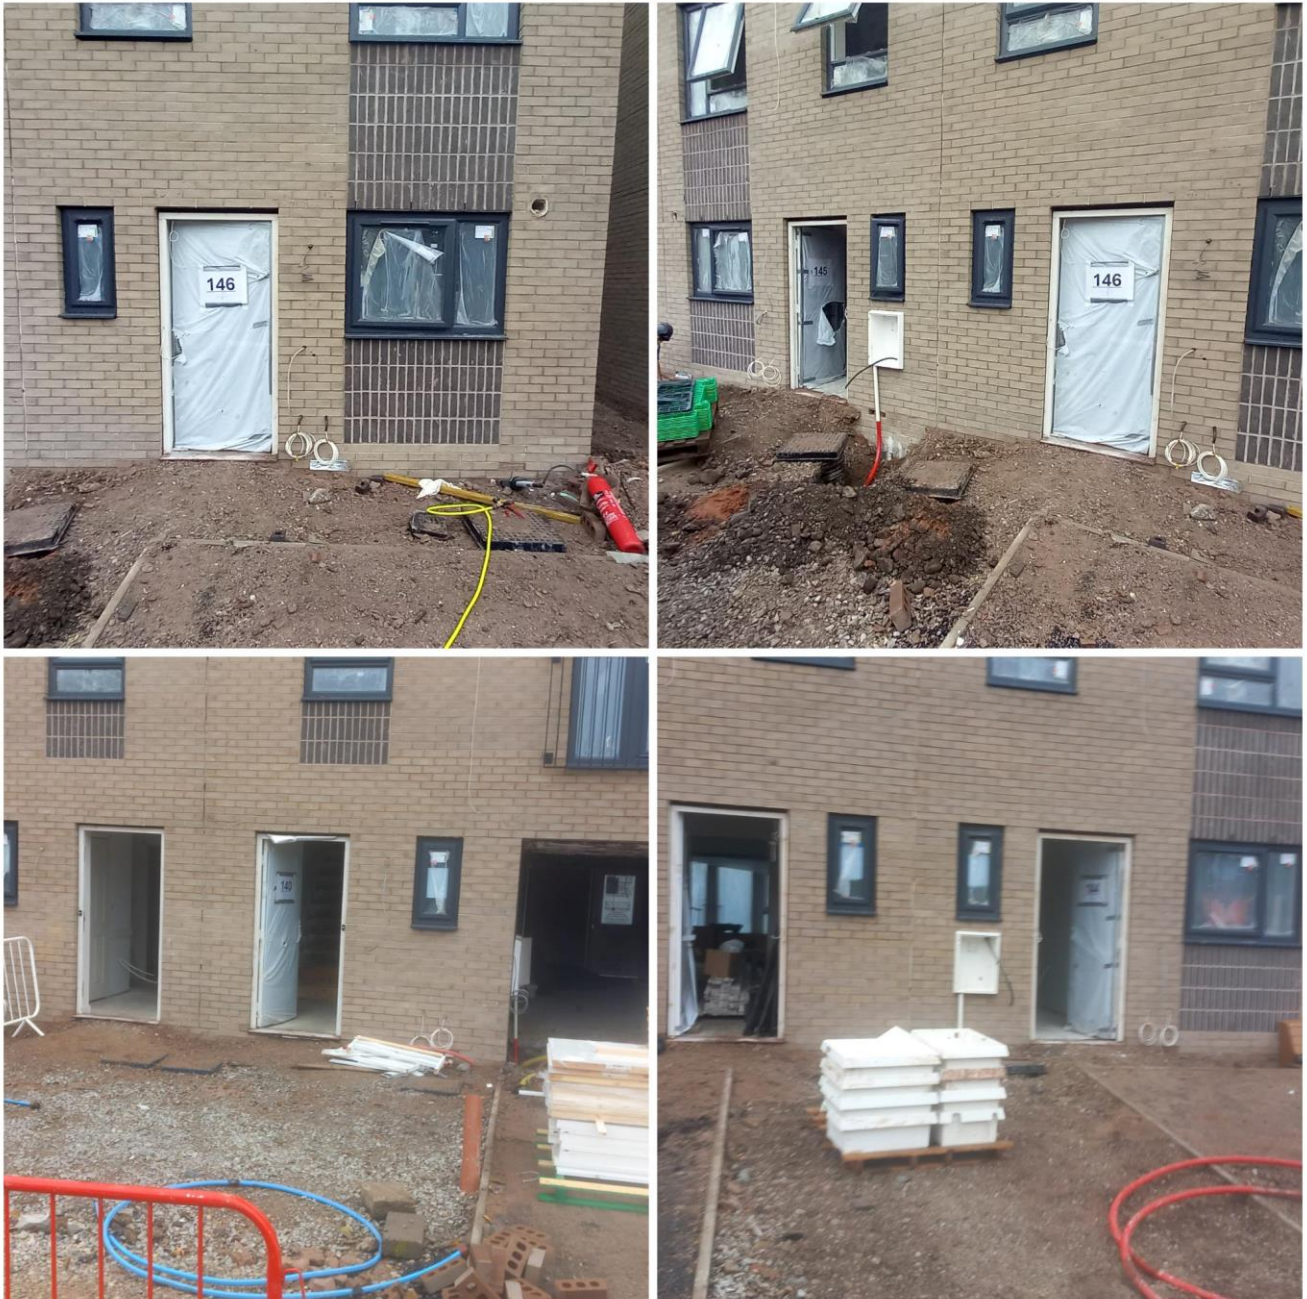
GeoEnginSeer undertook integrity testing of the membrane under the full time supervision of E3P. Integrity testing was undertaken utilising tracer gas leak detection methodologies for all plots, with one test undertaken per plot. Integrity testing results/reports are appended to this letter. The test results show that the tracer gas was present under the foundation but wasn't migrating up into the property.

Tracer gas test overview plots 139 – 146:

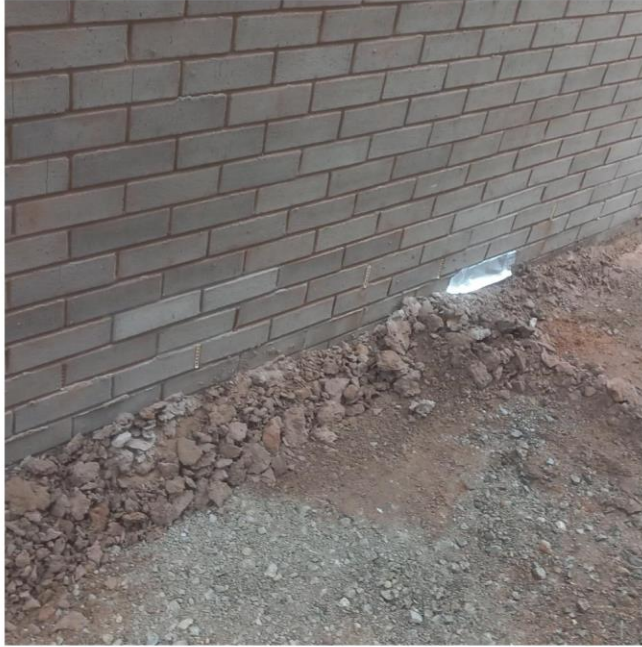
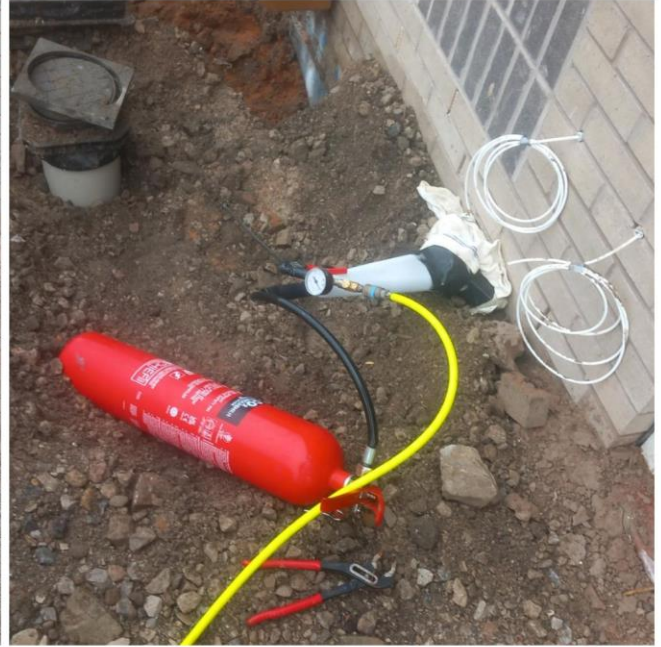
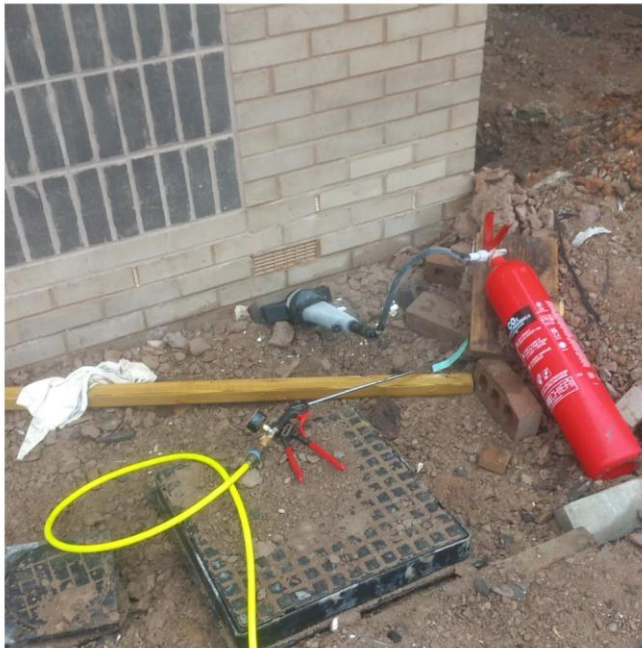
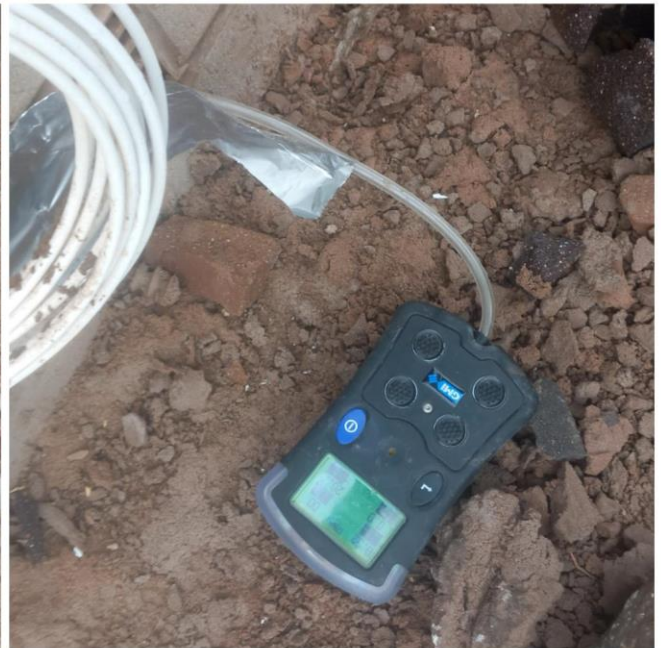
The air vents were then sealed, and a tracer gas (carbon dioxide) was pumped in through selected air vents (that were opened then re-sealed) and readings were taken on the opposite side of the property to show that the foundation of the property was filled sufficiently with the tracer gas.

Setup of tracer gas test:

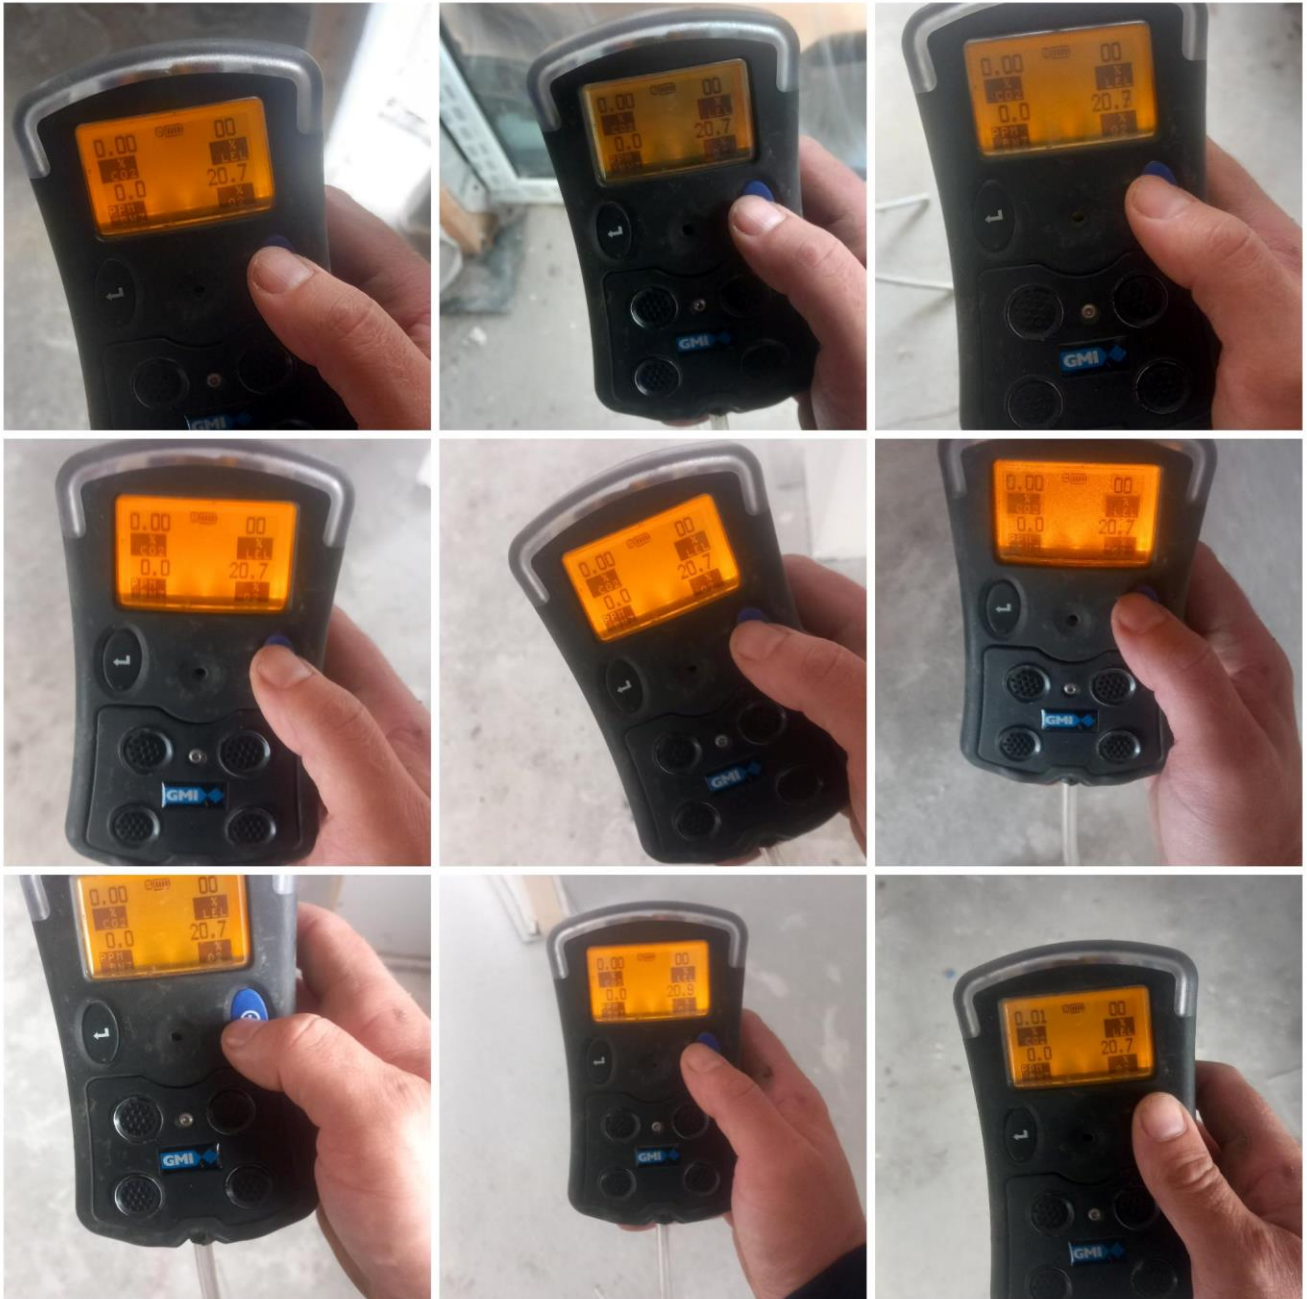
A test was carried out with the gas detector to show the tracer gas was present under the foundation.

Device readings:
