Midland Hotel  
West Elevation  
for Leonardo Hotels

Condition Survey &  
Repair Scope

PROJECT REF. 2045  
DRWG NO. P(220)  
REVISION  
SCALE AS NOTED  
DATE 1st May 25  
DRAWN HW

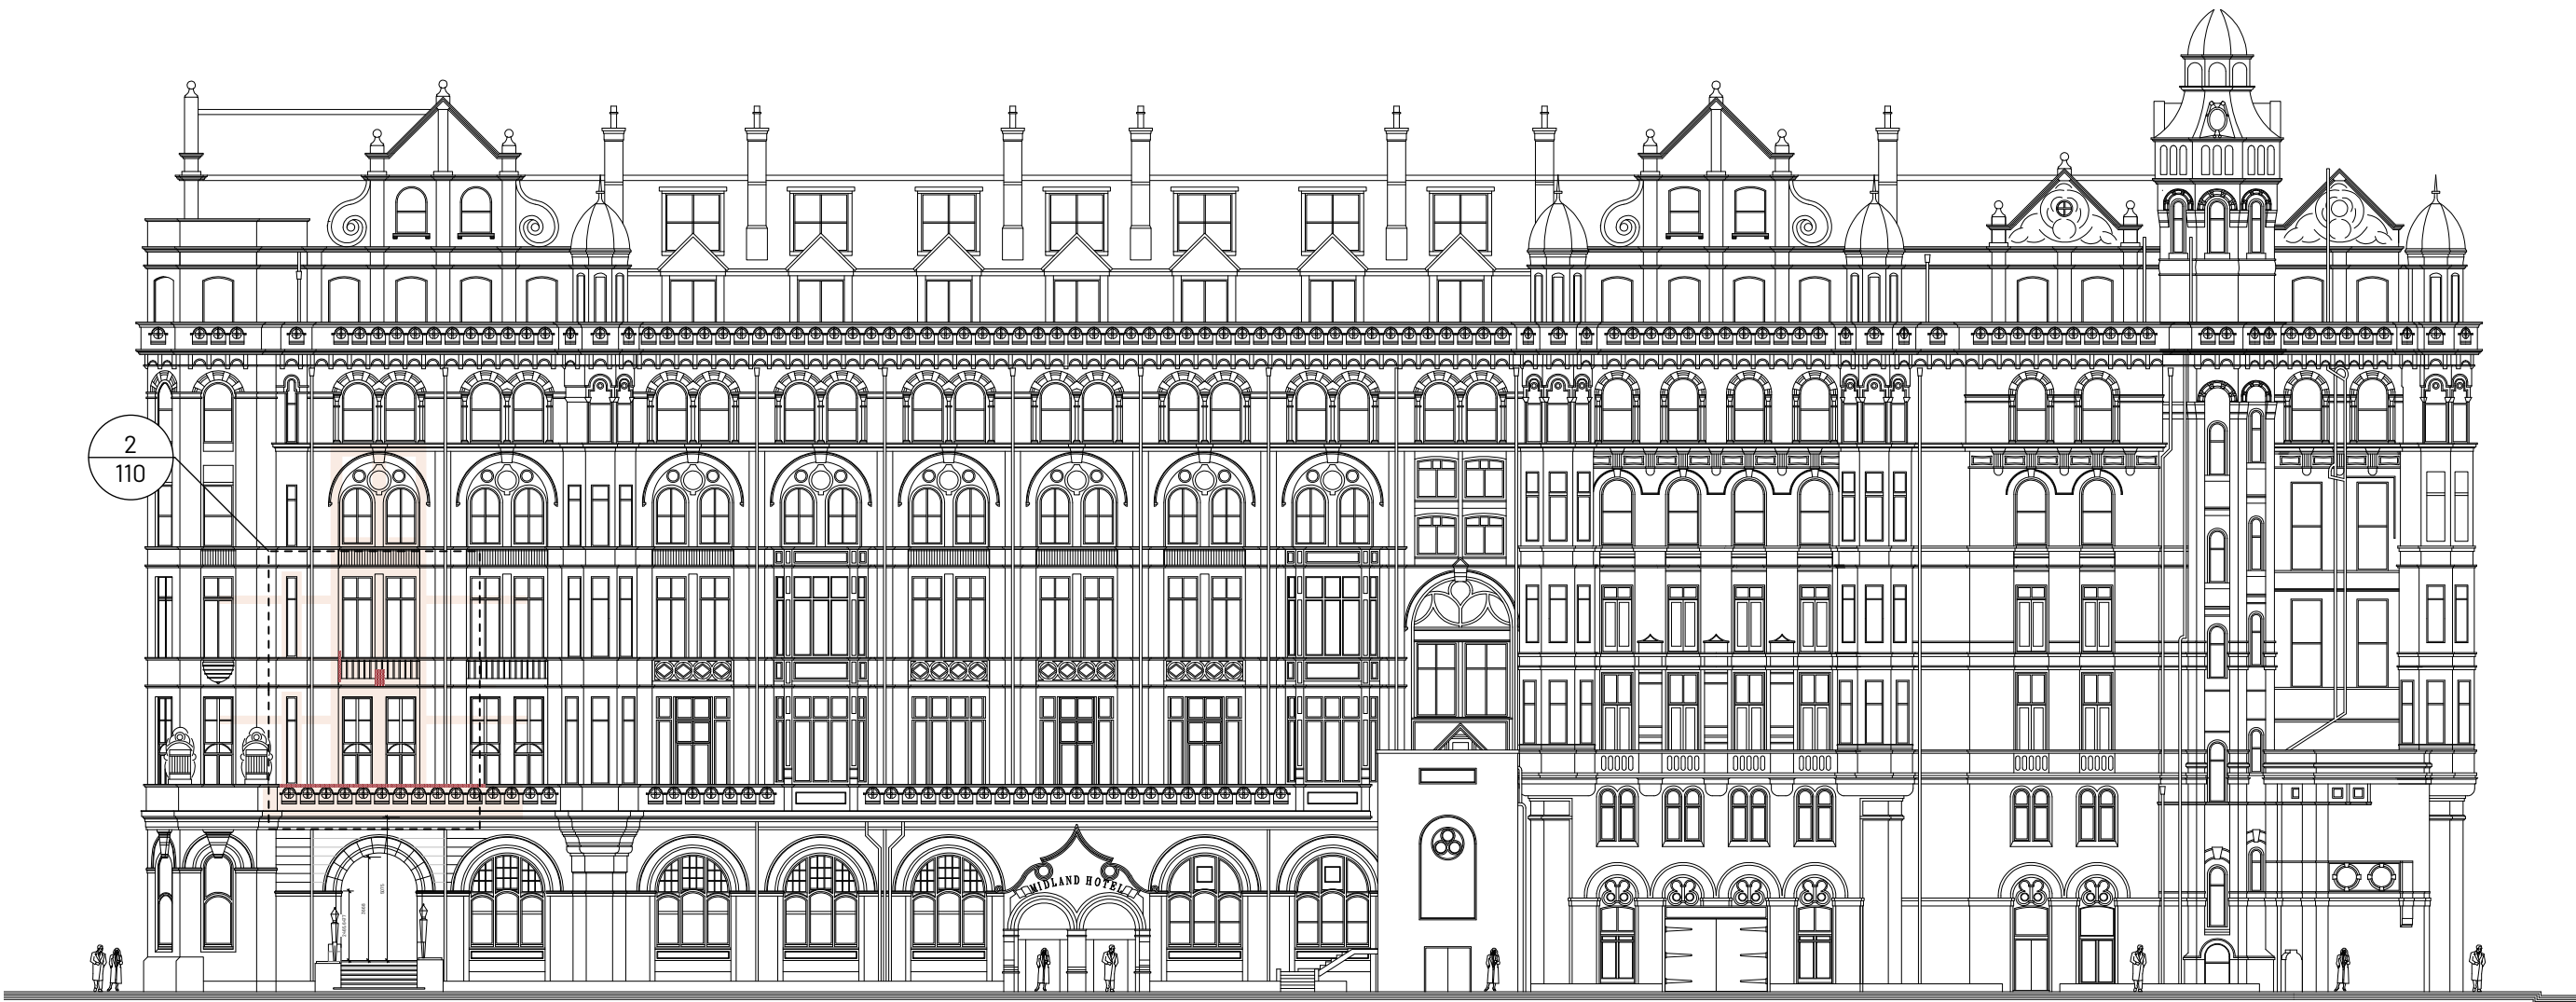
1 Mount Street Elevation  
Scale: 1:250

1. n/a
2. Cracked faience coping blocks. Clean cracks and locally remove paint finish to facilitate repairs. Fill faience cracks with lime mortar or repair mortar suitable for terracotta work, and finish with guilding size and sealant - colour and sheen to match adjacent faience.
3. Cracked glass to be replaced - like for like
4. Spalling brick to be removed and replaced - like for like
5. Remove localised loose material around faience cracks. Remove paint locally from balustrade, remove rust and apply zinc rich protective coating. Fill faience cracks with lime mortar or repair mortar suitable for terracotta work, and finish with guilding size and sealant - colour and sheen to match adjacent faience. Redecorate balustrade.
6. Peeling paint to outer face of glass to be removed and replaced with obscured film on inner face.
7. N/A
8. N/A
9. N/A
10. N/A
11. N/A
12. N/A
