Bennet Street

# Cornbrook Culvert Condition Survey

Ref. 222-176

# Bennet Street Culvert Survey- Comprehensive Report and Recommendations

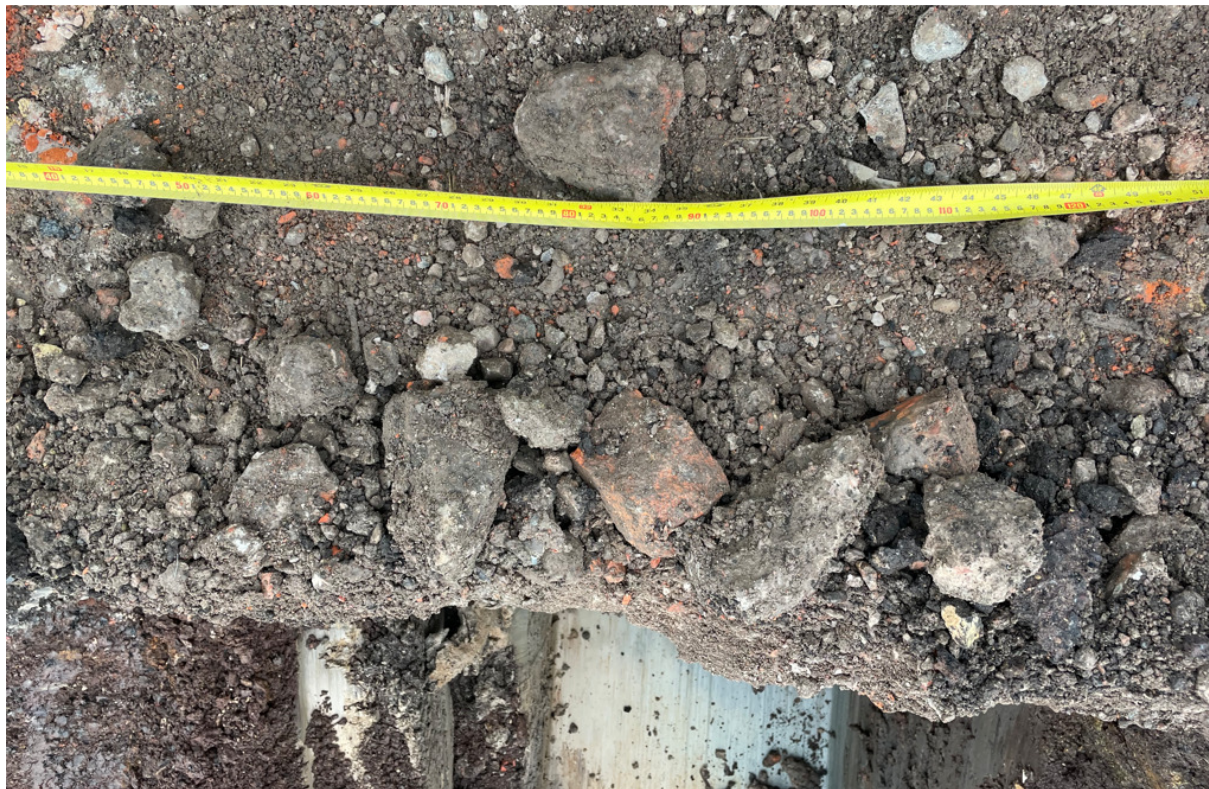
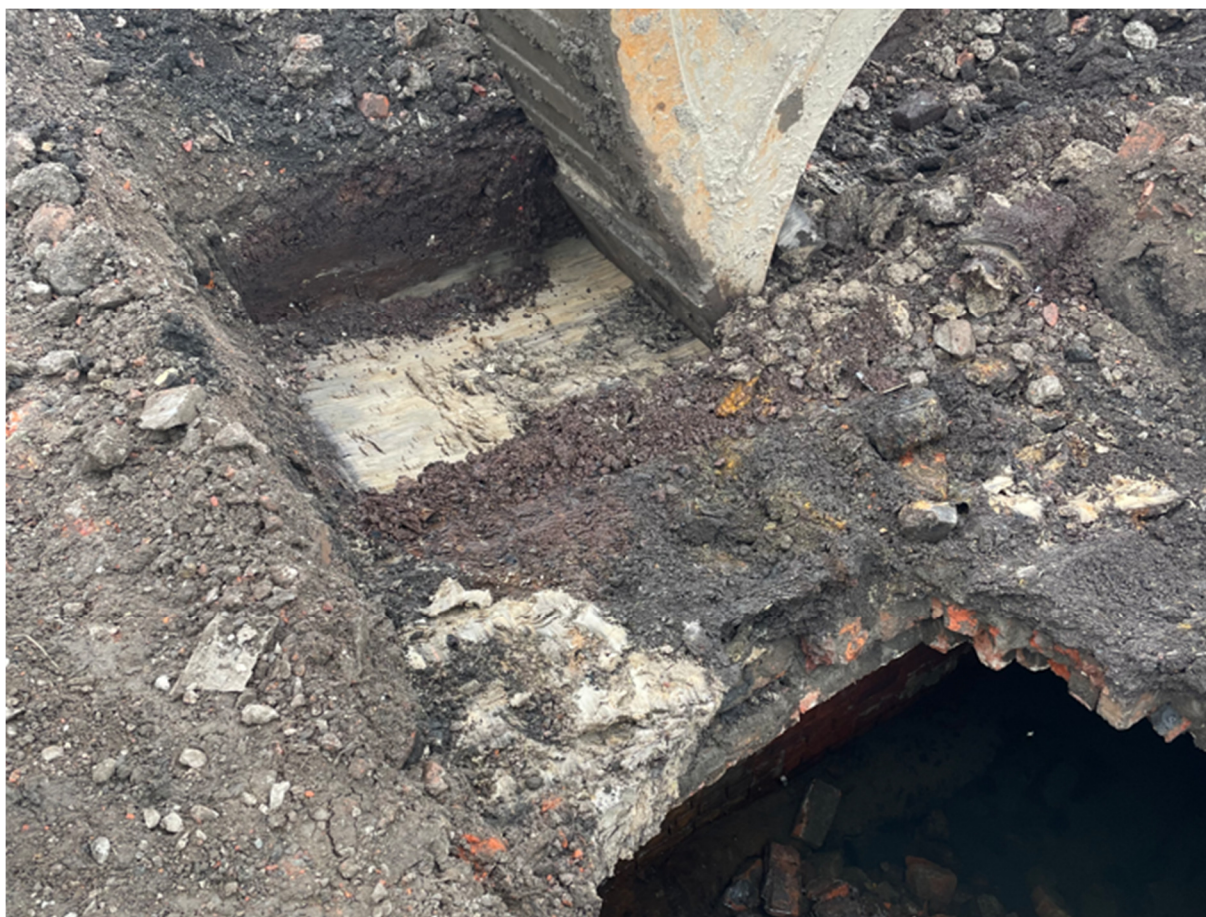
- A partial collapse of the culvert's brick archway was noted, resulting in a 1.5m diameter opening.
- The reduced ground cover above the culvert was identified as a contributing factor to the structural failure, as it limited the arch's capacity to distribute the applied loads.
- Debris and loose bricks were observed within the culvert, but it was confirmed that water flow remained largely unobstructed at the time of inspection.
- Ground investigations revealed a layer of site fill material, approximately 500mm thick, above a stiff clay layer encountered at a depth of approximately 1m. The clay stratum provided sufficient bearing capacity for the proposed remedial measures.

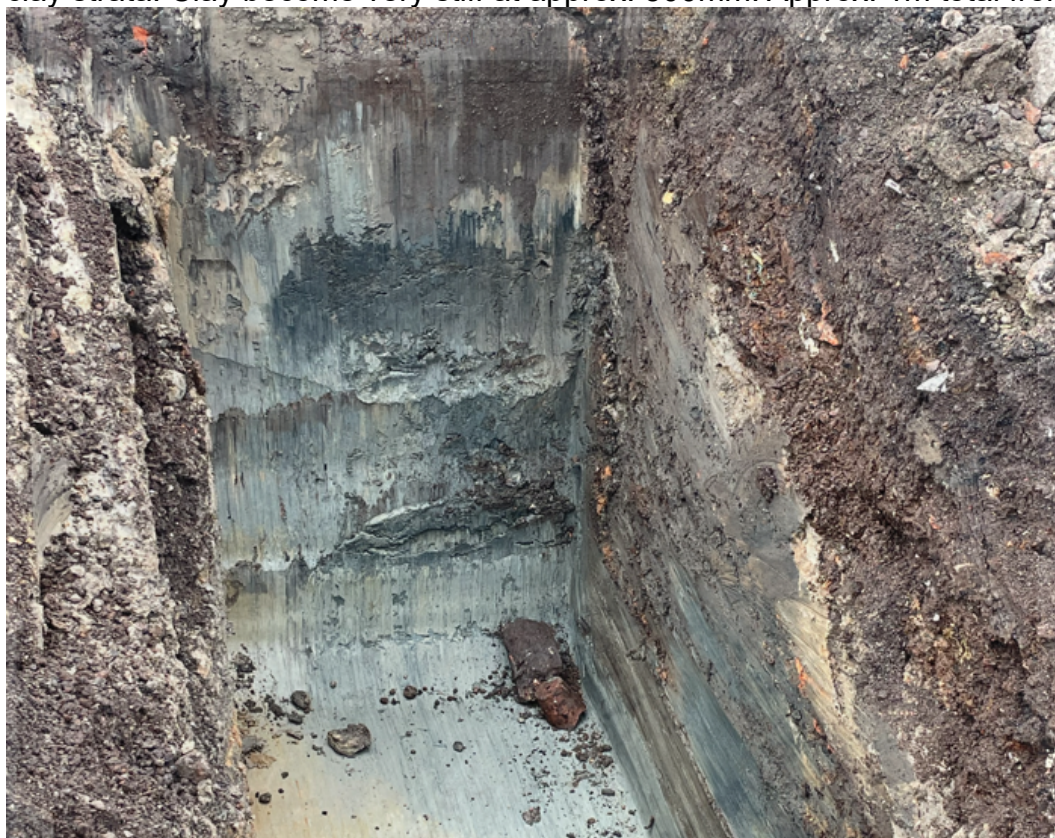
There was approx. 400/500 of existing site fill/stone from E.G.L until we reached the clay strata. Clay become very stiff at approx. 500mm. Approx. 1m total from E.G.L

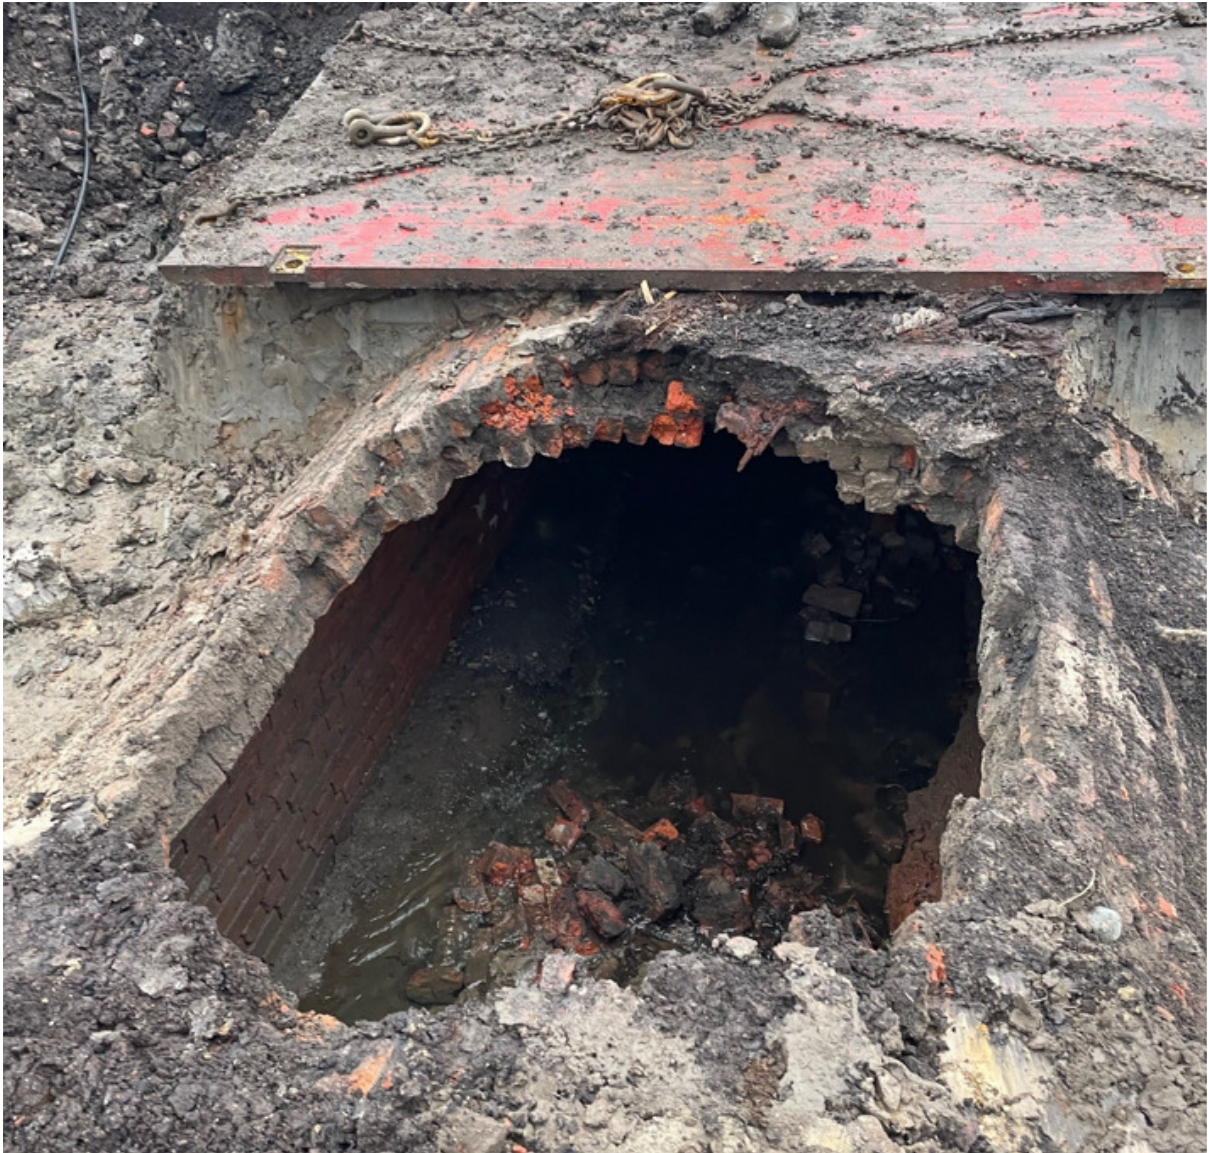
A video can be issue don required which shows the current flow
