**SDS Ltd**  
DRAINAGE SPECIALIST

## CCTV Inspection Report

**Liverpool Road, Manchester, Off Deansgate**

**28/01/2025**

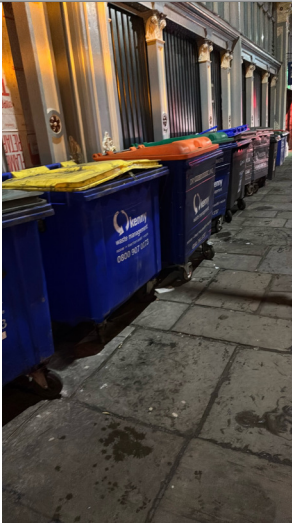
**Other Site Photos:** No MH underneath bins

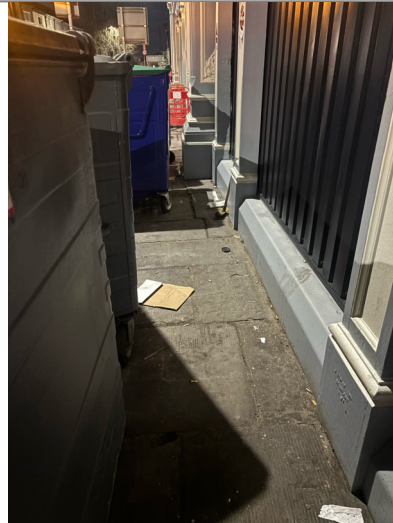
**Other Site Photos:** No MH as shown on plan

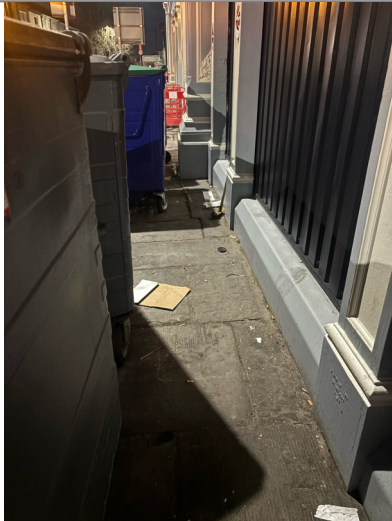
**Other Site Photos:** No MH as shown on plan

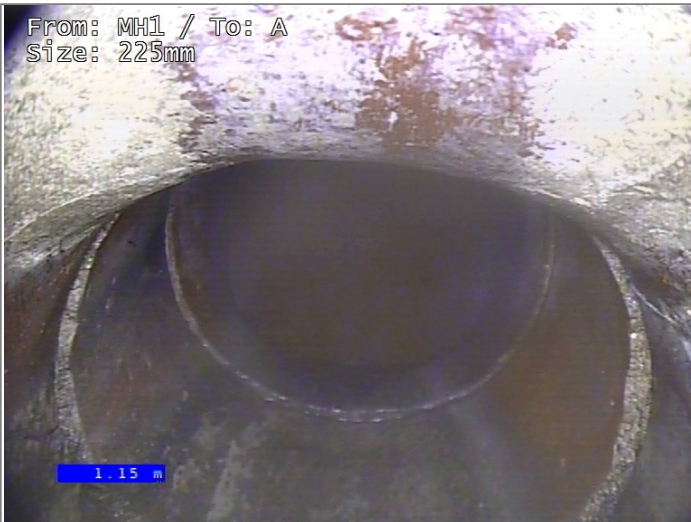
| Start Node Ref:MH1 I/L : metres | | | | | Photo | Type/Grade | |
|---|---|---|---|--|---|---|---|
| | 1.30 | LU | Line of drain/sewer deviates up - Remark: SHARP | | | 11161299 | Comment / 0 |

Line of drain/sewer deviates up - Remark: SHARP

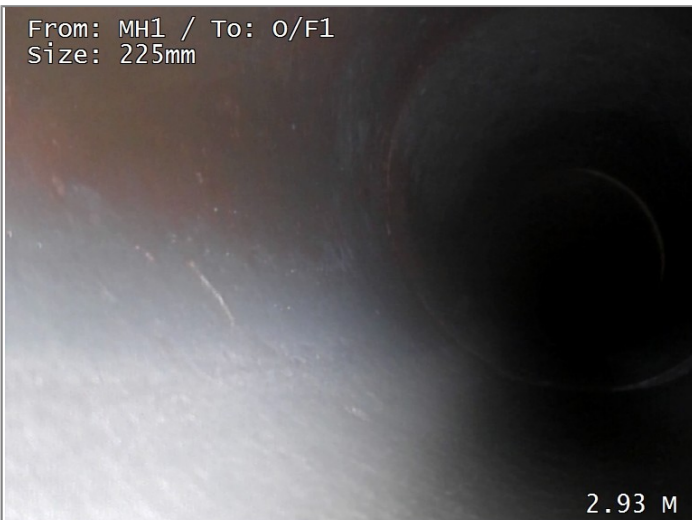
Line of drain/sewer deviates right

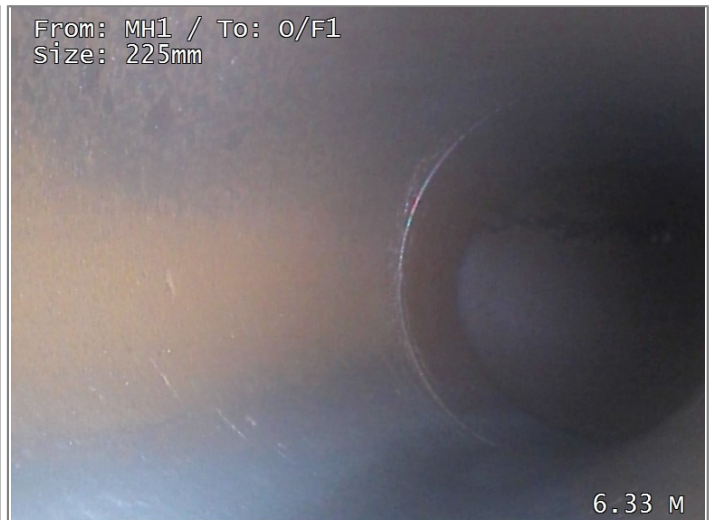
Line of drain/sewer deviates right

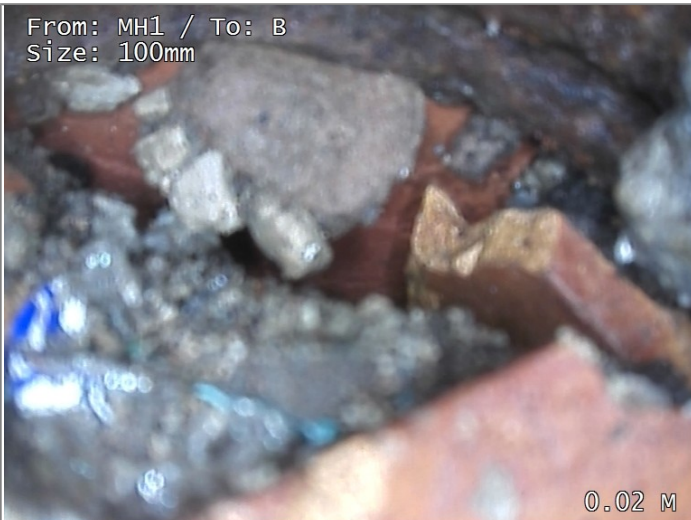
Manholes: **MH1 to B**  
Pipe Length: **0.02 metres**  
Structural Grade: **5**  
Service Grade: **0**  
Material: **Cast iron**  
Pipe Size: **100mm**  
Use: **Surface water**

Collapsed drain/sewer 100%

| Job Number<br>28.01.2025 | | | | Surveyed by (Operator)<br>Aaron | | | Base Unit<br>FRLS86BI29 | | | Date<br>28/01/2025 | | | |
|---|---|---|---|---|---|---|---|---|---|---|---|---|---|
| 3 | B X | U | S | 100 | 28/01/2025 | Cast iron | 0.02 metres | 0.02 | | 165 | 5 | 8,250.00 | 165 |

| Job Number<br>28.01.2025 | Surveyed by (Operator)<br>Aaron | Base Unit<br>FRLS86BI29 | Date<br>28/01/2025 |
|---|---|---|---|
| <p>5: Pipe is already or will shortly be impermeable: Eg. collapsed pipe, deeply rooted pipe or other drainage obstructions. Pipe loses water or danger of backwater in basements etc.</p> <p>REHABILITATION IS URGENT AND SHORT-TERM. IN ORDER TO PREVENT FURTHER DAMAGE,<br/>NECESSARY TEMPORARY SPOT REPAIR HAS TO BE CONDUCTED ON EMERGENCY LEVEL.</p> | | | |

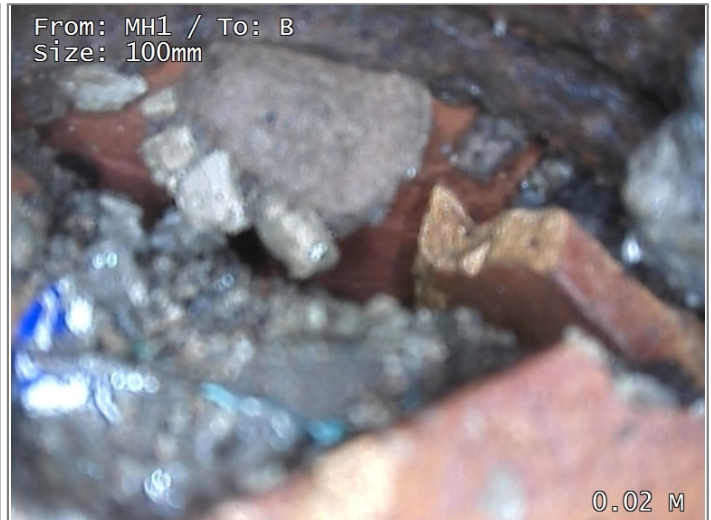
Survey abandoned - Remark: DUE TO COLLPASE
