Date: 22nd October 2024  
Reference: 15-974 V16

## GAS MEMBRANE VALIDATION – BENNETT STREET

| <b>Project Name:</b> | Bennett Street |
| <b>Plot:</b> | 91-94, 97, 98 |

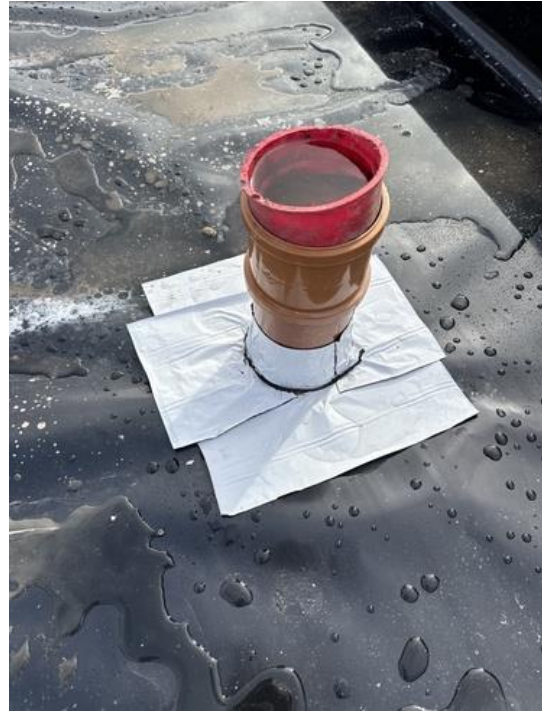
Photo 1

| Service entries seals: Top hats seal arrangements fixed around service entries? Use of Jubilee clips or Bitumastic Sealant | Pass |

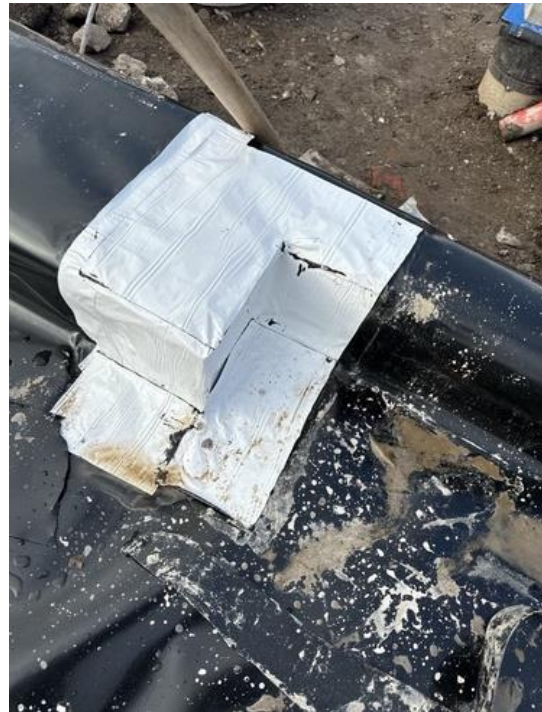
Photo 7

| Corners / Internal joints: Check all corners are correctly formed or contractor has used preformed corners. | Pass |

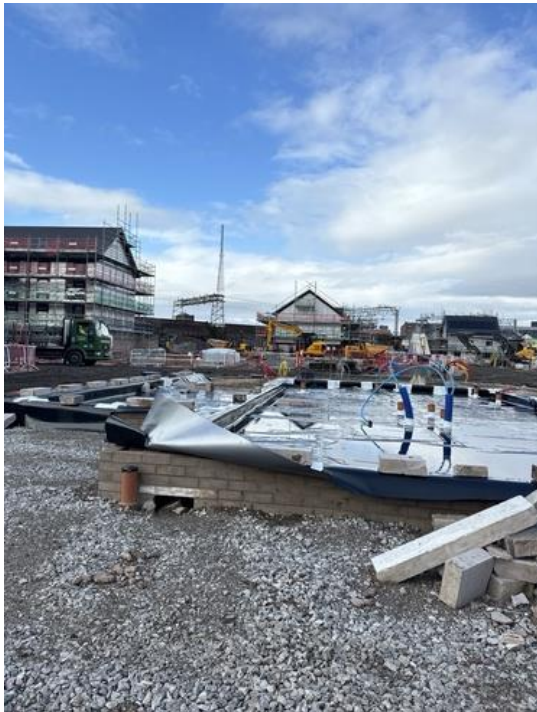
Photo 10

Extent of Coverage: Is the membrane covering the entire plot?  
Does membrane span over outside walls?

Yes

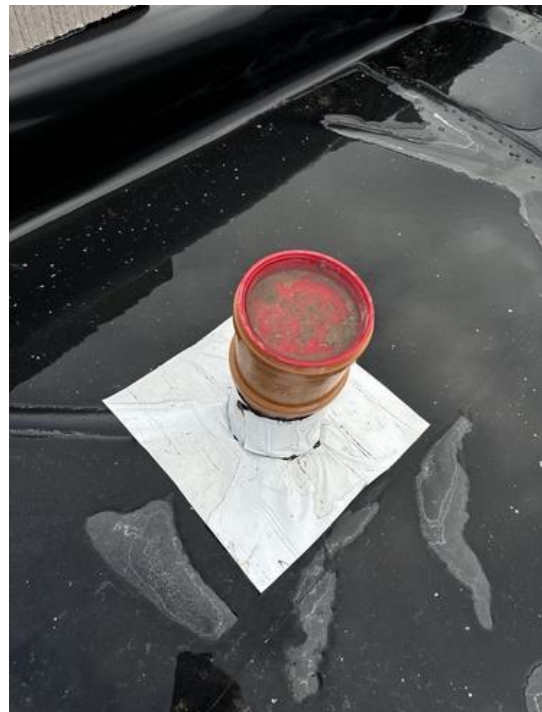
Photo 15

| Service entries seals: Top hats seal arrangements fixed around service entries? Use of Jubilee clips or Bitumastic Sealant | Pass |

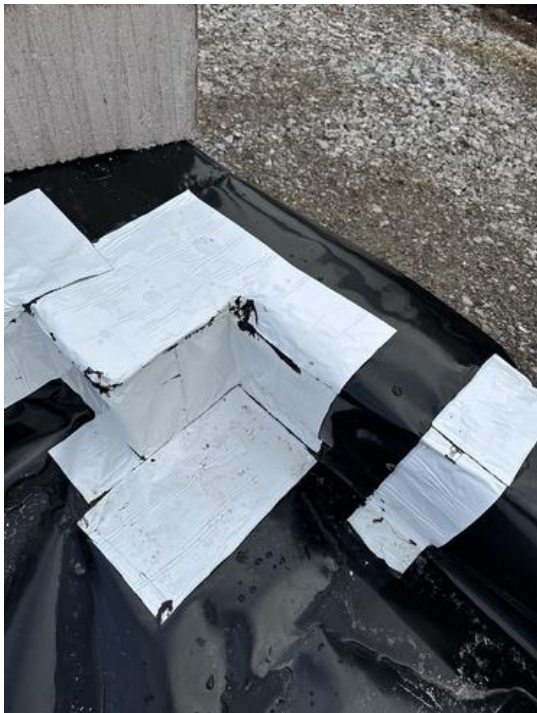
Photo 20

| Corners / Internal joints: Check all corners are correctly formed or contractor has used preformed corners. | Pass |

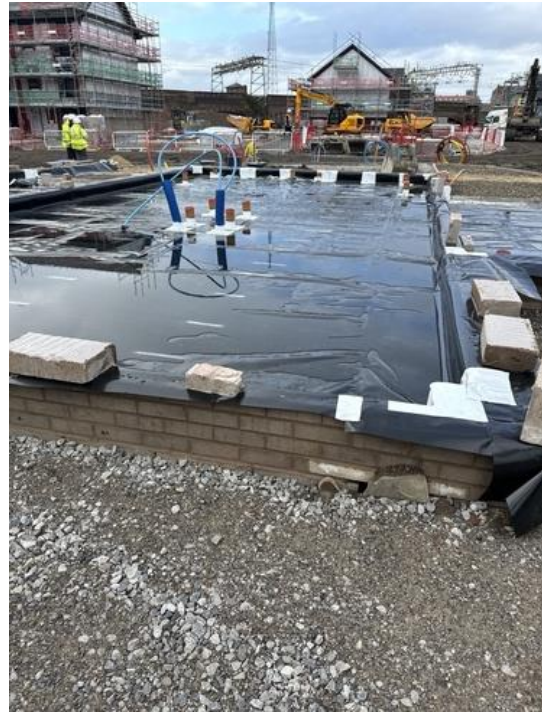
Photo 25

| Extent of Coverage: Is the membrane covering the entire plot?<br>Does membrane span over outside walls? | Yes |

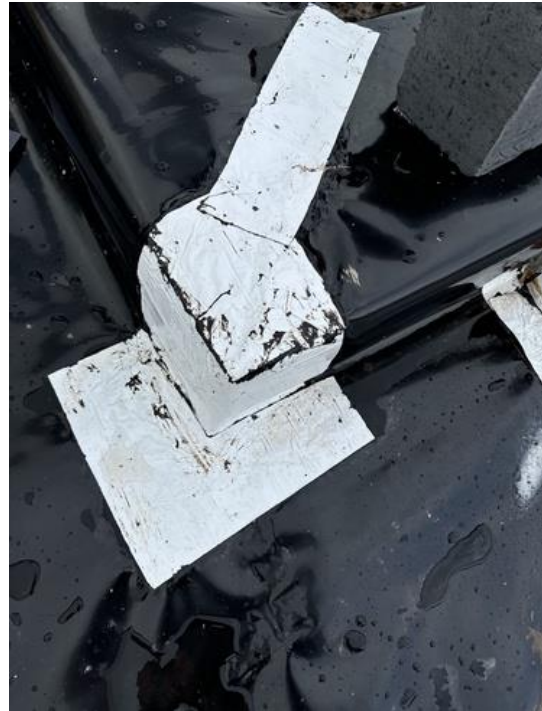
Photo 41

| Corners / Internal joints: Check all corners are correctly formed or contractor has used preformed corners. | Pass | |

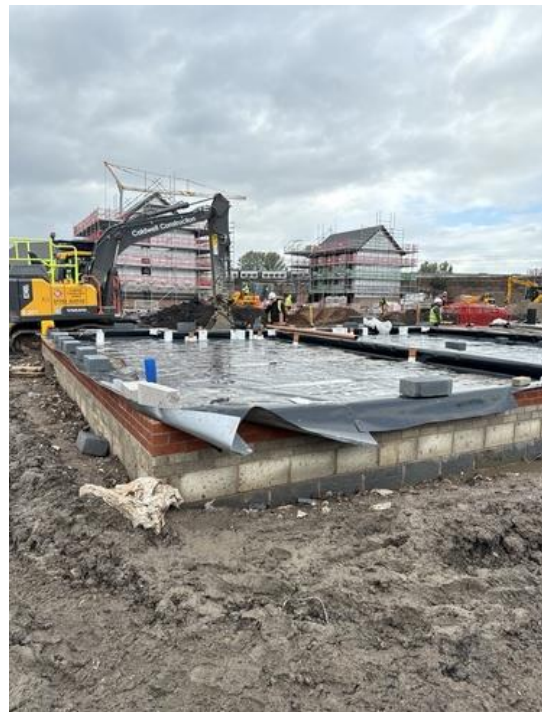
Photo 47

Extent of Coverage: Is the membrane covering the entire plot?  
Does membrane span over outside walls?

Yes

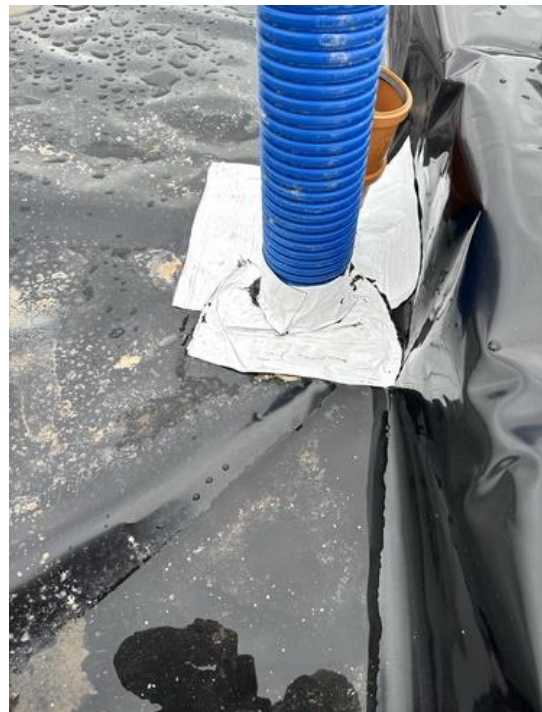
Photo 51

Service entries seals: Top hats seal arrangements fixed around service entries? Use of Jubilee clips or Bitumastic Sealant

Pass

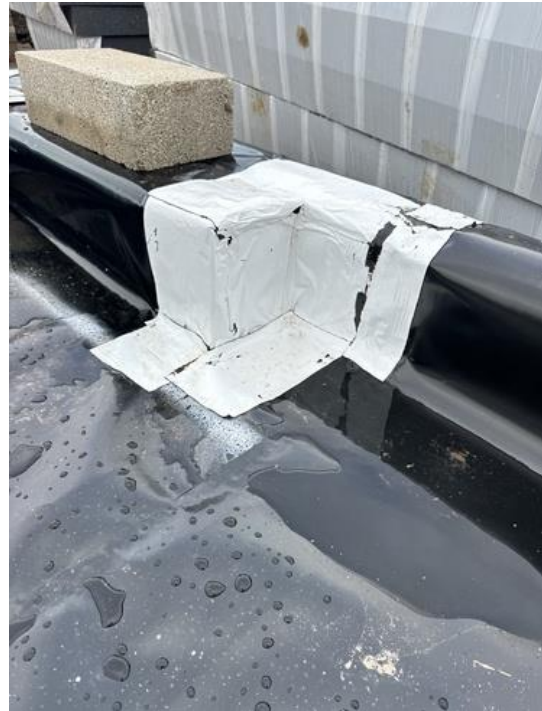
Photo 57

Corners / Internal joints: Check all corners are correctly formed or contractor has used preformed corners.

Pass

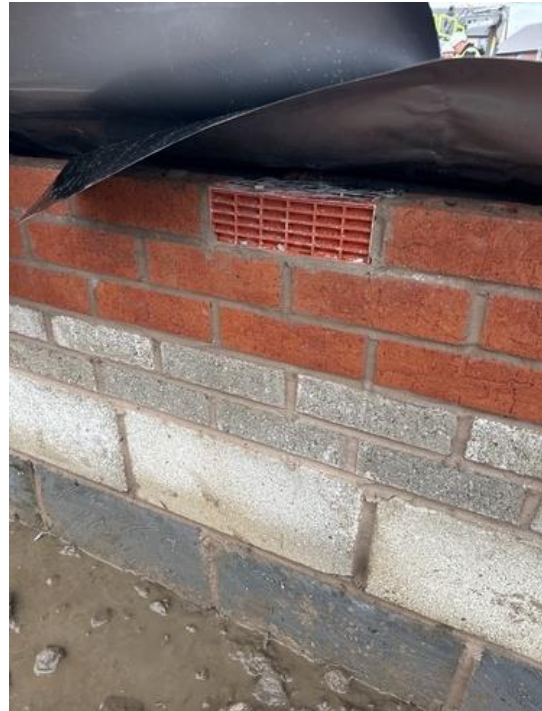
Photo 69

Extent of Coverage: Is the membrane covering the entire plot? Does membrane span over outside walls?

Yes

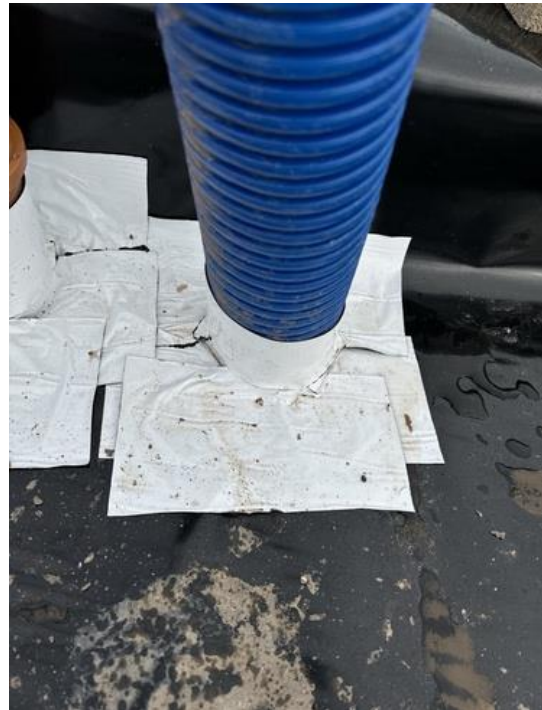
Photo 71

| Service entries seals: Top hats seal arrangements fixed around service entries? Use of Jubilee clips or Bitumastic Sealant | Pass |

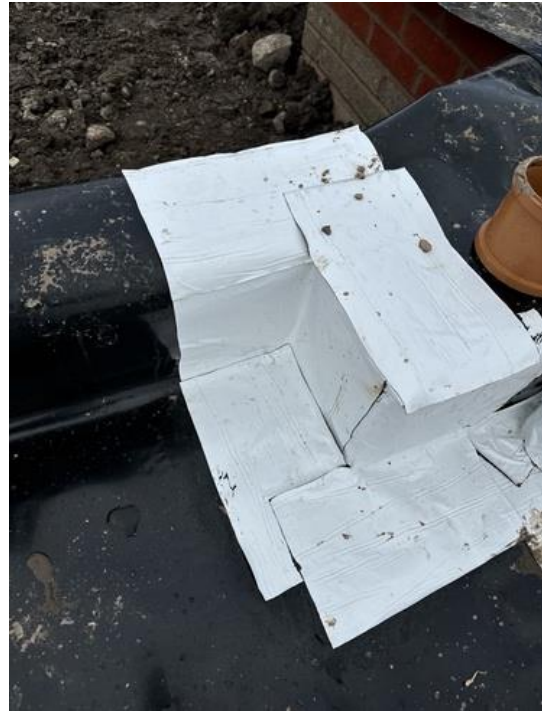
Photo 77

**Corners / Internal joints:** Check all corners are correctly formed or contractor has used preformed corners.

Pass

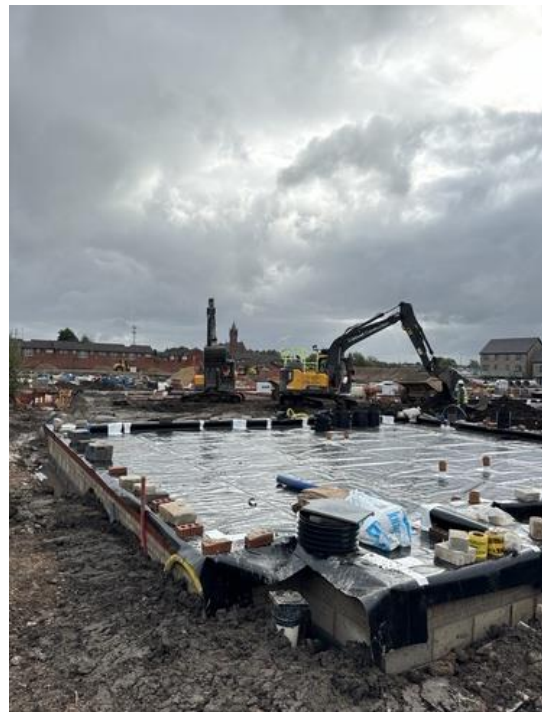
Photo 87

**Extent of Coverage:** Is the membrane covering the entire plot?  
Does membrane span over outside walls?

Yes

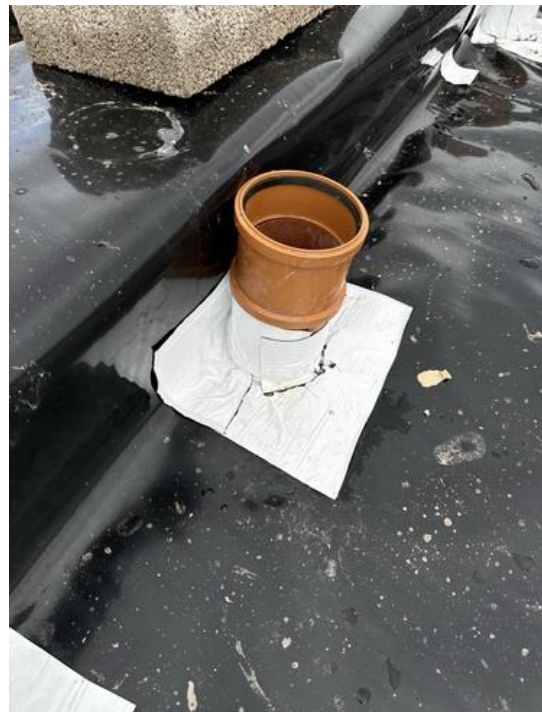
Photo 91

| Service entries seals: Top hats seal arrangements fixed around service entries? Use of Jubilee clips or Bitumastic Sealant | Pass | |

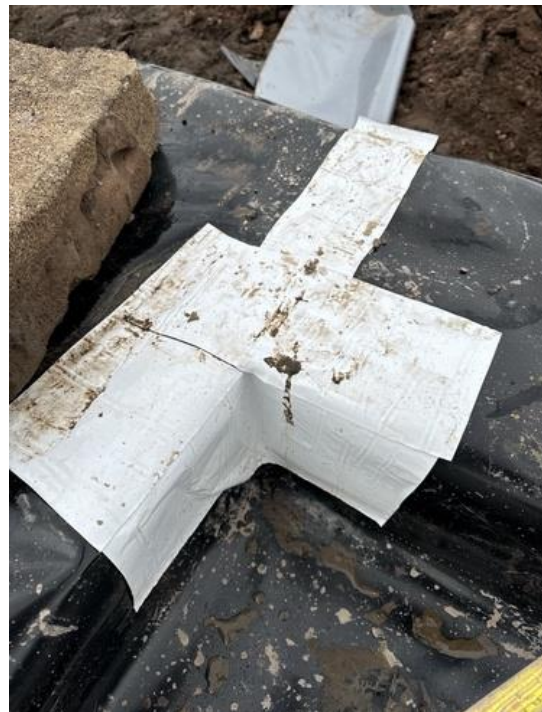
Photo 99

| Corners / Internal joints: Check all corners are correctly formed or contractor has used preformed corners. | Pass | |

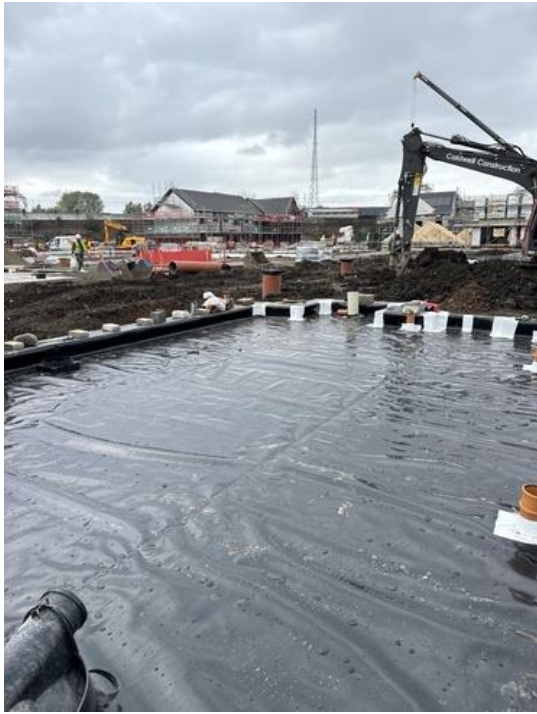
Photo 108

Extent of Coverage: Is the membrane covering the entire plot?  
Does membrane span over outside walls?

Yes
