Date: 6<sup>th</sup> September 2024  
Reference: 15-974 V12

## GAS MEMBRANE VALIDATION – BENNETT STREET

| <b>Project Name:</b> | Bennett Street |
| <b>Plot:</b> | 117-118 |

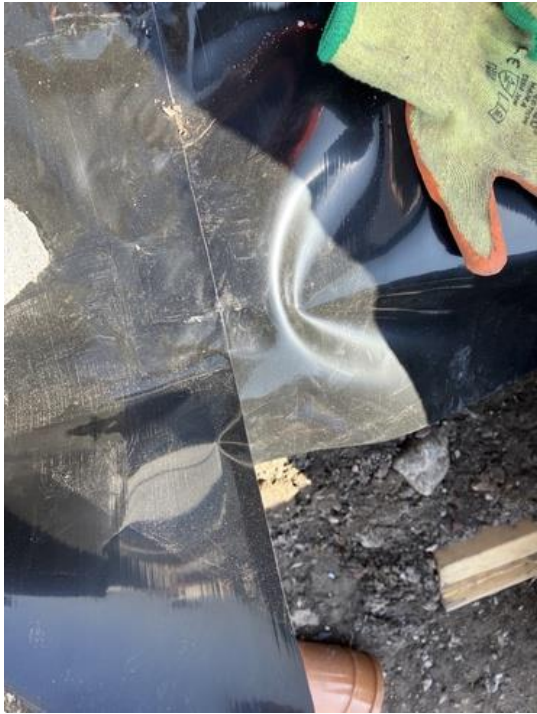
Photo 1

| <b>Gas Membrane Condition: Open punctures, tears, rips, stretching, Presence of debris, Repairs, Signs of weakness such as raised or sunken indentations, Protection plan in place to restrict access to lain gas membrane? IF FAIL DESCRIPTION IN ACTIONS AND PHOTOS REQUIRED</b> | Pass |
| <b>Are welds complete?</b> | Yes |

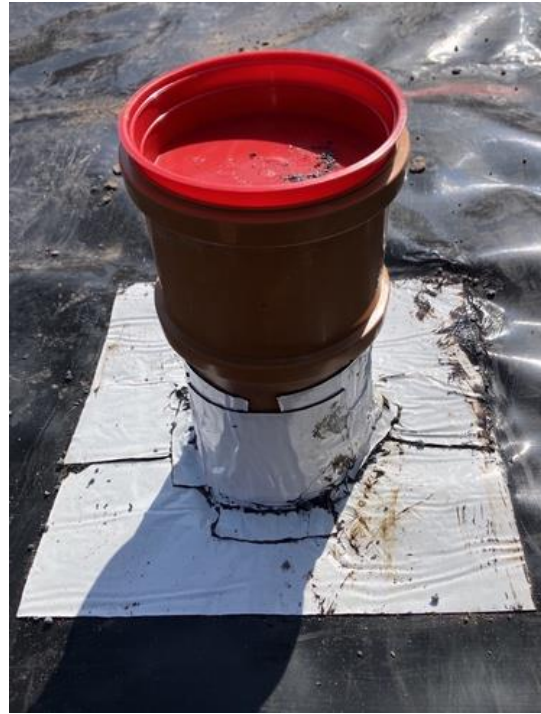
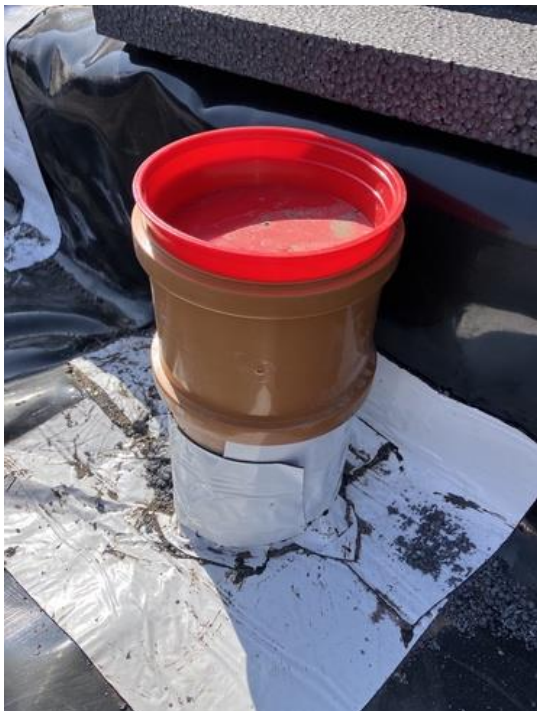
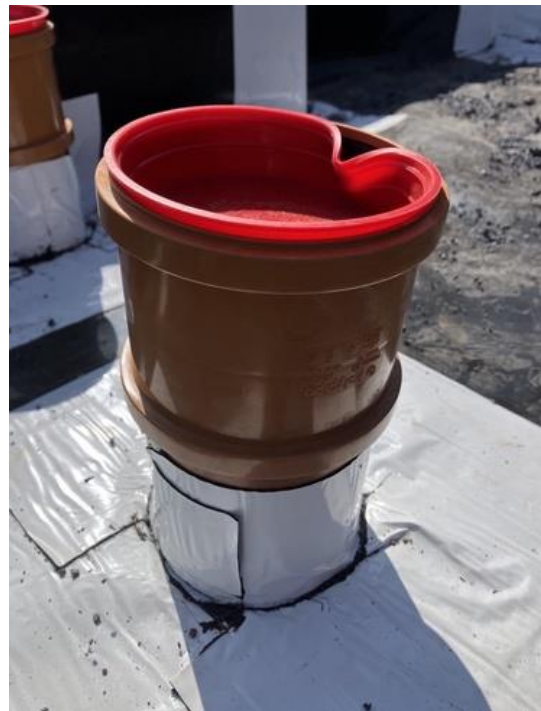
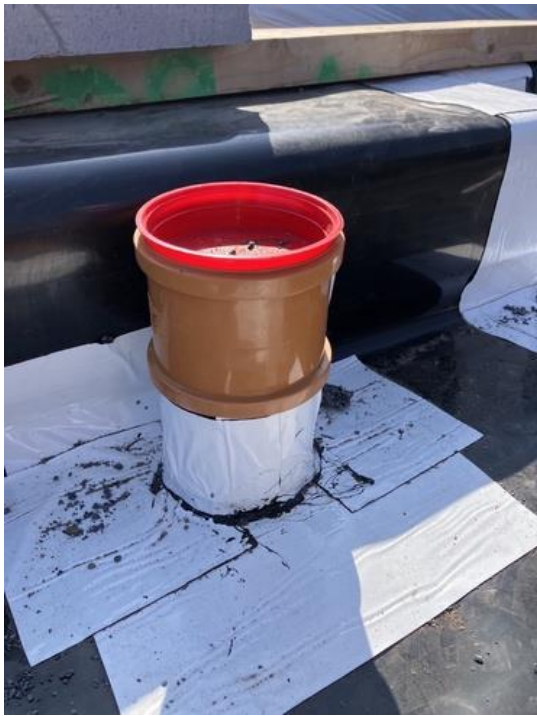
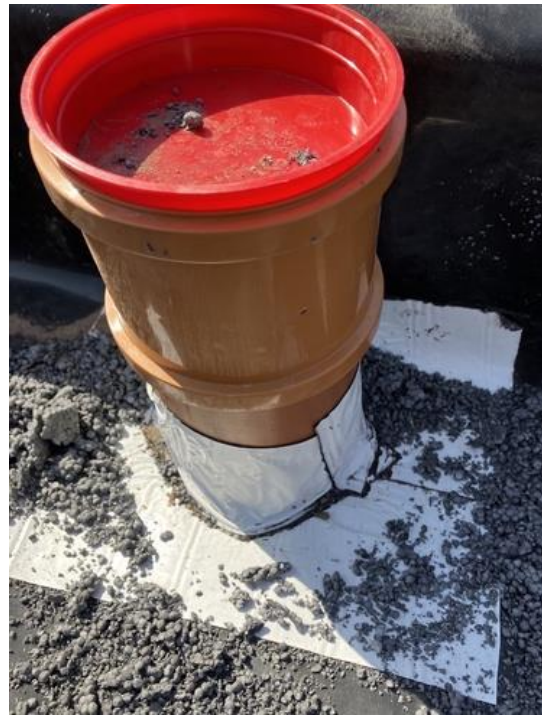
| <b>Service entries seals: Top hats seal arrangements fixed around service entries? Use of Jubilee clips or Bitumastic Sealant</b> | Pass |

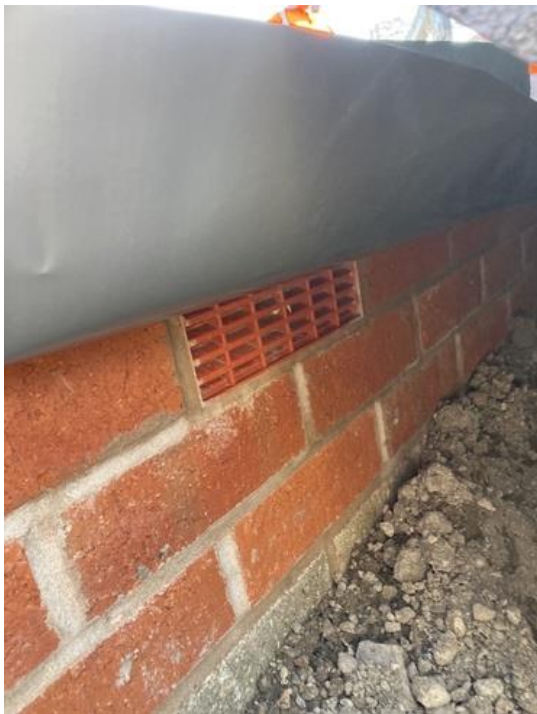
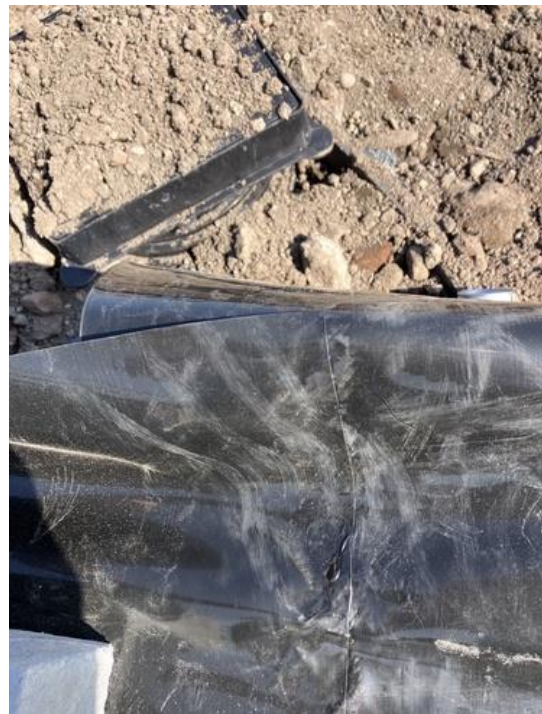
Photo 32

Pass

Only on 2 sides

Pass

Yes

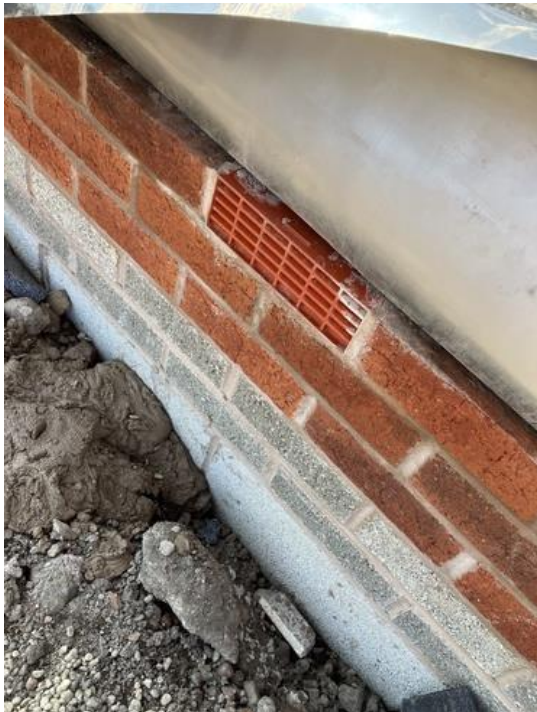
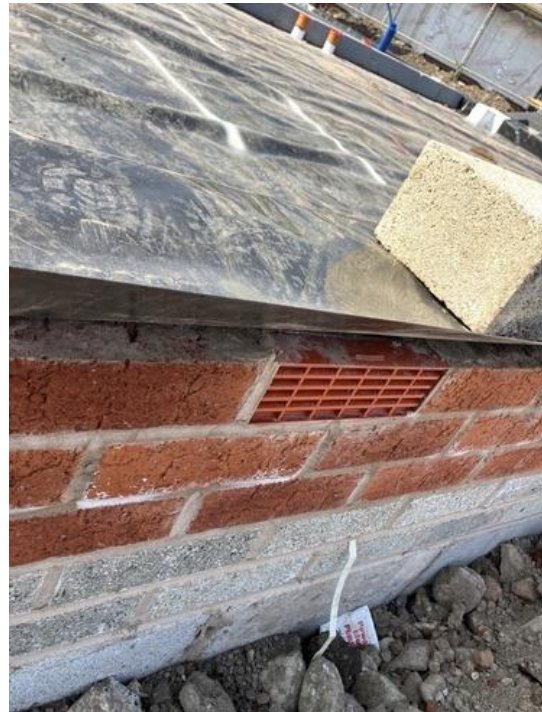
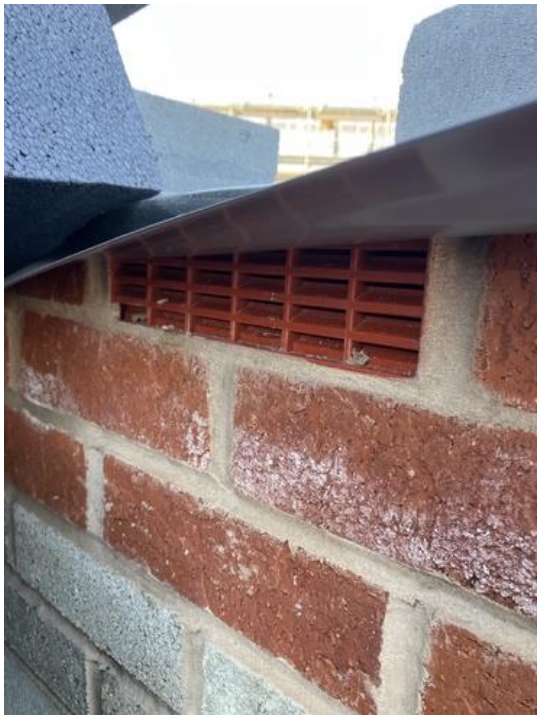
Pass

Only on 2 sides

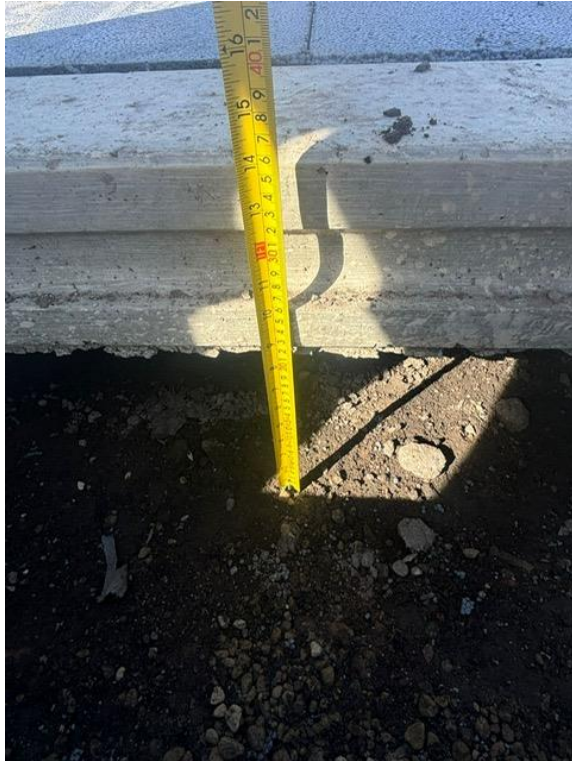
Plot 117

As per the Build Phase Contamination Risk Mitigation Strategy (report ref: 15-974-R5), sub-floor voids require inspection and validation at 50% ratio of substructures completed. E3P undertook subfloor void inspections for adjacent Plots 117-118 on the 3<sup>rd</sup> September, inspections confirmed there was a minimum void space of 150 mm for each plot. Validation photographs included within this letter.
