## GAS MEMBRANE VALIDATION – BENNETT STREET

| Project Name: Bennett Street |
| Project Number: 15-974 |
| Plots: 16 & 17 |

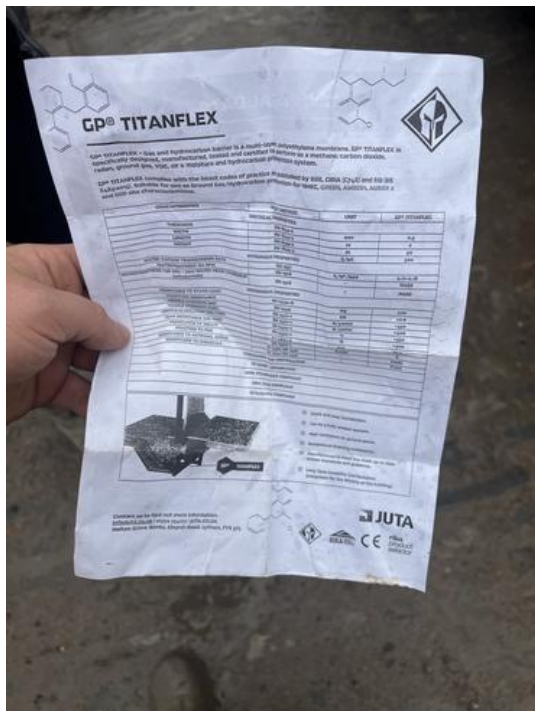
Photo 1

Gas Membrane Type: Manufacturer, gauge, and colour. See photo

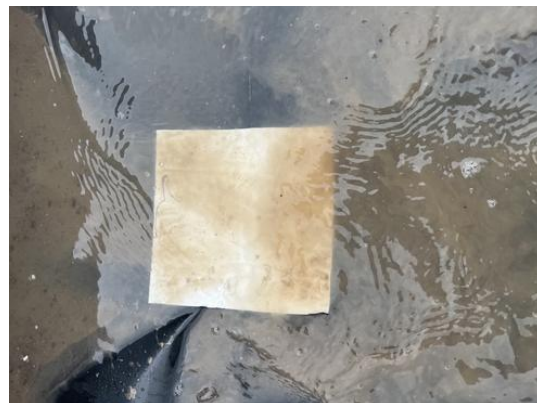
Photo 2

Gas Membrane Condition: Open punctures, tears, rips, stretching, Presence of debris, Repairs, Signs of weakness such as raised or sunken indentations, Protection plan in place to restrict access to lain gas membrane? IF FAIL DESCRIPTION IN ACTIONS AND PHOTOS REQUIRED

Pass

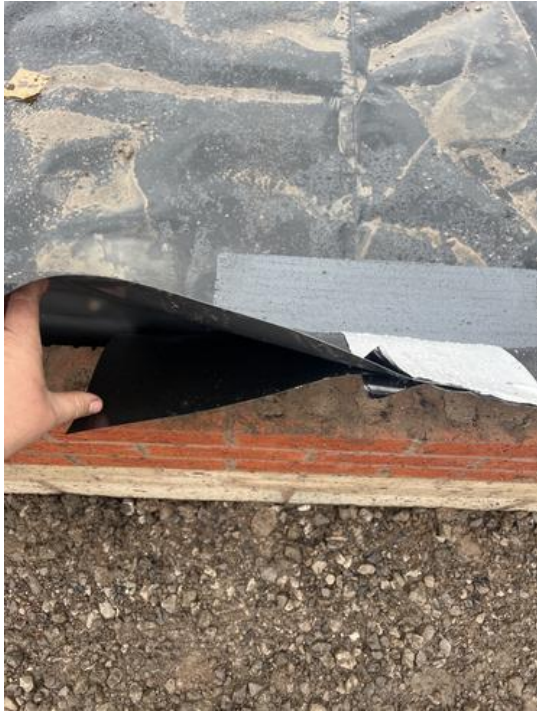
Photo 9

Laps, welds, and joints seals: Joints lapped and sealed in accordance with manufacturer's requirements/ specification? Minimum overlap insured? Sections taped twice? Are welds complete? Appropriate joining/double-sided tape used, Folds running in line with joints? (no joints cutting across folds)

Pass

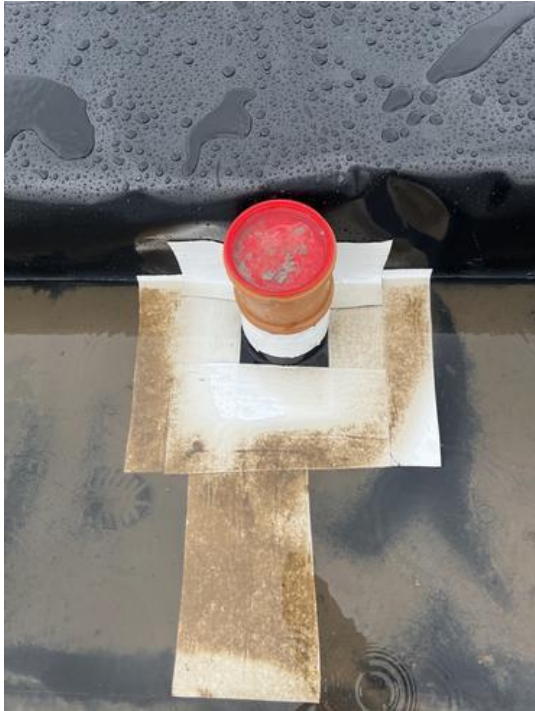
Photo 13

Service entries seals: Top hats seal arrangements fixed around service entries? Use of Jubilee clips?

Yes

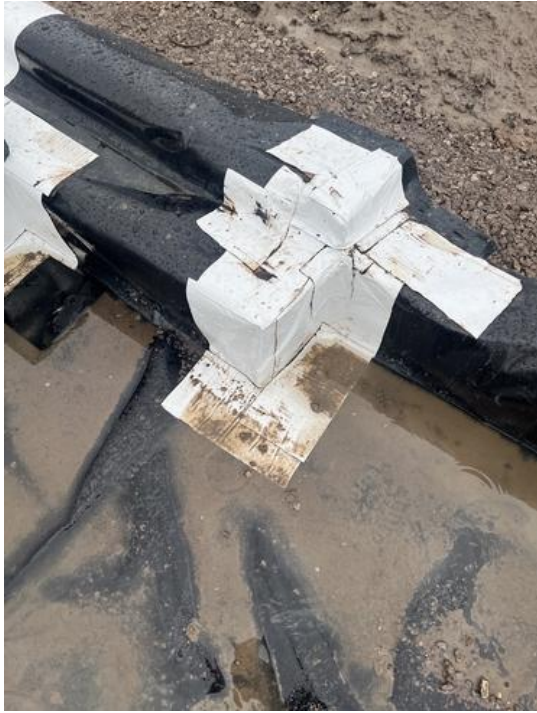
Photo 17

Corners / Internal joints: Check all corners are correctly formed or contractor has used preformed corners.

Pass

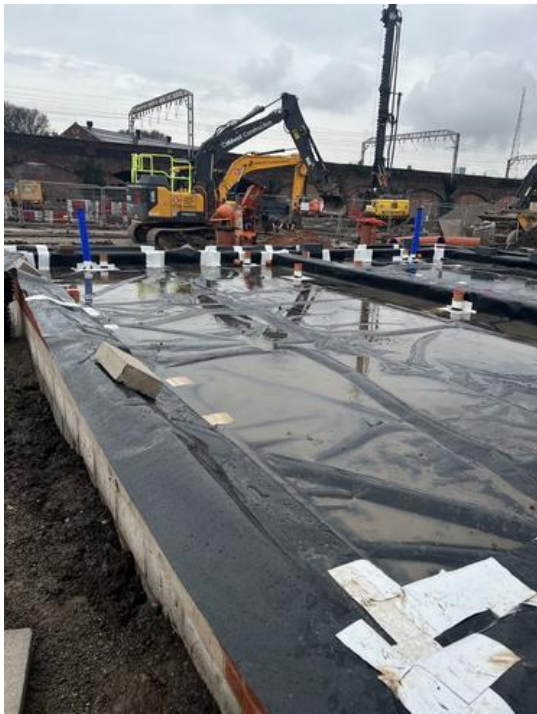
Photo 25

Extent of Coverage: Is the membrane covering the entire plot? Does membrane span over outside walls?

Yes

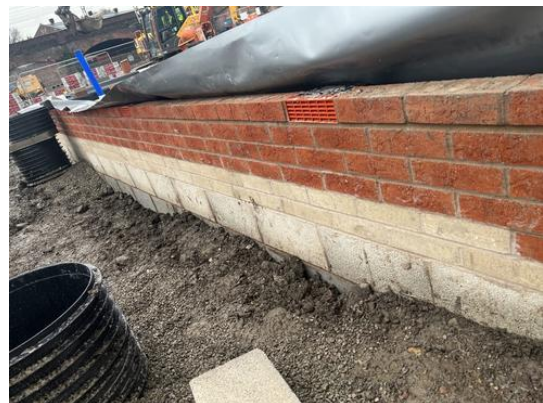
Photo 28

External Wall Air bricks: Numbers, size. positions as design drawing? (Minimum of 3 walls)

Pass

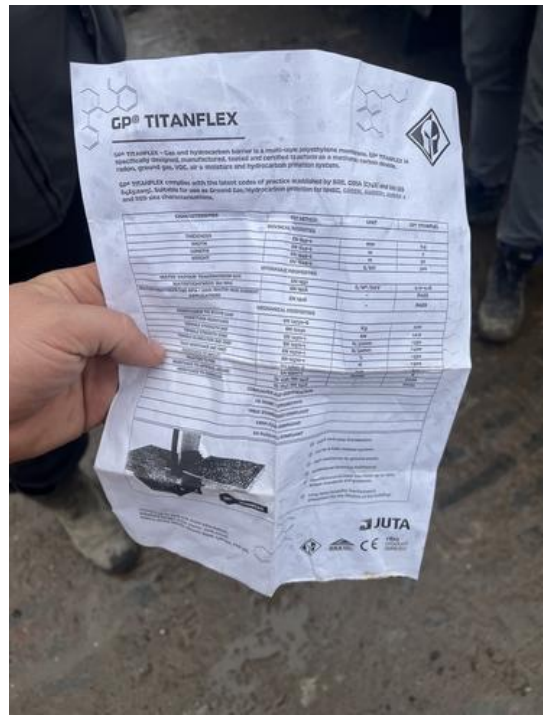
Photo 32

Gas Membrane Type: Manufacturer, gauge, and colour. See photo

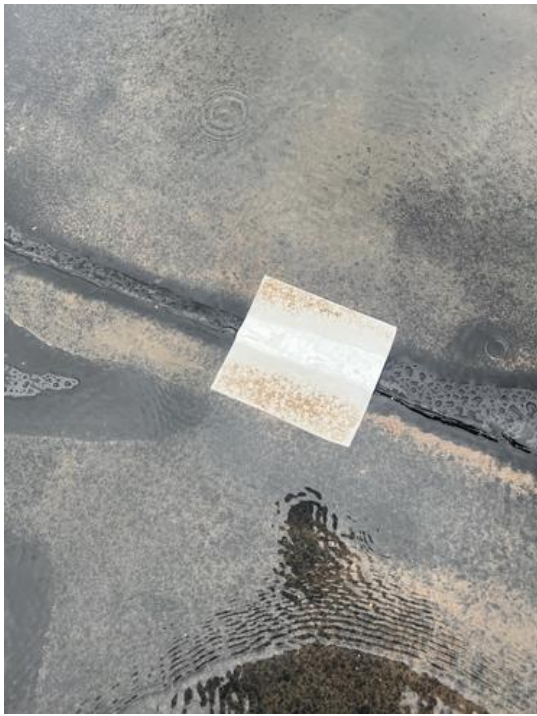
Photo 33

Gas Membrane Condition: Open punctures, tears, rips, stretching, Presence of debris, Repairs, Signs of weakness such as raised or sunken indentations, Protection plan in place to restrict access to lain gas membrane? IF FAIL DESCRIPTION IN ACTIONS AND PHOTOS REQUIRED

Pass

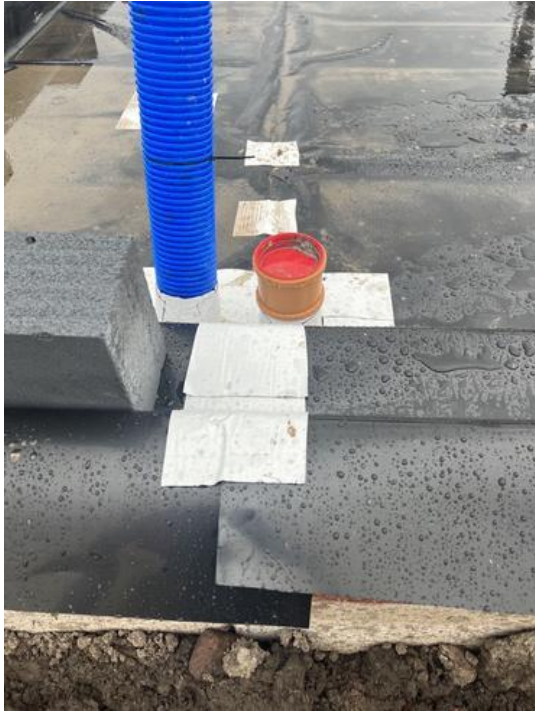
Photo 37

Laps, welds, and joints seals: Joints lapped and sealed in accordance with manufacturer's requirements/ specification? Minimum overlap insured? Sections taped twice? Are welds complete? Appropriate joining/double-sided tape used, Folds running in line with joints? (no joints cutting across folds)

Pass

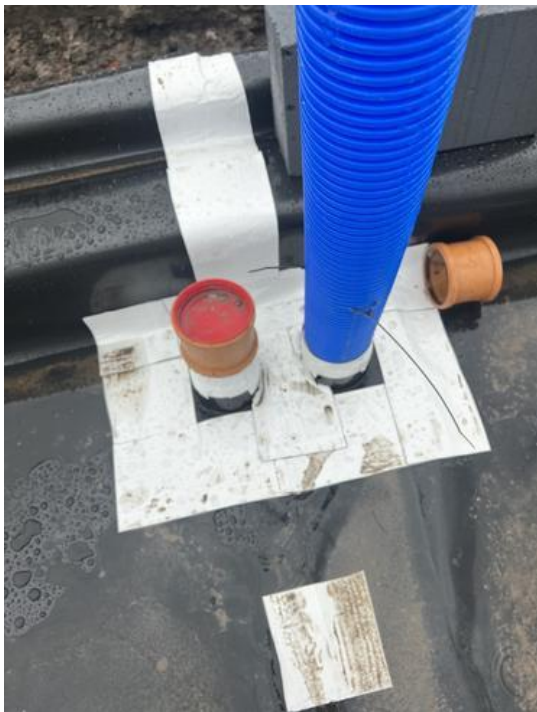
Photo 43

Service entries seals: Top hats seal arrangements fixed around service entries? Use of Jubilee clips?

Yes

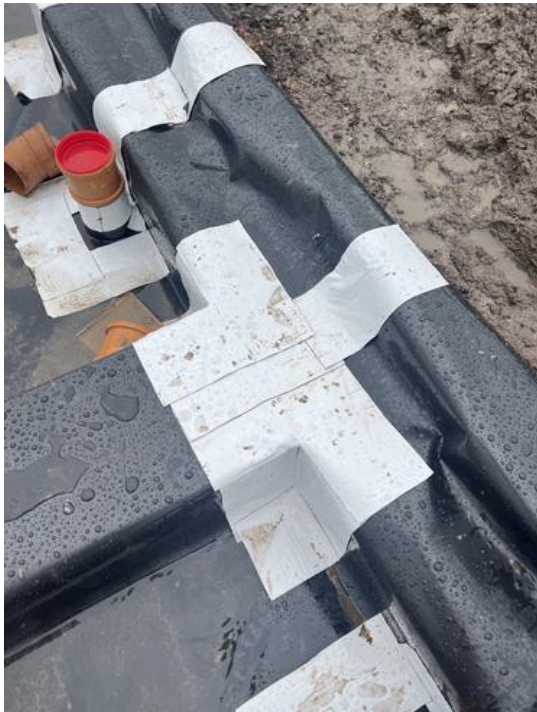
Photo 47

Corners / Internal joints: Check all corners are correctly formed or contractor has used preformed corners.

Pass

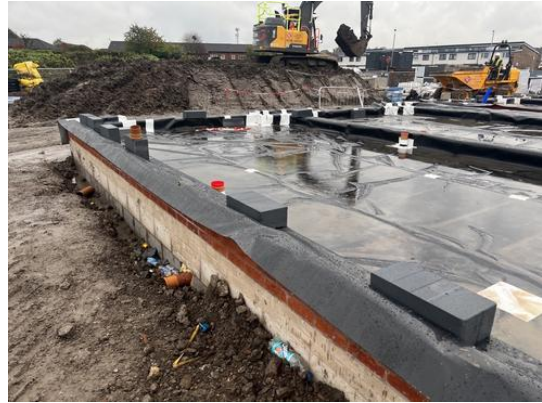
Photo 54

Extent of Coverage: Is the membrane covering the entire plot? Does membrane span over outside walls?

Yes

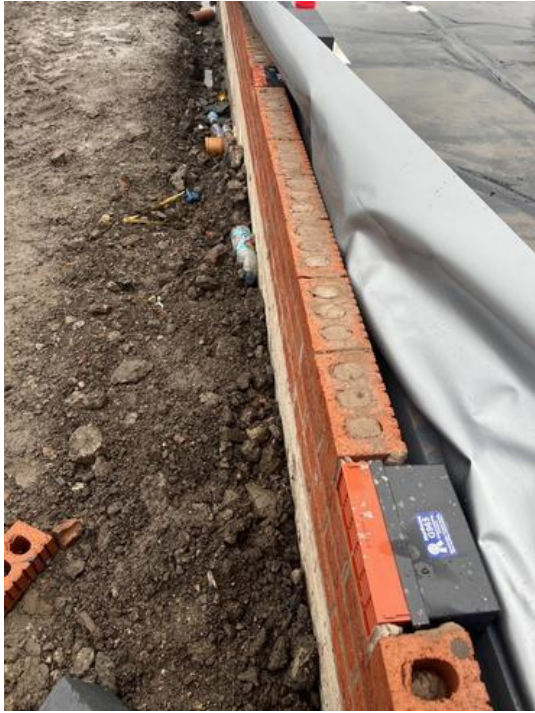
Photo 57

External Wall Air bricks: Numbers, size. positions as design drawing? (Minimum of 3 walls)

Pass

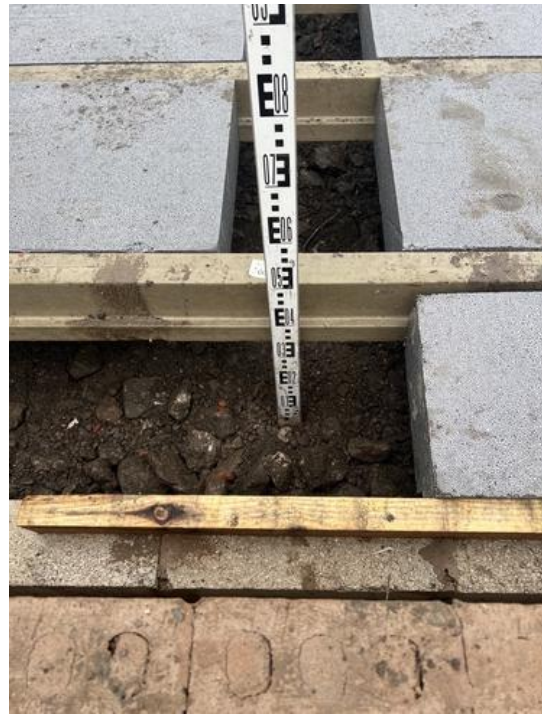
Photo 62

As per the Build Phase Contamination Risk Mitigation Strategy (report ref: 15-974-R5), sub-floor voids require inspection and validation at 50% ratio of substructures completed. E3P undertook subfloor void inspections during the visit on Plots 18 and 19, inspections confirmed there was a minimum void space of 150 mm for each plot. Validation photographs included within this letter.

Sub-floor Void: Is a check possible on future plots (insert Plot number or NO in text box)

18/19
